Church Farm, Thornington, Suffolk

Archaeological Record

**Church Farm,
Thorington Road, Thorington,
Suffolk**

An Archaeological Record

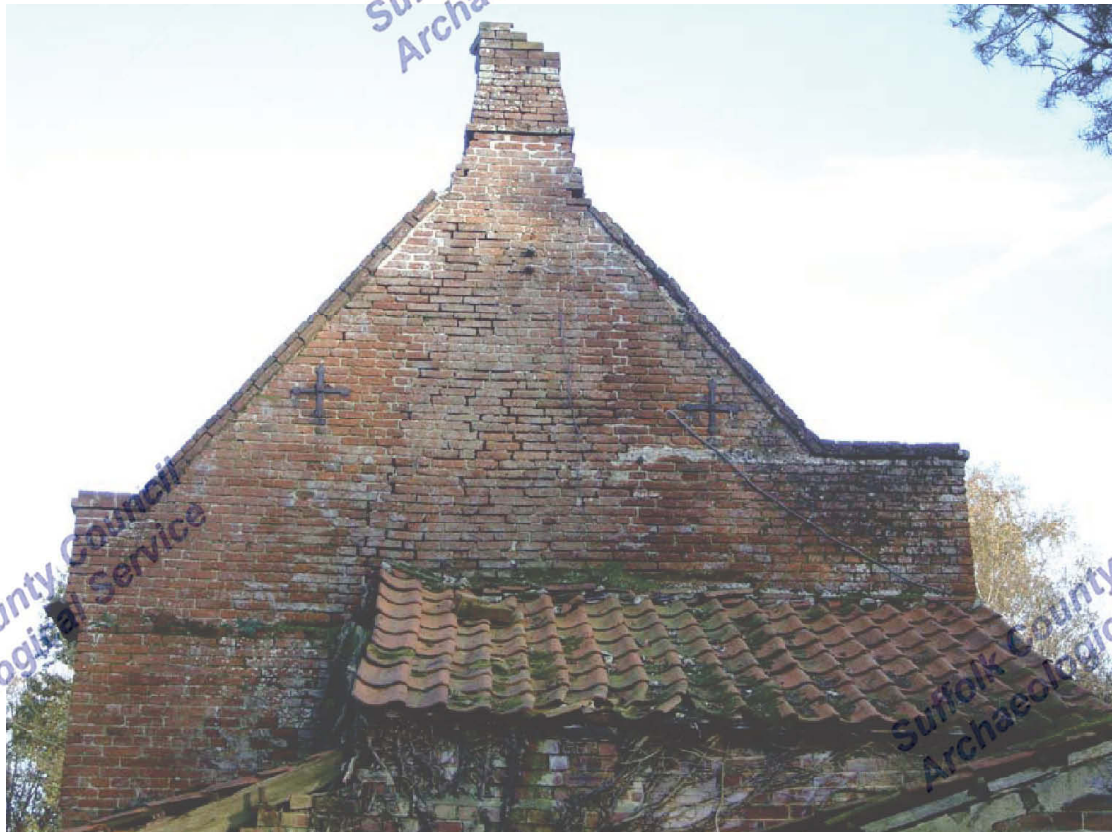
A2.3 Bakehouse. Southern external elevation with secondary brick façade showing central cross-entry with brick gable and integral chimney to left

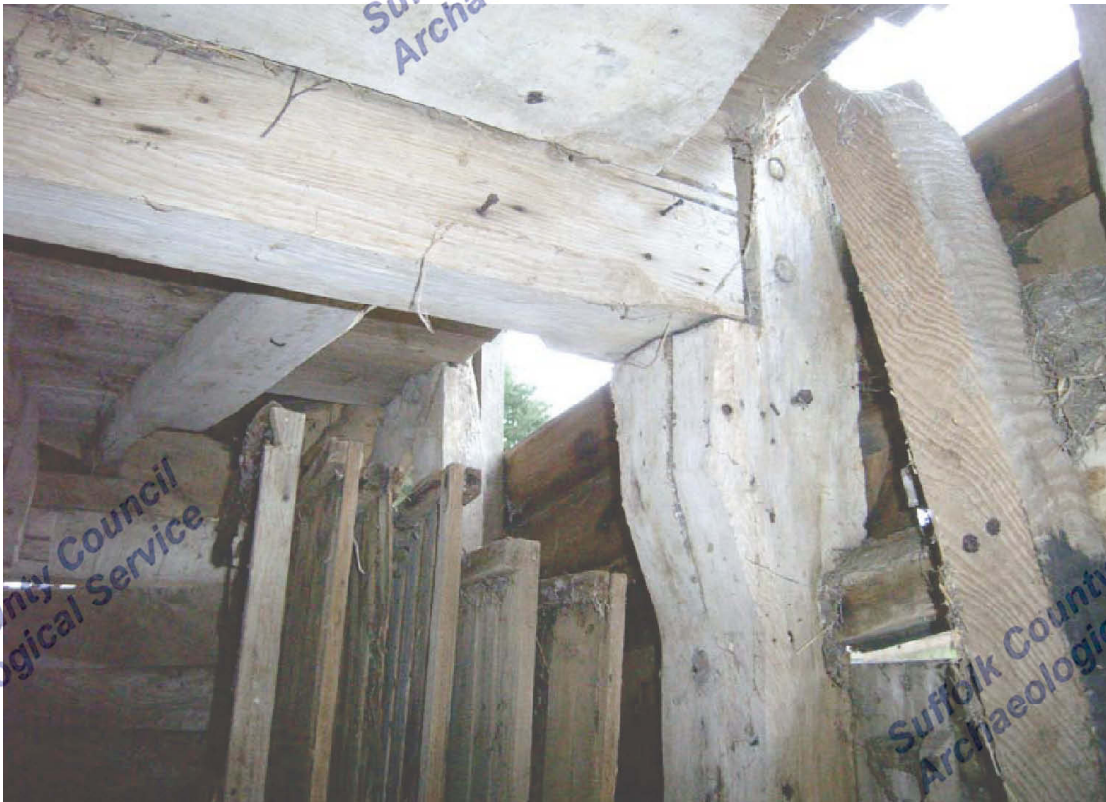
A2.17 Barn. Western internal elevation of stable loft showing original framed loading aperture to right
