HISTORIC BUILDING RECORD

SUBMARINE MINING ESTABLISHMENT PIER LANDGILADD FORT **FELIXSTOWE**

(HER Ref. FEX 064)

SCCAS REPORT No. 2009/001

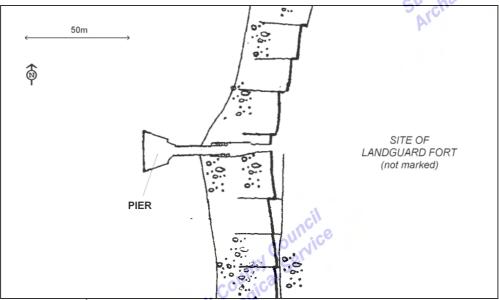
Figure 3: 2nd Edition Ordnance Survey 1:2500 scale sheet (rescaled extract)

The pier is marked on the 1st, 2nd and 3rd edition Ordnance Survey 1:2500 scale sheets (see figure 3 for an extract of the 2nd edition OS sheet). No detail is shown other than what is probably two flights of steps running down from east to west, one on either side of the pier about half-way down its length. Neither the fort nor any of the associated gun batteries are marked. These have been deliberately left off the maps for security reasons. This is also presumably why there are no details shown of features on the pier itself.

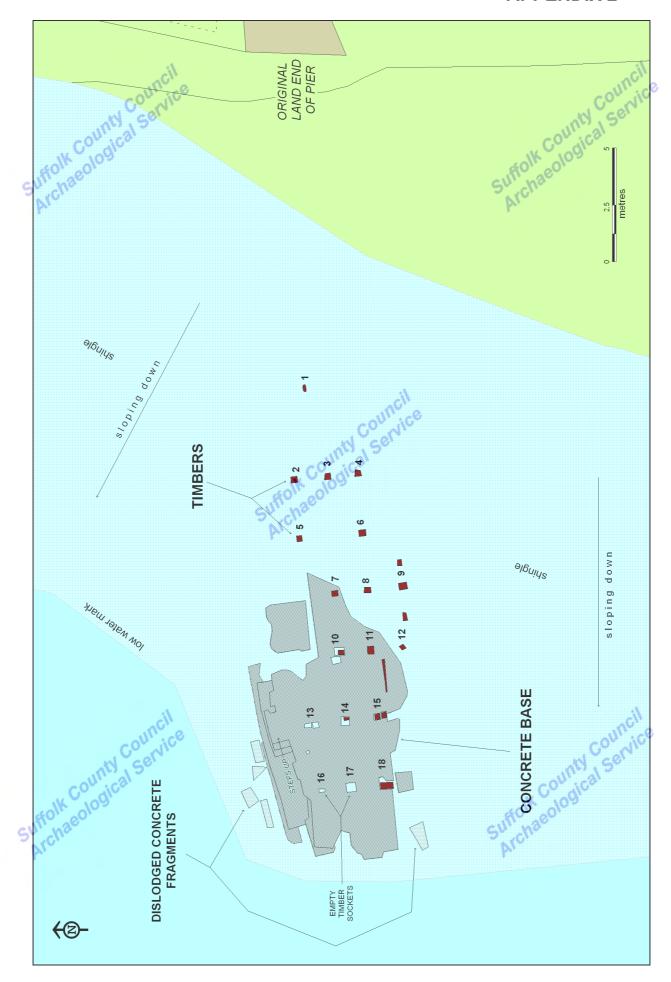
APPENDIX 2

The results of the measured GPS survey of the pier remains have been processed and are presented below. Figure 4 consists of the surface plan whilst figure 5 comprises a West to East profile.

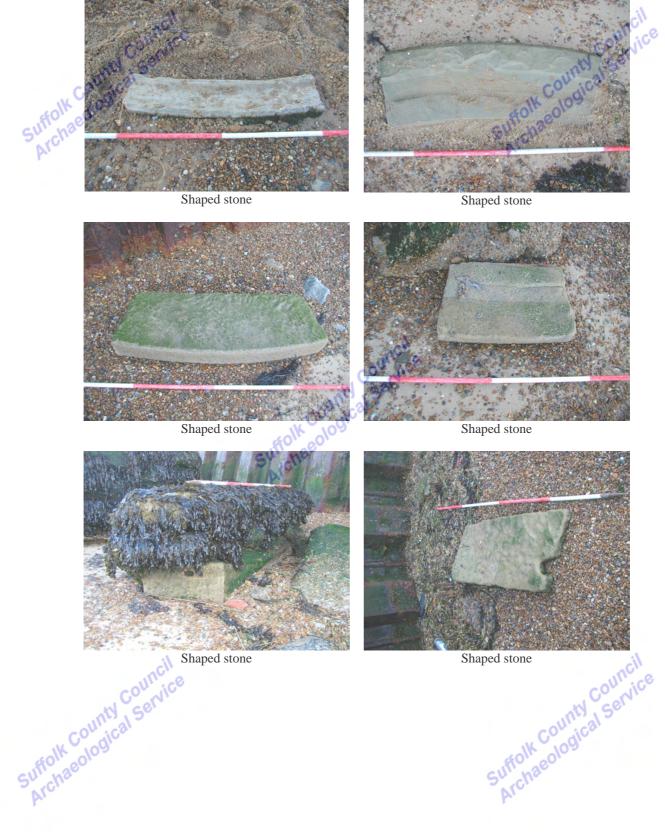
Shaped stone blocks on foreshore
