**White Wheat Farm,
Baylham,
Suffolk**

Archaeological Record

**White Wheat Farm,
Upper Street,
Baylham, Suffolk**

An Archaeological Record

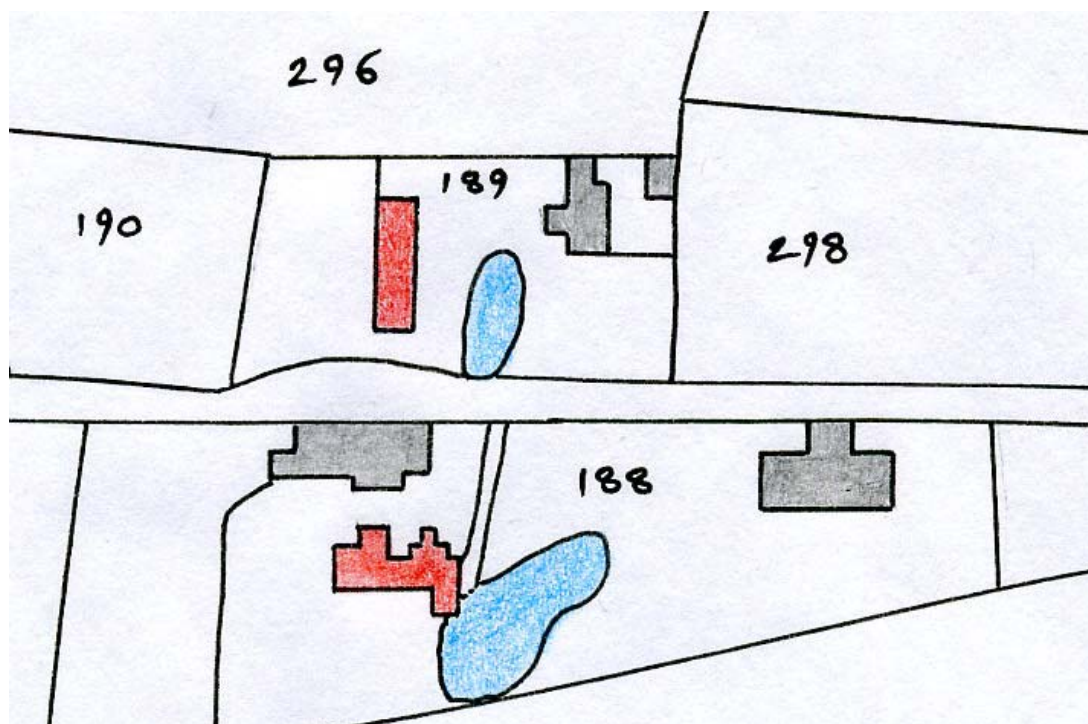
Figure 1

Baylham Tithe Map of 1840, showing White Wheat Farm to north of Upper Street (no.189) and Hill Farm to south (no.188). The present barn is recognisable with its porch facing the farmhouse to the west (no. 1 in figure 5 below). Another structure adjoins its northern gable and frames an eastern yard with another small building in its north-eastern corner – possibly a stable, stable yard and shelter shed.

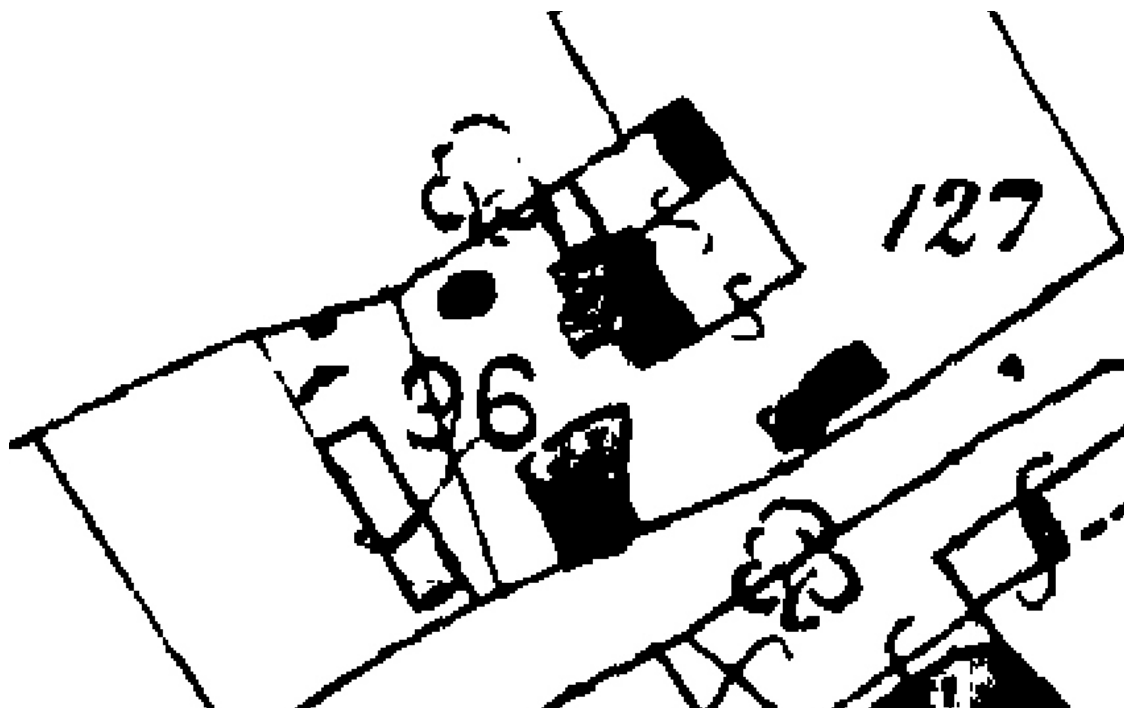
Figure 2
 First Edition 25 inch Ordnance Survey of 1884 showing the barn and attached yard unaltered since 1840, but with the addition of a new cartlodge to the south (6 & 7).

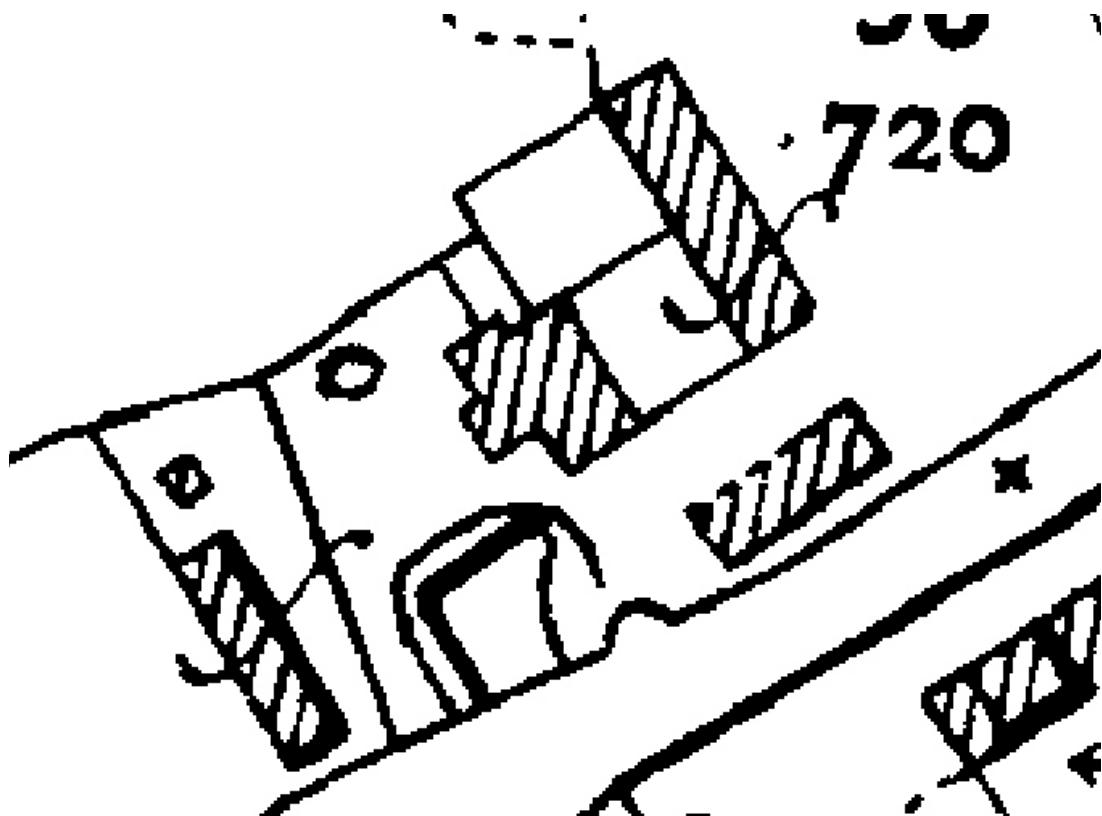
Figure 3
 Second Edition 25 inch Ordnance Survey of 1905 showing the addition of the present range of cattle loose boxes (4) the east of the yard. The shed or stable which adjoined the barn's northern gable in 1840 is now shown only as an empty yard

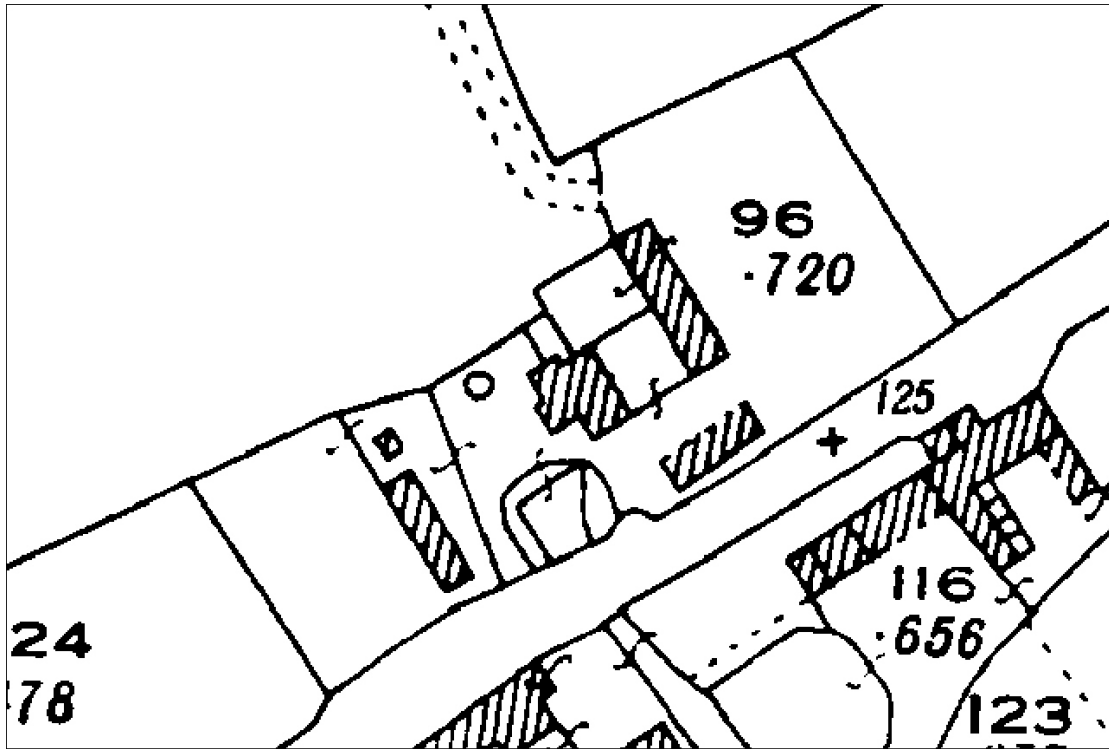
Figure 4
Third Edition 25 inch Ordnance Survey of 1926 showing no change since 1905.

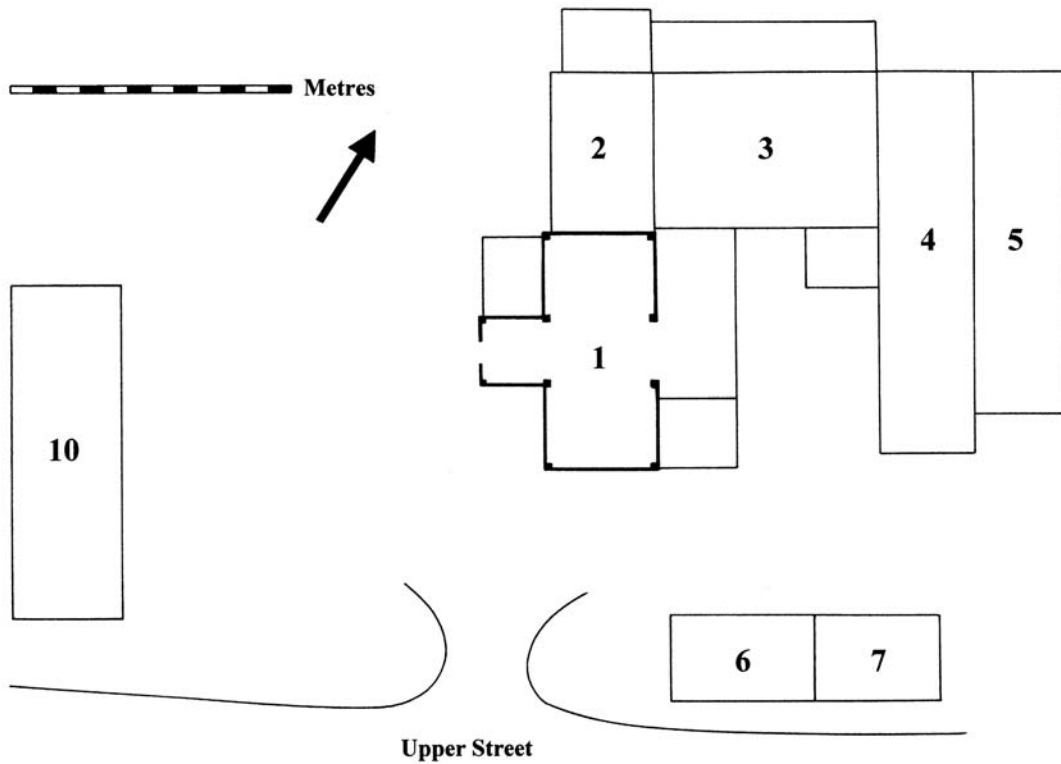
Figure 5
Schematic Block Plan of Farm Complex
Showing the timber buildings discussed in the text and illustrated in the Appendices.

1. An early-19th century three-bay timber-framed barn with original small porch to west of central bay and modified main entrance to east. Roof rebuilt. 20th century lean-to structures attached to eastern elevation.
2. A mid-20th century storage shed.
3. A mid-20th century covered cattle yard
4. An early-20th century cattle shed divided into loose boxes.
5. A mid-20th century open-sided vehicle and equipment shed
6. A late-19th century open-sided cart lodge (re-roofed)
7. A late-19th century open-sided cart lodge
10. Grade II-listed thatched and rendered farmhouse, described in the Schedule of Listed Buildings as a 15th or early-16th century sooted open hall with later alterations and extensions
