**Gissings Farm,  
South Green, Hoxne,  
Suffolk**

HXN 045

**Archaeological Record**

OASIS ID: suffolkc1-54017

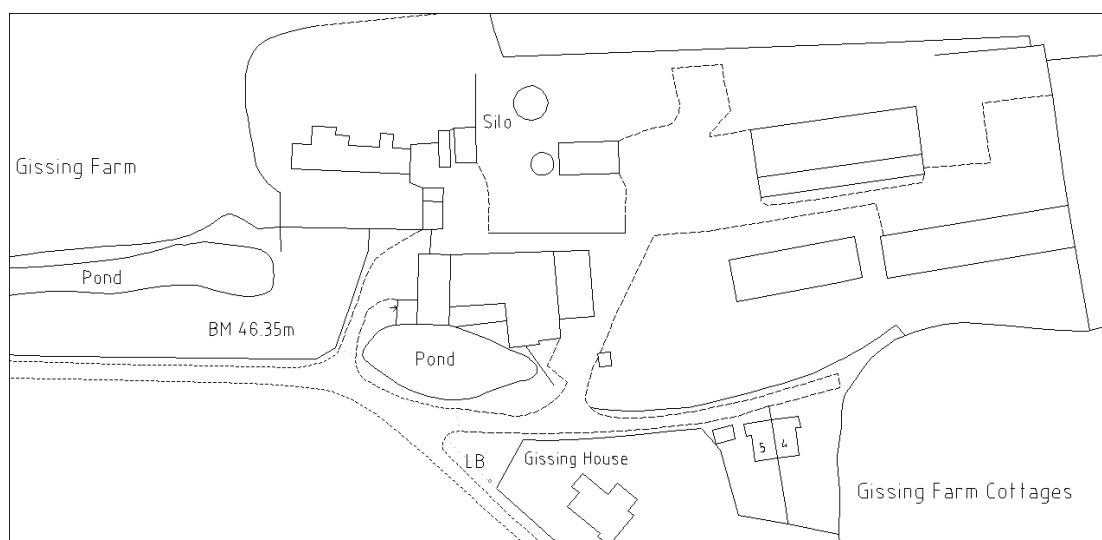
**Figure 1**  
**Existing site plan, showing historic farm buildings to north of central pond and farmhouse to north-west. The remaining farm buildings to the north and east date only from the mid- and late-20<sup>th</sup> century.**

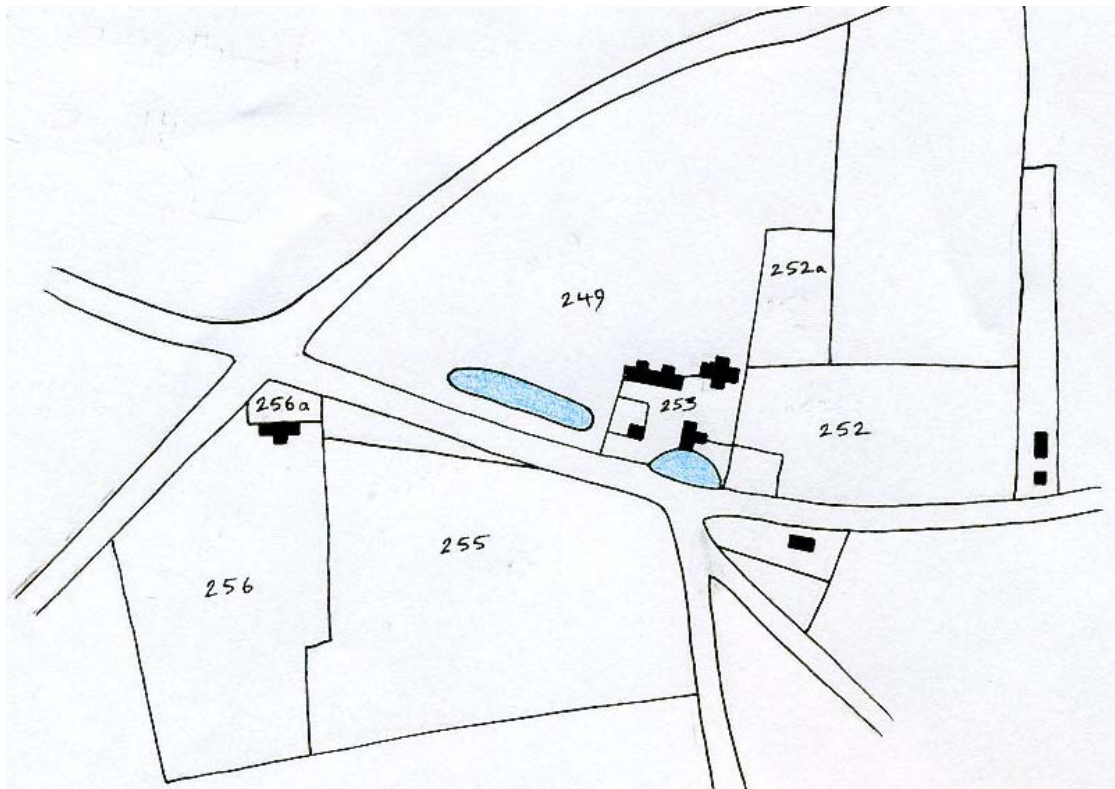
**Figure 2**

**Gissings Farm in 1842, redrawn from the Hoxne Tithe Map (SRO FDA 139/A1/1b)**

The barn (1) is clearly shown adjoining the northern bank of the roadside pond in front of the farmhouse with a porch projecting from the centre of its eastern elevation. There is structural evidence that the original barn doors opened in this direction instead of their present western orientation. The farm contained a second barn with a south-facing porch at the nearby crossroads to the west (256a), and two other yard buildings of which no trace now remains.

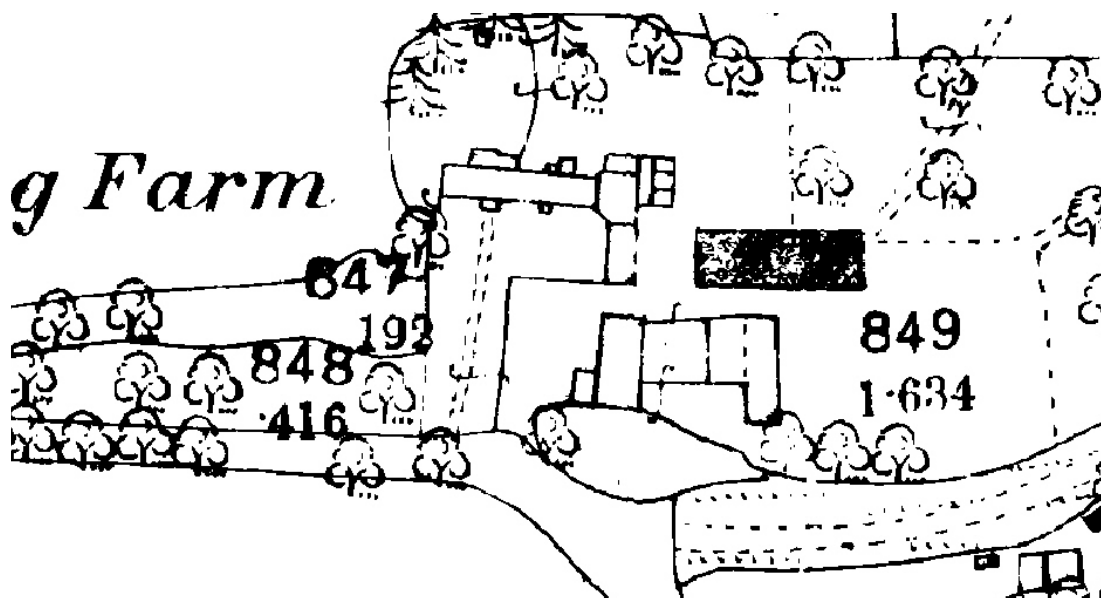
**Figure 3**

**First Edition 25 inch Ordnance Survey of 1885**

The Ordnance Survey of 1885 shows that significant changes had occurred since 1842. Only the farmhouse and barn (1) survived a major refurbishment which saw the removal of the

barn's eastern porch and the construction of two enclosed yards with an open-sided shelter (5 and 5a) to the east. A small shed (2) was built against the barn's western elevation, and a detached first-floor granary with ground-floor sheds open to the east (4) was erected to the north. The small enclosed yards to the east of the farmhouse were probably pig sties. The large rectangular building to the north-east may have been a second barn but does not survive. Similar alterations took place on many Suffolk farms during the 1850s and 1860s as arable farms responded to falling grain prices by diversifying into dairy and beef production, encouraged by new railroad access to urban markets. It is not clear, however, that the new yards at Gissings were designed for cattle rather than the seven to ten working horses that a farm of its scale would require.

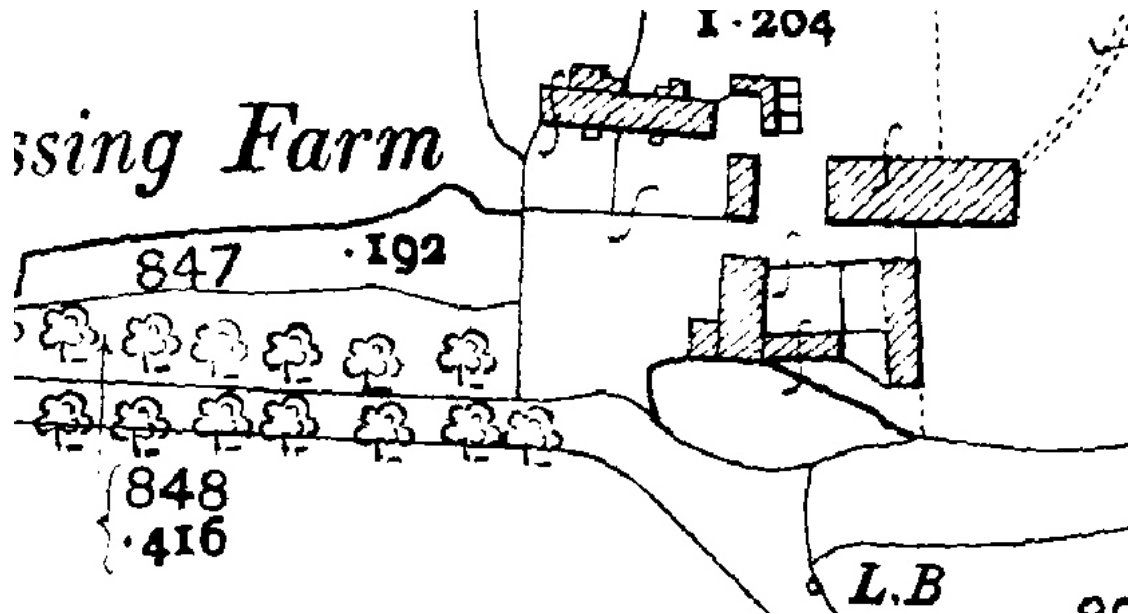
Figure 4  
Second Edition 25 inch Ordnance Survey of 1905

The Ordnance Survey of 1905 shows the new addition of the brick stable (3) to the south of the enclosed yard adjoining the barn, and a small brick extension to the southern gable of the brick and clay-lump shelter shed to the east (5b). The eastern elevation of the granary is no longer shown as open-sided (i.e. delineated by broken lines) and had presumably been enclosed by doors to form vehicle or equipment sheds. The situation remained unchanged in 1927 (figure 5 below).

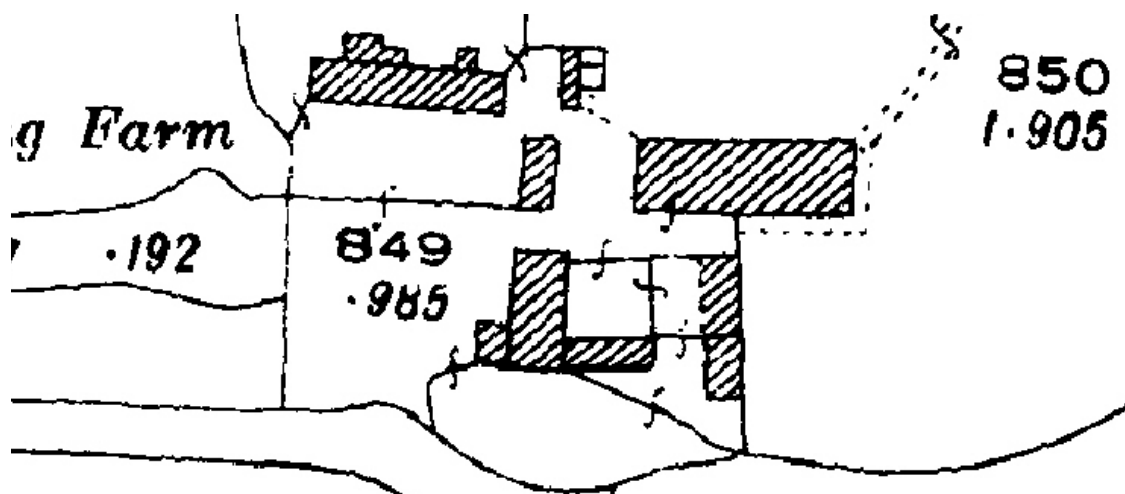
Figure 5  
Third Edition 25 inch Ordnance Survey of 1927

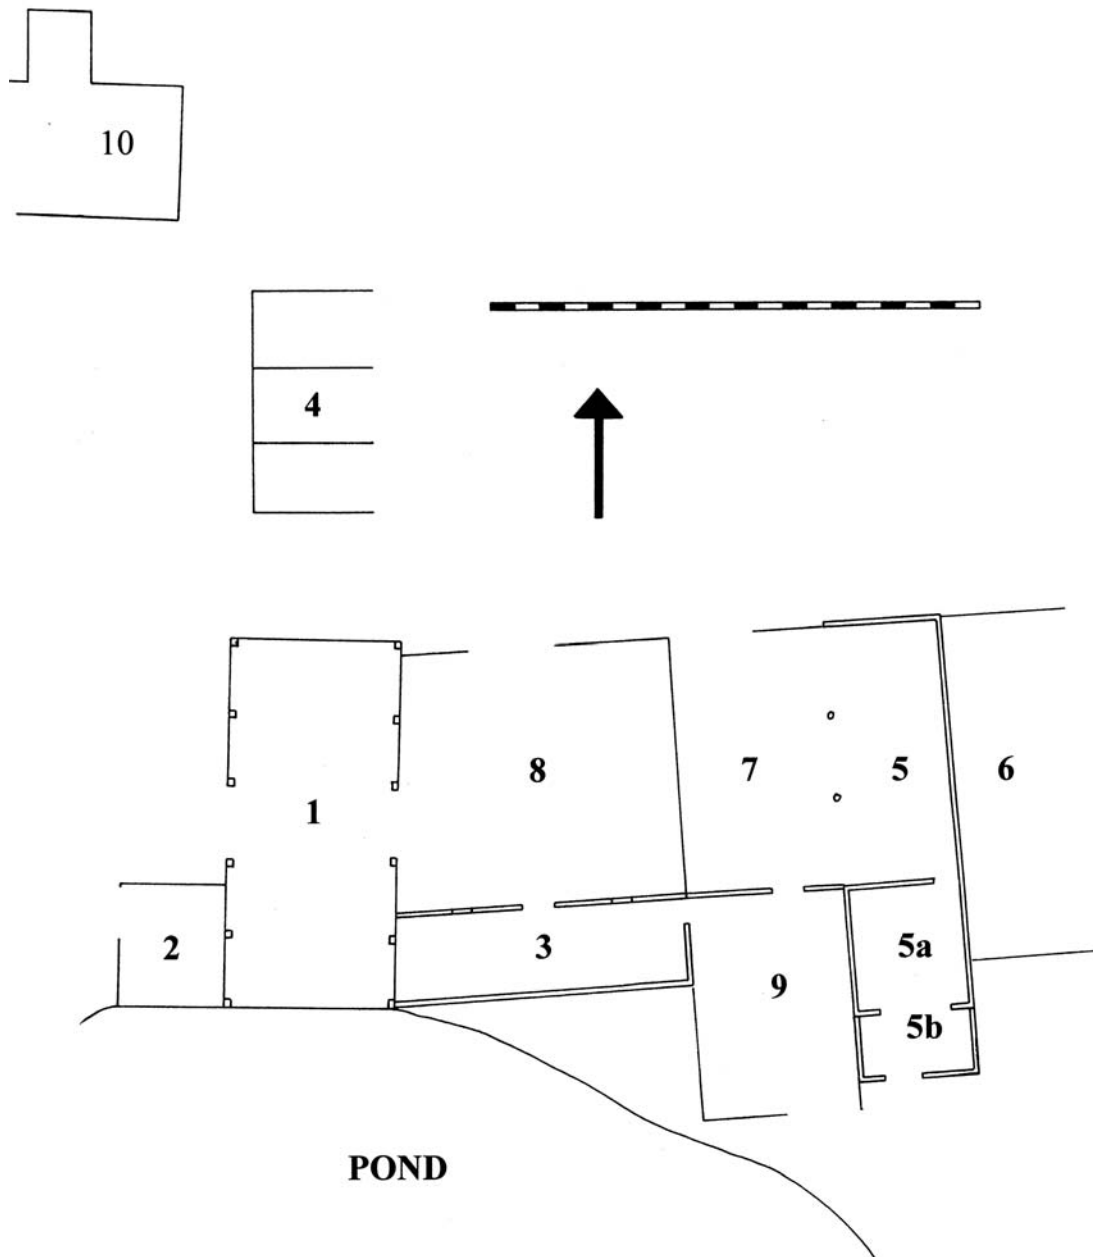
**Figure 6**  
**Schematic Block Plan of Farm Complex (Scale in metres)**  
Showing the various buildings and functional units discussed in the text and illustrated in the photographic record. The numbers follow those used in the architect's plans.
