Ringshall Free Church, Ringshall, Suffolk

Historic Building Record

Ringshall Free Church Lower Farm Road Ringshall, Suffolk

An Archaeological Record

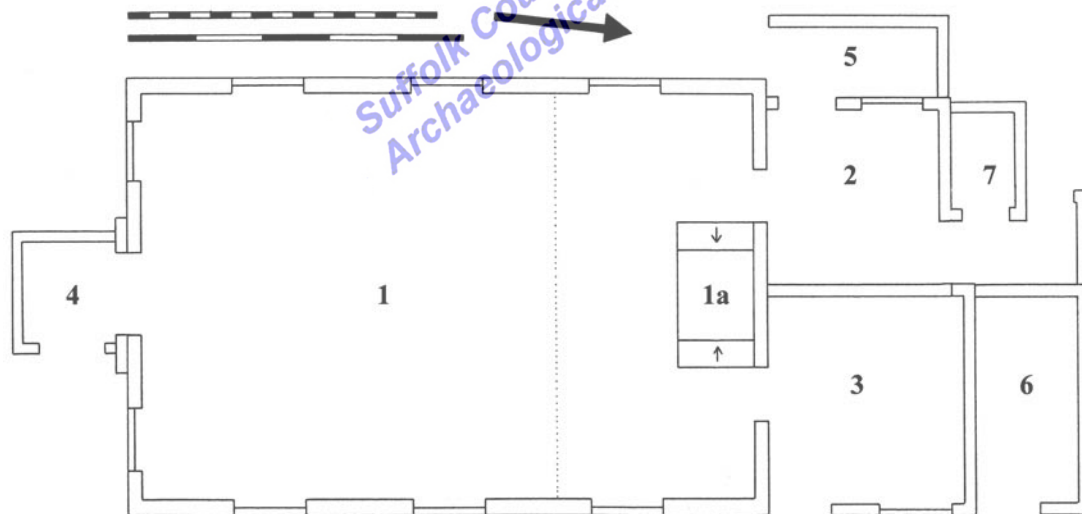
Figure 3

The 1886 Ordnance Survey shows a distinctively asymmetrical outline and includes the small room which was clearly built as a later extension to the original hall and is now fitted as a kitchen (area 2 in figure 3). The date of the hall's construction is narrowed by the absence of any reference to a Baptist chapel here in the Ecclesiastical Census of 1851 (Historical Atlas of Suffolk) and the 1855 edition of White's Directory, but its inclusion in Kelly's Directory of 1869 and subsequent editions of both Kelly's and White's (where it is described as 'small'). No Directories between 1855 and 1869 were available for consultation. The first reference to a Baptist baptism in Ringshall occurs in 1859 (Suffolk Record Office) and it is likely that the present hall was erected in this year or shortly afterwards. There are no obvious records of burials in Ringshall, but 19th century Baptist burial grounds were private, often short-lived, and can be difficult to trace in the documentary record. Most members of the Ringshall Baptist congregation appear to have been interned in the Needham Market burial ground, but it is possible that the small area between Lower Road and the entrance in the chapel's southern gable (as shown in figure 2a) was designed for burials and may contain the remains of its founding members and first ministers. The grounds of the chapel were considerably enlarged in the 20th century to create the present parking area and a large tract of lawn to the rear, but in the absence of documentary records (which would be more likely to exist at this later date) it is improbable that burial occurred here. A note in the baptism registers at the Suffolk Record Office suggests that the Baptist chapel became a free church (gaining greater autonomy over its management) in or shortly before 1951, and an elderly resident of the area recalled its closure in (or about) 2006.

Schematic Block Plan of Church (Scale in feet (top) and metres)

The original structure, shown as area 1 in figure 3, consists of uniform red brickwork in Flemish bond and extends to 6.4 m in overall width by 9.5 m in length (21 ft by 31). Aligned approximately north-south it formed a single hall rising to 3.4 metres (11 ft) at its eaves beneath a low-pitched slate roof. The building was arranged symmetrically, containing three tall windows in each side elevation and two narrower windows flanking an original entrance in the centre of its southern gable. This entrance was approached from the road through a small yard of approximately 10 metres by 10, but the grounds have since been enlarged considerably to the east and north as shown in figures 1 and 2. The window apertures lie beneath segmental arches and almost certainly contained vertical sashes, but now possess modern PVC replacements.

A small additional room was built as a lean-to at the western end of the northern gable before the Ordnance Survey of 1886 (on which it appears). This is now fitted as a late-20th century kitchen but retains its original sash window, external door frame and moulded wainscot rail. Its window contains two panes in each sash and the upper sash lacks horns (i.e. the downward corner projections normally found on such windows during the final quarter of the 19th century and later, but not before). The brickwork is neither keyed into nor aligned with the main hall and is evidently an extension, but appears to have been a very recent afterthought which presumably served as a vestry with its own external entrance.

A number of brick extensions of no architectural merit were added to the northern gable at different periods during the 20th century and now lie beneath a uniform roof of corrugated tin. A new room of 11 feet in length (no.3 in figure 3) was added to the north-eastern corner created by the 19th century extension (2), thereby unifying the chapel's outline. This probably occurred in the 1920s or 30s, to judge by its internal entrance door, but its window and external door have been replaced. The room contained an organ at the time of inspection and may have served as a crèche or Sunday school room. Mid and late-20th century additions formed an external shed, side porch and WC. The addition of the porch to the southern gable
