# Brick Kiln Farm, Sibton, Suffolk

## Historic Building Record

**Farm Buildings at  
Brick Kiln Farm,  
Rendham Road,  
Sibton, Suffolk**

**An Archaeological Record**

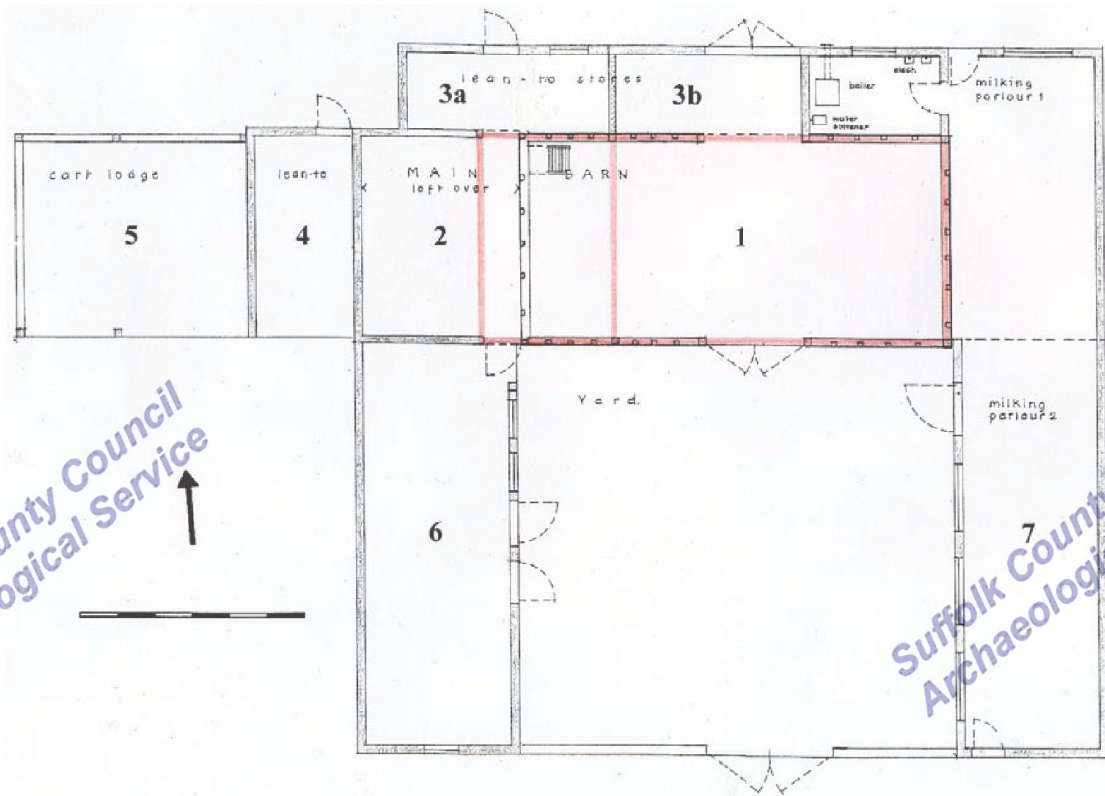
Figure 6

As Existing Ground plan of Historic Buildings

2. Mid-19<sup>th</sup> century brick stable and hay loft, built as an extension to the 17<sup>th</sup> century stable and retaining its entrance passage; the rest of the earlier stable was incorporated into the barn at the same time. Now with replacement early-20<sup>th</sup> century hay rack and manger to western gable (lowered for cattle). Horses stalled to west. Hay loft with loading door to south and ceiling vent above rack. The wall fabric incorporates brick wasters that probably relate to the contemporary kiln on the site.

7. Mid-19<sup>th</sup> century single-storied brick shed with western yard elevation rebuilt in 20<sup>th</sup> century brick. Now containing mid-20<sup>th</sup> century iron cattle stalls, trough and hay rack having apparently operated as a milking parlour. Probably designed as a cow shed with loose boxes to the south.

Building 1 in figure 6 (as outlined in red) is a timber-framed structure of four bays on an east-west axis which extends to 12.5 m in overall length and 5.7 m in width (41 ft by 18 ft 9 ins). The roof-plates lie 3.6 m (12 ft) above the ground, with uninterrupted studs of 2.9 m (116 ins) in height between the plates and sills, but the latter are not original and rest on brick plinths of 75 cm (30 ins) as the entire building was raised by between 30 and 45 cm (12-18 ins) in the mid-19<sup>th</sup> century. Timber-framed structures were often lifted by increasing the height of their plinths in this way. The building is framed in the medieval tradition with internally trenched braces rising from all four corner posts to both the roof-plates and gable tie-beams; the studs, which average 14 cm by 9 cm (5.5 ins by 3.5), are pegged and tenoned to the plates and are not interrupted by mid-rails.
