**Barn at Wenham Hill,
Great Wenham,
Suffolk
WMM 008**

Archaeological Record

**Barn at Wenham Hill
(Formerly Wenhamhill Farm),
Wenham Lane,
Great Wenham, Suffolk**

An Archaeological Record

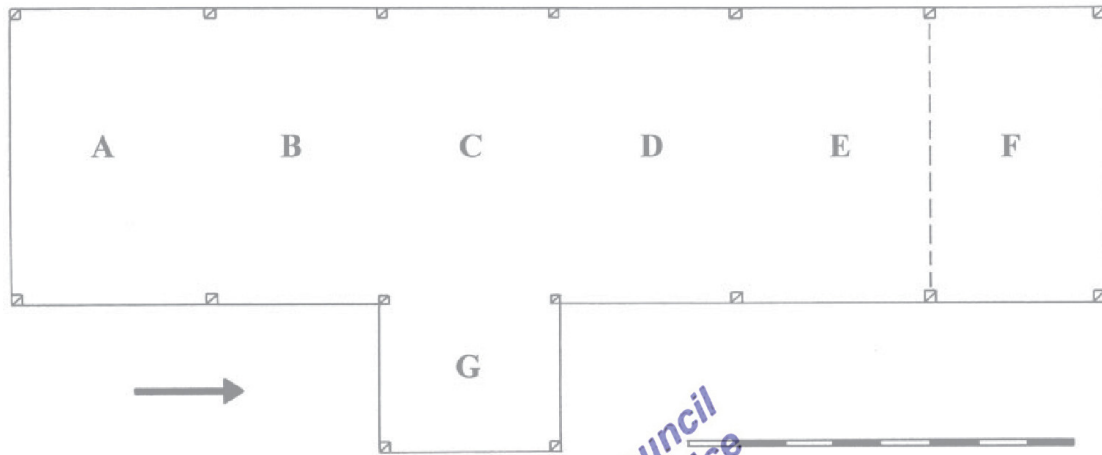
Figure 6

Ground plan of the barn numbering its various bays for ease of reference in the text and photographic record. Scale in metres. The northern bay (F) was originally partitioned from the body of the barn, as indicated by broken lines, and presumably formed a stable, but the position of its entrance is unclear
