DUNWICH GREYFRIARS: DUN 092 & 094 **Archaeological Recording Works Associated with the** **Rebuilding of a Section of the Precinct Wall and** **Repairs to the Gateways and Refectory**

SCCAS Report No. 2008/52; Oasis No. suffolkc1-57321

Stuart Boulter & Linzi Everett
Field Team
Suffolk C.C. Archaeological Service

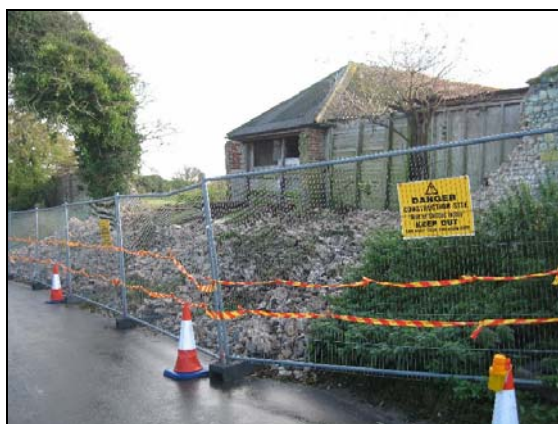
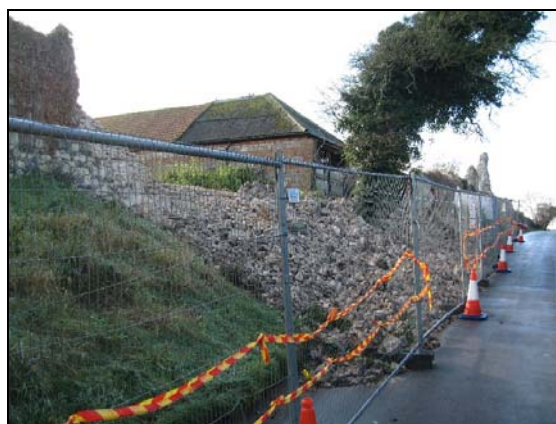
An initial assessment of the fallen material (Plates 1 & 2) was undertaken by SCCASFPT in January 2008 (Boulter 2008a), during which the following details were noted.

In the vicinity of the collapse, the precinct wall stood to a height of c.2.20 metres above the extant ground surface. An examination of the truncated ends of the standing structure revealed that the thickness of the wall varied between 0.5 metres at its highest point, increasing to c.0.75 metres at its base (Plate 3). The reduction in wall thickness was accommodated wholly on its internal face, as the external face was essentially vertical. The basal measurement included a 0.05 metre wide, 0.20 metres high (two-three courses of clasts) toe on the internal face of the wall (Plate 4). It was not possible to deduce whether a similar toe was present on the external face. However, it was clear that only the basal 0.2 metres of the wall, effectively up to the top of the toe, had been below ground on the internal side of the wall. The base of the wall was flat with a thin layer of lime mortar as the lowest component (Plate 4). A mix of sand and gravel could be seen to adhering to the base of the wall, a material not present at that level immediately to the east or west of the wall. This material was identified as the upper layer of an incised trench footing similar to that recorded in a trench excavated by SCCASFPT in 1992 across the line of the precinct wall c.30 metres to the north (DUN 016).

Plate 1 Collapsed wall section

Plate 2 Collapsed wall section

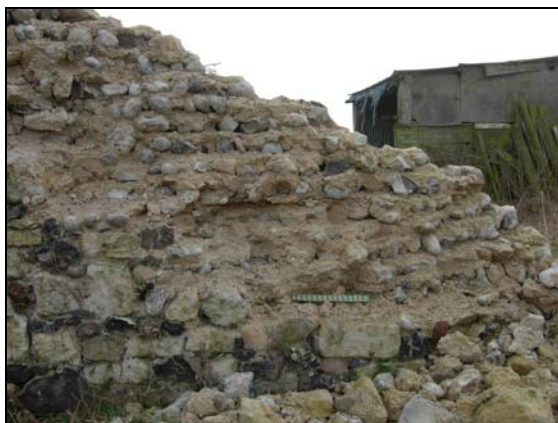
(mostly c.0.10 metres in diameter) set in a coarse, light coloured lime mortar with very frequent inclusions of beach gravel (Plate 5). The mortar was consistent throughout the fallen material and where visible, the wall courses were unbroken within the intact basal blocks and suggestive of one phase of construction. The wall face exhibited horizontal coursing with constructional lifts visible at approximately 0.5 metre intervals, one of which had acted as a line of weakness/fracture in the fallen material leaving a locally flat top/bottom to the surviving blocks.

Plate 5 Wall core

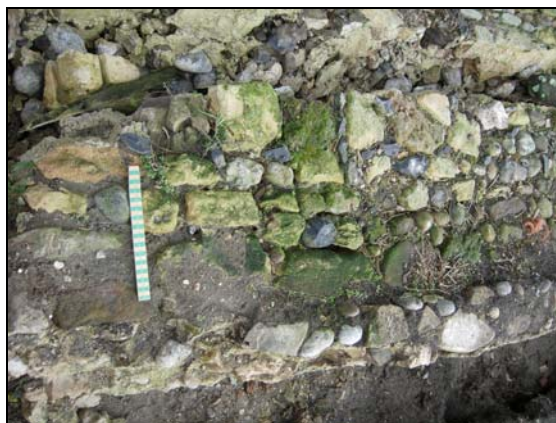
Similarly, the facing of the fallen wall (Plate 6) was consistent with that of the intact structure immediately to the north and south and comprised a wide range of materials including;

Plate 6 Wall face

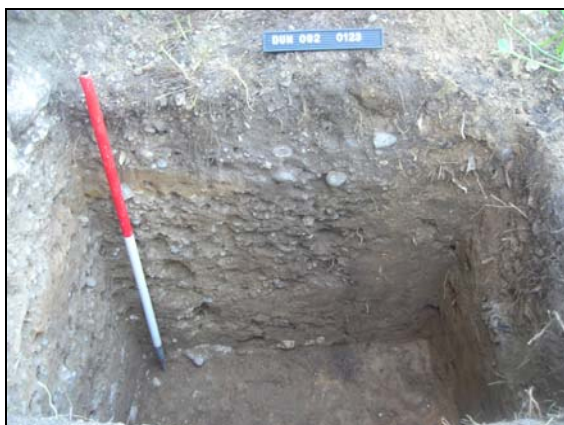
Two 1 metre wide test-pits (0123 & 0124) were hand excavated across the exposed footing in the locations shown on Figure 3. Only Test-pit 0124 (Plate 14) determined the total width of the footing as Test-pit 0123 (Plate 13) was limited on the south-east side by the stable building within the precinct. However, enough was exposed in each pit to suggest that the footing was broadly the same throughout the section of collapsed wall. Finds were recovered from four contexts associated with the test-pits, details of which are set out in the finds report at the end of this section.

Two elements of footing construction were identified in each test-pit. The lower 0.5-0.6 metres (0127) comprised alternate layers of compacted mid brown silty sand and lime mortar (0128 & 0130) in which fragments of medieval and re-used Roman tile were located. Above this was 0125, a 0.7-0.8 metres thick footing component onto which the standing precinct wall had been directly constructed. This comprised numerous thin layers of pale yellow and orangey brown gravelly sand (0126 & 0129) from which a small quantity of medieval pottery was recovered.

Plate 13 Test-pit 0123, SE-NW section

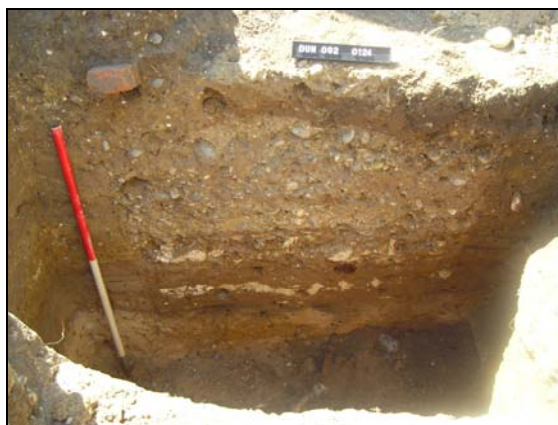
Plate 14 Test-pit 0124, SE-NW section

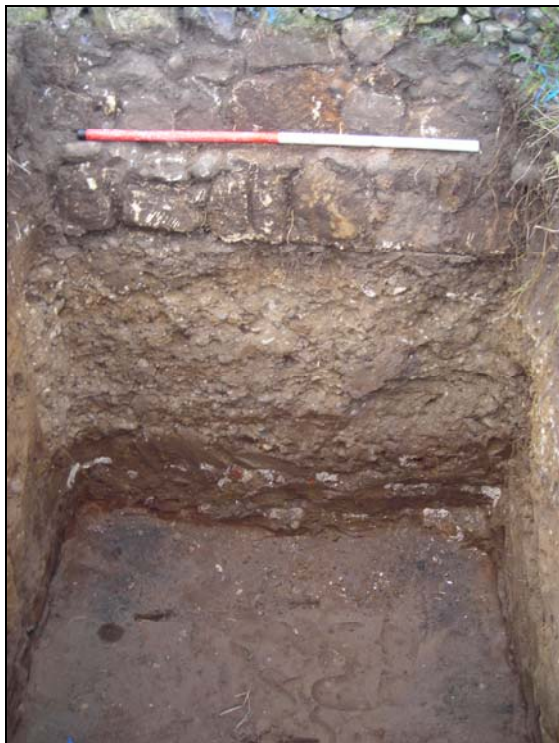
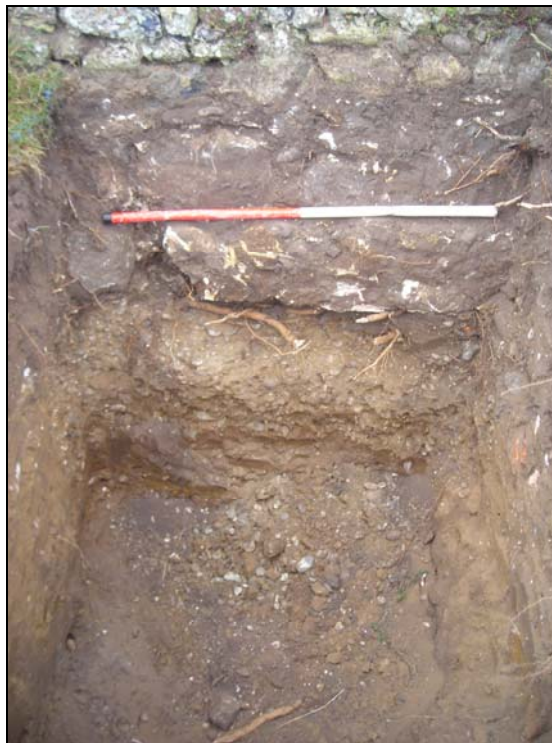
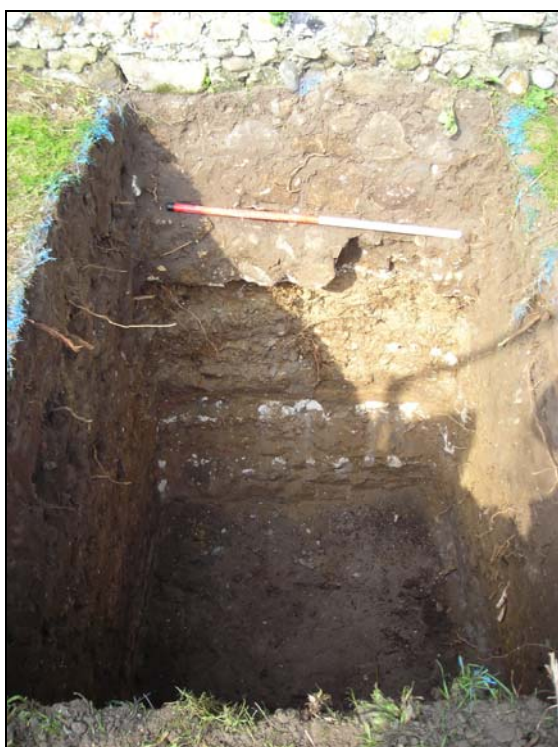
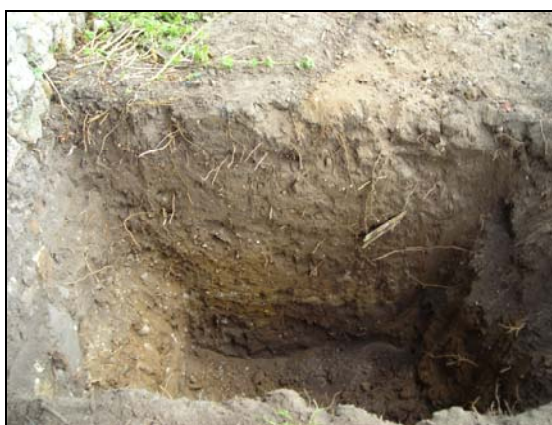
brown sandy loam topsoil with occasional pebbles and chalk and CBM flecks (Plates 17-20). Modern waste including plastic bags and twine were frequently present within the topsoil, often quite deeply buried. The topsoil sealed a fairly homogenous layer of pale yellowish brown silty sand with occasional rounded stones and chalk flecks measuring c.1 metre thick. The basal 0.2-0.3 metres of the trenches were cut into natural sand subsoil. Heavy root activity was noted throughout the topsoil and upper part of the silty sand layer.

The footings exposed below the wall in each trench were consistent in character, and appeared to follow the same pattern of construction observed in test pits 0123 and 0124, that is, a lower element of silty sand and lime mortar layers sealed by an

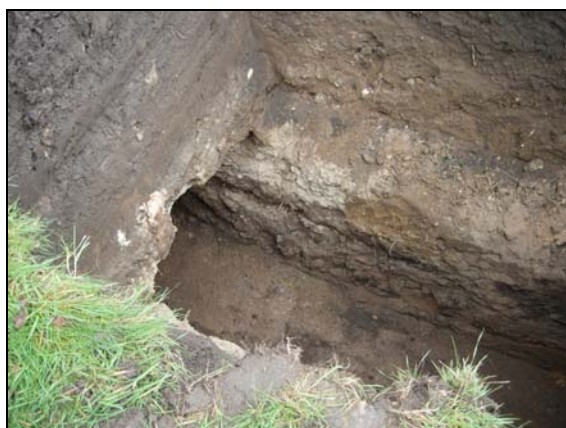
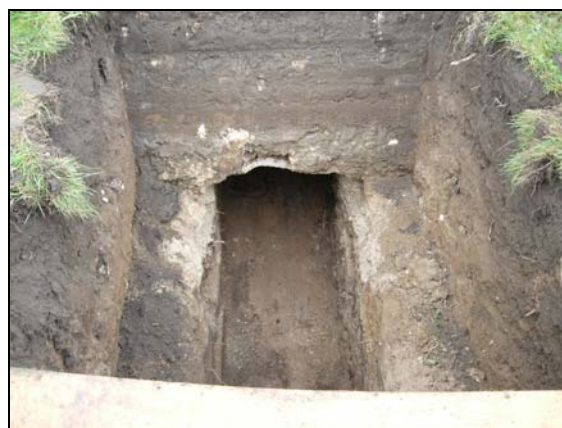
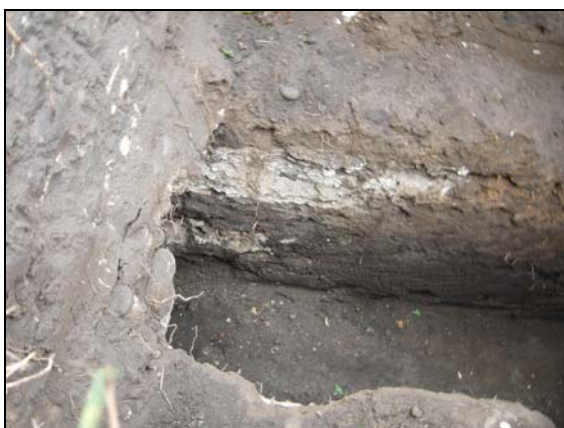
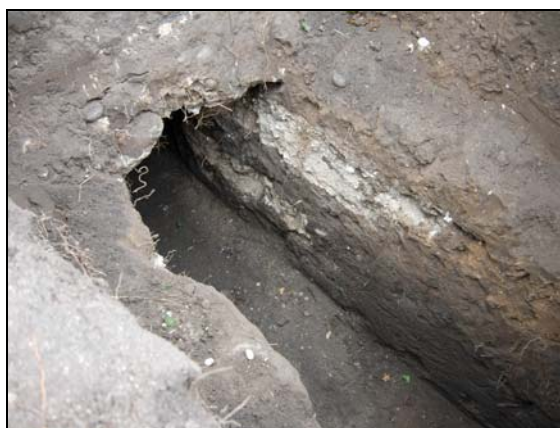
Access was gained into Trenches 7 and 8, but the others were deemed dangerous and only recorded photographically. However, visual inspection from the side of the trench suggested that the precinct wall footing profile in Trenches 5 and 6 (Plates 21-24) was similar in character to that of 7 and 8, the latter recorded in more detail (Figs. 9 & 10 & Plates 25-28).

The thick layer of mixed sand, gravel and mortar seen immediately below the wall in Trenches 5 – 7, and the stepped nature of the footing in Trench 8 were interpreted as a two phase foundation similar to those seen to the west, but with an upper component exhibiting a somewhat different composition.

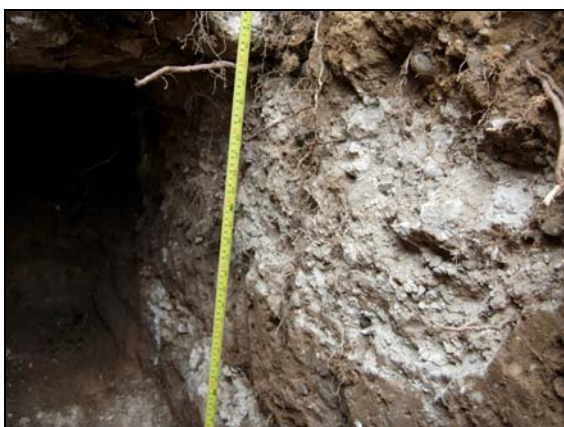
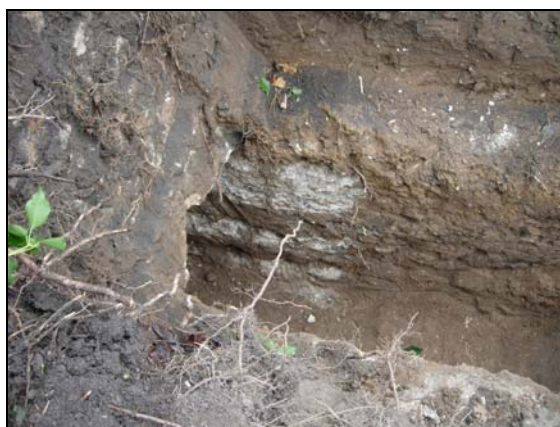
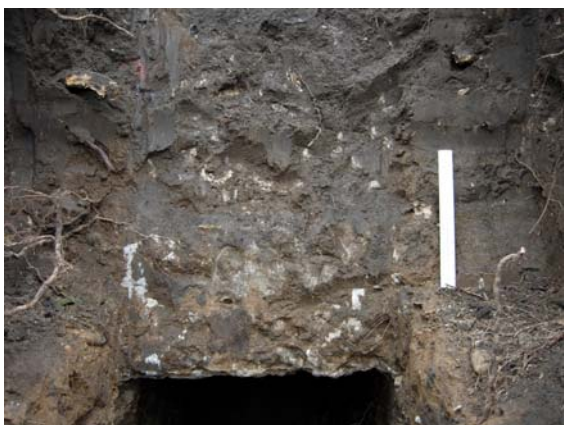
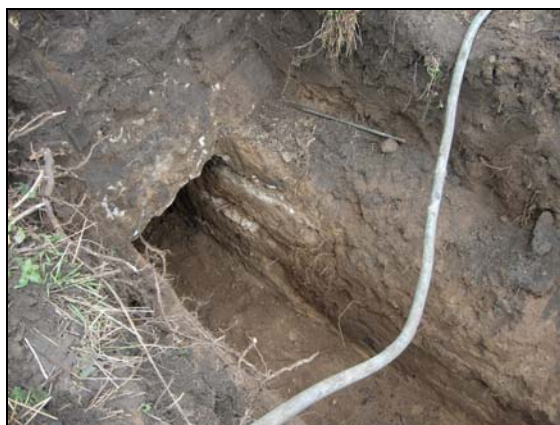
In all four trenches, the bottom of the precinct wall stepped out at a point c.0.25 metres from its base, the similar toed profile that was seen in the fallen section. The wall was 0.7-0.8 metres thick at its base. The underlying footing was vertical sided in Trenches 5-7, but stepped internally in Trench 8 (Figs. 9

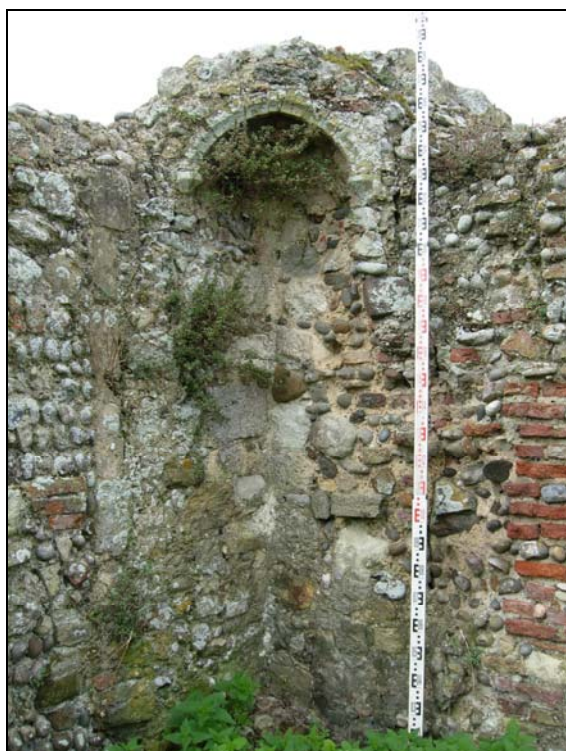
Plate 50 Niche 0058

Other elements of the standing complex which exhibited Phase I medieval fabric and features, although often patched during later phases, include walls 0052, 0055 & 0056, the latter with a contemporary niche (0058) with a moulded brick hood (Fig. 12 & various Plates).

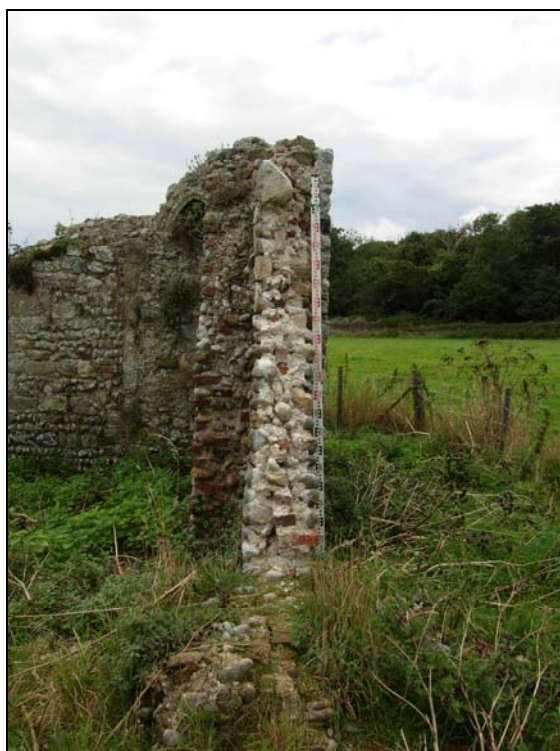
Plate 51 North end of 0054

In the wider area of the building complex, Phase III.b was only recognised as a section of rebuilt wall forming the northern end of west wall 0054. This section of wall had only been built to approximately half the thickness of the adjacent Phase II component of 0054 and had suffered recent collapse (Plates 51, 58 & 59)

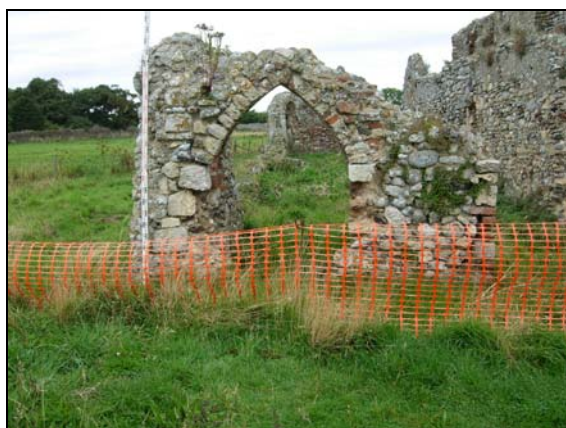
Plate 52 West wall 0057, external view

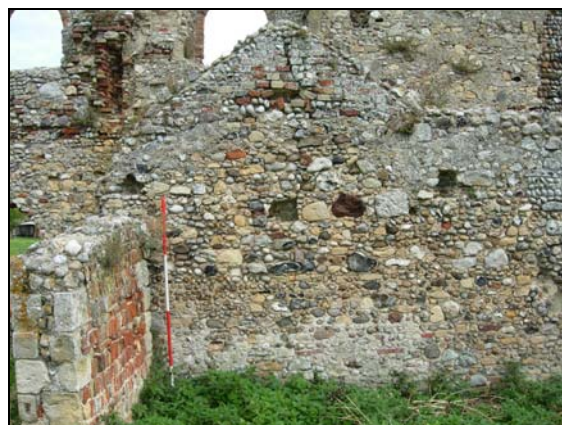
Plate 55 Wall 0052, south face with gable 0059

Phase III.a features were limited to the small gable end (0059) built onto the Phase I wall 0052, and the adjacent wall 0053 which clearly butted up against it (Plates 55 – 57). Map evidence (early OS) suggests that this was intact as a roofed structure at the turn of the 19th century. Gable end 0059 was constructed mainly in brick, while wall 0053 was faced with brick internally, lain as a series of upright header and diagonal courses, with coursed beach cobbles externally and a capping also of beach cobbles, the latter possibly later consolidation. Re-used limestone quoins were used as dressings.

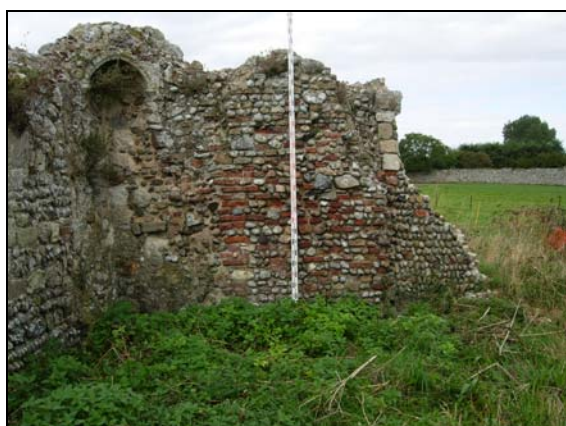
Plate 58 Wall 0054, internal face

Phase II features in the wider area of the ruin include the vestiges of an extensive brick façade, known to have been constructed to form the eastern end of the structure (0051 on plan Fig. 12, 0039 on elevation Fig. 14), a section of the west wall 0054 (Plates 58 & 59) and possibly the arch forming part of 0057 (Plates 49, 52 & 53), although this could equally well be a Phase III.b insertion. Attributing these features to sub-phases was not possible.
