**St. Andrews Church, Aldringham Cum Thorpe (ARG 015);
Building Recording & Monitoring Report**

SCCAS Report No. 2008/237; Oasis No. suffolkc1-63144

Stuart Boulter
Field Team
Suffolk C.C. Archaeological Service

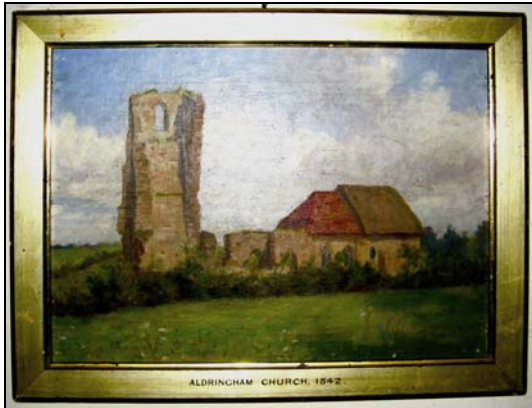
Plate 16 Painting of church c.1842

For the purposes of the interpretation, the information recorded on site has been complimented by two illustrations of the church. The first is an oil painting (Plate 16) that hangs on the south nave wall to the left of the door in the church and the second is a sketch drawing (Plate 17) of the south elevation, both of about 1842. The drawing is possibly by the builder (James Smyth) or the surveyor (Charles Kemp) both of whom were involved with some of the 19th century renovations.

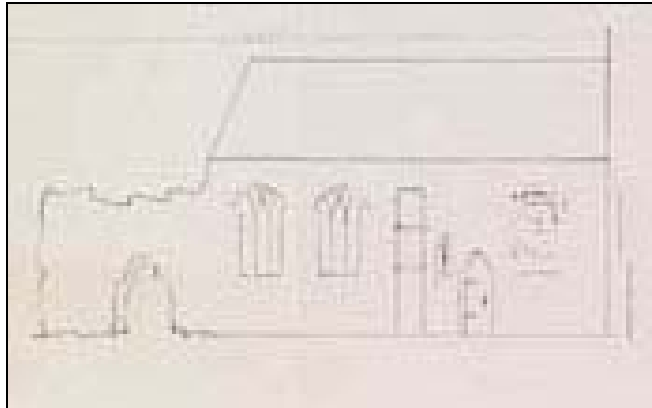
Plate 17 Drawing of church c.1842

Removal of the hard brown render coat (0150) from around the porch exposed the continuation of surface treatment layer 0129 and the remnants of another phase of applied lime render (0200) which included areas where its formal face remained intact (Plates 14 & 15). Given that this layer clearly extends over medieval fabric and the post-1842 rebuilt fabric (0201) above the porch, the extent of which was both visible in the face of the wall and could be inferred from the sketch drawing of c.1842 (Plate 17), then it must be contemporary or later than the major Victorian rebuild.
