**Barn at  
St Jacob's Hall,  
Laxfield, Suffolk**  
LXD 058

**Historic Building Record**

# **Barn at St Jacob's Hall, Rowe's Hill (B1117), Laxfield, Suffolk**

## **Historic Building Record**

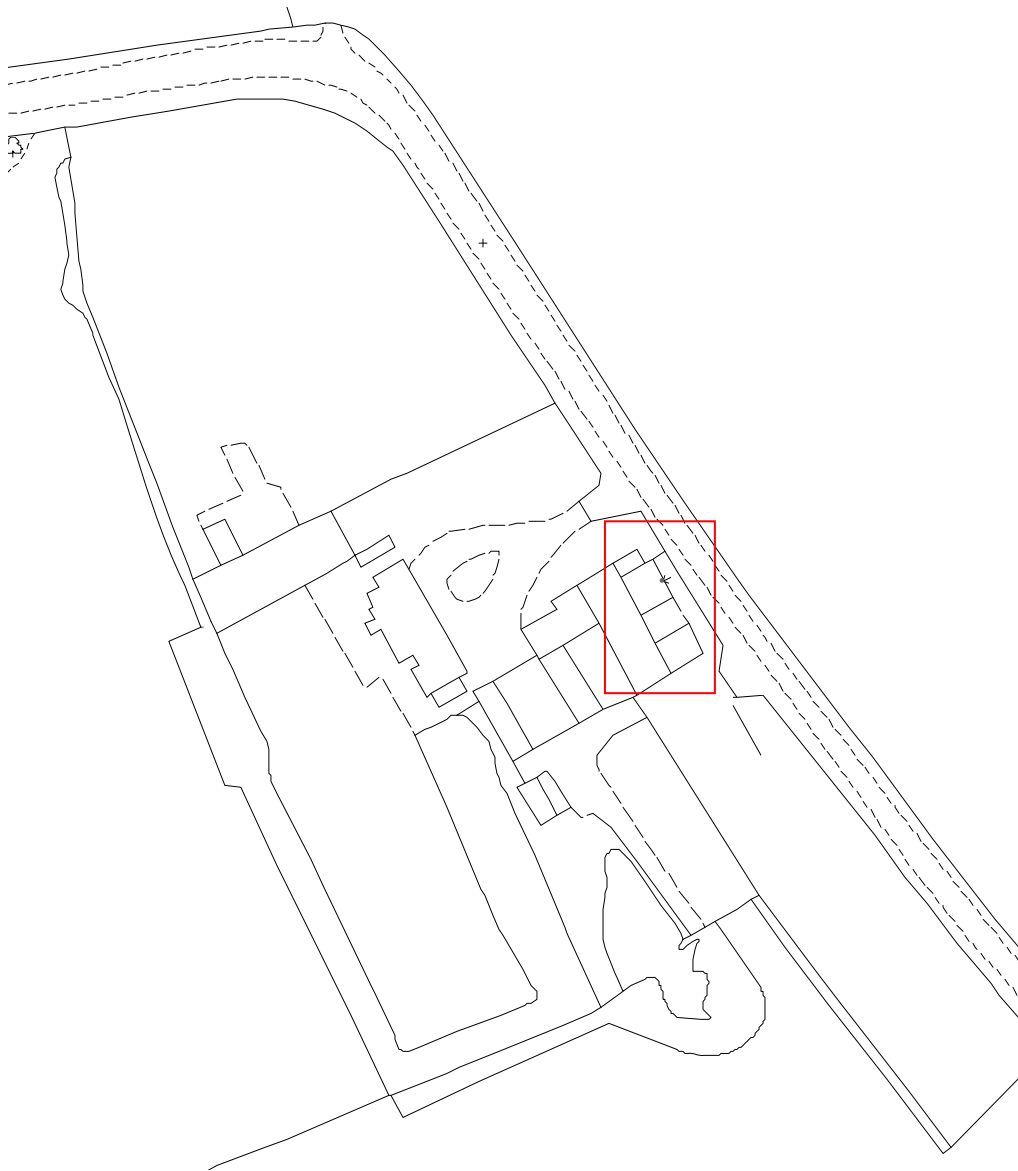
**Figure 1**

**Current Ordnance Survey Site Plan**

**Showing the site on a bend of the B1117 and enclosing the barn complex in red. The listed farmhouse lies to the west. See figure 5 below for a more detailed breakdown of the historic buildings.**

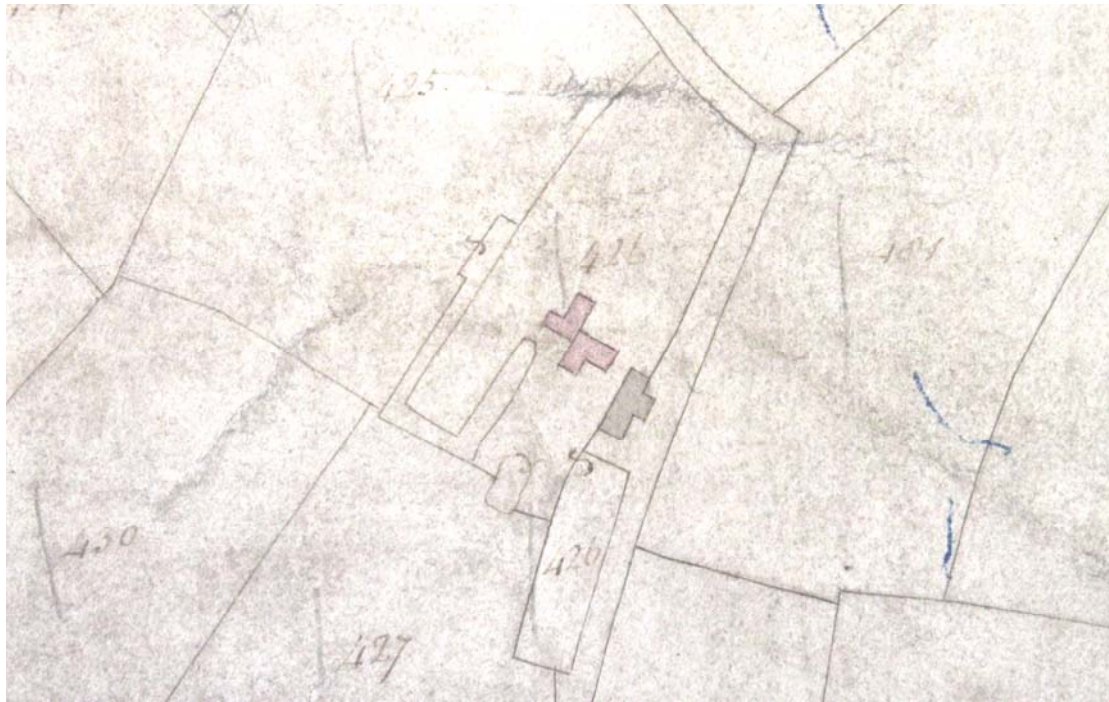
**Figure 2**

Laxfield tithe map of 1840 showing Jacob's Farm in the bend of Rowe's Hill (Suffolk Record Office). North lies towards the top right-hand corner. Note the rectangular moated orchard south-west of the house: the site (no. 426 on the schedule) was described as 'house, yards, orchard, etc.' The adjoining fields on the west (425) and south (427) were 'First Canal' and 'Cartshed Field' respectively

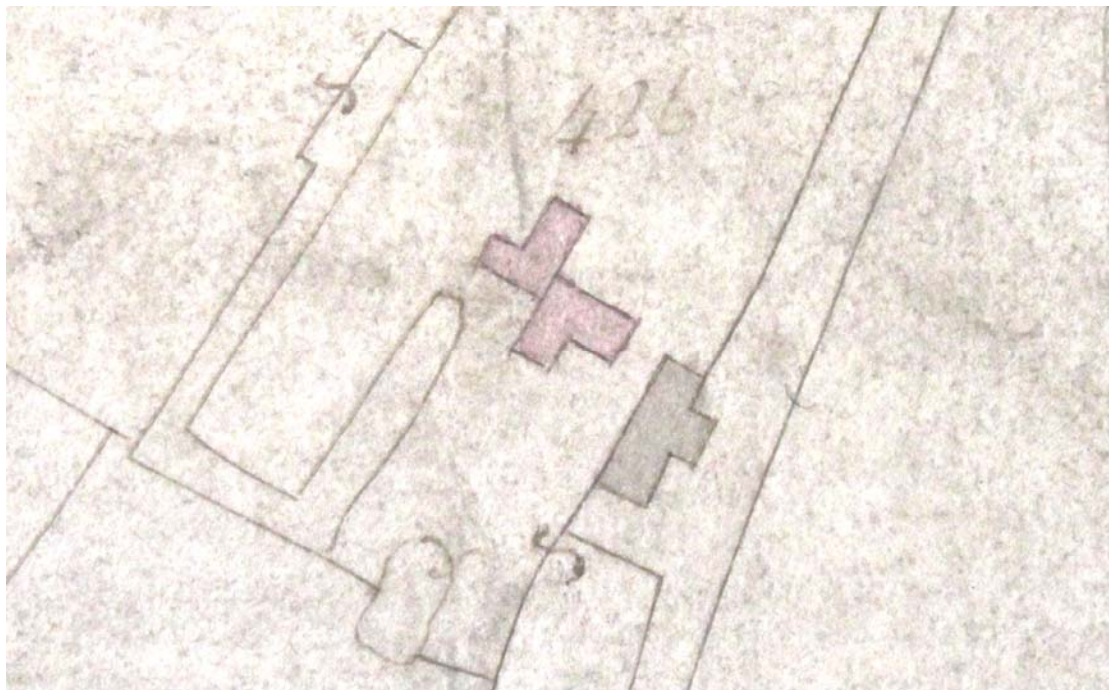
**Figure 2a**

Detail of the 1840 tithe map. The roadside barn is shown in grey as a simple rectangle with an eastern porch. An additional domestic structure which no longer survives adjoins the south-eastern corner of the present farmhouse – which still retained the rear bay of its southern cross-wing. This may have been a bake-house.

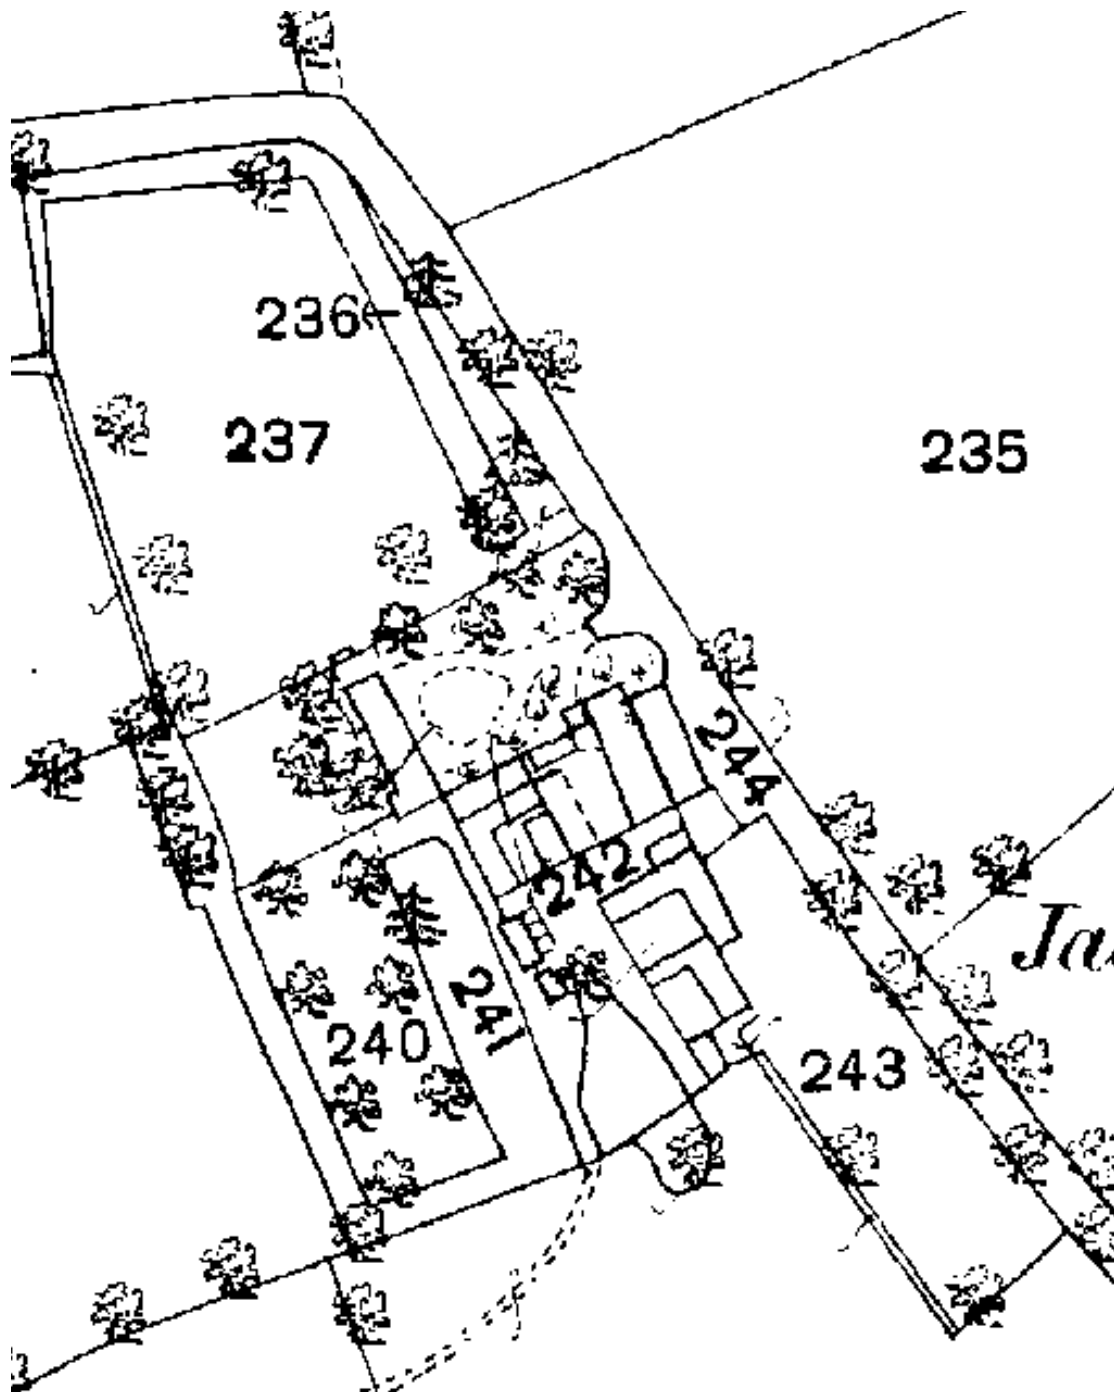
Figure 3

First Edition 25 inch Ordnance Survey of 1884.

The site had been transformed since 1840, with a large new complex of agricultural buildings to the south and west of the barn. The present farm buildings (nos. 1-5 in figure 5) are shown in their present form, but the southern buildings have been demolished. The rectangular moat surrounds an orchard.

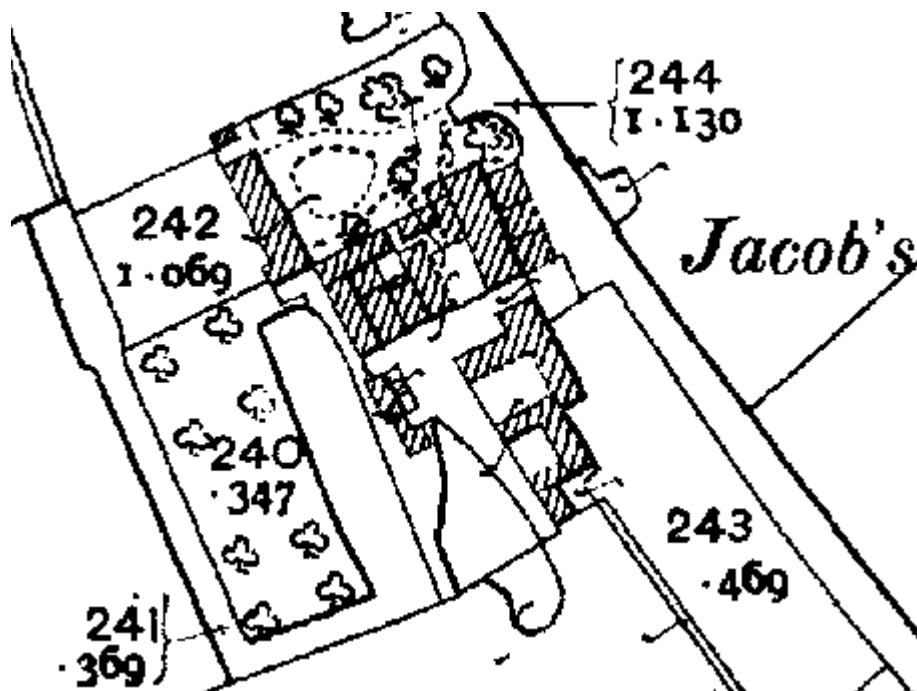
**Figure 4**  
**First Edition 25 inch Ordnance Survey of 1904, showing the mid-19<sup>th</sup> century complex in more detail. Open-sided structures are depicted with broken lines.**

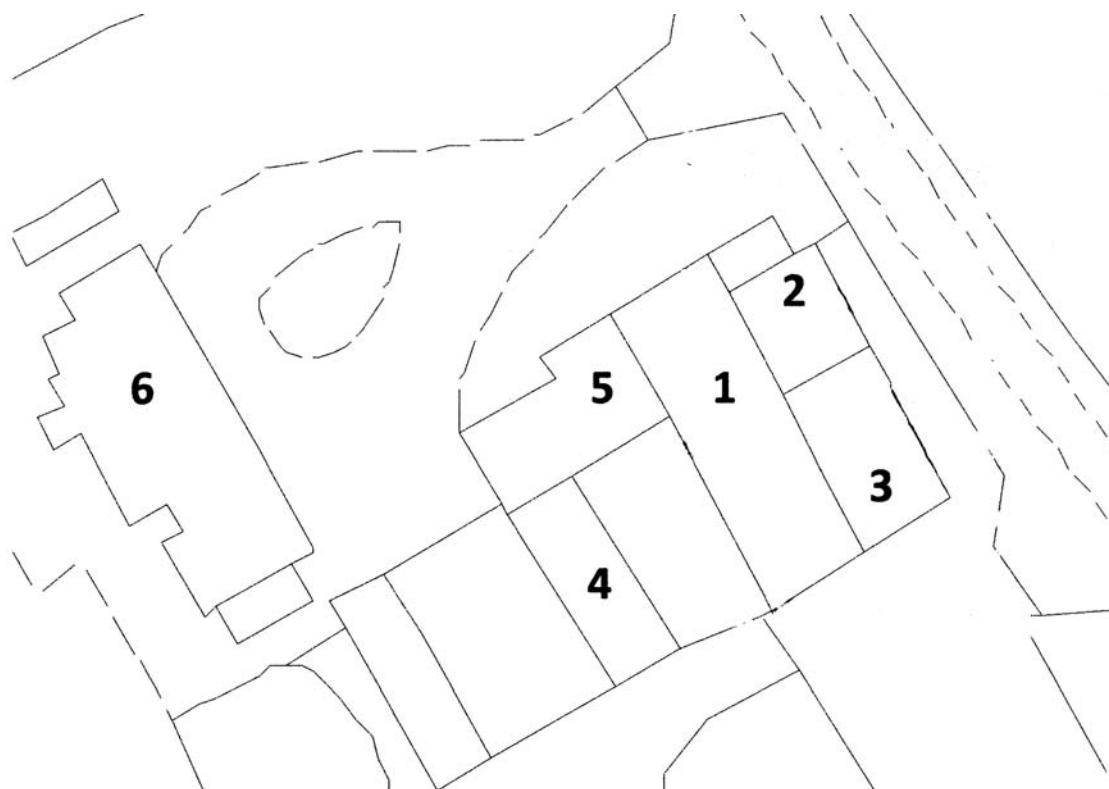
Figure 5

Block Plan of site, identifying each historic building with a number for ease of reference in the text and photographic record. Based on current Ordnance Survey.
