**Agricultural Buildings,
Abbey Farm,
Culpho, Suffolk
CUP 027**

Historic Building Record

This report provides a written and photographic record at English Heritage (2006) Level 2 of a complex of redundant agricultural buildings in the curtilage of a grade II-listed farmhouse. It has been prepared to a brief written by Suffolk County Council's Archaeological Service (ref. SpecHBR&Mon(EM)AbbeyFarm_Culpho_0191_09, Edward Martin, 26th October 2009), and is intended to fulfil a condition of planning permission for conversion (Suffolk Coastal District Council application C/07/0191/FUL, condition 9).

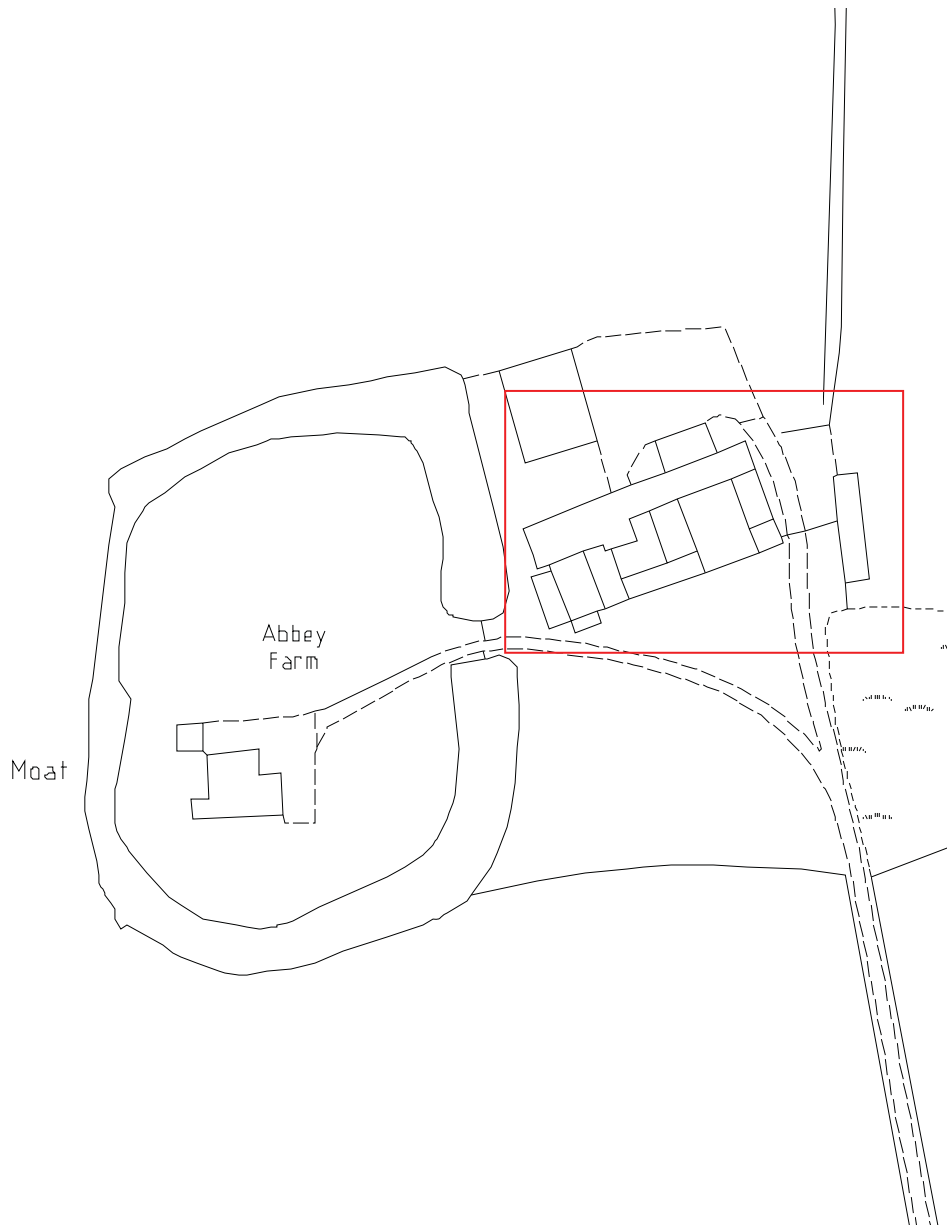
Figure 1 Current Ordnance Survey Site Plan.

Enclosing the complex of agricultural buildings in red, and showing the moated 17th century farmhouse to the west with the unmade farm track approaching from the south. The linear barn to the north of the complex was evidently positioned to flank the entrance to the moat.

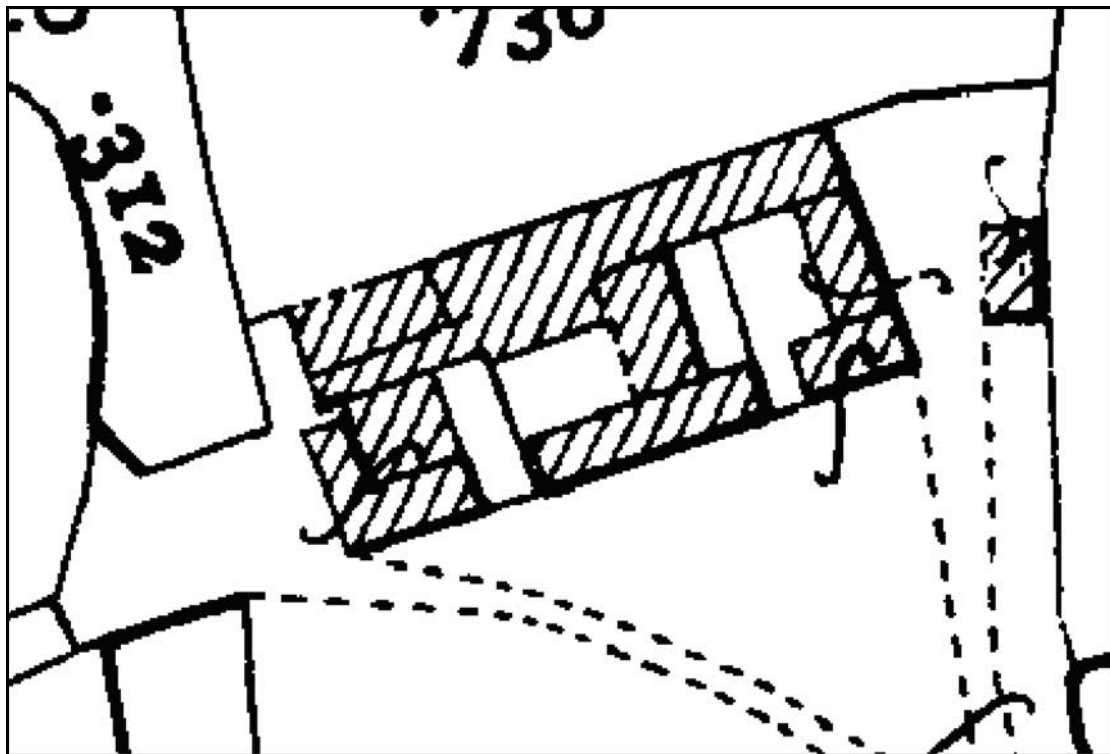
Figure 3a
Detail of the second edition Ordnance Survey showing the complex in more detail but without the northern projection of 1881. The detached cart lodge to the east (building 14 in figure 5) had not yet been built, but a smaller structure is shown on the site. The western animal yard had been provided with a roof since 1881.

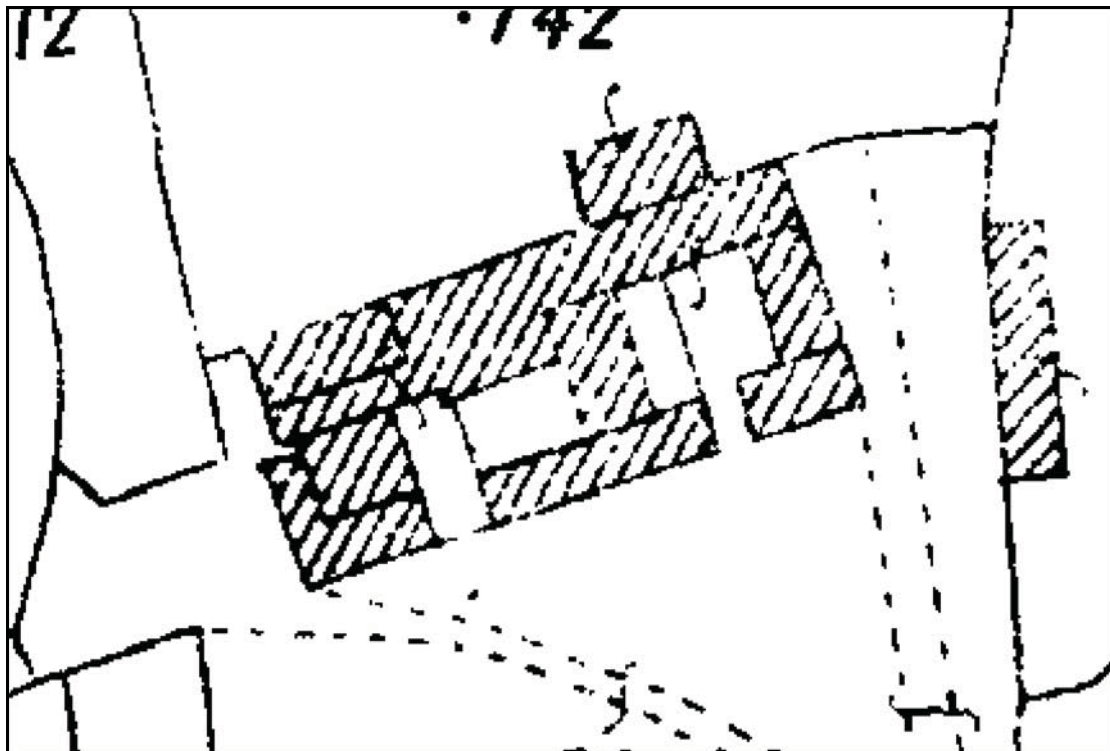
Figure 4a
Detail of the third edition Ordnance Survey showing the detached cart shed to the east (14) and the lean-to northern shed (6) for the first time

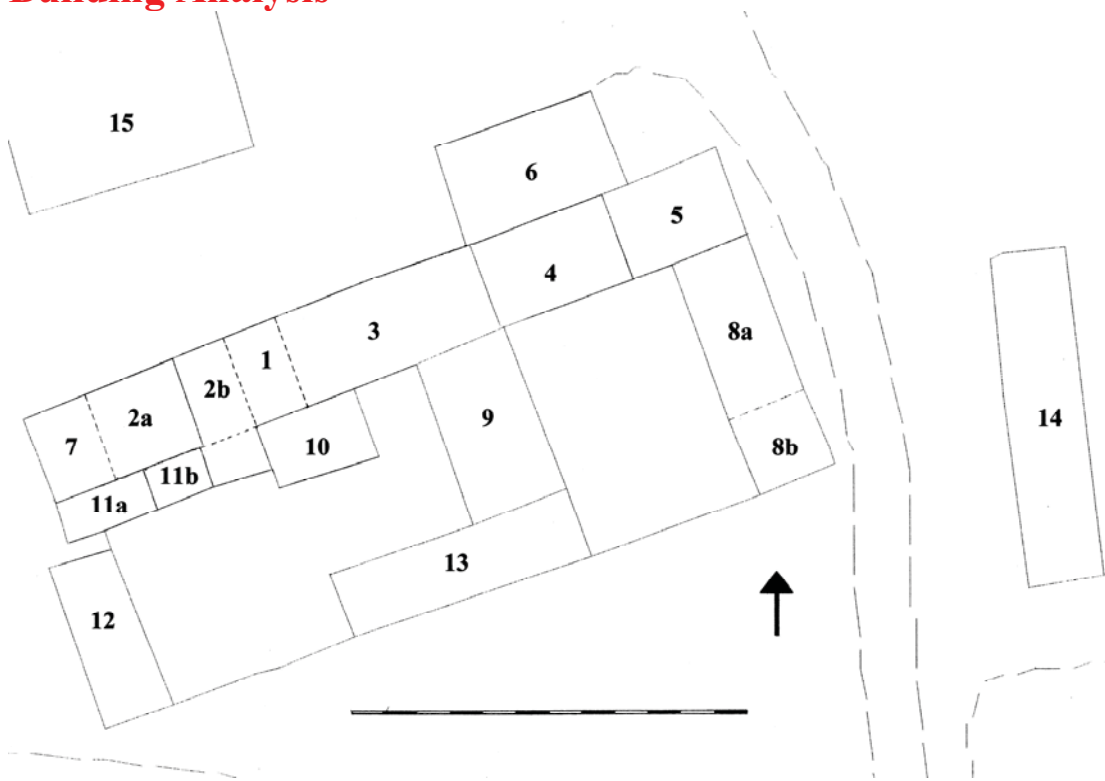
Figure 5

Identifying each area of the farm complex with a number for ease of reference in the text and photographic record. Scale in metres. The moat to the west is not shown.

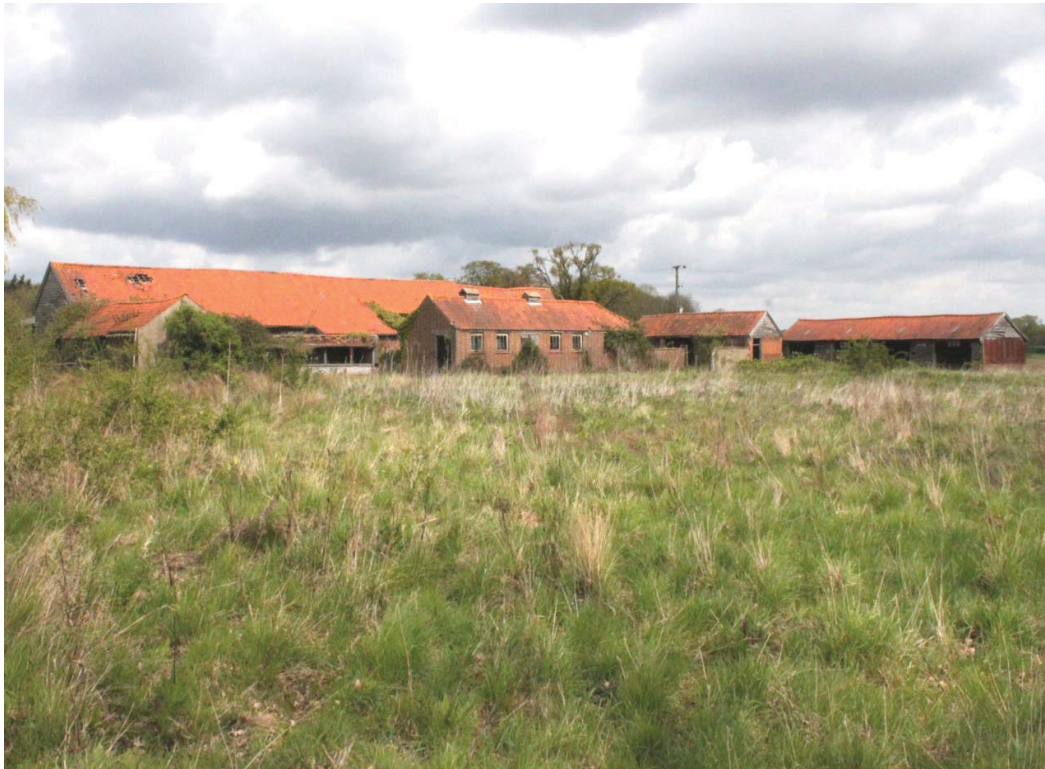
Illus. 1. General view of site from south-west showing the impressive length of the main barn in rear to left, with mid-19th and 20th century yard buildings in the foreground and the detached cart lodge (14) to the right.

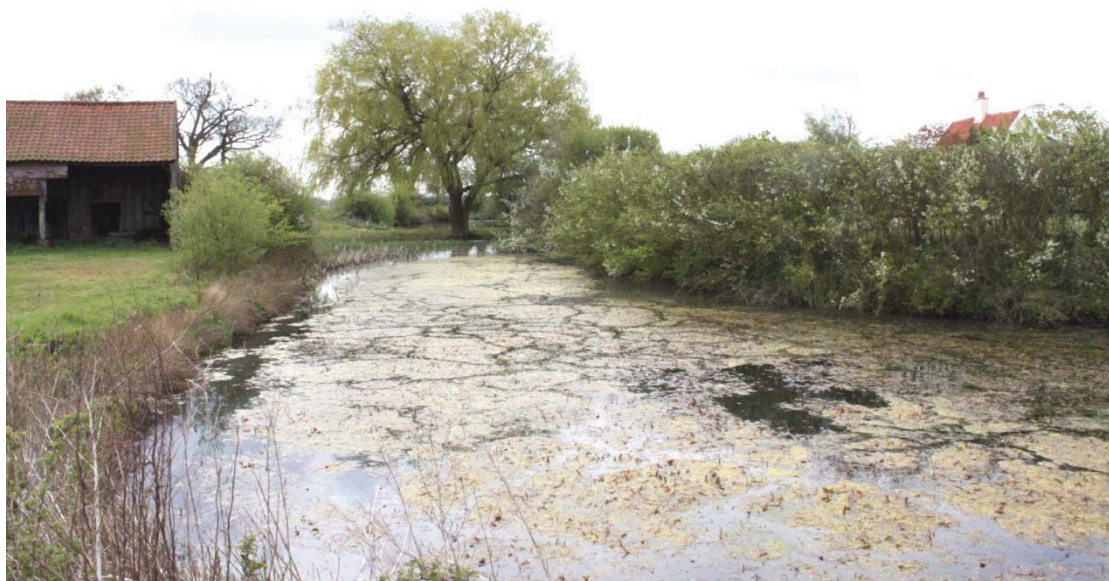
Illus. 2. The well-preserved moat seen from the north and showing its proximity to the barn (left) and grade II-listed early-17th century farmhouse (right).
