**Barn at Coppings Farm,
Hemingstone,
Suffolk
HMG 026**

Historic Building Record

October 2010

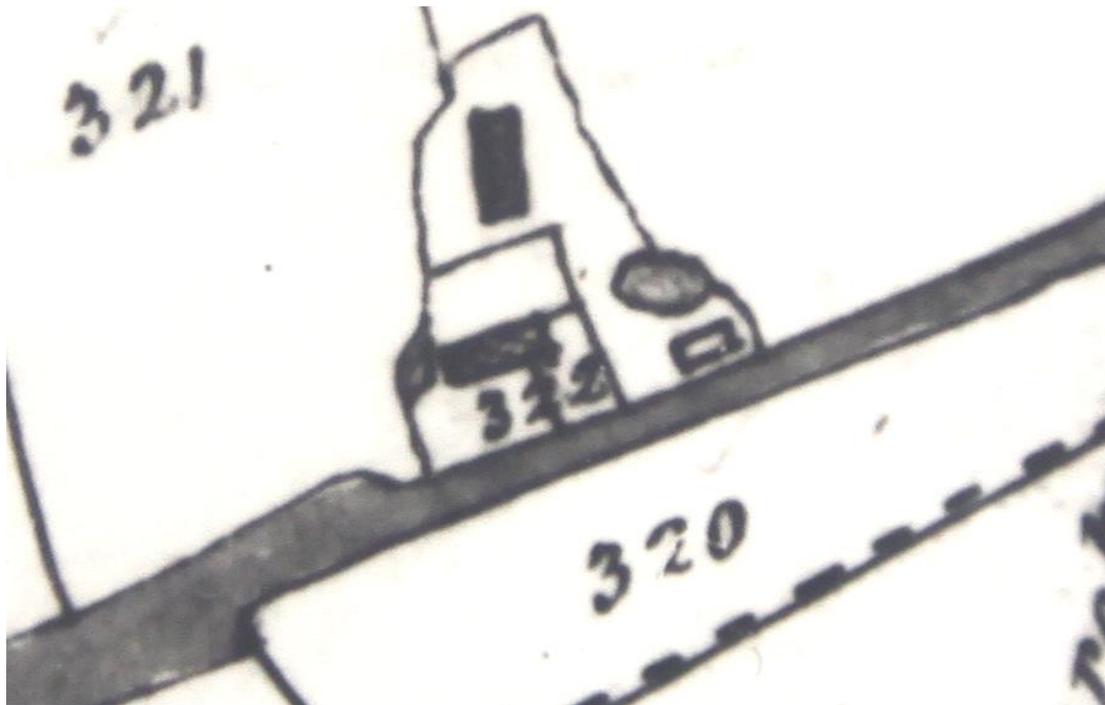
Figure 2a

Detail of the 1838 tithe map showing the 17th century barn on a north-south axis to the rear (north) of the farmhouse with the surviving pond to the east.

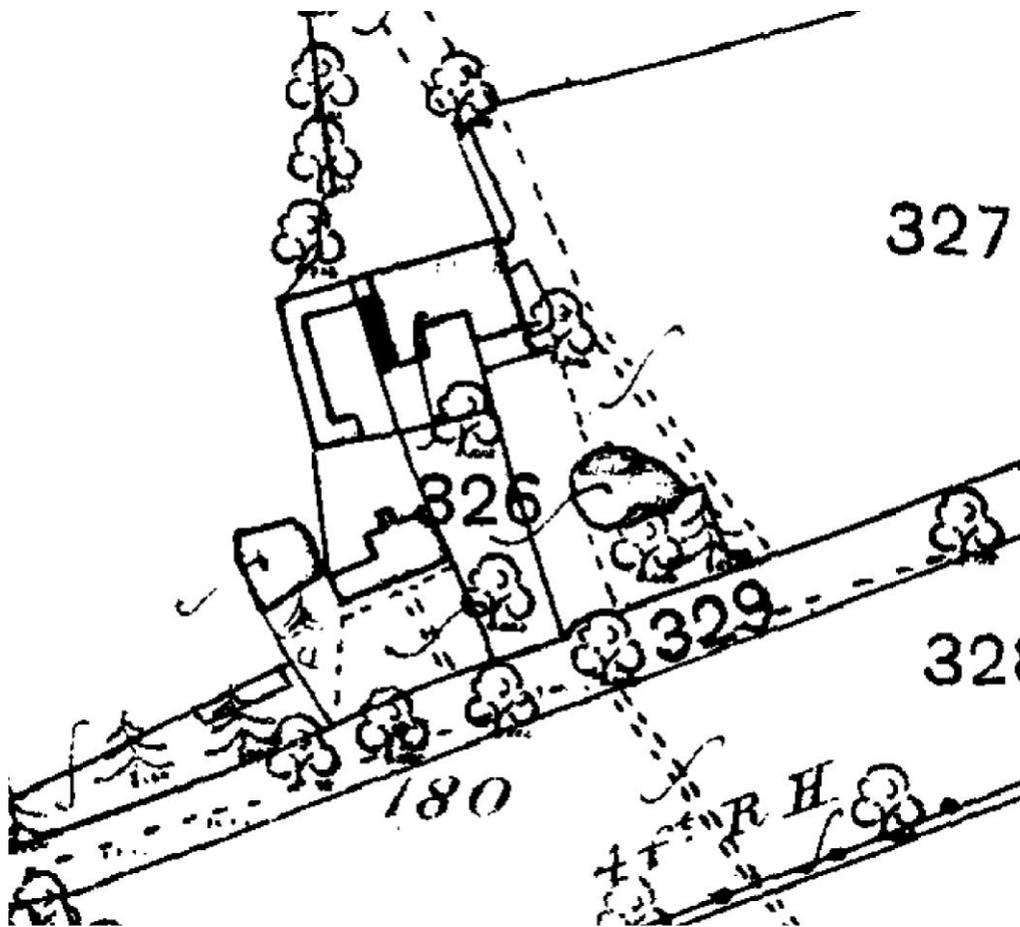
Figure 3

First Edition 25 inch Ordnance Survey of 1884, showing the present multi-purpose barn with its two southern wings incorporating the barn of 1838 to the west. Of the U-shaped shelter-shed to the west only a fragment now remains (converted into a shed for the preparation of pig feed).
