ARCHAEOLOGICAL BUILDING RECORDING AND MONITORING REPORT

SCCAS REPORT No. 2010/212

Barn at Green Meadows, The Green, Hessett, Suffolk

HTT 019

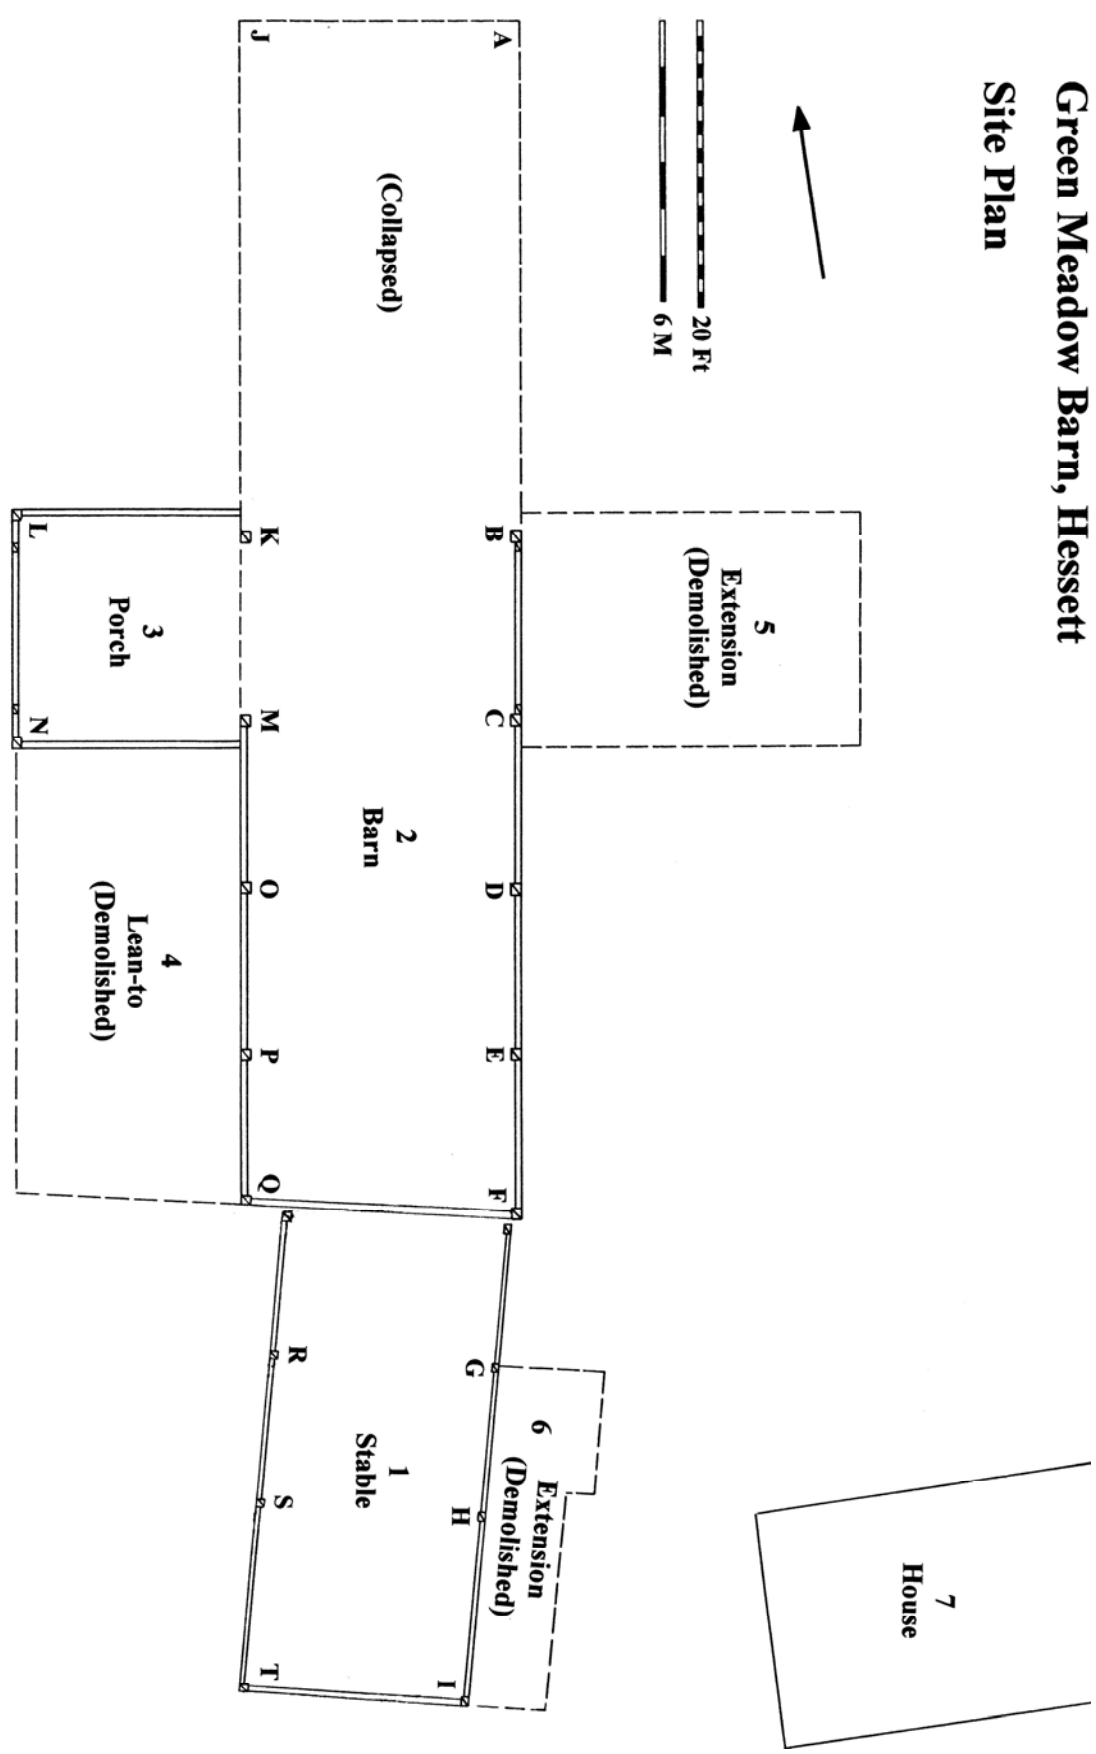
Figure 7. Numbered historic areas of building

The low, narrow weatherboarded structure at the southern end of the barn is the earliest part of the building (Area 1 in Figure 7). In contrast to the walls of the barn proper (Area 2), which consist largely of re-used studs nailed to primary diagonal braces in a style first employed at the end of the 17th century, this lower section is properly framed in the medieval tradition with externally trenched braces and pegged mortises throughout. The structure contains three bays as shown in the accompany figures, and extends to 34 feet (10.4 metres) in overall length by 16 feet (4.9 metres) in width, but the southernmost bay was added as a later extension. The general character of the framing and the use in the roof-plates of the earlier building of face-halved-and-bladed scarf joints (which came into standard use only during the second and third decades of the 17th century) suggests a date of c.1610-30, while the relatively thin, straight wall braces of the extension indicate c.1630-50. The original roof timbers have been lost and replaced by a mid-20th century single-slope structure of machine-sawn softwood covered, like the main barn, with corrugated iron. The missing roof was probably of clasped-purlin form and is likely to have been thatched (the steep pitch of the barn roof suggests that it was designed for thatch).

extension of uncertain form which has recently collapsed or been demolished (Area 6 in Figure 7). The outline of this building, which presumably formed a tack shed, is indicated by a modern concrete floor and by a lack of tar to the external weatherboarding. A small wooden pulley nailed to the northern face of post H (Figure 7) was presumably intended to assist in the manhandling of harness.

The large 7-bay barn to the north of the stable is a later structure which follows a slightly different alignment as shown in Figure 7, and perhaps reflects an encroachment on the margins of the green. The character of the timber-frame, which appears to have been designed for its present weatherboarding (as opposed to the wattle-and-daub infill of the stable) suggests a date in the late-18th or perhaps early-19th century, but the building is mistakenly dated as 'probably 17th or early-18th century' in the list description. The later date is consistent with the original clasped-purlin roof structure which employs nailed collars and a ridge board (as opposed to the pegged mortises and halved joints of early-

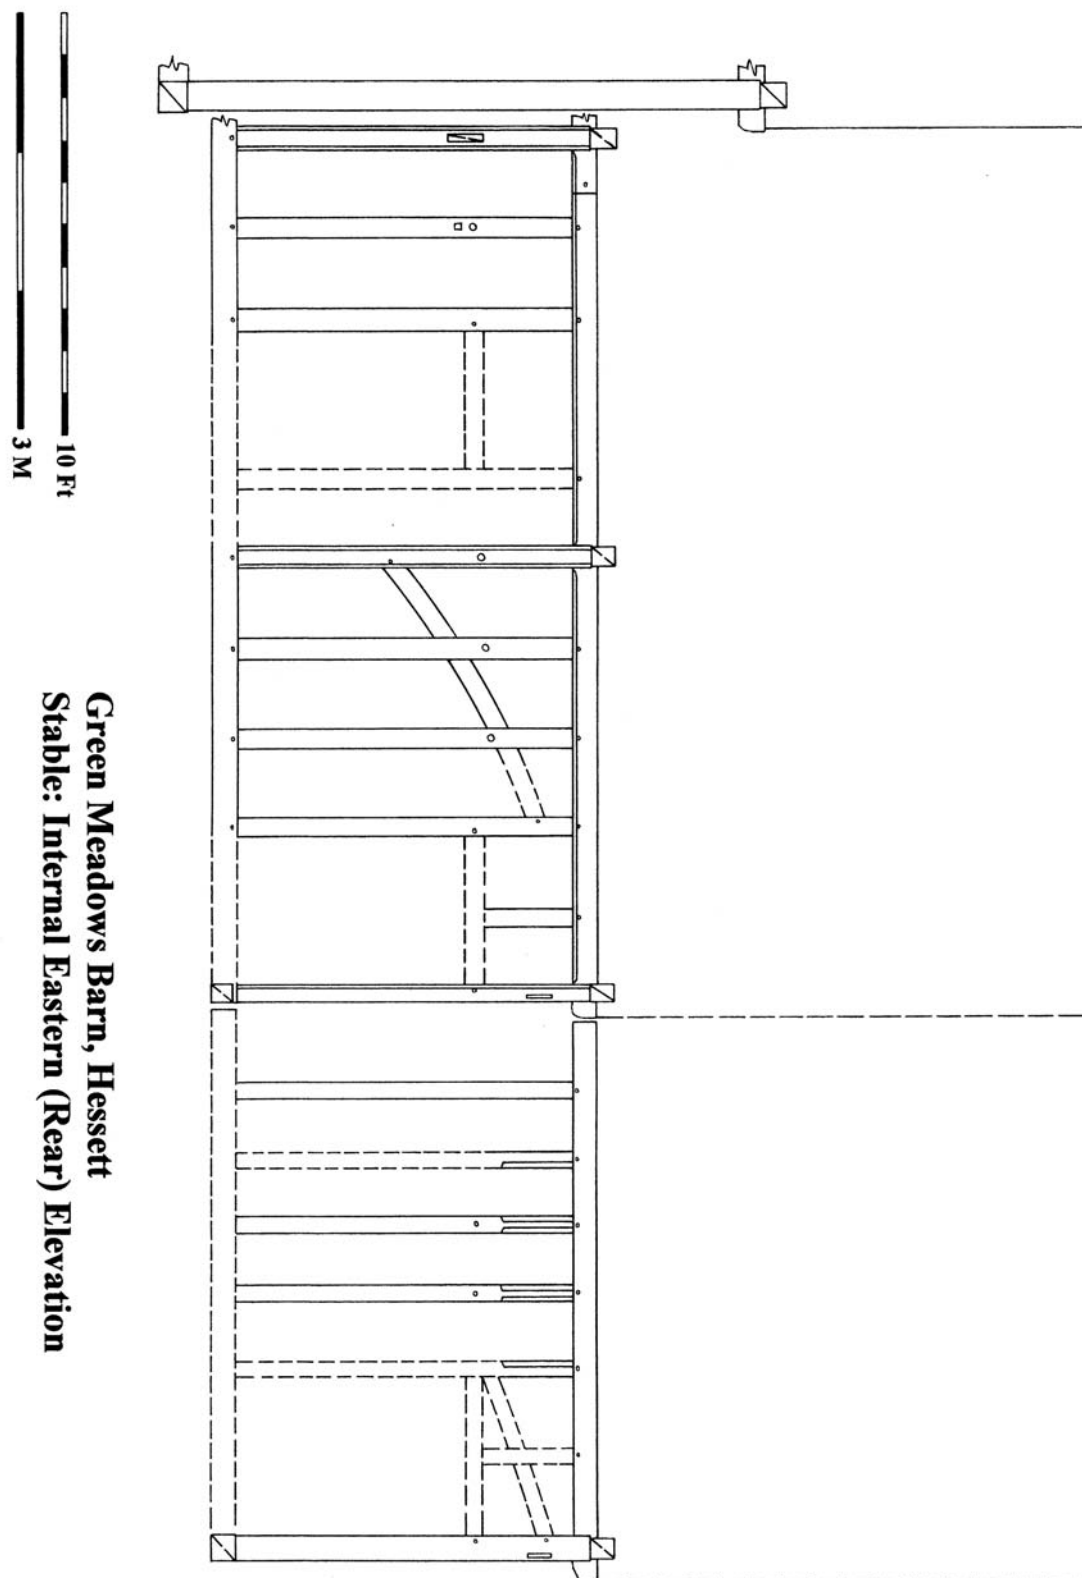
Figure 8. Stable internal eastern (rear) elevation

removed, but neither are there mortises for the tie-beam braces of an open frame. The northernmost truss, in contrast, did contain tie-beam braces although only its rear corner-post survives (complete with arch-brace mortise). There is, however, clear evidence of an original doorway in the rear wall of each bay, each door approximately 40 inches (1 metre) wide and rising to a lintel at ceiling height, as shown in Figure 8. The later southern bay possessed a third doorway as indicated by a pegged lintel mortise in its corner post. It therefore seems probable that the northern gable of the original building was open-framed against another building (perhaps the predecessor of the present barn), and that it contained two areas separated by a boarded partition of some kind; despite the unequal lengths of the bays, the size of each area would thus have been identical at 10 feet by 15 feet internally (3 metres by 4.5) as the northern boundary was formed by the wall of the adjacent structure. The partition is unlikely to have risen to the ceiling as there is no obvious source of light in the northern bay.

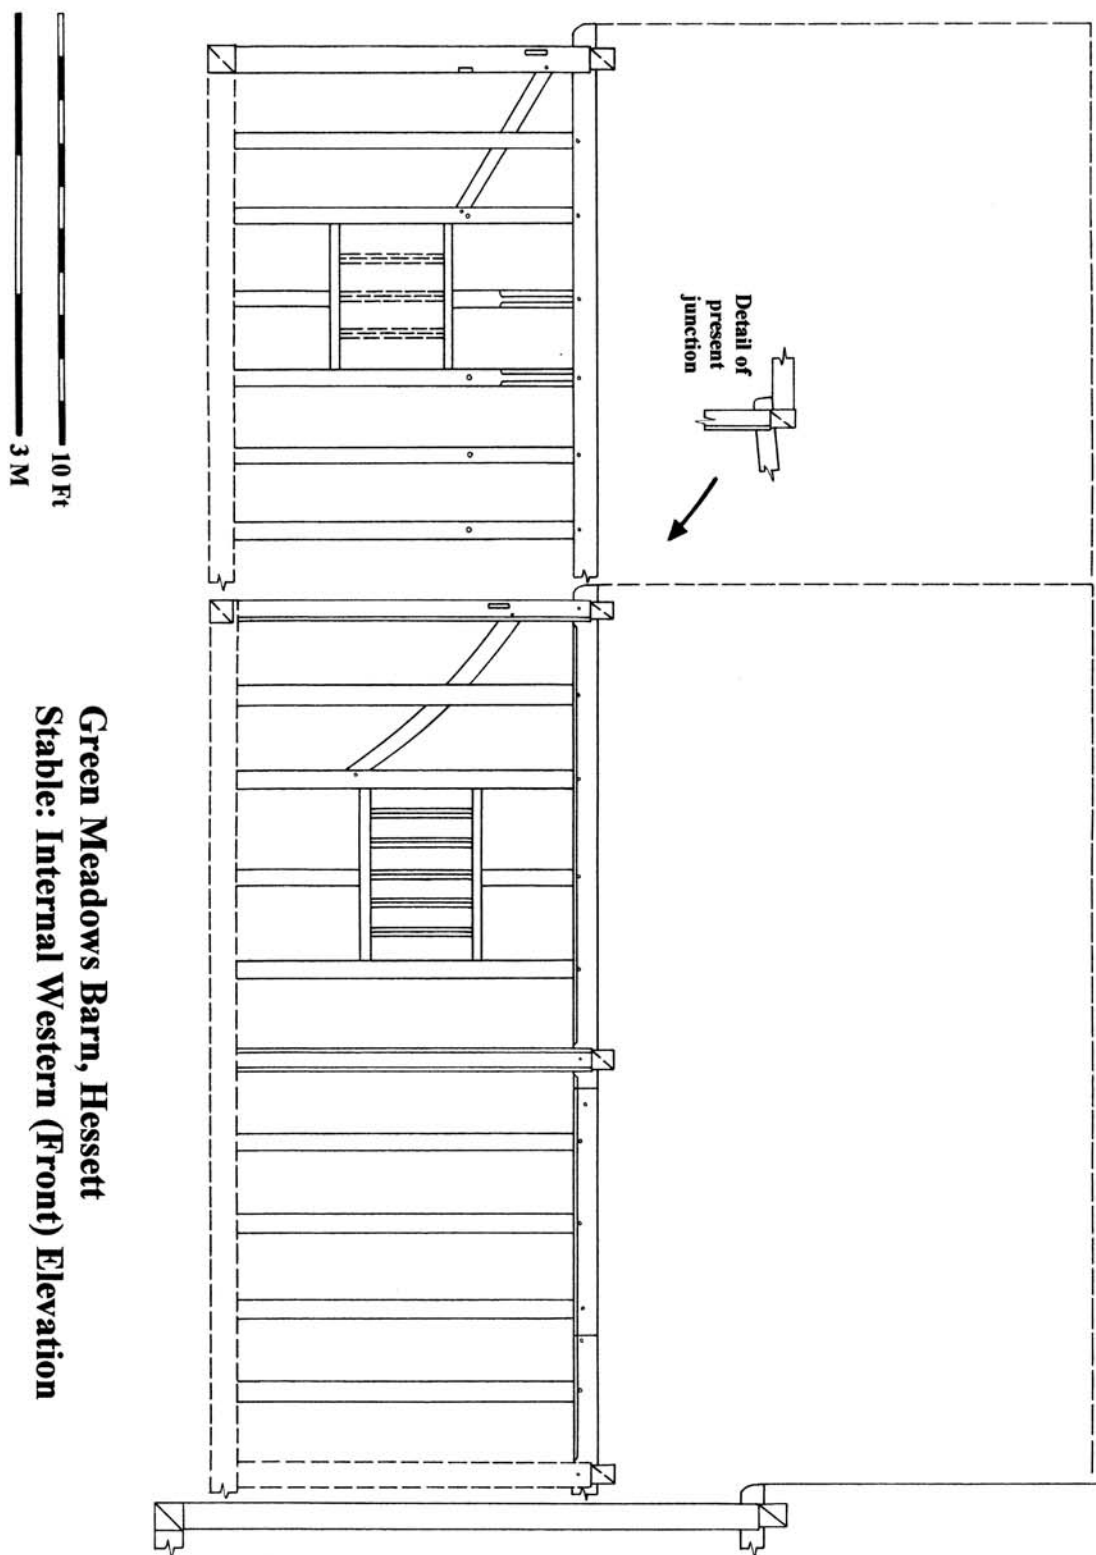
Figure 9. Stable internal western (front) elevation

The present fittings are of late-18th or 19th century appearance and are not original to the 17th century building. Low mangers extend along the entire western wall, and consist of heavy, nailed elm boards which are supported by crude frames; a number of iron tethering rings remain in the front rails. Angled timbers nailed to the external gable and the opposite partition provide clear evidence of a missing hay rack which extended across the original window of the southern bay. It would therefore appear that horses were most recently tethered laterally to the building (i.e. with their heads facing west), but were originally housed axially (with their heads towards one or other gable) in order to avoid blocking the windows. The present weatherboarding is also of 19th century appearance, but the three doorways in the eastern wall approximately coincide with the 17th century apertures shown in Figure 8. Two harness hooks in the form of naturally bent timber project from the external wall of the southern bay, and faced into an

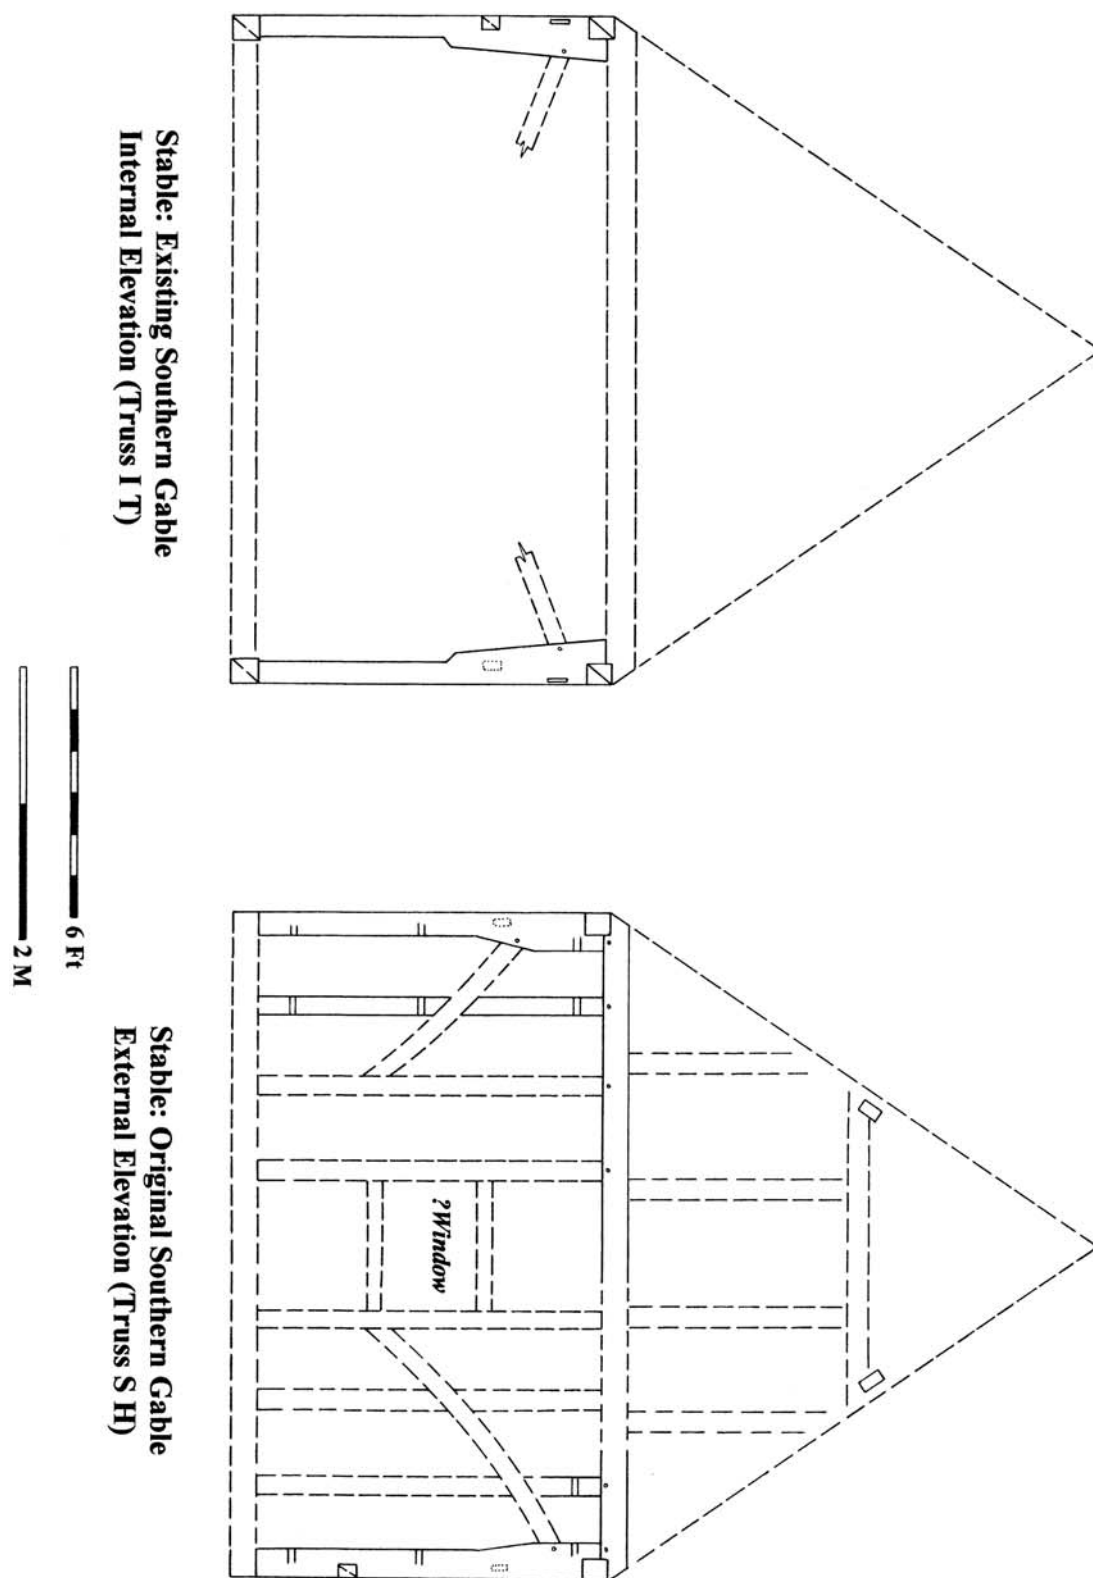
Figure 10. Stable, original and exiting southern elevations.

The presence of a ceiling is further indicated by neat chamfers and chamfer stops to the inner edges of certain studs in both the front and rear walls of the southern bay above the clamp pegs; these chamfered studs formed the mullions of low windows lighting the roof loft. Chamfered stud mullions of this kind are not common, but are occasionally found in local 16th and 17th century domestic houses. There is no obvious evidence of separate sills, and these were presumably formed by nailed boards, or perhaps by permitting the floorboards to project into the chamfered apertures. The ground-floor area of the same bay was lit by a more standard type of window which contained three 'diamond' mullions between a sill and lintel with hollow-chamfered terminals that projected by 1.5 inches (4 cm) beyond the external plane of the wall. The lintel lies immediately beneath the level of the ceiling clamp and remains *in situ* together with the sill, but the mullions, each 2 inches square, have been removed. The small size of the mullions is also indicative of a 17th century date, as 16th century and earlier equivalents are typically 3 inches square. A similar window survives completely intact, with all five 2-inch mullions *in situ*, in the southern bay of the earlier phase of construction as shown in Figure 9. There is no visible evidence of loft windows in the earlier phase, but this may have possessed a window in its missing gable or have been lit by roof dormers. The asymmetrical braces of the gable and apparent absence of a central stud in the expected position strongly suggests that a window also existed here, as shown to the right in Figure 10 (which is based on the positions of empty stud mortises in its tie-beam - from which only a small section has been cut). The southern gable of the extension may also have contained a window, but its present structure, which includes a length of ceiling clamp, was entirely renewed in the 18th or 19th centuries to leave only the original corner posts as shown to the left in Figure 10.

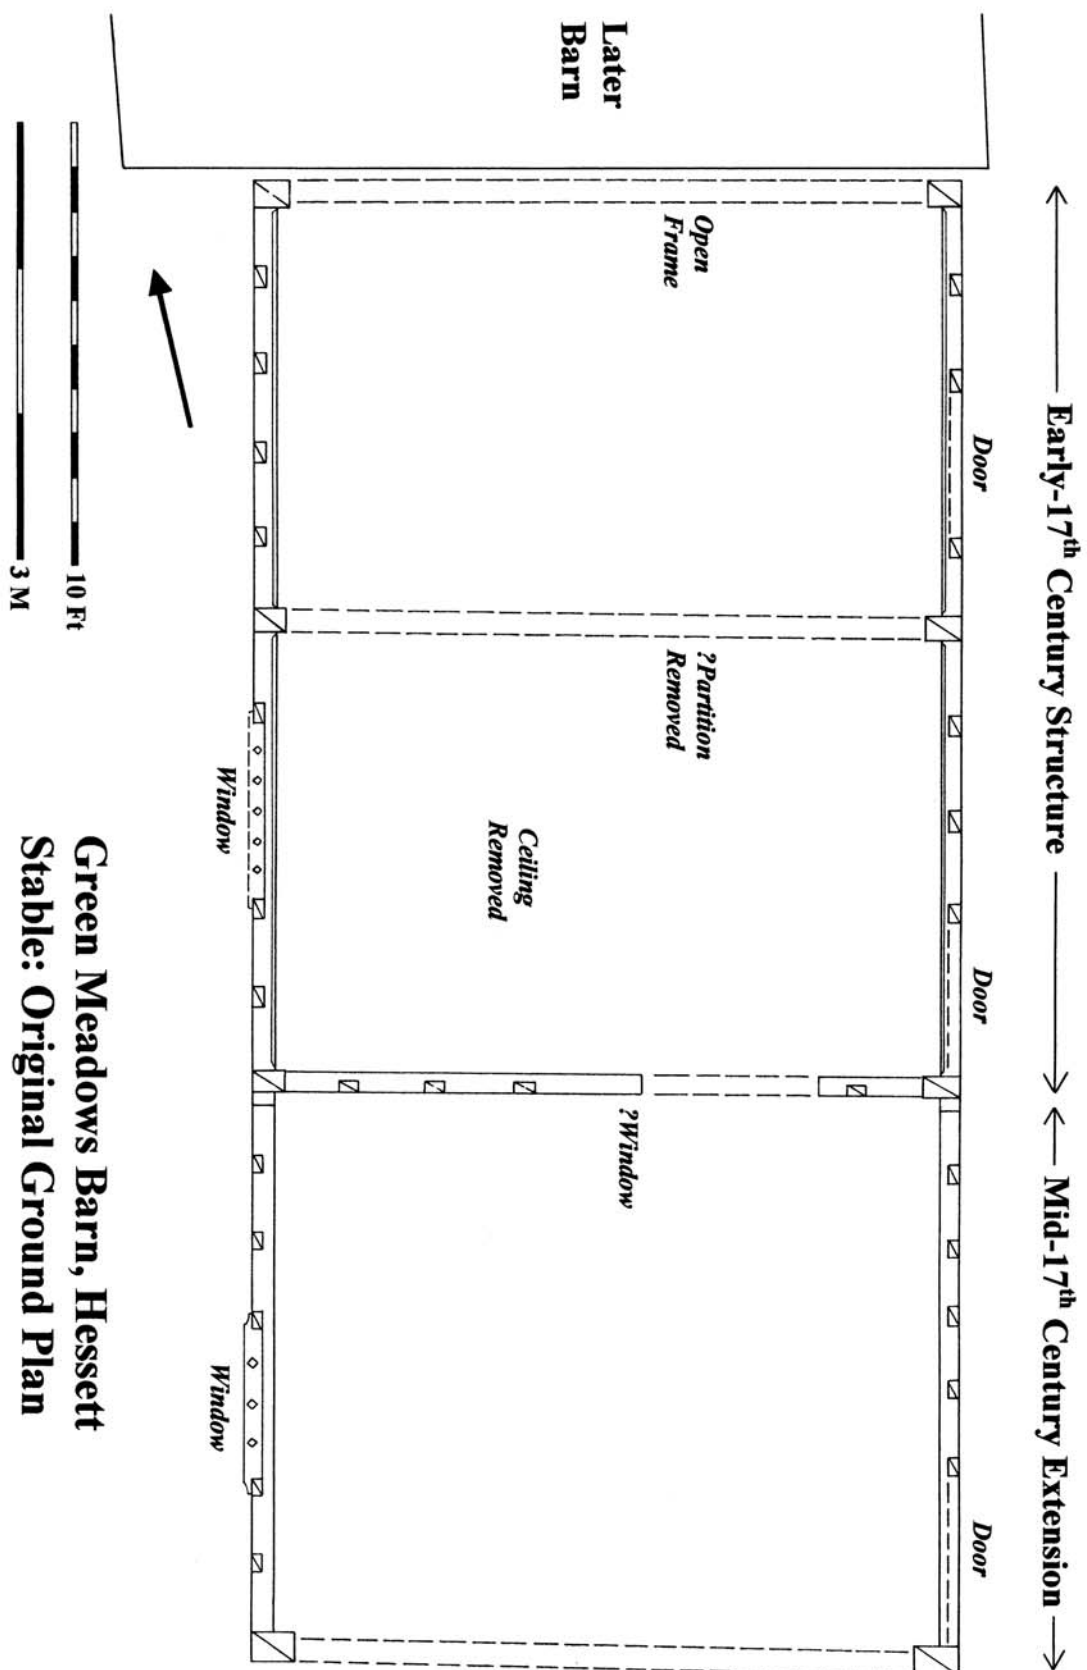
Figure 11. Stable, original ground plan

The northern bay of the earlier structure is 9 feet (2.75 metres) in length, and its southern counterpart 10 feet. The entire building extended to a little less than 21 feet (6.3 metres) in length before the addition of the new, longer southern bay increased this to 34 feet. It is not clear whether the two original bays were sub-divided as the tie-beam of the central truss has been lost and replaced with a lower timber supported on nailed brackets at ceiling level. There are no mortises for wall braces or wattle-and-daub fixing notches in the relevant wall posts, as might be expected if a solid partition had been

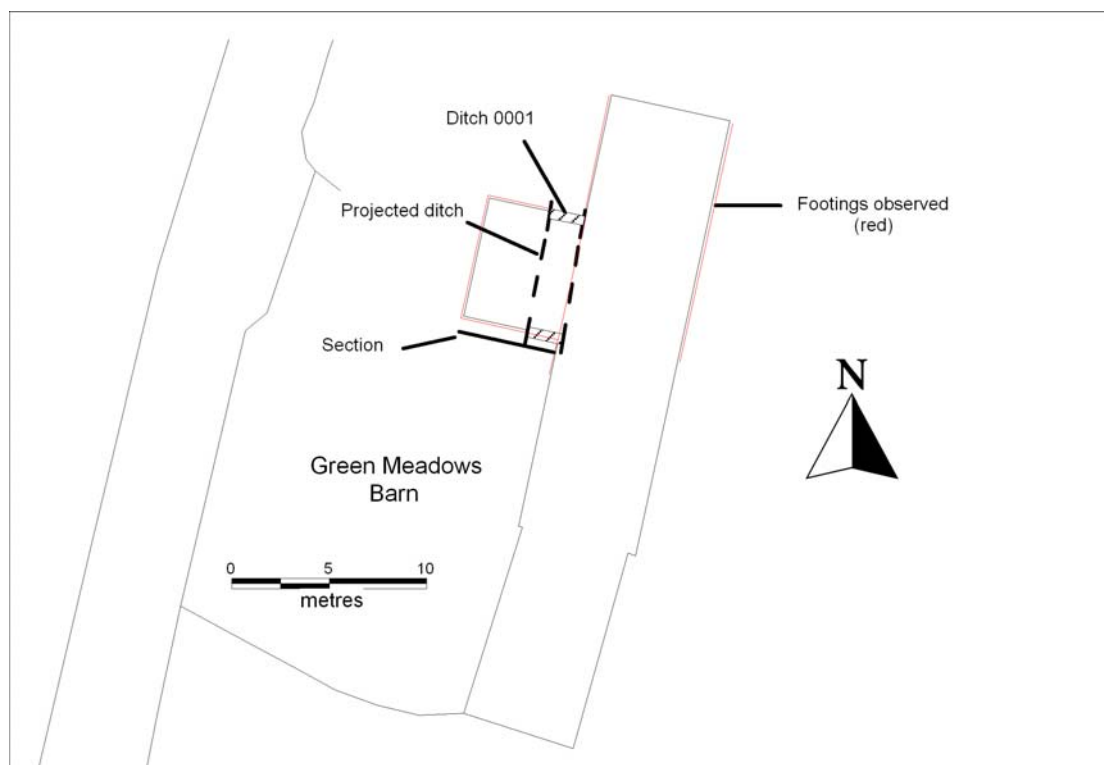
Figure 12. Site plan

The monitoring was carried out over three visits when footing trenches were observed after they had been excavated. The section revealed a mixed topsoil layer of c.0.4m over boulder clay. The cut for a brick culvert was identified at the western end of the trench and a second ditch was recorded that was aligned approximately north-south. The footing in which it appeared had already been partially infilled when the visit was made and the base of the ditch was therefore not seen. The recorded section includes a measured sketch of the south edge of this feature which ran beneath the north south wall.

Ditch 0001

This feature was c.2m wide and at least 0.7m deep. The visible fills comprised brown silt with a substantial layer of clay within the fill. No finds were recovered from the feature and no fragments of brick were observed in the section.

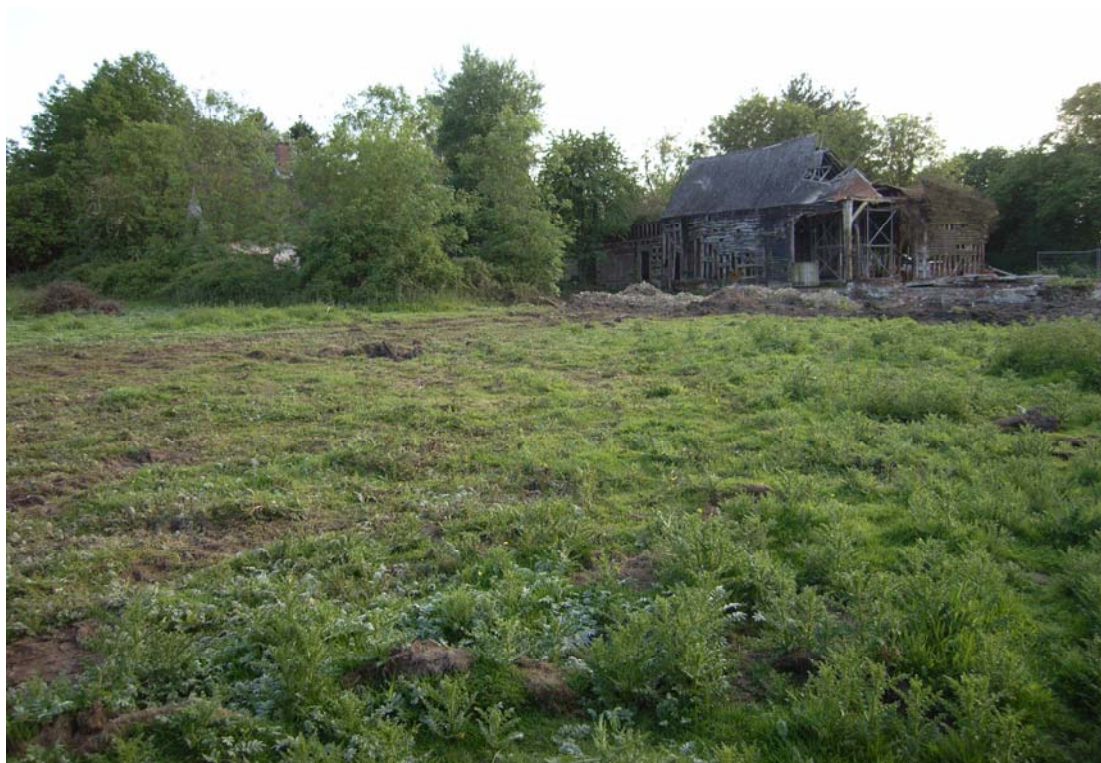
A2.1 General view of site from north-east showing the remaining fragment of Great Green in the foreground and 'Green Meadows' (the 17th century 'Green Farmhouse') to the left.
