**Barn at  
Mollett's Farm,  
Farnham, Suffolk  
FNM 019**

**Heritage Asset Assessment**

**Barn at  
Mollett's Farm,  
Main Road,  
Farnham,  
Suffolk  
(TM 366 602)**

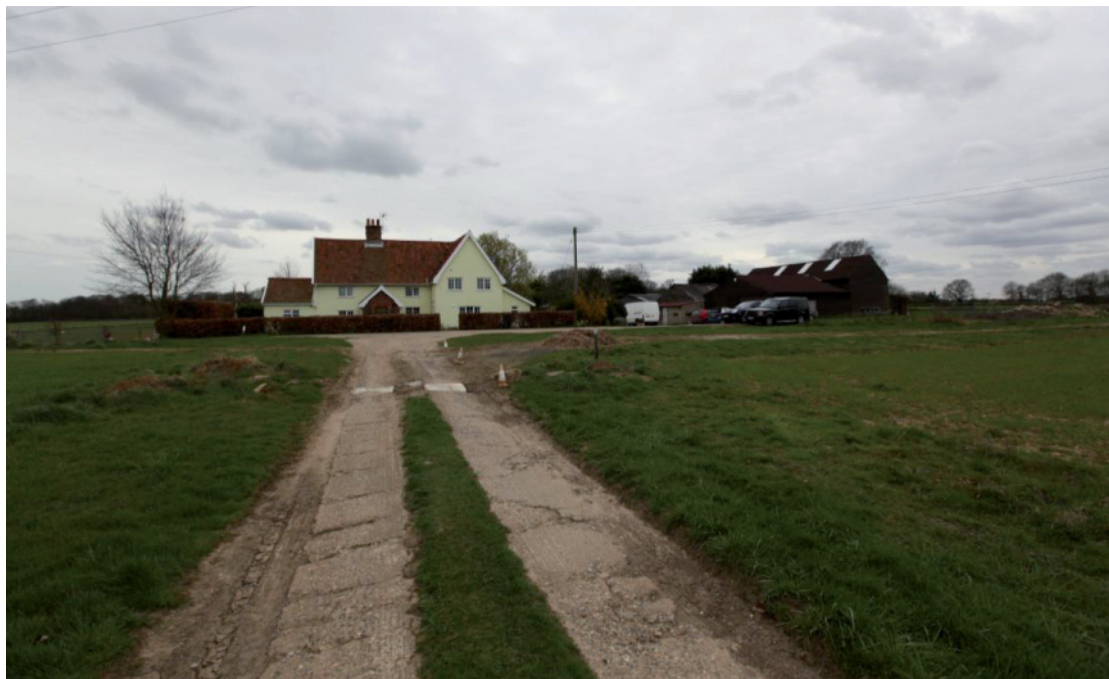
**Illus. 4 General view of the site from 20th century entrance leading from the main A12 to the north showing the unlisted farmhouse with an early-17th century parlour to the left and a late-20<sup>th</sup> century cross-wing to the right. The barn is shown to the far right. The track which passes from left to right in front of the house marks the boundary between Farnham and Benhall parishes (the photograph taken from Benhall).**

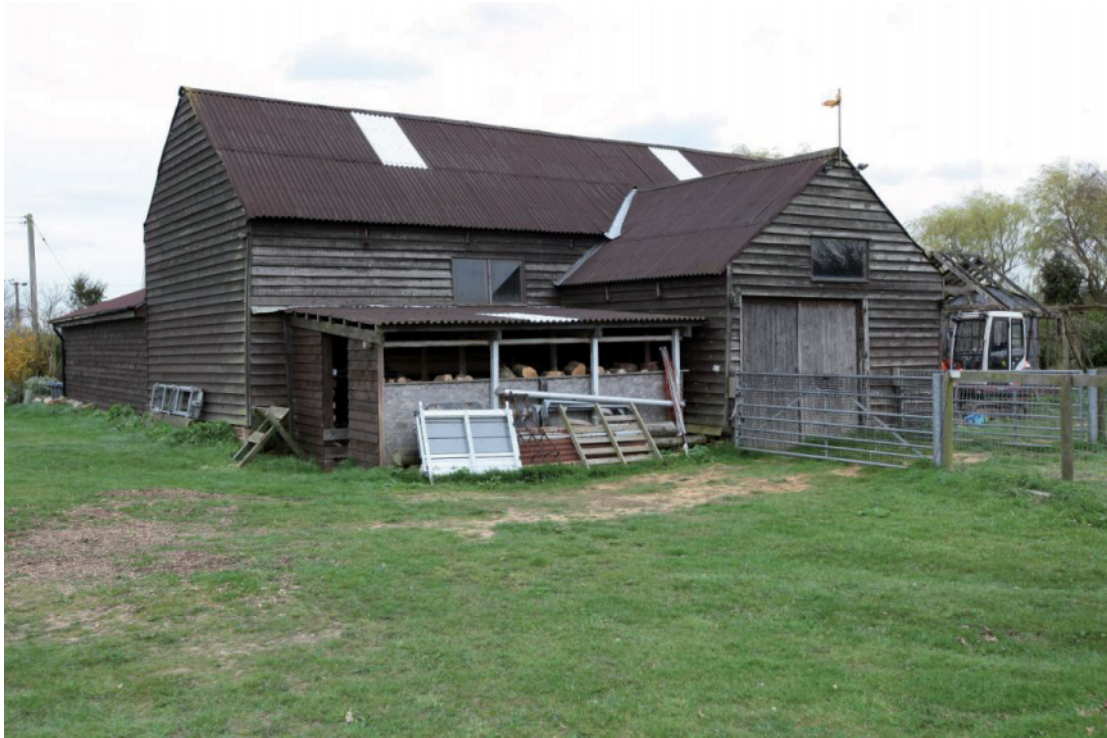
**Illus. 5** Exterior of the barn (1) from the north-west showing the modern lean-to woodshed (3) to the left & the 19<sup>th</sup> century porch (2) to the right.
