**Historic Building Record:
59 & 59a Highcross Street, Leicester
NGR SK 5835 0464**

For Hammerson Plc

Historic Building Record: 59 & 59a Highcross Street, Leicester

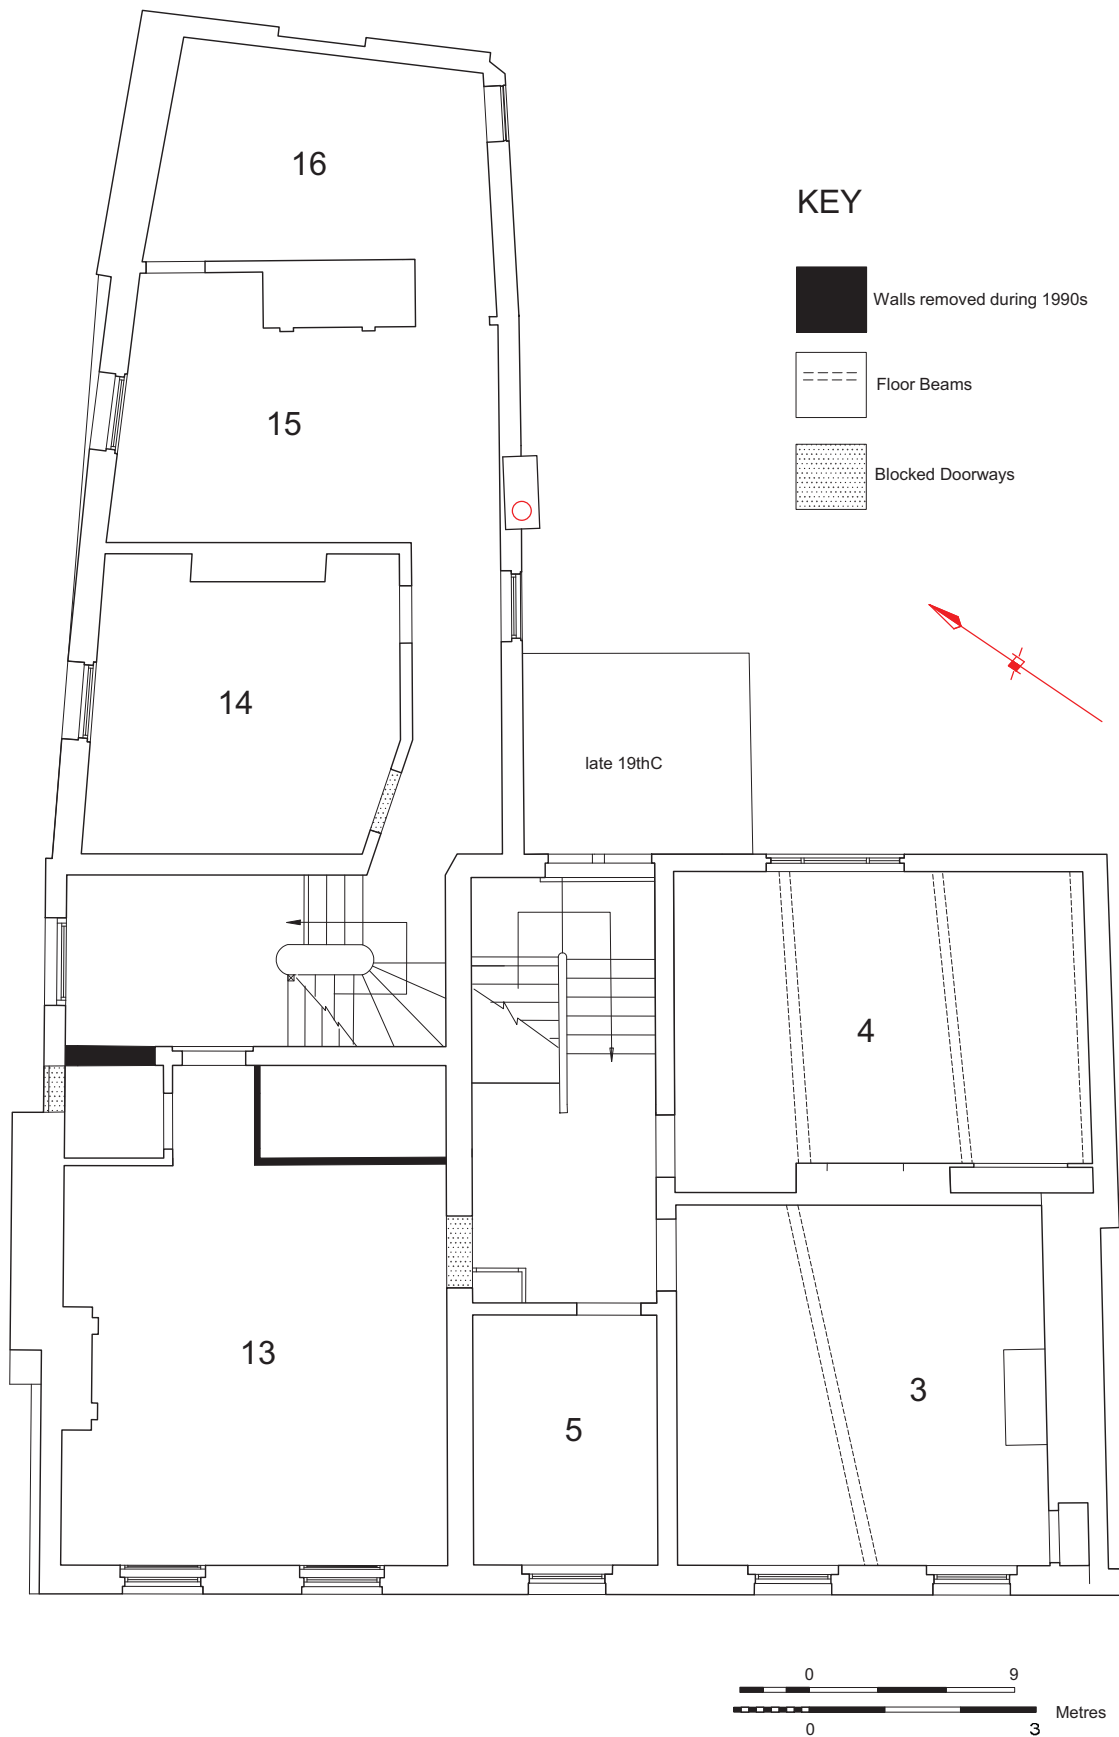
Figure 7. First floor plan omitting late 20th century partition walls.

No early features survive in this room. The present entrance is a recent insertion, the earlier doorway now blocked; its position is indicated on Figure 7.

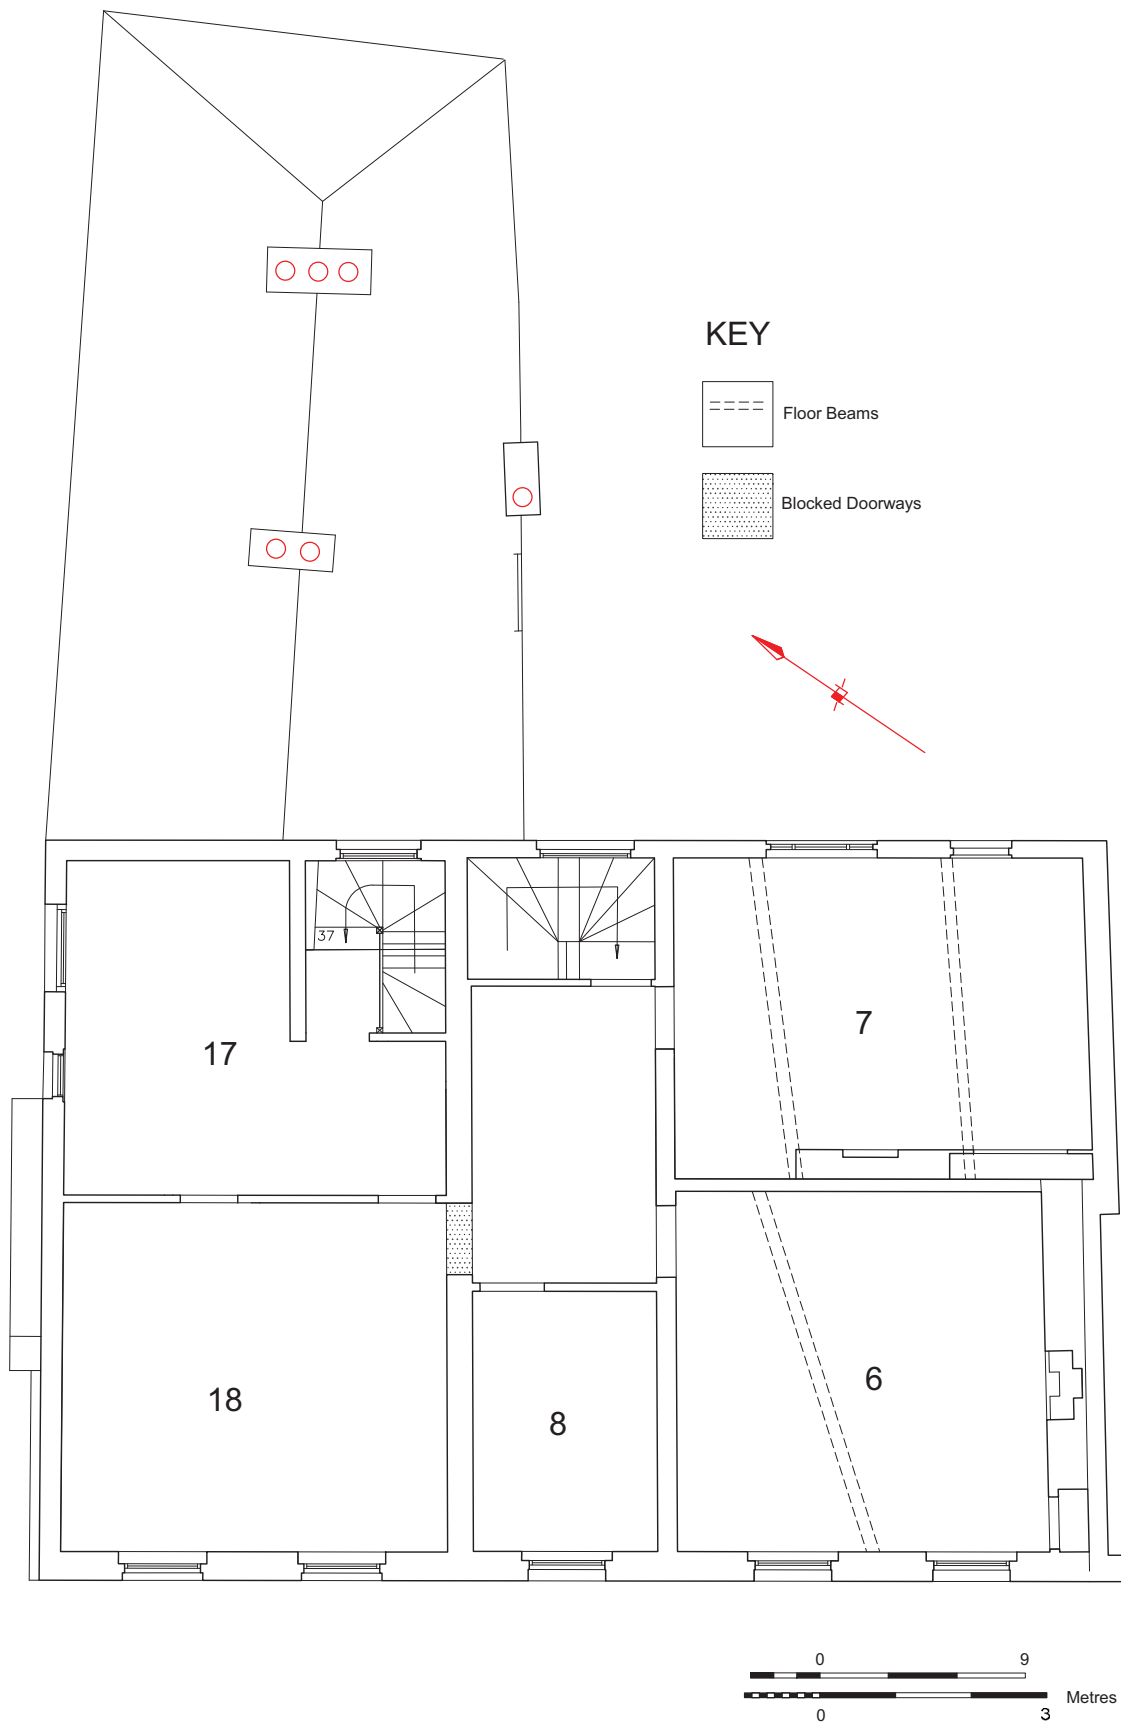
Figure 8. Second floor plan omitting late 20th century partition walls.

Evidence from the floor plans made prior to the 1990s conversion indicates that Flat 5 was formed from two separate second floor rooms, as illustrated in Figure 8. Room 17 opened off the service staircase. The final section of handrail and balustrade at the top of this staircase is missing and there is now a modern stud wall in this position. This room may have been unheated, possibly used for storage or service accommodation. There is a blocked doorway in the south wall of Room 18, opening onto the principal second floor landing. There was a secondary doorway from Room 17, opposite the service staircase which has been retained in the current layout, though the door is a modern replacement. A second door opening in this wall, to the north, is recent. No early fixtures or fittings appear to survive on this floor. The floor is again of gypsum plaster type. A variety of prostitution-related paraphernalia found within this flat at the time of the survey indicates that it was used most recently as a brothel and that this was a business, rather than a domestic arrangement. A series of diaries documenting the operation of the brothel, from its inception to closure have been retained and will be deposited with the Records Office for Leicester, Leicestershire and Rutland.

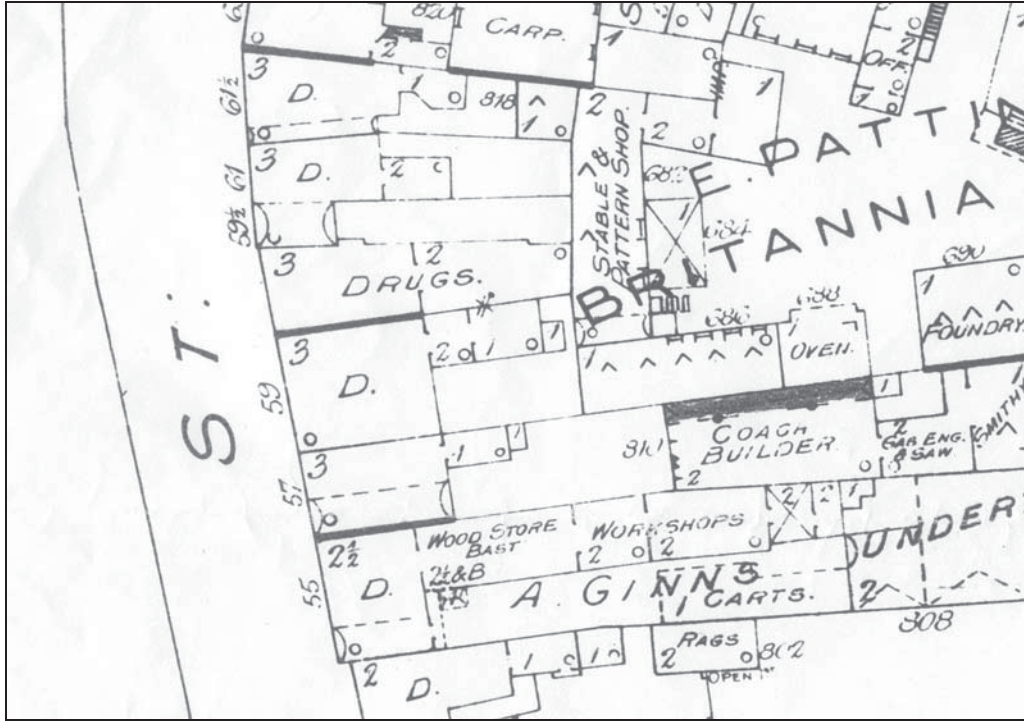
Three distinct structural elements are apparent from the external inspection (excluding a free-standing timber shed against the southern boundary wall of the property which is very recent in date and will not receive further consideration) (Figure 6). The earliest element is a small two-storey brick-built block with Welsh slate roof, on the north side of the plot (Figures 1 & 4, and outlined in green on Figure 6). This has a single first floor window with brick segmental arch head in the east gable wall. The ground floor forms part of the kitchen to the Rajah restaurant and is open into an adjacent single-storey range to the east (see below). Female and male toilets occupy the first floor. Access to the first floor is via an inserted doorway on the half landing of the 18th century frontage range; an original window opening was modified to form the doorway. This block was probably constructed in the latter half of the 19th century, certainly before 1895 as it appears on a Goad fire insurance plan of that year (LLRRO DE4702/14/2; Figure 4).

Figure 4. Extract from 1895 Goad fire insurance plan (LLRRO ref: DE4702/14/2) showing one and two storey ranges to the rear of 59 Highcross Street.

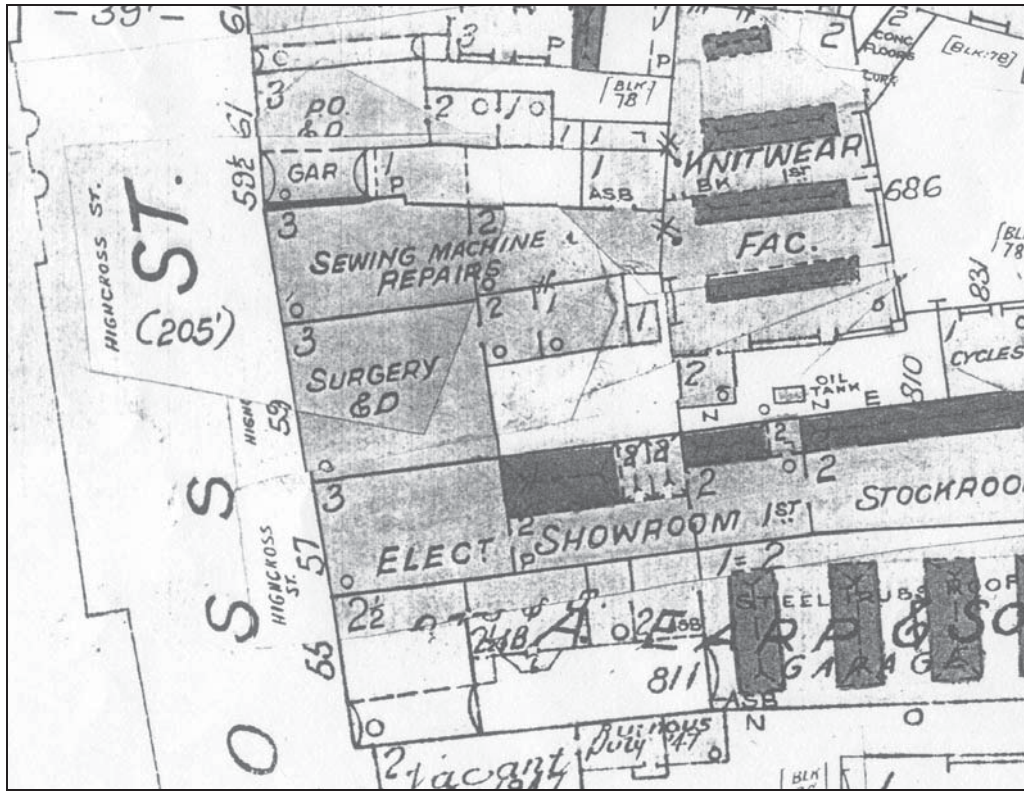
Occupying the southern part of the plot is a large single-storey flat-roofed range (outlined in orange on Figure 6). The brickwork of the east (rear) elevation is again attributable to the second half of the 20th century, and in all probability the last two or three decades (Figure 2). This range does not appear on a fire insurance plan of 1961 (LLRRO DE4702/15/2; Figure 5). The thickness of the south wall of this block suggests that it was constructed inside the line of the southern boundary wall to the property.

Figure 5. Extract from 1961 Goad fire insurance plan (LLRRO ref: DE4702/15/2) indicating that the large single-storey block on the south side of the plot was not extant by that date.

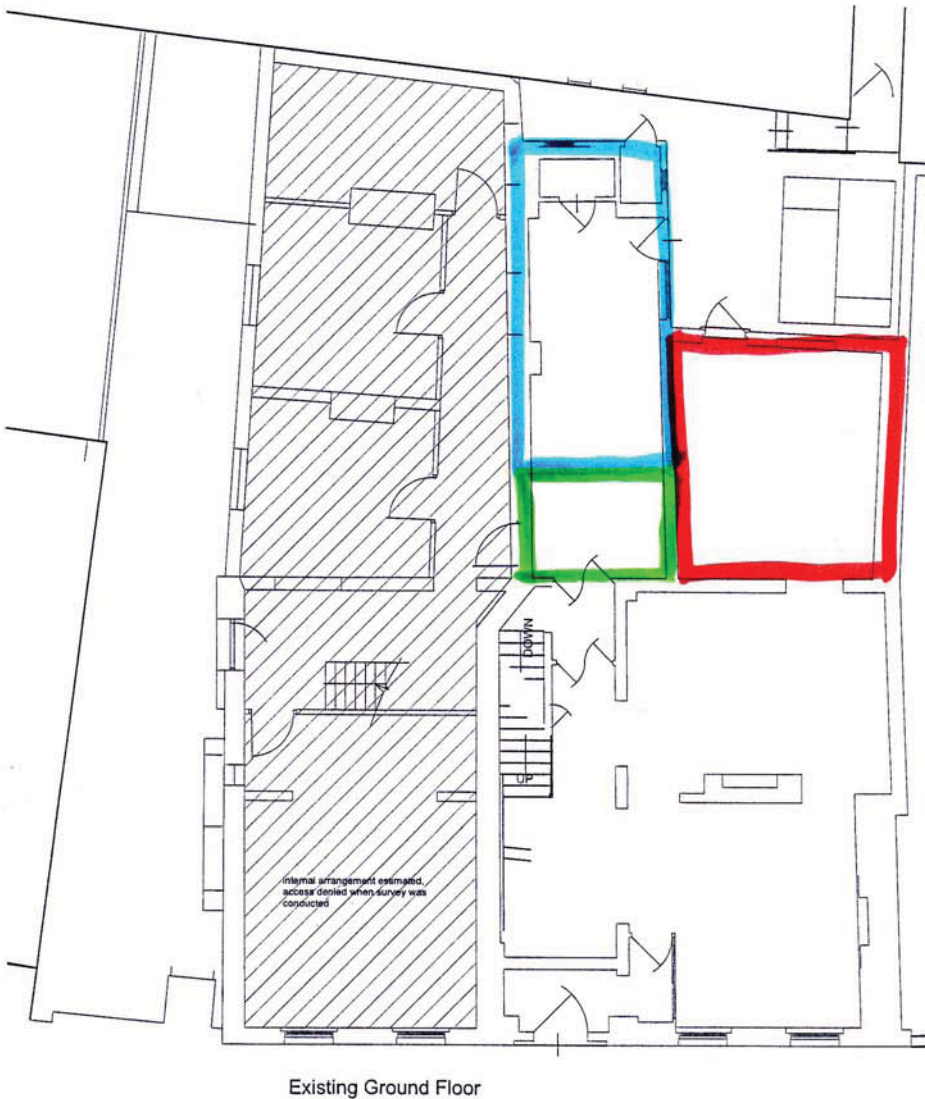
Figure 6. Ground Floor Plan of 59 and 59½ Highcross Street illustrating the three distinct structural elements to the rear range of number 59. North to left of page (approx.).

To the east of the two-storey range described above is a single-storey brick-built block with flat roof, mainly occupied by the restaurant kitchen. Beyond the kitchen area, towards the rear of the plot, is a toilet with separate access from the yard (Figure 3, outlined in blue on Figure 6). There are several distinct phases of brickwork in the south wall of this block. The earliest brickwork is in the lower section of the toilet. The toilet block was extant by 1895 and appears on the Goad fire insurance plan of that year (LLRRO DE4702/14/2), located to the rear of a single-storey range of similar plan form to the extant block (Figure 4). However, the brickwork of the south wall between the toilet area and the two-storey range is comparatively recent, certainly attributable to the second half of the 20th century and very probably the last quarter of that century (Figure 3).
