**An Historic Building Photographic
Survey at 49 Main Street,
Great Bowden, Leicestershire
NGR: SP74150 88835**

ULAS Report No. 2012-068
©2012

For: Mr and Mrs B Organ

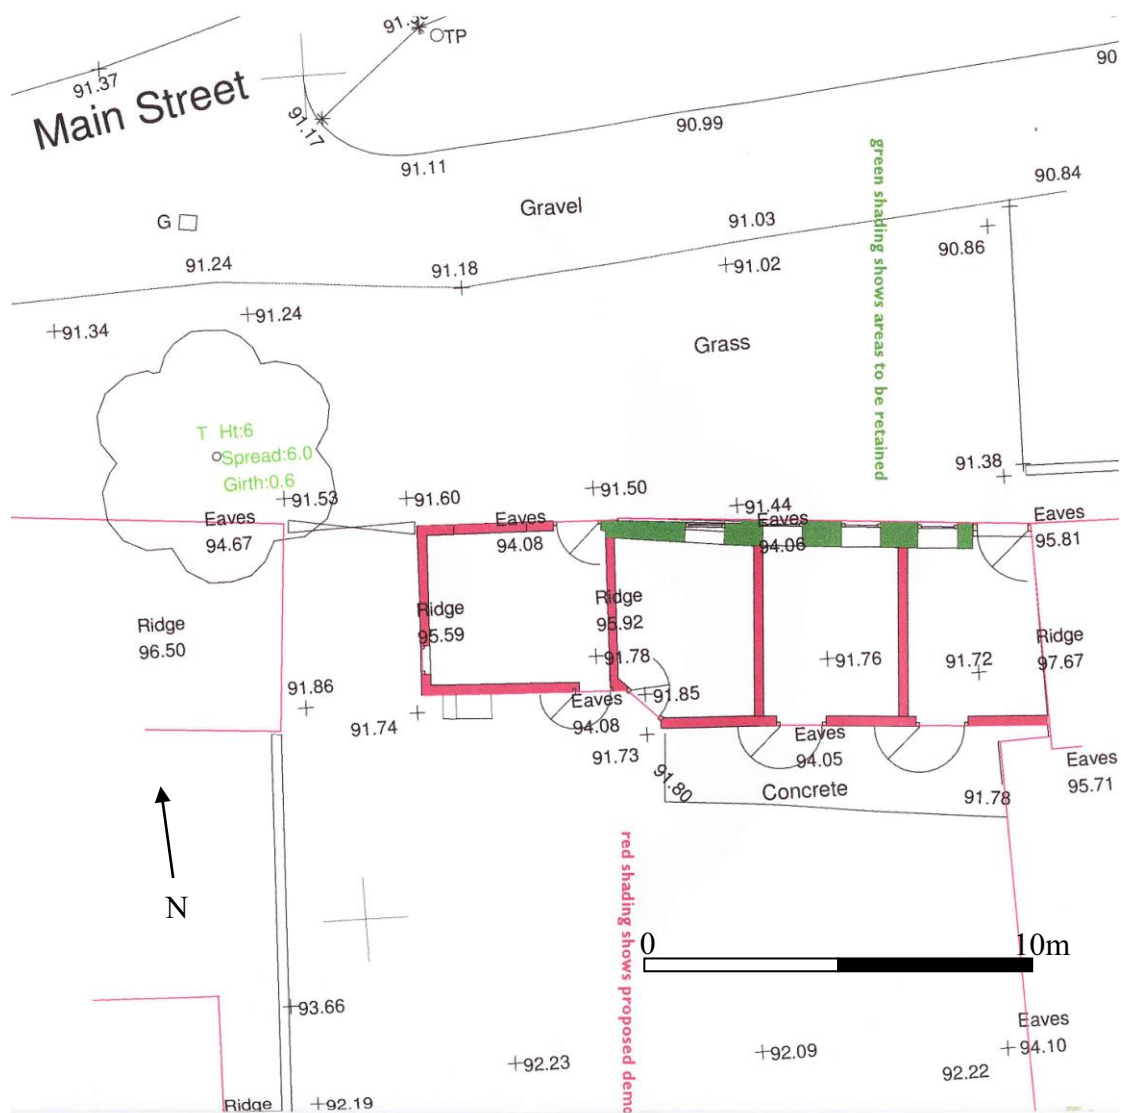
Figure 3. Existing plan of surveyed buildings
 Plan supplied by Henderson Scott Architects
 Red outline shows proposed demolition, green to be retained

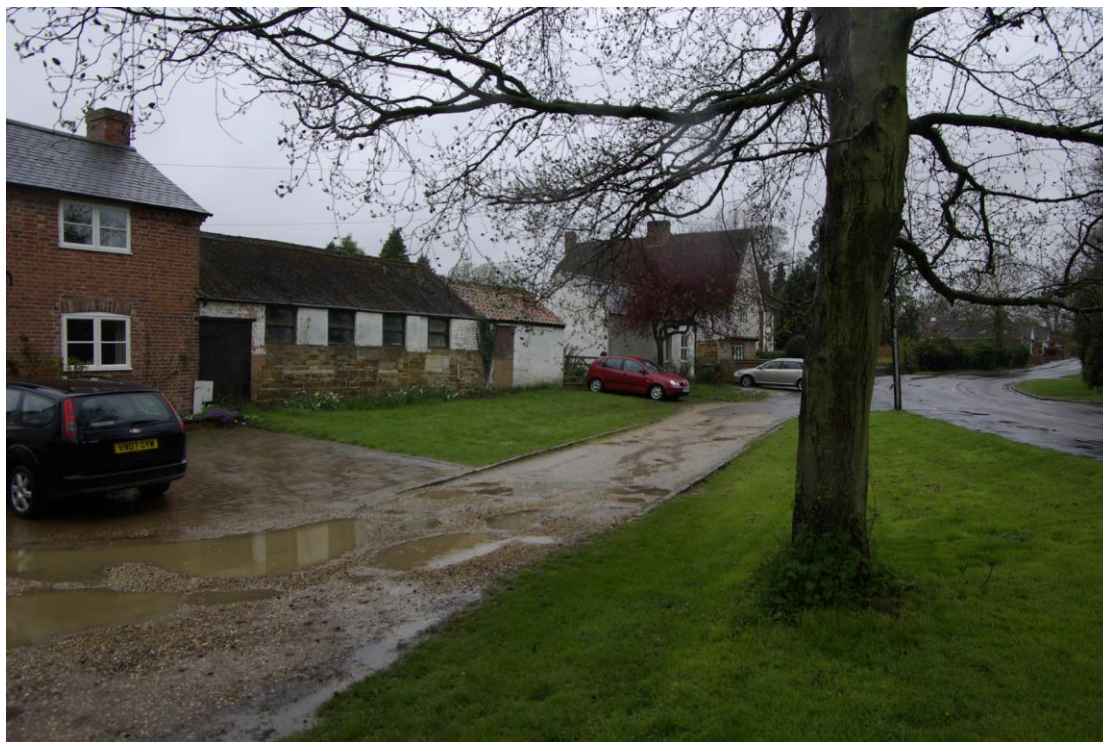
Figure 4. General view of site viewed from Main Street
Looking south-west. Note realigned road curving north to pass over railway to the east

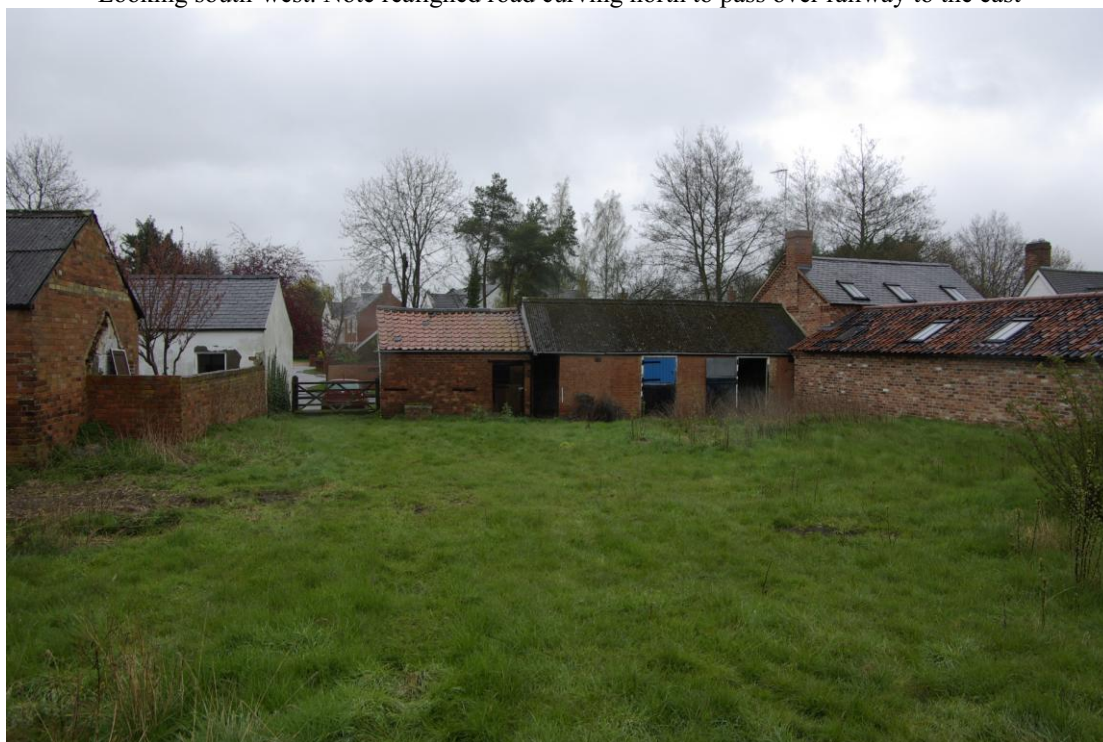
Figure 5. General view of site from rear of paddock
Looking north
