**An Historic Building Survey at
The Whittle Estate, Cambridge Road,
Whetstone, Leicestershire
NGR: SP 5565 9685 centre**

ULAS Report No. 2012-205
©2012

For: EDP/Revelan Ltd

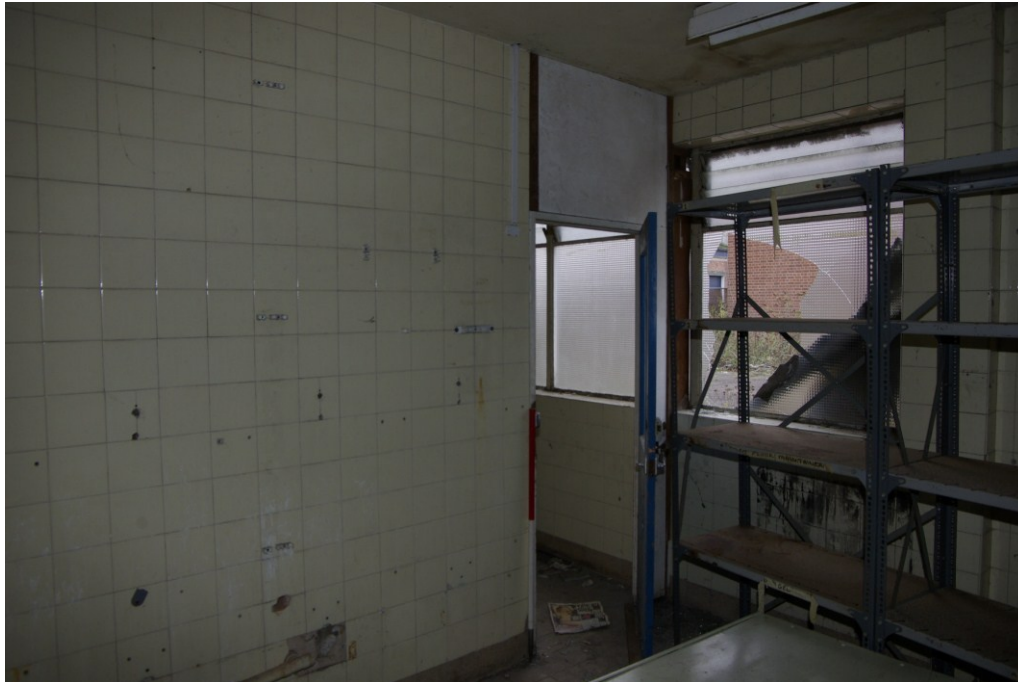
Figure 48 Toilet and cloakrooms (Looking south-east. 1m scale)

Starting at the western end of the main building there are a set of tiled rooms used for toilets and cloakrooms built under a mezzanine floor housing the water tank and other services as already mentioned (Fig. 48). These appear to be part of the original layout although the tile wall covering makes it difficult to identify phasing should any exist. The small lean-to office is clearly later and uses an earlier window on its east wall to look into the main body of the lean-to.

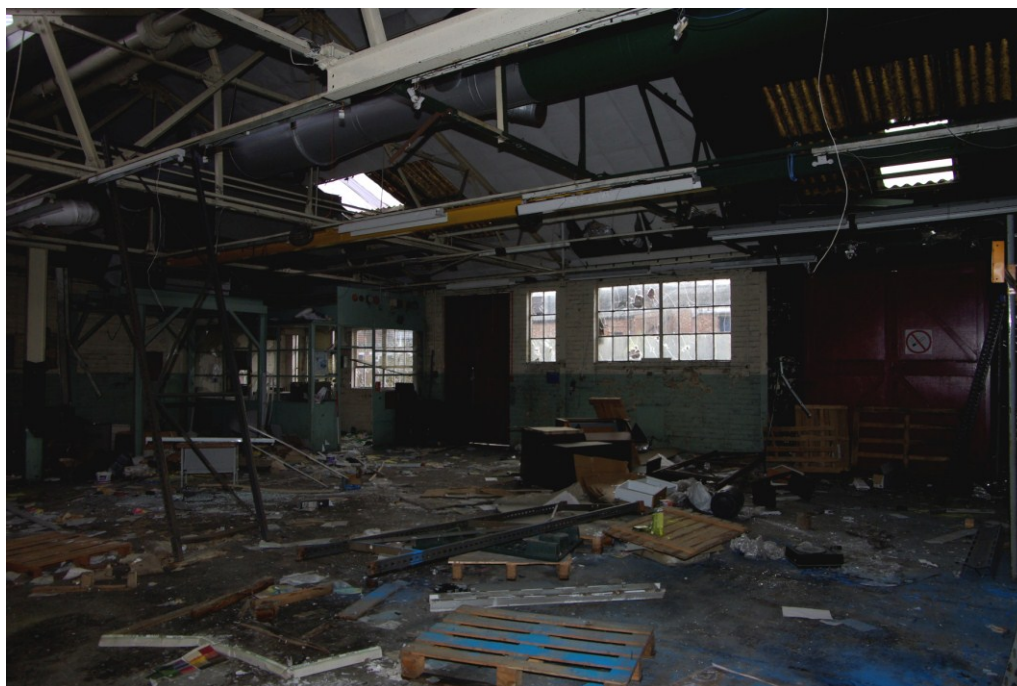
Figure 50 Room 2 (Looking south-east)

Room 2 is similar in layout to Room 1 but has a small metal and glass partitioned office in the south-east corner (Fig. 50). Running from east to west across the roof trusses is an I-beam which was used as a hoist as it is painted yellow and bears the safe working load limit of 500kg/10cwt. It is probable that this dates to the same time as the construction of Block 6 as it uses Skinningrove produced steelwork. If not original it must at least have been installed before 1951. A small doorway leading from the small office passes through a wooden panelled door into Room 3. The style of the door matches those seen in Room 4 discussed below.

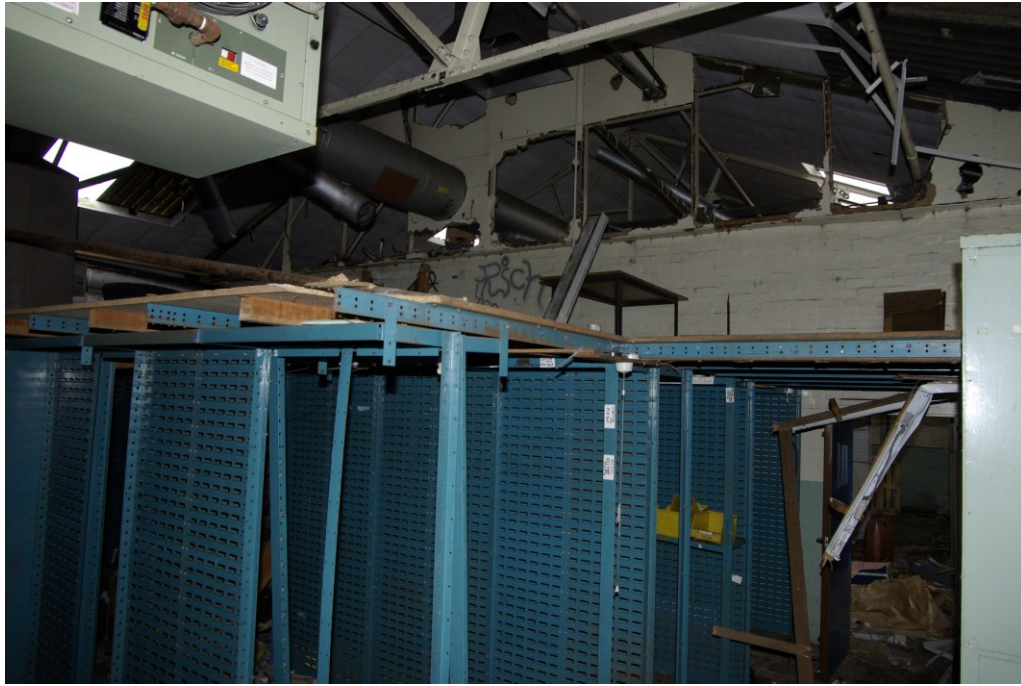
Figure 51 Room 3 (Looking north-east)

Room 3 forms a fairly small room in comparison with the others and is full of racking used to hold engineering spares and stores (Fig. 51). A lightweight mezzanine floor has been built over these racks but all are of a fairly modern date and do not have any relationship with the rooms earlier uses. A portion of the north wall has been removed to gain access into the lean-to extension which from this point eastwards forms a long room reaching as far as the north-east corner of the Block (Fig. 52). A single doorway near to the south-east corner leads into the next room.

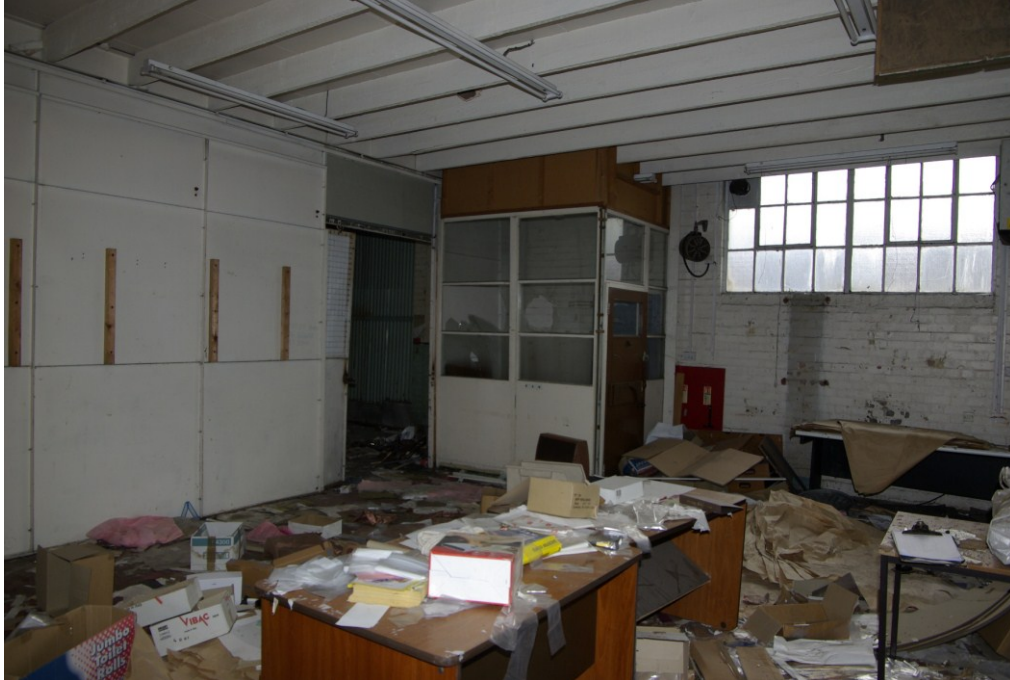
Figure 53 Room 4, office (Looking south-east)

Room 4 has been divided into a large office and a storage area using full-height partition walls (Figs. 53 and 54). A small metal and glass porch creates a minimally-sized entrance lobby into the office from North Road and, from the style of the fittings, appears to be as originally built or from very soon after. A brick built room is located in the north-west corner of Room 4 and has a doorway from Room 3 and one to the outside but has no clear function. A series of hoists built into the roof trusses

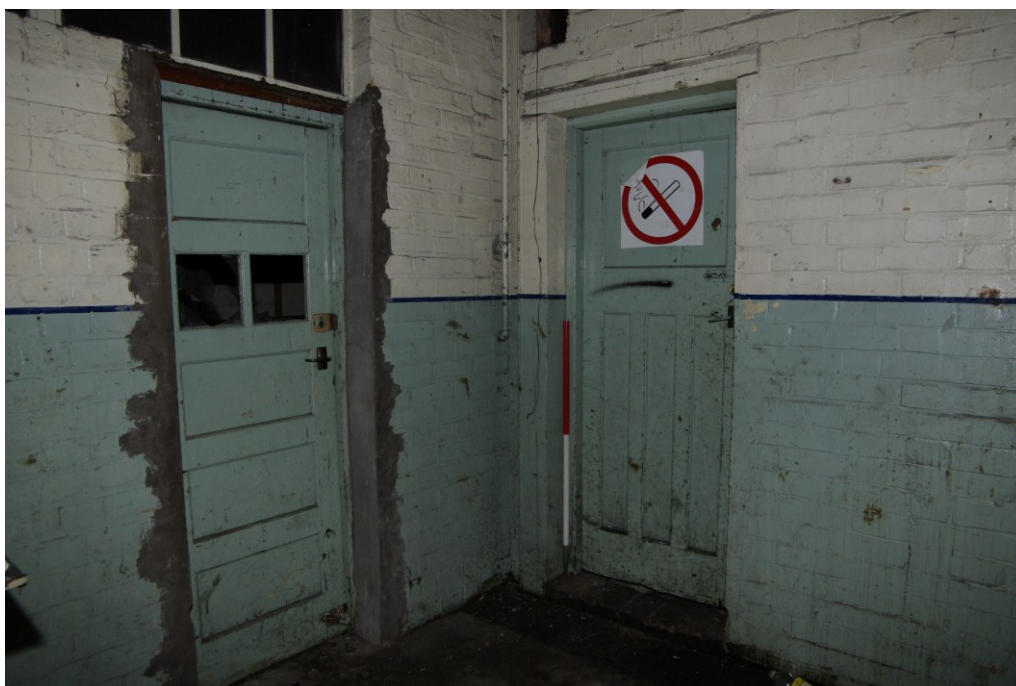
Figure 55 Room 4 door detail (Looking north-east. 1m scale)

have steelwork with the names of Skinningrove and Shelton on them which suggest that they are part of the original construction. Two wooden doors in the north-east corner of the room appear to be original and are of the same style as that seen between Rooms 2 and 3 (Fig. 55).

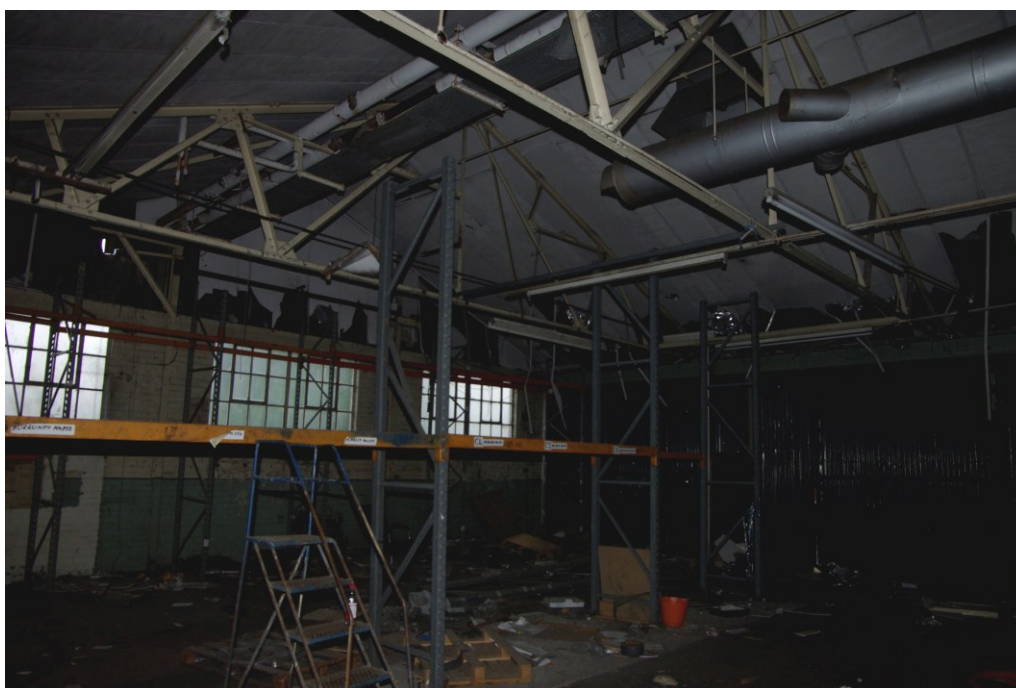
Figure 56 Room 5 (Looking south-east)

Room 5 is the easternmost room of the block and was most recently used as a small garage which appears to be a continuation of its originally intended use. It contains some racking but no other evidence of former uses (Fig. 56). Large sliding corrugated iron doors occupy most of the southern wall and are supported by a substantial steel beam acting as a lintel running across the top of them. There is evidence of a large steel hoist by these doors which has been cut off at eaves height but this is probably a later addition as the surviving steel upright which still remains has the name of BSC SSG Gt Britain indicating that it was obtained from the nationalised British Steel Corporation.

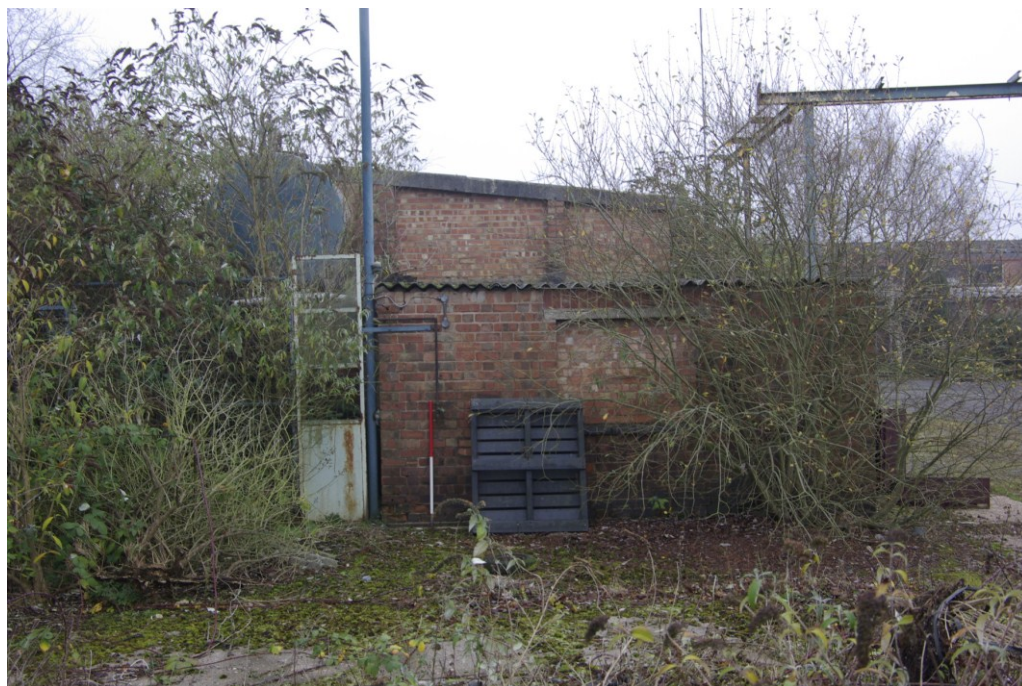
Figure 58 West facing elevation (Looking east, 1m scale)

Block 6a is a single storey brick-built structure with a number of different roof angles and heights. It has corrugated sheet asbestos and flat concrete roofs in the north-west corner which holds a drum-shaped tank (Figs. 57, 58, 59 and 60). It lies near to the north-east corner of Block 6 and is identified on EDP/Revelan plans and by numbers attached to the building as Block 44 which suggest that it may be a later addition to the estate although it does appear on the 1967 OS map. Despite its odd shape there do not appear to be any joints in the brick work which would suggest that it is all of one building phase.

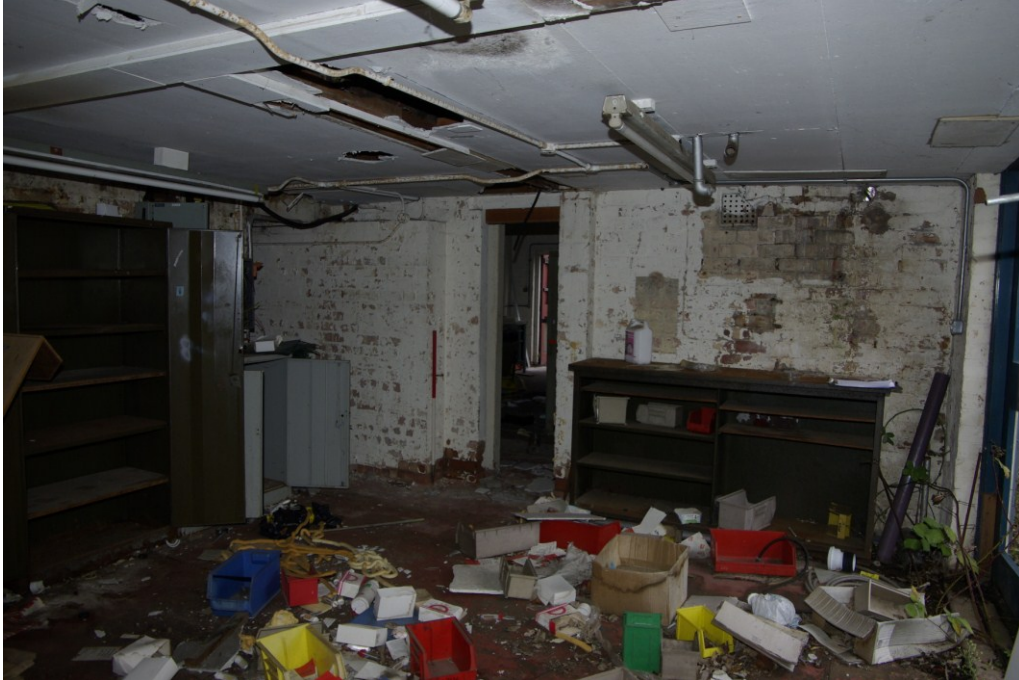
Figure 61 South-western room (Looking north-east)

Internally the building is divided into three rooms. The room to the south-west has large double doors leading into it from the south and a window has been blocked up on the west wall which could suggest that this space was once used as an office or small laboratory (Fig. 61). The room also has a lined ceiling and strip lights which further support the office idea, the remains of cabinets and benches are also present. On the north side of this room is a small store room without any windows and is

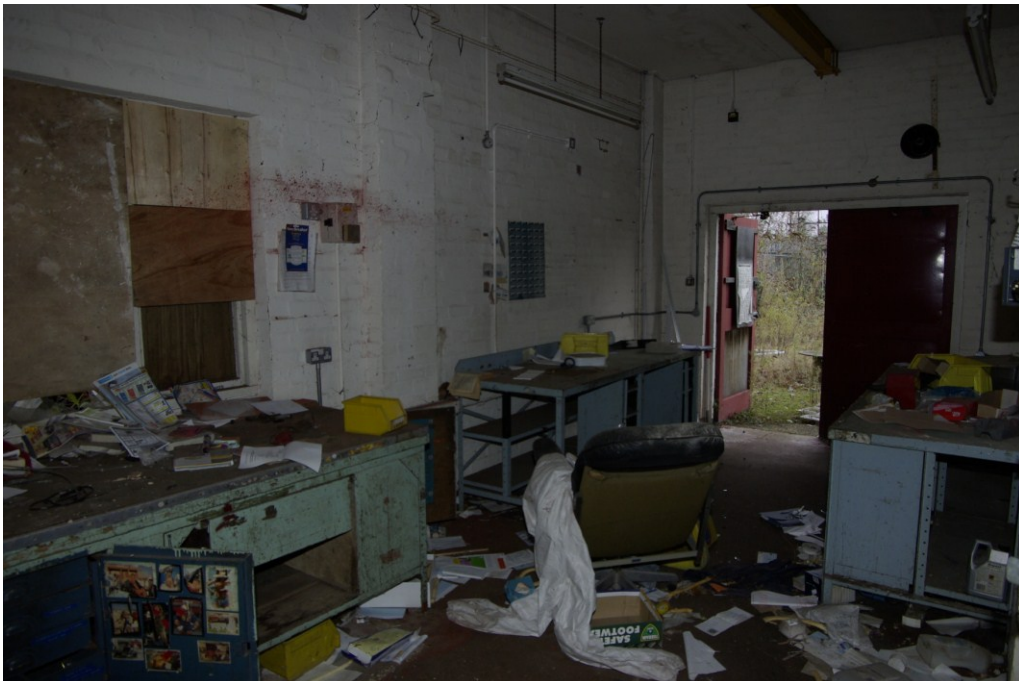
Figure 62 North-eastern room (Looking north-east).

devoid of any surviving fittings. The room to the north-east is an L-shaped room and was last used as a small workshop as the workbenches are still present (Fig. 62). A hoist is attached to the ceiling running from east to west from the double doors on the east wall.
