**Archaeological Survey and Recording of Rampart Erosion
at Burrough Hill Hillfort, Burrough-on-the-Hill, Leicestershire**

ULAS Report No 2014-006

**Archaeological Survey and Recording of Rampart Erosion
At Burrough Hill Hillfort,
Burrough-on-the-Hill,
Leicestershire
NGR: SK7605 1195 centre**

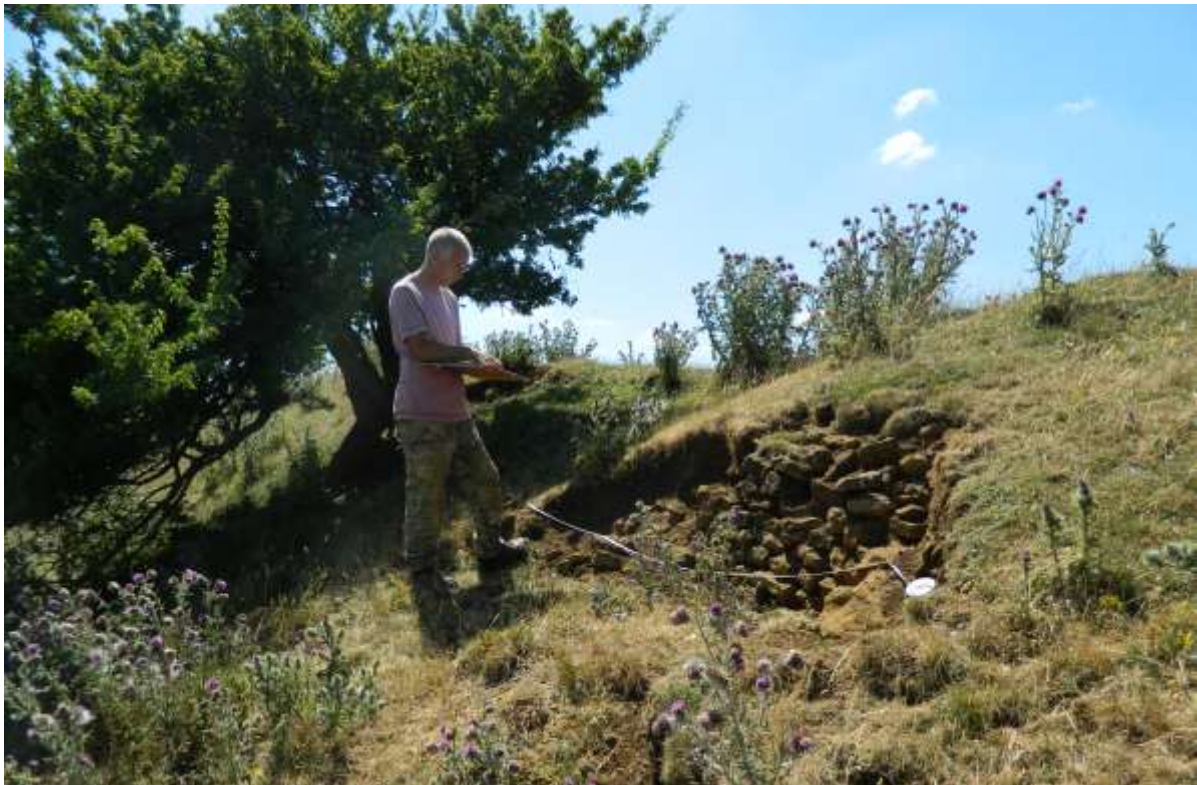
Figure 5 Recording exposed drystone walling.

Other areas revealed more coherent information relating to the construction of the hillfort ramparts.
