**A Level 2 Historic Building Survey at  
The Old Barn,  
Merry Tom Lane, Brixworth,  
Northamptonshire.**

**NGR: SP 744 694**

**ULAS Report Number 2016-022**  
©2016  
Event Number ENN108218

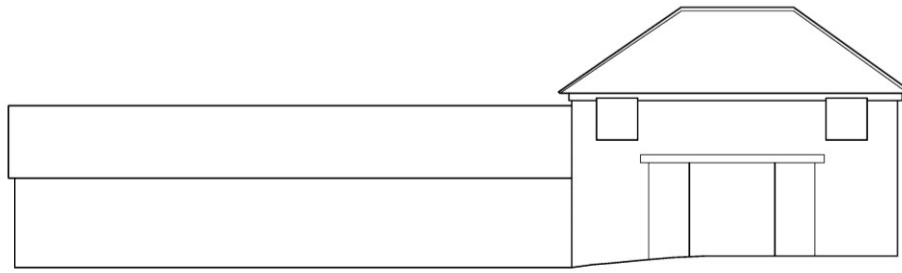
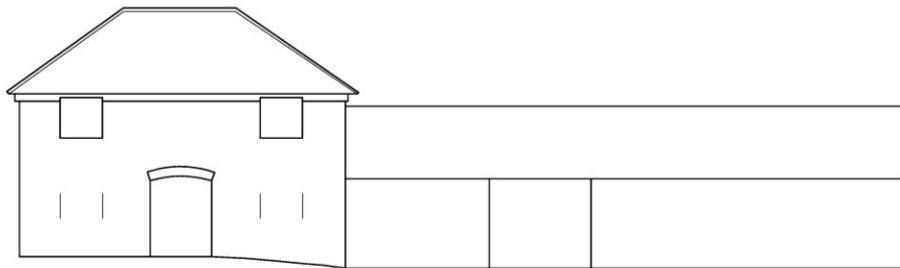
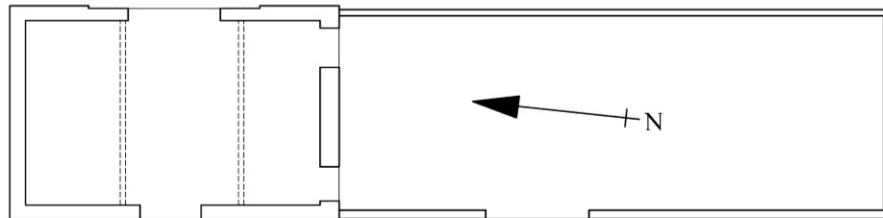
Figure 8 Elevations and plan  
Modified from drawings supplied by client

At first floor level are two rectangular openings housing modern window frames. These are not the original openings as the sides appear to cut through the stonework and the insertion of the lintels has removed part of the brick courses at the eaves (Fig. 11). Rather than being knocked through the stonework has been cut with a power tool creating a very smooth surface and sharp edges suggesting that this has happened in the last few years. The internal sides of both windows have been re-laid with red brick and modern mortar. The modern window frames that have been fitted are in a poor condition and are suffering from both vandalism and the effects of weather. The window openings may or may not replace earlier and smaller openings.

The slated roof is in a reasonable state of repair although there are two patches where the slates are beginning to slip.
