A Schedule of Internal Historic Features at the former Towers Hospital, Gypsy Lane, Leicester.

ULAS Report No. 2015-177 ©2015

# A Schedule of Historic Features at the former Towers Hospital, Gypsy Lane, Leicester.

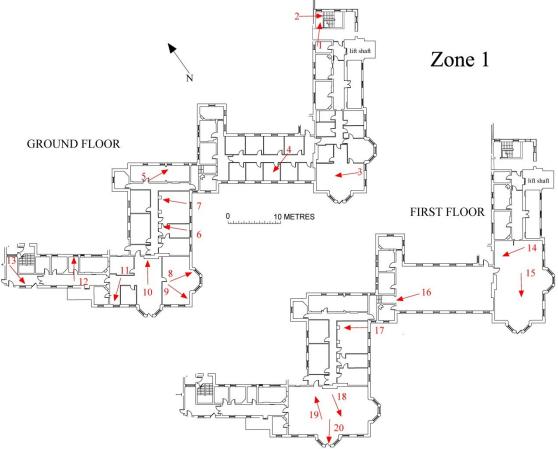
Figure 2 Zone 1, plan of historic features The numbers in red refer to the photographs shown below

- At the north-eastern end of the Zone is a set of stairs with an original panelled door and moulded pine hand rail (Figs 2, 3 and 4).
- Supporting ceiling joists in the former wards have beading and decorative bolts along their length. This feature is seen throughout all ground floor zones (Fig. 5).

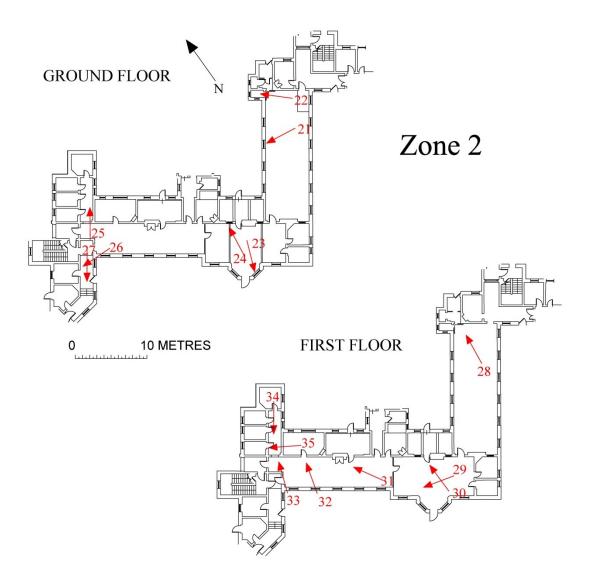
Figure 23 Zone 2, plan of historic features Red numbers indicate photograph locations

- Most timber window surrounds survive as do the remaining toilet windows. All have moulded edging although many have indications of rot (Figs. 24 and 25).
- The day room in this zone has had shaped hardboard sheeting nailed over the original wooden panelling (Figs 26 and 27). The later covering has been removed in places to reveal the panelling which survives in places although much appears to have been truncated or damaged.
- The original high skirting board with moulded tops can be seen in some of the cell corridors (Fig. 28).
- As with Zone 1 the connecting corridors and cells retain their glazed brick walls which have been painted over with white emulsion (Figs 29 and 30).
