**An Historic Building Assessment at  
Sleath Farm,  
Ashby Road, Gilmorton,  
Leicestershire.**

**NGR: SP 570 882**

ULAS Report No.2016-026  
©2016

**ULAS Report Number 2016-026**

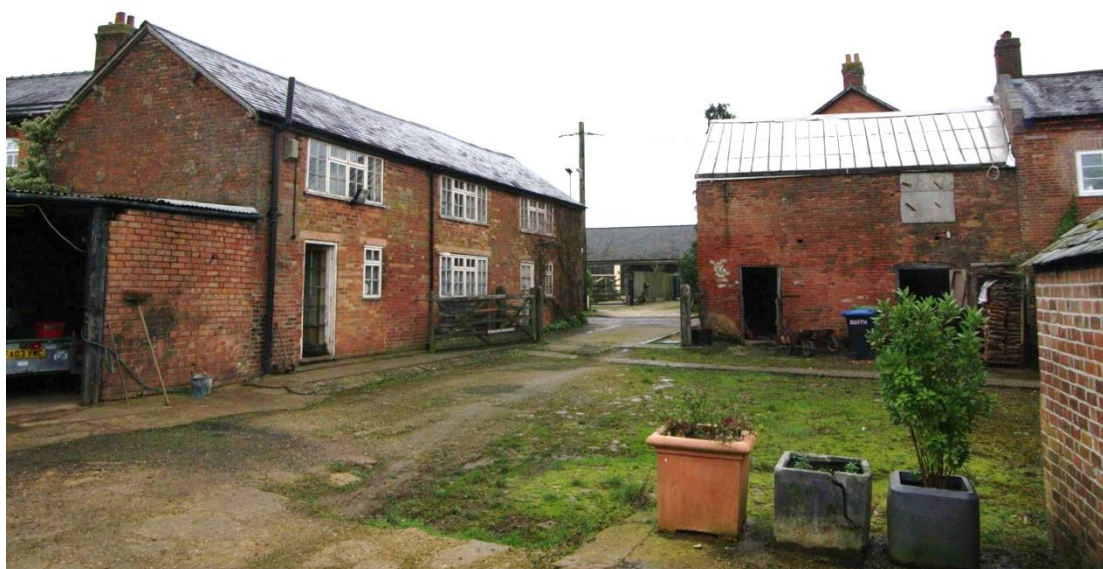
The two-storey buildings along the site's north boundary were converted in the late 20th century to a print workshop by the insertion of larger windows and other internal modernisation work (Fig. 7). At the west end of the workshop are a range of single storey outbuildings currently used for storage. The pigsty and stable type buildings to the south-west and west are shown in Figure 5 above. A gap between the stable buildings and the north range leads westwards to another grassed area but would originally have led out to the fields associated with the farm.

Figure 7 North boundary range of buildings and barn  
Looking north-east. Barn and farmhouse on right of picture

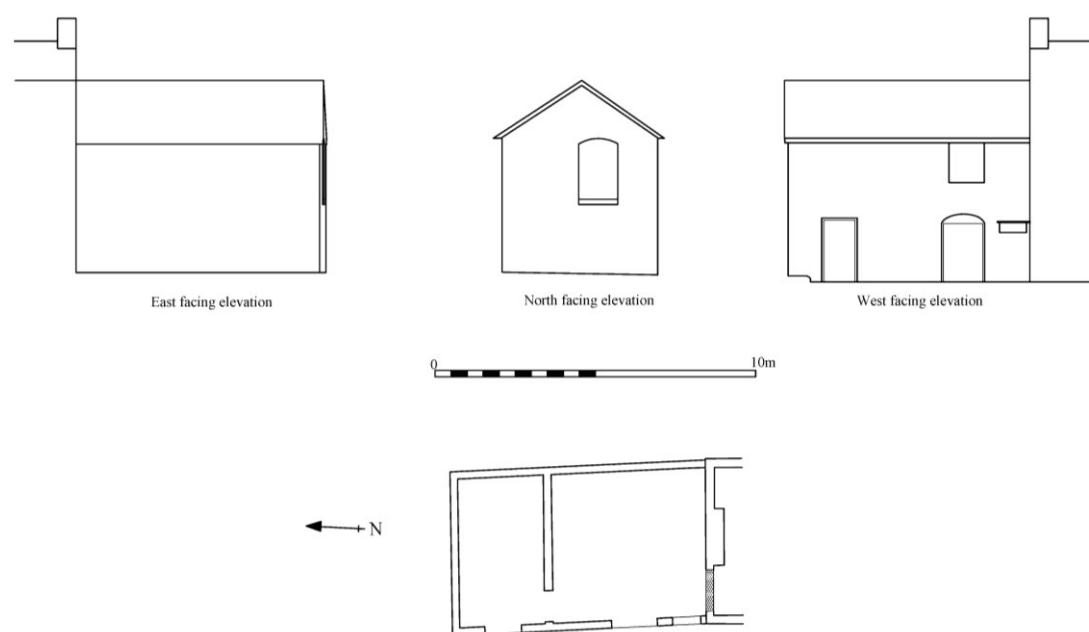
Figure 8 The barn

The barn is a brick-built structure with a slate roof. The walls are in a relatively poor state of repair and show signs of distortion. The bricks appear to be handmade and are laid in courses approximating to three stretchers and one header. The bricks measure approximately 230mm (9") long by 110mm (4¼") wide by 63mm (2½") high. Many of the bricks are suffering from damp and have been affected by frost and weathering. The slates on the west side of the roof have been removed to lessen the load on the walls.
