**A Level 2 Historic Building Survey at
Limes Farm, Main Street,
Kilby,
Leicestershire**

ULAS Report No. 2016-008
©2016

For: Leicestershire County Council

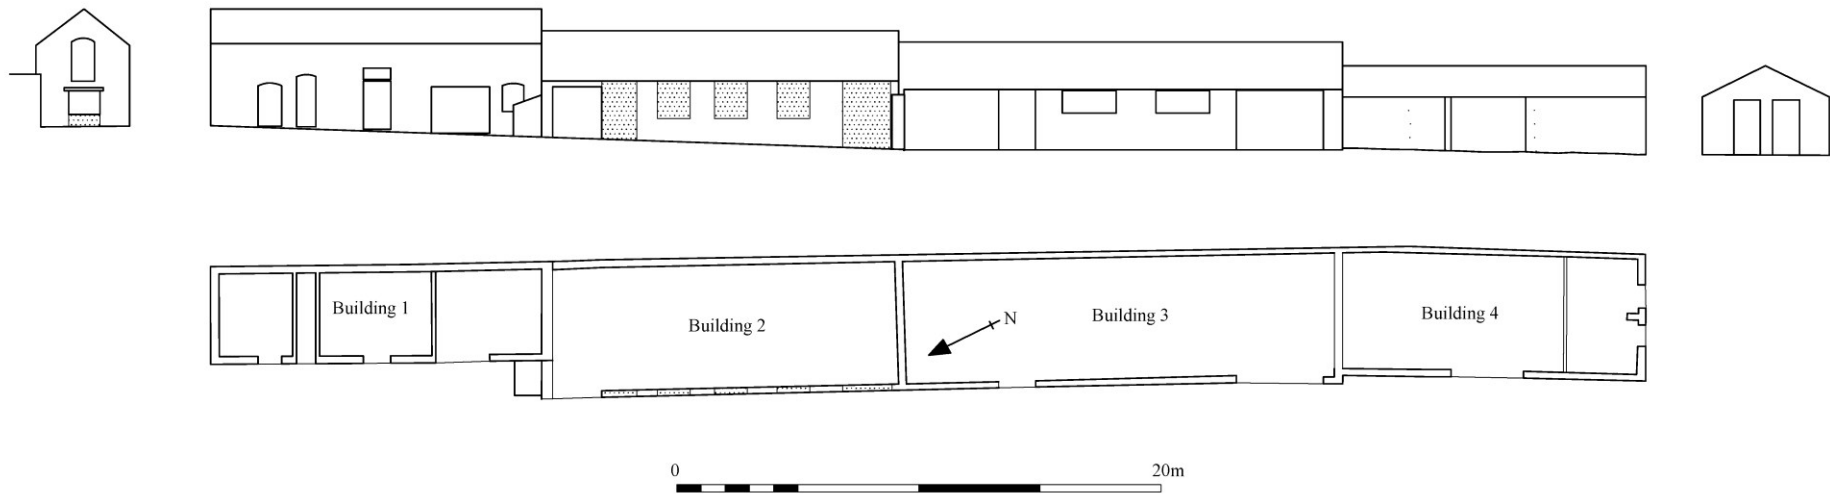
Figure 8 Unit 1 elevations and plan
South-east facing elevation not shown

The Unit 1 range of buildings run along the eastern site boundary and are built using red bricks and a variety of roof coverings. The range consists of four different buildings each with a successively lower roofline as they descend south-westwards down the slope of the yard. For the purposes of this survey the northernmost building at the top of the slope on Main Street has been given the identification designation of Building 1 with the southernmost named as Building 4 (Fig. 8). These identification numbers do not relate to any official designations or former uses.

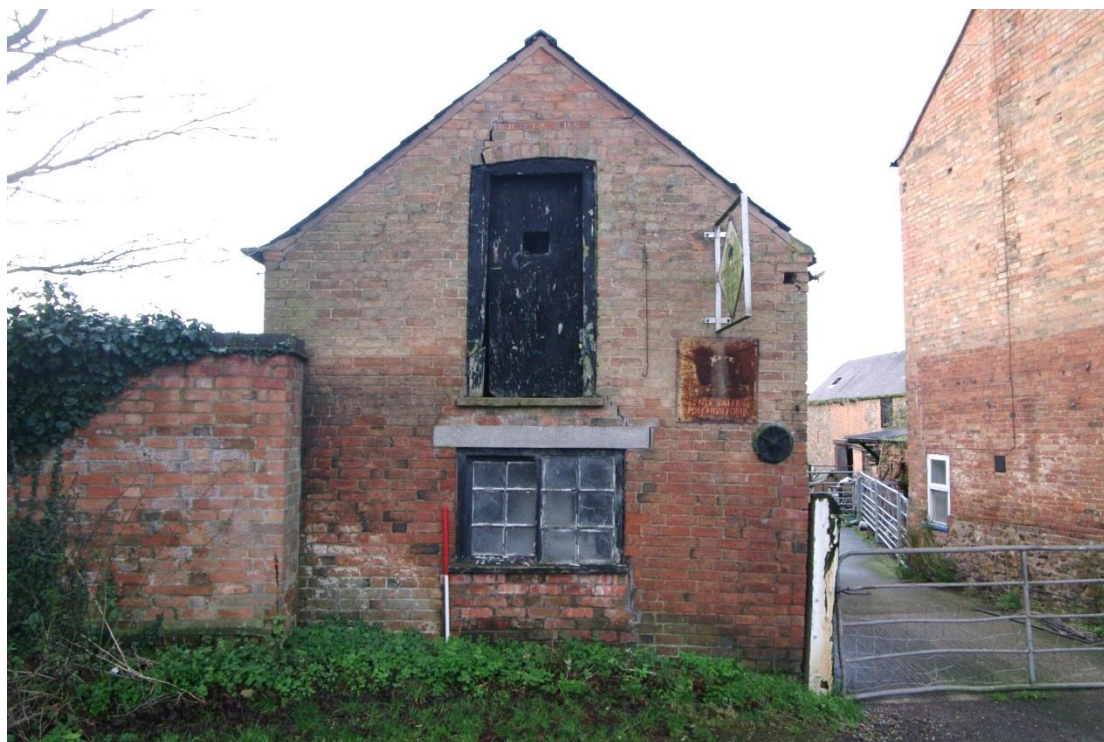
Building 1 is constructed from red brick and has a slate roof. It is showing signs of structural weakness and has several ties holding the walls which are bulging in a number of places. The north-east facing gable end fronts onto Main Street and is level with the farmhouse frontage (Fig. 9). The brickwork at ground floor level is slightly darker than at first floor level suggesting a possible rebuild or extension. The elevation has a ground floor rectangular wood framed window with a horizontal sliding York sash. This window appears to have been re-used from elsewhere as the original opening has been modified from a doorway which has now been partially blocked with brickwork. The window also has a concrete lintel. Above the window is a hayloft door with bricks with the initials W.D. T.W. D.G. carved into them (Fig. 10). In smaller lettering the date 1814 can be seen to the side of the brick with D.G. on it. By coincidence this is the date of the hand-drawn Ordnance Survey map. These bricks are slightly darker than the surrounding bricks so they may have been re-located from elsewhere on the building or even elsewhere on the farm.

Figure 9 Unit 1, north-east facing elevation gable end
Looking south-west. 1m scale. Note farmhouse on right and stone barn of Unit 2

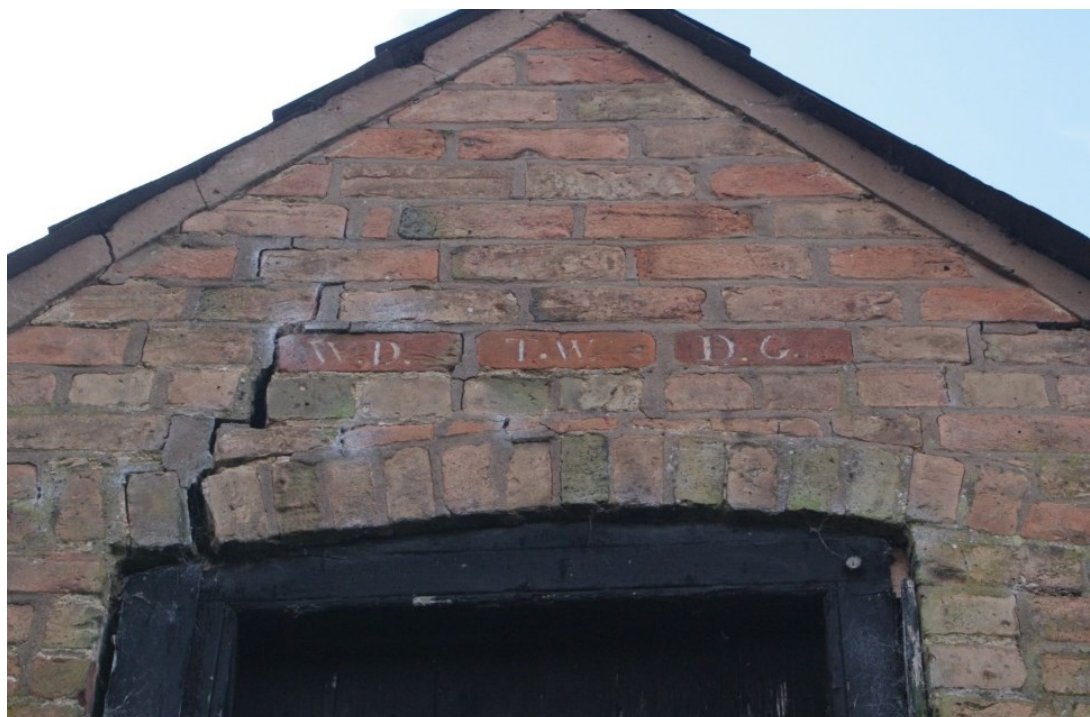
Figure 10 Unit 1, north-east facing elevation gable end bricks above hayloft door
Looking south-west

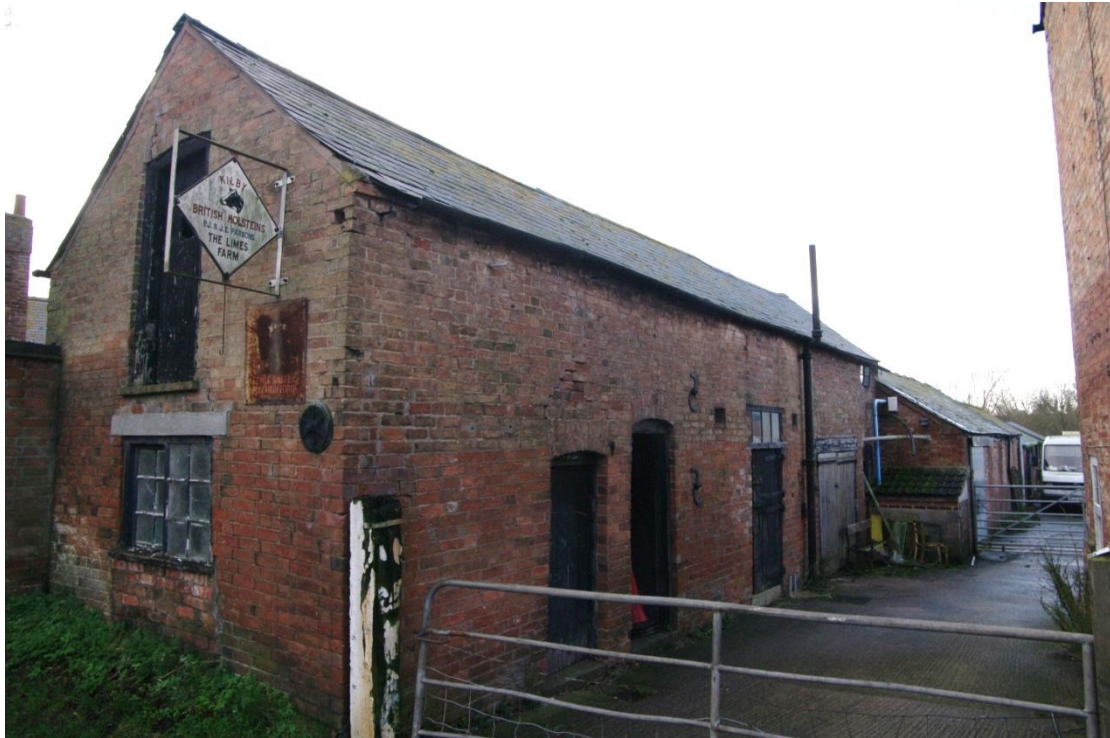
The north-west facing elevation runs parallel to the side of the farmhouse and the top of the long yard. This elevation also shows the difference in colour in the brickwork at ground floor and above (Figs. 11 and 12). There is a vertical joint in the brickwork towards the southern end of the elevation which appears to show that the building was always two storeys at this end. A modern breeze-block built structure with a cement tiled roof has been built into the angle created by Building 1 and Building 2.

Figure 11 Unit 1, Building 1 north-east and north-west facing elevations
Looking south. Note the rest of the Unit 1 buildings continuing down the slope

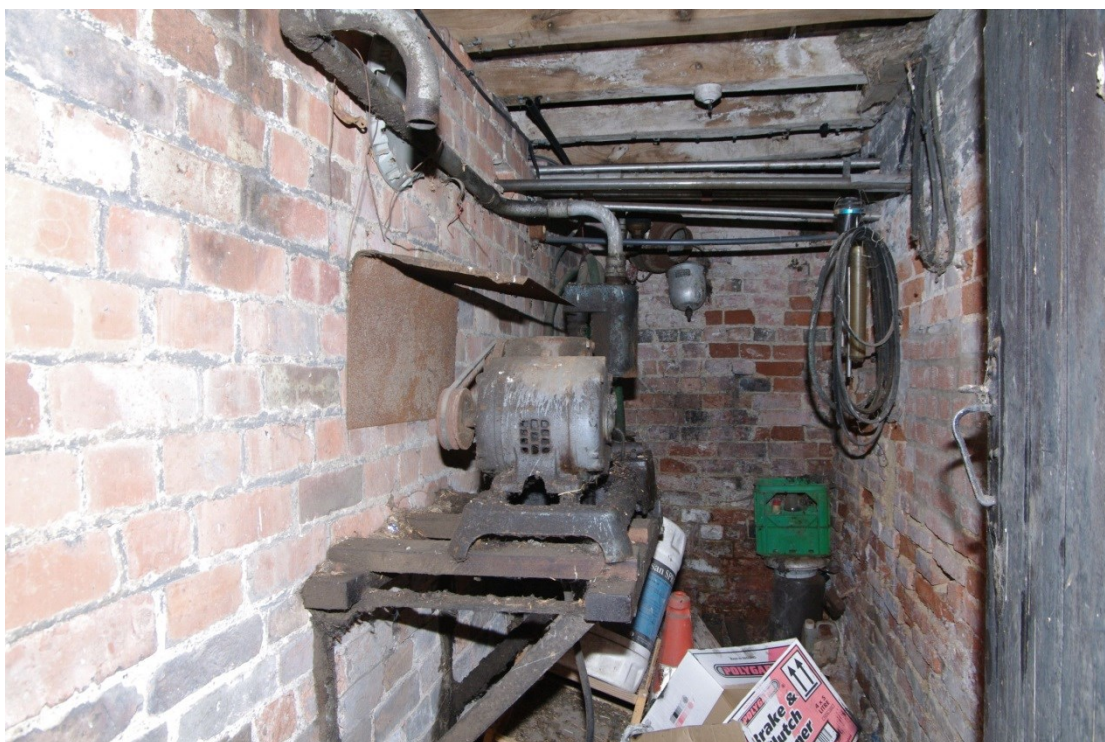
At the northern end of the north-west facing elevation is a low but wide doorway which leads into a small room with modern milk processing equipment inside (Fig. 13). The walls have been covered in a white boarding material presumably to aid cleanliness. The room has a low ceiling which has been plastered and is supported by a substantial chamfered beam. A narrow doorway with a brick-arched head is located to the south of the northernmost room. This doorway leads into a narrow passageway which runs the width of this building although the purpose of this is not clear as there is no evidence of a doorway, blocked or otherwise, on any of the walls (Fig. 14). A number of modern pipes for transporting milk run across the room at ceiling height.

Figure 14 Unit 1, Building 1 passageway adjacent to northernmost room
Looking south-east

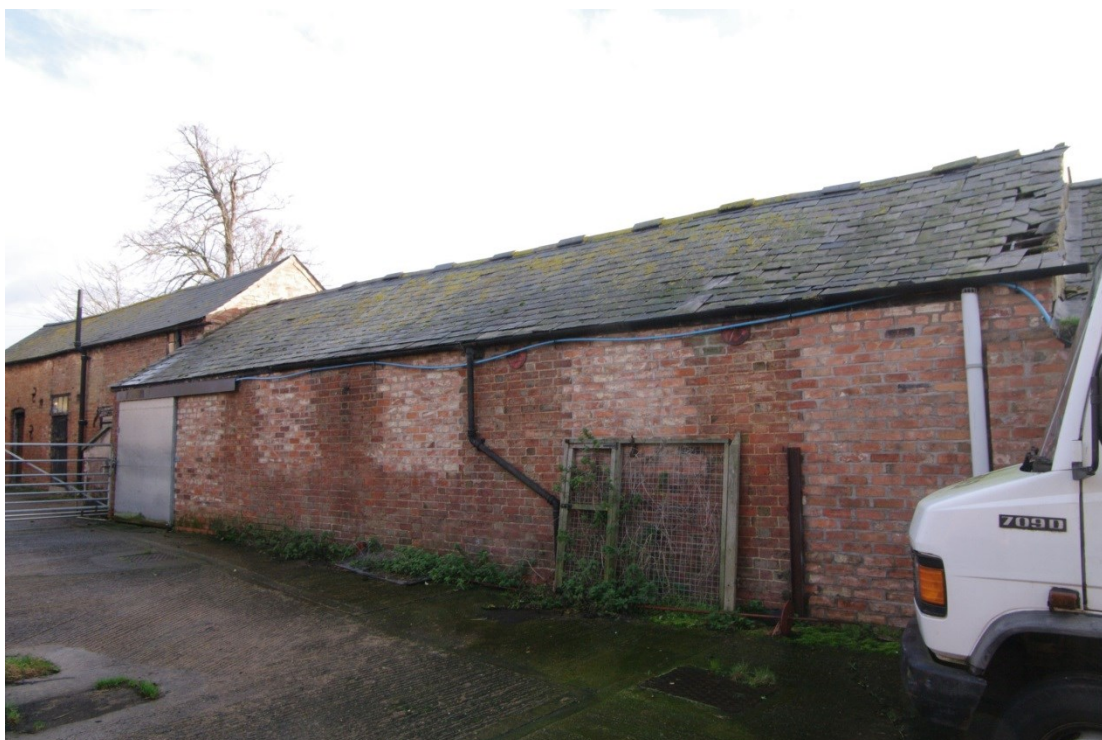
Figure 19 Unit 1, Building 2 north-west facing elevation
Looking north-east

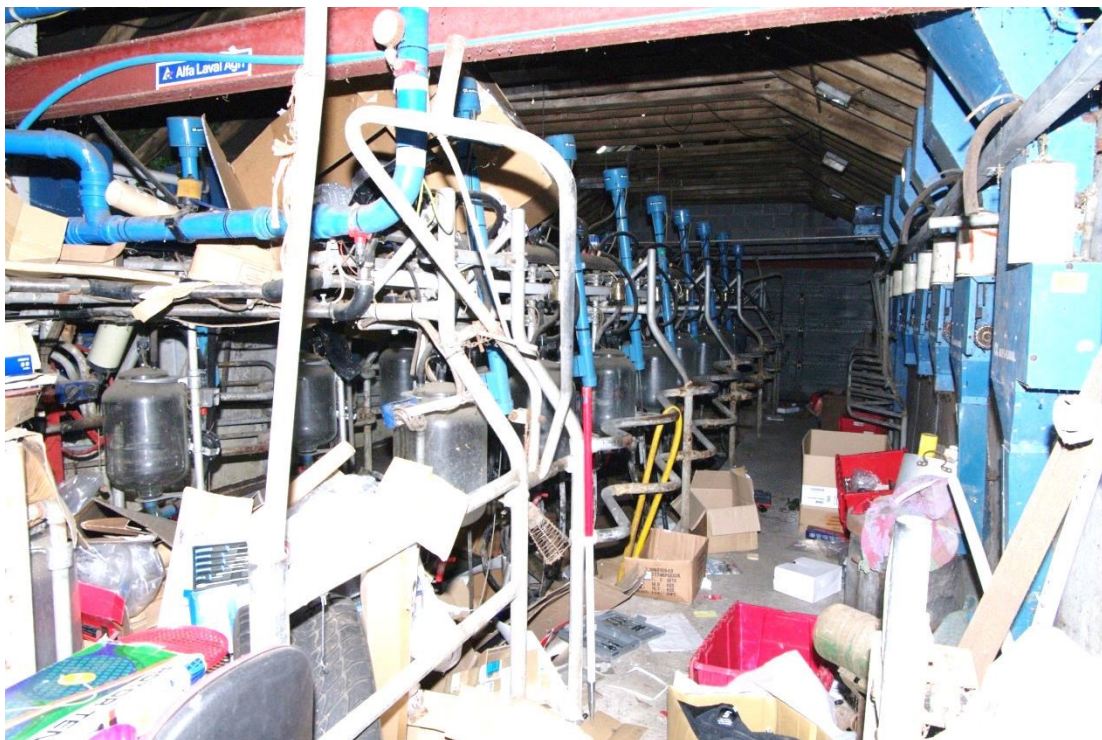
Figure 21 Unit 1, Building 2 interior
Looking south. Note roller shutter door into Building 3 at far end of room. 1m scale

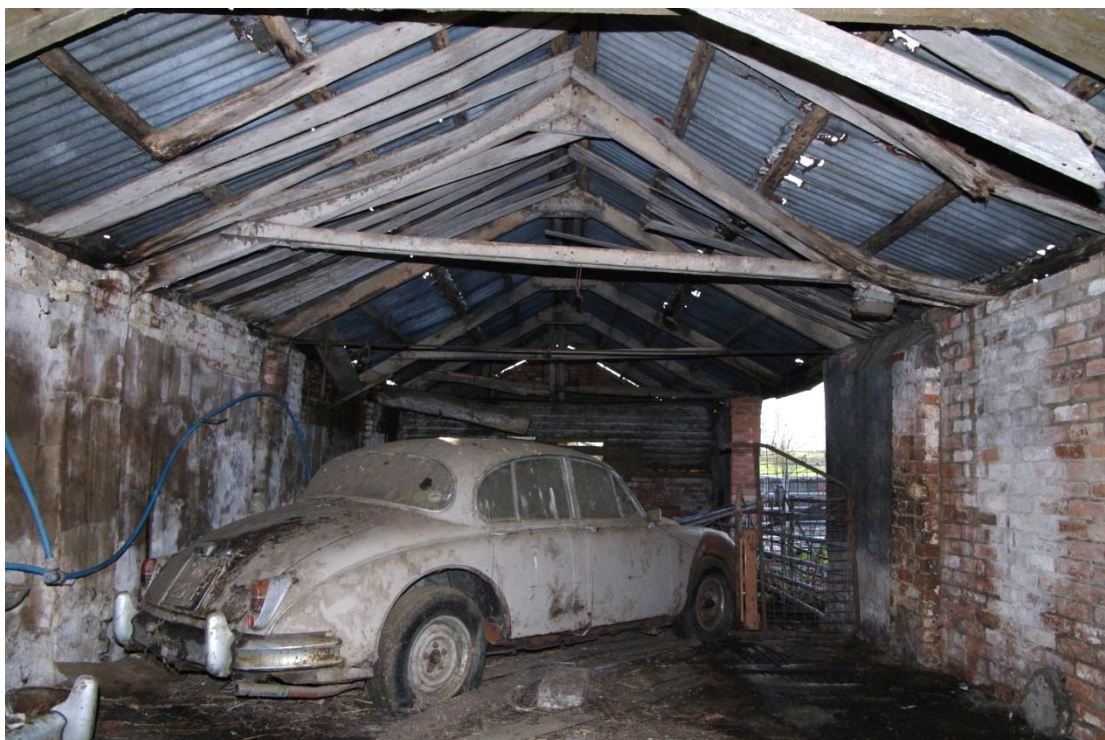
Building 4

Figure 27 Unit 1, Building 4 inside
Looking south-west

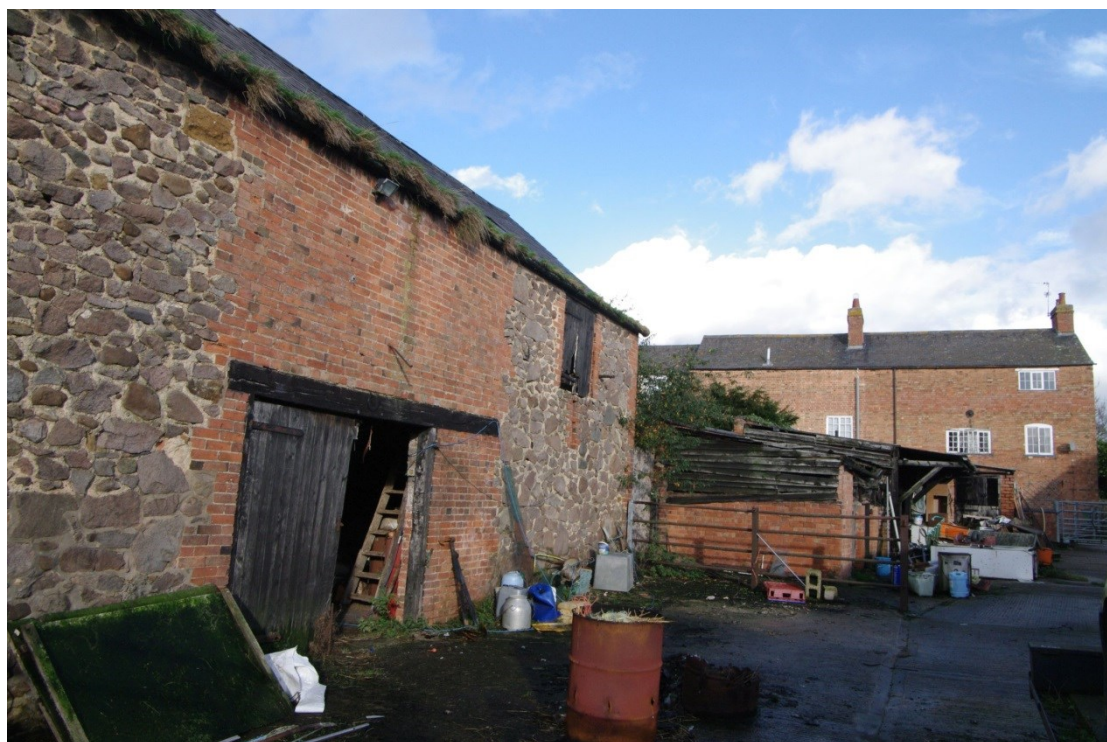
The barn building is built from granite rubble with red brick corners and inserts around the doors and windows (Figs. 30 and 31). The building has a slate roof which, according to the tenant farmer was renewed around fifty years ago. The granite appears to be of the same type as that used for the platform supporting the farmhouse walls and the same as a number of boundary walls seen elsewhere in the village.

Figure 31 Unit 2, Barn and outbuildings
Looking north. Outbuildings immediately to left of the barn

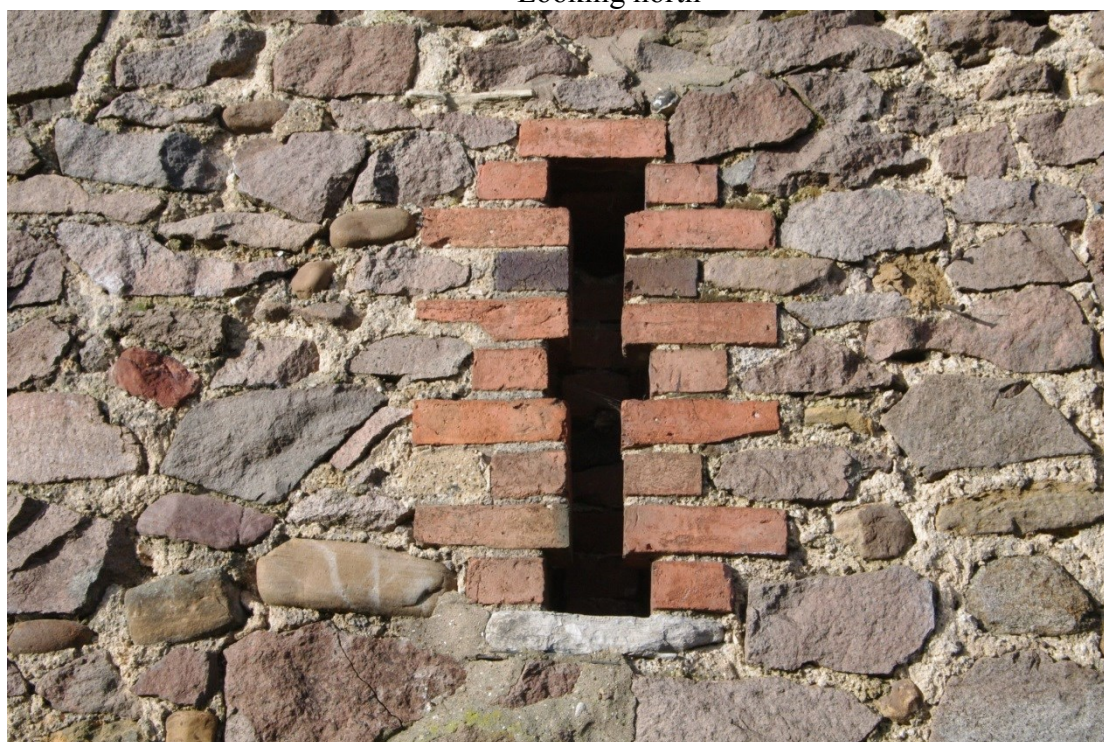
Figure 33 Unit 2, Barn vent
Vent on south-east facing elevation
