**A Level 3 Historic Building Survey at
98-100 Welford Road,
Leicester**

ULAS Report No. 2017-170
©2017

For: Invicta Universal Limited

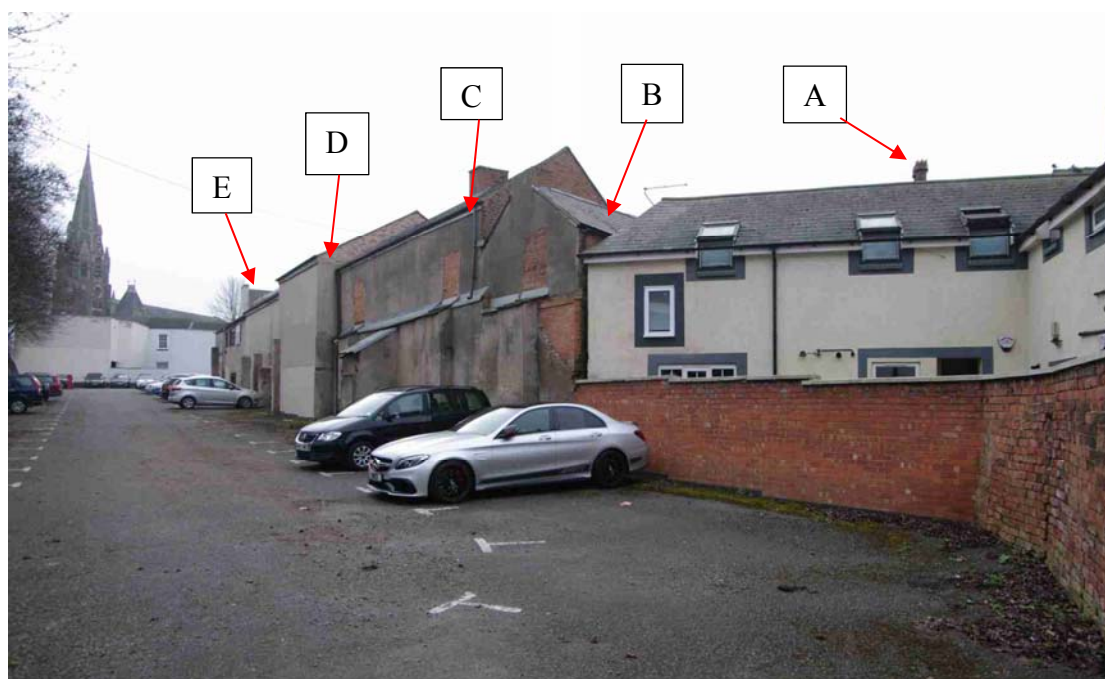
Figure 13 North-west elevation of Building A obscured by later building
Viewed from Regent Road looking south-east. Chimney pot of Building A is just visible over ridgeline.

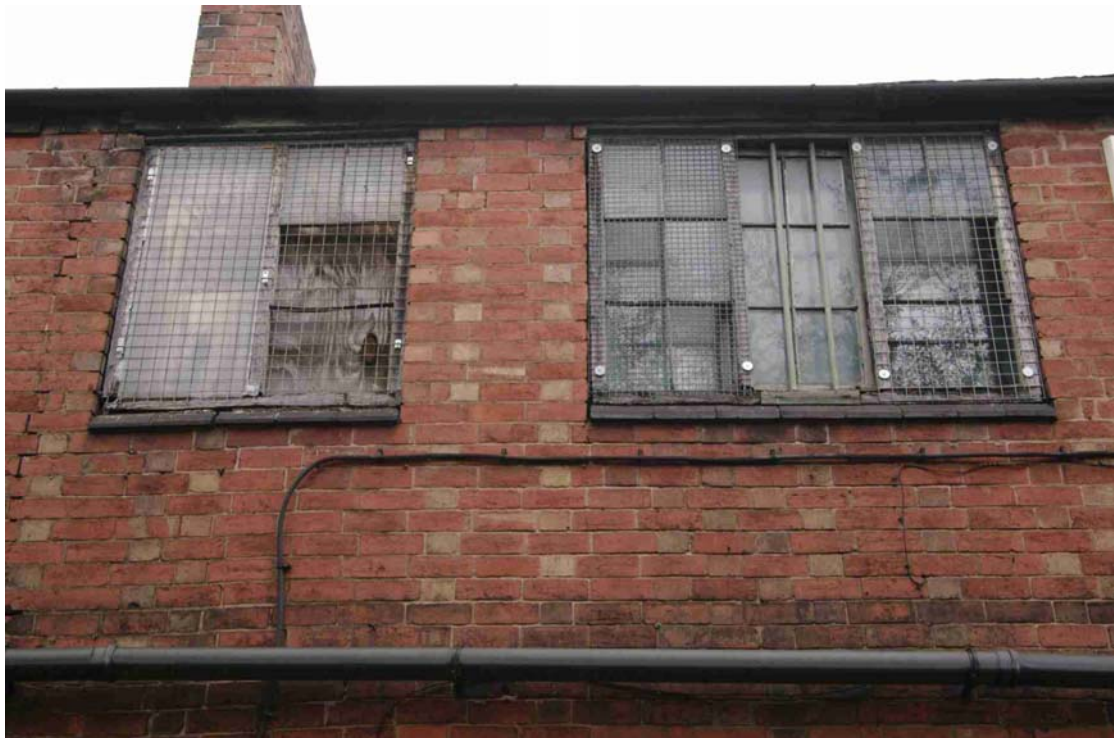
There are three first floor windows each of slightly different style (Fig. 17). The westernmost window only has the outer frame surviving. The remaining two windows may be original although the centre one is in a poor state of repair. The eastern window is a York sliding sash and has a central horizontally sliding panel. They do all however retain their original blue brick sills which suggests that the size of the openings has not changed. The roof appears to be slate but has been covered in a tar covered textile which is in a state of disrepair. The centrally positioned brick-built chimney stack has two crown chimney pots which are probably part of the original building.

Figure 17 First floor of Building A
Looking north-west

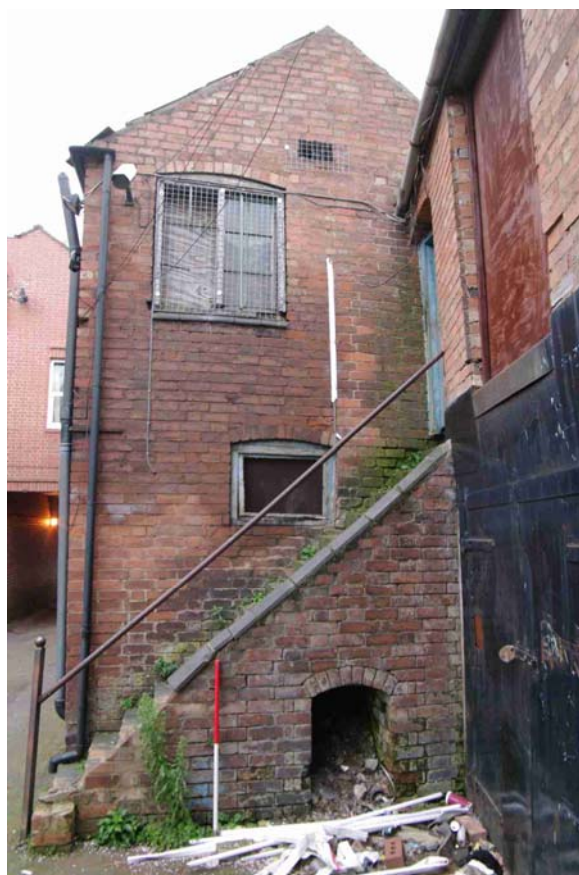
Part of the north-west facing gable end is obscured by the outside steps leading to the first floor of Building B (Fig. 18). The steps are butted against the brickwork of Building A rather than being built as part of it. The corner of Building B also overlaps the corner of Building A at an angle and is also butted against A rather than being bonded to it. As noted the patterned brickwork does not extend onto this elevation although the general trend of three stretchers to one header continues. A small window with a brick arch is set just above the level of the stairs to light the ground floor room. This has a single opening pane and is probably a replacement or later insertion as it is unlikely that such a large sheet of glass would have been used in such a building as this in the 1840s. The first floor window has fixed multiple panes in a wooden frame similar to the smaller first floor window on the south-east facing elevation.

Figure 18 Building A north-east facing elevation
Looking south-west. 1m scale. Building B on right

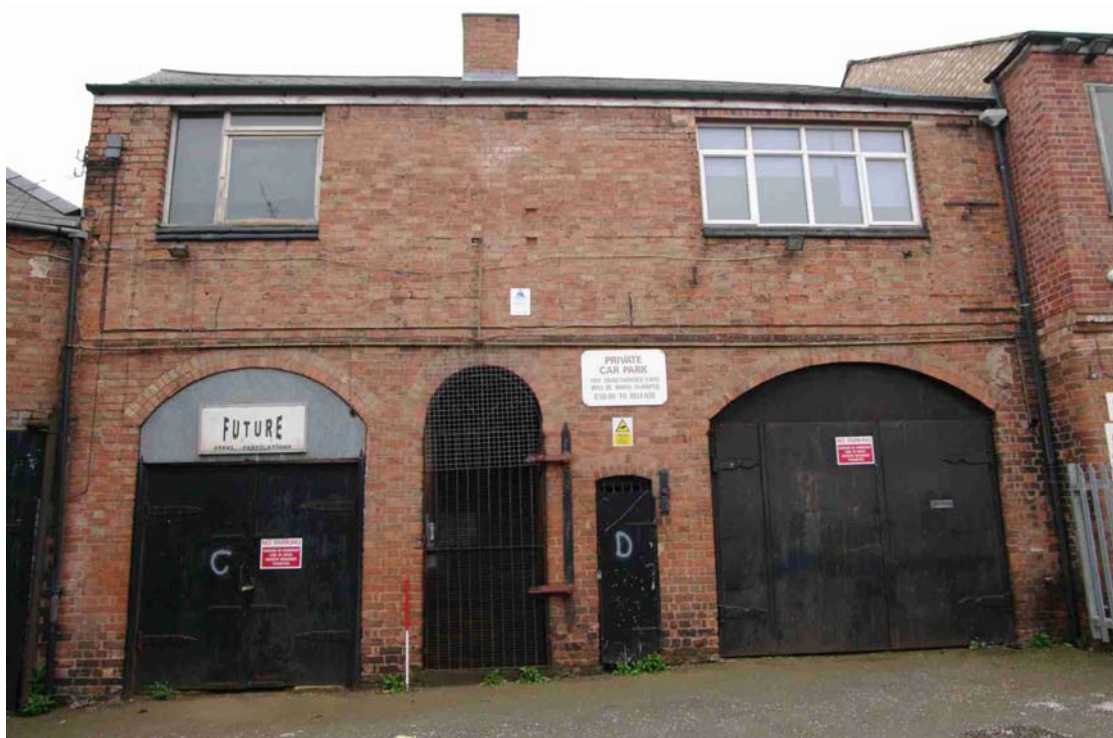
Figure 23 Building C south-west facing elevation
Looking north-east. 1m scale. Building B to left, D to right
Open staircase to first floor behind the centre door with the grille

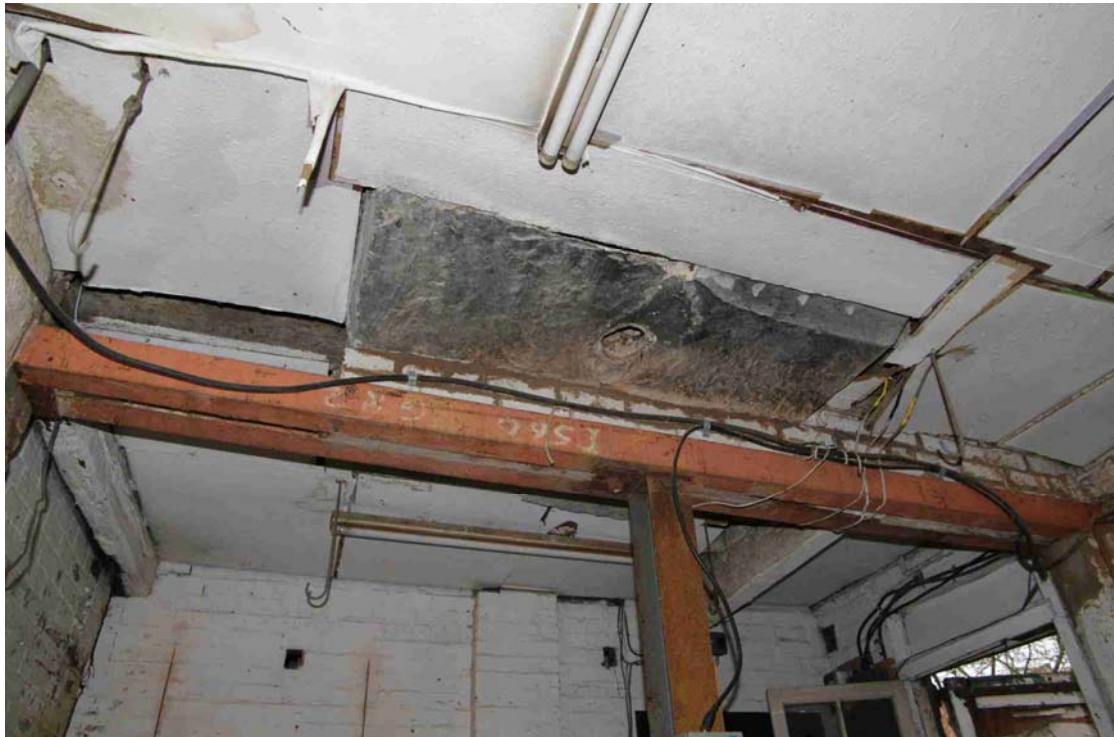
Figure 30 Building A ground floor, Room AG1 supported chimney stack
Looking east

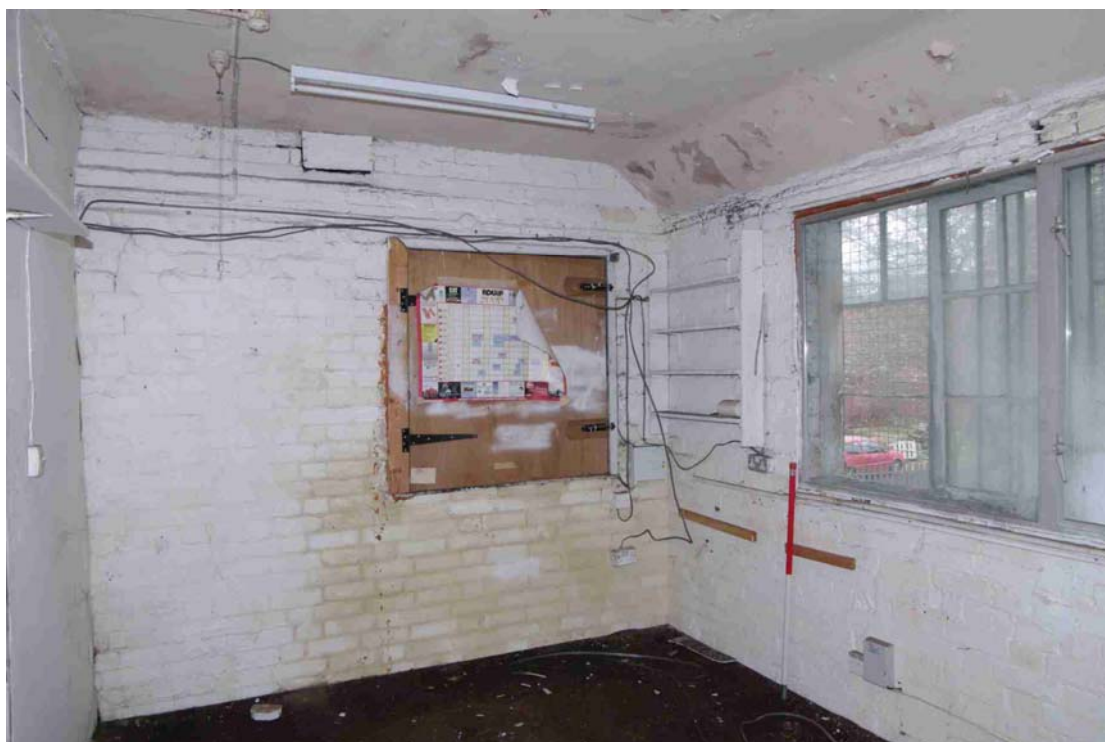
Figure 38 Building A first floor, Room AF2
Looking east. 1m scale note boarded window on north east wall

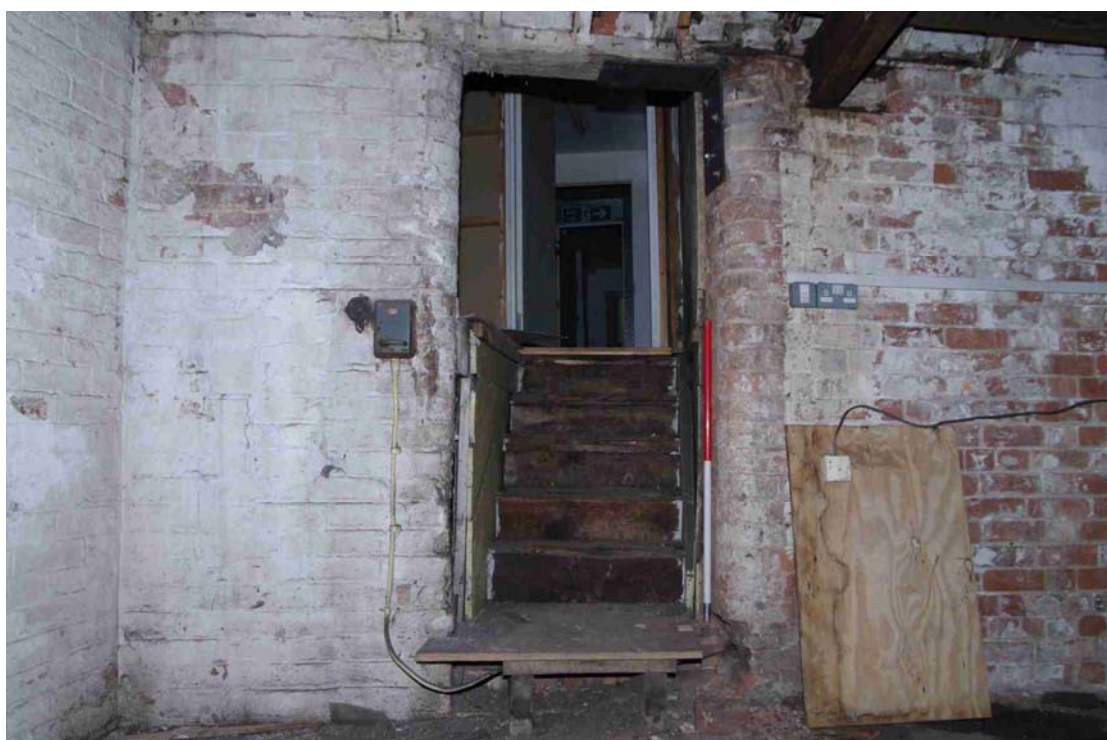
Figure 45 Building B first floor
Doorway and steps into Building C

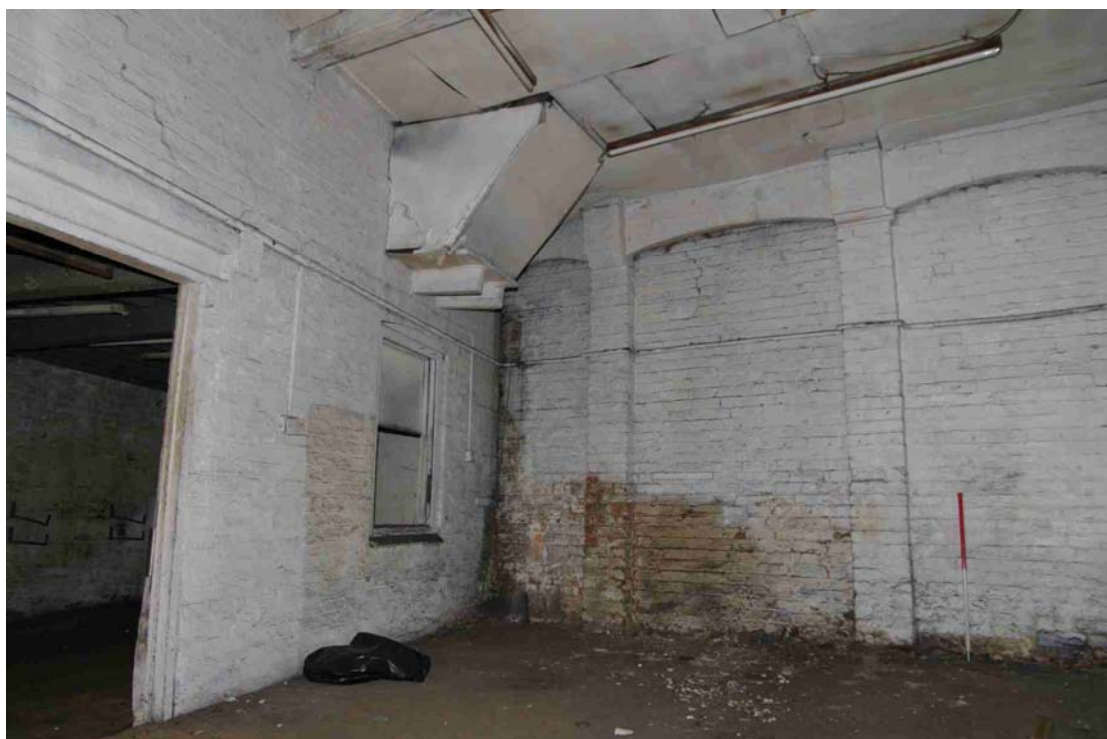
Room CG1, the western room of Building C has painted brick walls and a concrete floor (Figs. 49 and 50). The former outside north-east facing wall Building B forms an angle to the rest of the building and has a single doorway and sash window as discussed above. As noted above, only the doorframe survives but the sash window is still present along with the sloping brick sill showing that this was an outside wall when first built. The north wall has brick pilasters supporting wide brick arches rather than timber beams as in the previous two buildings. Two of the pilasters have moulded stones, probably re-used, supporting the brick arches. The third pilaster has corbelled brick suggesting that not enough reclaimed moulded stone was available. A small fireplace is located on the east wall with the chimney breast standing proud of the wall. In the north-east corner is a doorway leading into an enclosed space partially under the staircase. Another doorway from this space has been knocked through the north wall into one of the former outhouse toilets. The hole that has been knocked through is quite crude and has been supported by modern steelwork.

Figure 50 Building C ground floor, Room CG1
Looking north-west. 1m scale. Former door and window from Building B on left.
Note moulded stone on the right brick pilaster and the corbelled brick on the left

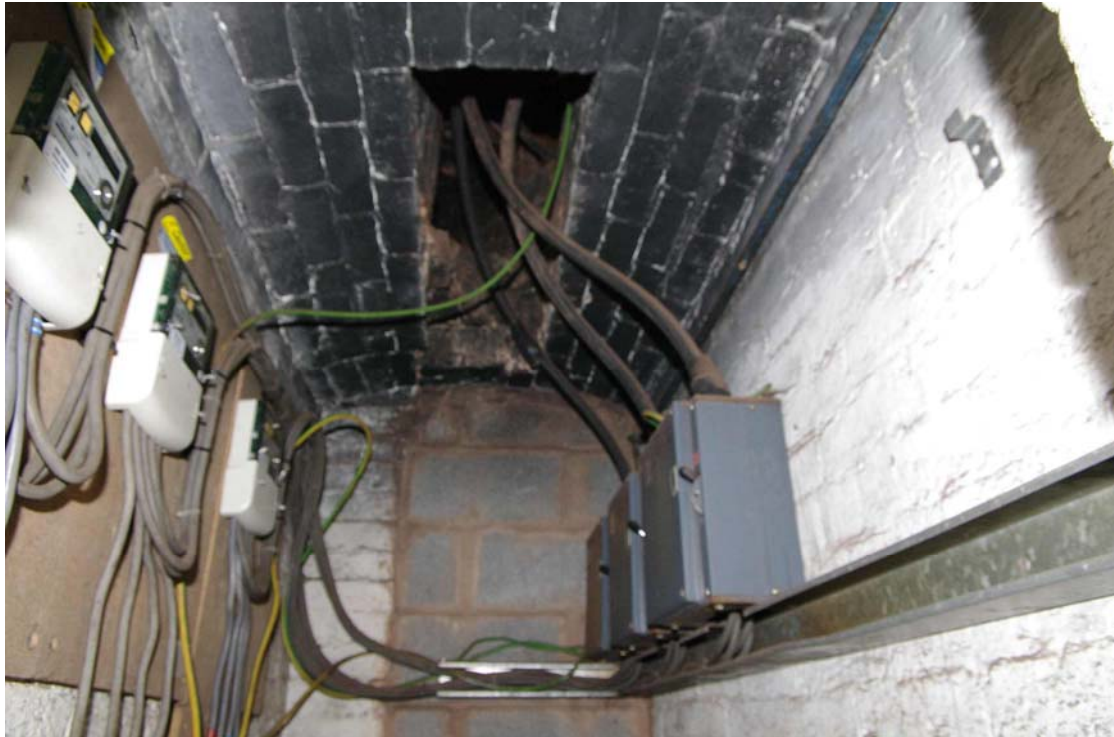
Figure 53 Building C ground floor, central passageway
Looking north

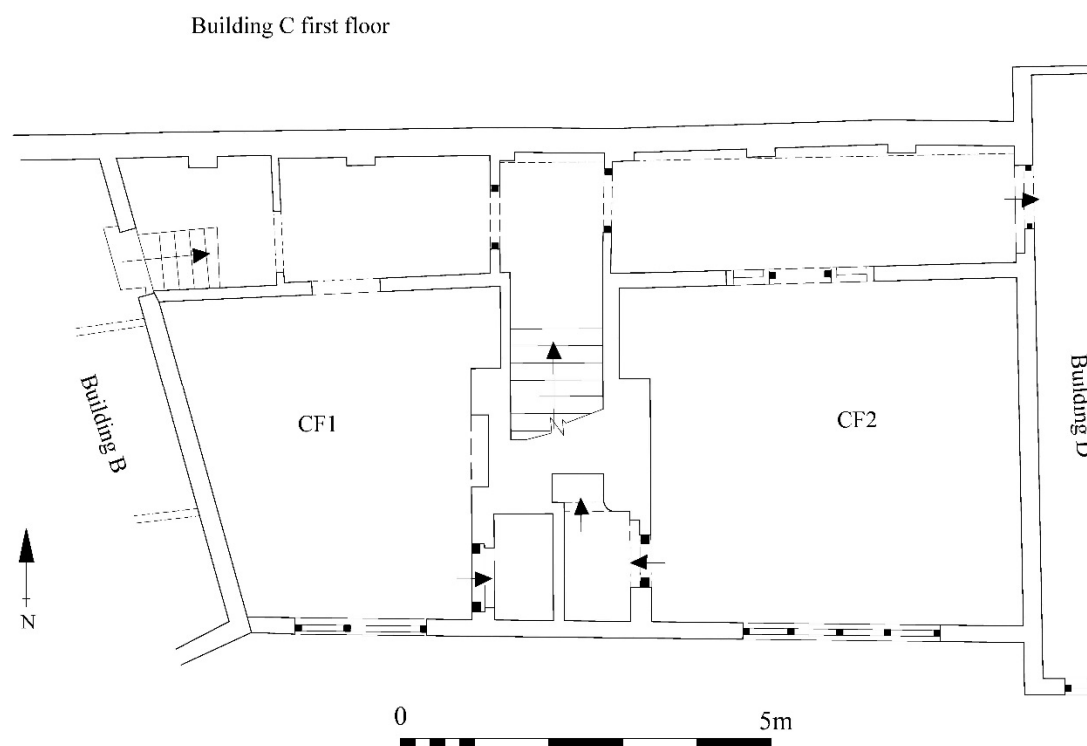
The first floor of Building C has two main rooms connected by a corridor running along the back (north) wall (Fig. 55). The corridor is reached via the short flight of steps from Building B (see Fig. 45), from a doorway into Building D (Fig. 56) or up the enclosed central steps from the yard (Fig. 57). The corridor is broken up into a number of small spaces starting in the west with a small space around the top of the steps from Building B. This space leads into another space leading to the top of the stairs and into Room CF1.

Figure 55 Building C first floor plan
Modified from Feldmann Architects Ltd plan

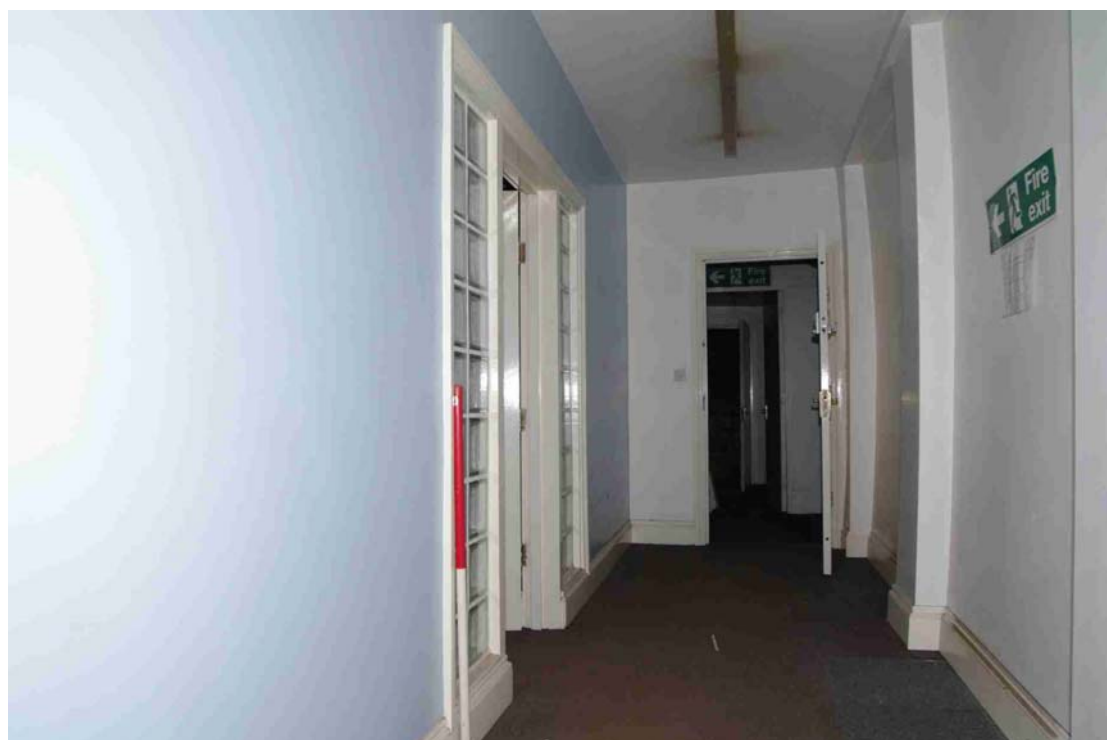
The eastern first floor room, CF2, has a modern doorway with glass bricks set into a plasterboard north wall which suggests that this is a modern replacement (see Fig. 56). It seems likely that there was a fireplace on the west wall but this has been blocked and plastered over leaving no clear trace (Fig. 63). The skirting board has a basic design with a moulded bead along the top. It extends across the former fireplace so is likely to

Figure 56 Building C first floor corridor
Looking west from doorway into Building D. Room CF2 on left. Doors to top of
central stairs ahead

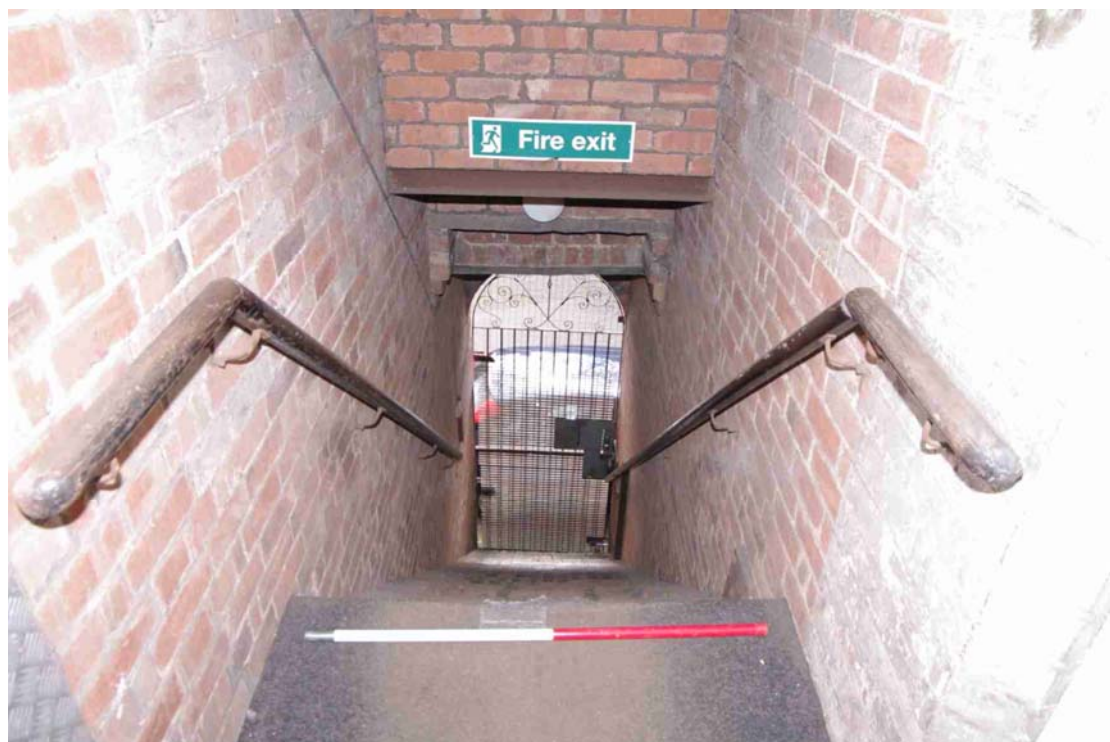
Figure 57 Building C first floor, enclosed central stairs
Looking south. 1m scale

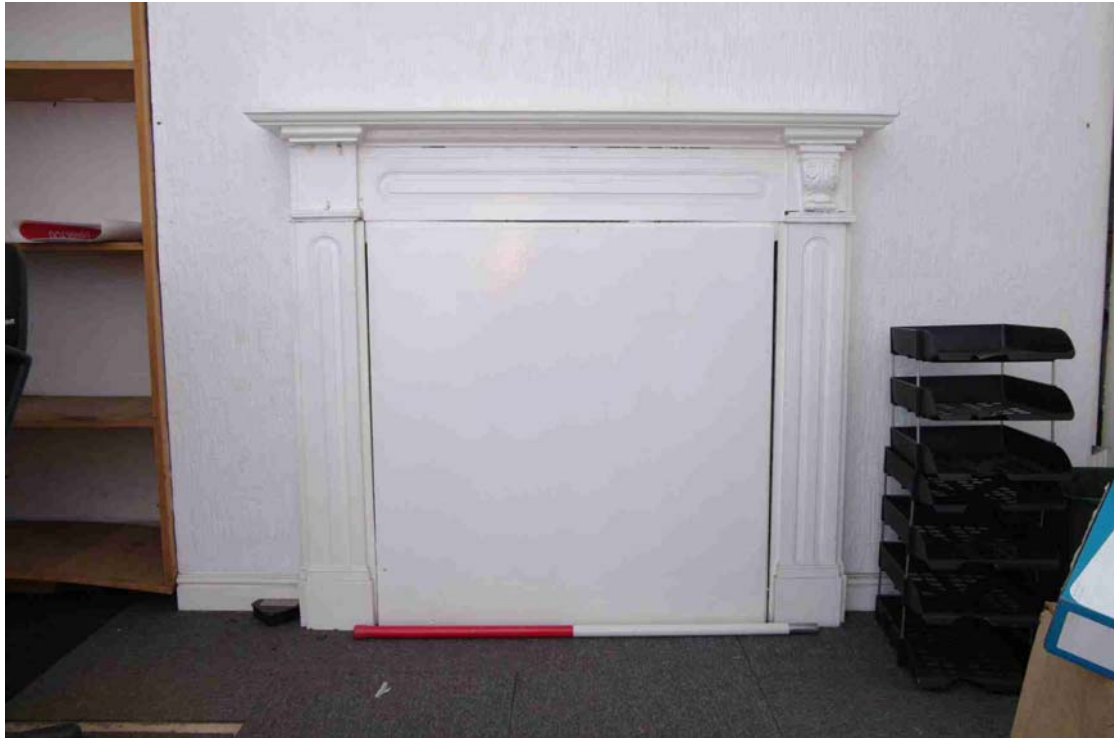
Room CF1 has modern wall coverings which mask any earlier details as does the modern ceiling covering (Fig. 58). This room has a low skirting board with a moulded beading along the top. The height of the skirting suggests early 20th century rather than 19th century. The window is of mid to late 20th century design. On the east wall is a large fireplace with carved details and a mantelpiece of probable 19th century design (Fig. 59).

Figure 59 Building C first floor, Room CF1 fireplace
Looking east. 1m scale

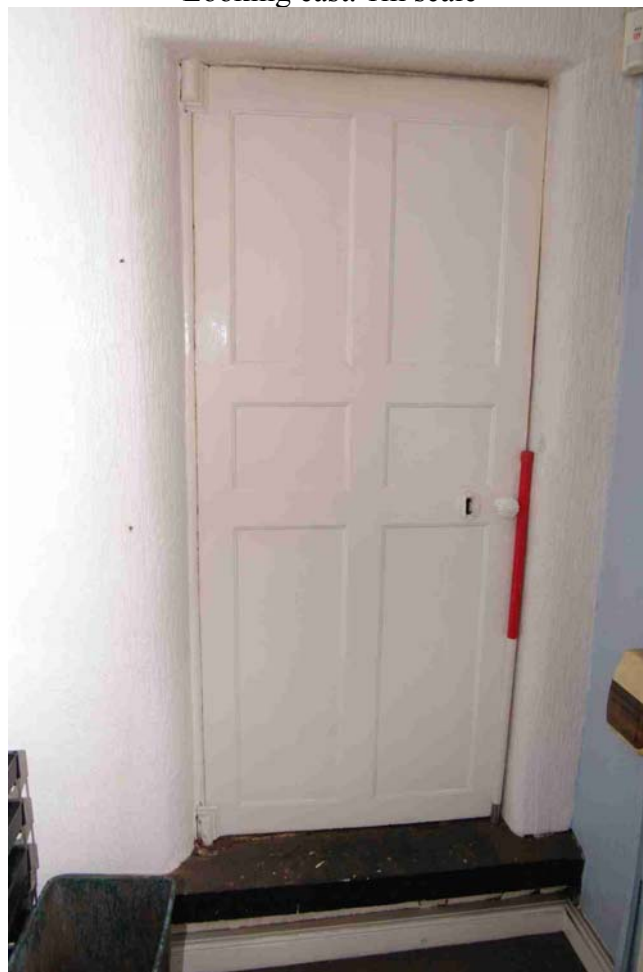
In the south-eastern corner of Room CF1 is a large steel door made to look like a wooden six-panelled door but which is actually a safe with a large alcove behind it which has been built over the enclosed stairs (Fig. 60). Inside the safe there are a set of stone shelves clearly designed to be both fireproof and to take heavy loads (Fig. 61). A hole at the top of the safe allows a limited inspection of the roof structure which appears to be a modern replacement. On the inside of the safe door are a number of remnants of paper labels. One fragment has the word seeds, oats and possibly wheat on it which supports the suggestion made by the previous owner that the offices were used by a grain merchant (Fig. 62). Another label which seems to be cut from a newspaper or journal reads:

Figure 60 Building C first floor, Room CF1. Safe door
Looking east. 1m scale

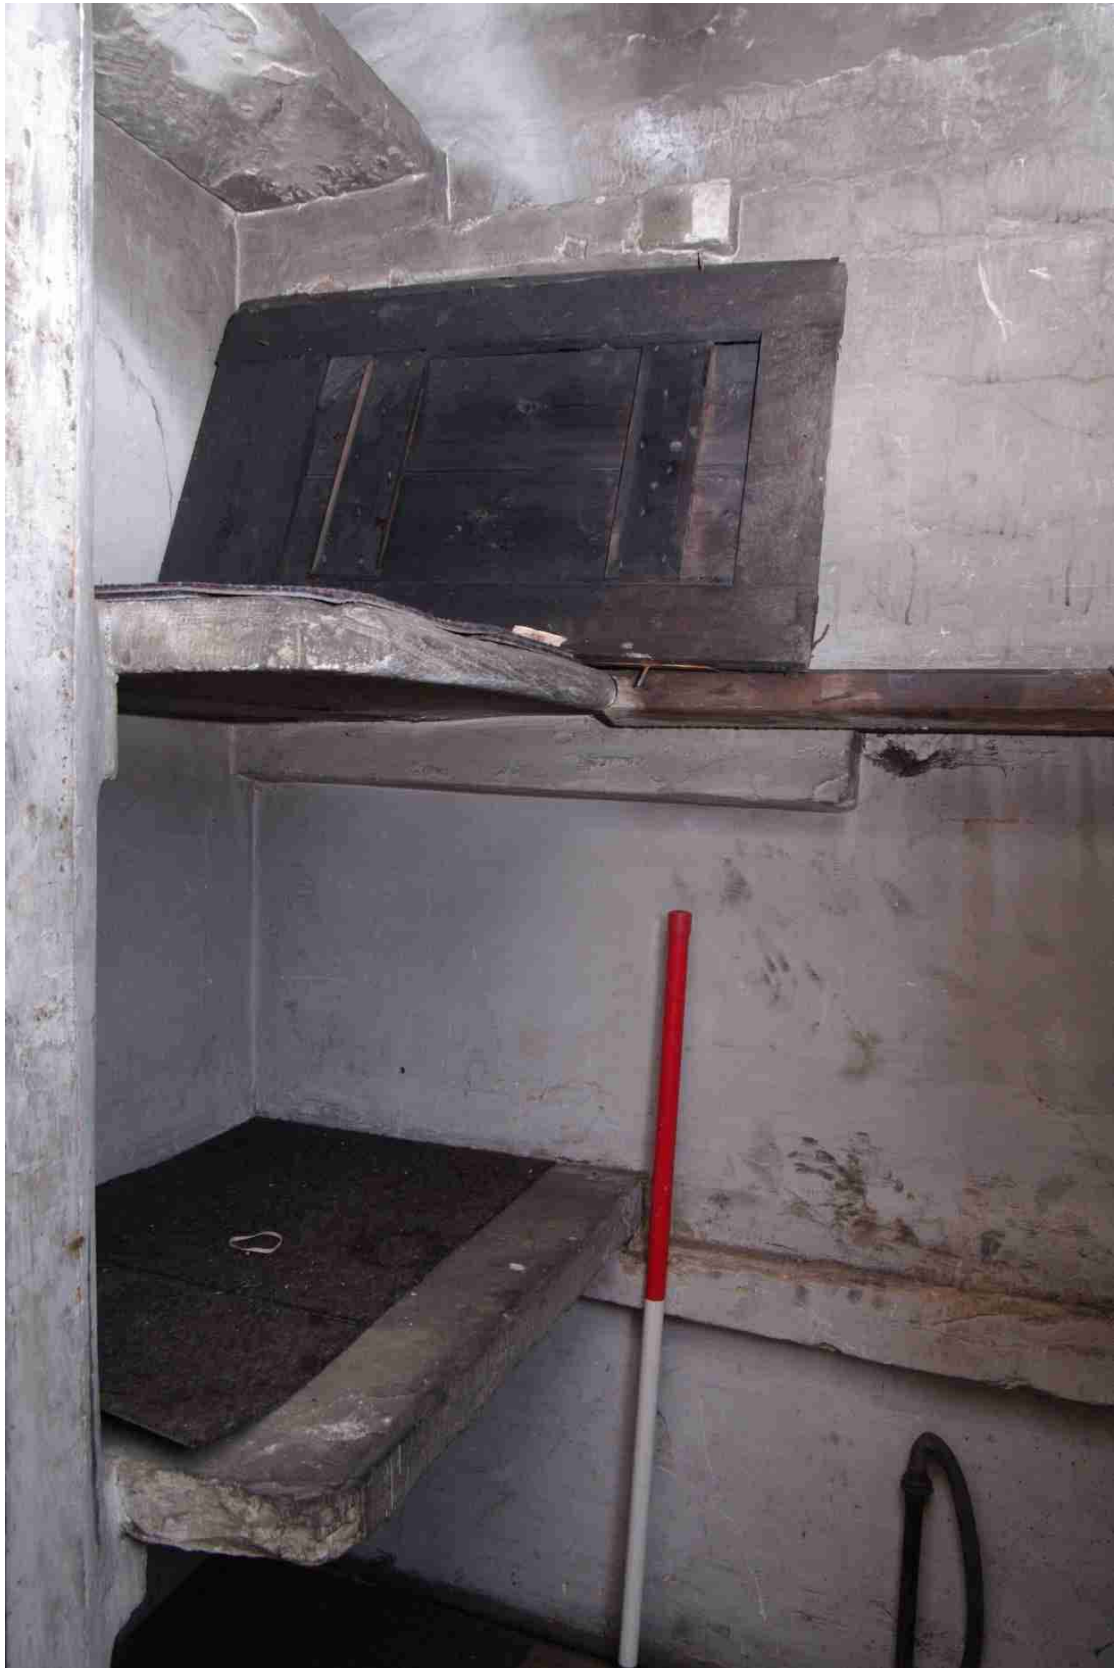
Figure 61 Building C first floor, Room CF1. Inside the safe
Looking north-east

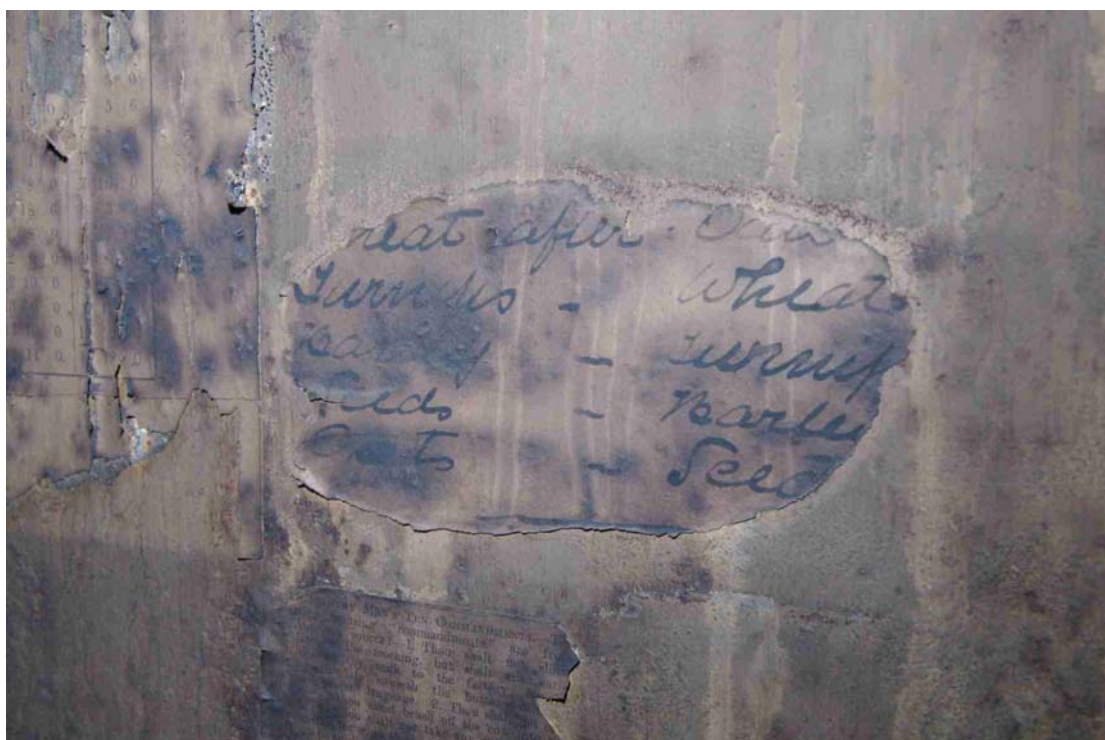
Figure 62 Building C first floor, Room CF1. Label inside the safe

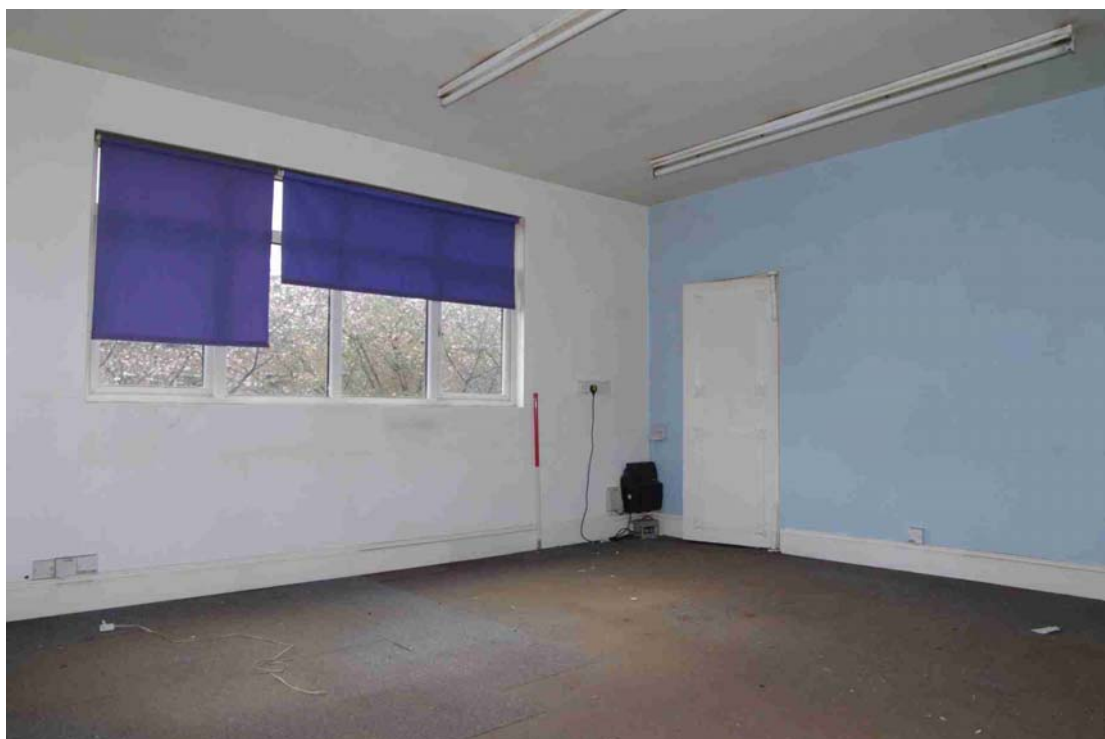
be quite late in date. The windows are modern uPVC giving the impression that the whole room has been refurbished quite recently. This may have been a result of the fire damage seen in Room CG2 immediately below this room.

Figure 63 Building C first floor, Room CF2
Looking south-west. 1m scale. Safe door in corner

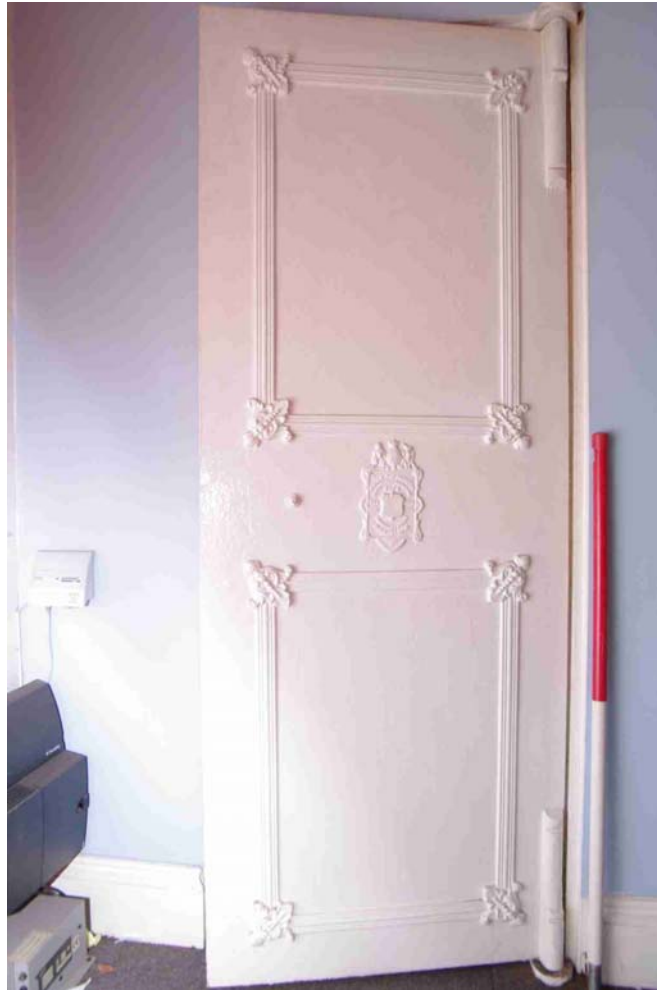
In the south-west corner of Room CF2 is a large steel door behind which is a large safe set over the enclosed stairs. This safe backs up against the safe in Room CF1 but also has an additional smaller alcove on its northern side. The door makes no attempt to disguise itself as anything but a safe and has a large crest on the front showing it to be made by John and Jo^R (Joshua) Taunton safe makers based in Birmingham (Fig. 64). The inside of this safe does not have any stone shelves but has the base of a gas light fitting just inside the door (Fig. 65).

Figure 64 Building C first floor, Room CF2. Safe door

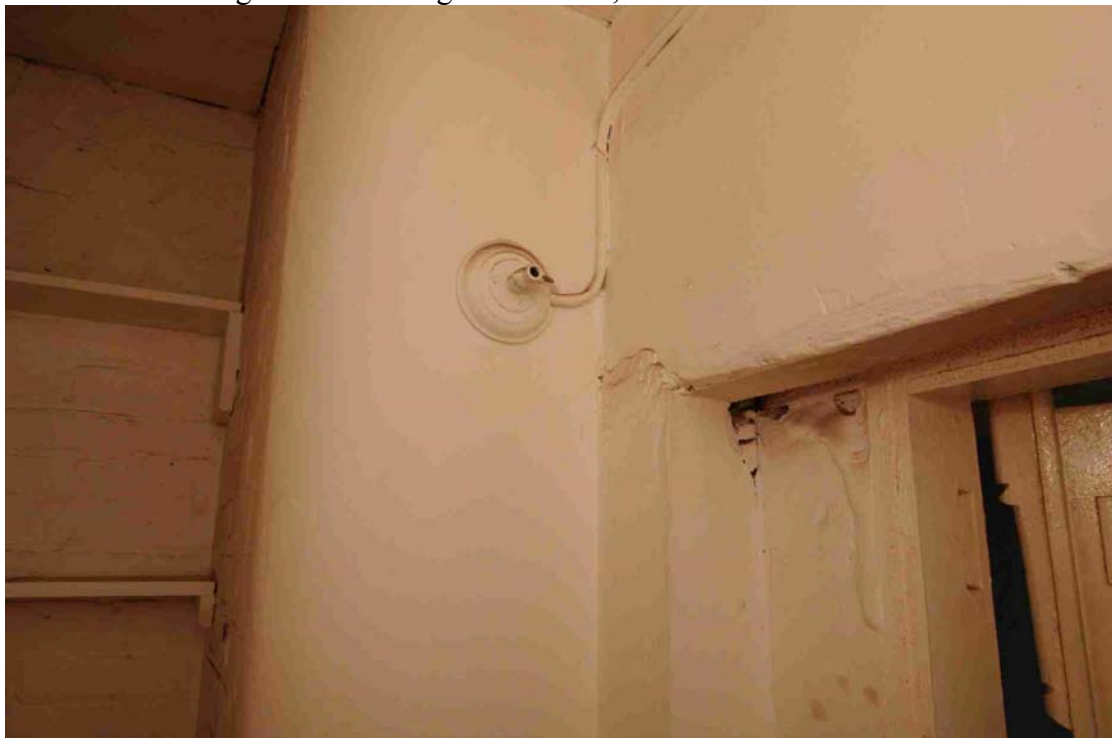
Figure 65 Building C first floor, Room CF2. Safe
Gas fitting inside the safe

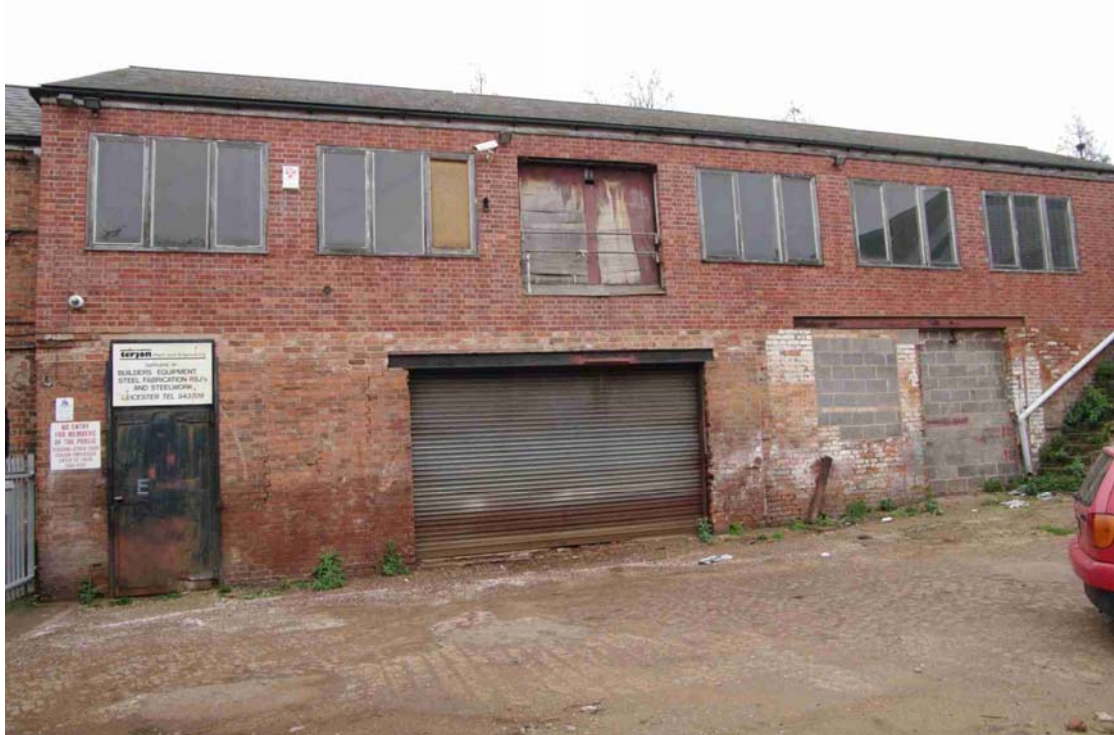
Buildings D and E continue the range of buildings forming the northern and eastern sides of the open yard (Figs 66 and 67). Building D steps out from Building C and appears to butt against Building C. The ground floor is built of red brick which has been heavily modified with a number of alterations and rebuilds around the doors all of which have modern fittings and may not be in their original locations. The ground floor brickwork does not show any patterns but is laid in courses of three headers and one stretcher as used on the other buildings. A set of outside stairs built of brick lead up to a first floor doorway. The first floor of this elevation appears to be a complete rebuild and uses modern bricks along the entire elevation. The windows are also modern. It seems likely that this is a rebuild as the outside stairs appear to be much older if not the same age as the ground floor walls.

Figure 66 Building D south facing elevation
Looking north

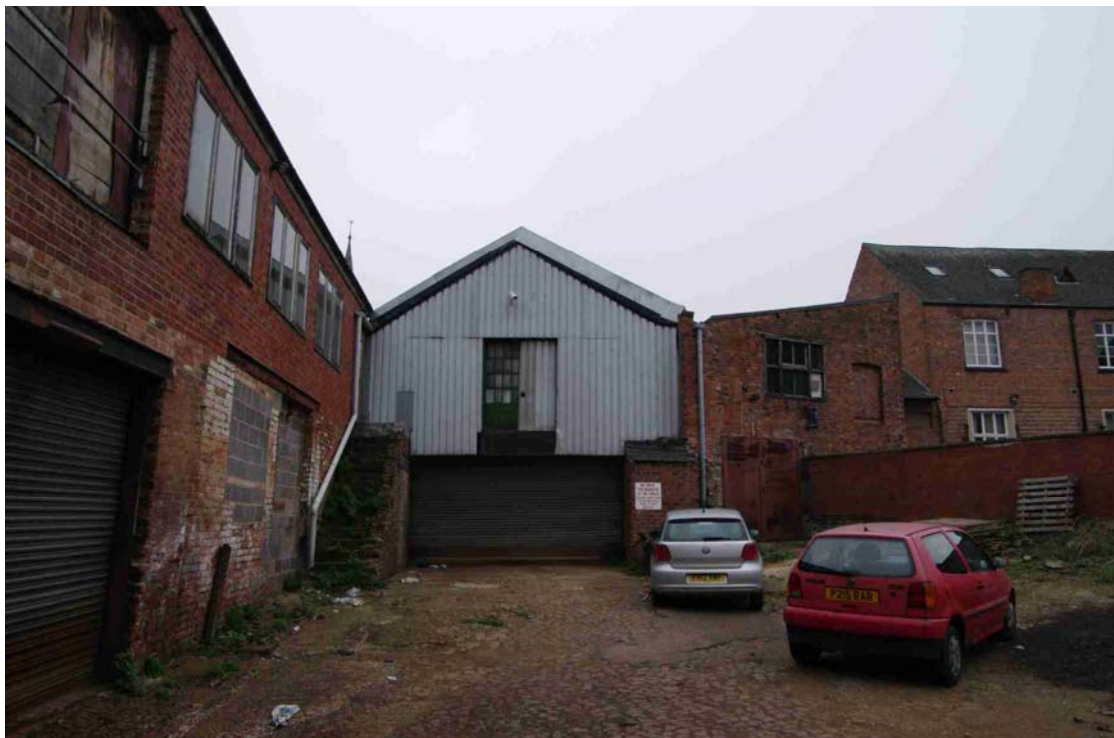
The west facing elevation of Building E sits at a right angle to Building D and has been almost entirely clad in modern corrugated metal sheeting. The southern wall is visible and is made of red brick which may be of similar age to the ground floor of Building D. Another large building with a sloping roof is built against the south wall of Building E. Although the ground floor doors of this building open into the yard this building is not part of the proposed development and no access was gained into it.

Figure 67 Building E west facing elevation
Looking east

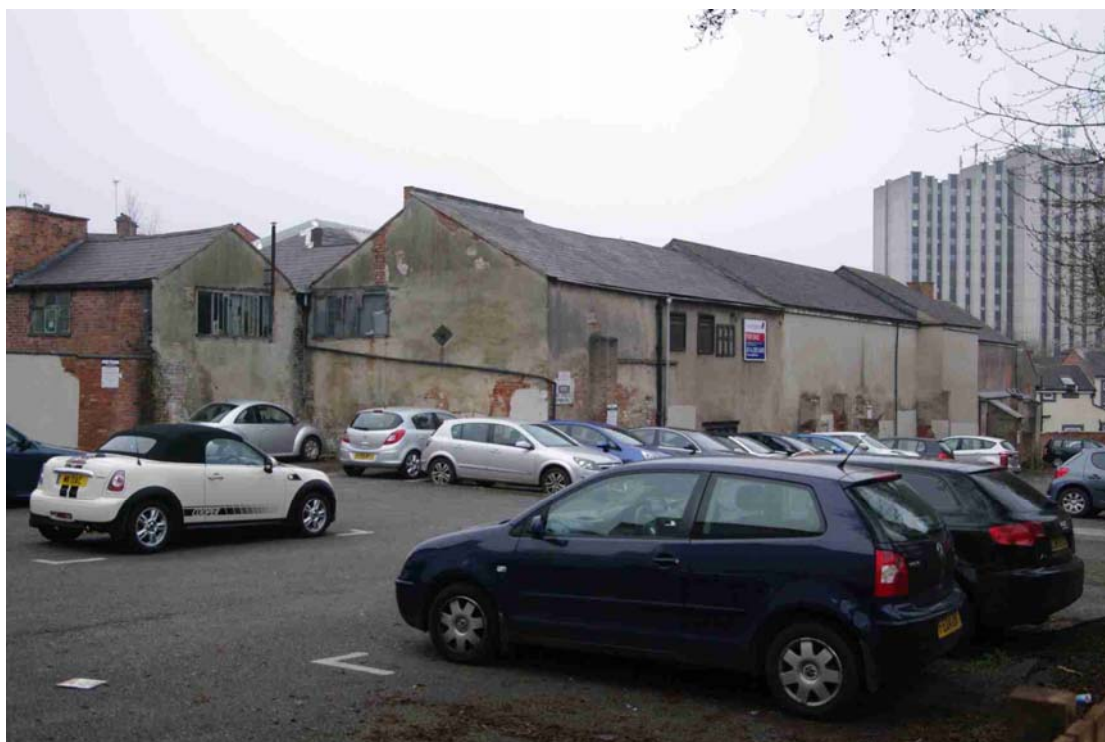
The north facing elevation of Buildings D and E face out onto the Regent Road car park (Figs 68 and 69). Although much of the elevation is covered in render enough has been broken away to reveal the brickwork underneath. On this side there does not appear to have been any rebuilding of the first floor. The roofline can also be seen as at least three separate buildings with the wall line of the most westerly portion stepping out beyond the build line of the other buildings. The eastern end of Building E projects further east than the end of D. It can also be seen that the roof of Building E is different at the east end suggesting that this was first built as free-standing two storey structure which was then extended westwards.

Figure 68 Buildings D and E north facing elevations
Looking west

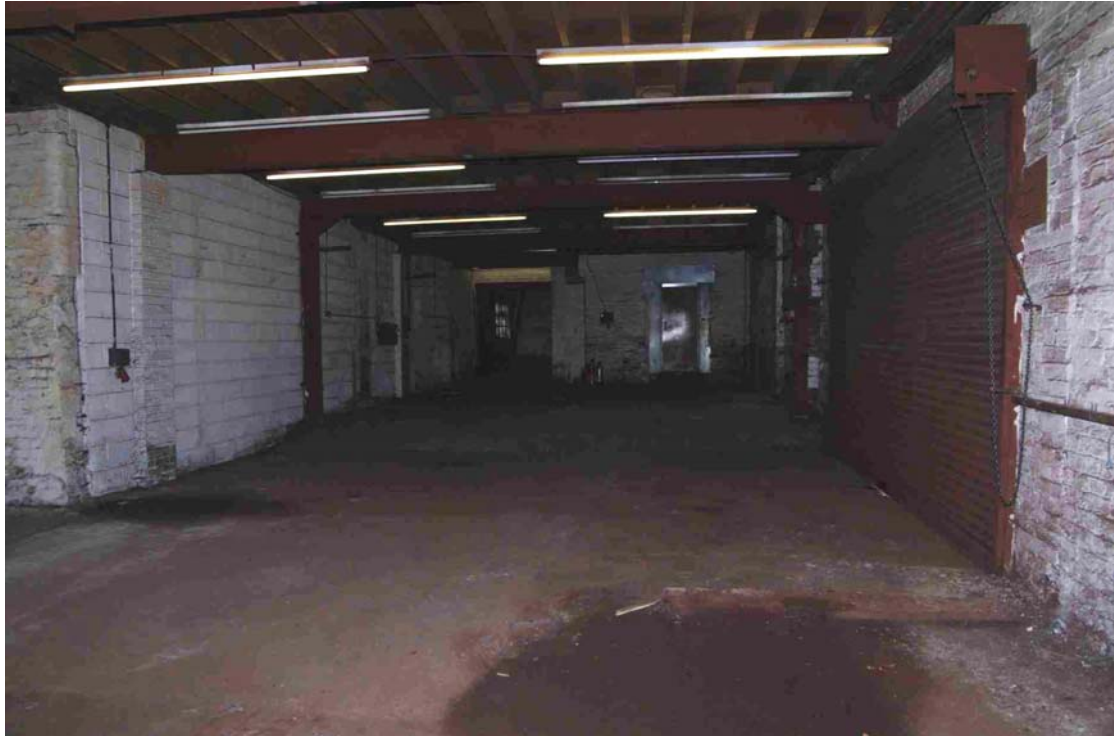
The ground floor of Building D is a large open space at the west end with small subdivided spaces at the eastern end (Fig. 69). At the western end most of the ceiling support is of modern steel and the north wall has had a skin of breeze blocks added. A set of modern steel stairs lead up to the first floor. The eastern end of Building D has painted brick walls and has timber ceiling joists which appear to be part of the original fabric.

Figure 69 Building D ground floor west room
Looking east. Roller shutter door to yard on right

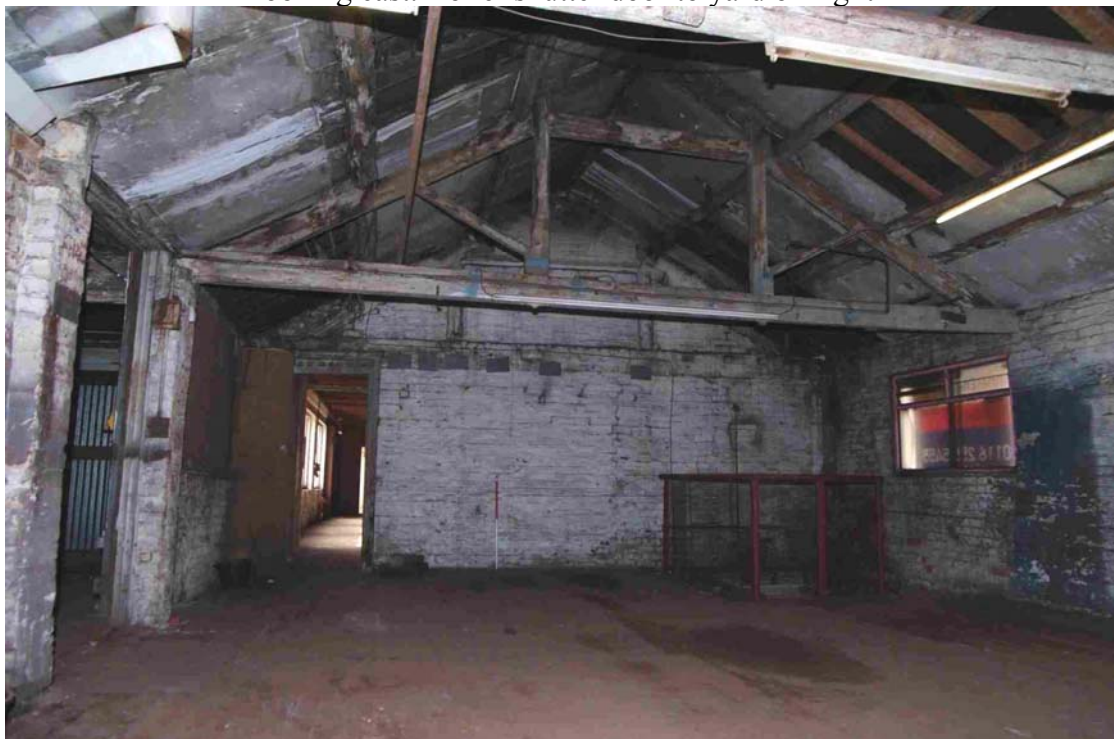
Figure 70 Building D first floor east end
Roof truss. Looking west. Door to Building E on left, door through to west room of
Building D in centre. Stairs to ground floor on right
