**A Level 3 Historic Building Survey at
98-100 Welford Road,
Leicester**

ULAS Report No. 2017-170
©2017

For: Invicta Universal Limited

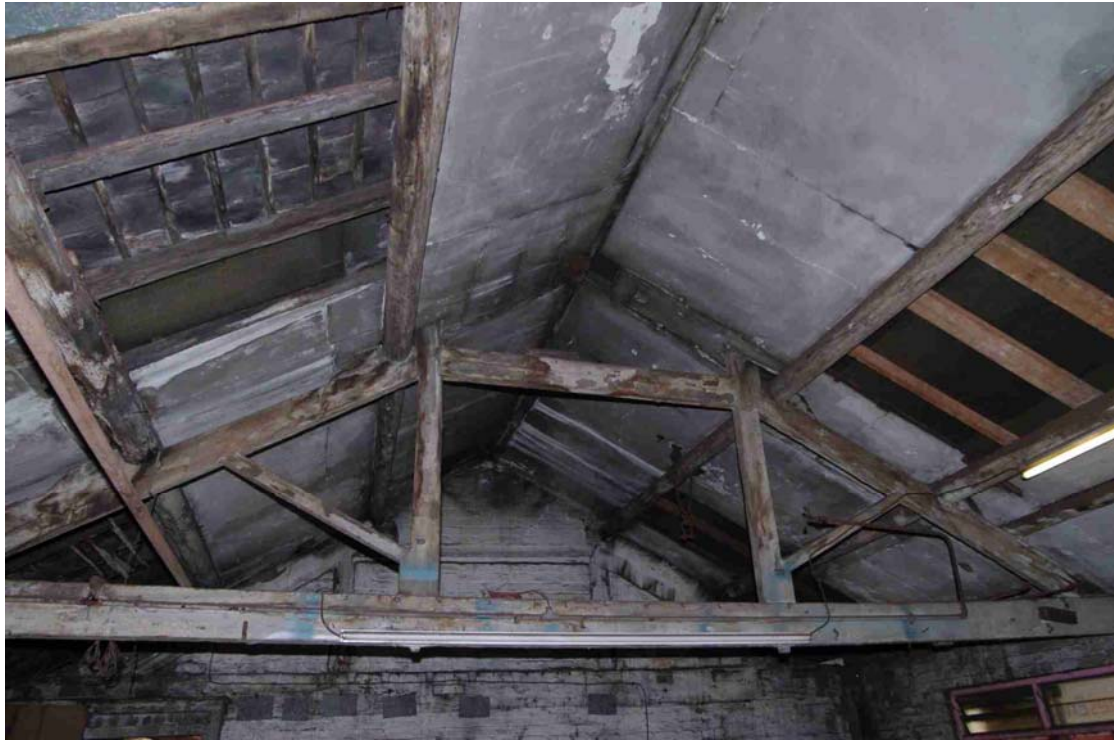
Figure 71 Building D first floor east end, roof detail
Looking west

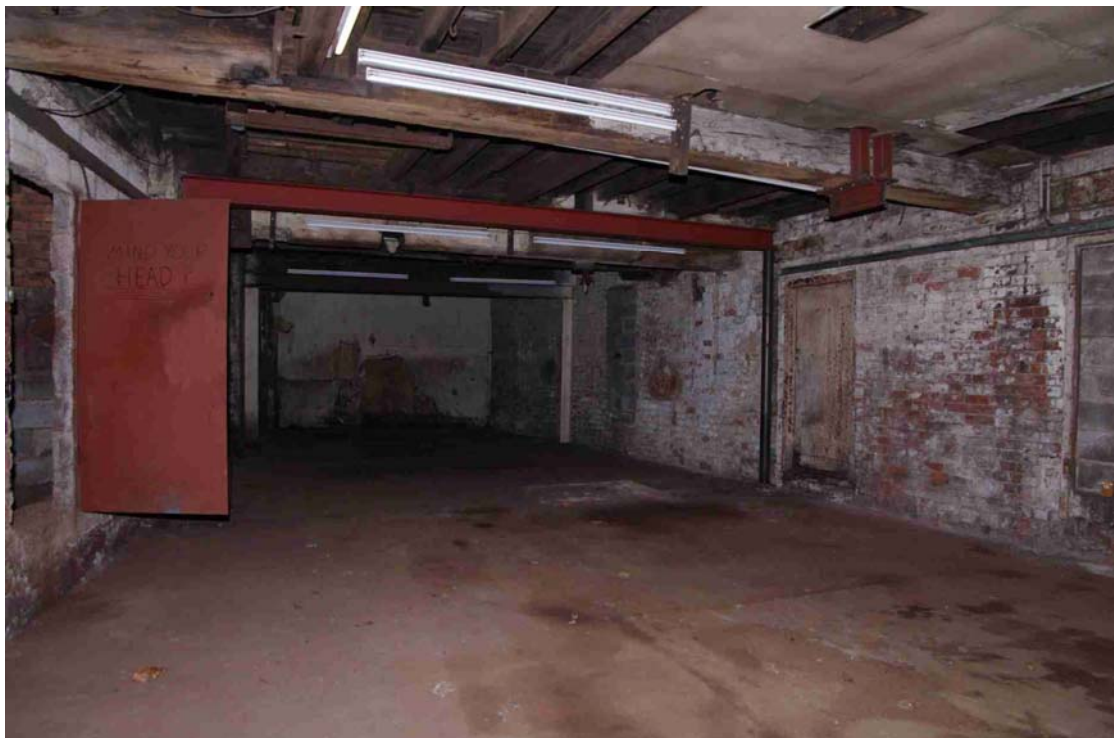
The ground floor of Building E has a number of doorways, some blocked, into the adjacent building to the south (Fig. 72). There is no clear evidence that the eastern end of this room was once a smaller separate building although there is a step in the wall line on the north wall close to the east end. A variety of substantial timbers support the floor above which suggests that the building was used for relatively heavy duty activities. The first floor has a number of different roof supports some of which are

Figure 72 Building E ground floor
Looking east

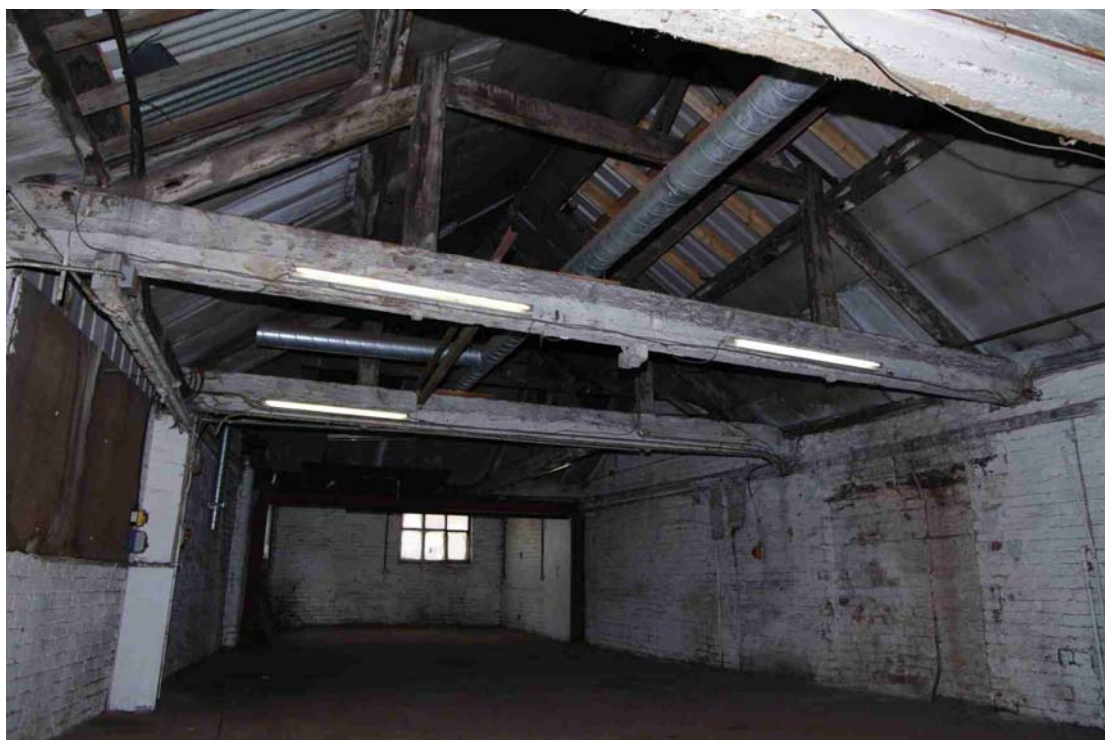
relatively modern. Others, which look to be part of the original fabric are of mid-19th century design and also use round-section purlins (Fig. 73). A self-closing fire door connects this room with the unsurveyed room to the south.

Figure 73 Building E first floor
Looking east. Note steel fire door in wall on right just beyond the modern steel support
