**A Level 3 Historic Building Survey at
the Queens Buildings,
37-43 Rutland Street,
Leicester**

ULAS Report No. 2017-100
©2017

For: Staniforth Architects

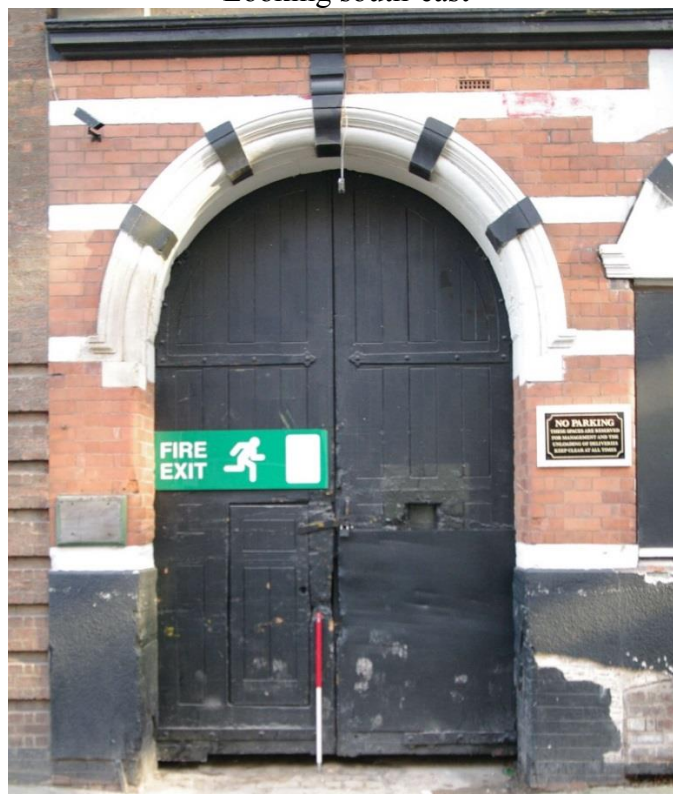
The ground floor of the Queens Building is built of red brick with stone detailing and a rendered base. Part of the rendering at pavement level has been chipped off as part of the present refurbishment programme and has revealed evidence of bricked-up windows into the basement. The rendering must therefore be relatively modern. Most of the stone banding and archway detailing on the ground floor has been painted white with the keystones on the segmental arches being picked out in black making this floor stand out in contrast to the floors above (Fig.13). The eastern ground floor corner of this elevation has a tall gateway leading through the building to a small loading bay. The wooden plank-built double gates have strap hinges and a small single doorway set into the larger door (Fig. 14). The segmental arch of the gateway matches that of the ground floor windows and this theme continues along the entire ground floor principal elevation. As the elevation curves round to the north-west elevation a recessed full height single doorway leads to a set of stairs down to basement level. There is no evidence of a flush doorframe which indicates that this has always been a recessed door. The two main ground floor windows on this side of the building have been boarded

Figure 14 Gates into loading bay, NE facing elevation
Looking south-east. 1m scale. Note bricked up basement window at ground level

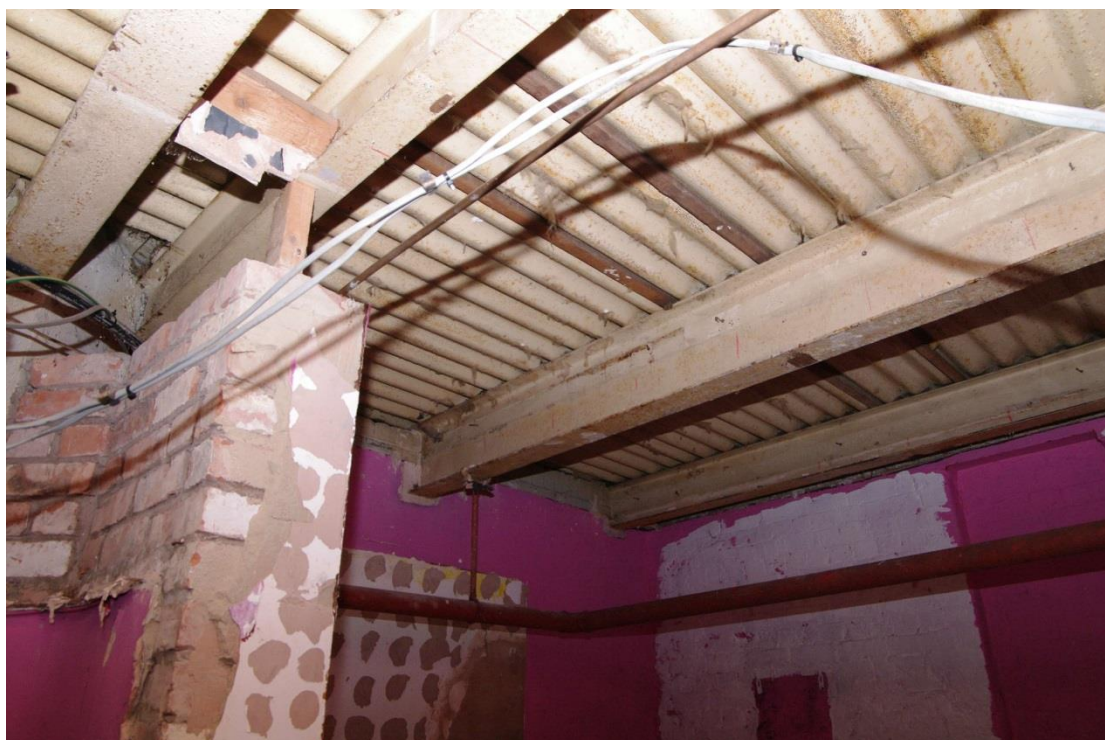
Figure 35 New basement ceiling and supports beneath rear range

Internally, the areas which have undergone most changes appear to be the basement and ground floors. The basement has been extensively rebuilt to support a replacement floor and new steelwork. It is not entirely clear why this happened but it may have been as a consequence of structural weaknesses caused by the curved frontage structure rather than having a stronger corner structure. The type of materials used in the rebuild suggests a mid-20th century date. The date that this took place may also coincide with the moving and rebuilding of the stairs up from the basement to ground floor level in the north corner. The internal alterations to the ground floor seem likely to have taken place more recently with many internal walls being removed to open up the former rented spaces. The widening of the second stage of the main stairs also seems to have taken place relatively recently given the use of modern plasterboard and the wrought iron copied balustrade. The rebuilding of the stairs probably took place at the same time as the removal of the stairs on the 2nd floor. Unfortunately there is no trace of the earlier 2nd floor stairs. Similarly it is not known when the 1st floor offices had their walls removed.

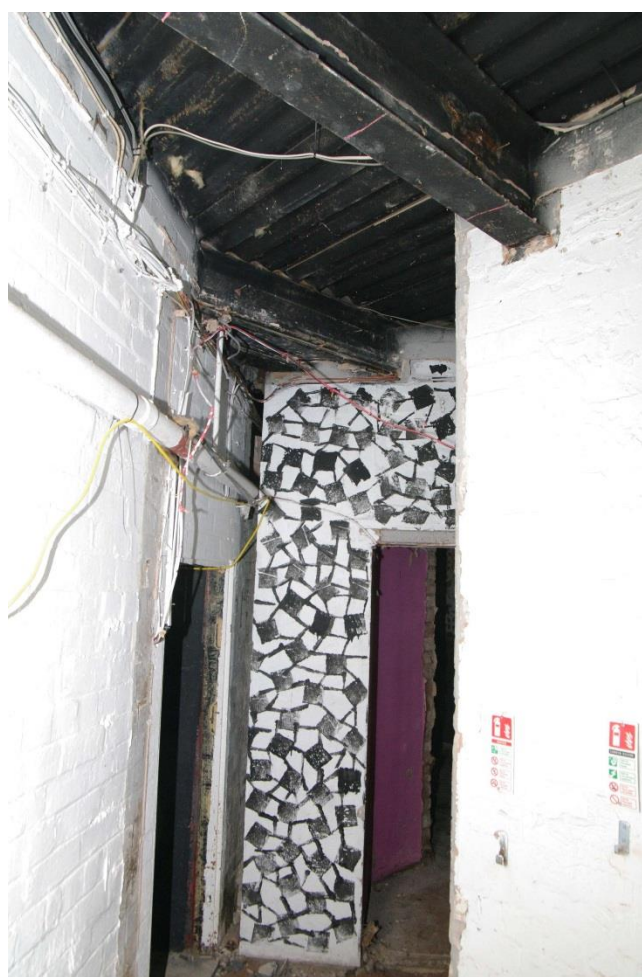
As noted, the basement below the rear range has had a number of partition walls inserted making this area something of a warren (Fig. 36). The space seems to have been used for toilets and small offices. Most of the floor appears to be laid with concrete, elsewhere in the basement a modern covering of slabs and sand has been removed to expose the original red brick flooring. The blocked basement windows seen on the south-west facing elevation cannot be seen from the inside which suggests that there is a new skin of bricks lining the inside of the wall which was added when the new ceiling and steelwork was installed. Two wide steps lead out of the basement to the small open area in front of the south-west facing elevation (Fig. 37). On the opposite (north-eastern) side of the rear range is the goods lift which is set at approximately 45° to the room. This rather strange angle appears to have been forced on the architects so that it would open at right angles onto the cramped loading bay. Unfortunately the 45° angle has had to be maintained on every floor which intrudes into the available storage space. The steps leading out to the loading bay are shown on the 1897 plan as reaching ground level just where the later fire escape is located. They also appear to be narrower than they are at present meaning that it is likely that the basement steps have been moved and widened to accommodate the bottom of the inserted fire escape and to allow extra space for the rebuilt ceiling (Fig. 38). The area around the former boiler has been rebuilt and altered making a number of small inaccessible spaces.

Figure 36 Basement rear range, inserted walls
Looking south-west. Lift shaft door on right

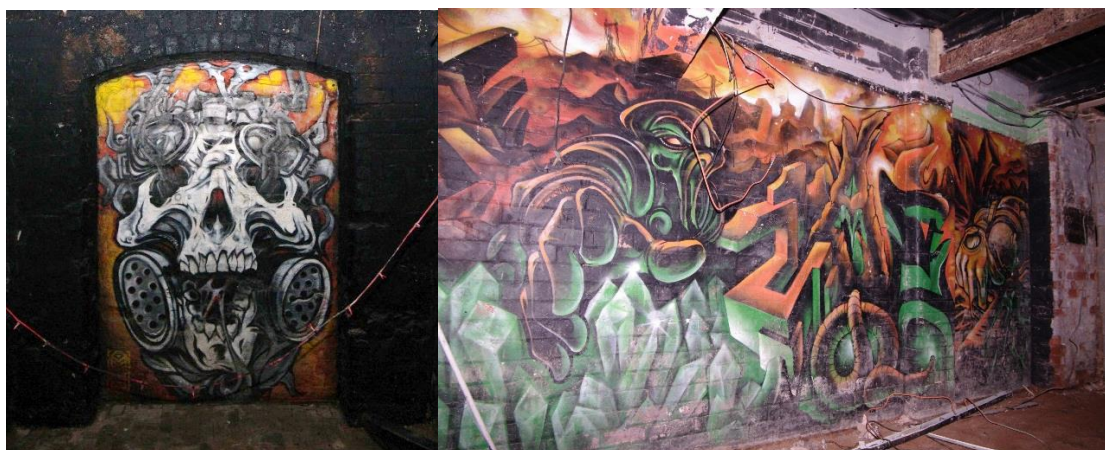
Most of the walls in the basement are decorated with a fairly garish paint scheme no doubt originating from its time as a club. Whilst not part of the original fabric they do have an interest as part of the history of the building and the history of Leicester's nightclubs (Fig. 44).

Figure 44 Basement, wall art

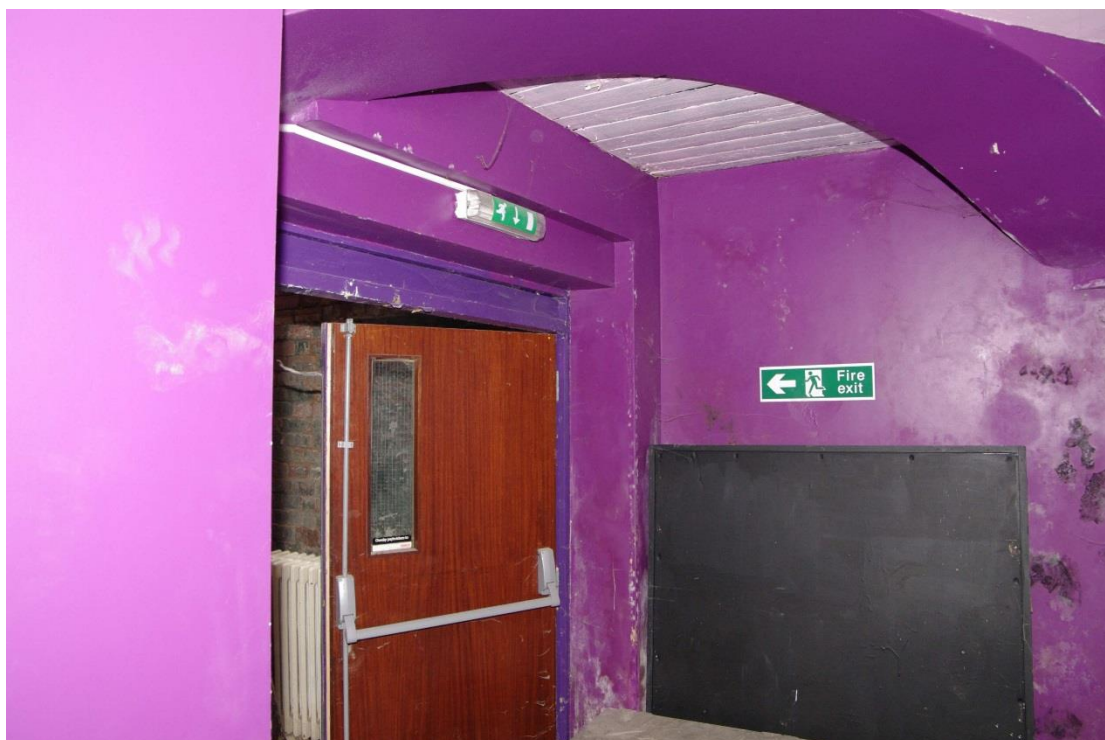
As noted, the former warehouse belonging to the rear range was built with access to the loading bay and goods lift. The lift has been boarded over and hidden by an inserted room. The route to the loading bay is also restricted by the modern partitions (Fig. 59). The doors out to the loading bay are modern fire doors.

Figure 59 Ground floor, exit to the loading bay
Looking east

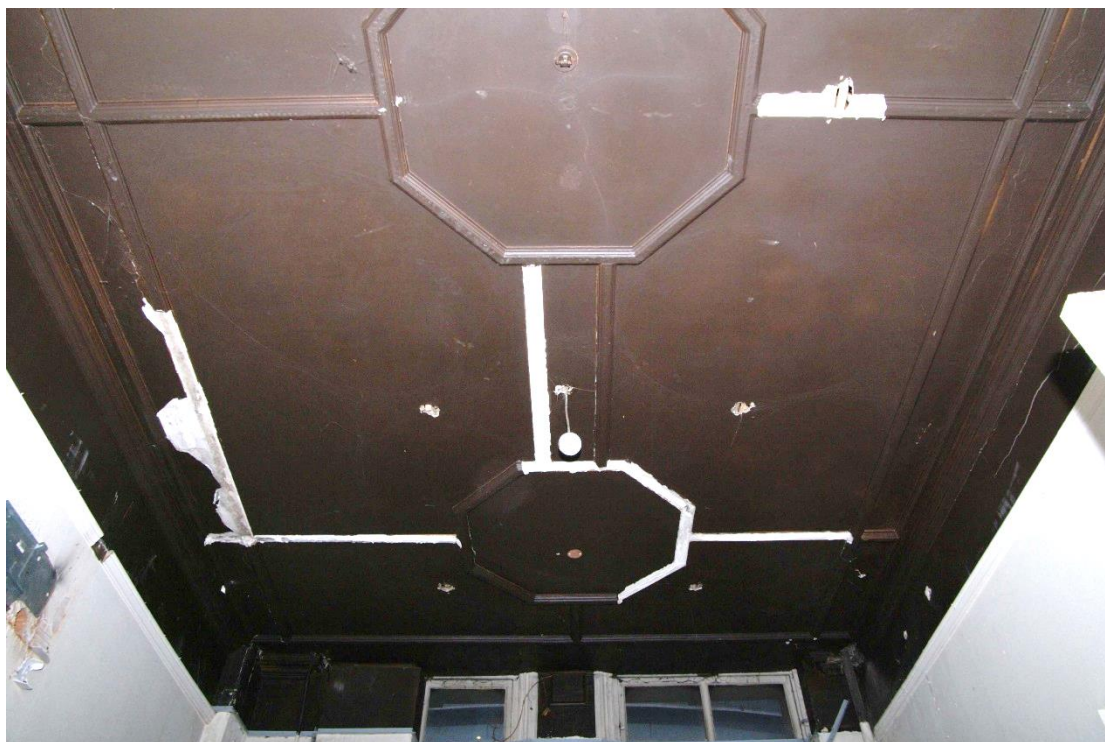
In the north-west corner of the north-west facing range is a small room with a brick wall which is shown on the 1897 plan as the reception room. This room has a plastered wall with moulded picture rails and moulded wooden skirting boards (Fig. 65). The ceiling has a moulded plaster decoration on it although this is in a poor state of repair (Fig. 66). The windows are wooden-framed two over two panes with the small upper

Figure 66 First floor, former reception ceiling
Looking north

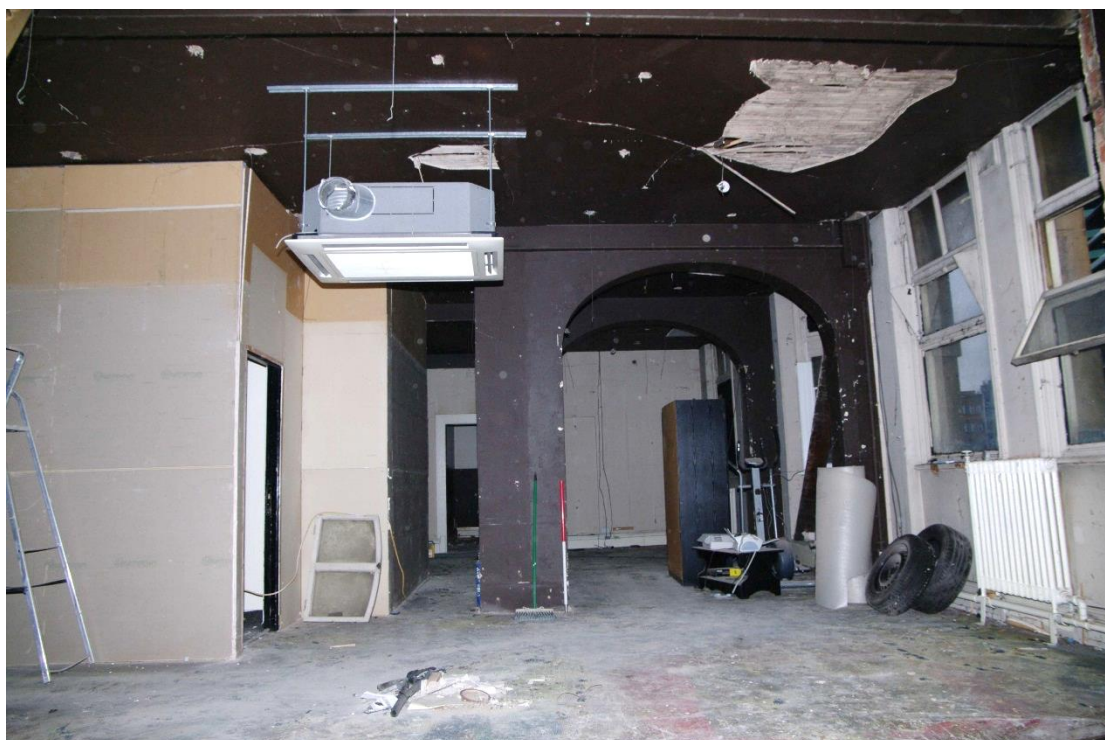
Very little evidence of the other front offices survives except for two masonry stubs with wide arches extending towards the bay window on the north-west facing elevation (Fig. 69). No marks can be seen on the wooden floor which may mean that it has been re-laid. The floor is laid with herringbone pattern wooden parquet blocks. The wooden-framed windows in the bay have fixed larger panes and smaller tilting upper panes (Fig. 70). The bay and most of the north-west and north-east facing elevation walls have moulded skirting boards, plastered walls and plaster ceilings. The plaster ceilings are undecorated. The windows of this elevation are mostly two panes over two with top opening panes although some have been modified to create a smaller opening lower pane (see figure 69). Rainwater downpipes run down the inside face of the building at the side of the windows. These come from concealed gutters in the attic and are discussed below. On this floor the downpipes are circular section.

Figure 69 First floor, former office area
Looking south-west. 1m scale. Boxed-in stairs on left. Masonry stub and arch of
clerk's office centre right. Note modified windows on right

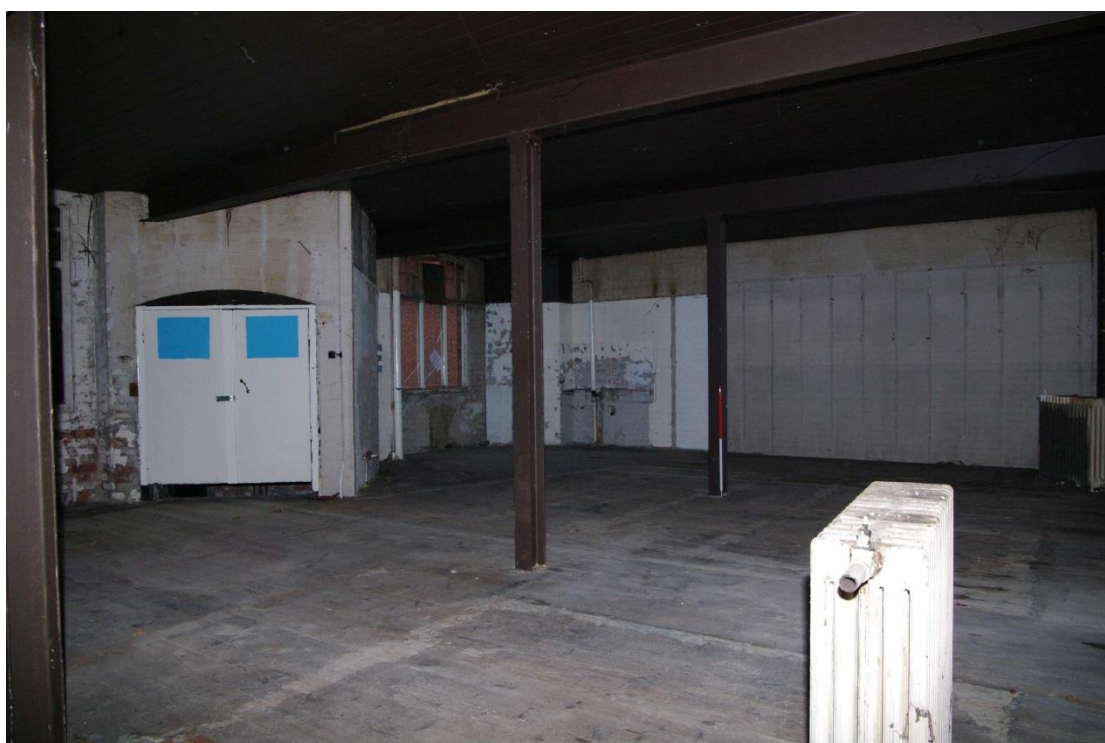
rear range again uses I-section columns supporting overhead steelwork made by the Leeds Steel Works (Fig. 79). The walls are unplastered painted brick with no evidence of any skirting boards or other decorative features.

Figure 79 Second floor, rear range
Looking south-east. 1m scale. Note goods lift on left

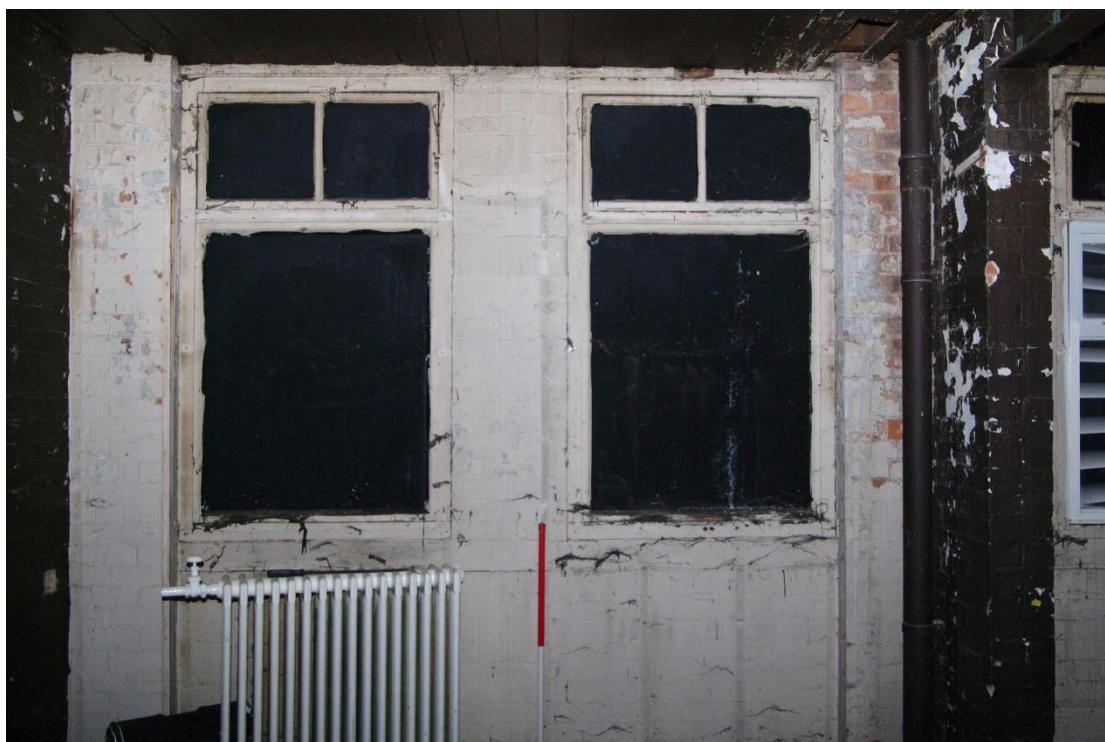
The north-west and north-east facing windows match the window details of those seen on the floor below although not as many have been modified to add an extra opening in the lower panes (Fig. 80). The internal rainwater pipes can be seen running down from the third floor at the side of the windows. The windows facing out over the fire escape to the south-west have arched heads and smaller panes (Fig. 81). The toilet windows to the side of the north-west facing range have the same window details (Fig. 82). Traces of the recent toilet wall survive but no trace of the original toilets is present. The goods lift projects out at 45° into the rear range, as it does on all of the other floors.

Figure 80 Second floor, north-east facing elevation window detail
Looking north-east. 1m scale. Note rainwater downpipe on right

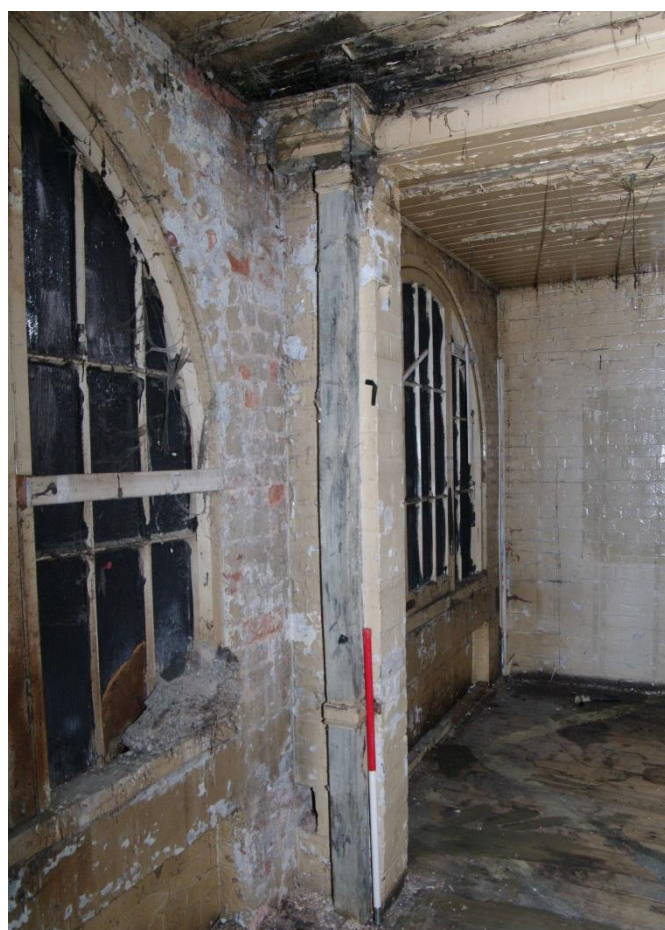
The rainwater downpipes from the internal gutter are located to the side of the north-west and north-east facing windows. On this floor most downpipes survive in their original form as rectangular section lead channels (Fig. 89). They also have cast lead hoppers at ceiling height.

Figure 89 Third floor, internal lead downpipe and hopper
Looking east. 1m scale

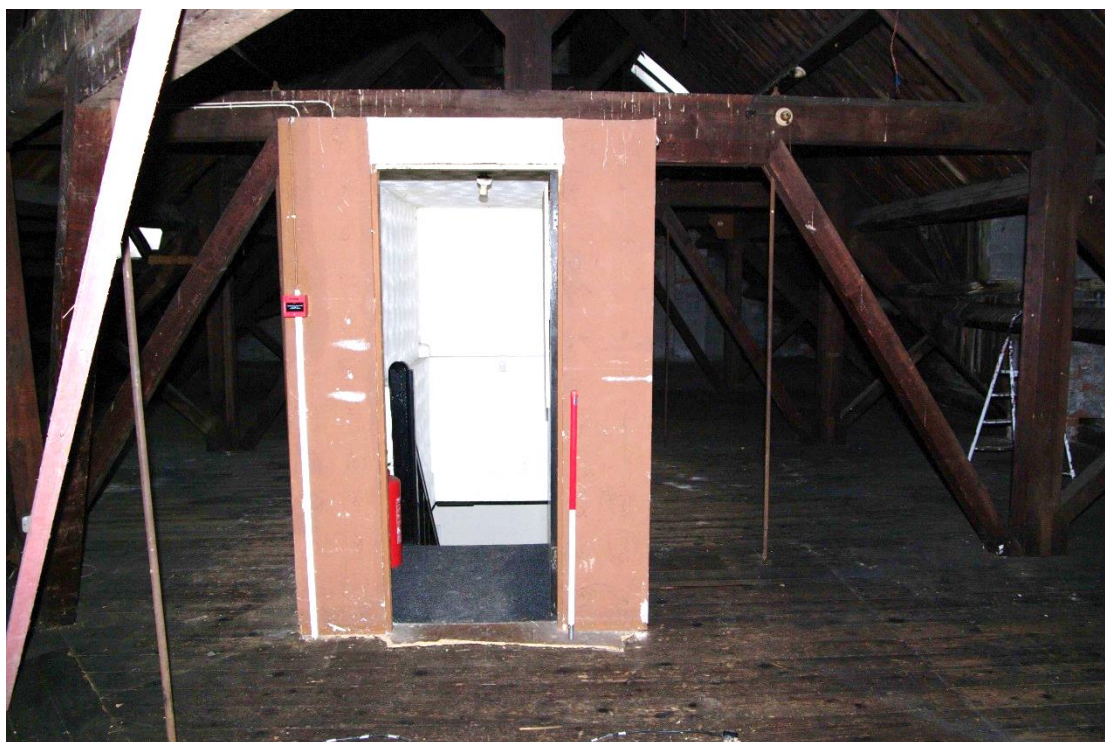
A single flight of centrally located narrow stairs runs up from the 3rd floor to the 4th-floor attic space (Fig. 90). The stairs were open when first built but have had a plasterboard surround added to enclose them (Fig. 91). The handrails still remain as do the square section balusters on the southern side. The balusters on the north side have been removed.

Figure 91 Fourth floor, stairs to lower floors
Looking south-east. 1m scale
