**A Level 3 Historic Building Recording  
at Cedar Lawns,  
Church Street,  
Burbage,  
Leicestershire**

ULAS Report No. 2017-117  
©2017

**For: Tony Morris Builders**

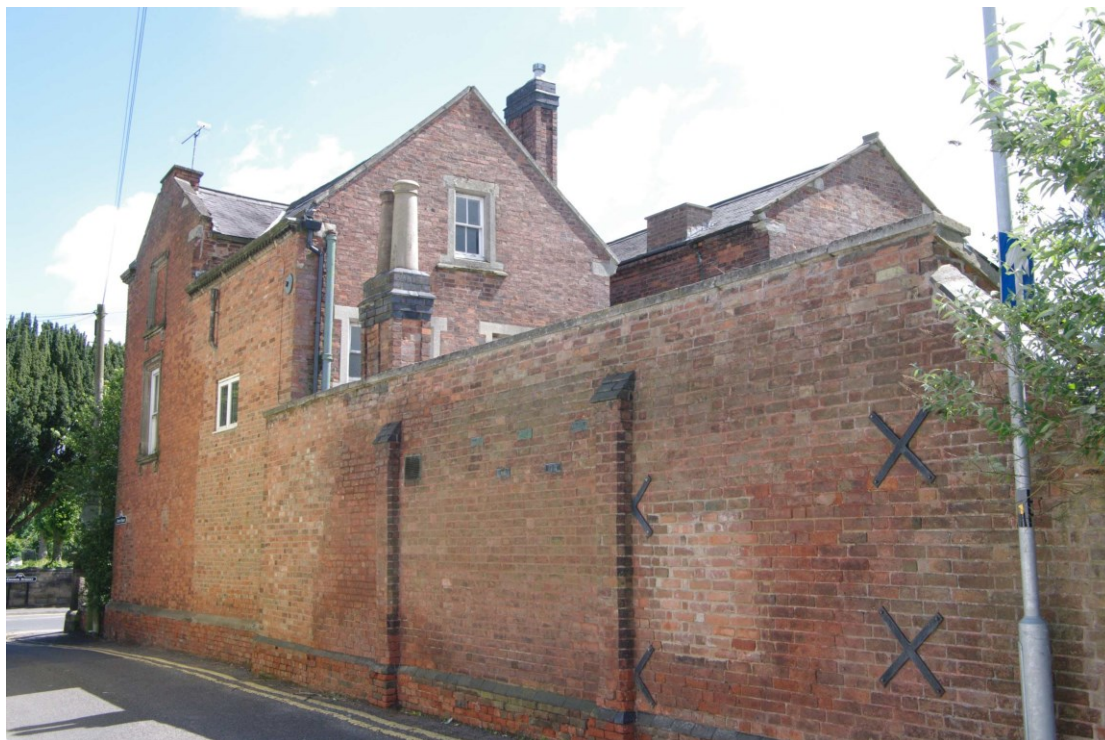
Figure 18 North-west facing elevation from Grove Road  
Looking west. Note drop in wall height to become the garden wall to the side of the  
lamp post

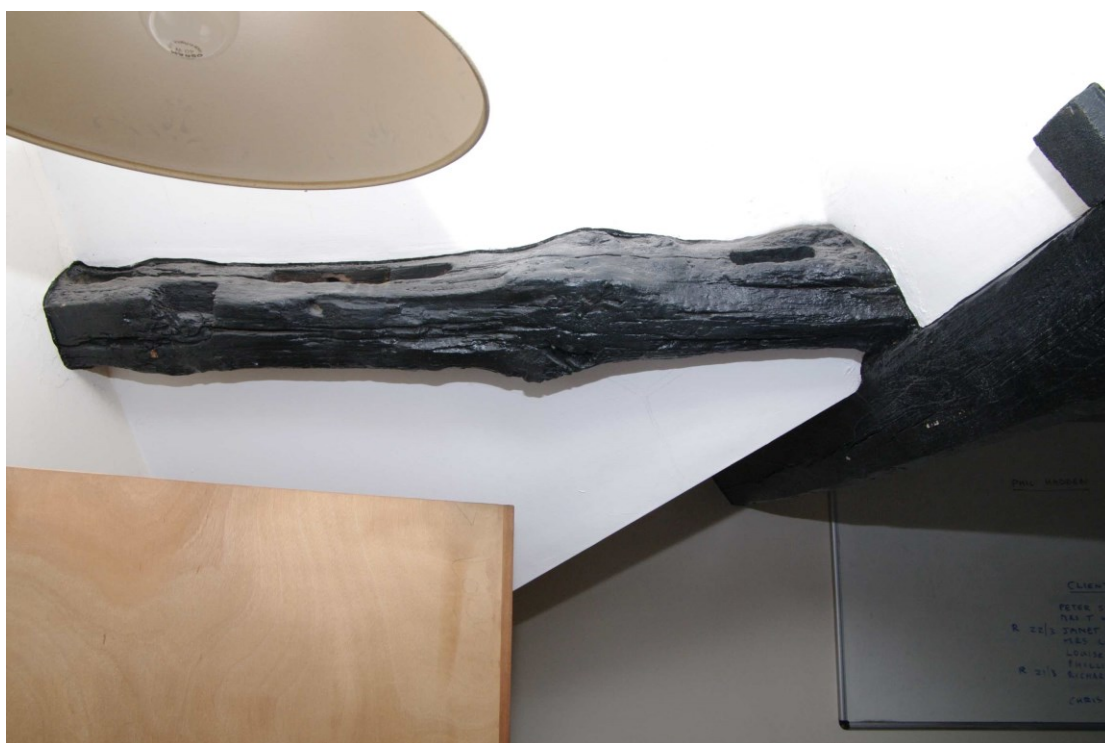
Figure 83 Purlins in Room S6  
Looking north-west

Room S6 is reached via a set of three steep steps from corridor S4 to create a floor level similar to that in Room S3 (Fig. 80). As with Room S3 the floor height also cuts across the bottom of the window which was obviously not perceived as a problem to the builders. The purlins seen in Room S3 continue through into this room (Fig. 81). The end of the purlins extending across corridor S4 and into Room S5 rest on top of the main house purlins (Fig. 82). These timbers have been reused from elsewhere as they have redundant slots where boards for panels were once located (Fig. 83). There is no sign of the possible blocked window which can be seen on the north-west wall.

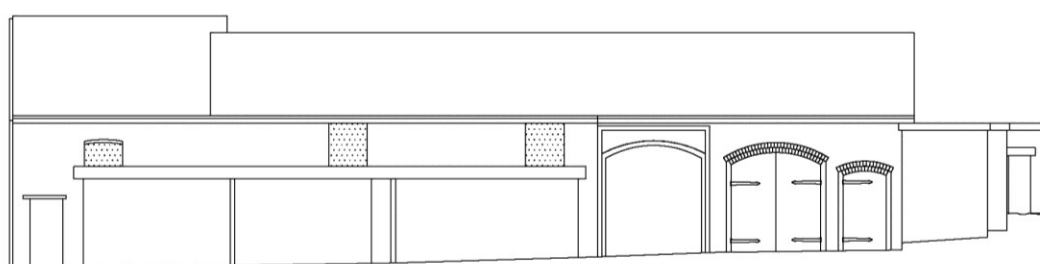
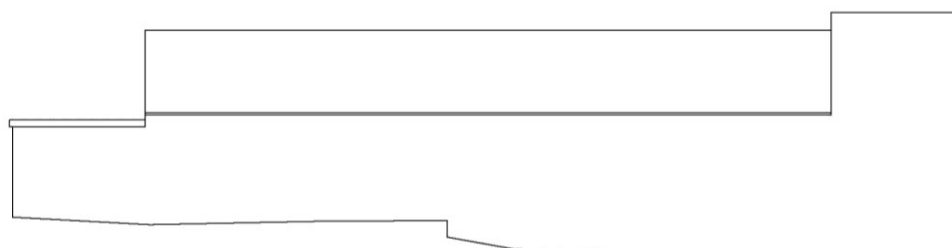
Figure 84 Outbuilding elevations  
Modified from drawing supplied by client

The single storey brick-built outbuildings form a continuous range of buildings along the north-eastern edge of the site (Figs 84 and 85). It seems likely that they were constructed as the stables, tack rooms and carriage sheds for the house. The roof is covered with Welsh slate and is in good condition and may have been laid relatively recently. The roofline is stepped at the northern end where it leans against the outbuilding of the adjacent property. The bricks are laid in a variety of bonds which suggests a number of rebuilds and repairs. The building shown on the early Ordnance Survey maps which fronted onto Church Street has been replaced by a small tarmac parking area and the refaced side wall of the adjoining property to the north-east. For ease of identification during this survey the rooms have been labelled as rooms OB1 to OB8 (Fig. 86). These references do not relate to any previous uses.

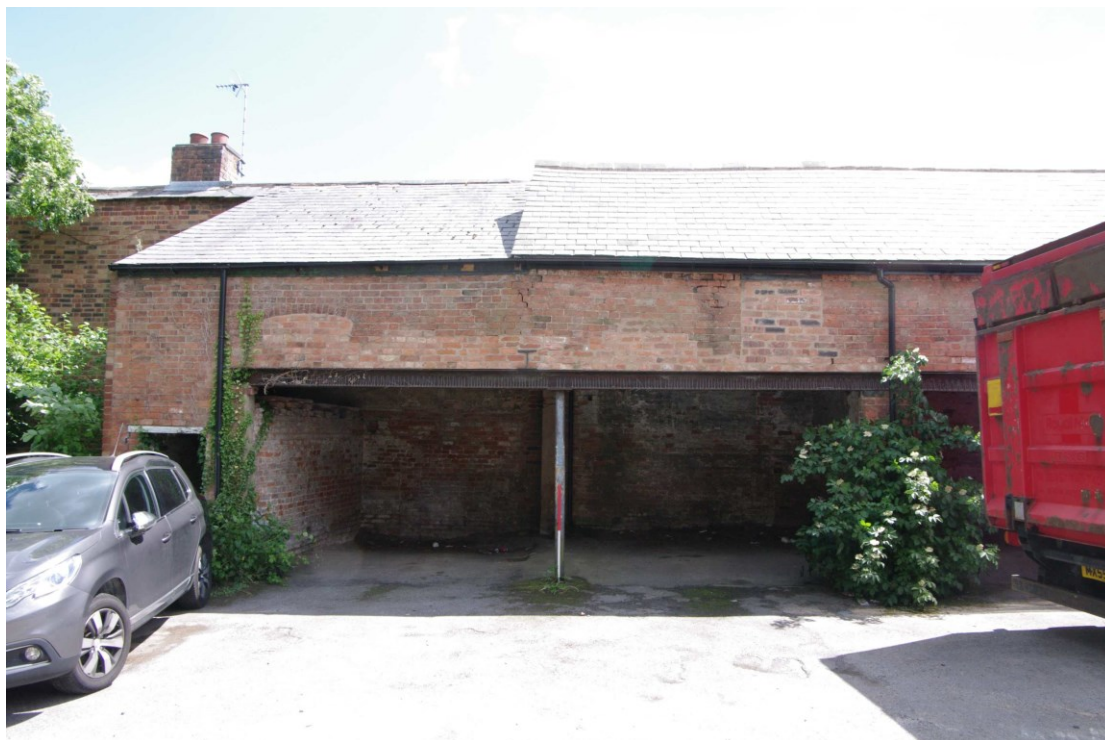
Figure 87 Outbuildings, north-west facing elevation, northern end  
Looking south-east

The north-west facing elevation is broken into a number of elements facing towards the main house (Fig 87). The brick frontage has been heavily modified by the insertion of a long steel beam supported by a square section steel support and a brick pillar with rounded bricks. This was probably done relatively recently to provide car parking for the office staff. The insertion of the beam has cut through three first floor windows which have now been blocked with brick. This indicates that there used to be a first floor level. Much of the brickwork over the beam has been replaced and repaired and there is no trace of a joint in the brickwork where the roof line changes. A narrow single doorway with a wooden lintel at the farthest northern end of the building leads into a small rectangular room (Room OB1).

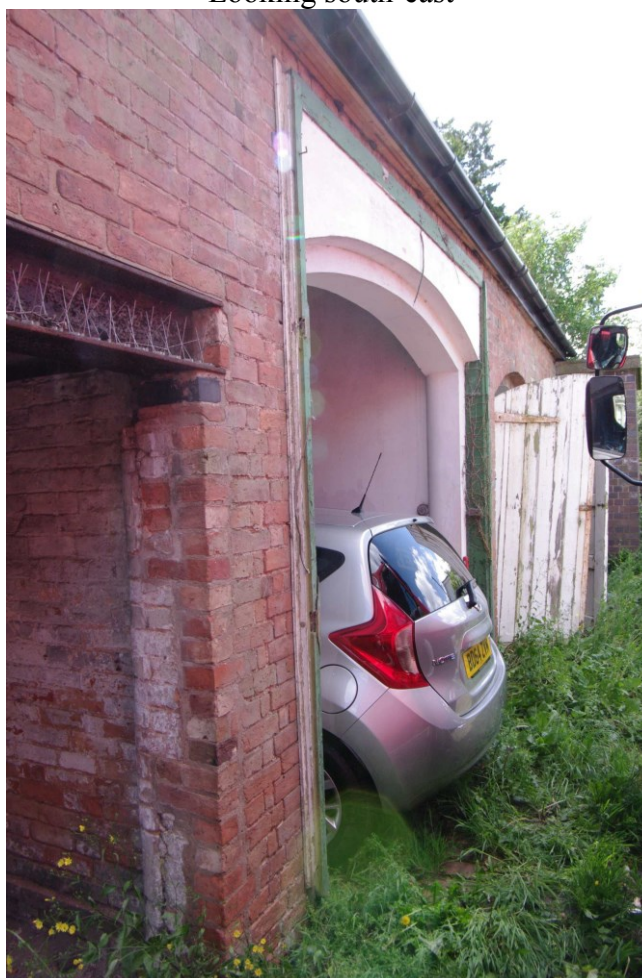
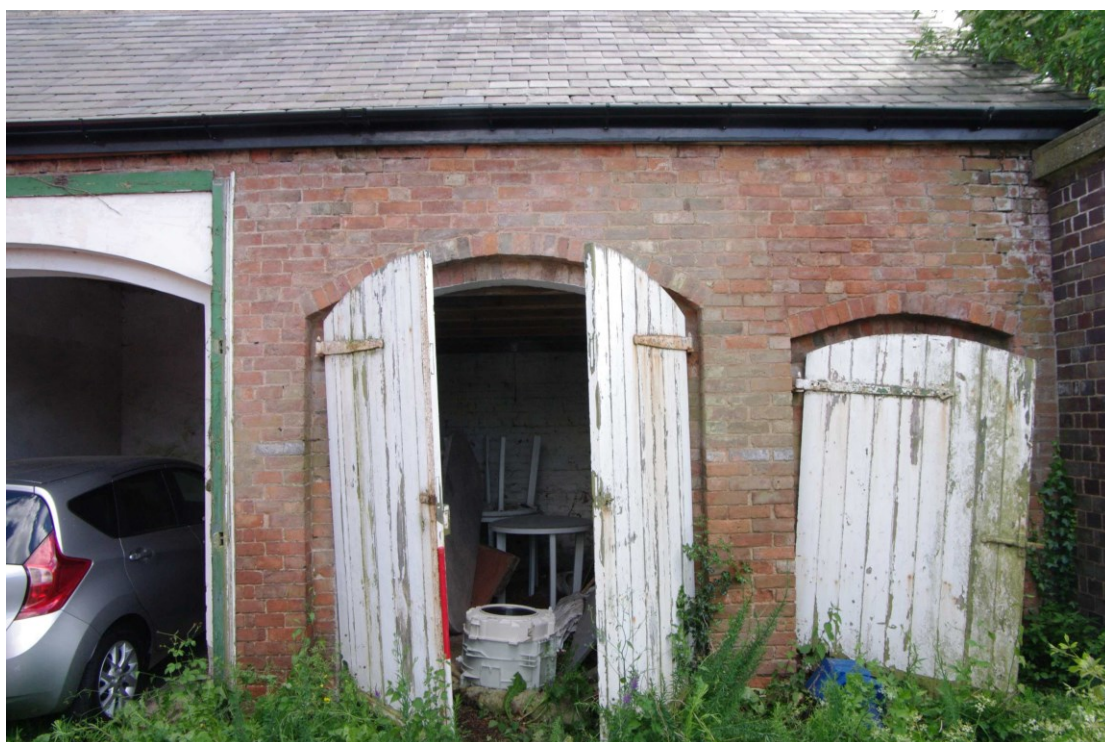
To the south of the steel beam opening are three doorways which are probably the carriage shed and tack rooms (Figs 88 and 89). The largest doorway (Room OB5) has a large wooden frame with a painted plaster arch. There is no trace of the door hinge mountings. The other two doors have arched brick heads with wooden plank doors which have long strap hinges of probable mid-19th century date. The larger doorway (to Room OB6) has double doors which can be locked with a wood-framed door lock case (Fig. 90). This may have been reused from elsewhere as it is probably late 18th century in date.

Figure 88 Outbuildings, north-west facing elevation, southern end  
Looking south

Figure 89 Outbuildings, north-west facing elevation, southern end  
Looking south-east. 1m scale

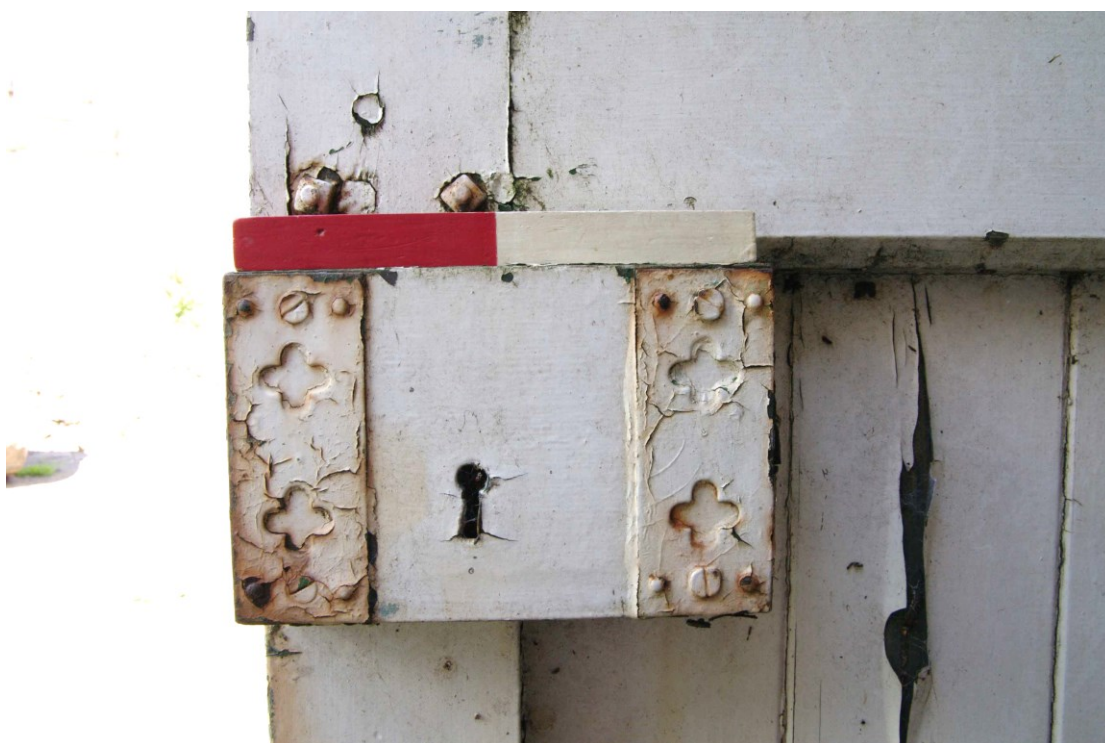
Figure 90 Door lock case on door of Room OB6  
0.2m scale

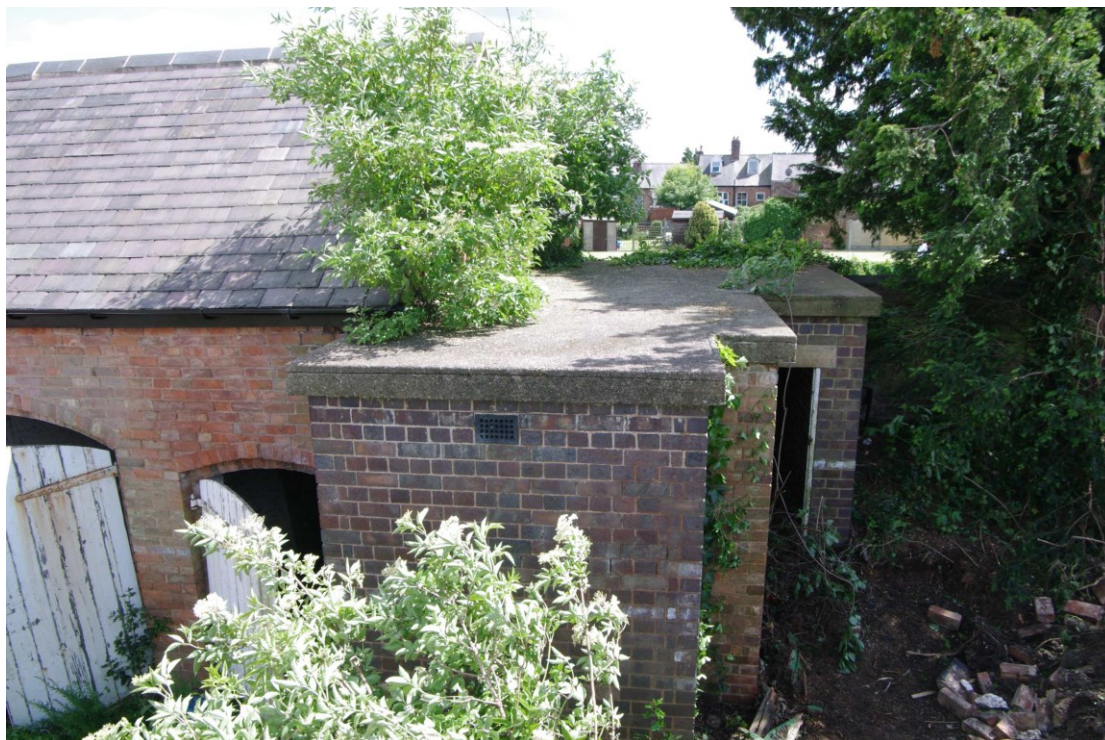
At the south-western end of the outbuildings is a flat concrete roofed building (OB8) built from blue bricks (Fig. 91). This appears to be a Second World War air raid shelter, presumably for the household. It is built with an English bond although part of one wall has slightly more stretchers in it. The two narrow doorways have thick concrete lintels.

Figure 91 Air raid shelter at south-west end of outbuildings  
Looking south-east

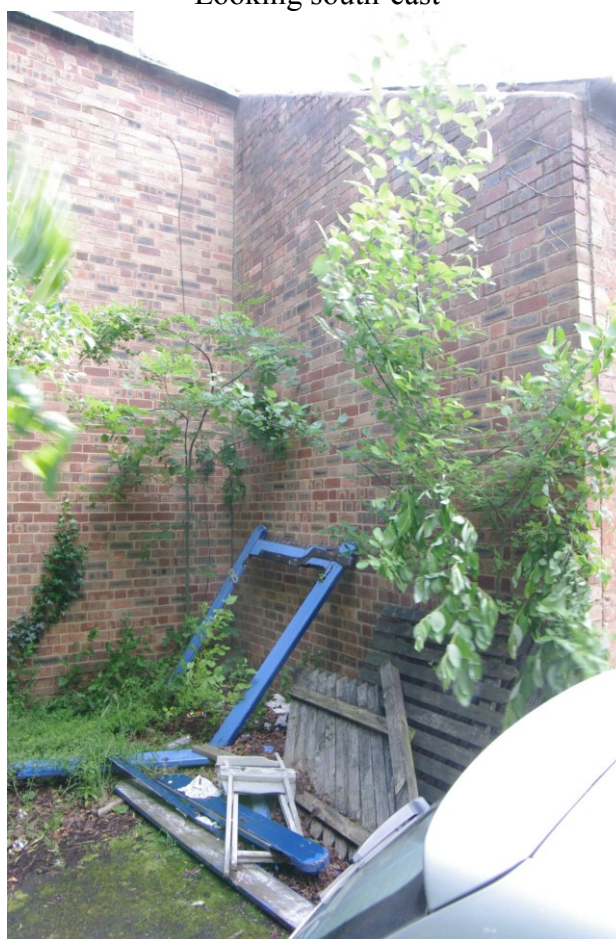
The entire face of this elevation has been re-faced with brick as has the rear (north-west facing) elevation of the adjacent property's outbuilding (Fig. 92). The bricks are mostly laid in a stretcher bond and are no earlier in date than the 1960s or 1970s. These were presumably added to provide a weatherproof skin to the remaining buildings when the building in this corner was demolished. This would then suggest that the demolished building was older than the surrounding outbuildings which would have been built against it.

Figure 92 Outbuildings, north-east facing elevation  
Looking south

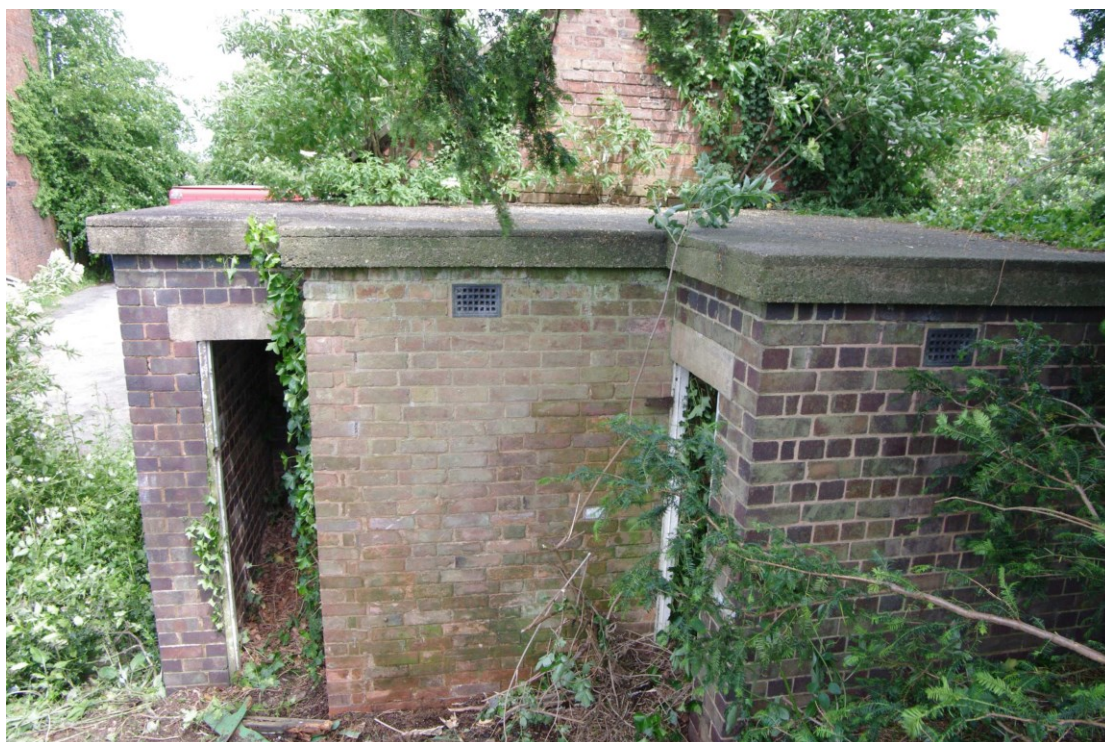
The red brick gable end of the main outbuilding has been partially obscured by the air raid shelter which wraps around the north-west corner and backs against the tall garden wall which extends south-westwards (Fig. 93). The thick concrete roof partially sits on top of the garden wall presumably to give additional support against collapse.

Figure 93 South-west facing elevation of air raid shelter  
Looking north-east

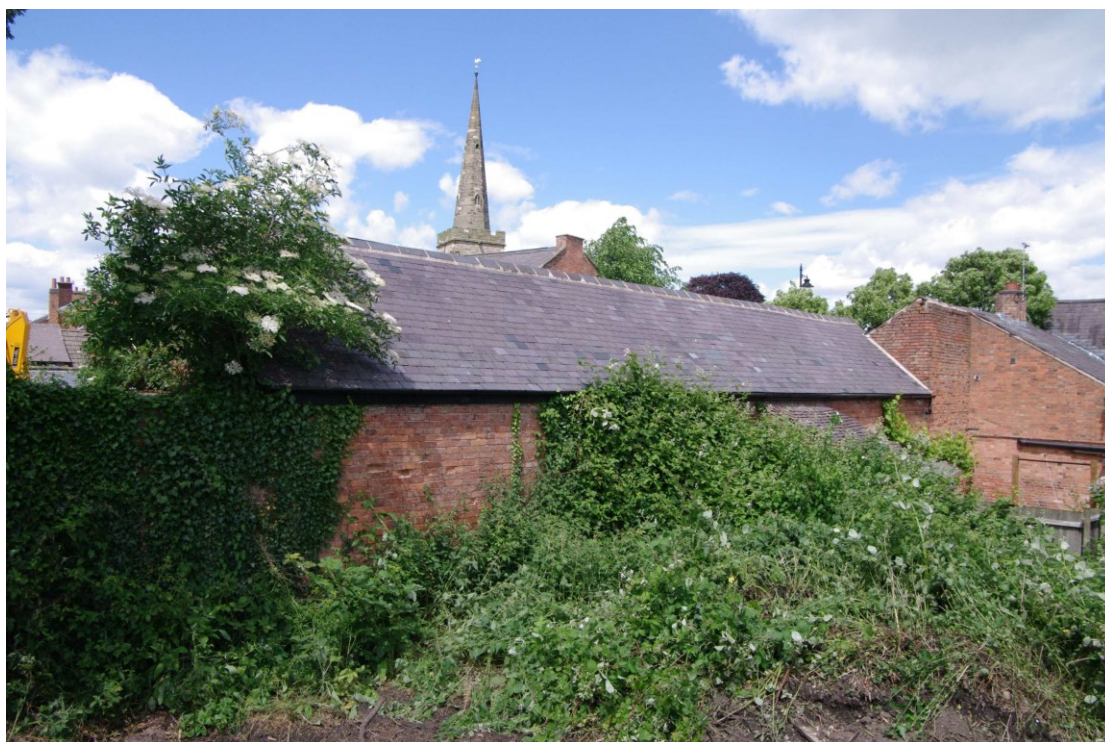
The south-east facing elevation forms the boundary wall between Cedar Lawns and the adjacent property (Fig. 94). The wall is plain brick with no openings or evidence of any blocked openings.

Figure 94 Outbuildings, south-east facing elevation  
Looking north

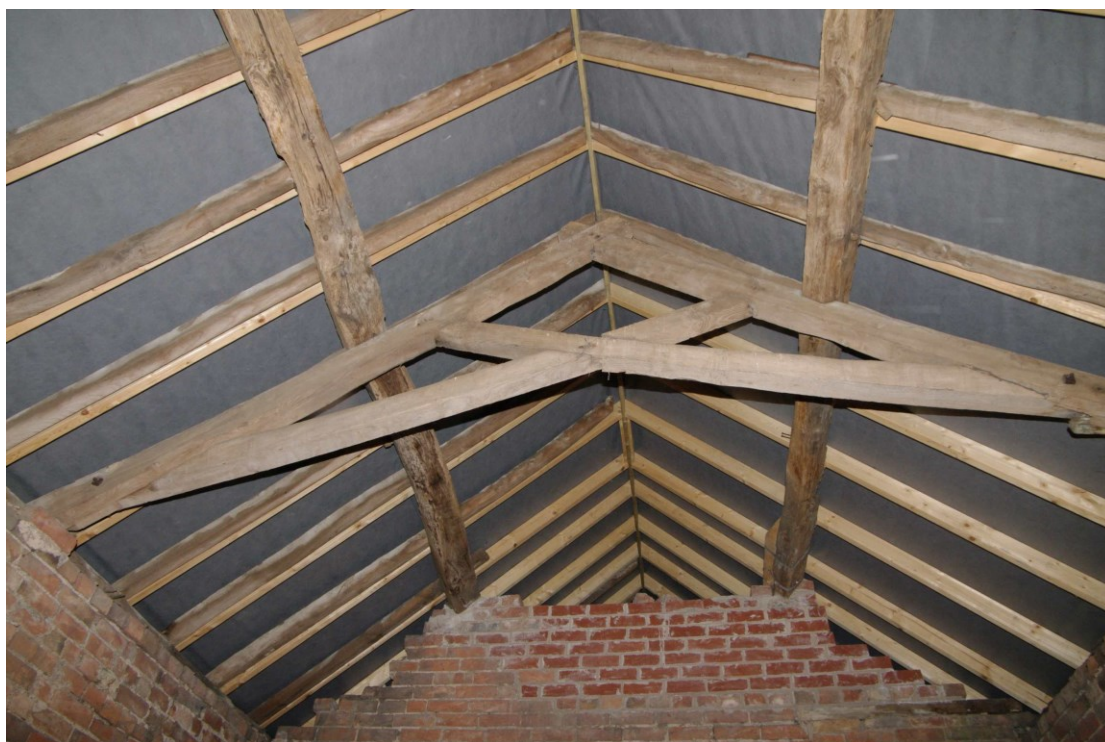
Room OB4 is a small open fronted room which was probably altered at the same time as OB2 and 3. The front has been modified by the insertion of a steel beam but it has retained its supporting brick pillars which still have iron pintles for the missing doors. The room has empty floor joist sockets on the north-eastern wall (Fig. 97). It also has a recently repaired roof although the purlins are probably original and a shallow pitched bolted scissor truss suggests a later 19th century date (Fig. 98).

Figure 98 Roof structure of OB4  
Looking south-west

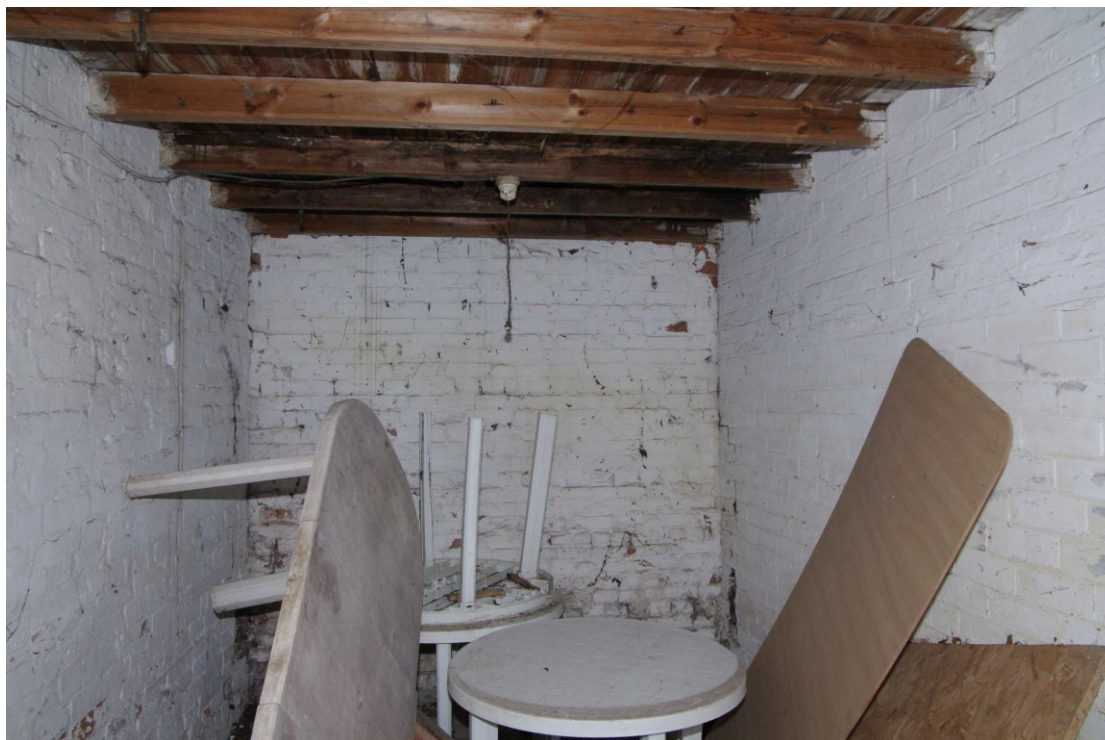
Room OB6 still retains its wooden double doors. Inside, the room has a brick floor and painted brick walls (Fig. 100). It has a ceiling with exposed wooden floor joists and wooden floor boards which look reasonably fresh and may not be the original timbers.

Figure 100 Outbuilding Room OB6  
Looking south-east

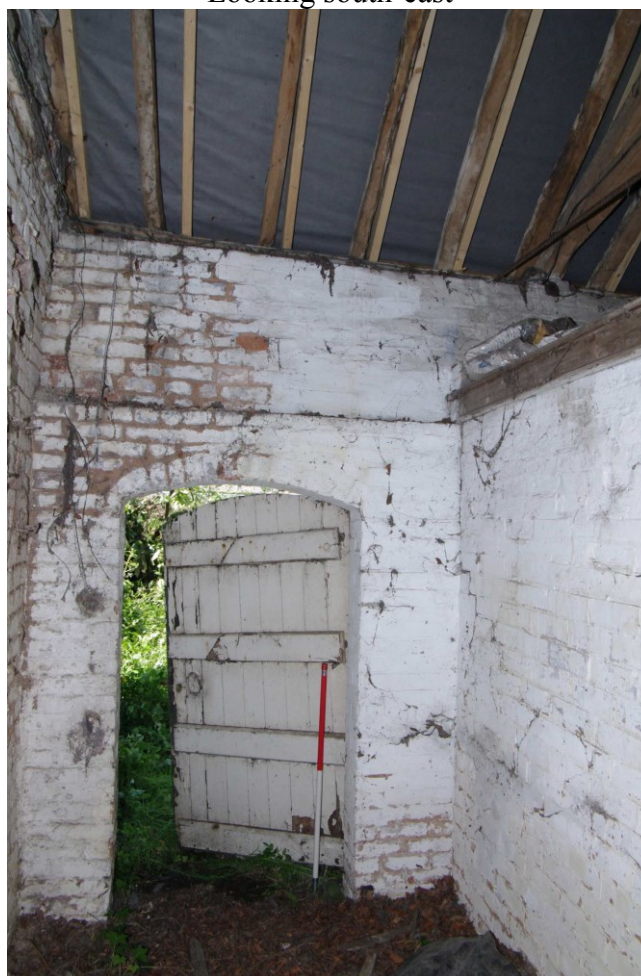
This room is a narrow room which extends up to the roof with no evidence of having a first floor (Fig. 101). The north-eastern wall only reaches to the eaves and so is open to the floor above Rooms OB5, 6 and 7. Although there is no access to this floor it could be seen that the floor is boarded and that the common rafters and slates are recent replacements. The roof is also supported by bolted scissor trusses as seen in Room OB4 (Fig. 102).

Figure 101 Outbuilding Room OB7  
Looking south-west. 1m scale

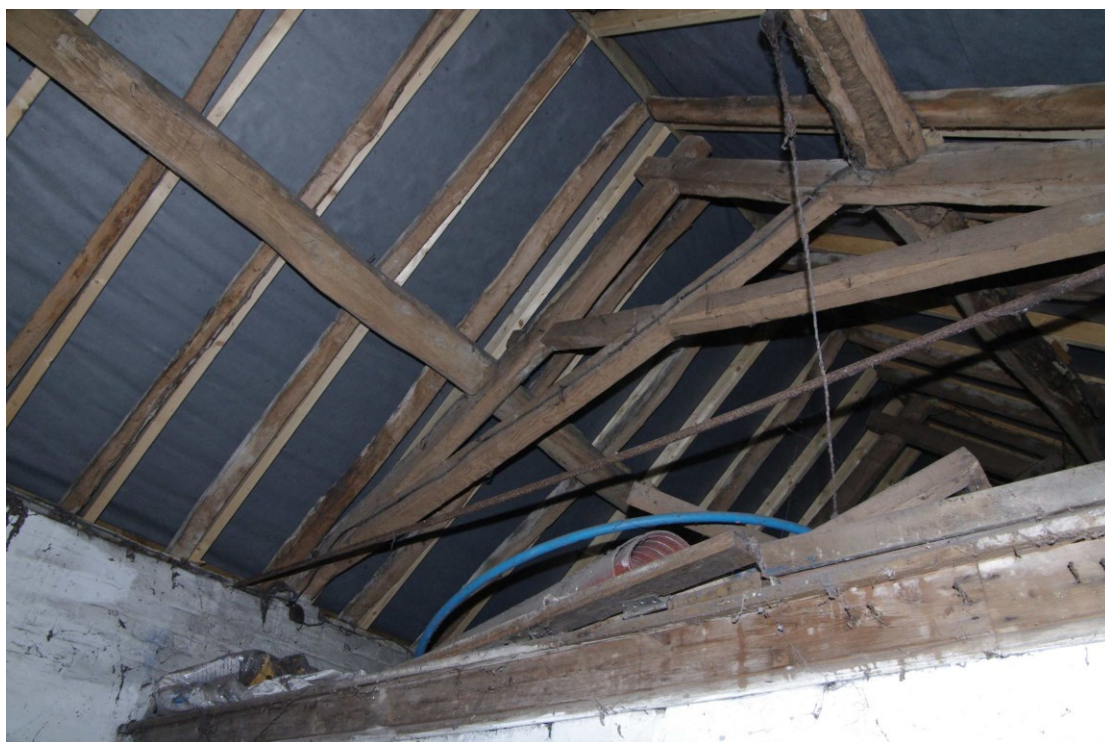
Figure 102 Roof support over Rooms OB5, 6 and 7  
Looking north-east from Room OB7
