**A Historic Building Assessment to
Level 2 at
Welham Lodge,
Cranoe Road,
Welham,
Leicestershire**

ULAS Report No. 2017-155
©2017

Preplanning Application Number: PREAPP/17/00149

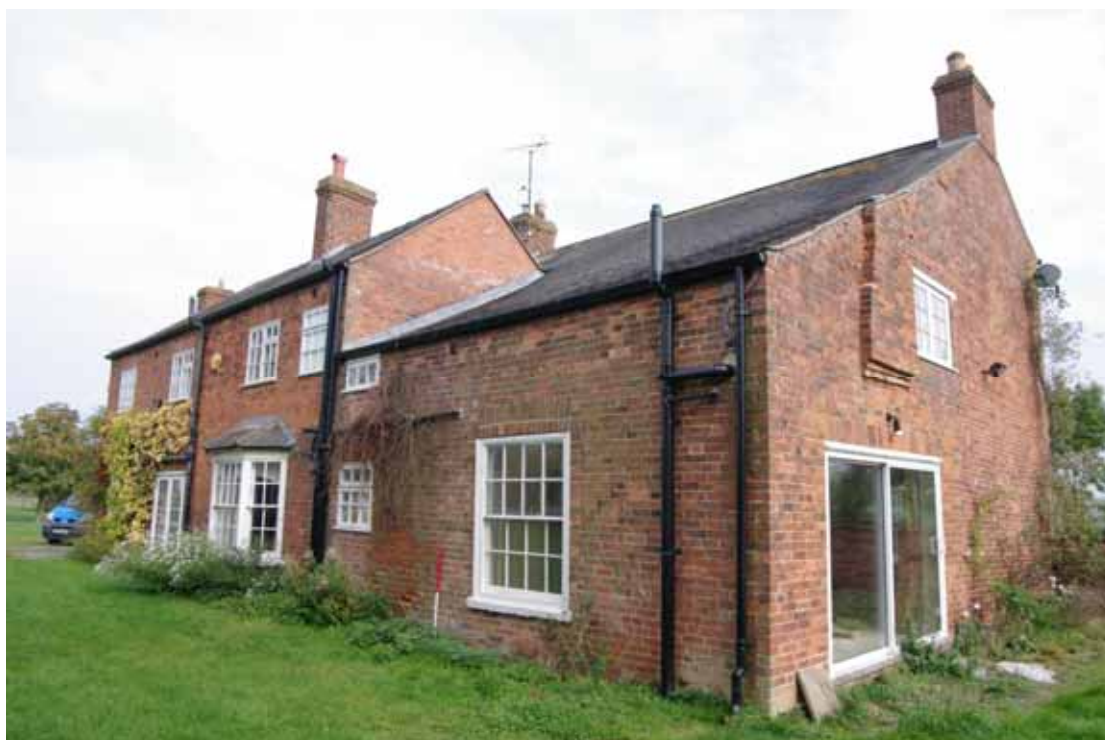
Figure 19 South-west and north-west facing elevations
Looking east. 1m scale

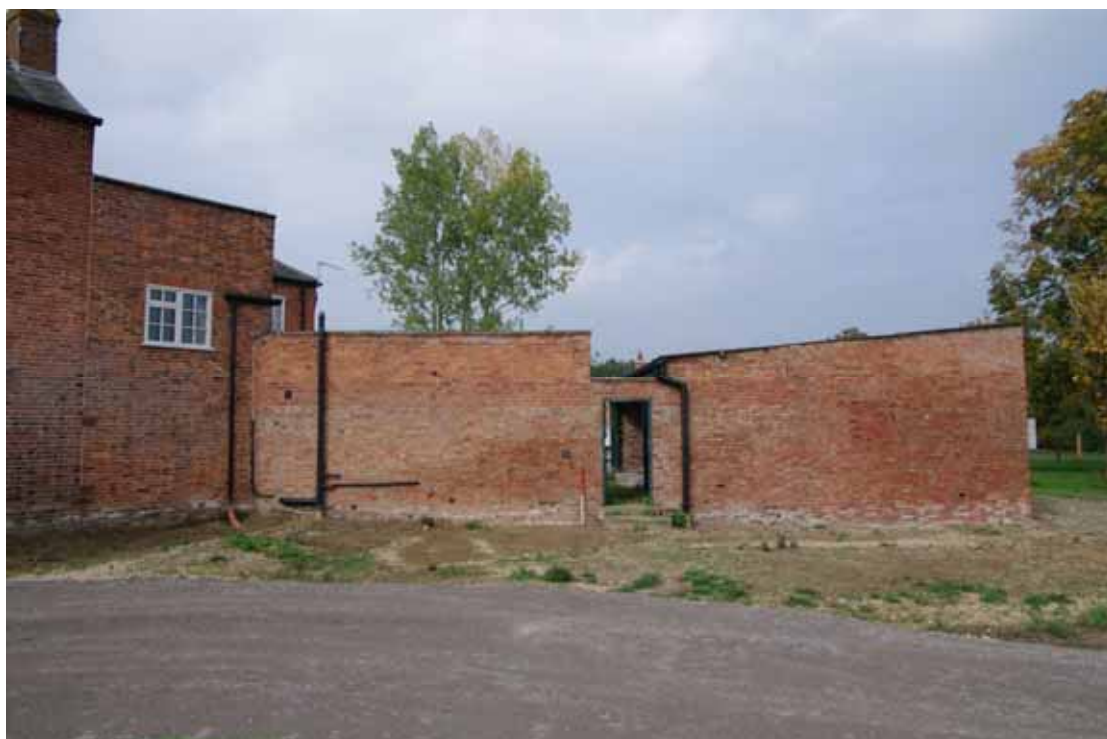
The open-fronted garage also shows evidence of many rebuilds and repairs and has blocked windows on its south and north facing elevations. It is a fairly poor state of repair. The bricks are quite narrow and may be of similar date to the main house but the building quality is extremely poor and they may have been reused from an earlier structure. The west facing open front is supported by substantial steel beams which bear the maker's name of Skinningrove. This company began in 1880 and continued under this name until 1951. The shallow pitched roof has a corrugated sheet covering supported on re-used timbers of a variety of sizes. A small breeze block room has been added into the south-east corner.

Figure 24 Outbuildings, south facing elevation
Looking north. 1m scale. Garage building on right

The proposals are to demolish both outbuildings and replace them with a new garage to the north-east of the house.

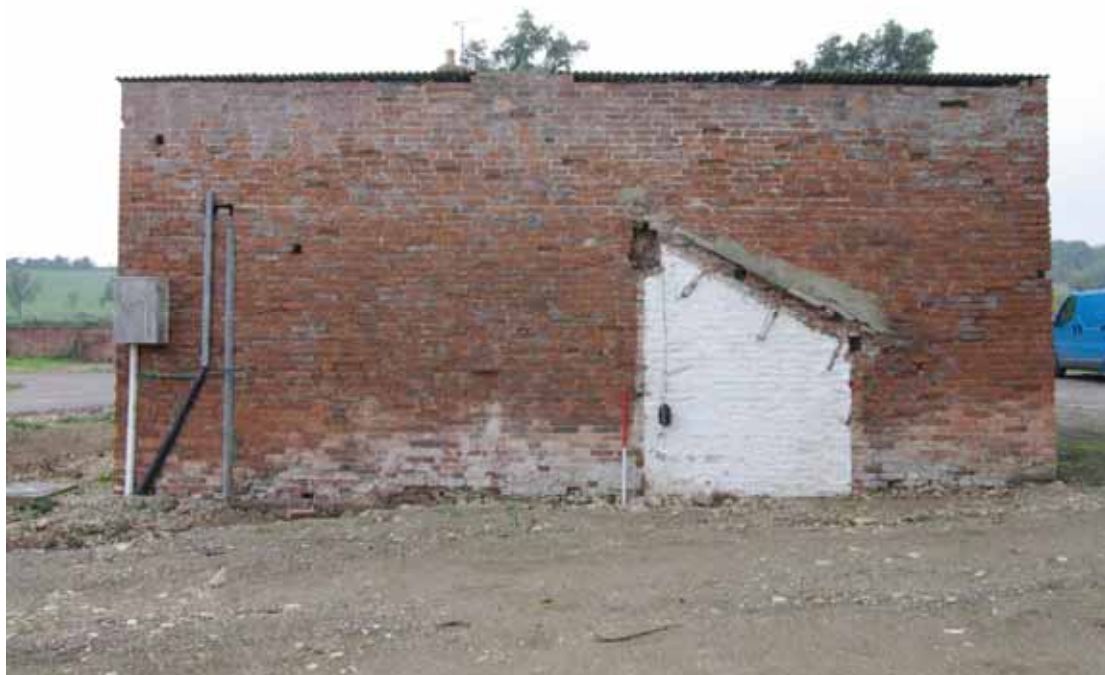
Figure 25 Garage outbuilding, east facing elevation
Looking west. 1m scale

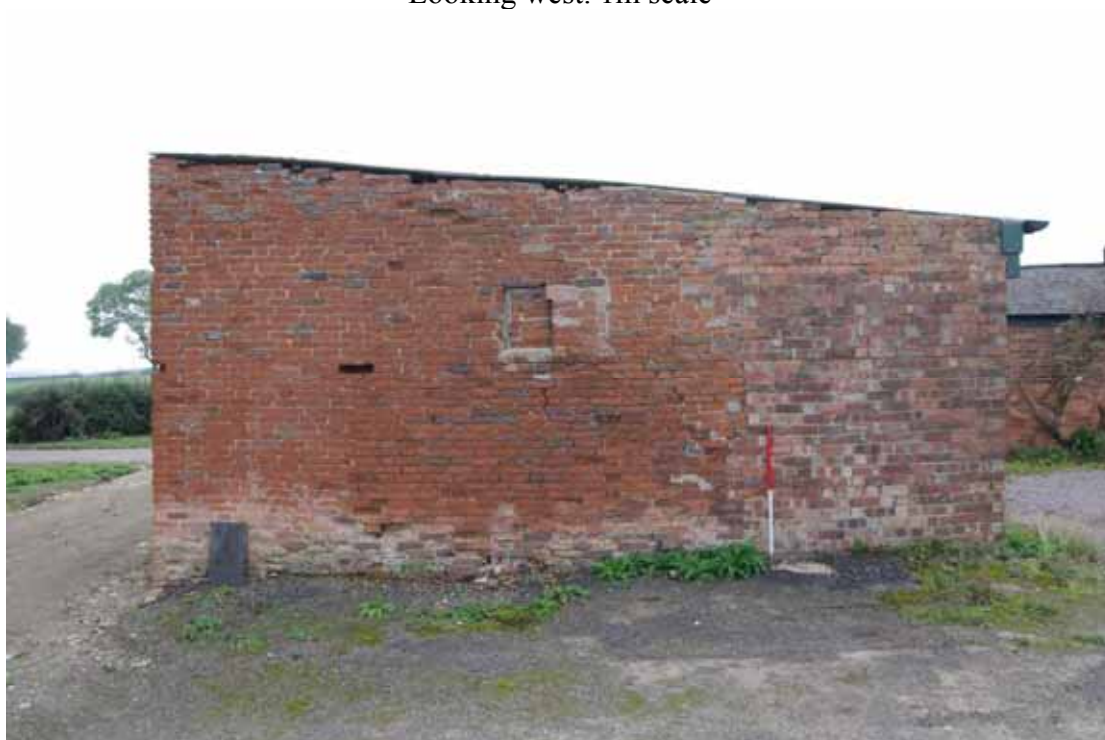
Figure 26 Garage outbuilding, north facing elevation
Looking south. 1m scale. The other outbuilding can just be seen on far right

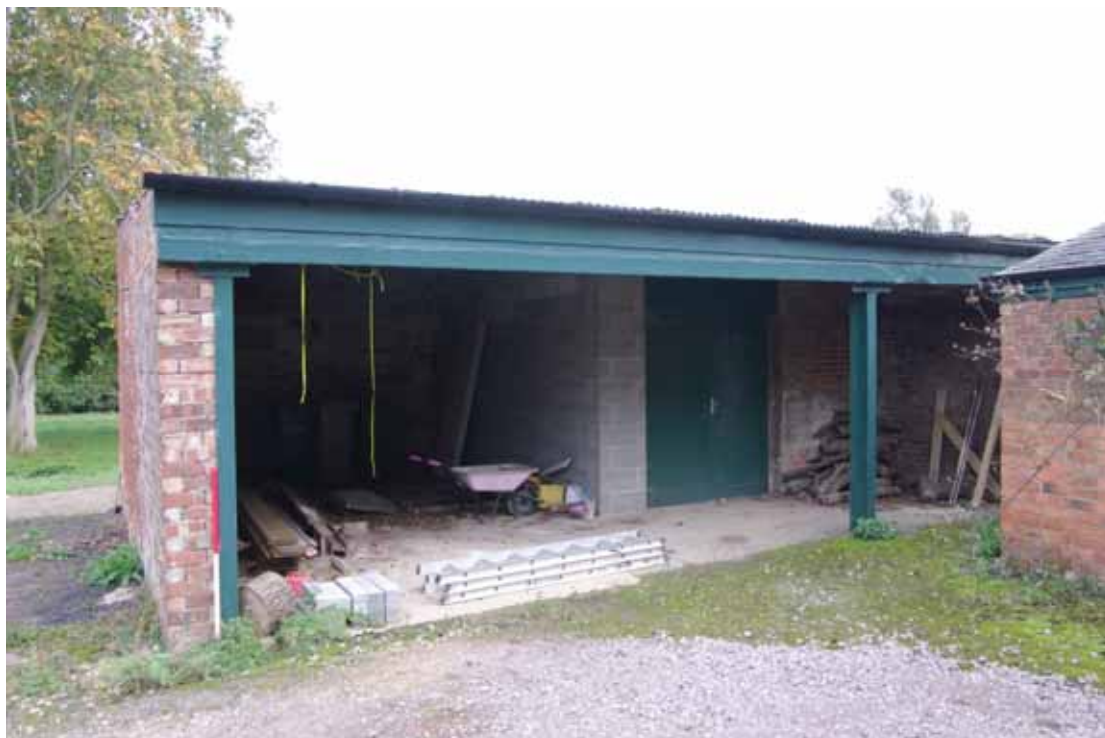
Figure 27 Garage outbuilding, west facing elevation
Looking east. 1m scale. The other outbuilding can be seen on the right

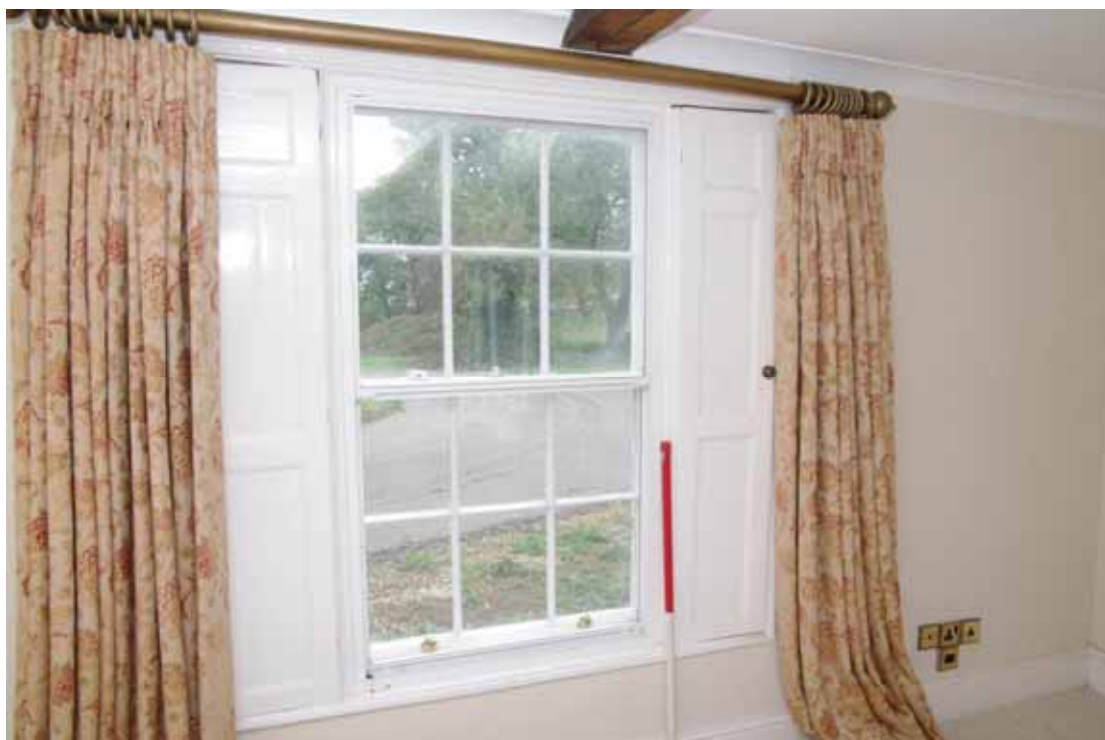
The sash window retains its 3-leafed shutters each with three panels (Figs 30 and 31). The shutters are locked by an iron bar which is held in place by a spring clip of the type commonly seen within the region and dates from the late 18th and early 19th centuries. It is curious that this is of similar date to the house but that the outside wall suggests a rebuilding around this window.

Figure 30 Room G1 window detail
Looking south. 1m scale

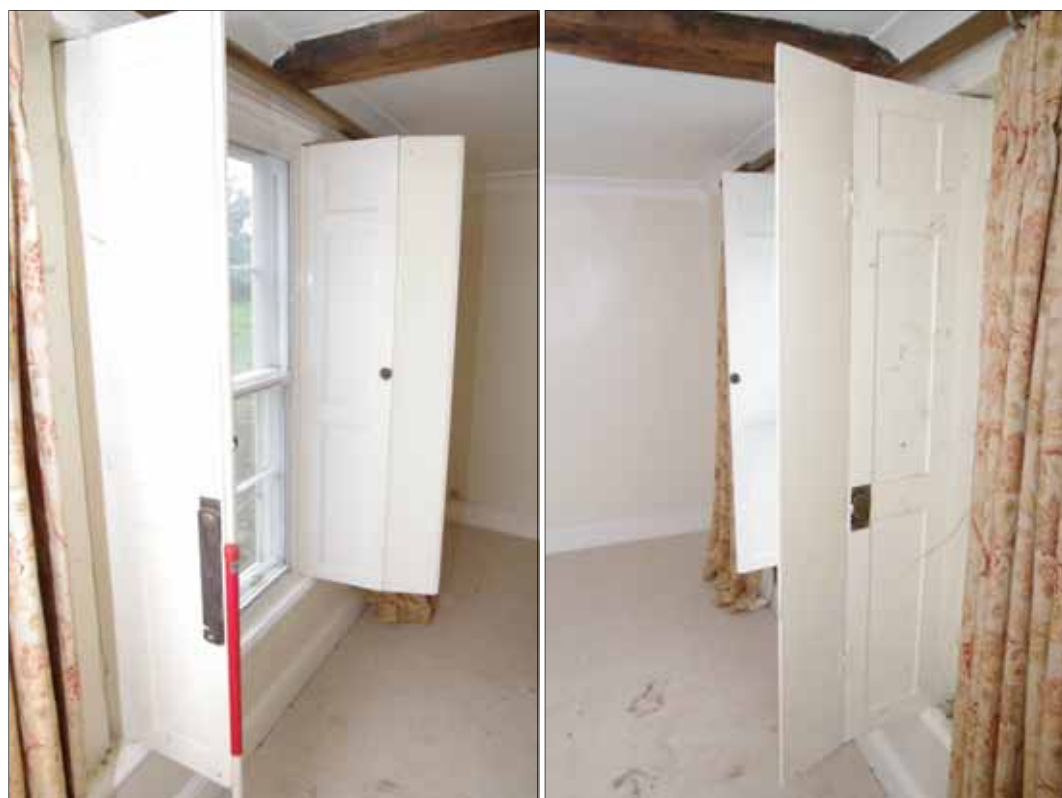
Figure 31 Room G1 window shutter detail
Left: looking SW. Right: Looking NE

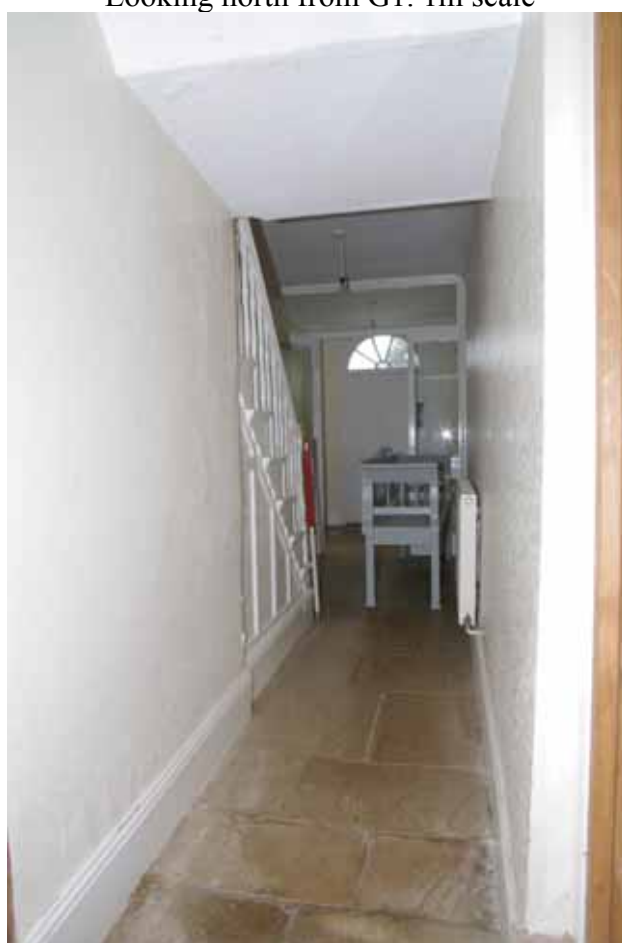
Room G3 is the original hallway leading from the front porch and the staircase (Fig. 33). This rather narrow space has a floor laid with stone flags which may not be original. When first built it is probable that side doors led into the Rooms G1 and G6 rather than making the residents squeeze past the stairs as they do now. There is however no trace

Figure 33 Room G3 hallway
Looking south-east towards porch past staircase. 1m scale

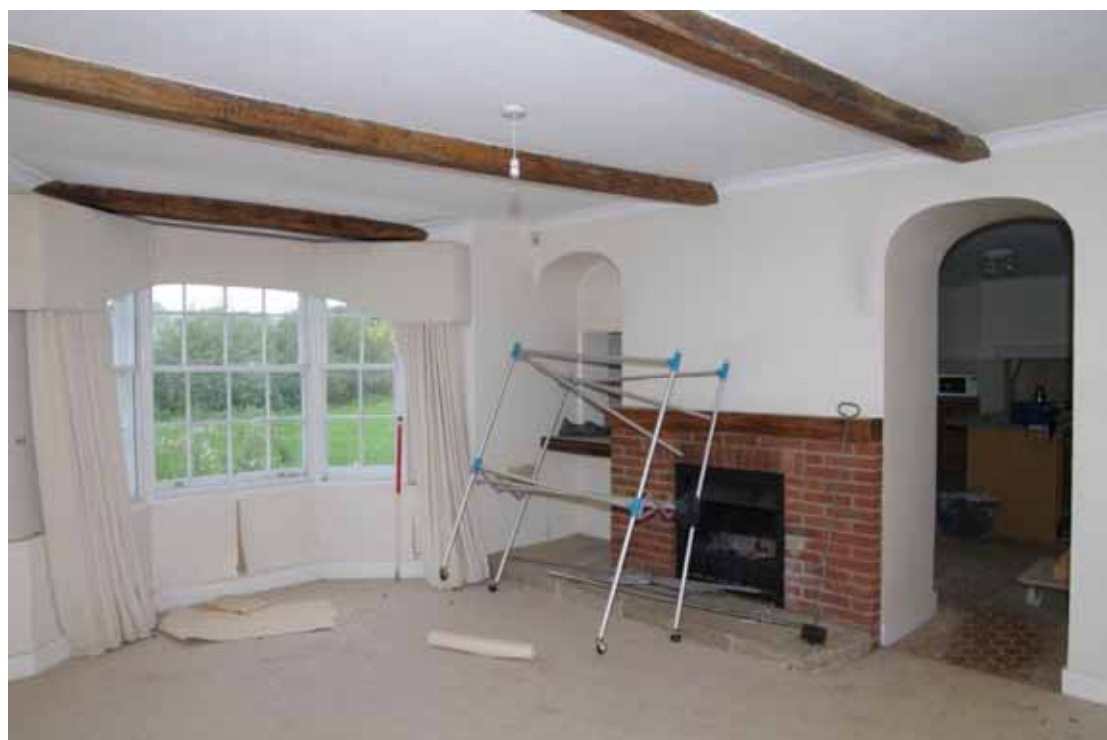
Figure 37 Room G5

G5 is located in the later 19th-century farmhouse extension attached to the north-western corner of the original house. The room is relatively plain and has a plain cornice and skirting board (Figs 37 and 38). The fireplace is modern brick and, under the proposals, will be replaced by a log burner which will face into this room and the adjacent kitchen G7. Either side of the fireplace are tall archways, one leads into G7 the kitchen whilst the other is partially blocked and acts as a small serving hatch. It is intended that the serving hatch will be fully opened up to provide a second doorway into the kitchen. The bay window has a central sash window flanked by two fixed non-functioning windows built to look like sash windows. These are probably 20th century in date. The doors leading into Rooms G4 and G6 are wide 6-panelled doors of probable 19th century origin.

Looking north. 1m scale. Kitchen G7 can be seen through archway

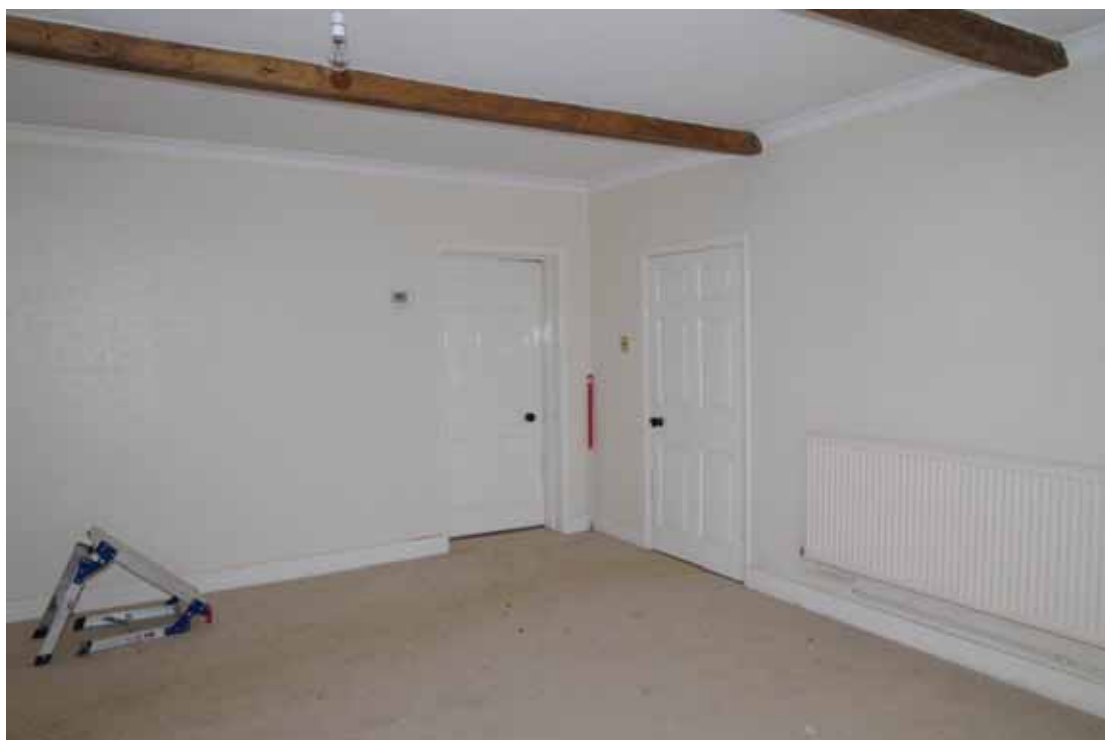
Figure 38 Room G5
Looking south. 1m scale. Door to G6 on left, G4 on right

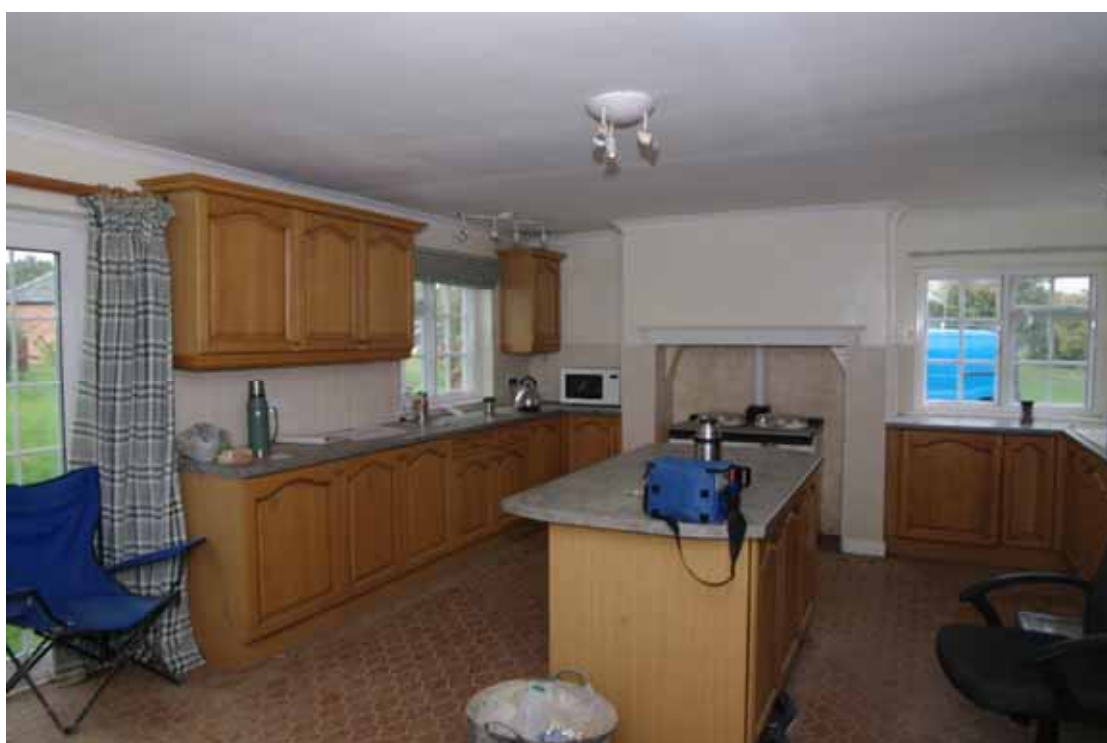
G7 is fitted out as a modern kitchen and is located in the ground floor of the later 19th century farmhouse extension (Figs 41 and 42). Modern French doors are located on the north-west wall and will be replaced in the proposed refurbishment. The three windows have modern casement fittings which will be replaced and the position of the openings altered slightly. A short flight of steps leads down past Room G7 to a short passageway

Figure 41 Room G7 kitchen
Looking north

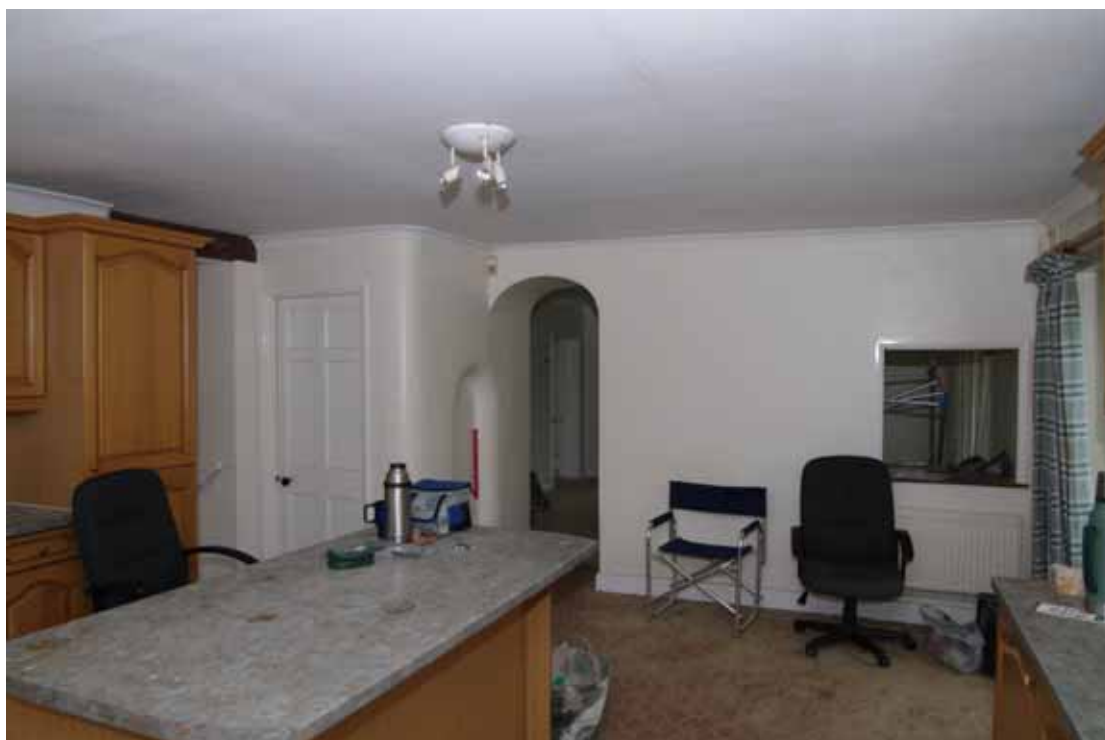
Figure 42 Room G7 kitchen
Looking south. Pantry G8 to left of archway

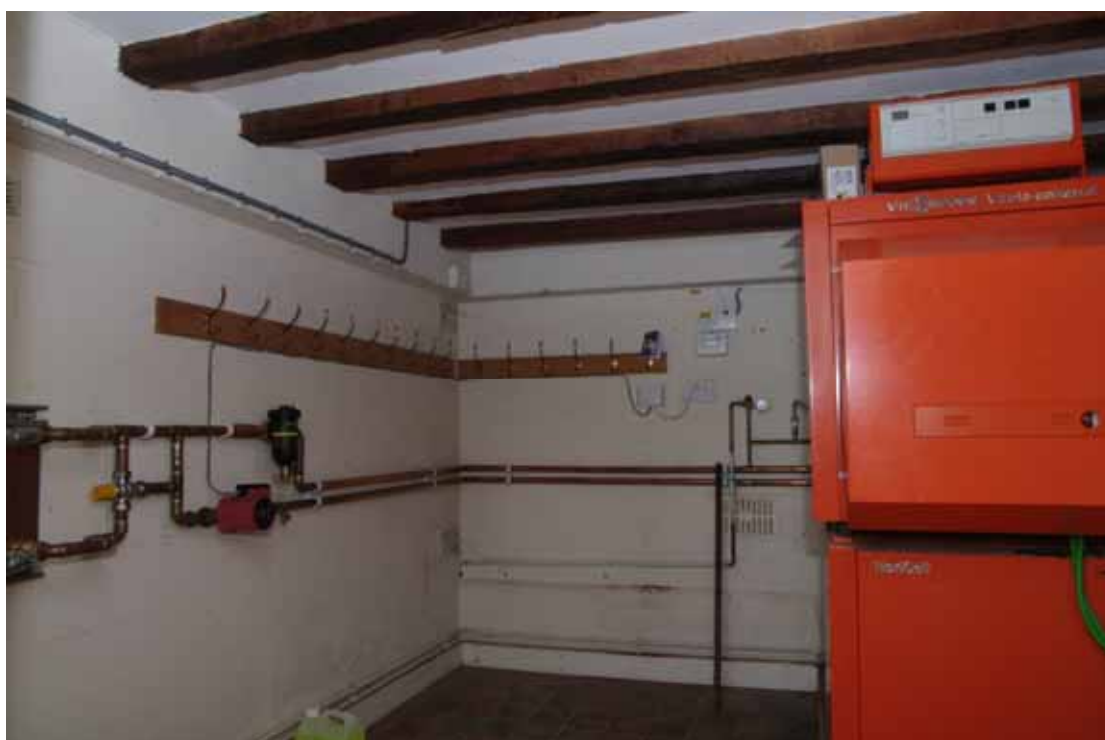
Room G9 fills the ground floor room of the extension butted against the north-east side of the original house. It presently houses the boiler and has a flat ceiling (Fig. 45). The floor level is slightly below ground level presumably to achieve a useable head space in this low room. The room has been modernised removing any traces of its origins as a lean-to roofed structure. Under the refurbishment proposals this room and the brick, glass and timber porch will be removed and replaced by a new construction slightly set back from the main house frontage to house a utility room, lobby and cloakroom. A new lean-to porch will also be added to the north-east side of the new build. The outbuilding which is presently attached to the eastern corner of the house will also be removed.

Figure 45 Room G9 boiler room
Looking south-east from doorway

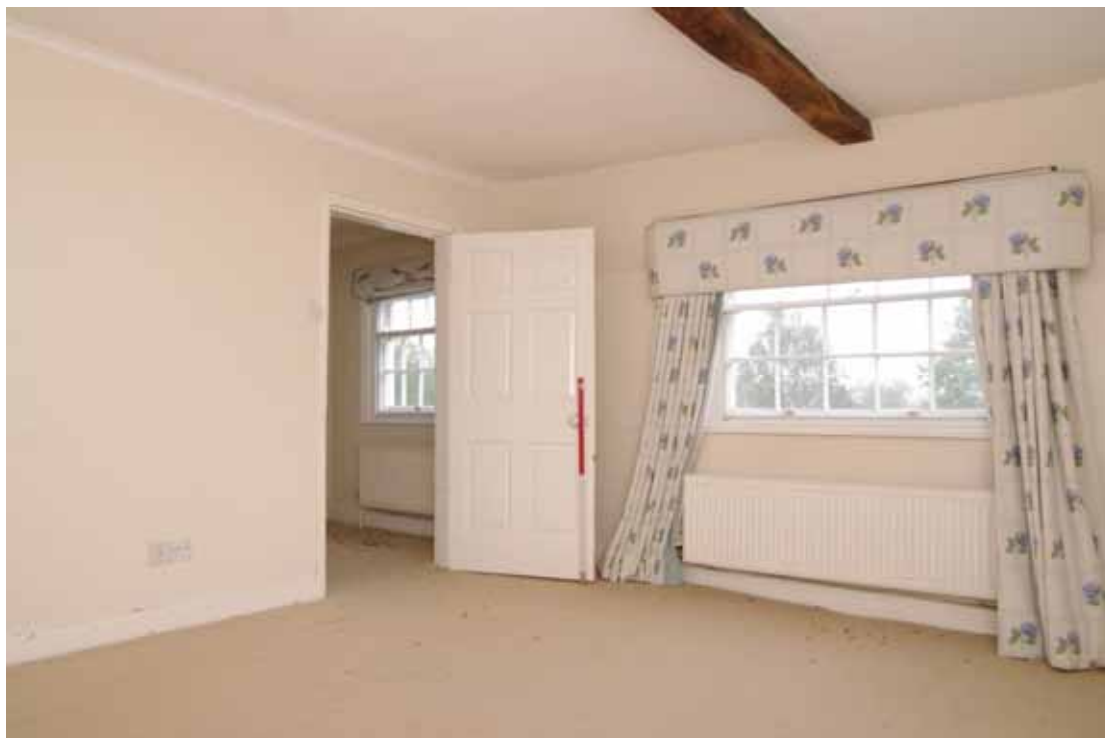
Room F1, directly above G1, is located in the original part of the house to the south-west of the staircase and landing (Figs 46 and 47). It has a late 18th- or early 19th-century fireplace and grate with fitted cupboards set into the recess of the chimney breast. The cupboards are likely to be original fittings. A roughly worked north-west to south-east timber beam supports the ceiling and was probably never intended to be seen. A 6-panelled door leads to the landing F3 and is probably later 19th century in date. A modern sliding door leads into Room F2. The sash window has multiple panes and horns and is therefore likely to be a later replacement.

Figure 47 Room F1
Looking north-east. 1m scale. Door to landing F3 in centre of picture

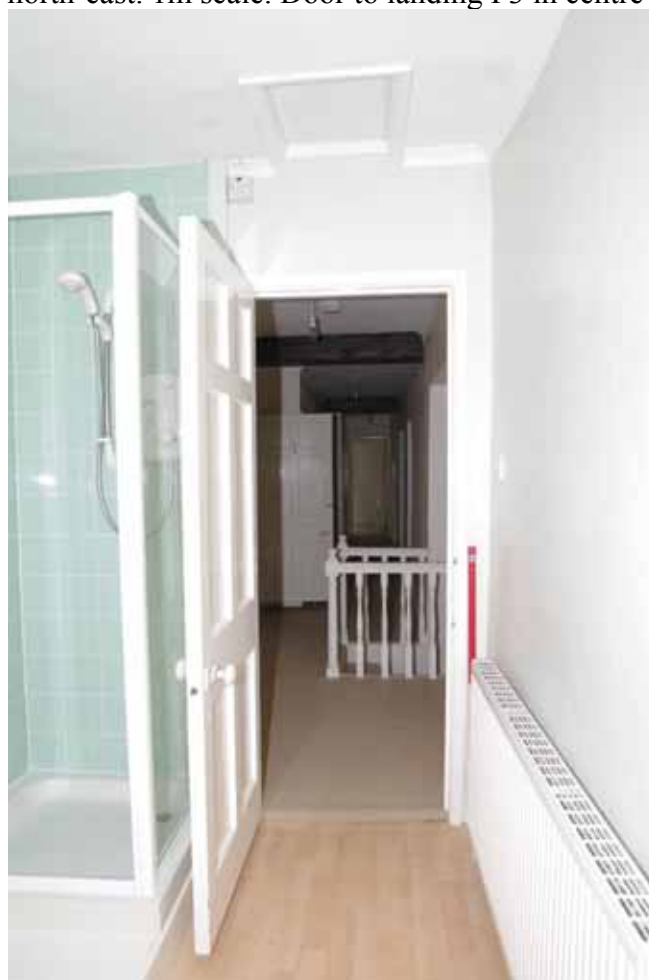
Room F2 is presently used as a bathroom for Room F1. It is the first floor of the catslide extension built against the western side of the original house (Fig. 48). Because of the low angle of the roof only the eastern half of the room is useable as a bathroom with the western half being used as low cupboards. A 19th century panelled door leads out to the corridor which runs along the length of the house. Under the proposals the walls and roof of the catslide extension will be raised to create an area with a more useable ceiling height. The internal walls, some of which are stud walls, will also be rearranged.

Figure 48 Room F2 and corridor to other rooms
Looking north-east. 1m scale

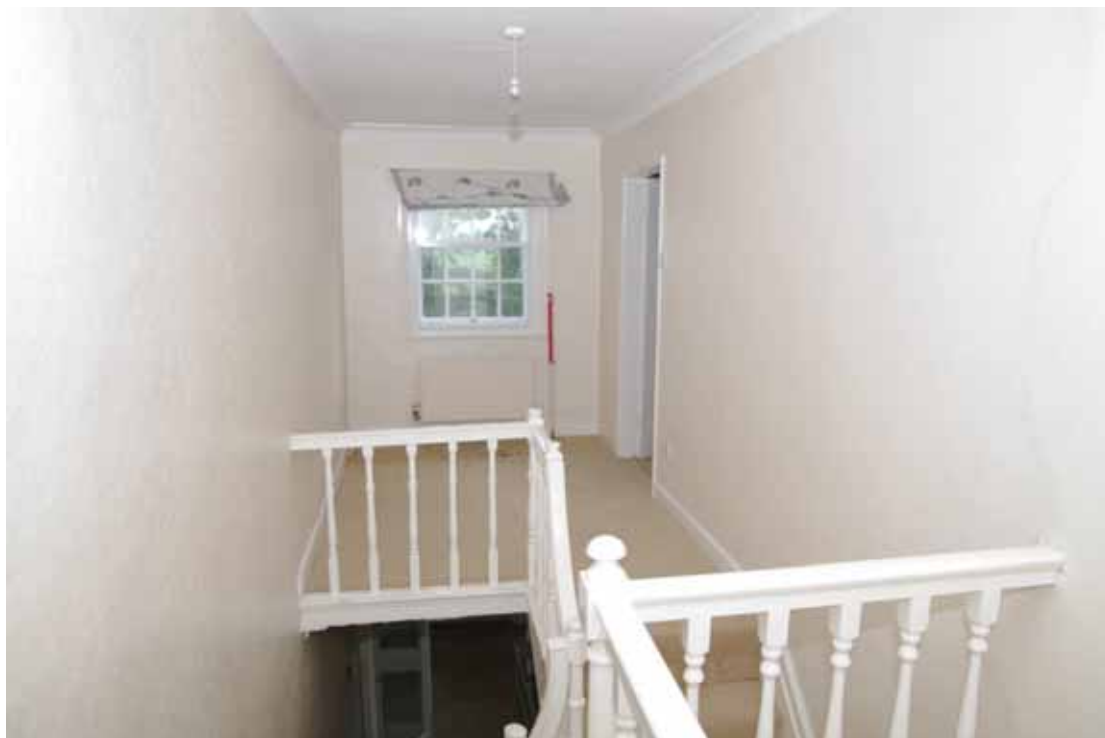
F3 forms the landing and stairs of the original house. Before the addition of the catslide roofed extension the stairs rose from the hallway G3 before turning up to F3 (Fig. 49). Presumably doors led from the landing to Rooms F1 and F6 although there is now no doorway into F6 from this point. With the addition of the catslide extension the rear (north-west wall was removed and the stairs extended to form a branch leading to the rear corridor. The later balusters have a different turned pattern to the original parts of the staircase.

Figure 49 Room F3 landing
Looking south-east. 1m scale. Doorway to F1 on right

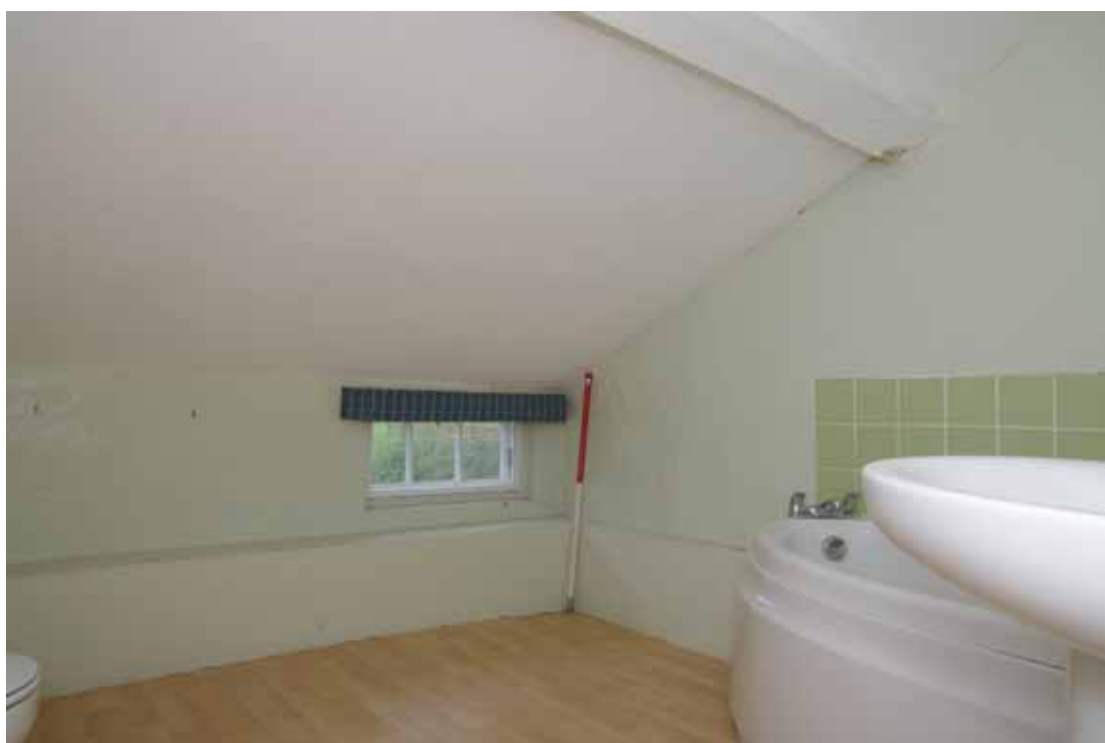
Room F4, presently used as a bathroom, clearly demonstrates the low ceiling created by the catslide roof (Fig. 50). Along with raising the walls and roof of the catslide extension, the proposals are to remove the stud wall closest to the landing and stairs and create a new flight of stairs up to the second floor.

Figure 50 Room F4
Looking north. 1m scale

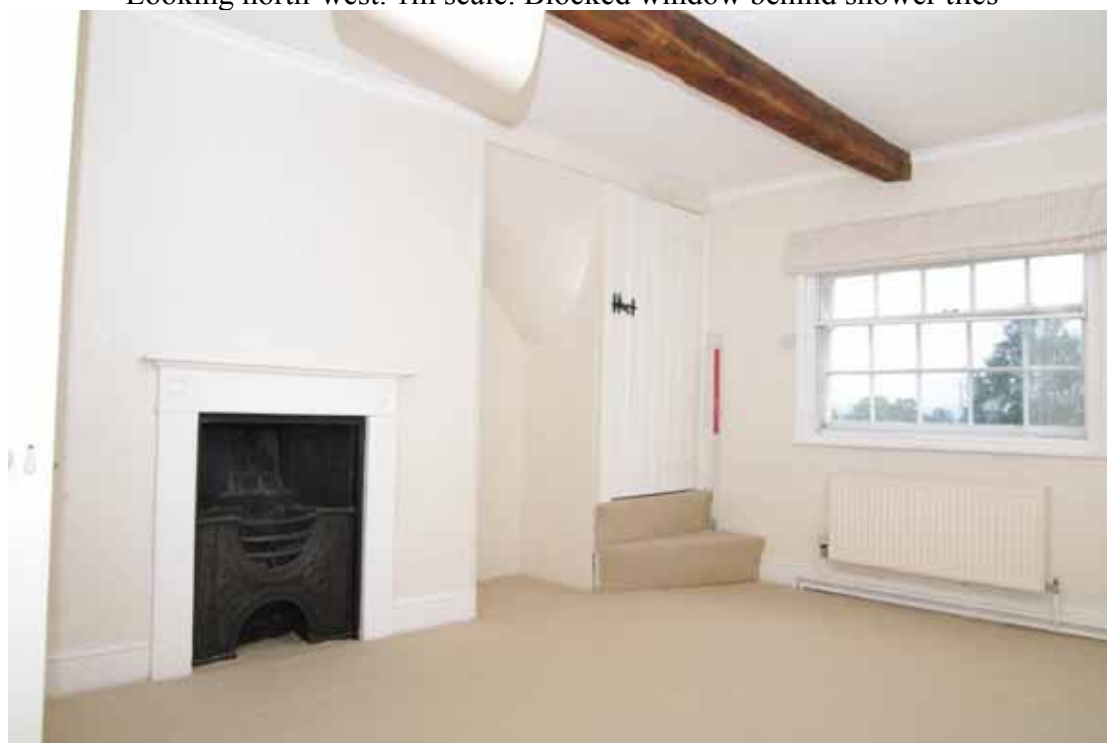
Room F6 is one of the bedrooms in the original part of the house (Figs 52 and 53). It is entered via a doorway on the corridor within the later 19th-century extension although presumably the original doorway was from F3 landing. The fireplace appears to be of 19th-century date as is a large cupboard built into the recess to the side of the chimney breast. The multi-paned sash window has horns and is therefore a modern copy. This room may have served as a bedroom for staff as there is a plank door leading up to the second floor which is likely to have served as the staff quarters.

Figure 52 Room F6
Looking east. 1m scale. Second floor stairs behind door on right

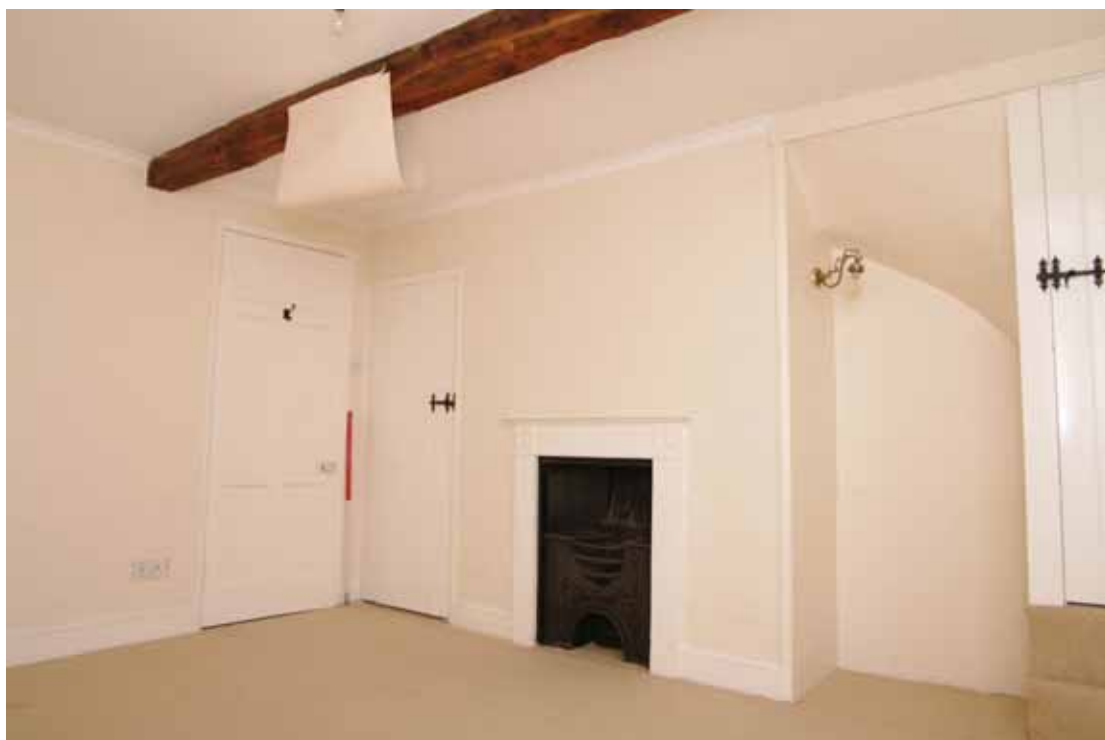
Figure 53 Room F6
Looking north-west. 1m scale. Door to corridor on left, door to second floor stairs on right

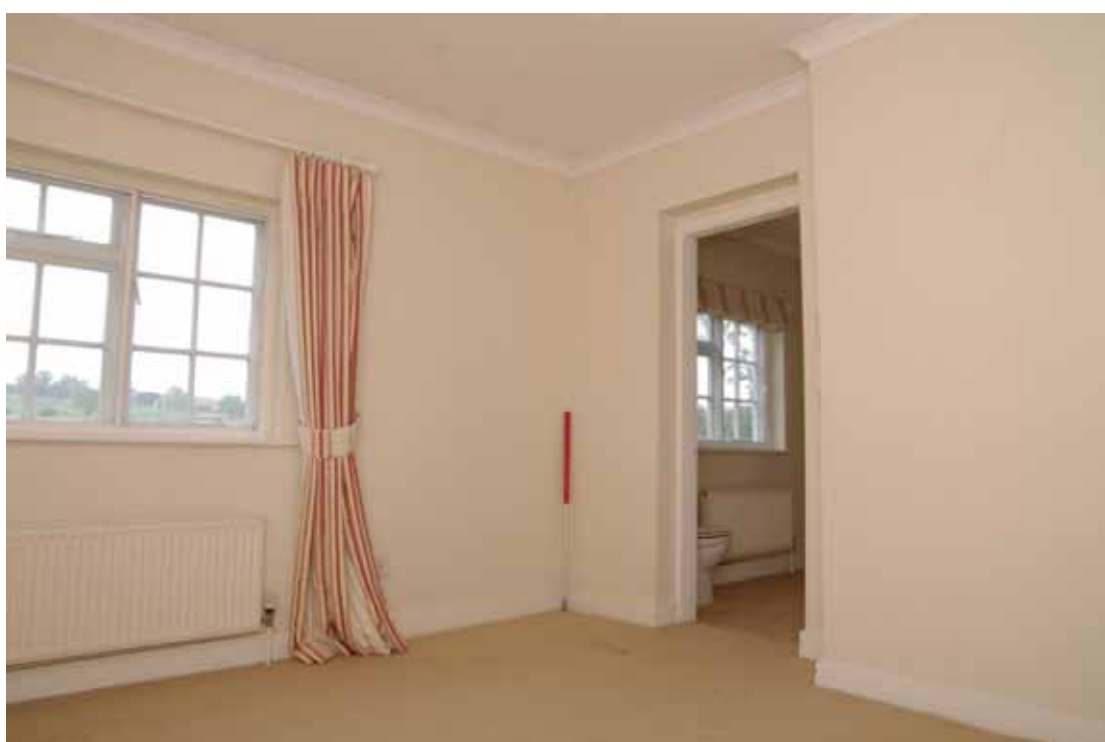
Room F7 is presently quite plain with minimal decoration in the form of a small cornice and undecorated skirting boards (Fig. 54). It has a 19th-century door out into the corridor and a doorway leading into Room F8 which serves as a bathroom. As noted, the proposals are to remove the wall between this room and F5 to create a larger room.

Figure 54 Room F7
Looking north towards door to Room F8. 1m scale

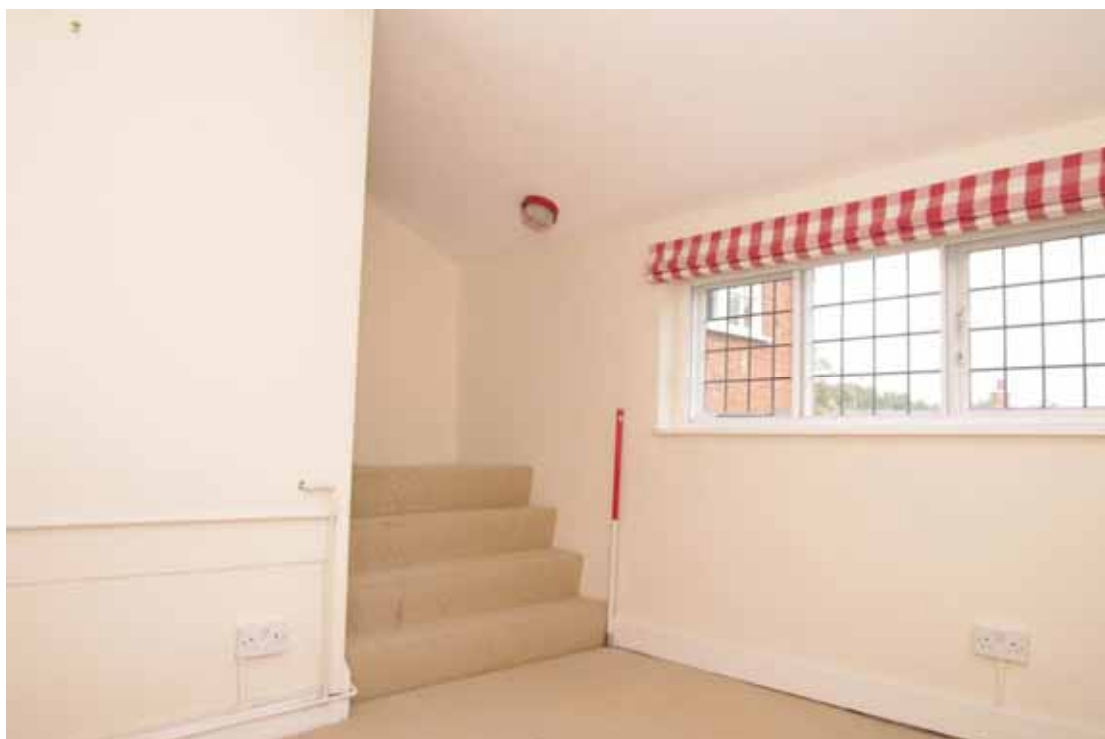
Figure 56 Room F11

Room F11 is the first floor room of the extension butted against the north-east side of the original house. It is a very awkwardly sized room as the floor level is nearly 1 metre below the floor level of the corridor and the rest of the first floor (Fig. 56). The lean-to style of the roof also means that the doorway from the corridor into the room is difficult to get through. In the west corner of the room is a large cupboard which opens out onto the corridor. The proposals are to remove this room entirely and rebuild the extension to double its width and with an increased ceiling height.

Looking north-west. 1m scale. Steps lead up to corridor and the rest of the first floor

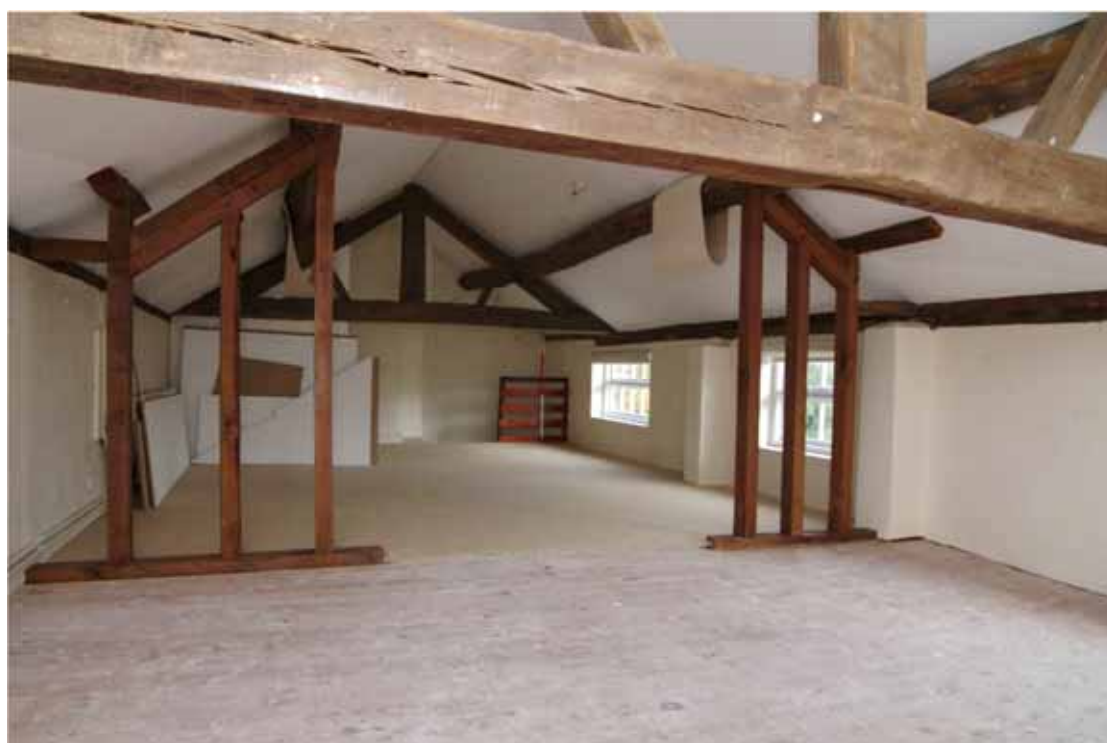
The second floor consists of a single long room above the original house (Figs 57 and 58). None of the earlier extension phases have affected this room. The room is presently reached via a set of narrow stairs leading up from Room F6. The roof is supported by two large timber trusses which have a king post and two raking struts supporting the principal rafters. The purlins are jointed into the principals and all of the joints are wooden pegged (Fig. 59). A steel RSJ in the south corner of the roof indicates that some recent repair work has been carried out to support this corner of the building which may help explain the repaired brickwork seen on the south-west facing elevation. The windows on the south-east side of the room are all modern replacements. It is not clear if any windows were ever present on the opposite side of the room.

Figure 57 Second floor
Looking north east. Stairs down are behind the 1m scale

The refurbishment proposals are to insert an additional set of stairs rising from the remodelled Room F4 on the first floor to enter the second floor room from the north-west side. A water tank set within a modern partitioned cupboard in the north of the room will also be removed and replaced by a new bathroom filling just over one third of the length of the present room. A new partition wall will create a second bathroom to serve Room F6 on the floor below which will be reached via the existing stairs in the north-east corner.

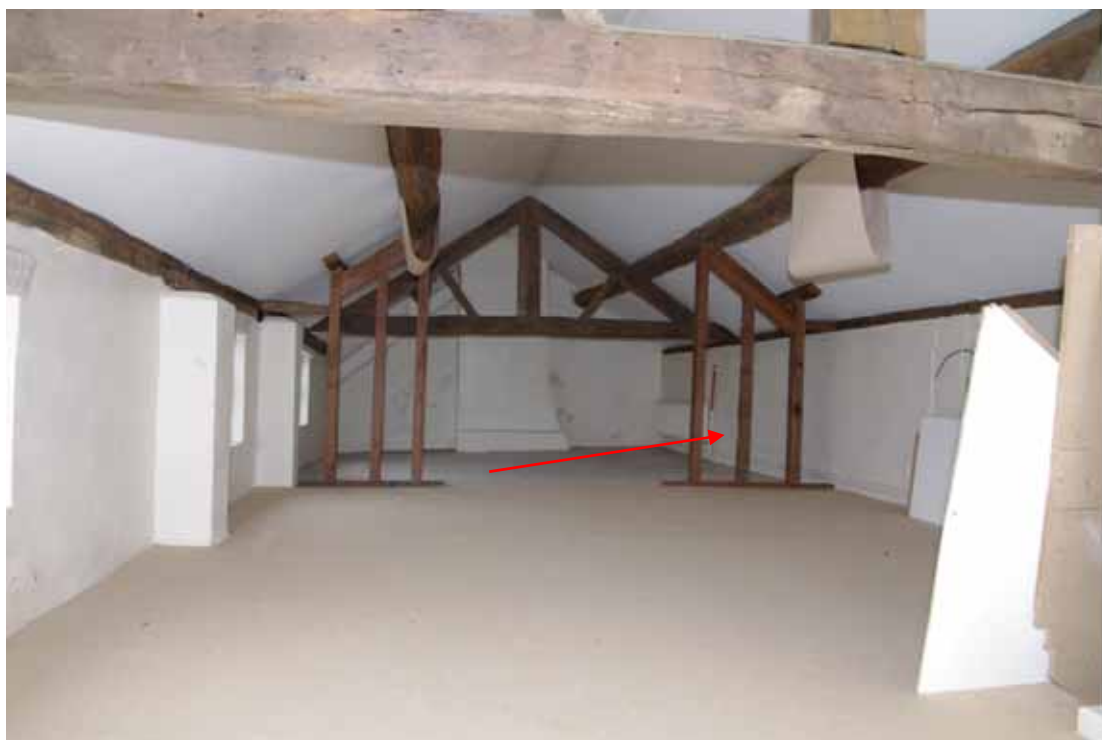
Figure 58 Second floor
Looking south-west. 1m scale. Arrow marks approximate point where new stairs will enter the room.
