An Historic Building Survey at the Former War Memorial Hospital, Ankle Hill, Melton Mowbray, Leicestershire.

For: Sowden Developments

Date:06.04.2016. Revised 08.07.2016

ULAS Report Number 2016-063v2 ©2016 Accession Number X.A25.2016

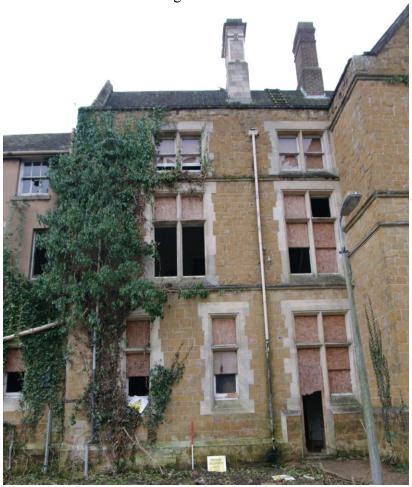
Figure 21 North facing elevation to east of entrance Looking south. 1m scale. Note modified ground floor window on right

windows has had half of the sloping stone sill removed and replaced by a narrow doorway giving access to a tiny hall with steps down to the basement. The modified doorway also leads into a hall and to the servant's stairs. It is not clear when this was modified although the vestiges of woodwork and door suggest that it was no earlier than the mid-20th century. The roof above this range has a limestone chimney stack and a rebuilt brick stack.

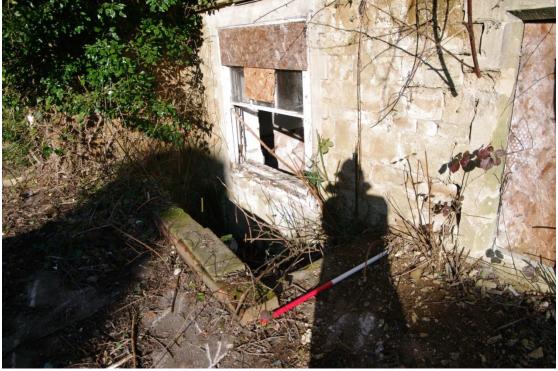
Figure 35 Wyndham Lodge. Eastern end of south facing elevation, steps to doorway Looking north-west. 1m scale

On the east side of the eastern gable the frontage steps back slightly to a three storey structure with small windows at the second floor suggesting the presence of smaller rooms for staff. To the east of this is a single storey height ironstone wall with the added rendered two storey extension behind it (Fig. 34). The ironstone wall has a low parapet with a pitched slate roof behind it, both of which are in a poor state of repair. At this point the garden ground level rises up from the sunken garden to a low terrace. The rise in ground level appears to form an area where the early OS maps show the location of a large glasshouse built against the ironstone wall. A set of sunken steps leads down to

a former doorway which has been converted to a window (Fig. 35). It seems likely that the door and steps were used to gain access to the glasshouse from indoors. Two windows with their sills at ground level are to the east of the sunken doorway as is a large area of wall collapse probably caused by blocked guttering behind the parapet wall. Beyond this, to the east, the façade steps out slightly to a modified doorway with a lancet window built into a small partially collapsed gable (Fig. 36). The doorway appears to have started life as a narrow doorway but which has been widened to become a window by the insertion of a substantial lintel and windowsill. From the available maps it seems that this door once opened into the glasshouse located here. The parapet wall has been repaired and rebuilt with brick rather than ironstone and a line of bricks has been used to join the structure to a rectangular flat-roofed brick room. The brick room first appears on the 1931 OS map and is likely to be related to the early days of the hospital. The structure is fairly utilitarian in design and materials with red brick walls, steel-framed Crittall windows and concrete sills (Figs. 12 and 37). The back wall of this rectangular room partially sits on top of an ironstone garden wall which runs eastwards towards the stables (Fig. 38).

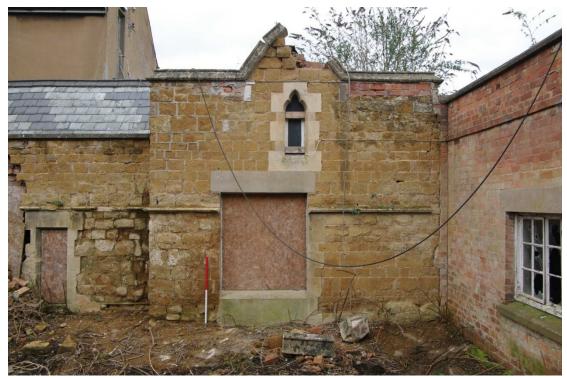
Figure 36 South facing elevation at eastern end of façade Looking north. 1m scale. Service range on left

Room R5 is actually an extension of the spur corridor running past R5 and is reached by ascending three steps. The floor has rotted and collapsed so could not be closely inspected (Fig. 42). On the south wall is a wide window which appears to have been modified from a doorway. This is the modified doorway which can be seen in Figure 36 below the partially collapsed gable with the small lancet window.

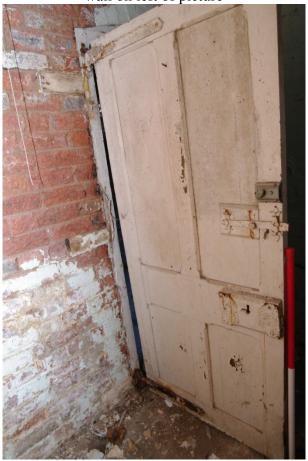
Figure 39 Room R1 door detail Looking south-west. 1m scale

Room 1 is a rectangular brick-lined room set into the north-east corner of the gable-ended lancet windowed building. There is no evidence of what this room was used for although the initial plans supplied by the client indicate that it was used as a store. The four-panelled door has late 19th century fittings except for the lock which appears to be re-used from elsewhere as it is of probable early 19th century design (Fig. 39).

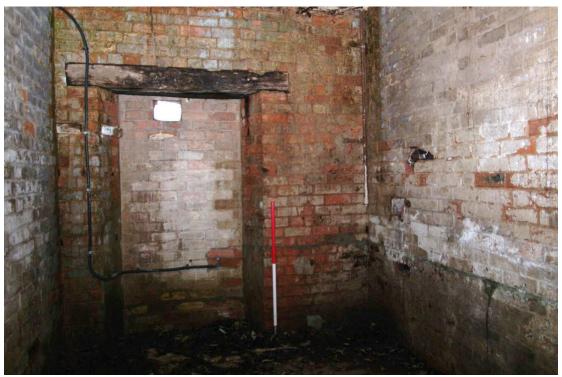
Figure 40 R3 corridor Looking west. 1m scale

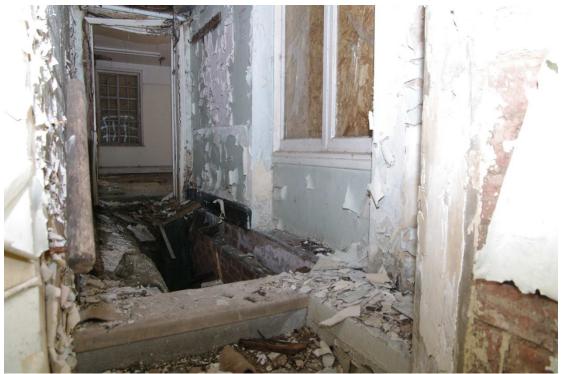
Figure 41 R4 blocked east wall doorway Looking east. 1m scale

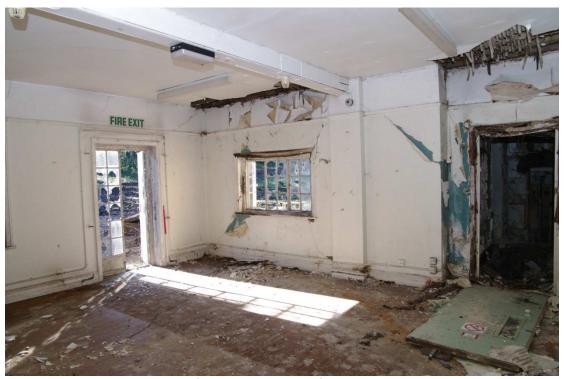
Figure 42 R5 and blocked south doorway Looking south-east

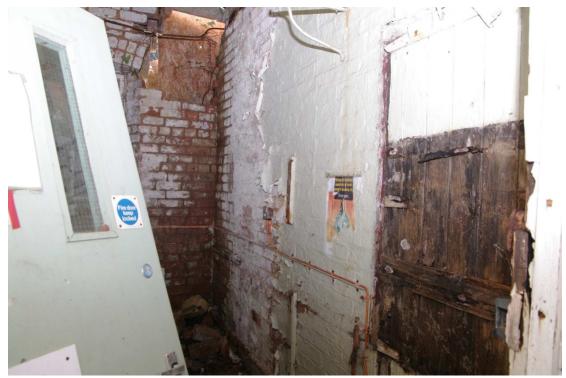
Figure 43 R6 recreation room
Looking south-west. 1m scale. Corridor R5 on right of picture

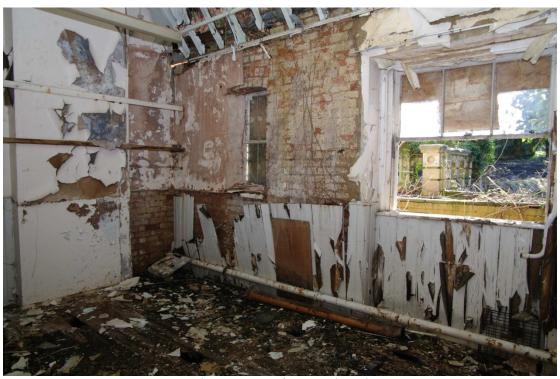
Figure 44 R7 former washroom Looking south-west. Door to R8 on right

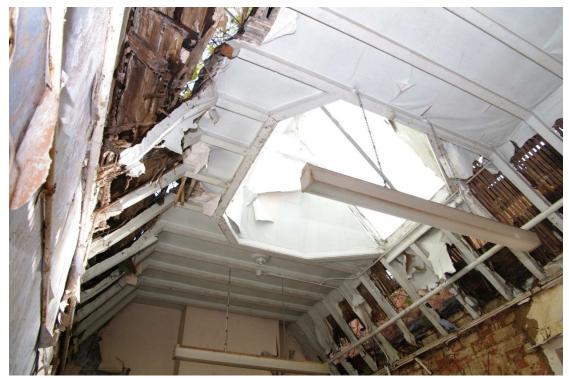
Figure 45 R8 former chapel Looking south-west. Former doorway to garden on right

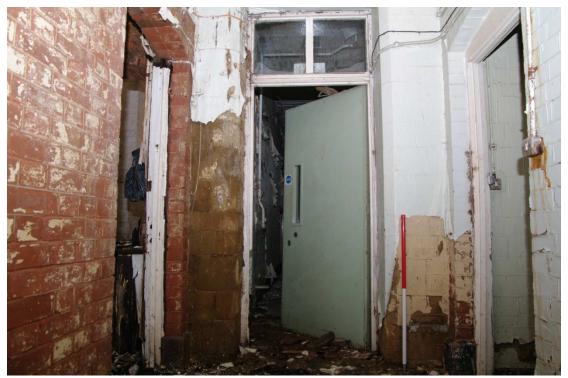
Figure 47 Corridor R10 Looking east

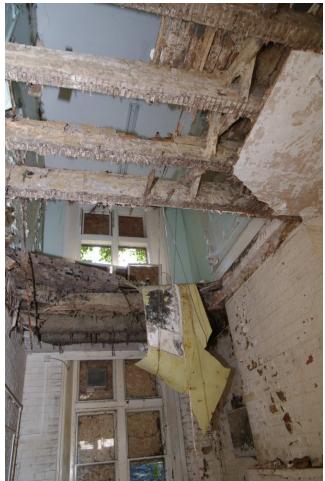
Figure 49 R11 domestic supervisor's room Looking south-west

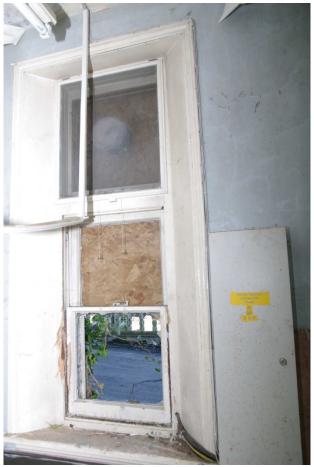
Figure 51 R12 former switchgear room Looking west. 1m scale

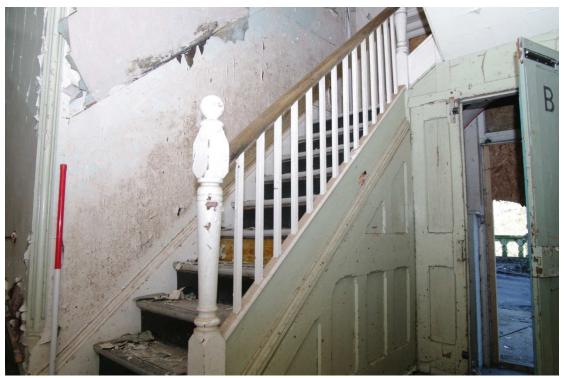
Figure 53 Servant's staircase in R13
Looking north. 1m scale. Doorway to cellar steps and through modified window on right of picture

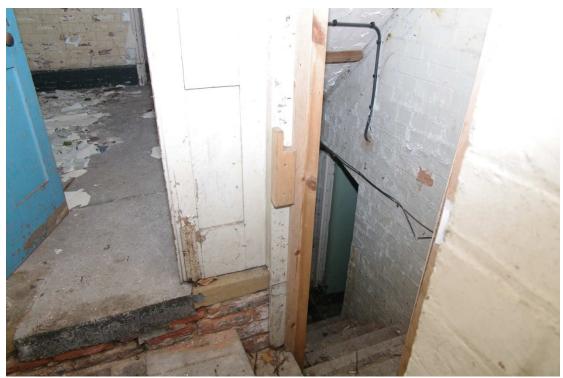
Figure 54 Servant's staircase in R13 Looking north-west. 1m scale. Note moulded detail to left

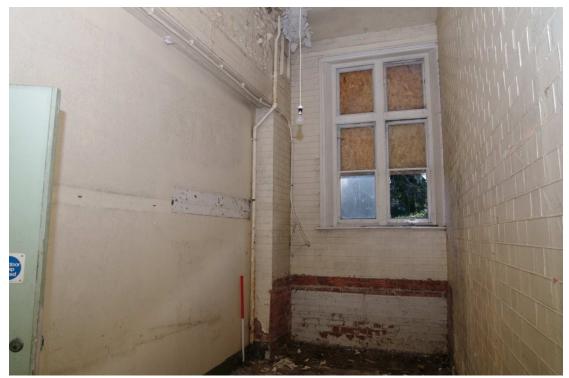
Figure 57 Room R14 Looking south-east. 1m scale

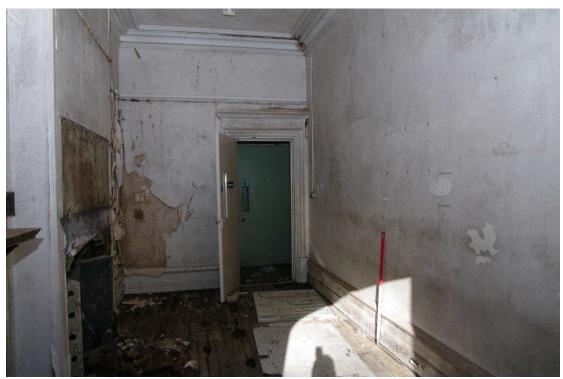
Room R16 is part of the family rooms of Wyndham Lodge and has a high skirting board, moulded plasterwork cornice and moulded door frames (Figs. 59 and 60). The arched double doorway on the south wall leads out to the sunken garden via the balustraded steps shown in Figure 32. The door and the two window lights above the door are the only light source for this room. The large fireplace on the west wall has been heavily robbed and the wooden mantelpiece and surround moved closer to the door ready for illicit removal. The remnants of the fireplace have two glazed metal and cement panels with floral decoration on (Fig. 61). The panels have been partially removed and broken to reveal the maker's name of *W M??tin. London+Solihull, Middlesex* written on the side. Presumably the illegible letters form the word Martin.

Figure 59 Room R16 Looking south towards rear garden

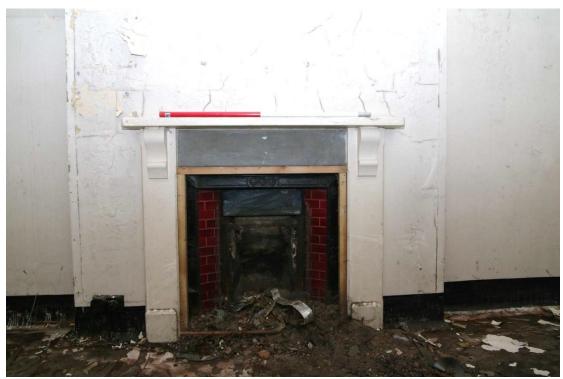
Room 17 is a large rectangular room which has been subdivided by two thin wooden partitions one of which bisects the sash window on the north wall (Fig. 63). The panelling in the partition and panelled door in the partition appear to be from the pre Second World War period and are likely to be part of the 1920s hospital conversion work. The fireplace is still present and has glazed brick side cheeks (Fig. 64). The floors of the subdivided rooms have terrazzo type floors with curved edgings to aid washing the floor and to prevent dirt being caught in corners. Although the plan from the client shows the rooms as examination rooms it may be possible that they were original used as minor surgery rooms.

Figure 63 R17 and partition Looking north-east. 1m scale. Note bisected window

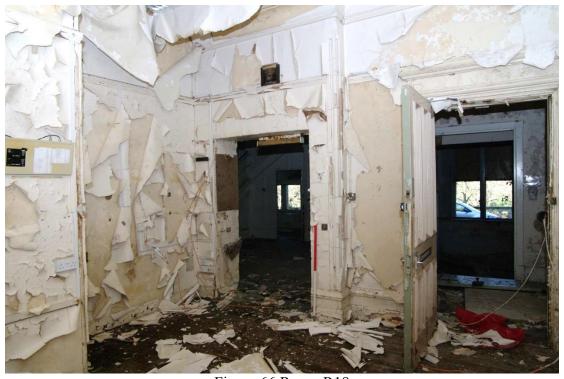
Room R18 is one half of a larger room (with R20) which has been subdivided by the insertion of a modern partition wall (Figs. 65 and 66). The room has two entrances from the main hall (R21) with the easternmost one having a moulded surround matching that seen in the adjacent R16. The six-panelled door with beading and moulding around the panels survives as do some of the moulded skirting boards. The western entrance has no frame or surround and appears to be a later opening through the wall. The large window on the south wall has stone mullions and transoms and a modern steel grille. Below the window, which has sash windows, is a wooden panel with rectangular decoration on it. The floor boards are laid in a geometric pattern. The room has moulded cornices and a picture rail which are broken by the inserted partition (Fig. 67. There is no fireplace in this room or in the adjacent R20 although a thickened section of wall

Figure 65 R18 general view Looking south-west. 1m scale. Modern partition wall on right

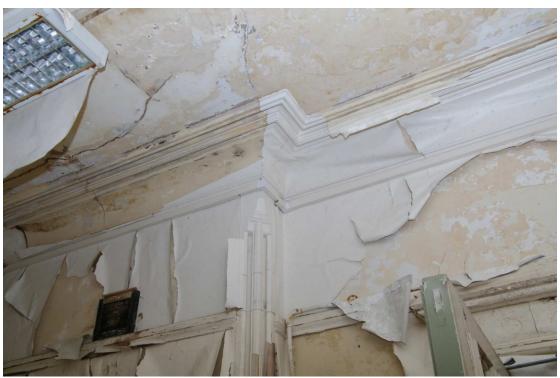
Figure 66 Room R18
Looking north-west into hall R21. 1m scale. Possible knocked through fireplace to left of scale

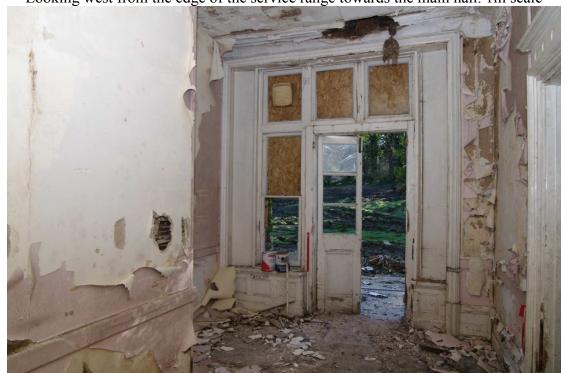
R19 is the western end of the service corridor which has a large door separating the service range from the main house and hall (Fig. 68). The doorframe mouldings on the family side of the doorway are significantly more ornate than on the service side.

Figure 68 Corridor R19
Looking west from the edge of the service range towards the main hall. 1m scale

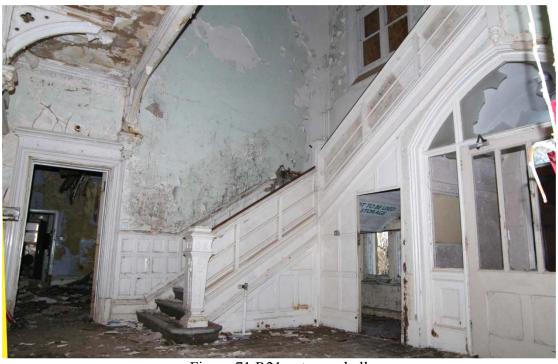
R21 is the main entrance hall and is of double height up to the roof space (Figs. 70 to 73). The large staircase has a half landing and wraps around the west and north walls passing over the entrance doorway to reach a balcony on the east and south walls. The layout of the stairs is such that the flight from the half landing up to the first floor rises and cuts across the north wall window. The stairs have a large carved newel post at the bottom with plain square-section balusters. Running through each baluster are a pair of circular section poles which have been boxed in on the stair side. The boxing in of the balusters is likely to be a post war or later alteration. The handrail is fairly plain with beaded mouldings running below it. The balcony is supported by pierced brackets resting on five plaster capitals with floral decoration each one of a slightly different design (Fig. 74).

Figure 70 R21entrance hall Looking north-east. Entrance door in centre of picture below the stairs

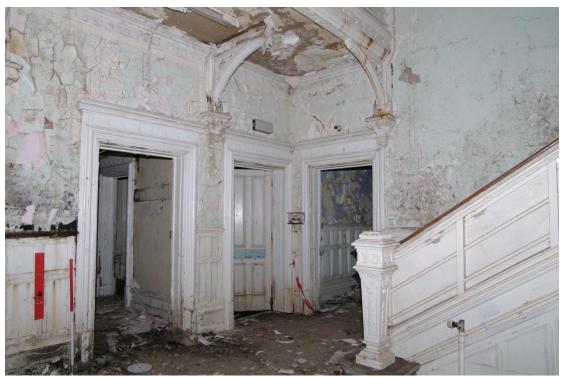
Figure 71 R21 entrance hall Looking north-west. Room R23 doorway on left

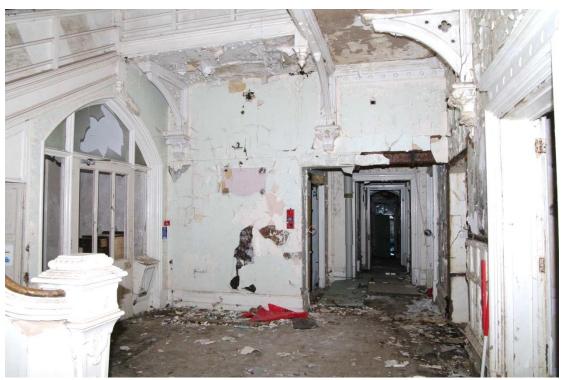
Figure 72 R21 entrance hall Looking south-west. 1m scale. Left to right: Doors to R20, R22, R23

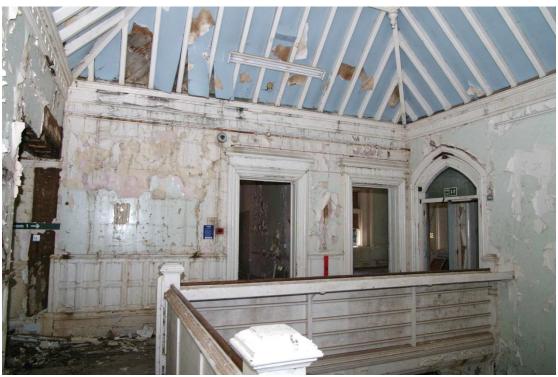
The stairs lead up to the first floor landing which is a state of partial collapse and was not entered (Fig. 78). From the top of the stairs it could be seen that the doorway decoration and mouldings are similar to those on the ground floor but are on a diminished scale (Fig. 79). On the west wall of the hall is a metal pole which appears to have been placed to hold a large picture or possibly a tapestry.

Figure 78 North window viewed from R21 hall Looking north

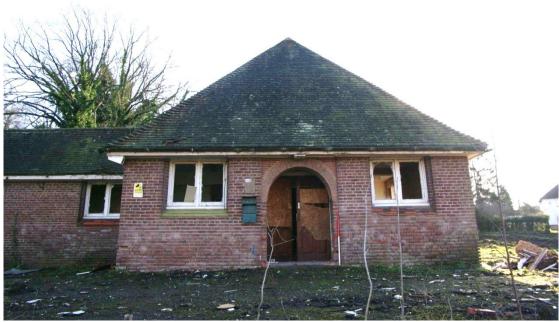
The entrance to the main wards is a small single storey building with a steeply pitched hipped roof leading down to the gutters (Fig. 92). The corners of the roof have prominent hip tiles to continue the inviting Arts and Crafts style. The centrally placed doorway has a Romanesque arch built with thin terracotta tiles over a small porch with double four-panelled wooden doors. Either side of the doorway are a pair of rectangular casement windows with steeply sloping sills made from flat terracotta tiles. The sloping sills are a common feature throughout this entire range of buildings. The entrance roofline is lower than the rest of the buildings and steps up to the rear to match their height (Fig. 93).

Figure 92 North-east facing elevation of main entrance Looking south-west. 1m scale

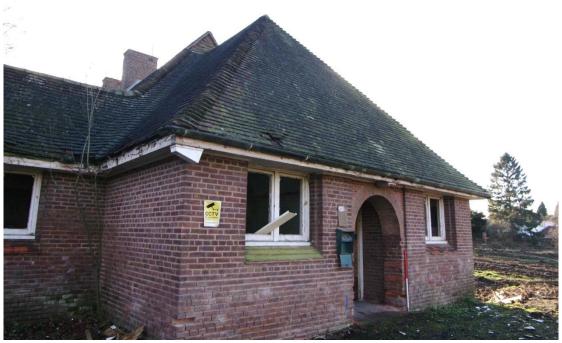
Figure 93 North-east facing elevation of main entrance Looking west. 1m scale

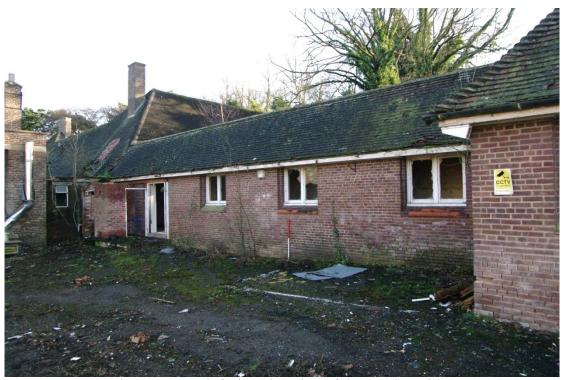
To the east of the main doorway is the north wall of the single storey north-west to south-east spinal corridor which connects all three wards (Fig. 94). The elevation has three casement windows which match those flanking the main entrance doorway. A fourth window has been modified into a doorway and a modern outbuilding for gas bottle storage has been added into the eastern corner where the elevation turns towards the north-east. The ground level in front of this elevation is beginning to drop down towards the north-east.

Figure 94 North facing elevation of the ward corridor
Looking south. 1m scale. Entrance porch on right of picture. Roof and chimney stack
of Mowbray Ward rising in centre left

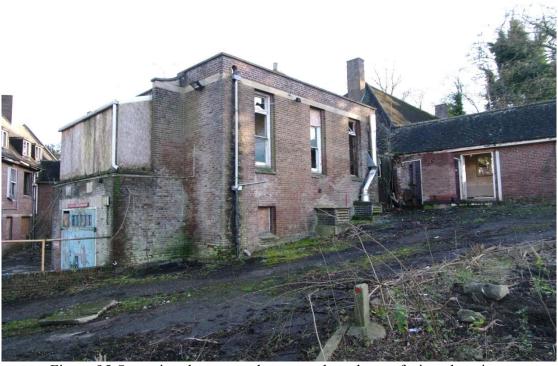
Beyond this point, to the east, is a flat-roofed building which housed the operating theatre (Fig. 95). The bricks are slightly lighter in shade than the rest of the ward range and may suggest a later phase. This part of the range is not shown on the 1950 OS map but is present by the time of the publication of the 1966 map. The flat roof has a coped parapet and the walls have decorative stone banding above the upper windows which match the decorative features on the eastern range building which indicates that it was built to the same overall design of the other buildings. The tall sash windows also have sloping tiled sills. It is likely that the 1950 map was a snapshot of the hospital when it was only partially complete and before the final elements were added. The ground slopes to such an extent that the north-east facing elevation of the operating theatre has a ground level basement with garage style wooden doors housing the accumulator and battery back-up room (Fig. 96). Above this was a glazed end room presumably to allow in the maximum amount of light. Above the glazed room, which is boarded over, are a pair of decorative curving parapets with flat copings showing that this slightly later addition was still constructed to fit in with the overall design. The south-east facing elevation has two storeys with the operating theatre above a basement boiler house with a single doorway and two windows (Fig. 97). Both ground floor and first floor windows have tall sash windows with tiled sills as seen on the north-west facing elevation. The theatre building has a higher roofline than the eaves of the rest of the range and has a flat-roof portion and a balcony area which join the two segments. The eastern wall of the operating theatre and the western wall of the east range form a semi enclosed yard.

Figure 95 Operating theatre north-west and north-east facing elevations Looking south-east. Mowbray Ward roof centre right

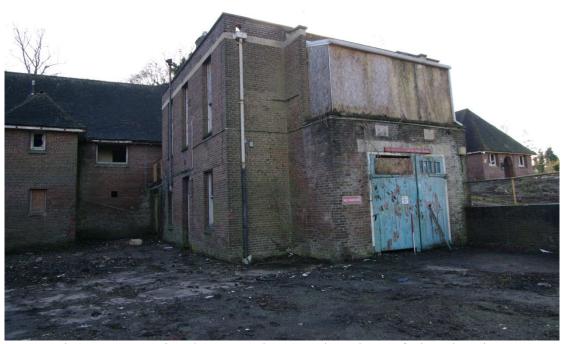
Figure 96 Operating theatre north-east and south-east facing elevations Looking south-west. 1m scale Glazed end portion boarded over

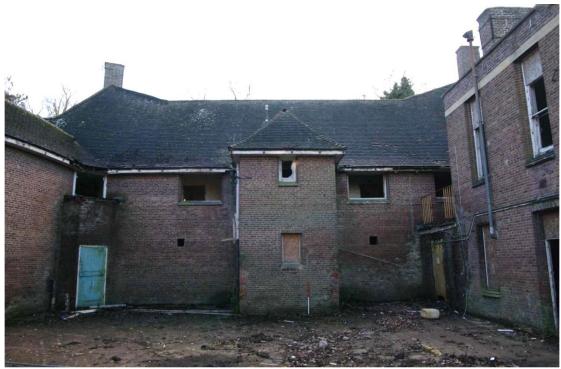
To the south-east of the operating theatre is the eastern end of the spinal corridor which is at first floor level by this point (Fig. 98). The first floor level corridor has two rectangular windows looking north-east into the semi enclosed yard. There are no

Figure 98 East end on spinal corridor, north-east facing elevation Looking south-west. 1m scale. Lift shaft in centre of elevation. Operating theatre on right, curved corridor link on left

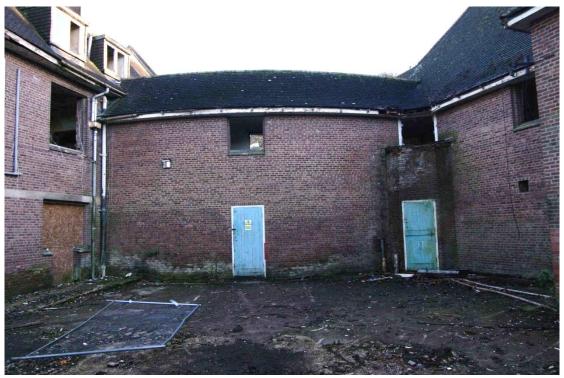
The curving link corridor joins the eastern end of the spinal corridor and curves towards the north-east to join the eastern range building (Fig. 99). Once again, because of the sloping ground level the corridor is at first floor height and it therefore enters the first floor of the eastern range. The ground floor space below has two doorways which were sealed with one having an asbestos warning sign on. The rooms inside were not investigated.

Figure 99 North-east facing elevation of curved corridor link Looking south-east. 1m scale

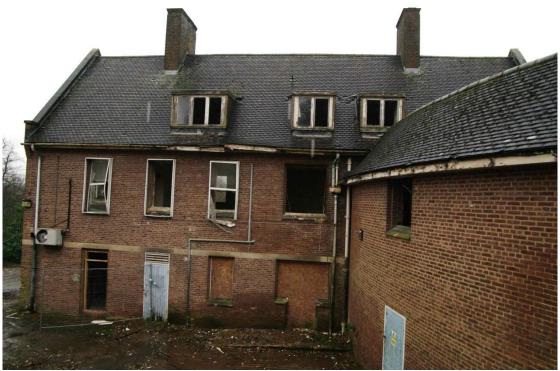
The eastern ward range is a free standing rectangular range through which the curving link corridor passes at first floor level (Fig. 100). The walls have a decorative limestone band running around the building in the same style as is present on the operating theatre walls. The south-west facing elevation has three doorways and a window at ground floor level. The northernmost door leads into a small hall with steps up to the first floor. Surprisingly the remaining doors and windows were securely boarded over preventing access to the rooms. The first floor windows have the remnants of mesh screens over the sash windows suggesting the location of a possible food preparation area. This range has a second floor within the attic and has three dormer windows set into the roof. The north-west facing elevation is a flat gable end with coped verges and an arrow slit vent in the apex (Fig. 101). It has two decorative limestone bands to match the other elevations. The ground floor and first floor windows are wooden-framed sash windows whilst the wide attic window is a wooden-framed casement window.

Figure 100 South-west facing elevation of eastern ward range Looking north-east

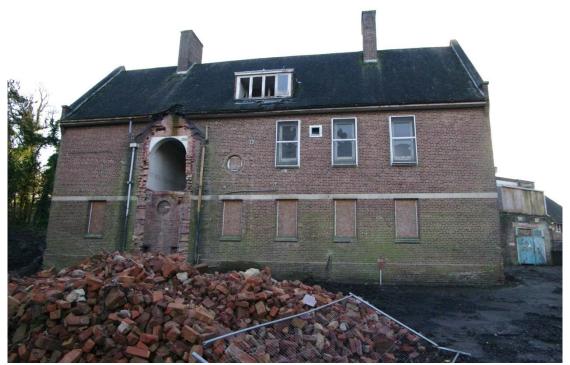
The north-east facing elevation of the eastern ward range contains the scar of the curving link corridor which used to join it with Wyndham Lodge (Fig. 102). The scar left by the now demolished link shows that the corridor was only accessible from the first floors of the lodge and the eastern ward range. A photograph of the curving link, taken in 2004, shows that it consisted of three ground floor arches which allowed access into the sunken garden area (Fig. 103). The ground floor windows are larger on this elevation as the ground level has dropped sufficiently to allow for five full height windows. The first floor sash windows have mesh screen covers with the exception of a small circular window set close to the side of the corridor. The roof has a single dormer with a wooden-framed casement window. The south-east facing elevation closely matches the north-west facing elevation with the exception that the first floor windows have flat-arched brick lintels and instead of a central window a doorway leads out to a shallow balcony (Fig. 104).

Figure 102 North-east facing elevation of eastern ward range Looking south-west. 1m scale. Note circular window to left of first floor windows

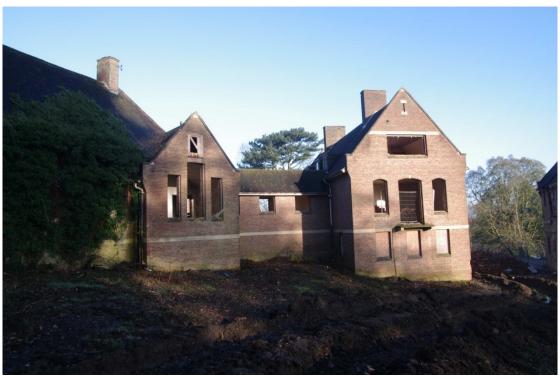
To the west of the eastern ward range is the south-east facing elevation of the curving link corridor (Fig. 105). This elevation of the link corridor matches the detail on its north-west facing elevation. The west end of the link corridor joins the eastern end of the spinal corridor at this point and is marked by a single storey gable end which has a Venetian style window with a small rectangular attic door in the apex of the gable (Fig. 105). This gable end appears to be more for cosmetic reasons than practical as it masks an otherwise awkward joint between the corridors and the Barfoot ward. It also creates an attractive view when looking across the sunken gardens from the east.

Figure 105 South-east facing elevations of eastern range, corridor and Barfoot ward Looking north-west. Barfoot ward on left, link corridor in centre, eastern range on right of picture

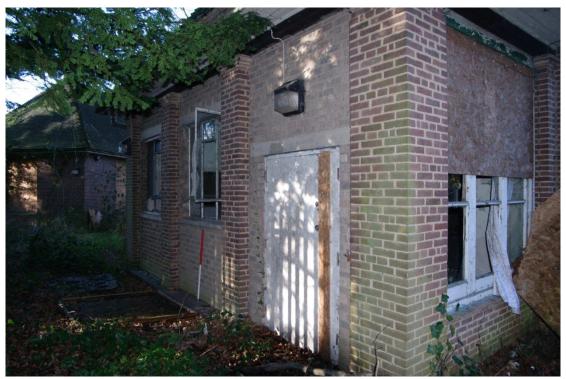
Figure 111 Mowbray Ward infilled south-west end Looking north. 1m scale

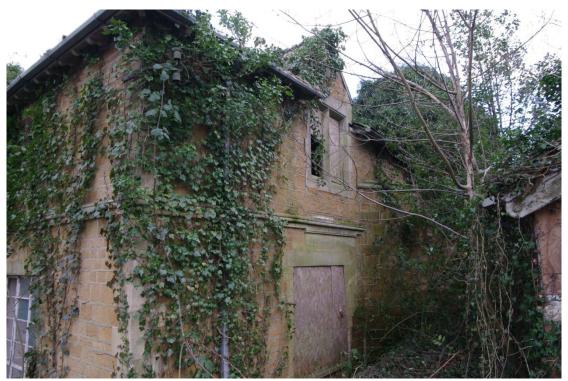
The northern end of the west facing elevation has a modified ground floor window enlarged to accommodate a Crittall window. The head of the much thinner original window can be seen above the modern window (Fig. 152). The first floor window has a central stone mullion and is set into a small gable which breaks the eaves. Around the window are dressed limestone blocks. To the south of the northernmost windows the stone garden wall extends westwards as mentioned above. The wall appears to be bonded to the stable wall and joins at a slight angle although it is in a state of collapse at this point making it difficult to be sure of this (Fig. 153). The western elevation consists of the two storey range which drops down to one storey where it joins the

Figure 152 North end of west facing elevation
Looking south-east. Note the top of the original window above the ground floor window

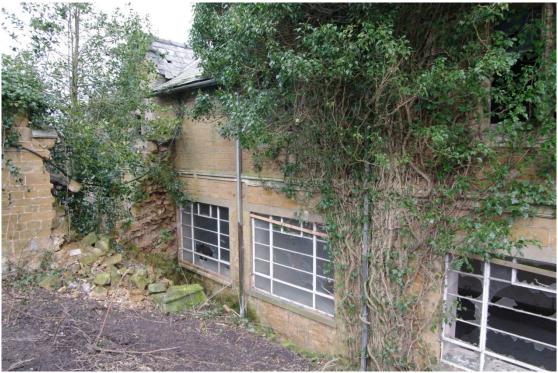
Figure 153 Stable block, west facing elevation
Looking north-east towards joint of stable wall with the (collapsing) garden wall.
Note retaining wall and height of ground level in comparison to the windows

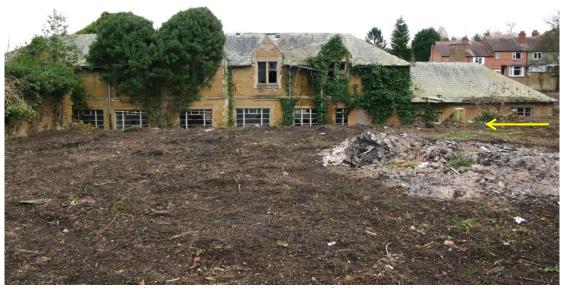
southern range (Fig. 154). Because of the changes in ground level a retaining wall has been built approximately 1m away from the stable block wall leaving a small sunken walkway around this elevation and the south facing elevation. All of the ground floor windows have been widened to fit modern Crittall windows, a modification which seems likely to have taken place during its time as a hospital. The first floor windows retain their two-light mullioned windows set into small gables. The central bay of the two storey range projects outwards very slightly and corresponds with a similar projection on the east face of this range. At the southern end of the two storey range a set of steps leads down to a small doorway with a carved dripmould around it and around a small stone framed window (Figs. 155 and 156). Above the doorway is a carved shield with the initials WAHC on indicating that this was William Augustus Chaplin's private entrance from the lodge into the stables. The lower half of the doorway has been bricked up to create a small round headed window. The balustrade either side of the steps appears to have matched the design used elsewhere around the lodge although it has been badly damaged in the recent past. To the south of the doorway the elevation drops down to a single storey which has two modern Crittall windows replacing the original windows.

Figure 154 Stable block, west facing elevation Looking east. Steps down to doorway arrowed

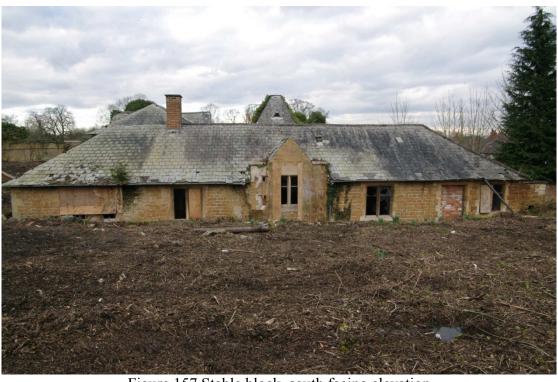
The south facing elevation of the stable block is a single storey structure set below the height of the present ground level which rises up to the south (Fig. 157). A modern brick-built chimney rises through the roof ridgeline. All of the windows are the original stone-mullioned windows and do not appear to have been modified. The apex of the central gable has been repaired using pale yellow bricks in an attempt to match the original stonework. A doorway at the eastern corner has been bricked up and there is no evidence of any steps in the retaining wall which holds back the ground to the south. The eastern end of the south facing elevation butts against a modern brick wall which extends eastwards to reach Ankle Hill. Before the eastern range was demolished there was a gap in the south-east corner of the central courtyard which may have been used for trade deliveries from Ankle Hill.

Figure 157 Stable block, south facing elevation Looking north

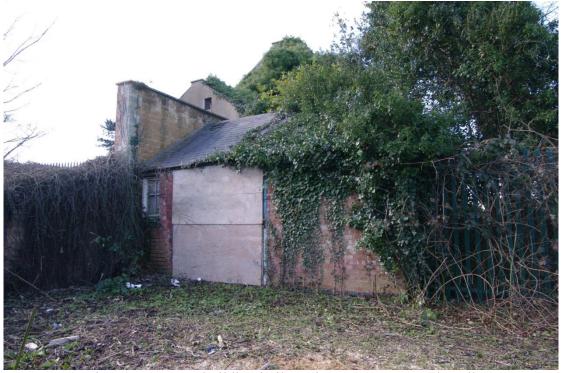
The main feature of the north facing elevation is the central gatehouse which has a pyramid style roof above a wide four-centred arch gateway which contains a set of modern gates (Fig. 150). The gateway surround is built from ashlar limestone with heavily moulded decoration around it (Fig. 151). The two single storey flanking buildings are not symmetrical and indicate the different uses of the rooms inside. On the west side of the gatehouse the single-bay room has a large Crittall window set into a widened opening which has removed any evidence of the earlier window. To the west of this is the two storey north end of the west range. This has a modern Crittall window at ground floor level and a moulded mullion window with four-pointed arched decoration at first floor level. The first floor window is likely to be original. To the east of the gatehouse is a single doorway reached via a set of steps dug into the ground. Above the door is the carved head of the original window showing that the doorway has been made by extending an existing window. The northern end of the east range is partially missing although a low single storey brick-built shed built against its north end ensures that part of it still remains (see Fig. 159). This brick shed is shown in the 1931 map and probably forms part of the first hospital additions.

Figure 159 1930s building built against east range north wall Looking south-west. Brick and stone wall on left

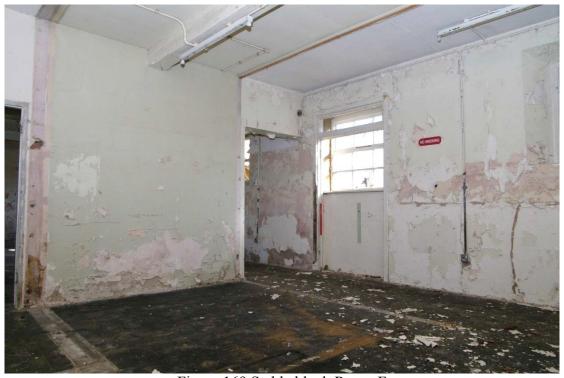
Figure 169 Stable block Room F
Looking north-east. 1m scale. Blocked doorway to right of scale. Knocked through doorway on extreme left of picture. Note scars left by modern partition walls

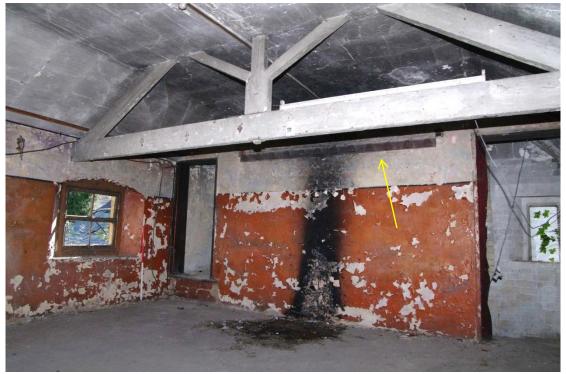
Room O appears to have been used as living accommodation for the stable block staff as it has the remains of a cooking range on the north wall (Fig. 187). The chimney which served the range no longer breaks the roofline outside which again indicates that the slates have been re-laid. The doorway to the stairs is located in the west corner of the south wall (Fig. 188). Above the stairs is a large cupboard with evidence of shelving built into it. The walls have been painted a dark brown colour up to picture rail height and which may be original. Above the range is a small gaslight fitting showing how the rooms were lit before the introduction of electricity (Fig. 189). On the west wall is a plank of wood onto which semi-circles of wood have been attached and was presumably used as a row of riding hat hooks or other personal riding equipment (Fig. 190).

Figure 187 Stable block Room O Looking north-east. 1m scale. Doorway to Room N to left of scale

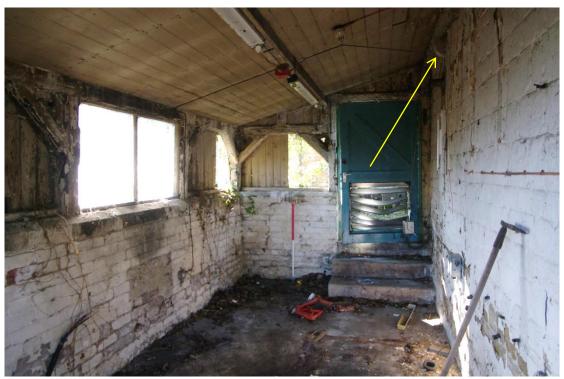
Close to the western end of the garden wall a brick and timber outbuilding has been inserted into the corner where it turns south (Figs. 192 and 193). The timberwork has floral decorations and may have begun life as a small summer house. The roof structure rests on a row of projecting stone corbels built into the wall suggesting that the building is part of the original layout. The first edition 1886 OS map appears to show a similar sized structure in this location. Other projecting stone corbels on the south side of the garden wall may indicate where the glass houses shown on the early OS map were once located.

Figure 193 Interior of outbuilding Looking south. 1m scale. Note roof resting on projecting corbels

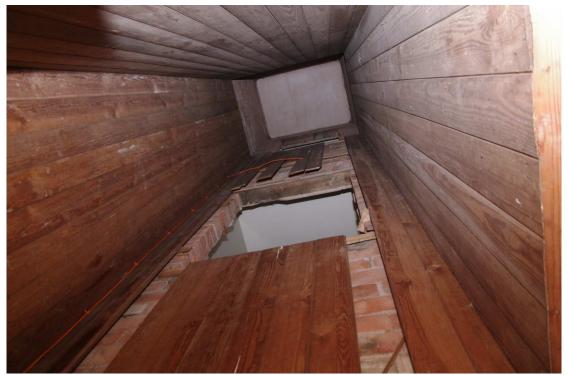
The eastern doorway leads into a short room which has a small goods lift shaft although no lift or mechanism is present so this may be a laundry chute. The shaft is lined with wood and extends up to the roof space (Fig. 201). A hatch opens onto the ground and first floor levels. The centre doorway is the boiler house entrance which still retains some pieces of modern heating equipment (Fig. 202). The equipment is clearly quite modern but no traces of earlier equipment are present.

Figure 201 Nurse's home, wood-lined shaft up to each floor Looking upwards

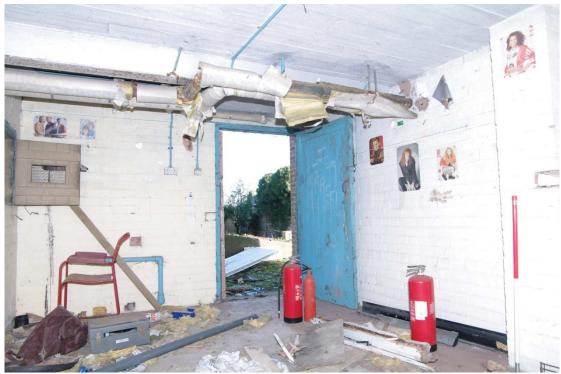
The westernmost basement room has whitewashed brick walls and appears to have most recently been used as a staff changing room or rest room as there are a number of lockers present and posters on the wall (Fig. 203). An access hatch on the north-west corner wall leads to a small tunnel below the ground floor of the building along which the main heating pipes run.

Figure 203 Nurse's home, basement room
Looking north-east. 1m scale. The access hatch to space under the floors is on the left
of the picture

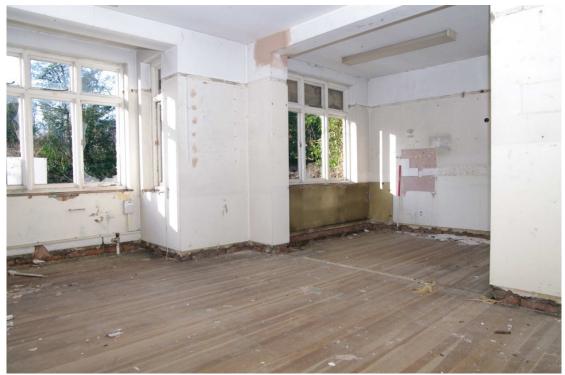
With the exception of the middle and west end rooms the ground floor rooms are identical. Each has a single doorway on the north side onto the corridor and a casement window on the south side (Fig. 206). The window fittings, where they survive, are

Figure 206 Nurse's home, ground floor bedroom Looking south-west from corridor doorway. 1m scale

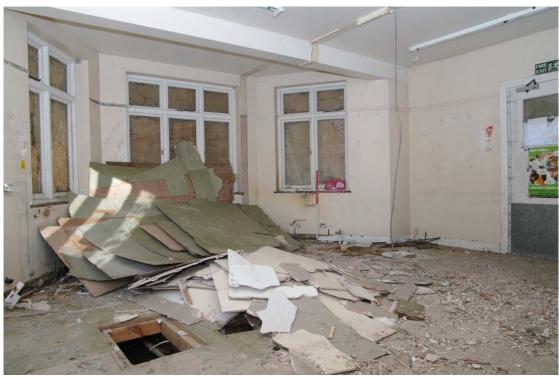
similar in style to the ward windows. Each room has a sink and, when first built, had a fireplace although all of the fireplaces have been removed and blocked. The floors are covered in wooden floor boards. It seems likely that each room had space for at least two beds. The middle room has a small rectangular bay window on the south side and has a smaller room on its western end (Fig. 207). The wall layout appears to indicate that this was part of the original design. There is no indication of what this room was made for but it is possible that it may have been used as a kitchen or dining area. On the corridor side of the smaller room is a large cupboard, probably intended as a linen cupboard. The westernmost room has a bay window on its western side (Fig. 208). This room may have first served as a common room. A surviving poster on the wall suggests that most recently this room appears to have been used as a dentist's. A doorway has been knocked through the eastern wall into one of the former bedrooms.

Figure 207 Nurse's home, ground floor. Centre room and possible kitchen Looking south-east. 1m scale

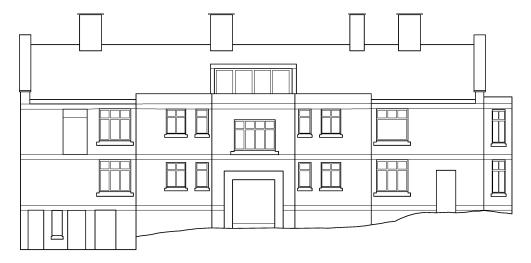
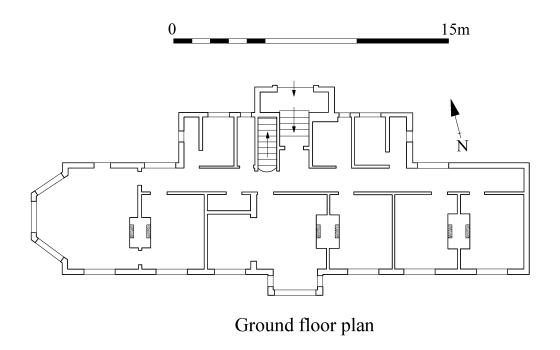
Figure 210 Nurse's home, elevation and ground floor plan

North facing elevation of former nurse's home

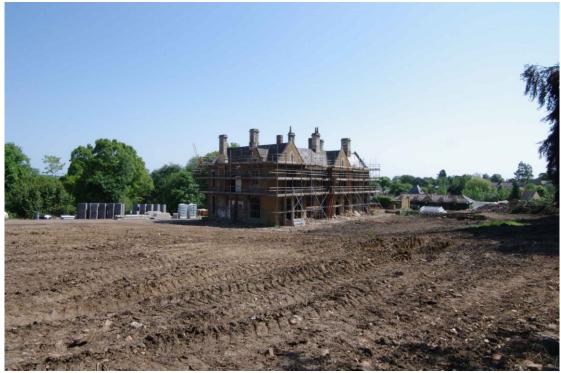
The lodge now stands in isolation with the stables to the east much as it did when first constructed (Fig. 211). The removal of the western extension reveals that the ground floor part of the extension built in the earlier part of the 20th century was reached via a narrow window which was elongated to create a doorway (Fig. 212). A second ground floor doorway appears to have knocked through what was a solid wall. The later first floor extension also utilised a window to create a first floor doorway into the curving link corridor

Figure 211 General view of Wyndham Lodge and former garden area Looking north-east

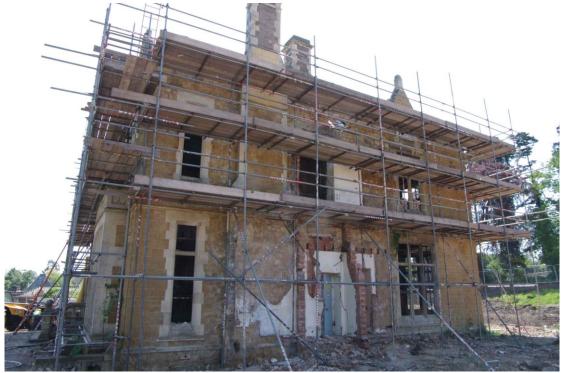
Figure 212 West facing elevation of Wyndham Lodge after removal of extension Looking south-east

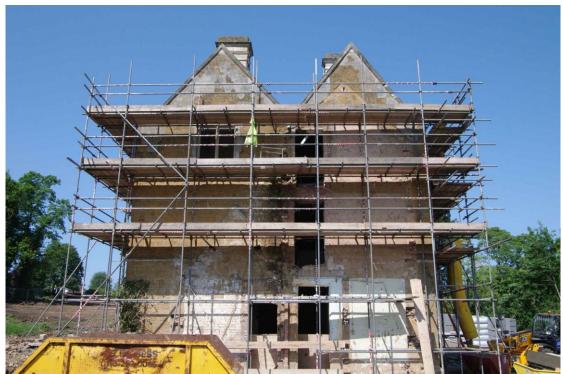
Now that the service range has been removed the double gable ends of the lodge can be seen (Fig. 213). A number of doorways to each floor pierce the wall in order to reach the service wing which all, apart from the ground floor door, appear to be later modifications. The only original opening is a mullioned window on the first floor on the south gable which suggests that, although of a slightly later date, the service wing was planned from the start.

Figure 213 East facing elevation after removal of service range Looking west

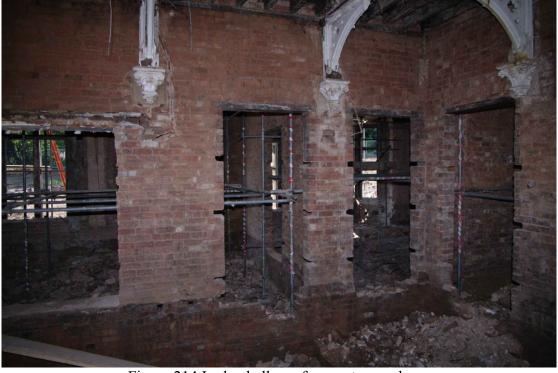
Inside most of the ground floor and first floor floors had been removed leaving only the main stairs and balcony within the main hallway (Fig. 214). The wall plaster has also been stripped away to reveal the brick-built internal walls with relieving arches over each doorway. The first floor rooms have been stripped in a similar fashion and show that each room contained a shallow fireplace with glazed brick surrounds (Fig. 215). Towards the western end of the lodge the service stairs were still intact and lead up to the first and second floors. Most of the original floors had been removed and were in the process of having new steel joists inserted (Fig. 216). The second floor rooms are built into the roof space and were clearly designed to be used as accommodation as the roof timbers have small decorative beads and appear to have been varnished. Close to the top of the service stairs is a wooden-framed box let into the brick wall (Fig. 217). The box contained a number of pulleys and wires which are the remnants of the bell system used to alert the servants from each of the main rooms. The box would have held a glass frontage but this is no longer present.

Figure 214 Lodge hallway from entrance doors Looking north-west

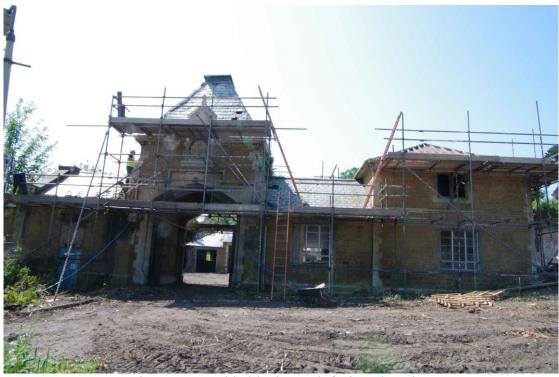
As noted, at the time of the June visit the stables are much as seen in February 2016. However, the removal of the ivy has given the opportunity to take some less-obscured elevation photographs of the north and west facing elevations (Figs. 218 and 219). The largest gable on the west facing elevation appears to have held a sundial as a small stone plaque in the apex has the following motto *I NUMBER THE SUNNY HOURS ONLY* (Fig. 220). There is no trace of the sundial face or gnomon.

Figure 218 Stable block, north facing elevation Looking south

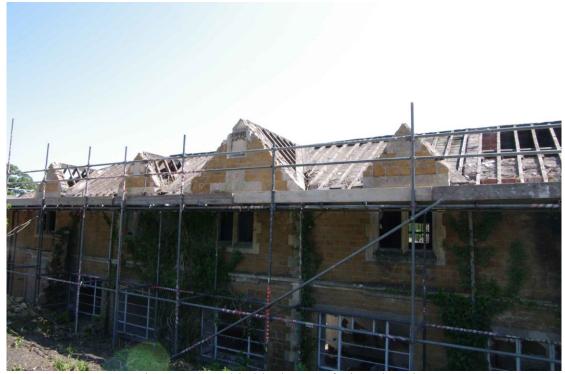
Figure 219 Stable block, west facing elevation Looking north-east
