**An Historic Building Recording at
The White Lion Inn,
1 High Street,
Moulton,
Northamptonshire.**

ULAS Report No. 2016-104
©2016

For: Fernbrook Builders Limited

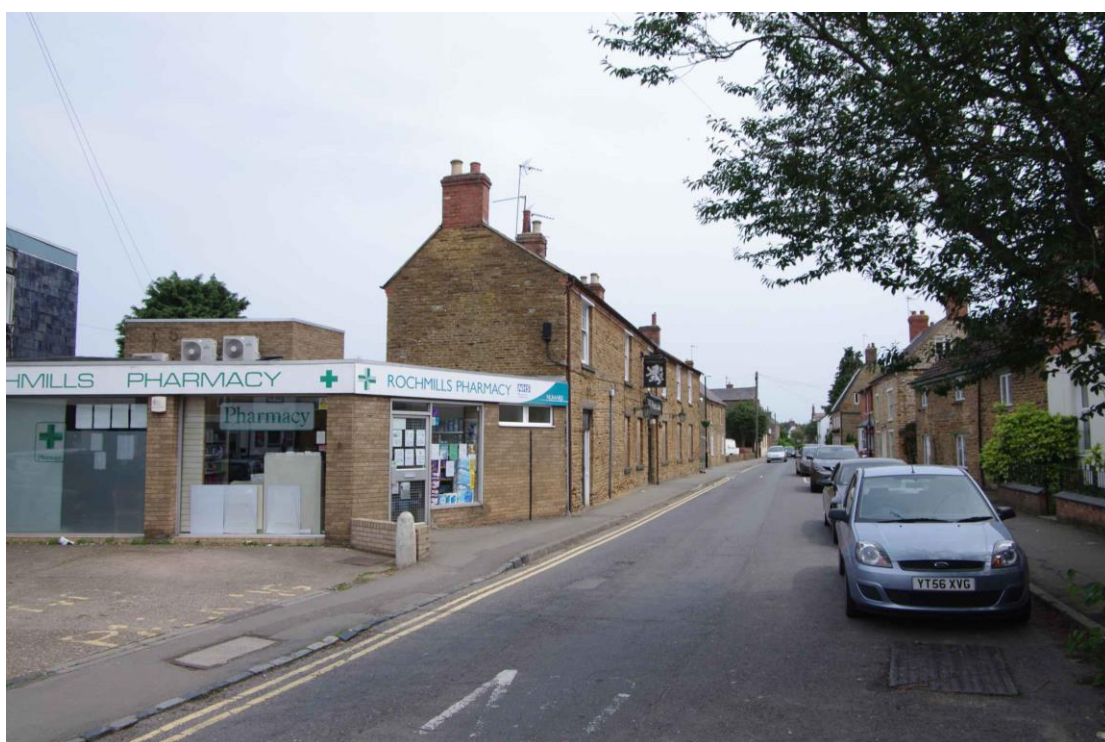
Figure 7 The White Lion seen from High Street
Looking north-east

The west facing elevation is obscured at ground level by a modern pharmacy building although the first floor and the apex of the flat gable end can still be seen (Fig. 7). The pitch of the roof is unequal on the north and south sides which may indicate a rebuilding or modification of the roof (Fig. 13). The chimney stack is brick-built and sits at the top of the ridge. A trace of slightly less weathered stone forming the outline of a single storey gable-ended building can be seen on this elevation showing where a later building has been removed to make way for the present modern building.

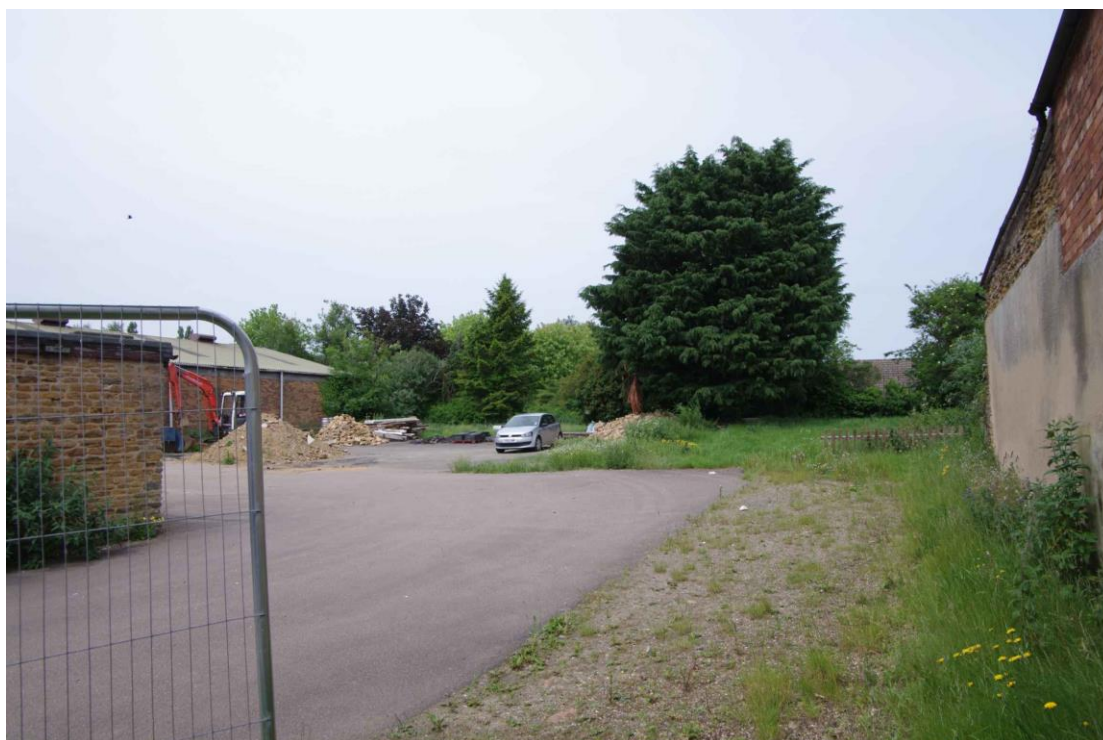
As noted the White Lion site consists of a two-storey building running along the edge of High Street. An entrance drive leads to the rear of the site which forms a large tarmac car park with a grassed area along the northern boundary (Figs. 6, 7, 8 and Appendix 1). A row of brick and stone outbuildings extended northwards from the north-west corner of the main buildings but these had been demolished shortly before this building survey took place. Inside the main building virtually all of the fixtures and fittings have been removed along with all internal dividing stud walls and ceilings (see Appendix 2 for pre-refurbishment plan). No doors or doorframes survive either. Despite this level of alteration the state of the building did afford the opportunity to study the fabric of the building more closely than is often possible. The ground floor windows of the main building had been boarded over but otherwise the rest of the external appearance remained unaffected by the redevelopment work.

Figure 8 White Lion rear car park
Looking north from entrance

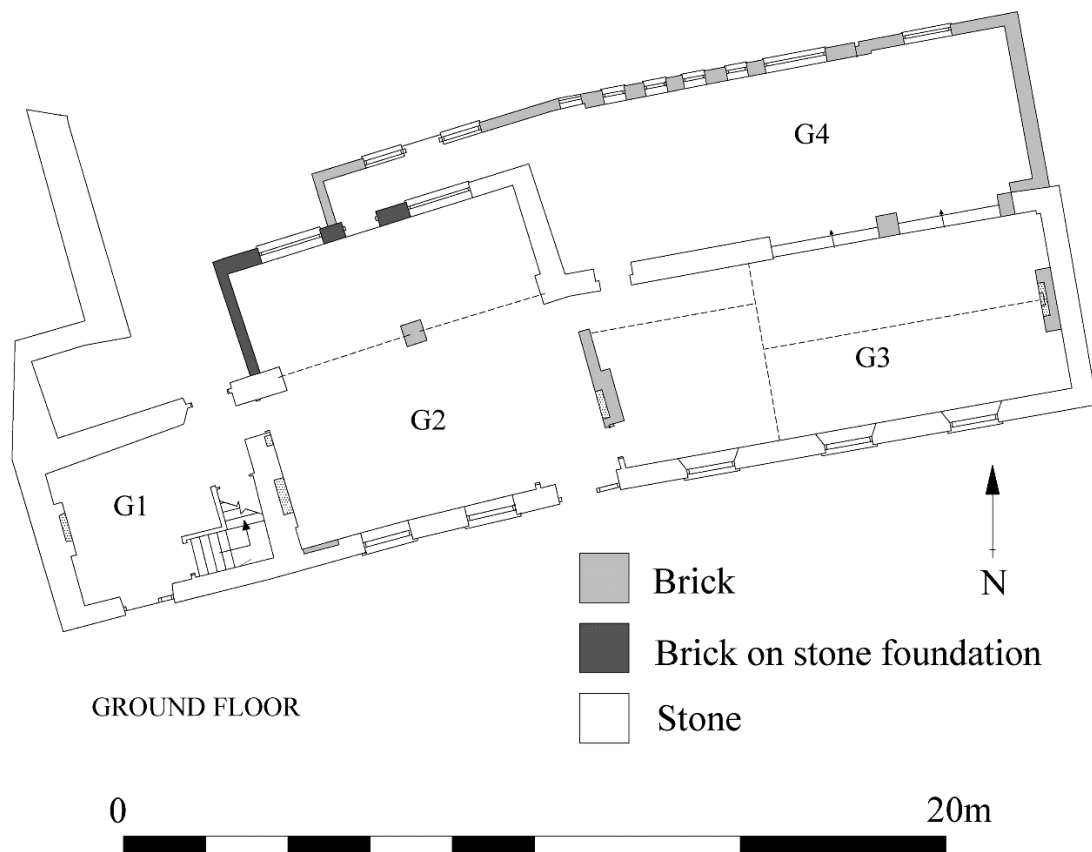
Ground floor (Fig. 20)

Figure 20 Ground floor plan
Modified from plan supplied by ABDS Ltd

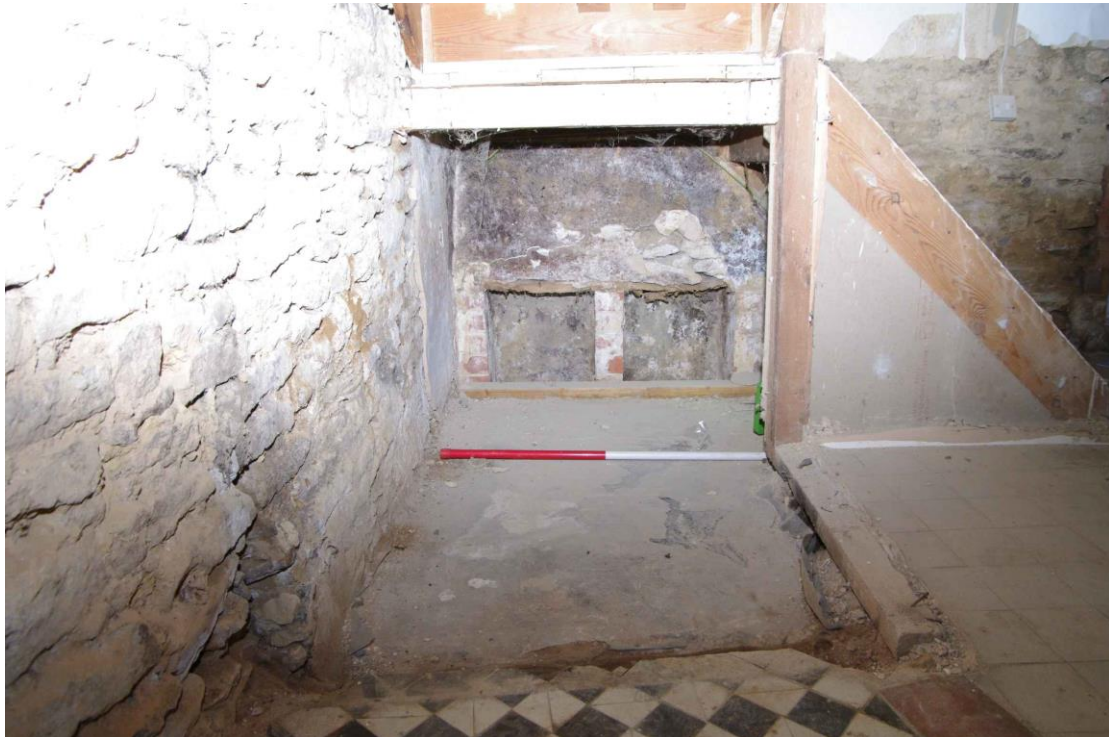
Figure 23 Room G1 former cellar below stairs
Looking south. 1m scale

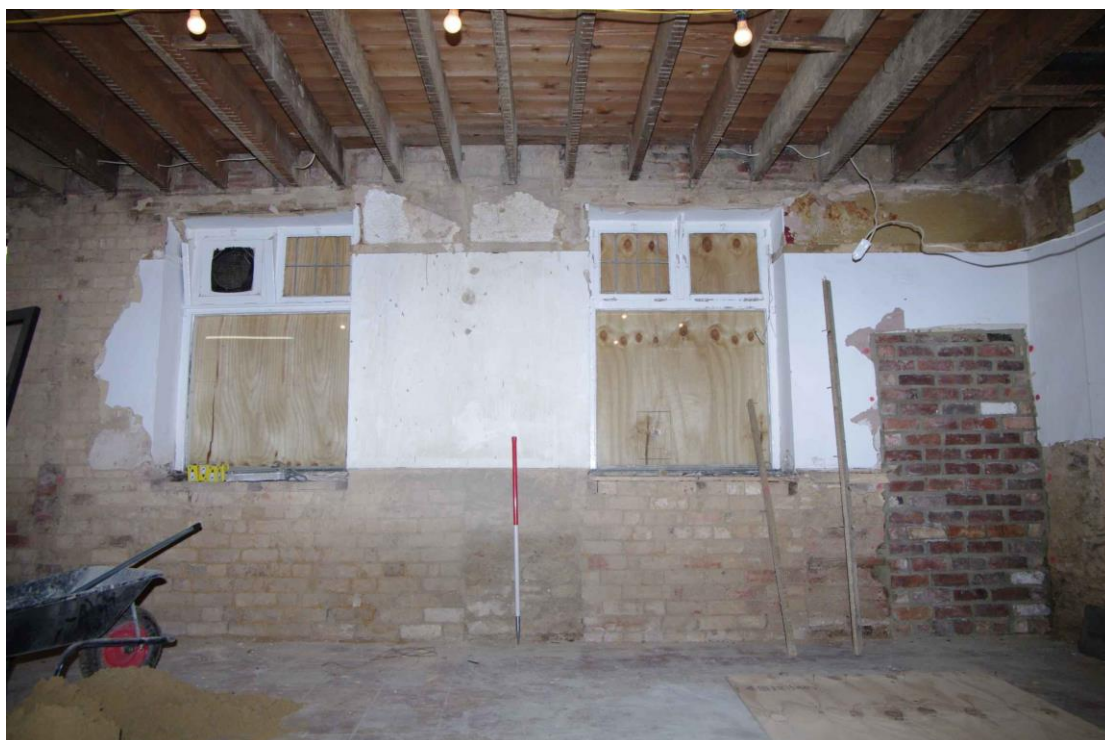
Room G2 is part of the former bar area although no fittings now survive (Figs. 25 and 26). The original back (north) wall has been removed and replaced by a central brick pillar with the rest of the wall being supported by two I-profile steel beams. A single step leads northwards into a rectangular extension area which has wall made from brick and stone built on stone foundations as discussed in the north elevation description above. The west wall of the main part of G2 has a blocked-in fireplace along with a small flue, possibly for a stove, to the north side of it. Another blocked fireplace can be seen in the east wall which appears to have been entirely rebuilt in brick, probably to support the chimney stack which appears to be a late 19th century addition to the building as it straddles both the east and west parts of the main building. Doors either side of the chimney lead into room G3. The south wall onto High Street appears to have a number of rebuilding phases or patches (Fig. 27). Areas beneath the windows appear to be built of brick with areas of stone elsewhere on the wall. None of this patching is evident from outside.

Figure 27 Room G2 south wall
Looking south. 1m scale

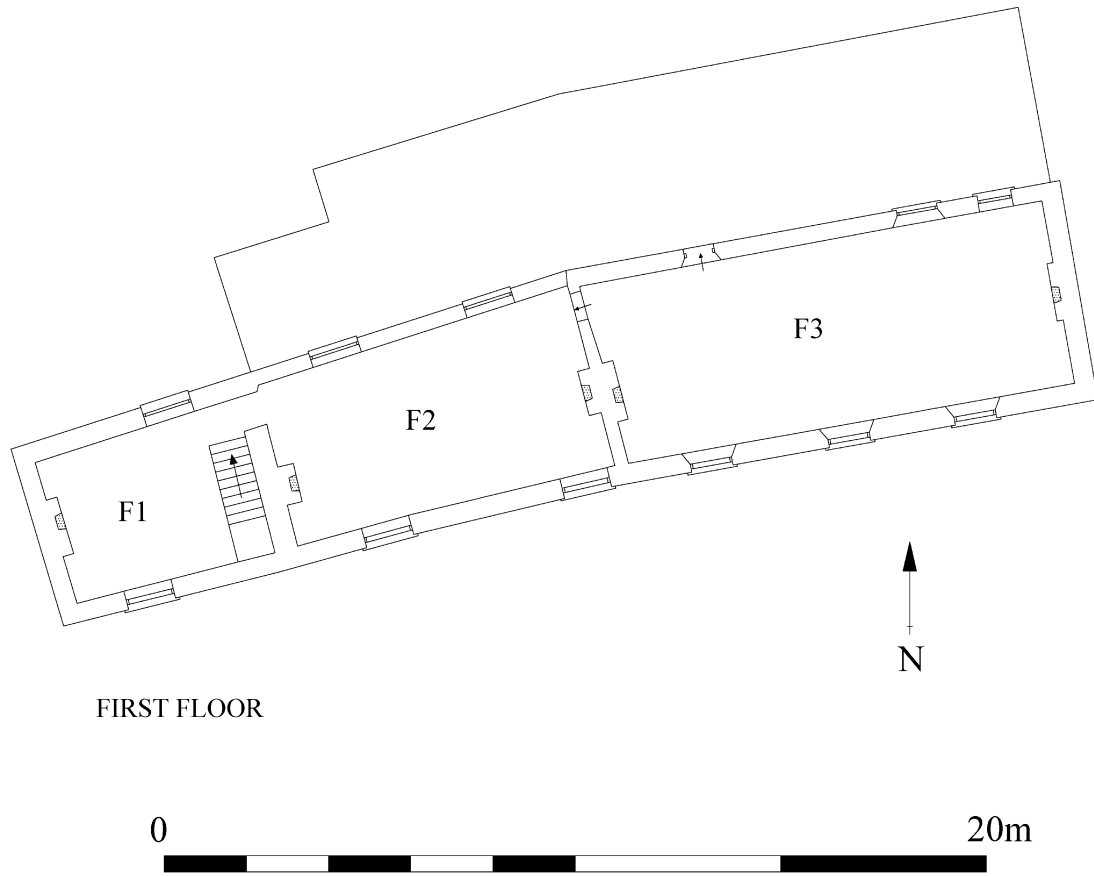
First floor (Fig. 32)

Figure 32 First floor plan
Modified from plan supplied by ABDS Ltd

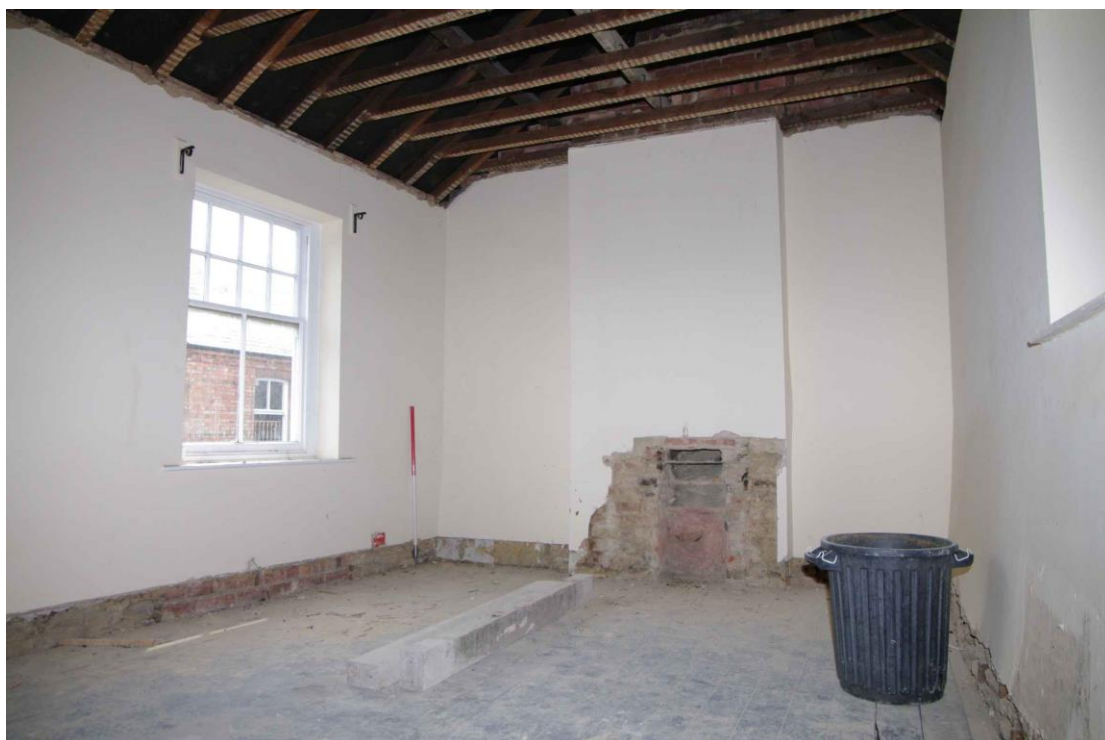
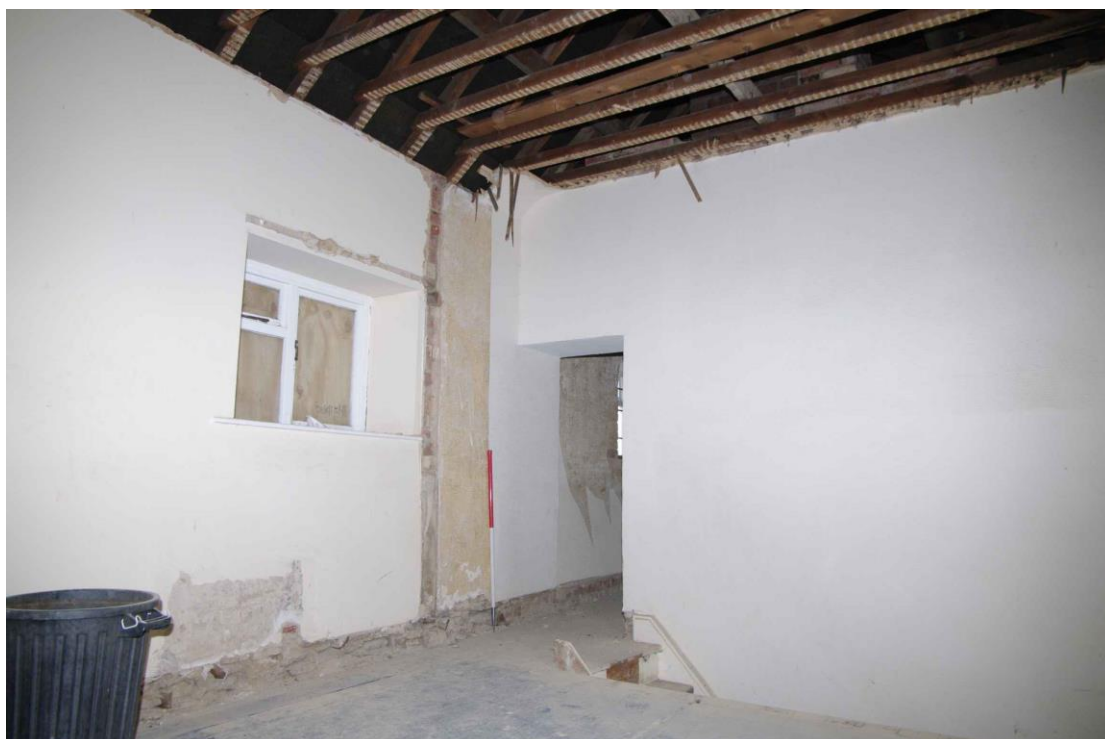
The only access to the entire first floor is via the staircase in room G1 which leads up into Room F1. A partition wall between the stairs and the room has now been removed leaving an open space (Figs. 33 and 34). The floor is laid with wooden floorboards with a number of patches and repairs. The roof structure appears to be relatively recent, probably mid-20th century and consists of lightweight tie-beams attached to each common rafter. The tie-beams are more likely to act as supports for the (now removed) ceiling rather than to support the roof. The roof has been recovered in the second half of the 20th century as it has roofing felt beneath the slates.

Figure 33 Room F1
Looking south-west. 1m scale

Figure 34 Room F1
Looking north-east. 1m scale

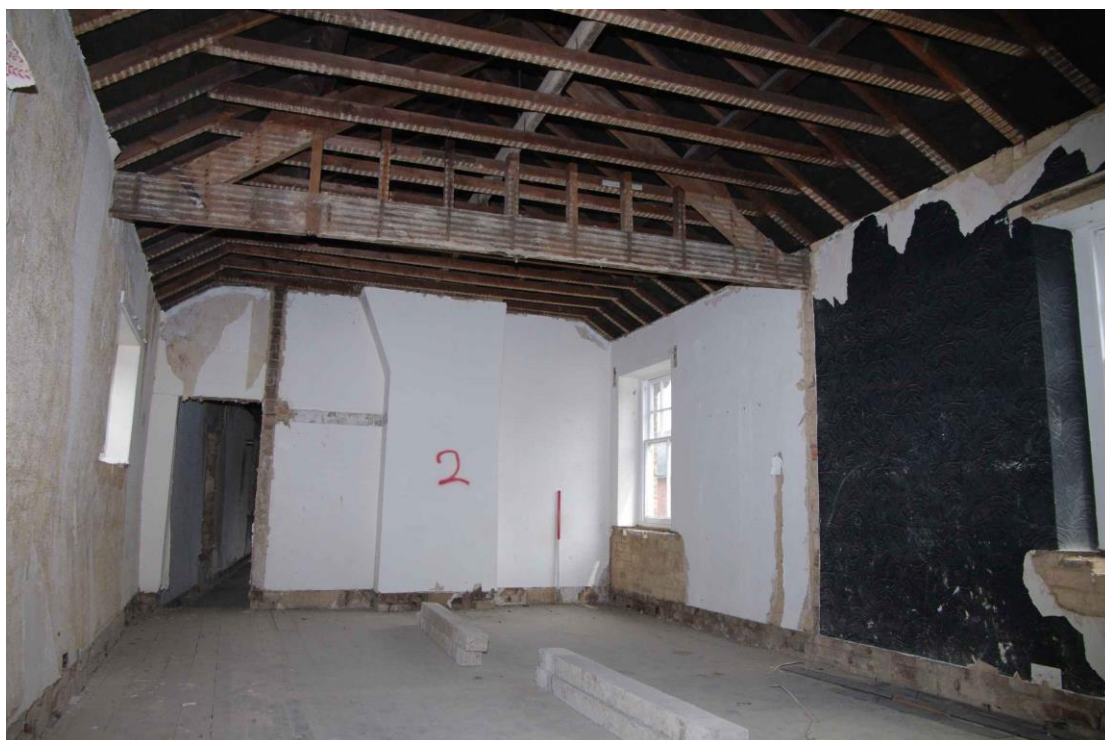
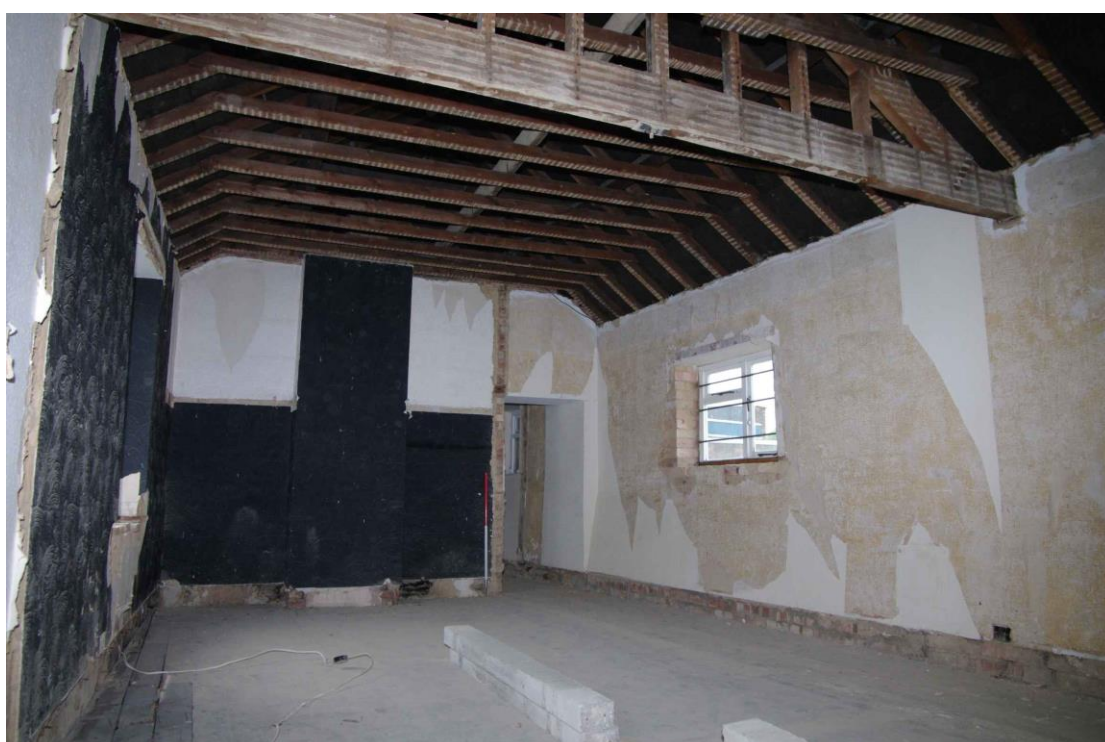
The stud walls which formed a corridor and two separate rooms have been recently removed to create a single open room (Figs. 35 and 36). The alignment of the north and

Figure 35 Room F2
Looking south-east. 1m scale

Figure 36 Room F2
Looking north-west. 1m scale

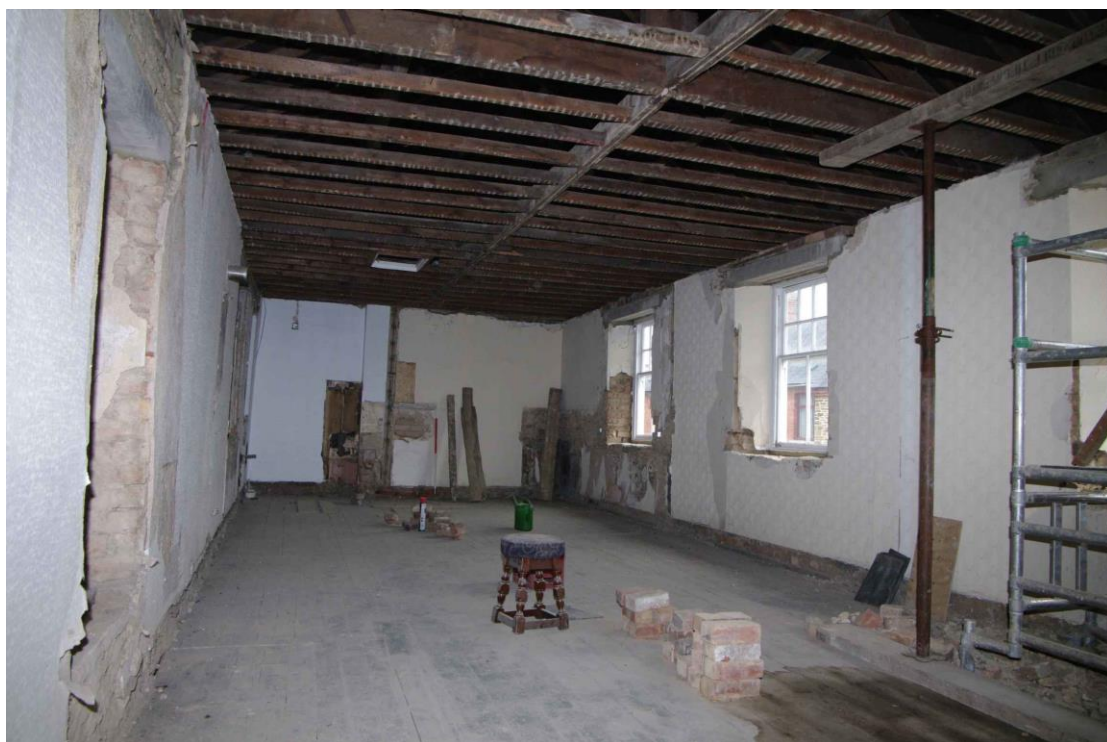
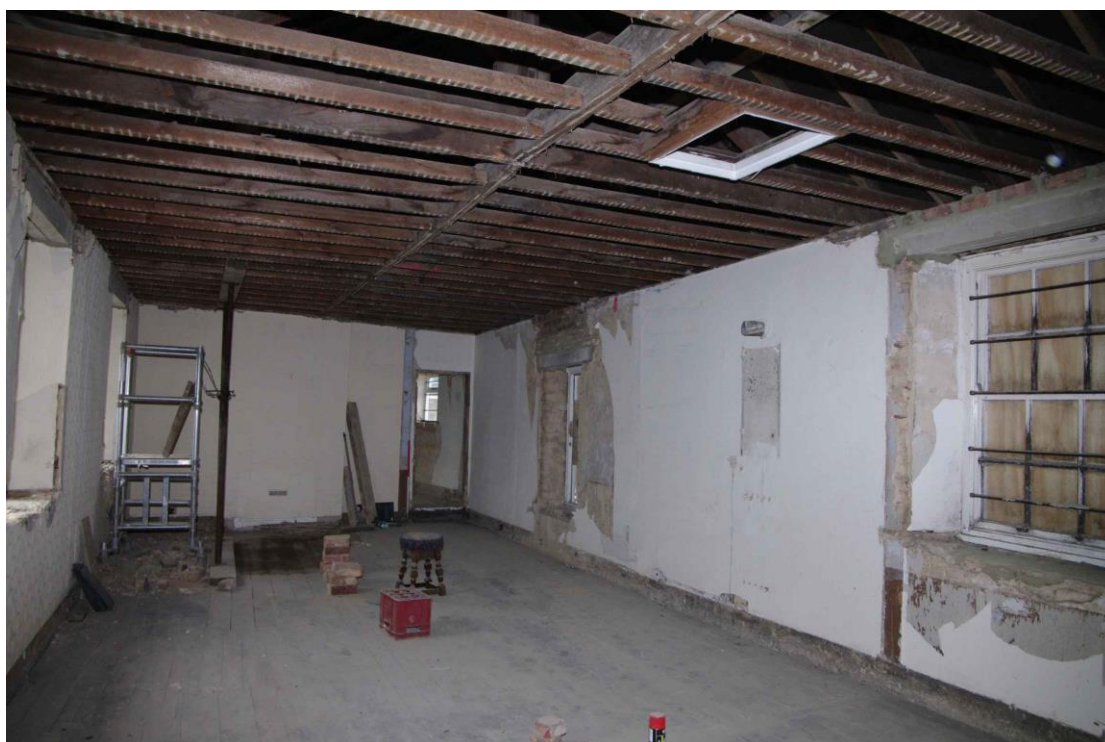
Room F3 fills the entire first floor space of the eastern half of the main building as Room G3 does on the ground floor. The alignment of the north and south walls differs slightly to rooms F1 and F2 (Figs. 38 and 39). Before the stud walls were removed the space was occupied by two bedrooms, a kitchen, bathroom and an access corridor. As in F2 this room has a blocked fireplace and glazed tile hearth at the east and west ends. The south wall appears to be stone-built with brick inserts to strengthen the floor joist sockets. The three sash windows have splayed jambs although the woodwork appears to be relatively recent and matches those in F1 and F2. The north wall is also stone-built and has three different sized openings. The westernmost of the openings has been modified into a fire escape and may have been modified from a window. The larger of the two openings close to the north-east corner has splayed jambs and is wide enough and tall enough to be a doorway. The smaller opening has square sides and may be a later inserted window.

Figure 38 Room F3
Looking south-east. 1m scale

Figure 39 Room F3
Looking north-west. 1m scale

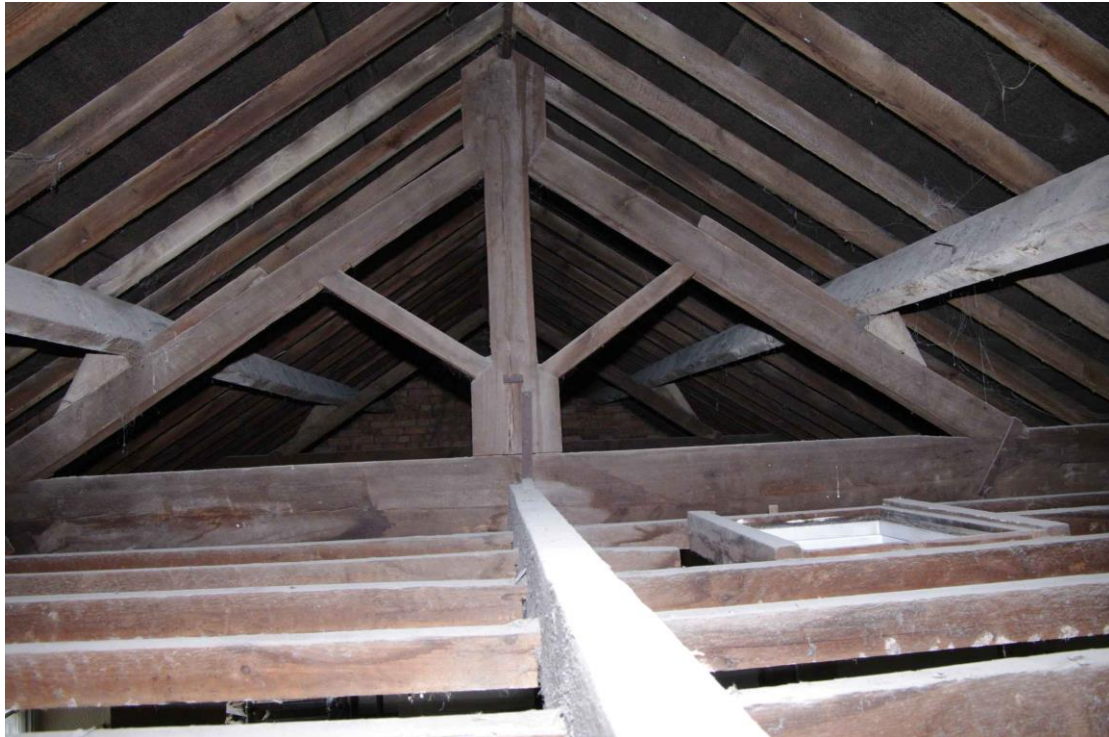
A rectangular patch in the floorboards close to the north-west corner of the room shows where a staircase led up from Room G3 below (Fig. 40). The roof is supported by two trusses which are of a different design to that used in Room F2 (Fig. 41). The king post is bolted to the tie-beam and has two raking struts supporting the principal rafters. The purlins sit on thin wooden blocks or spacers attached to the backs of the principals which suggests a later rebuilding of the rafters and roof covering. As in Room F2 the top of the king posts are out of alignment with the current ridgeline.

Figure 41 Room F3 roof detail
Looking west
