**A Level 3 Historic Building Survey at  
Home Farm,  
Markfield Road,  
Groby,  
Leicestershire**

**NGR: SK 51099 08227**

ULAS Report No. 2018-014  
©2018

**For: Cawrey Limited**

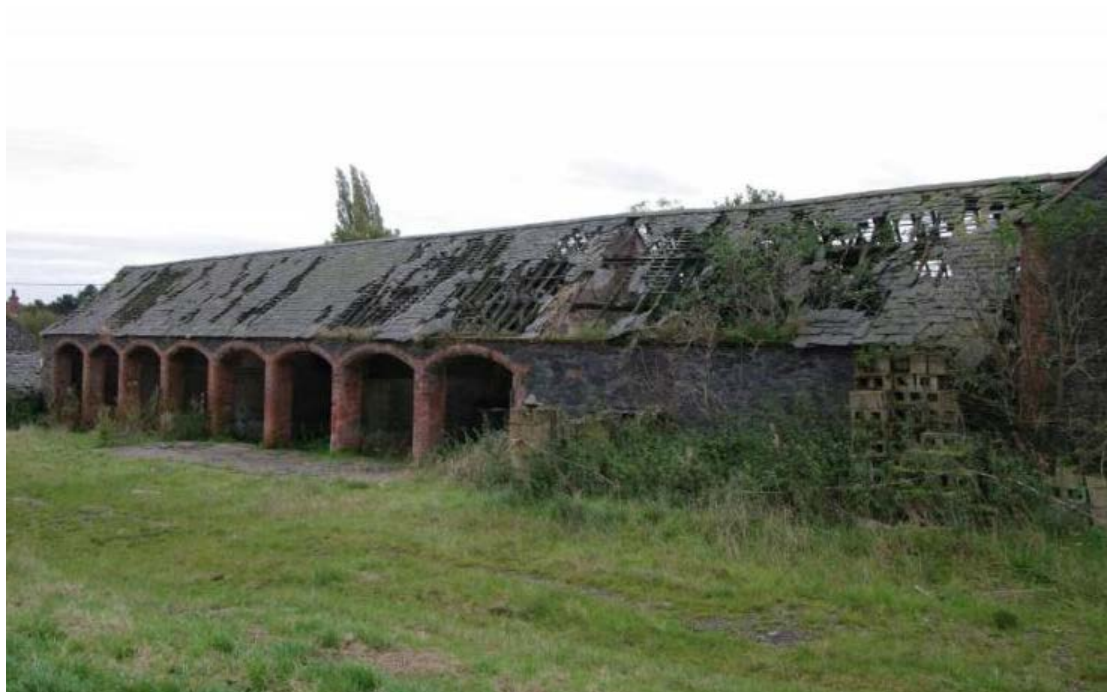
As with all of the buildings this structure is rubble-built using locally sourced stone and has a graded locally sourced Swithland slate roof (Figs 12 and 13). Doors and windows are detailed with red brick. The building forms the northern range of the western yard buildings and joins Building B in the north-west corner. A gap between the east end of Building A and the north end of Building D provides access into the yard.

Figure 12 Building A north-facing elevation  
Looking south-east

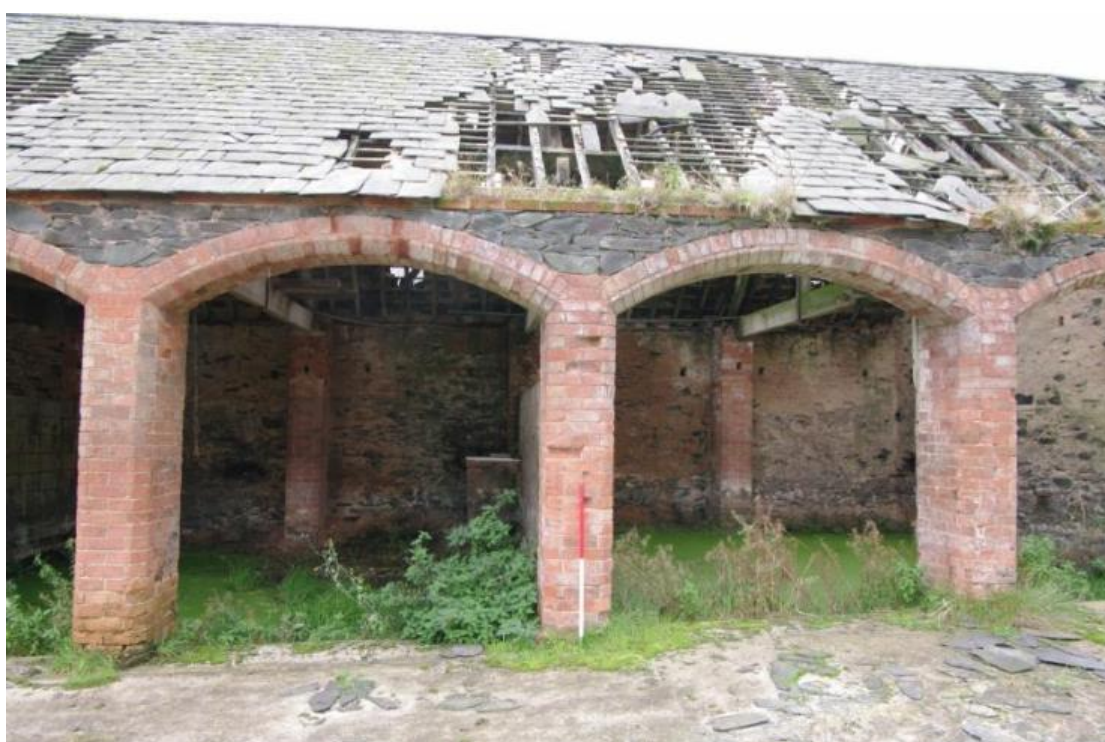
pillars (Fig. 14). The western end of the north elevation is a blank wall which backs onto a range of three open bays facing southwards into the yard. At its western end the building joins Building B where a small step in the building line marks the joint between the two buildings. Despite the step in the wall the two structures appear to be of the same phase of construction with the stonework bonding into each other.

Figure 14 Building A north-facing elevation brickwork detail  
Looking south. 1m scale

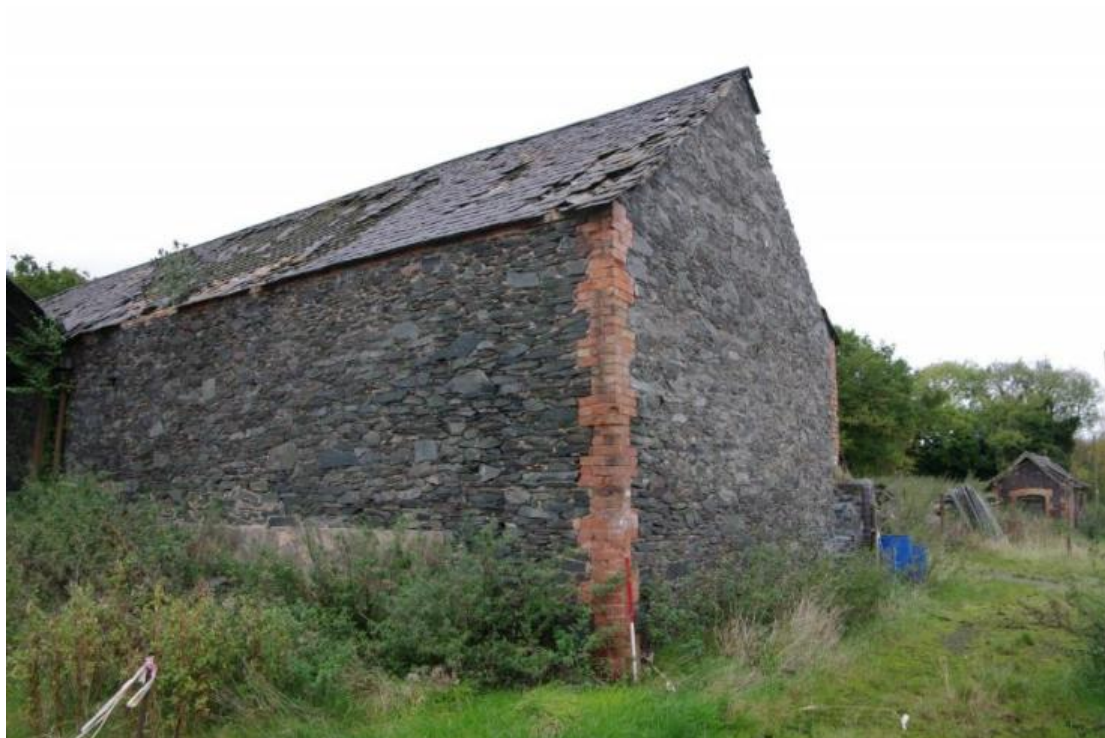
The east-facing gable end of Building A is plain stonework with brick detailing at each corner added to support the otherwise irregular large lumps of stone (Fig. 15). There is no evidence of a hayloft door or any other opening. The south-facing elevation faces into the enclosed yard and is predominantly blank as it forms the rear of the open bays seen on the north side. At the western end of the elevation are three open bays which match the detailing seen on the bays facing to the north (Fig. 16). Much of the south-facing elevation is obscured by a large steel Dutch barn structure which fills most of the north-western part of the yard (Figs 16 and 17). The corrugated sheet metal roof, with iron beam and round section rod trusses, is supported on tall cast iron pillars which do not bear any maker's marks. This open barn first appears on the 1904 Ordnance Survey map and is similar in style and construction to others around the county which were being built at the turn of the century. A recent survey on a farm in the north-west of the county studied a similar structure which had been delivered to the local railway station in a pre-fabricated form.

Figure 15 Building A east-facing gable and south-east corner  
Looking north-west. 1m scale

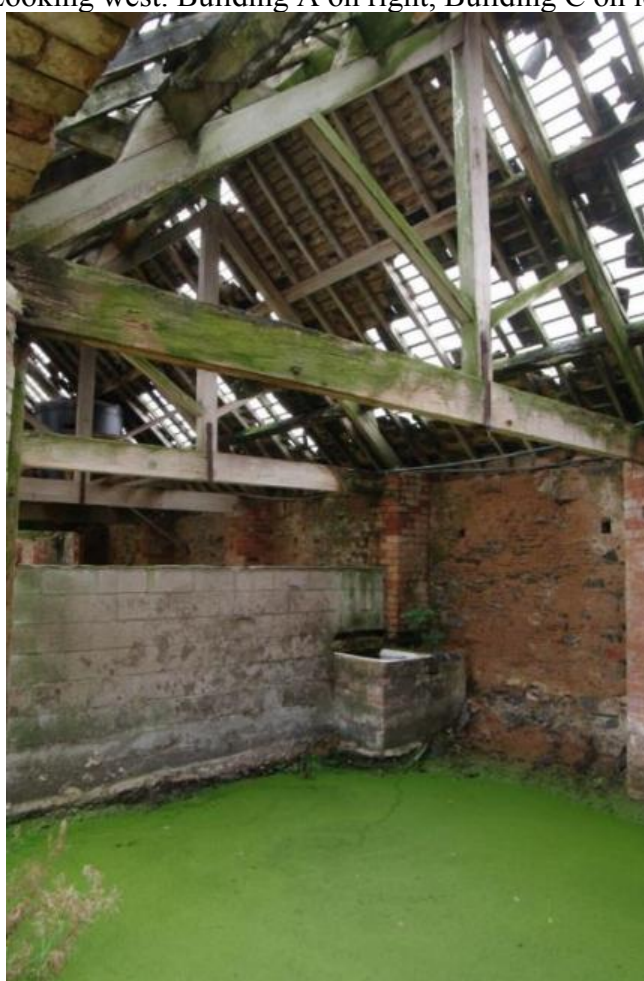
The roof structure is supported on brick pillars and consists of relatively slight timber tie beams and principal rafters with a king post attached by an iron stirrup to the tie beam (Fig. 18). The purlins resemble thin machine-cut planks laid on their sides to give adequate support whilst minimising on timber. The method of construction of the roof structure suggests a construction date after the 1850s. Such a date would support the suggestion of being built around the 1850s or 1860s by the Earl of Stamford.

Figure 18 Inside Building A  
Looking south-east. Note later inserted dividing wall and trough plus the flooded floor

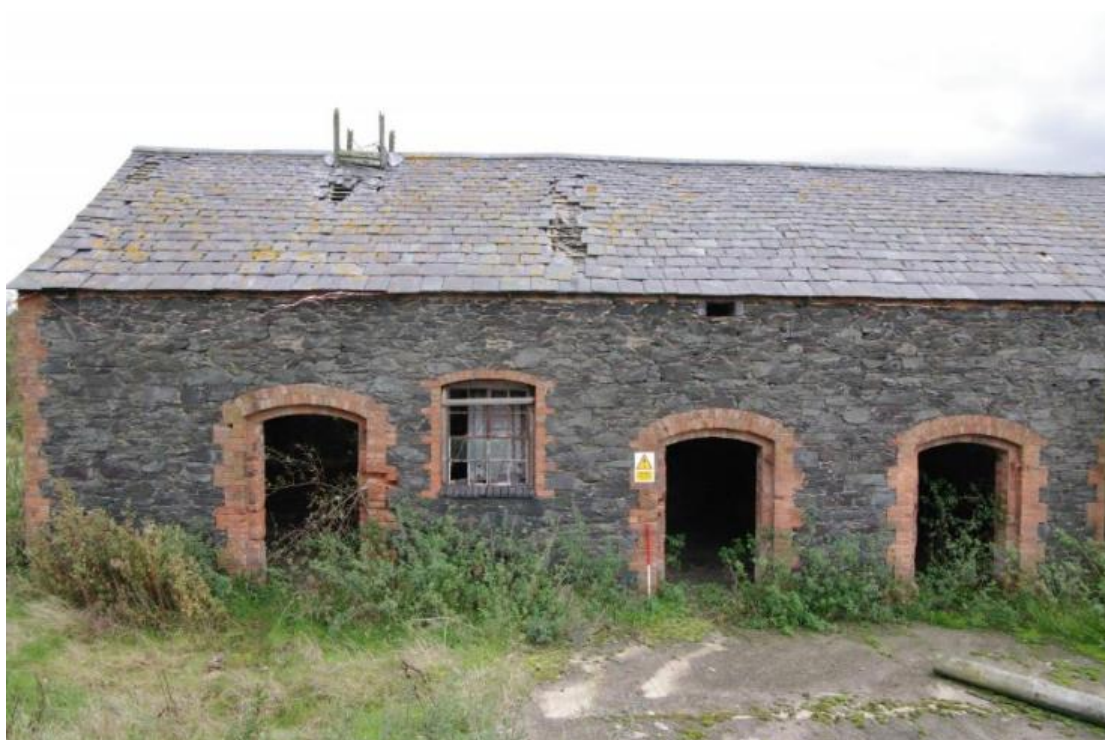
Figure 20 Building B north end of west-facing elevation  
Looking east. 1m scale. Note remnant of roof vent on ridge

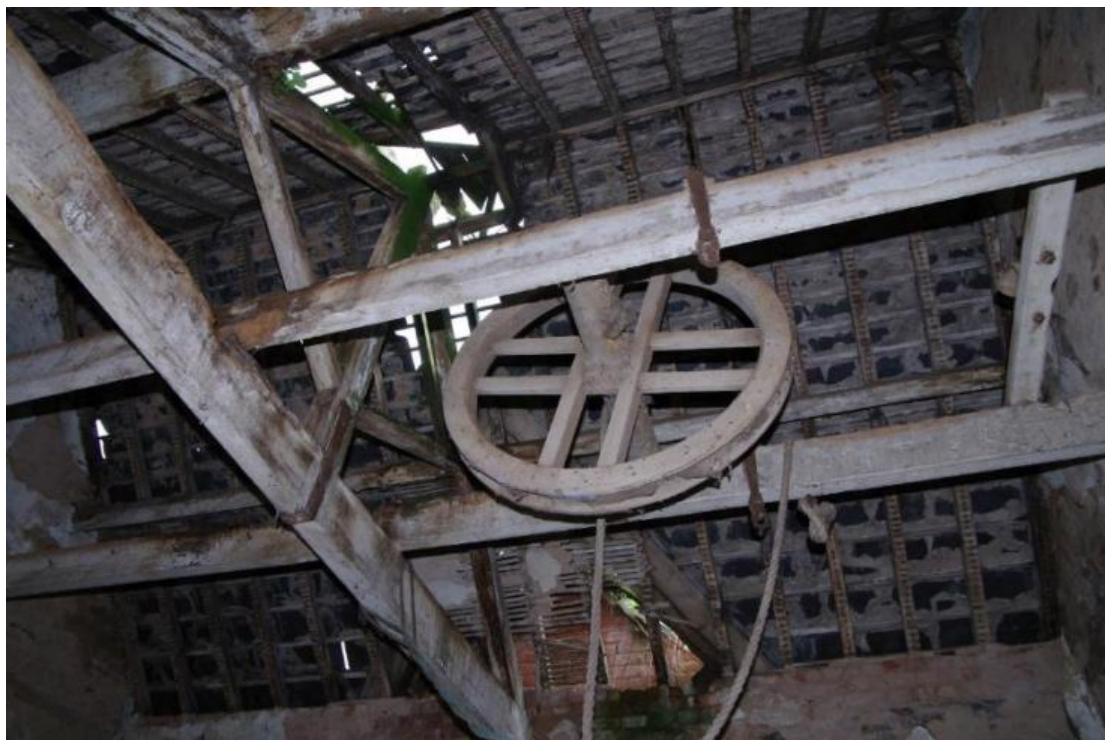
Figure 37 Building B north room, pulley wheel in roof  
Also note remnants of laths and plaster on the underside

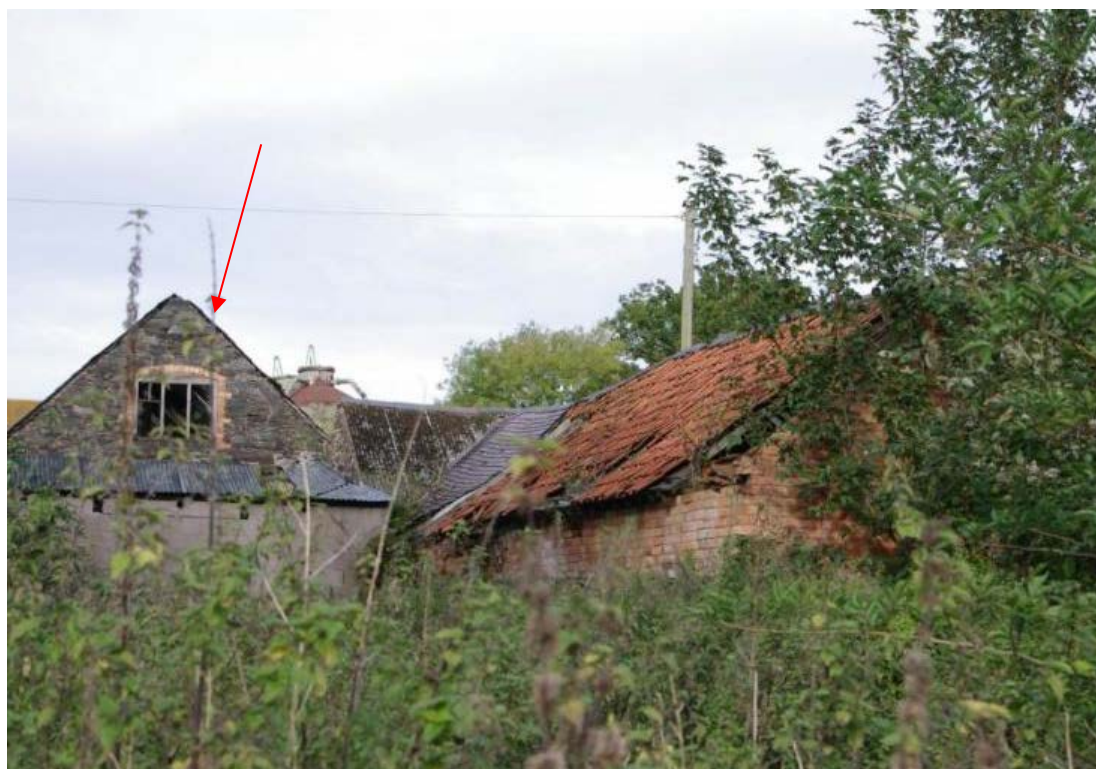
Figure 43 Building C east facing gable end  
Looking west. Building C arrowed. Note modern lean-to built against gable end. Pan  
tiles of Building E on right

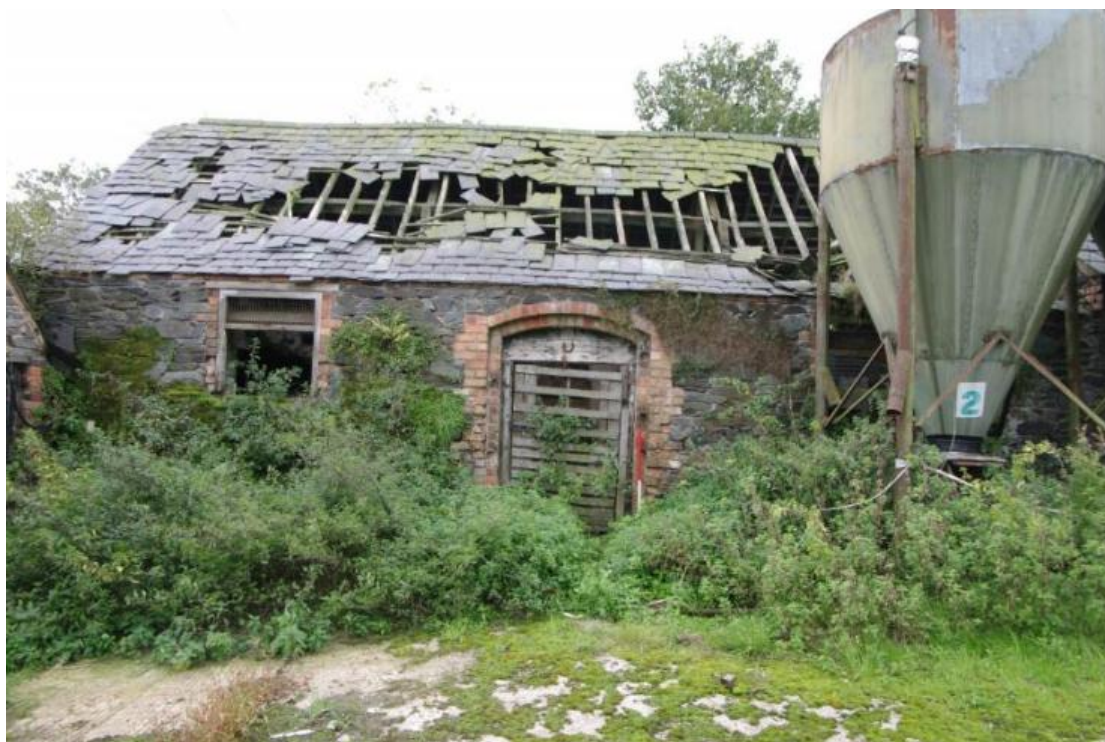
Figure 45 Building C north-facing elevation, west end  
Looking south. 1m scale

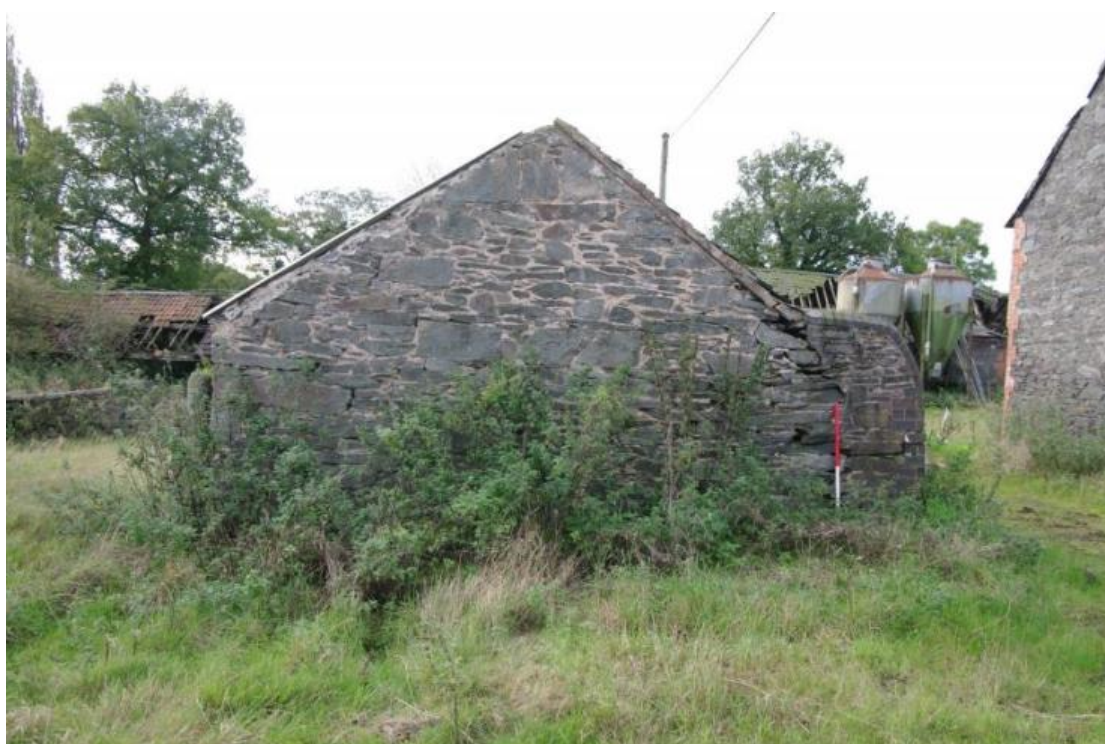
Figure 51 Building D west-facing elevation, blocked doorway  
Looking east. 1m scale. Yellow line indicates joint in stonework

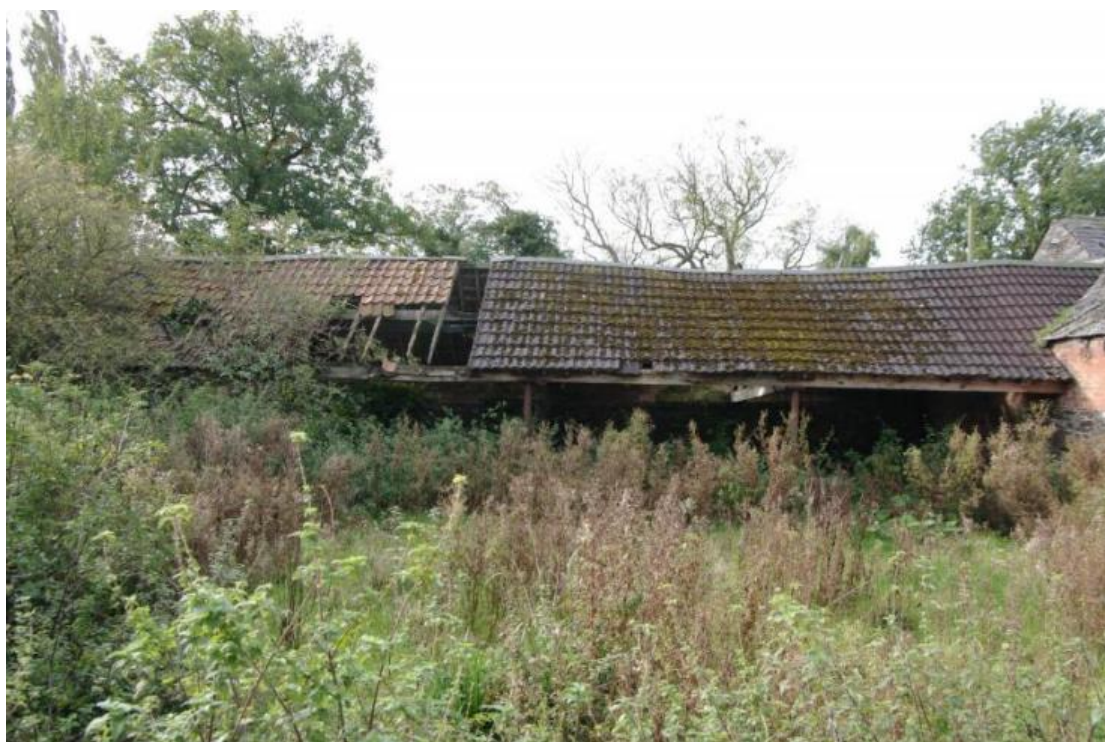
Building E is a low cart shed running from east to west along the southern side of the yard (Fig. 60). The north-facing elevation is open fronted and is supported by cast iron columns (Fig. 61). The eastern half is covered in pan tiles which are more commonly seen in the eastern parts of Leicestershire and were used as a lightweight low cost roofing material in the late 19th and early 20th centuries. This date would match the early 20th century construction date indicated by the cartographic evidence. The western half of the roof has been recovered with modern roof tiles from the later 20th century. The different areas of roof coverings do not represent any internal arrangements.

Figure 60 Building E north-facing elevation  
Looking south

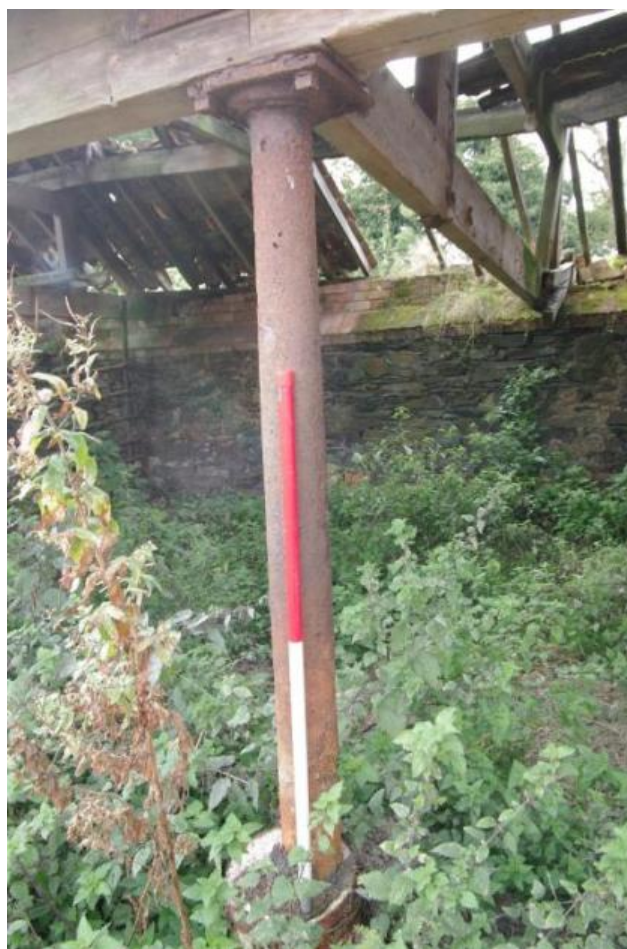
Figure 61 Building E north-facing elevation, column detail  
Looking south-east. 1m scale

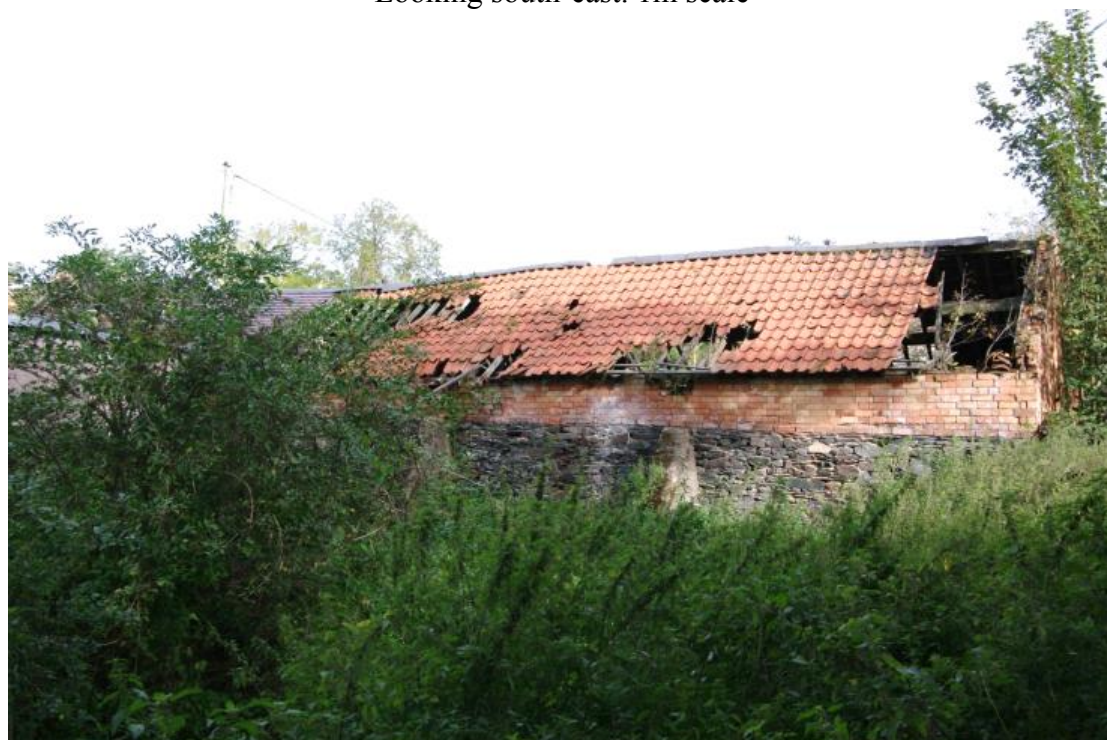
The south facing elevation is also built with a lower half of local stone and an upper half of red bricks with the same three stretchers to one header bond (Fig. 62). Rendered buttresses support the stone portion of the wall to prevent it from falling southwards into the boggy area left by the partially infilled pond shown on the earlier OS maps. On this side of the building the roof covering is divided into pan tiles and Welsh slate.

Figure 62 Building E south facing elevation  
Looking north across infilled pond area

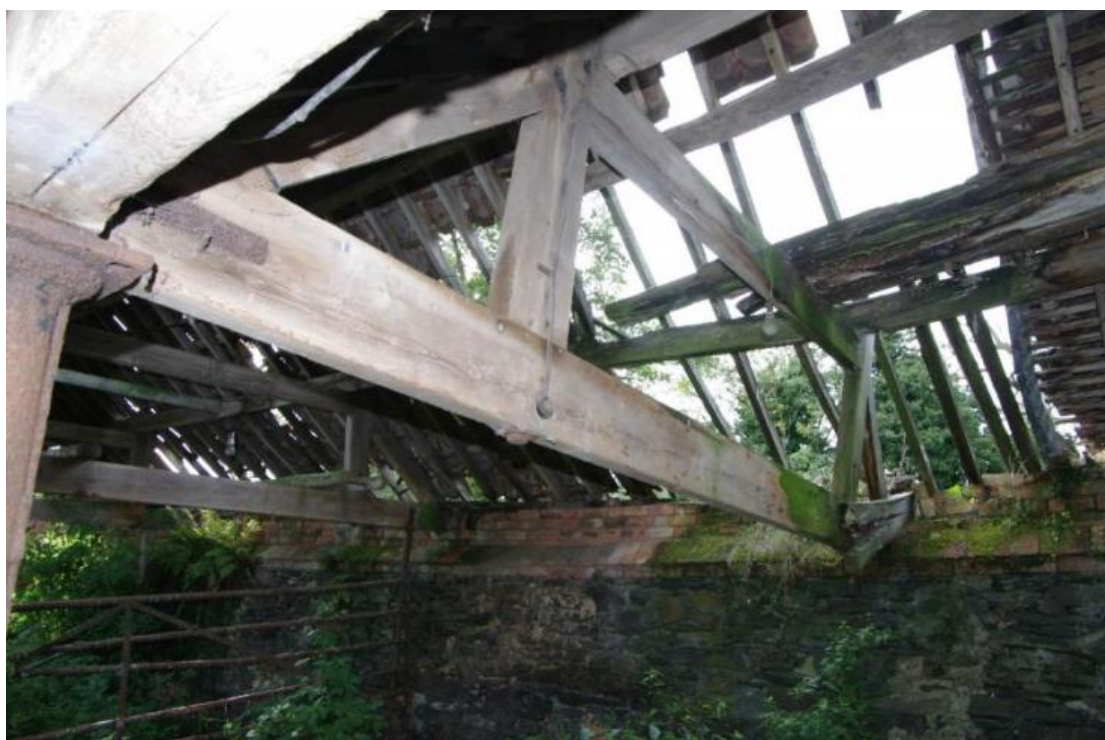
Because the tiles and slates were in a very poor state of repair most of the roof timbers were beginning to collapse (Fig. 63). However it could be seen that the bolted and strapped structure was a typical example of an early 20th century agricultural roof with short queen posts and principal rafters supporting the purlins. A timber lintel or wall plate rests across the cast iron posts to support the north side of the roof.

Figure 63 Building E roof structure  
Looking south-east

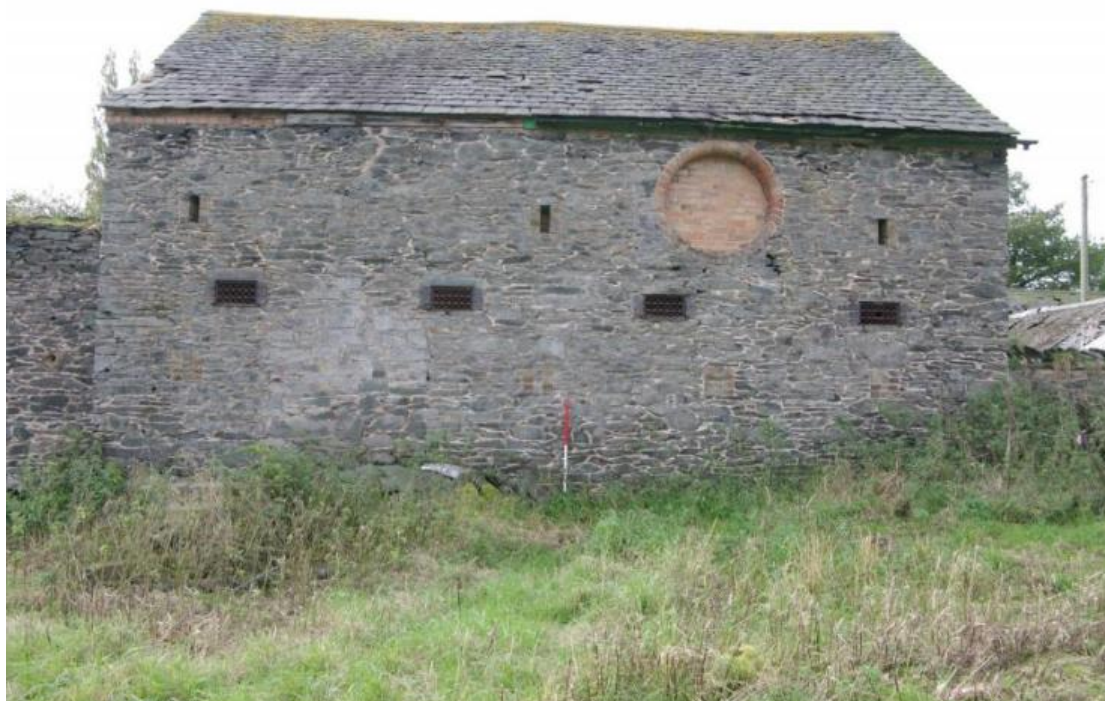
The north-facing elevation faces away from the east yard across an open field towards Markfield Road (Figs 65, 66, 67). There are brick-lined arrow slit vents at both ground and first floor height although those on the ground floor have been blocked with small rectangles of stone. At the top of ground floor height are four larger vents fitted with cast iron grilles and with blue brick sides. All of the vents appear to be part of the original design. A prominent feature of the north-facing elevation is a large circular recess with a moulded brick surround. This off-centre feature is at first floor height and is blocked by red bricks. It is not clear if this was originally a glazed window, a louvered

Figure 66 Building F north-facing elevation  
Looking south. 1m scale. Note blocked vents at ground floor level

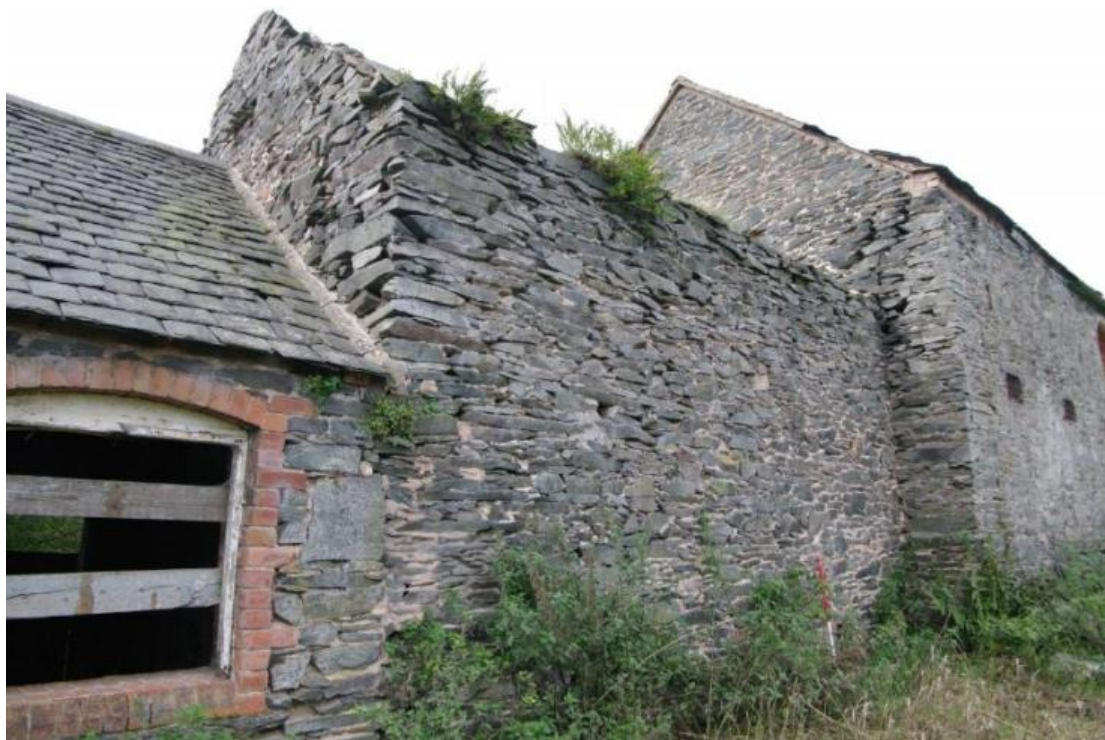
The east-facing elevation is partially obscured by Building G (Fig. 68). Building G is stepped back (southwards) slightly from the north face of Building F and there is a butt joint between both buildings. Building G is only a single storey structure and its roof has collapsed leaving the plasterwork of its gable end visible. There are no openings on the gable end of Building F.

Figure 68 Building F east-facing elevation  
Looking south-west. 1m scale. Building G on left

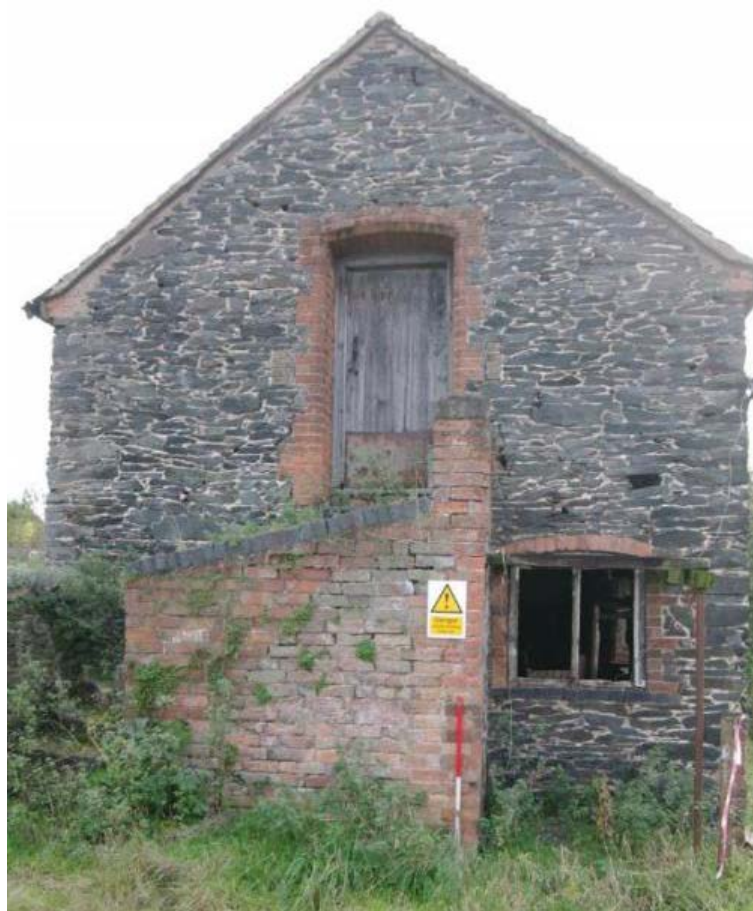
The west facing gable end of Building F has an external set of stone-built steps with a red brick skin leading up to the first floor (Fig. 69). A ground floor window has the same red brick detailing as used around the buildings elsewhere on site. The remains of a wooden window frame survive but nothing else. At first floor level is a single doorway with a chamfered brick surround and a plank door.

Figure 69 Building F west-facing elevation  
Looking west. 1m scale

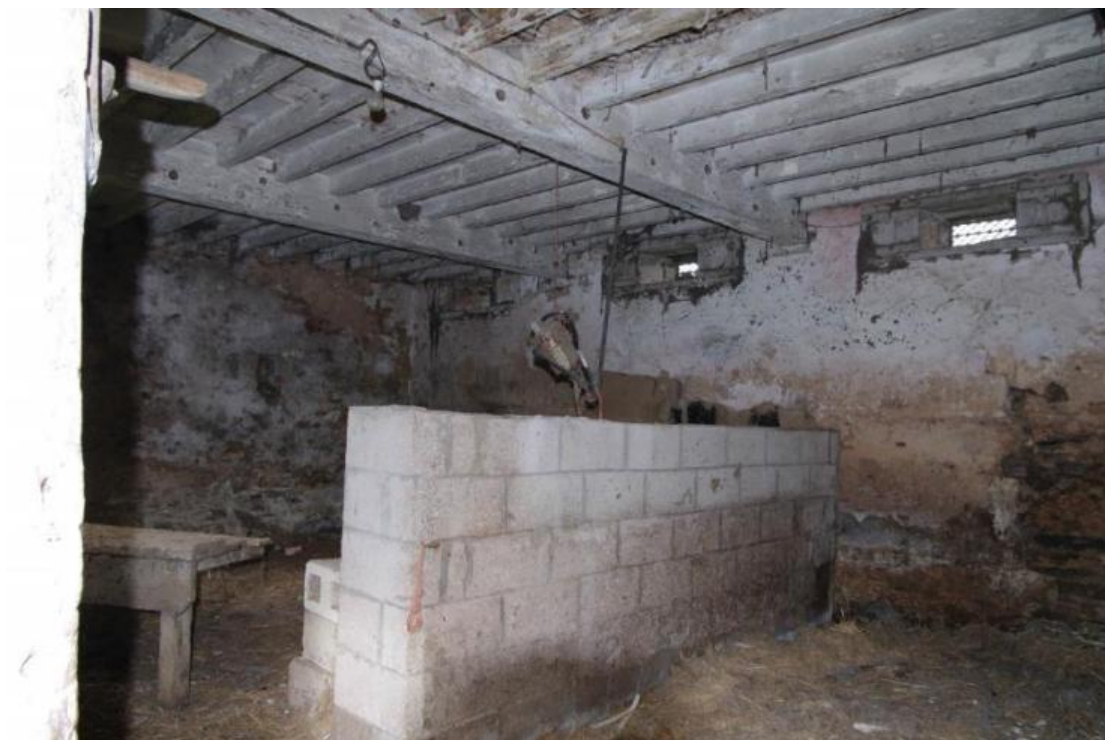
Inside Building F the ground floor room has most recently been used as animal stalls and has a modern breeze block stall wall built in the middle of the room (Fig. 73). Remnants of wall plaster survive in this room. The north wall has small sliding wooden shutters over the cast iron grilles to enable the ventilation to be regulated. A small wooden door on the east wall leads into the adjacent Building G. The first floor of Building F is a single large room with a plaster floor (Fig. 74). The roof structure has a bolted king post and raking struts consistent with a mid to late 19th century agricultural roof. The inside of the recessed circle can be seen and there is no evidence of any window frame within it (Fig. 75). The arrow slit vents also appear to have been blocked.

Figure 73 Building F ground floor  
Looking north-west. Note breeze block stall and wooden shutters on grilles in back wall

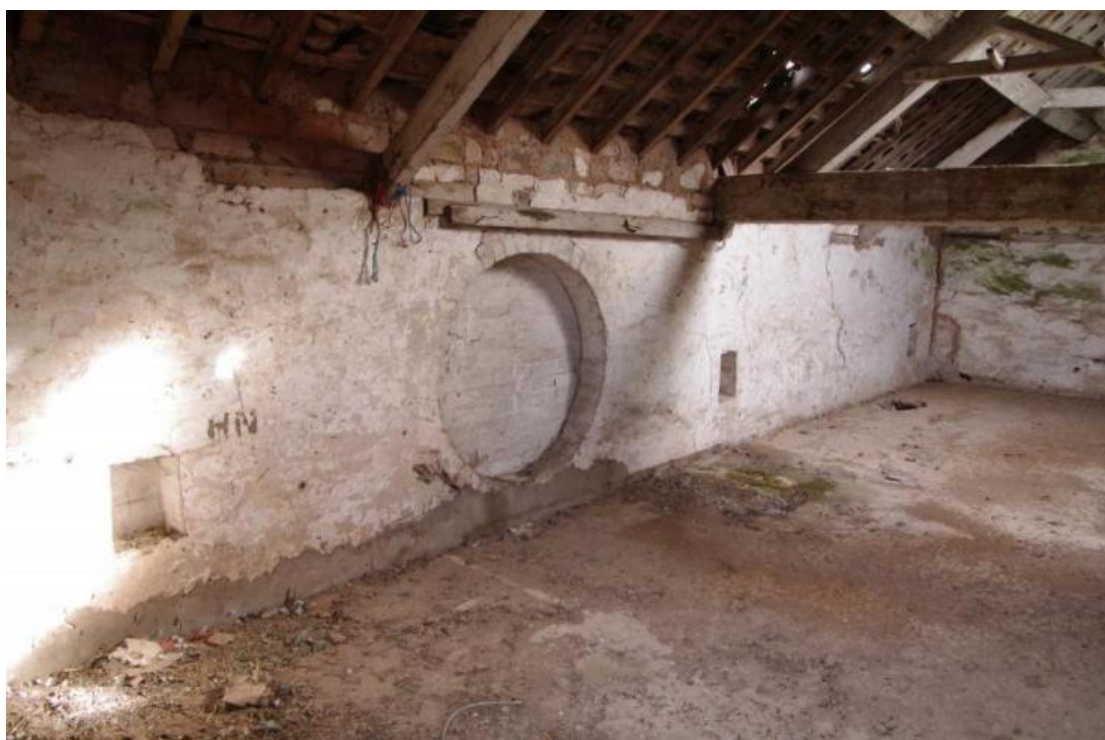
Figure 75 Building F first floor  
Looking north-east

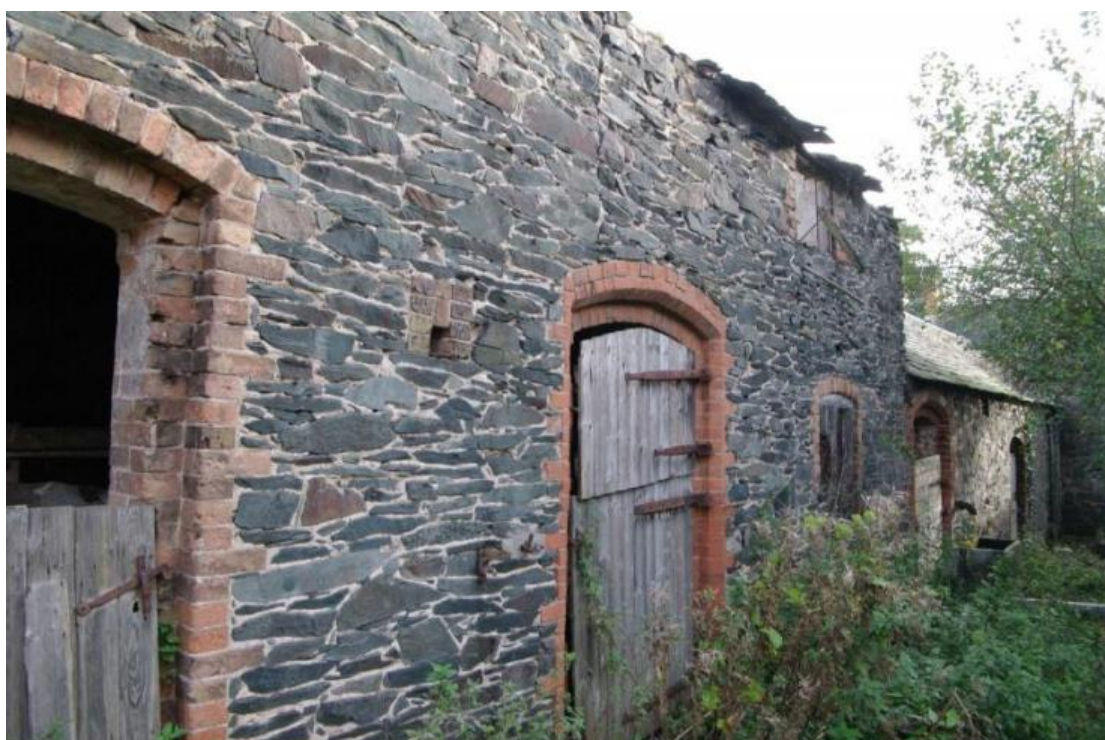
Figure 78 Building G south facing elevation  
Looking north-east. Note joint in stonework above doorway

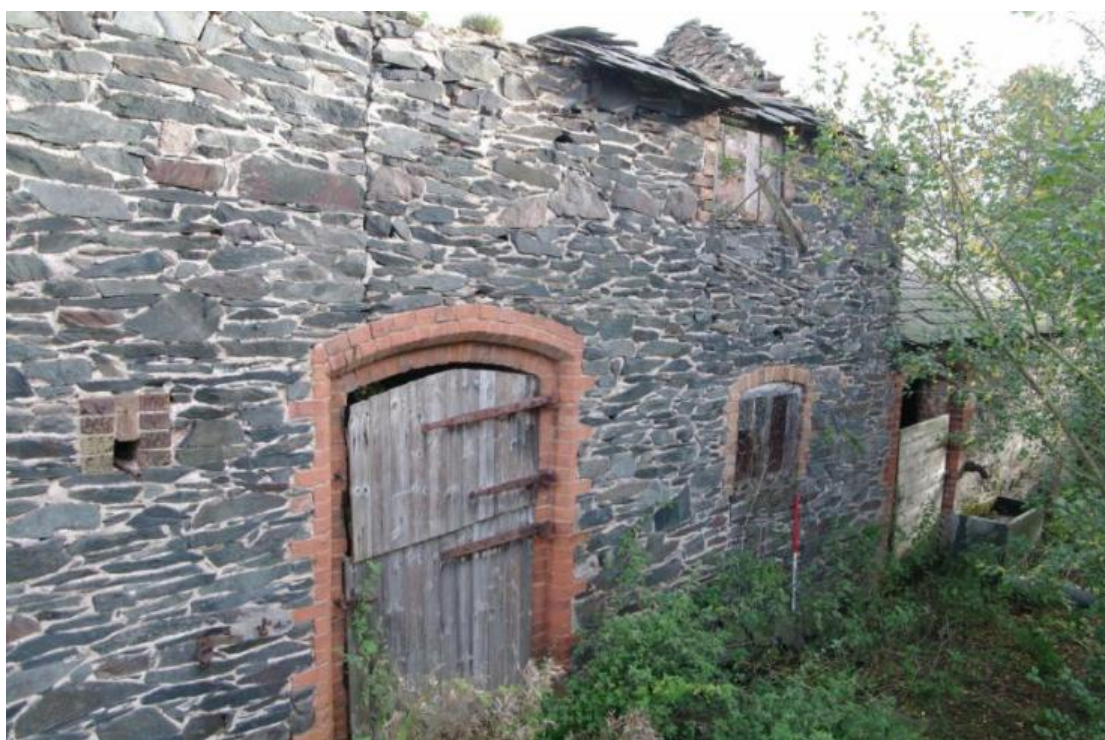
Figure 80 Joint between Buildings F and G on south facing elevation  
Looking north-east. 1m scale

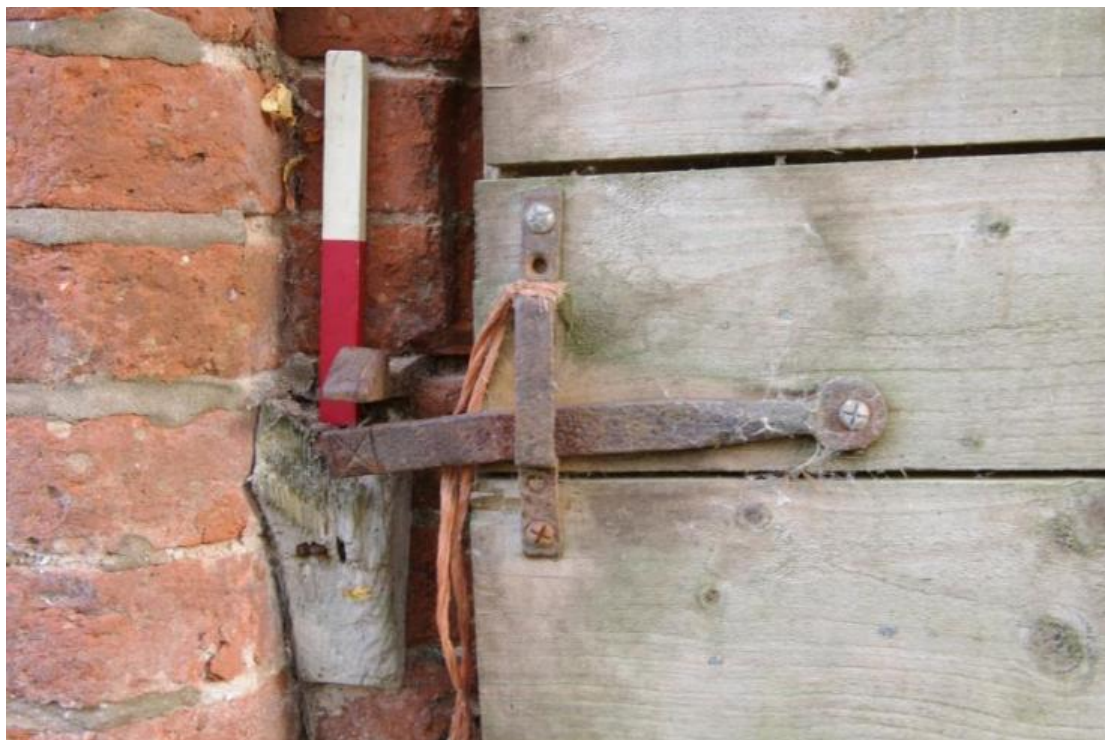
Figure 81 Building G south facing elevation latch detail  
0.2m scale. Note use of modern screw fixings

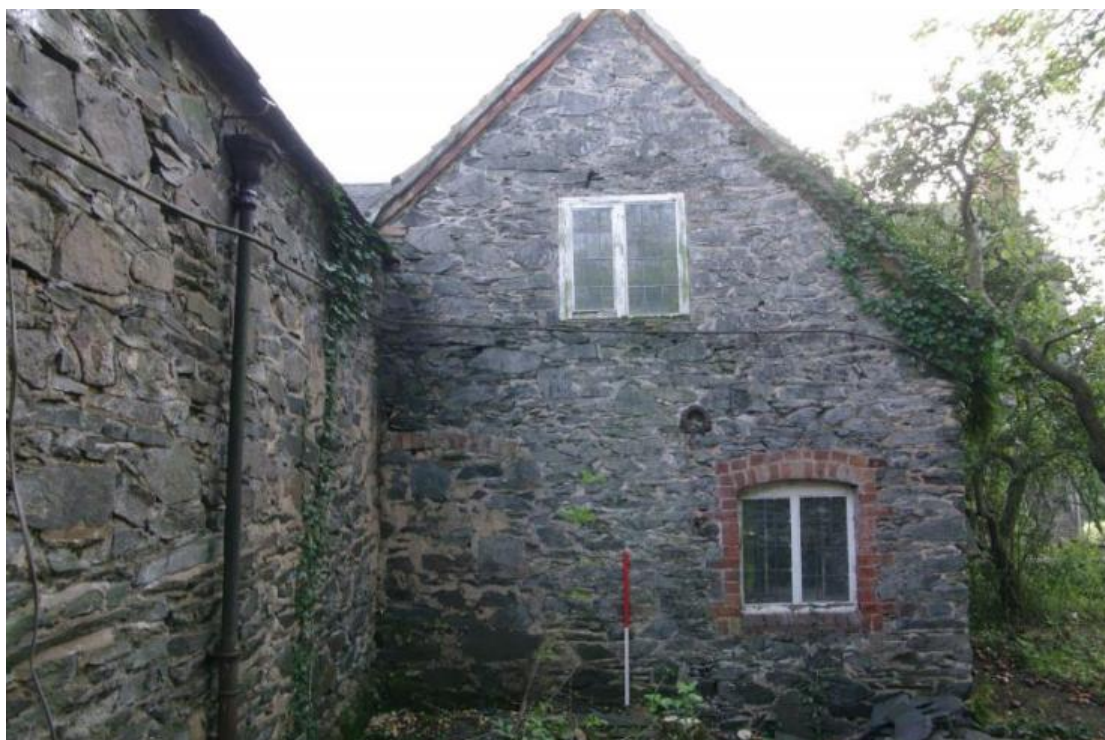
A rear range (Building H) extending from the west side of the main house runs alongside the north extension of the house (Fig. 106). The rear range follows the alignment of the house rather than the north extension and buildings F and G. This building is stone rubble built with a first floor set into the roof space. The south facing elevation steps back to join the east yard buildings which appear to be butted against this building. The window on this extension does not have any brick detailing around it although the doorway does which suggests a midway phase between the building of the house and the rest of the farm complex. A blocked window on the west end gable of this building has been partially obscured by the east yard buildings which wrap around its north-west corner and again suggests an earlier building date for this extension (Fig. 107).

Figure 107 West-facing elevation of buildings attached to rear of main house  
Looking east. 1m scale. Note blocked window to left of scale

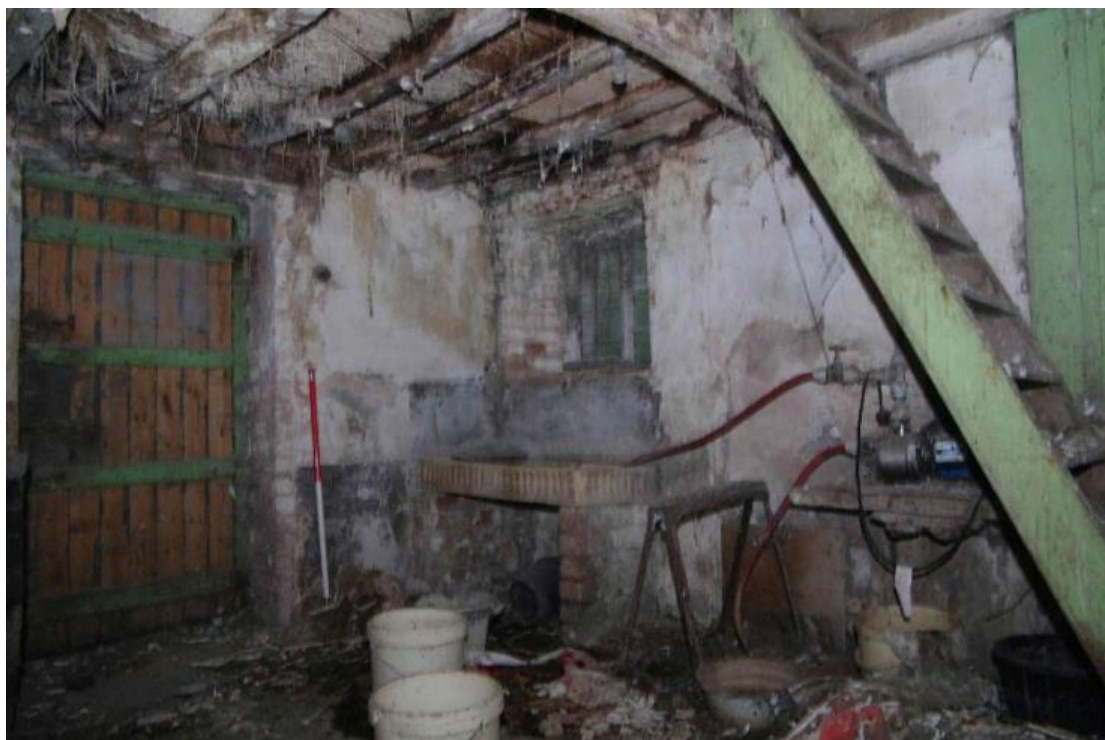
Rooms 1 and 2 are located in the extension to the rear (west) of the main house and are on the same alignment as the house. They appear to have been used as a washhouse and possible kitchen area (Fig. 108). The walls are brick lined with a plaster coating and the room has an outside doorway on the south wall. Internal access is via a short corridor from Room 4. A copper has been built into the south-east corner of the room which uses the chimney for a larger fireplace seen in adjacent Room 2. The blocked window on the west wall mentioned earlier has been turned into a cupboard with doors on. A simple set of plank-built steps leads up to the first floor room (Room 9) which has partially collapsed due to water ingress.

Figure 108 Room 1  
Looking south-west. 1m scale

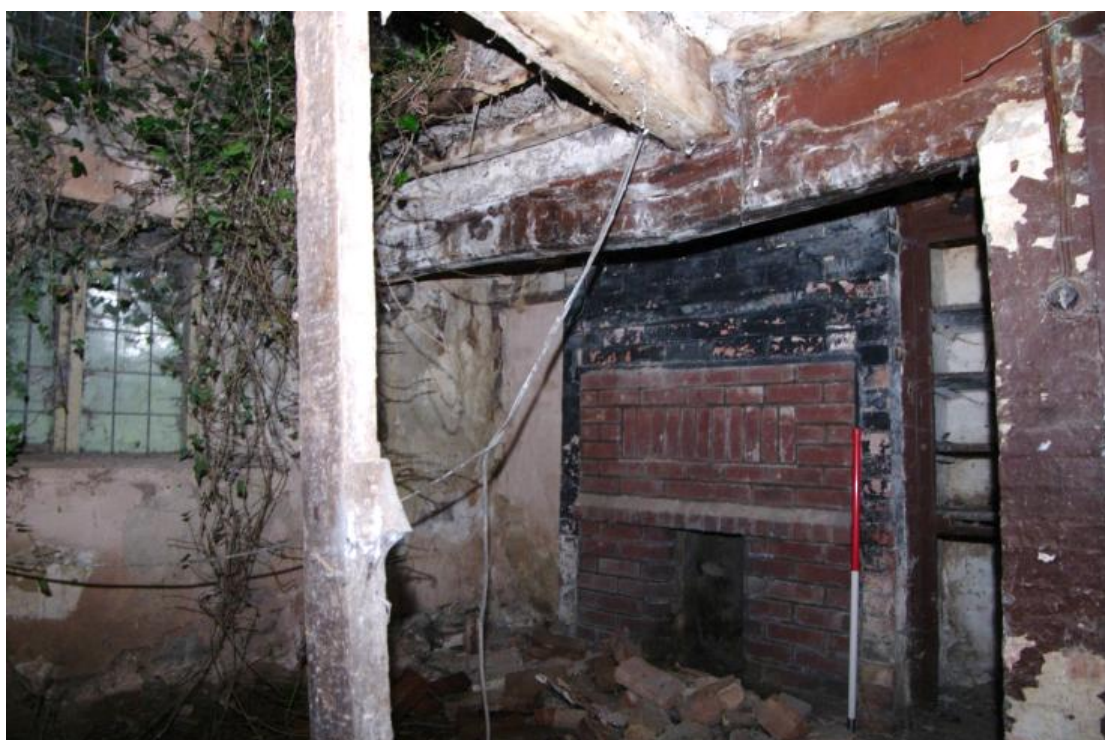
Room 2 has a large bricked-up recess which presumably held a range (Fig. 109). The reed and plaster ceiling is in a very poor state so a close inspection of the room was not possible. A blocked window on the north wall has been made into a cupboard in a similar way to the one seen on Room 1. This is likely to be a window which has been blocked by the building of the east to west range of buildings along the east yard (Fig. 110). At the east side of the room is a narrow corridor which used to lead into the rear of the house but has now been blocked. Following the construction of the east west range the entrance into the house is now through Rooms 4 and 5.

Figure 109 Room 2 fireplace  
Looking south-west. 1m scale

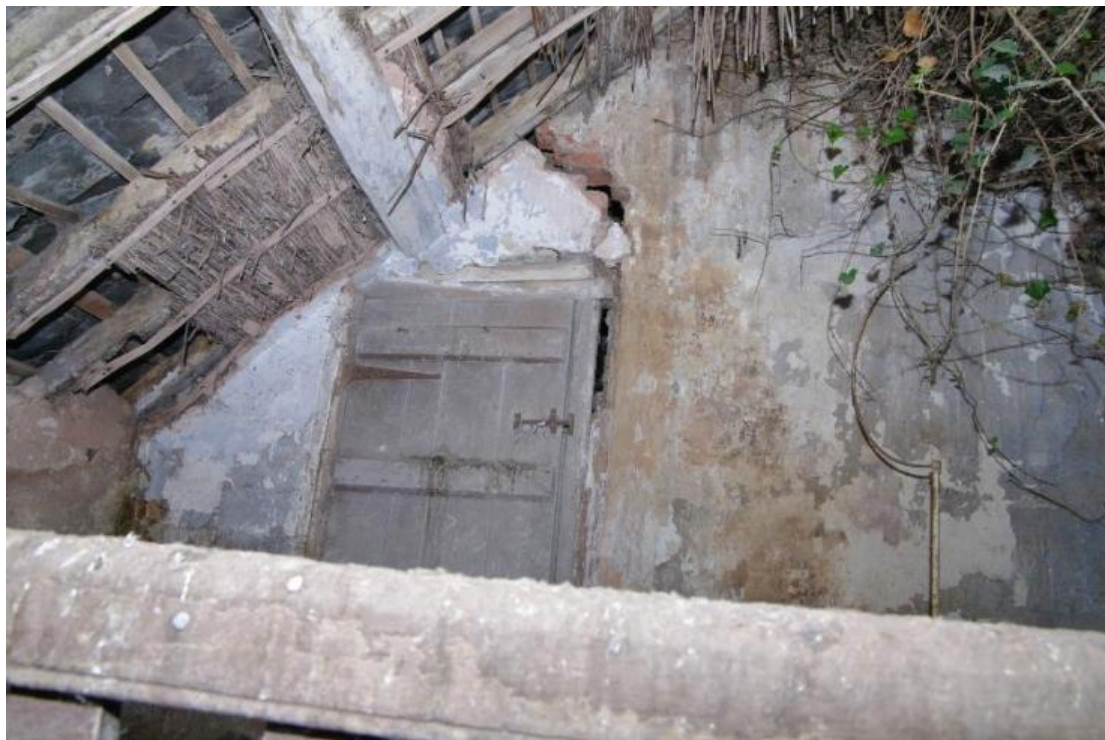
Room 9 is located above Room 1 and is reached via a set of narrow plank steps. The partially collapsed roof has damaged the floor making inspection dangerous. A plank door can be seen leading into another collapsed room (Room 10) above Room 2 (Fig. 124). The floor appears to be made from reeds and plaster.

Figure 124 First floor Room 9  
Viewed from steps looking east towards door leading to adjacent first floor Room 10
