**A Level 3 Historic Building Survey at  
Home Farm,  
Markfield Road,  
Groby,  
Leicestershire**

**NGR: SK 51099 08227**

ULAS Report No. 2018-014  
©2018

**For: Cawrey Limited**

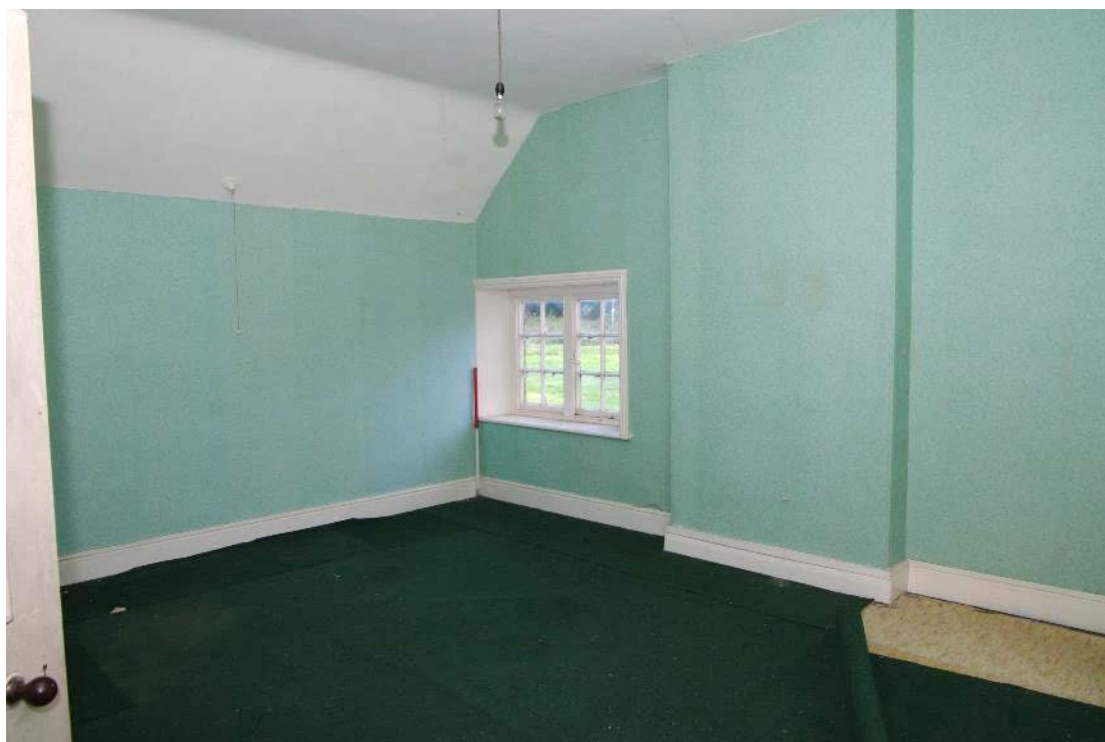
This room has a noticeably skewed south wall which is created by the different alignments of the house, rear extension and this extension. It is reached by three steps up from the rear landing and has two casement windows and a blocked fireplace (Fig. 127). The room has a low moulded skirting board. A four-panelled door with a steel lock plate is of later 19th-century design.

Figure 127 Room 11  
Looking north-west. 1m scale

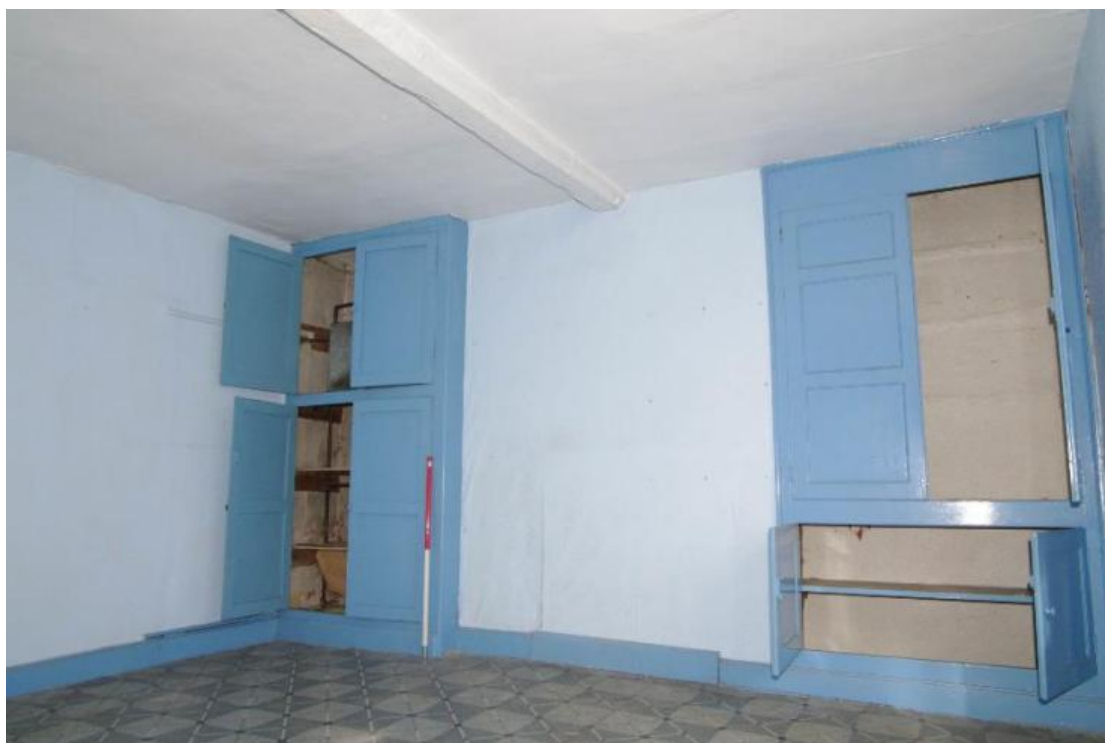
Room 13 has fitted cupboards either side of the chimney breast similar in style to those in Room 7 on the ground floor (Figs 128 and 129). The fireplace is blocked but marks on the wall show where it was located. The doorway to the central landing has a six-panelled door as used on the downstairs room. A blocked doorway on the west wall once led to the rear landing but only a recess in the landing wall remains. As with the ground floor west wall this wall is unusually thick for no clear reason. The ceiling is supported by a chamfered beam with an ogee stop chamfer very similar to that in Room 7 (Fig. 130). Beneath the linoleum appear to be wooden floorboards. The wooden casement windows have leaded panes.

Figure 128 Room 13  
Looking north-west. 1m scale

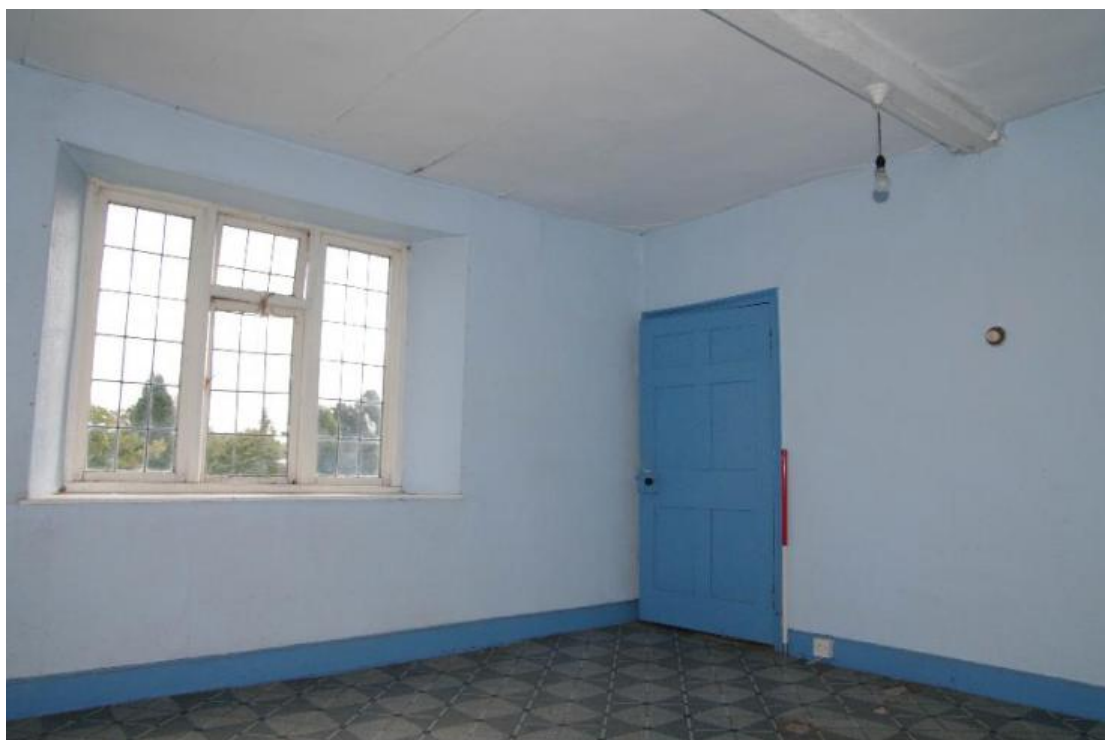
Figure 129 Room 13  
Looking south-east. 1m scale

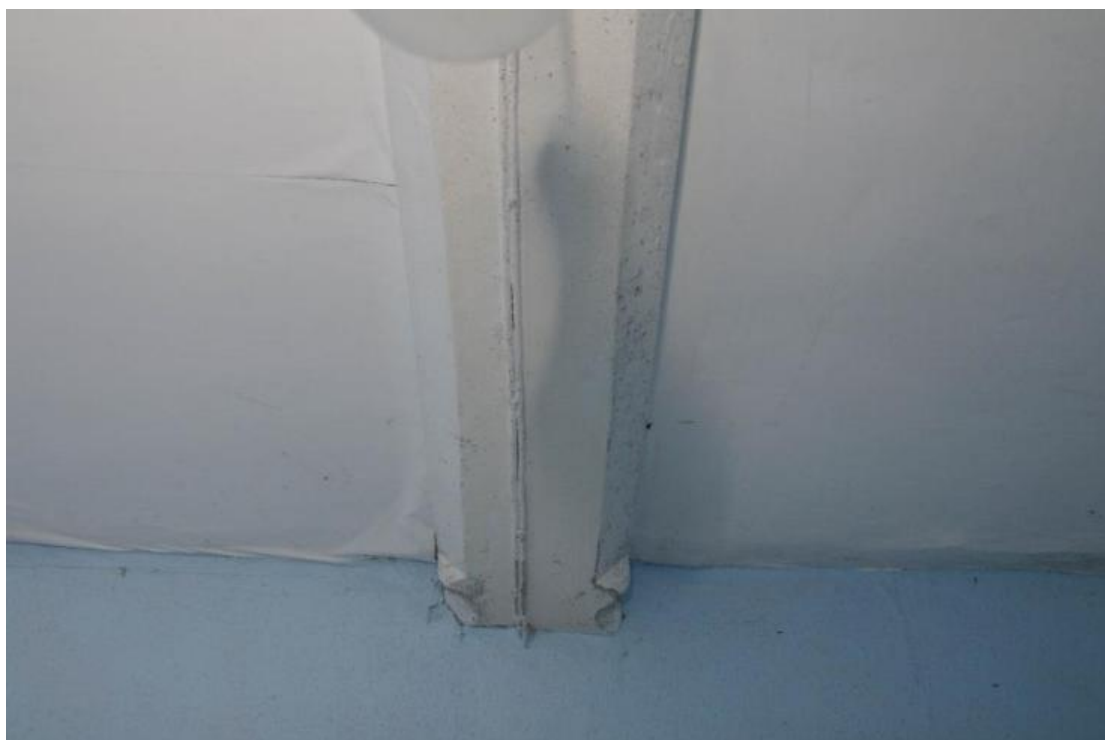
Figure 130 Room 13 chamfered beam

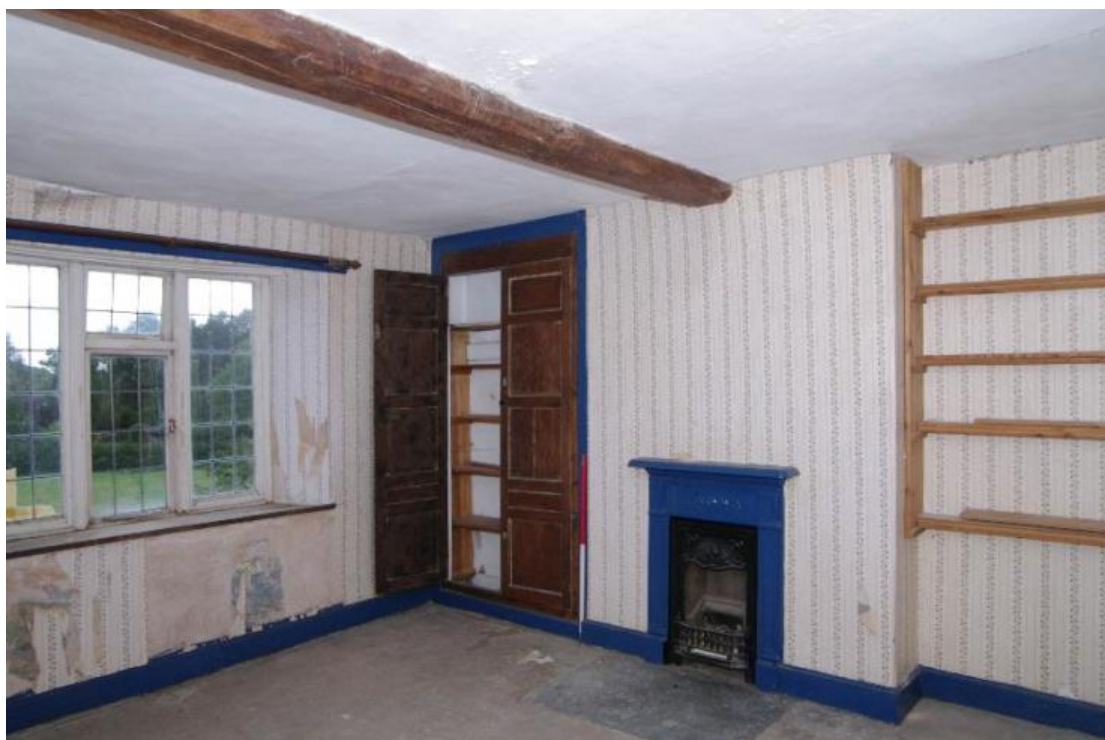
This room also has fitted 19th-century cupboards to the side of the chimney breast although the doors on the west side have been removed (Figs 131 and 132). The fireplace is still in place and has a mid to late 19th-century style surround and hearth. The door to the landing is the same six-panelled door as in Room 13. The north to south beam in the ceiling has a chamfer but in this case the stop is in the form of a small pyramid very reminiscent of 16th-century stop chamfer ends (Fig. 133). Unlike the

Figure 131 Room 14  
Looking south-west. 1m scale

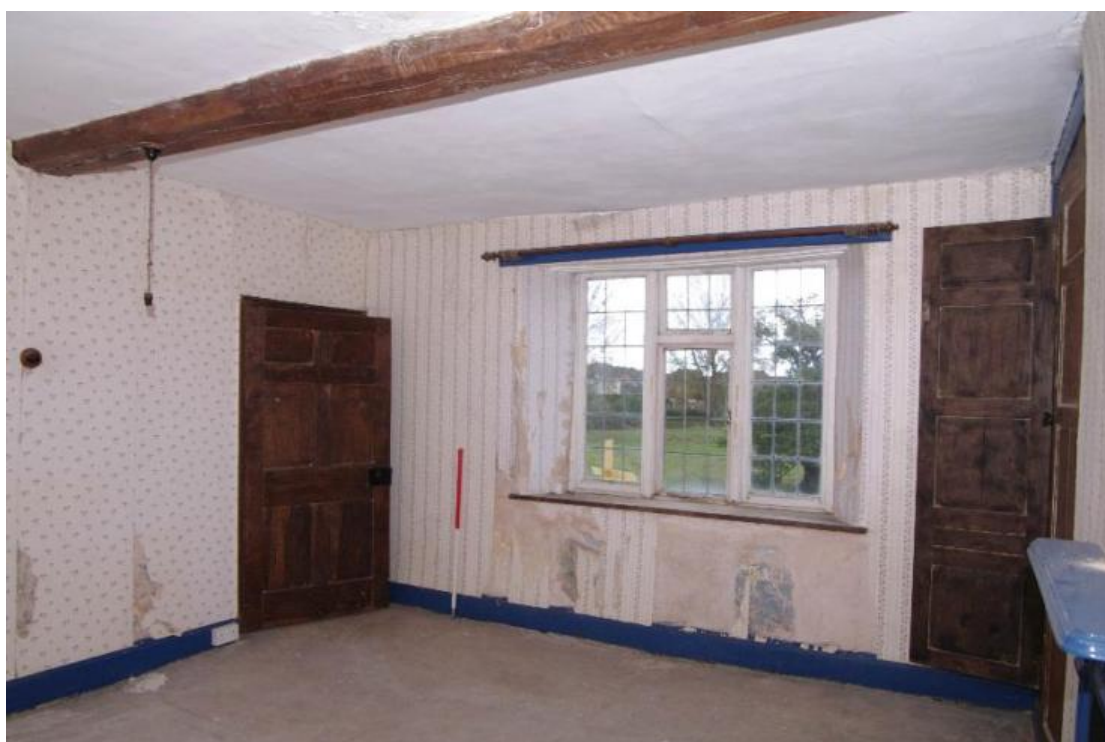
Figure 132 Room 14  
Looking north-east. 1m scale

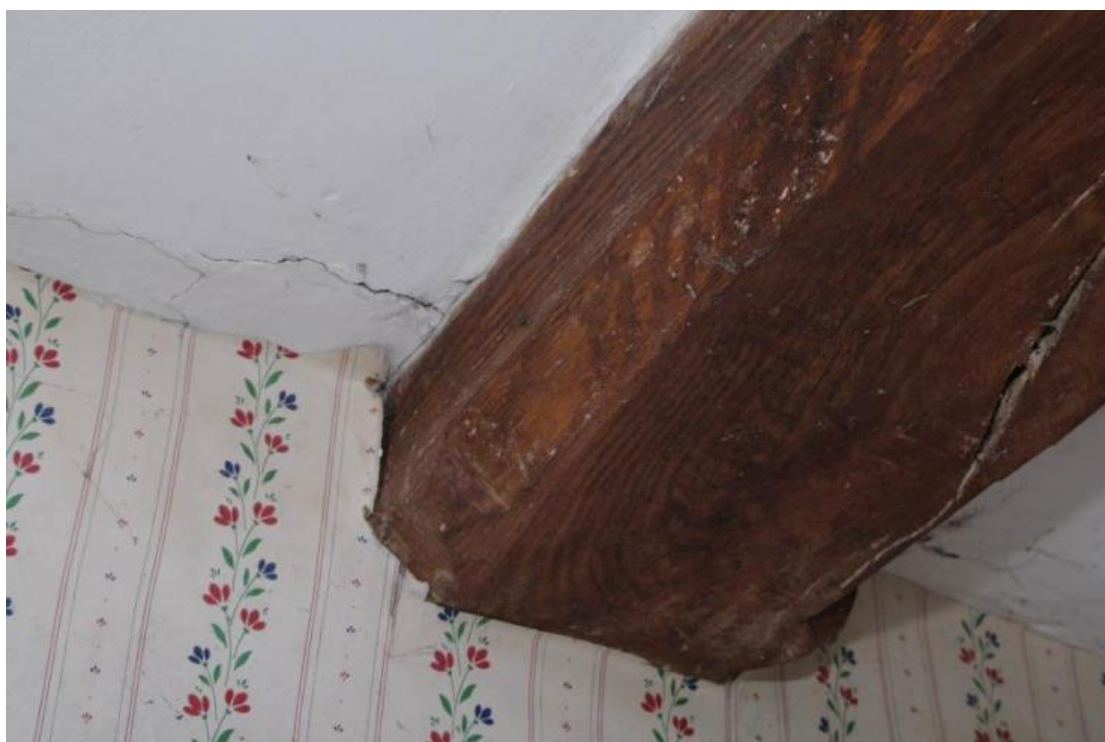
Figure 133 Room 14 stops on beam

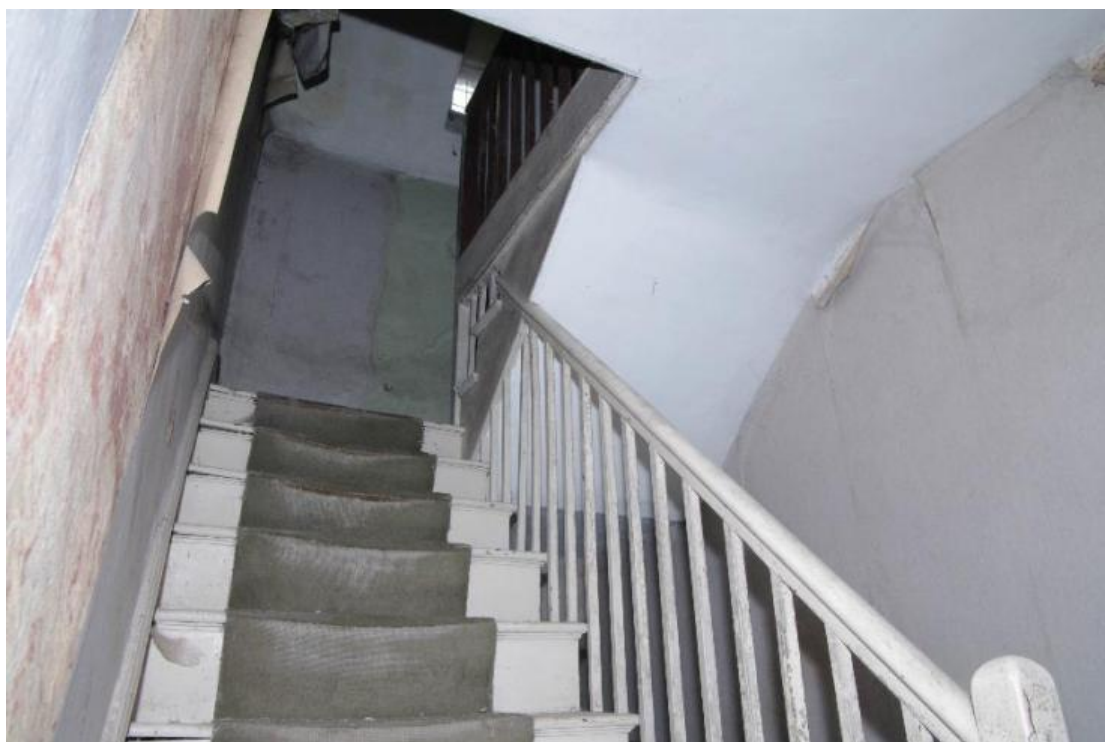
The attic rooms are reached via a flight of stairs leading up from the original landing (Fig. 134 also see Figure 97 for floor plan). The handrails are quite plain but have not been updated to the 1930s style as the ground floor stairs have. The stairs follow the same pattern of turning back on themselves at a short landing. The lower quality of the attic rooms suggests that this area was intended for domestic staff or perhaps for younger members of the family. The main landing has a linen cupboard with doors (Fig. 135). A small dormer window on the west side of the roof allows a little light onto the stairs.

Figure 134 Stairs to attic rooms  
Looking west from first floor landing

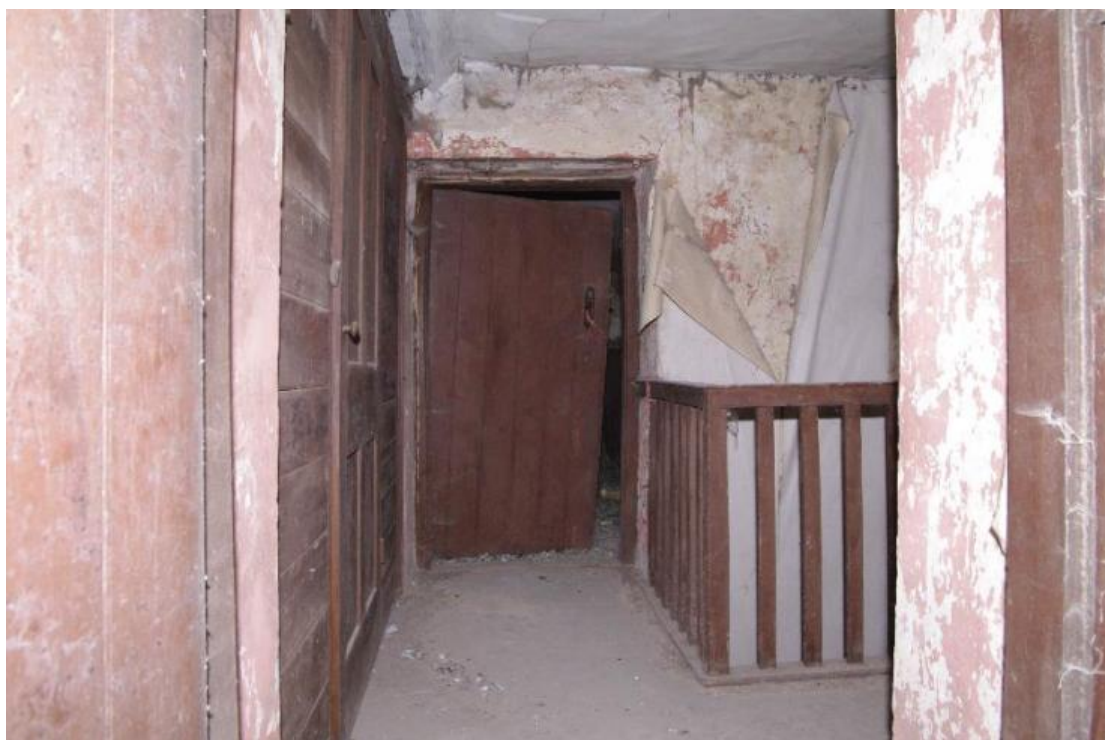
Figure 135 Attic landing  
Looking south towards Room 16. Linen cupboard on left

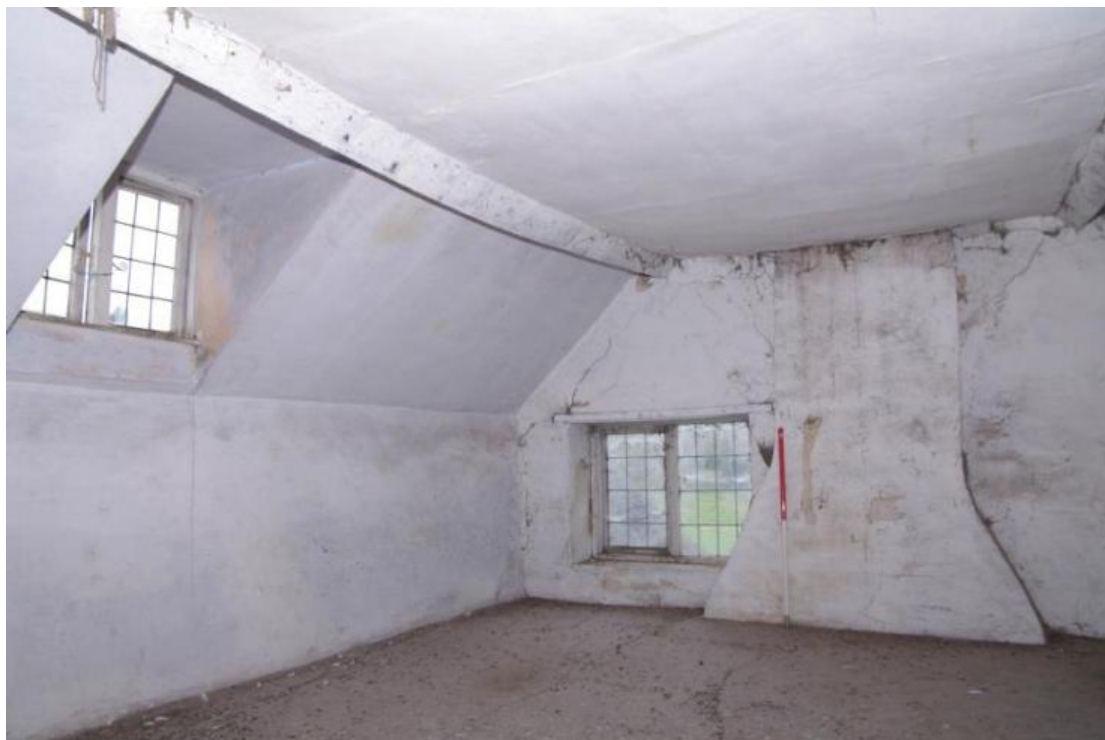
Room 15 on the northern side of the attic has small dormer windows on the west side and a small casement window on the gable end to the side of the chimney breast (Fig. 136). The purlins are partially squared off but the rafters have been covered with lath and plaster. There are no other visible constructional details of the roof and there are no trusses supporting the roof. The door to the landing is a crude plank-built structure with a wooden lock case (Fig. 137). The plaster floor is cracked and sagging but is generally sound.

Figure 136 Attic Room 15  
Looking north-west. 1m scale

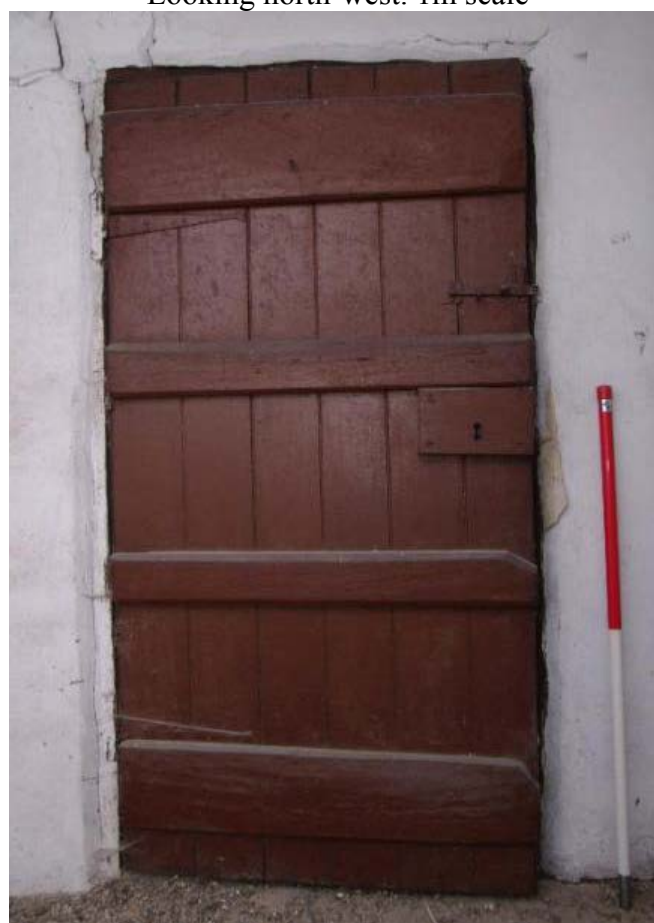
Figure 137 Attic Room 15 door detail  
Looking south. 1m scale

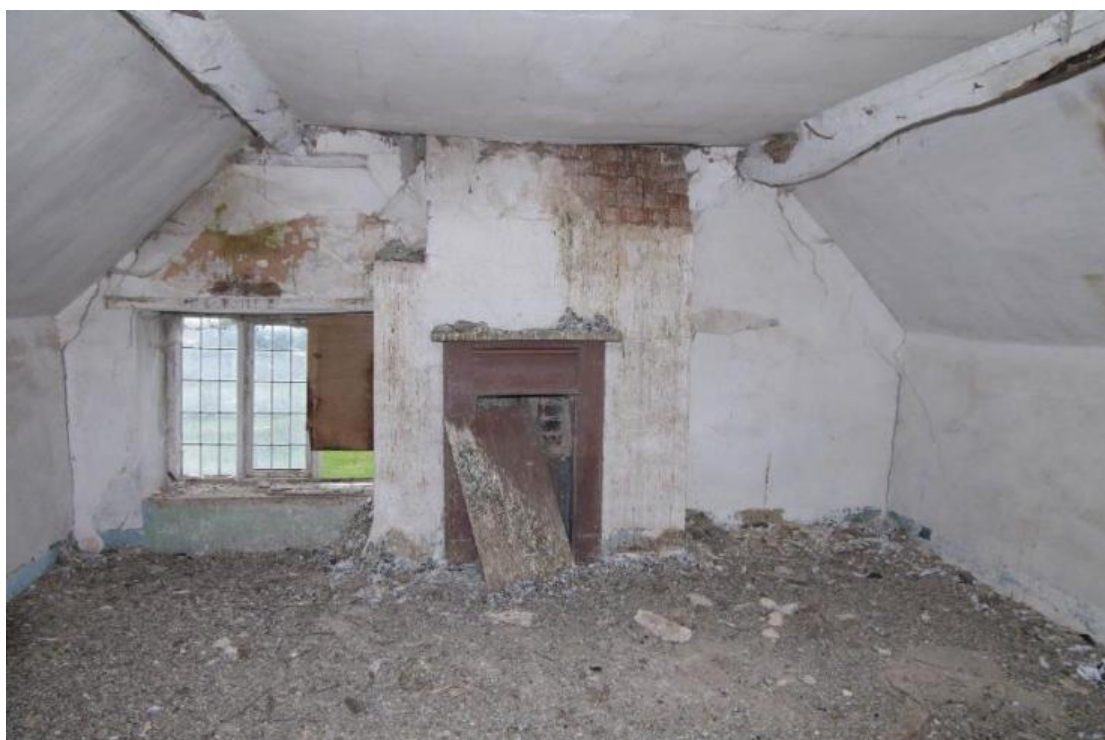
Room 16, at the southern end of the attic, matches Room 15 but this room has a small fireplace (Fig. 138). Thick deposits of pigeon droppings meant that this room was not entered during the survey.

Figure 138 Attic Room 16  
Looking south

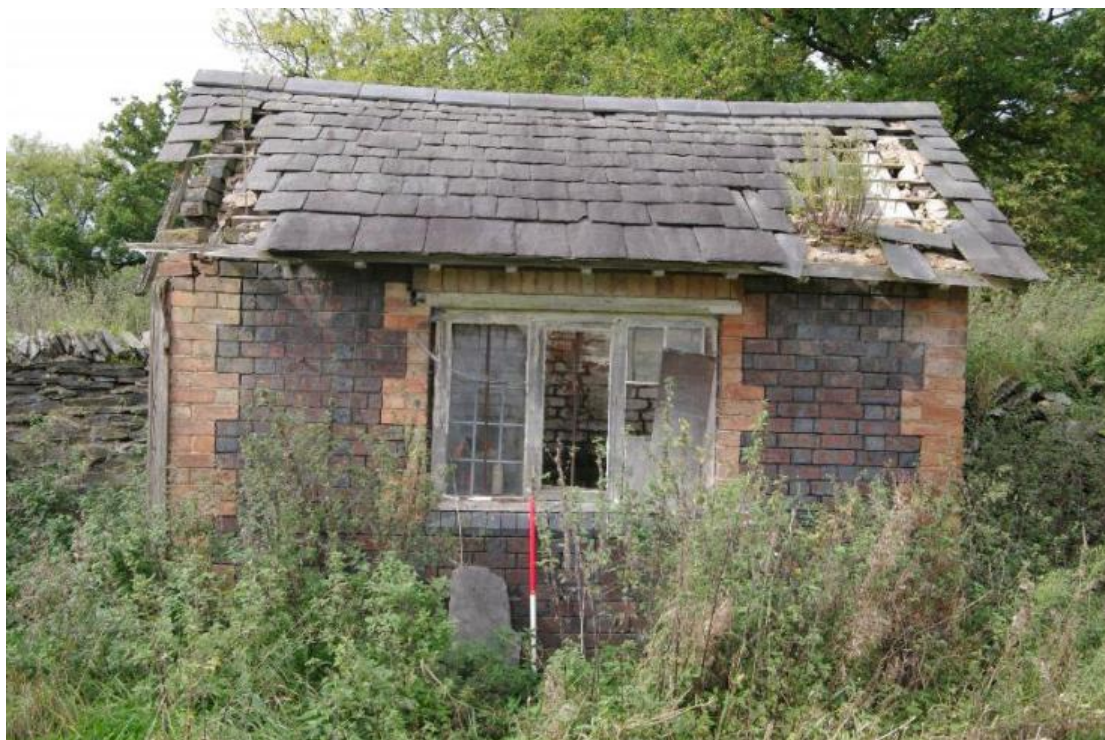
This is a small structure built of blue bricks with red brick detailing around the windows and quoins. It has a local slate roof (Figs 139 and 140). A wooden-framed window with a horizontal sliding sash is located on the east-facing elevation which presumably looked out onto the weighing equipment. No trace of any such equipment survives. On the south-facing elevation is a plank-built door which leads into the single room. Very little survives inside the building although a light switch indicates that it had power and must have been in use well into the 20th century. A row of partially broken open-fronted boxes are located beneath the window and may be associated with its use as a weighbridge (Fig. 141). The roof structure consists of common rafters which project beyond the eaves to create a decorative effect.

The general style of the weighbridge and the use of blue bricks rather than local stone suggests a late 19th-century construction date rather than 1850s or earlier. This late date would post date the quarry. Local historian David Ramsey has suggested that the Ellis Family, who took over the Groby and Swithland quarries in the 1860s, may have been responsible for building a replacement weighbridge when they took over. An original weighbridge for the adjacent quarry may well have been derelict by this date. This is probably true although the architectural style suggests that they may well have delayed erecting the building for 30 or so years.

Figure 139 Weighbridge east-facing elevation  
Looking west. 1m scale

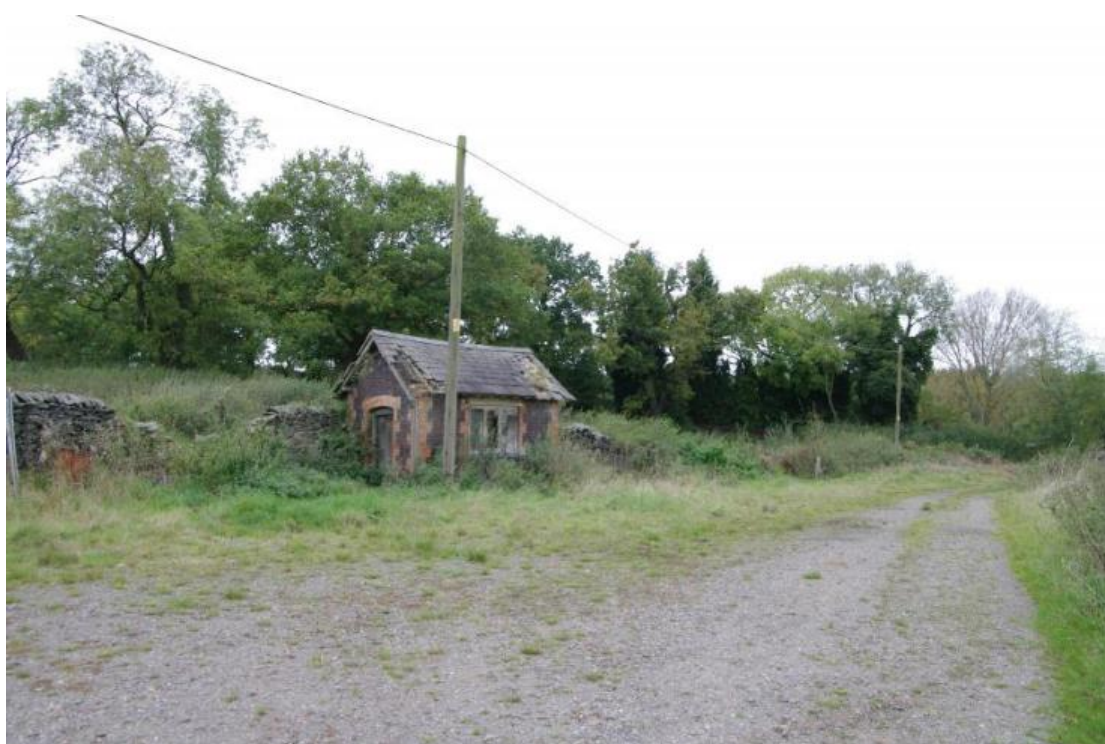
Figure 140 Weighbridge  
Looking north-west along track to Markfield Road. Entrance to quarry to right of building

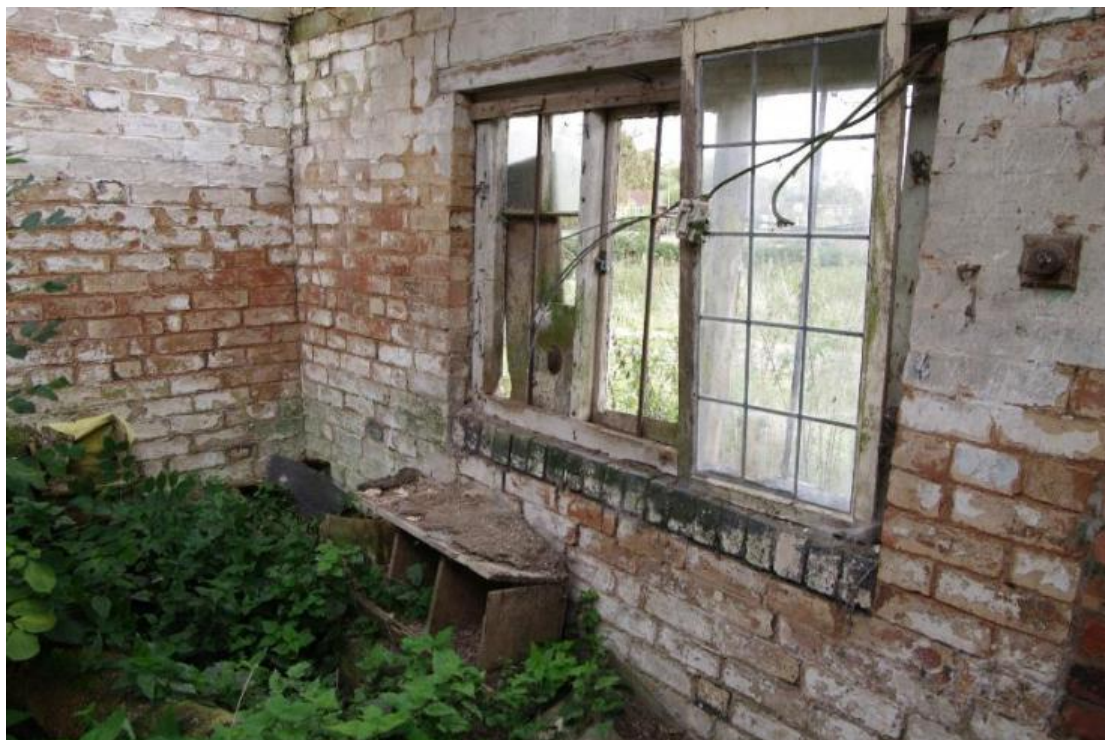
Figure 141 Inside the weighbridge  
Looking north-east
