**A Level 3 Historic Building Survey at  
The Rose and Crown,  
Tilton on the Hill,  
Leicestershire**

**NGR: SK74292 05655**

ULAS Report No. 2018-024  
©2018

**For: D W Hicks Building Co**

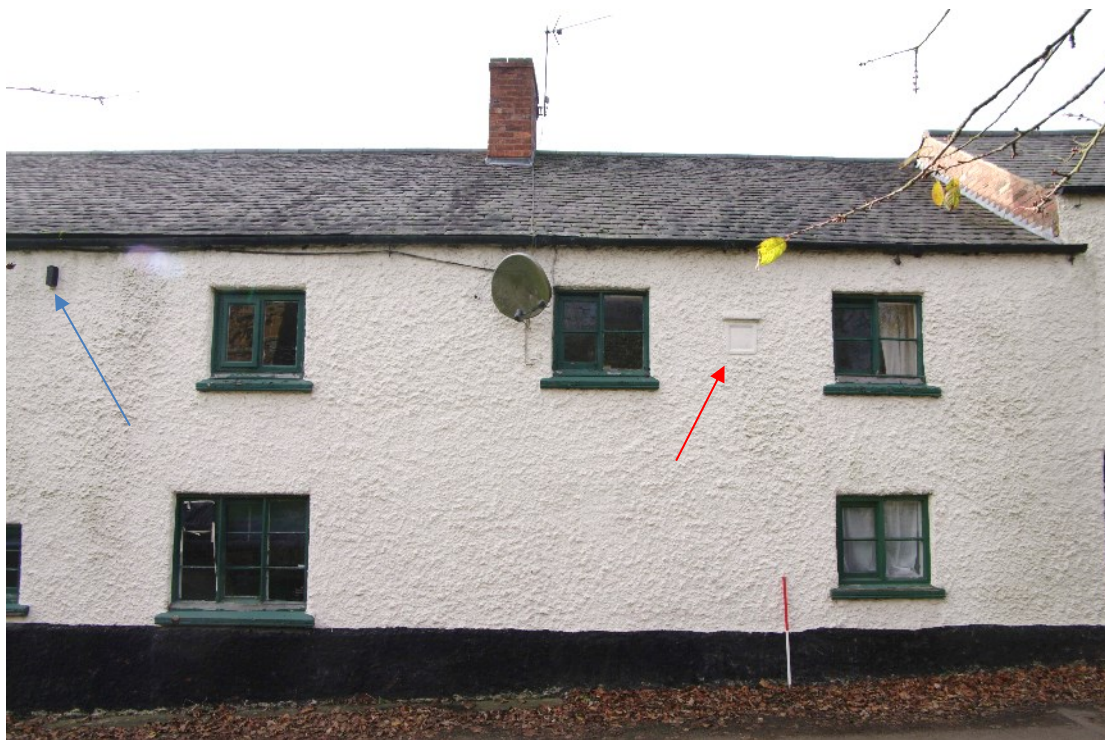
The east facing elevation of the Rose and Crown has been covered with a coating of pebble-dash and render which effectively obscures any joints or modifications to windows and doors (Figs. 14 to 17 and Appendix 1 elevation drawings). From the outside it is not even clear if the walls are of brick or stone although internal inspection shows that the north and south parts of the building are definitely built from stone and that the wall thickness of the centre section is indicative of stone walls. The road drops down to the south by around 2 metres although the ridgeline of the main range only steps up towards its northern end. Where the ridgeline steps up the angle of the building also changes slightly to follow the alignment of the road. Photographs taken of the site in the mid-1950s show that a similarly sized building, but with a lower ridge height, continued from the northern end of the present buildings to the corner of Main Street. The photographs cannot be shown in this report for copyright reasons. This building is also shown as still being present on the 1959 Ordnance Survey map. The photograph shows that there were no windows on the eastern side of the now demolished building. It also indicates that there was a large Rose and Crown pub sign projecting out over the road. A short timber beam still remains embedded in the wall and is shown in Figures 15 and 16.

A small rectangular stone plaque is located between the northernmost first-floor windows which gives the date of 1707 beneath the initials A over a T and B (Figs 16 and 20). The date may relate to a rebuilding or refurbishment date for reasons which are discussed later on in this report.

Figure 16 East-facing elevation, north side of front door  
Looking west. 1m scale. Projecting beam (blue arrow), date stone (red arrow)

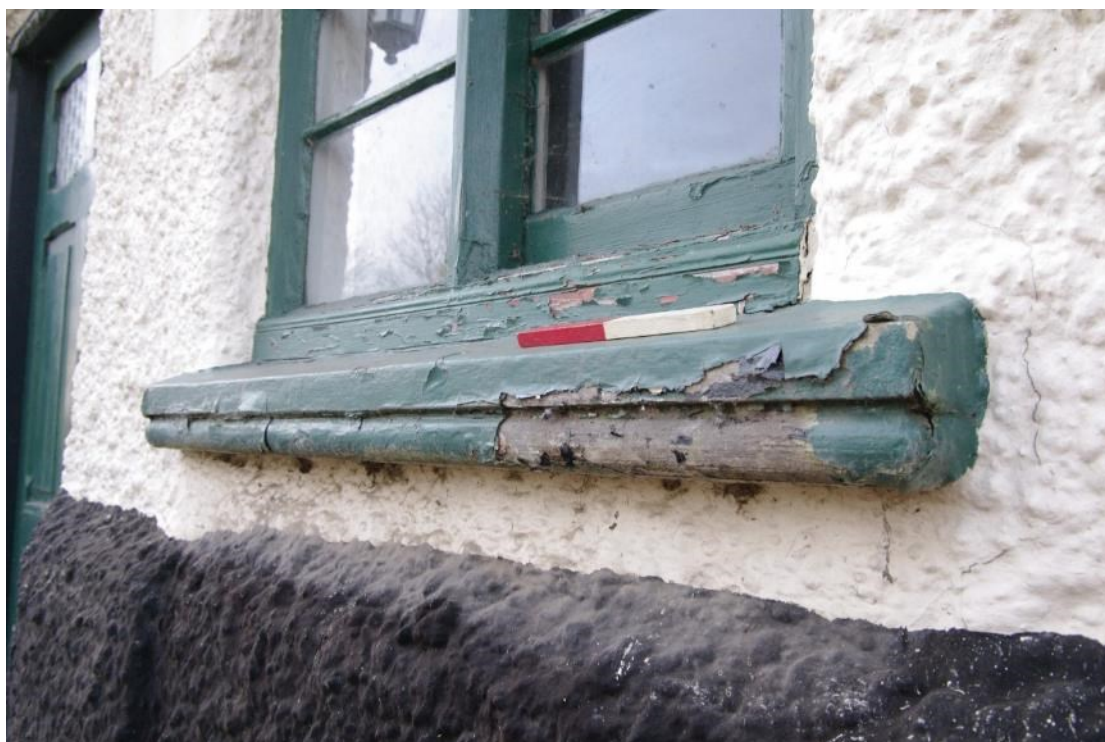
The windows on the east-facing elevation are placed at irregular intervals at both ground and first-floor levels which may suggest that the building was not constructed in a single phase. Although heavily coated in many layers of paint it can be seen that a number of windows have moulded timber sills whilst others are made from moulded stone (Fig. 18). Both timber and stone sills have a very similar style which might indicate that one material is trying to copy the other and may represent an effort to

Figure 18 East-facing elevation, stone window sill  
Looking south-west. 0.2m scale. Front door to left of window

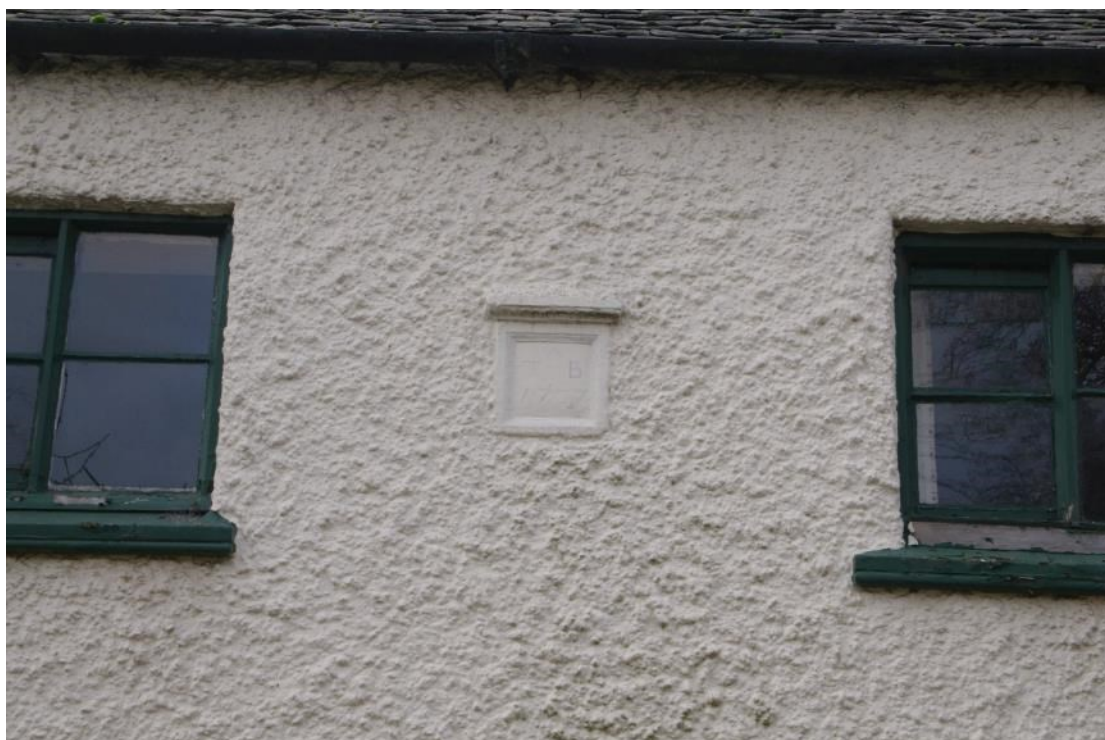
Figure 20 East-facing elevation, date stone  
Located at first floor level. Plaque: *A TB 1707*

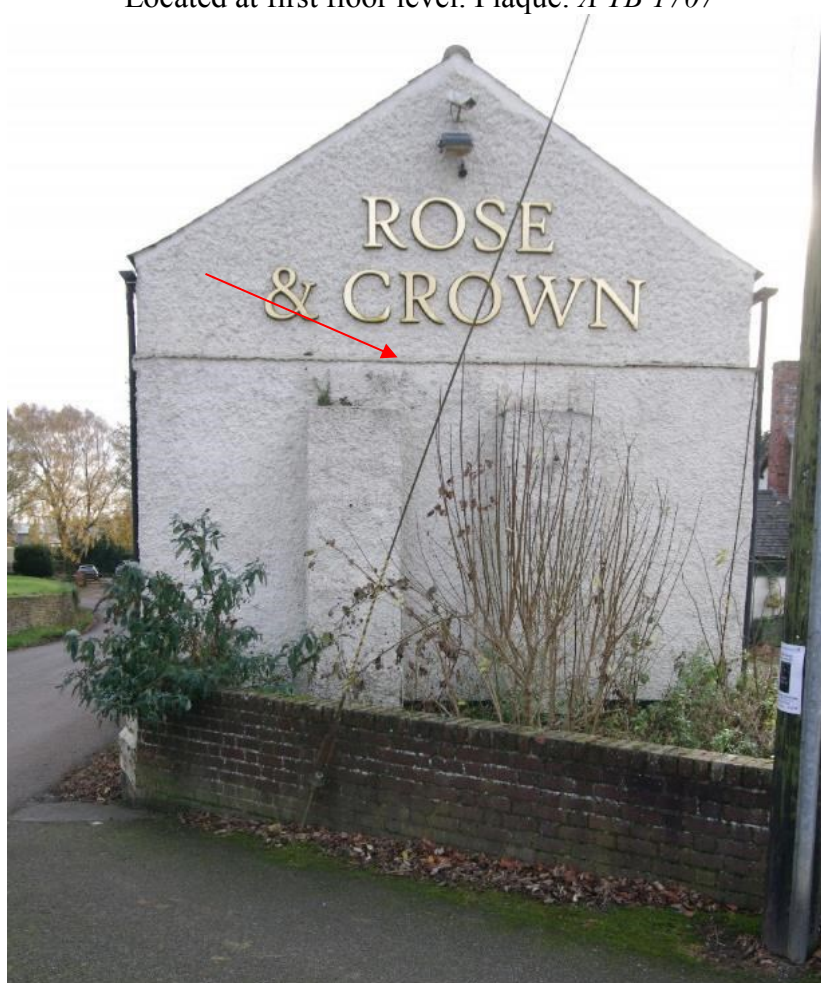
The truncated end of the principal range along Main Street has a blank north-facing gable end with two supporting buttresses added in place of the now demolished end building (Fig. 21). The lower part of the wall is thicker and has a ledge capped with small roof tiles showing where the now demolished north building was attached. The fact that the wall is thicker and that buttresses have had to be added suggests that the missing building was of a similar phase to the remaining building to which it was attached.

Figure 21 North-facing gable end of principal range  
Looking south. Main Street on left. Note scar (arrowed) left by demolished building

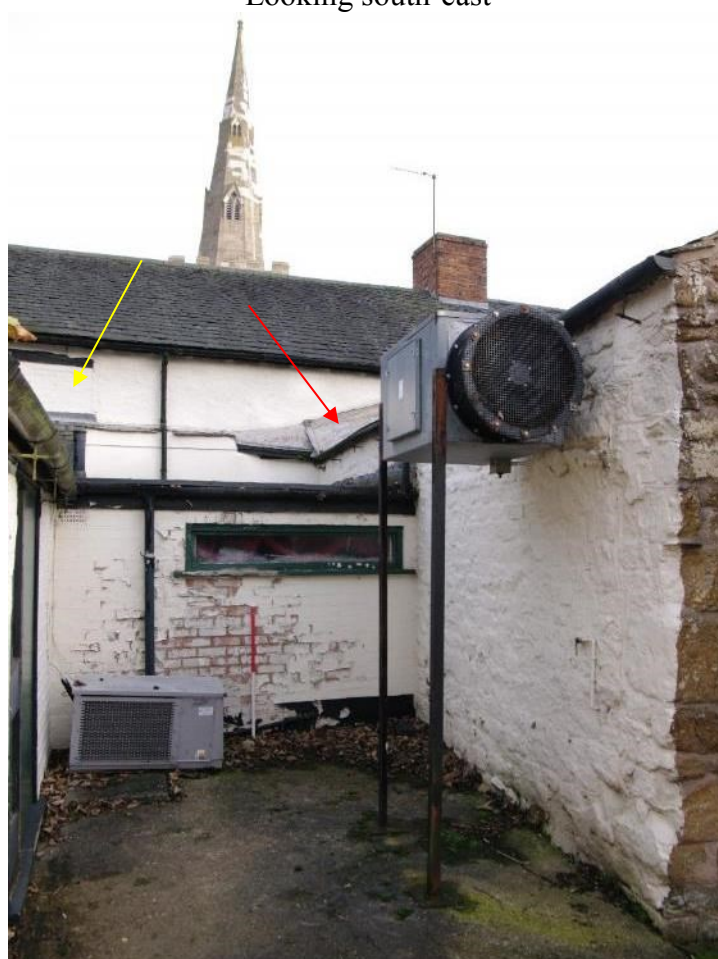
Figure 27 West-facing elevation between both east to west ranges  
Looking east. 1m scale. Blocked window (yellow) and structural timbers (red)

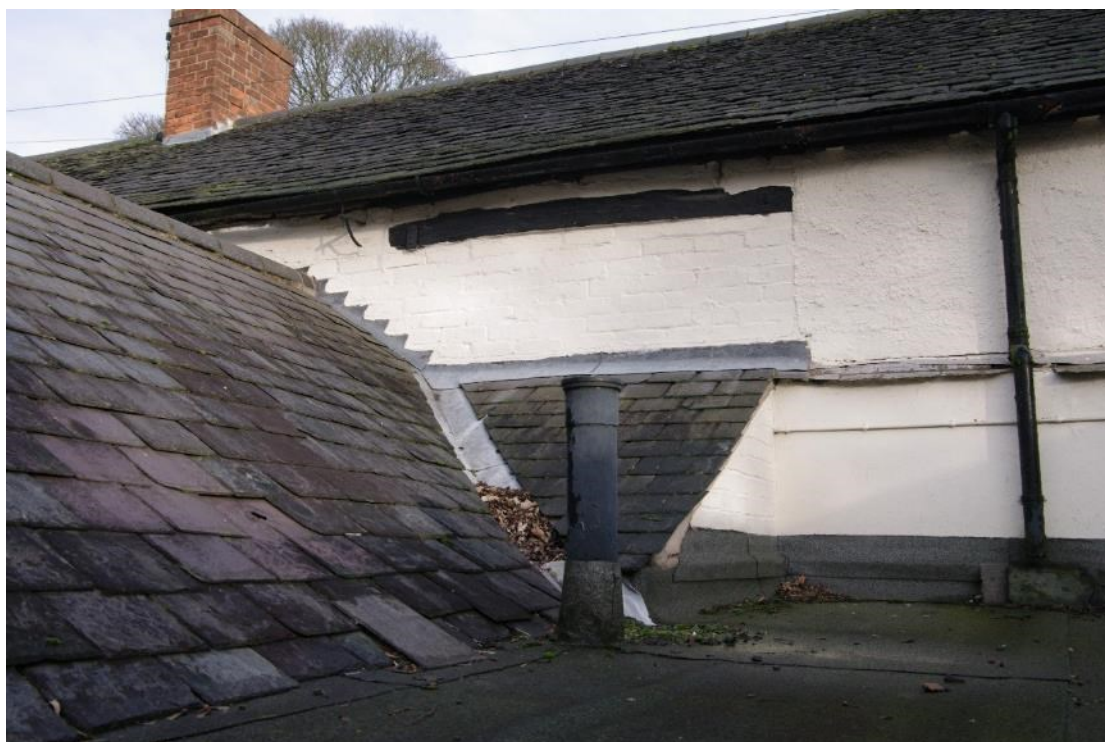
Figure 28 West-facing elevation, blocked window above east to west stable range  
Looking north-east

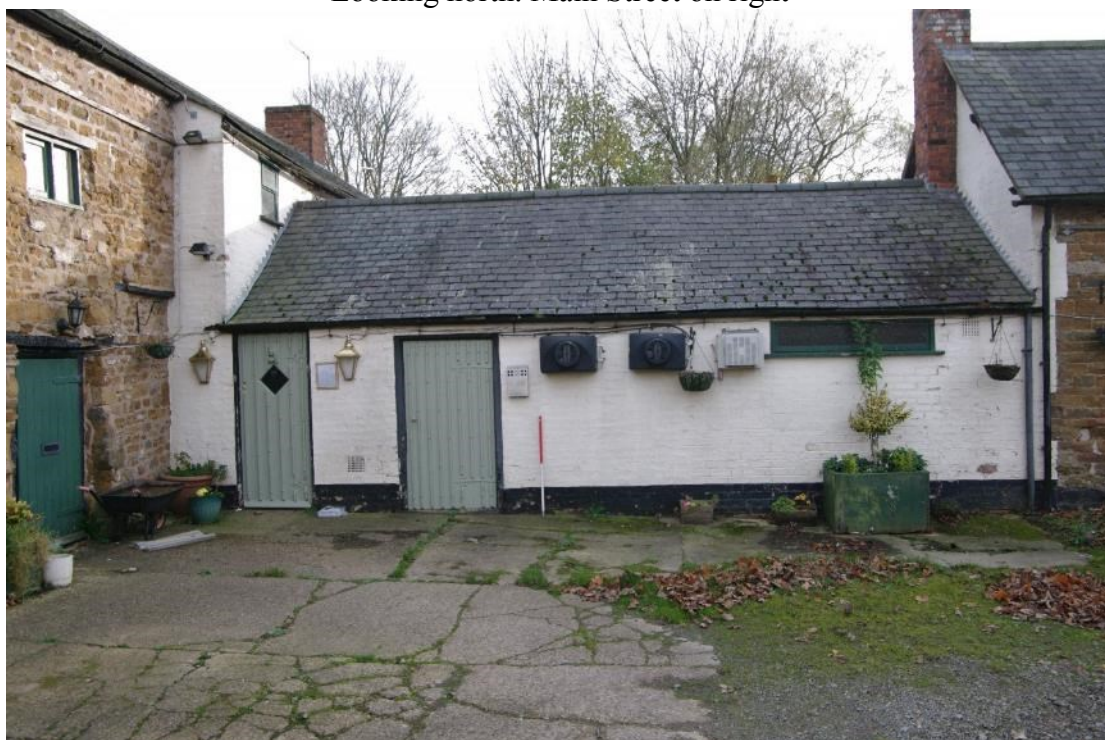
The brick-built structure, as noted earlier, butts against the brickwork of the west facing elevation of the principal range which steps out at this point (Fig. 33). Both the west-facing elevation and the north-facing elevation are laid in a rather variable header/stretcher bond which uses quite thin handmade bricks. A narrow doorway in the eastern corner is the main doorway into the pub from the house although its small size may suggest that it was not originally intended to have such an important role. To the side of this door is a wider doorway leading into what is presently used as the ground-floor beer cellar. The door is modern but the brickwork around it seems undisturbed indicating that this is an original doorway. A wide but thin window lights the gents'

Figure 33 North-facing elevation of east to west stable range, eastern end  
Looking south. 1m scale. Note how N-S range construction changes from stone to  
brick and steps out at this point

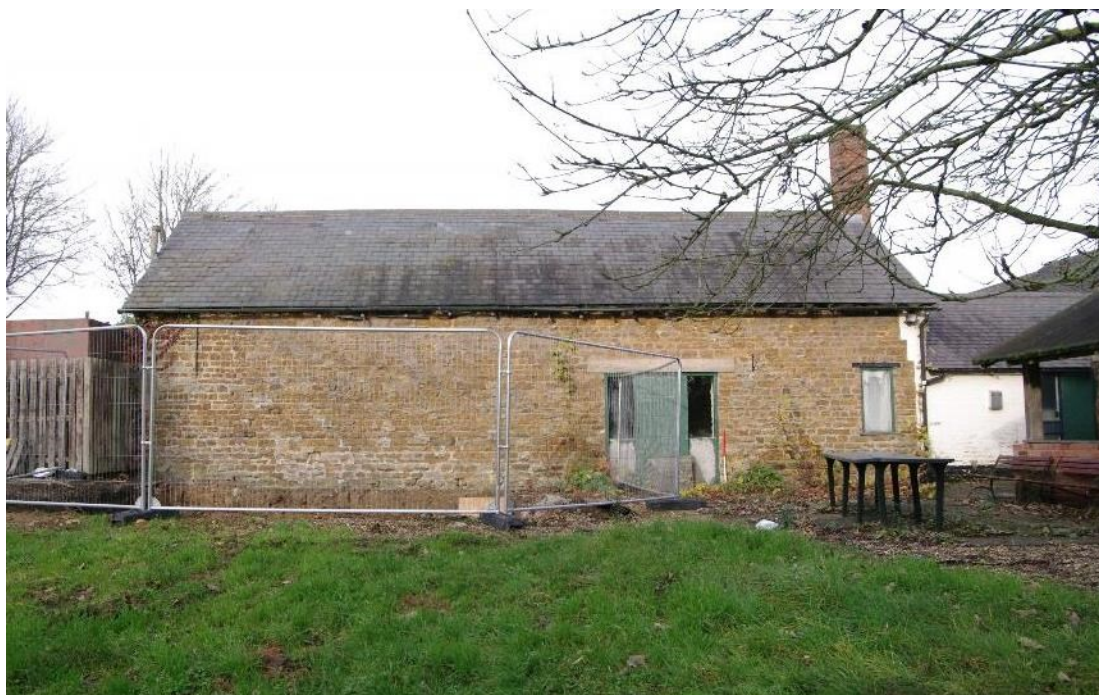
The south-facing elevation of the east to west stable range consists of the stone and brick elements as seen on the north facing elevation. The coursed rubble stable part of the range has a blank wall with a single modern fire-escape doorway in it (Fig. 36). The wide doorway has a modern concrete lintel and may be a modified smaller opening. There is no evidence of any other former openings on this wall. The eastern gable of the stable is built of brick, as discussed, which then drops down to the single storey building (Fig. 37). The brick range also has a modern doorway and no other openings. The toilet block built between the two east to west ranges butts against it. The gable end of the east west stable range butts against the principal range and partially blocks a first floor window as discussed above.

Figure 36 South-facing elevation of east to west stable range, west end  
Looking north. 1m scale

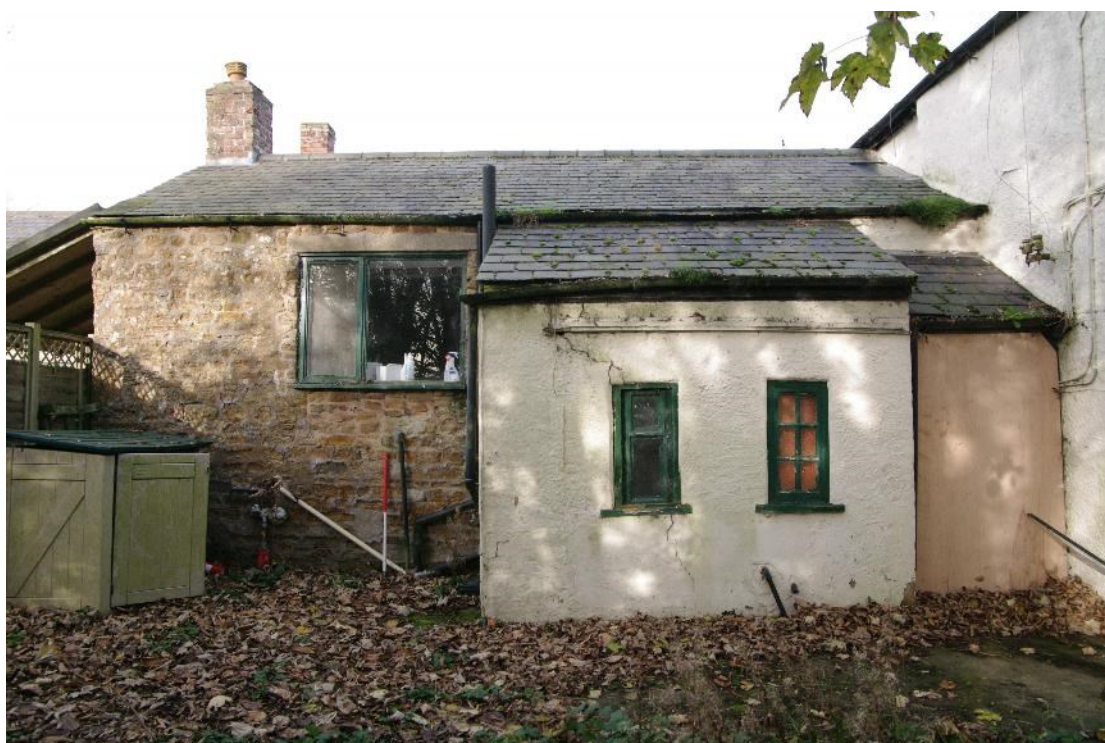
The south-facing elevation has a large casement window with a concrete lintel which seems likely to have been modified from a smaller opening (Fig. 39). A small lean-to toilet block butts against the south-facing elevation and fills in the covered passageway between the kitchen and principal range. Map evidence indicates that the lean-to was added between the 1929 and 1956 editions and the style of building suggests a mid-1930s date. As already discussed above, the roofline of the kitchen range partially blocks an infilled window on the principal range which indicates that this is a later addition but one which still pre-dates the 1839 tithe map.

Figure 39 South-facing elevation of east to west kitchen range  
Looking north. 1m scale

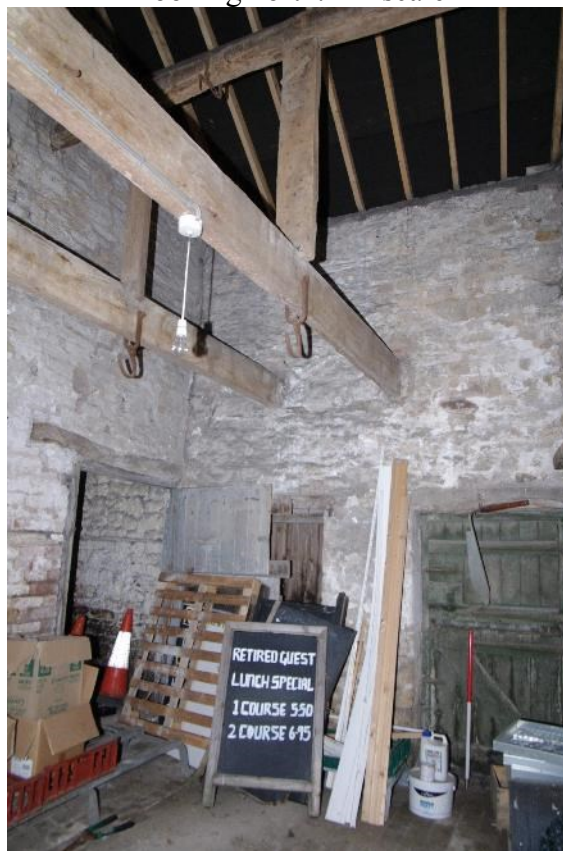
Figure 73 Room 9 pilaster over blocked doorway  
Looking north. 1m scale

Room 9 fills the stone-built portion of the east to west range and was presumably built with stalls and looseboxes although no trace of this remains (Fig. 72). Most recently it appears to have been used as a function room. The stone walls have been painted rather than plastered. Large north to south beams are supported on brick pilasters built against the side walls. The pilasters may be a later addition as one of them covers a blocked doorway as seen on the north facing elevation. Although filled with stone on the outside the doorway has brick infill on the inside (Fig. 73). It is possible that the ends of the beams were rotting and needed additional support from the new pilasters. The doorway

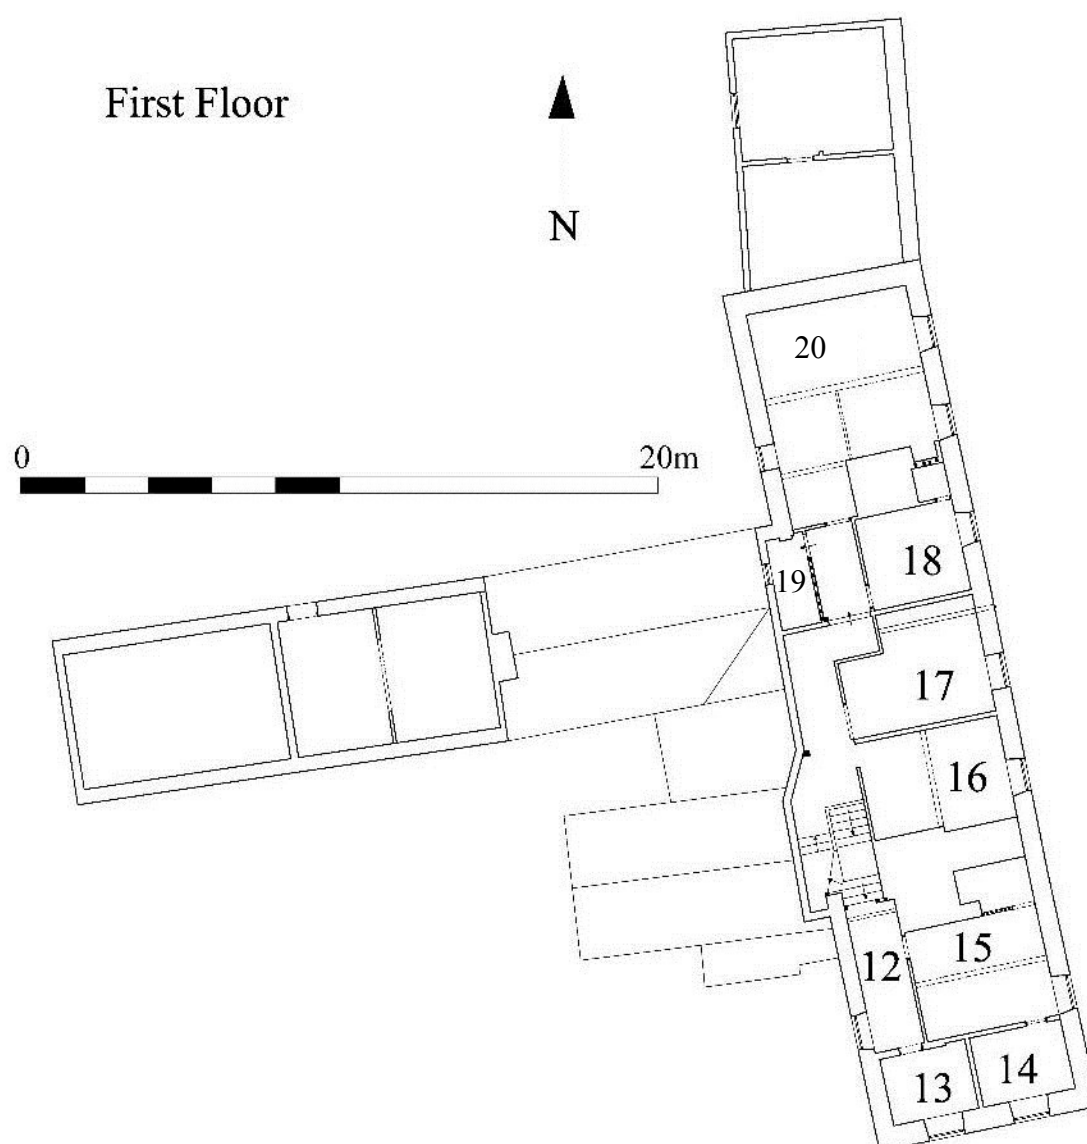
Figure 79 First floor plan

The first floor rooms above Rooms 10 and 11 were not entered due to the dangerous condition of the floor. Access was not possible in the attic space over Room 9.

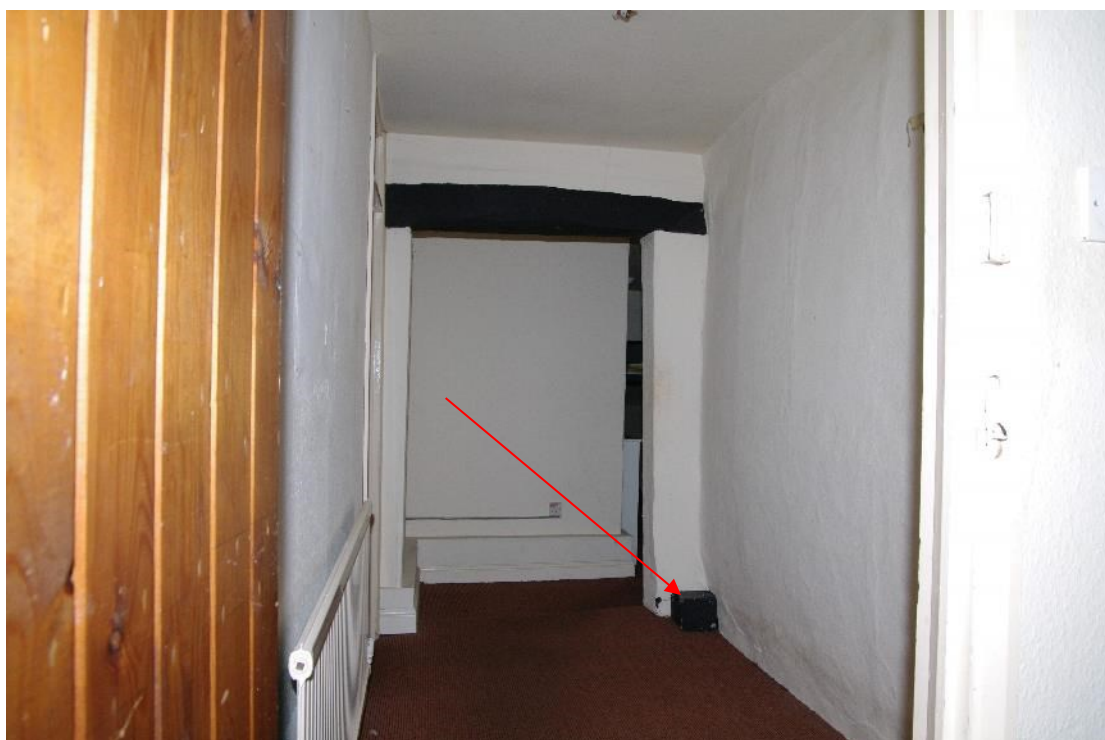
Figure 80 Corridor 12 at northern end

principal range along Main Street (Fig. 80). The corridor then bends around small side Room 20 which has a timber-framed wall (see below) and leads to the landing around the stairs (Fig. 81).

Looking south from doorway of Room 19. Doorway to Room 20 on right. Note curved timber frame wall of Room 20 and top of timber posts shown below in Figure 82 (arrowed)

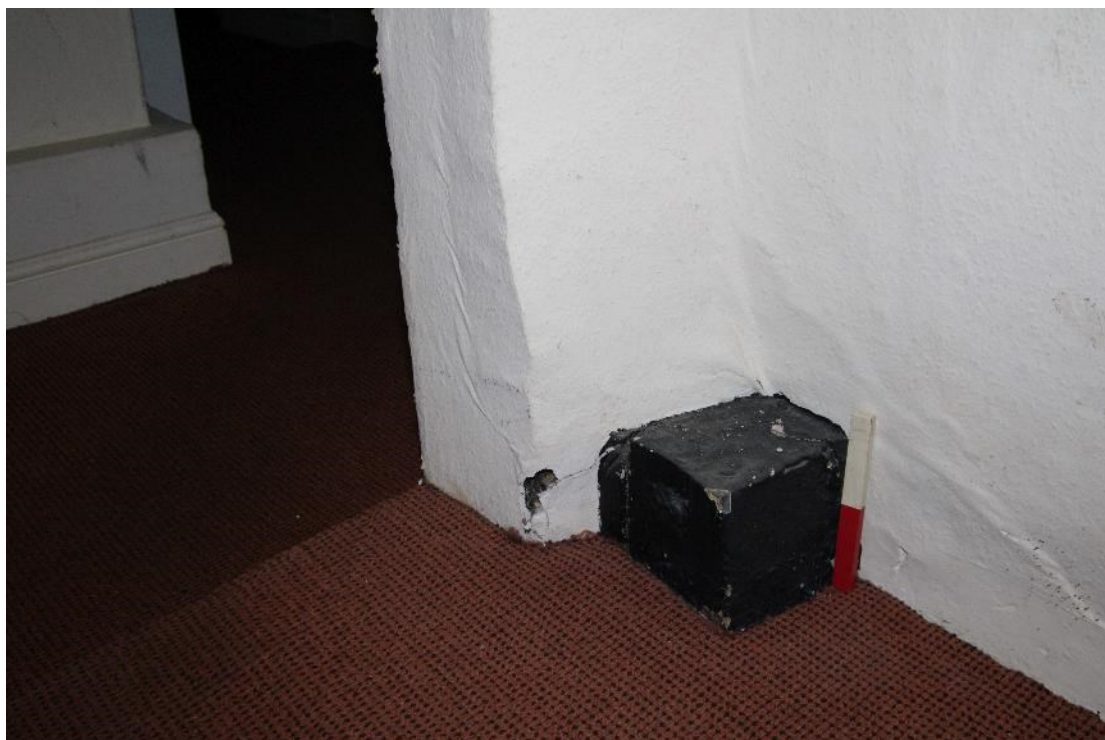
Figure 82 Corridor 12, top of timber posts projecting from ground floor  
Looking south-west. 0.2m scale

A stub of two timber posts rise through the floor next to the south corner of Room 20 (Fig. 82 also Fig. 80). These correspond with the tops of the timbers supporting the axial beams in ground floor Room 2. Further south along the corridor, to the west of Room 16 and at the side of a bricked-up window over the east to west range, a large timber post supports the roof (Figs 81 and 83). This may be part of a former cruck blade but now supports a brace on one side and a horizontal tie beam at the top. Presumably this timber continues down to ground floor level although it is not visible at this point.

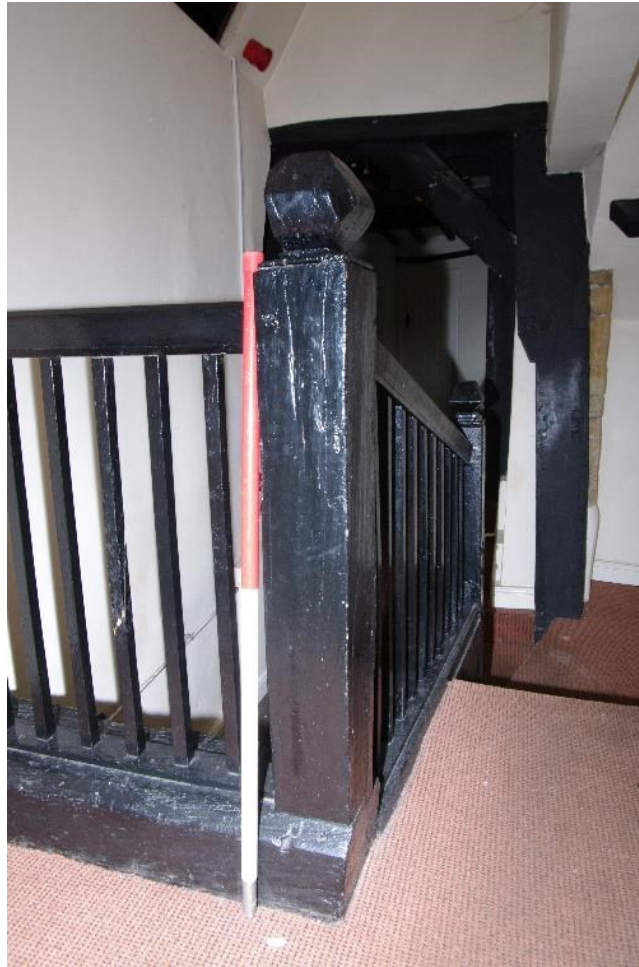
Figure 84 Corridor 12 staircase  
Looking south. 1m scale. Note also possible part of cruck blade on right

On the west side of the stairs is another very large timber post which may be another part of a former cruck blade (Figs 84 and 86). This post has a number of pieces of inserted wood filling former holes and sockets and also has some empty mortice holes with evidence of wooden pegs being removed (Fig. 87). The carpenter's setting out marks can still be seen on one of the mortice holes. A pegged strut presently extends from the east side of the post to support a horizontal chamfered beam running across the corridor at ceiling height. The horizontal beam also has empty mortice holes.

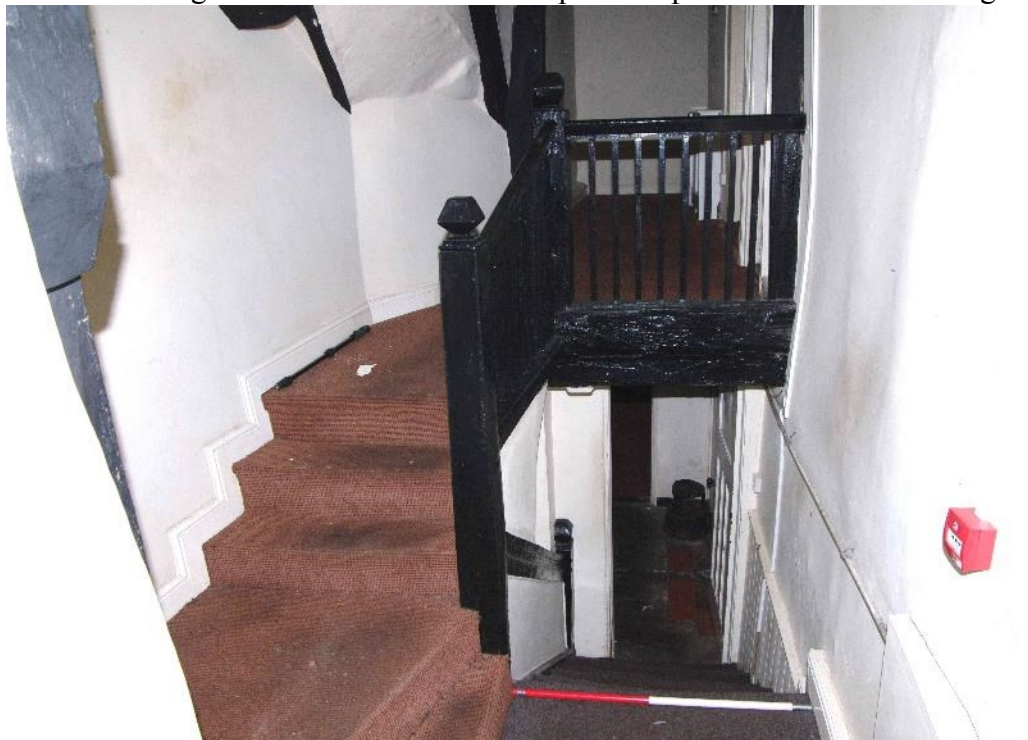
Beyond Room 16, to the south, the corridor widens to form the landing around the staircase (Figs 81, 84 and 85). The rectangular section newel posts are of the same probable early 17th century style as seen at the foot of the stairs in Corridor 5. The handrails and balusters are not boxed in at this point and give an indication of what the original open staircase might have looked like. The handrails however at first floor level do not have the moulded decoration seen rising from Corridor 5 and may be later replacements. The balusters are simple square section pieces of timber but are likely to be original.

Figure 85 Corridor 12 staircase  
Looking north. 1m scale

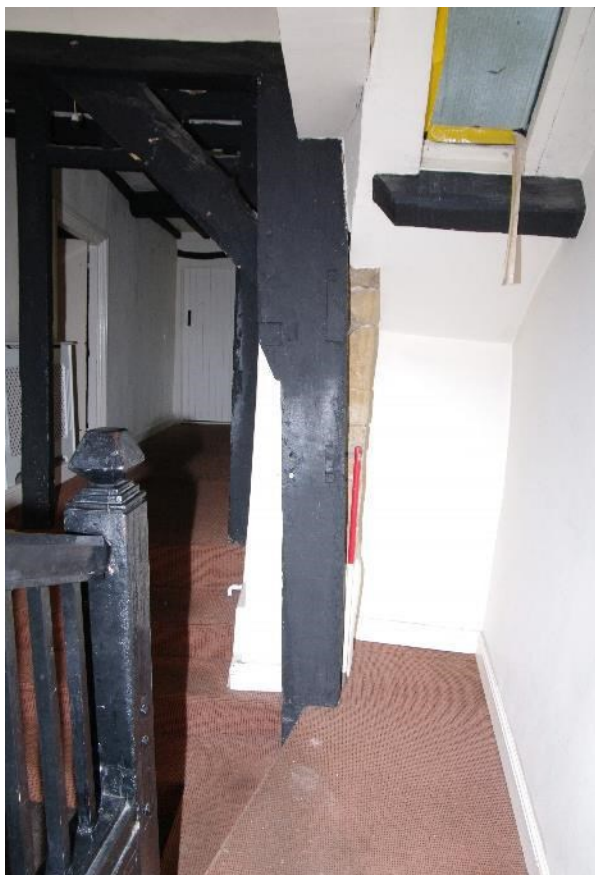
Figure 86 Corridor 12 large timber post  
Looking south. 1m scale

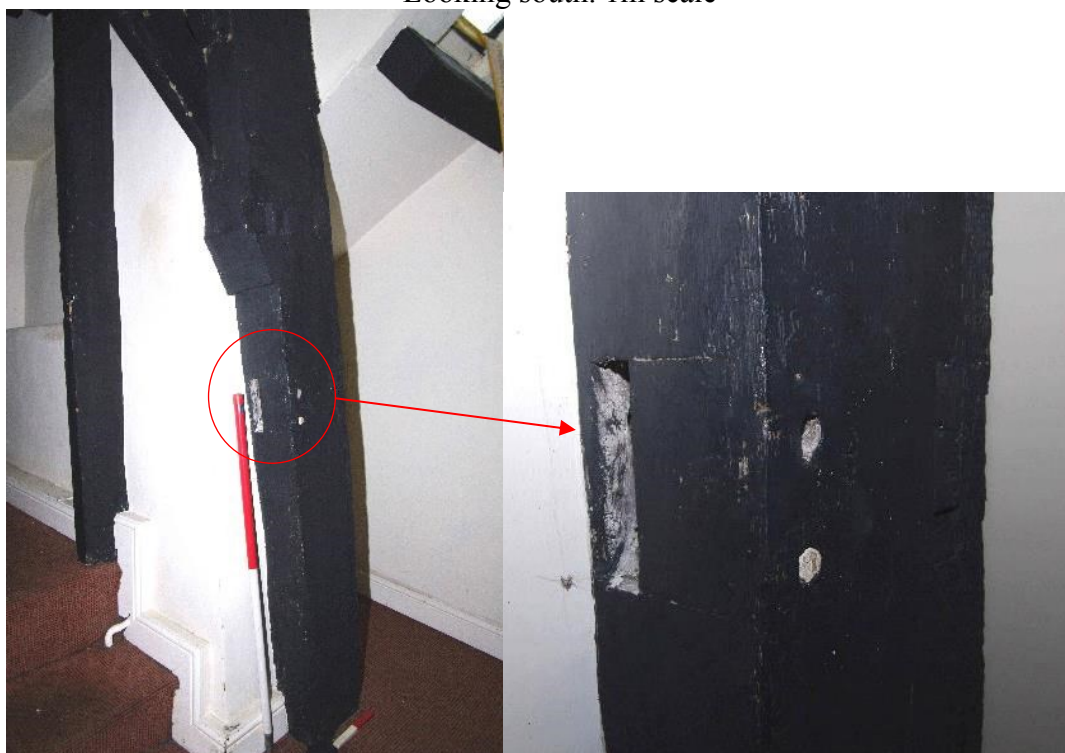
Figure 87 Corridor 12 large timber post near staircase  
Looking west. 1 and 0.2m scales. Note empty mortice and peg holes near to top of 1m scale, also shown in inset picture

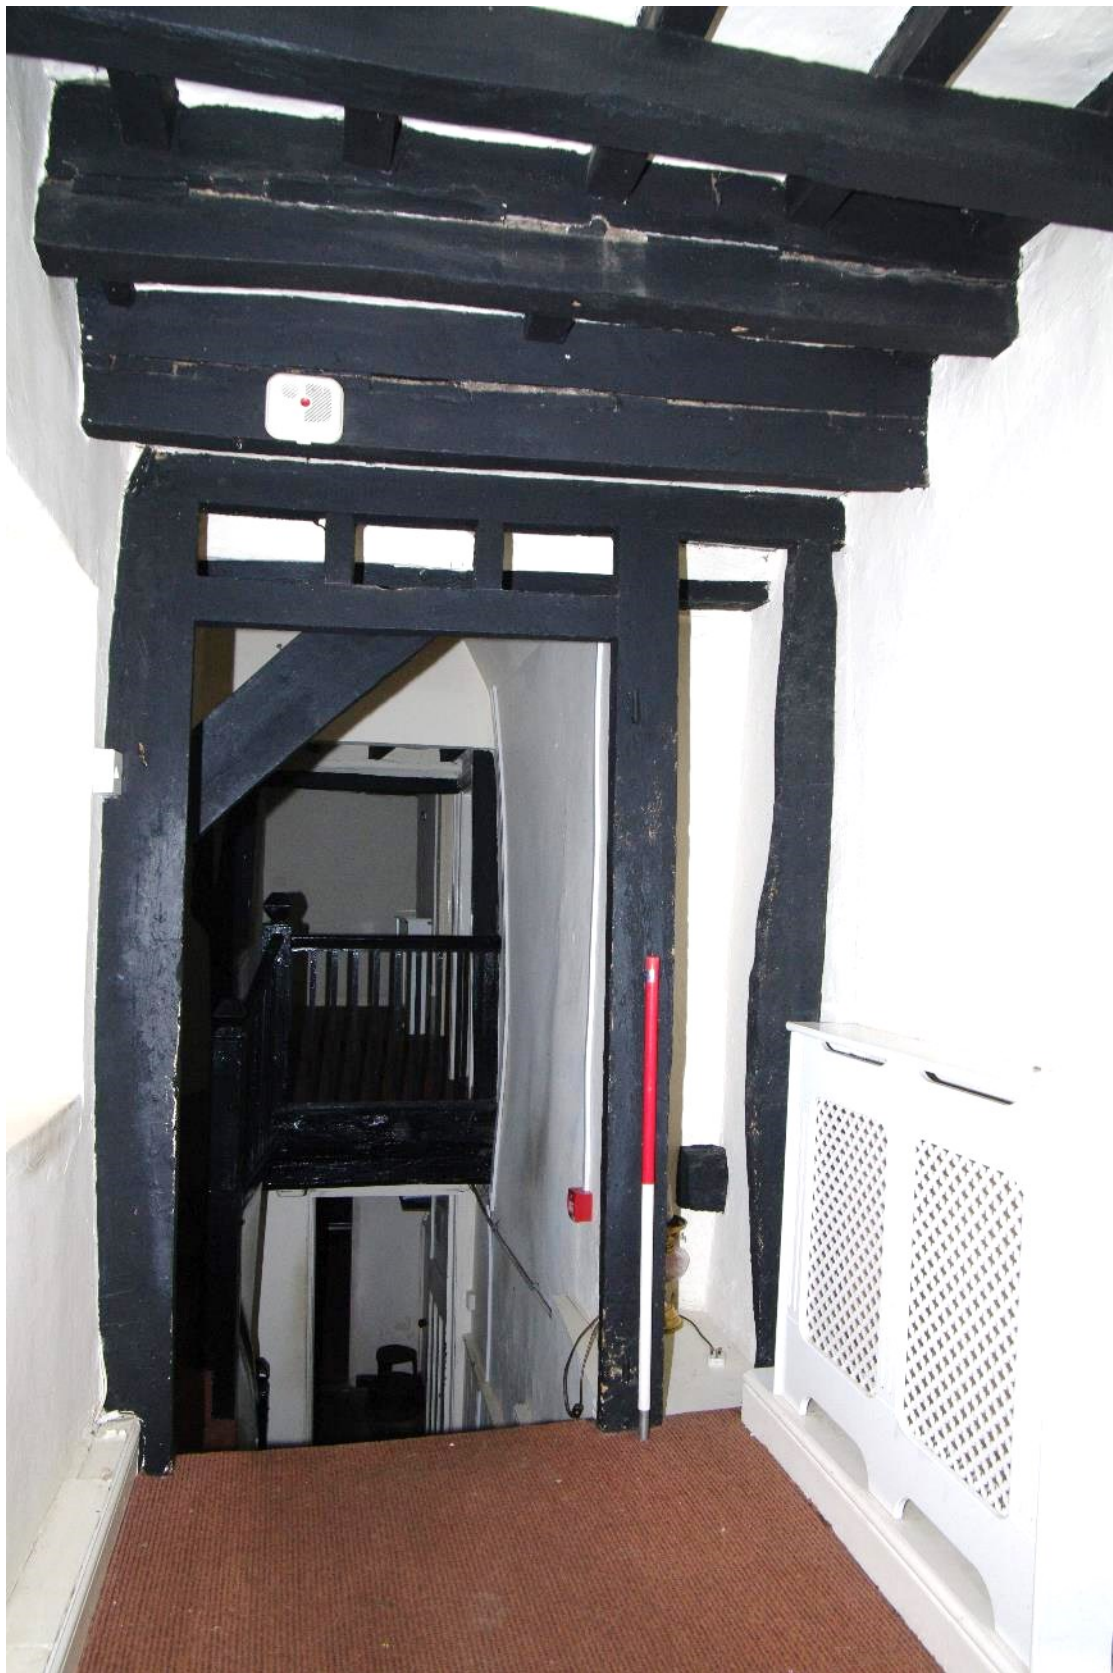
Approximately 1m to the south of the timber post mentioned above is another square section post and frame (Figs 88 and 89). This appears to be part of a former dividing wall from which the wattle panels have been removed. On the southern side of the frame are two metal pintles on which a door has been hung.

Figure 88 Corridor 12 timber stud walling  
Looking north. 1m scale

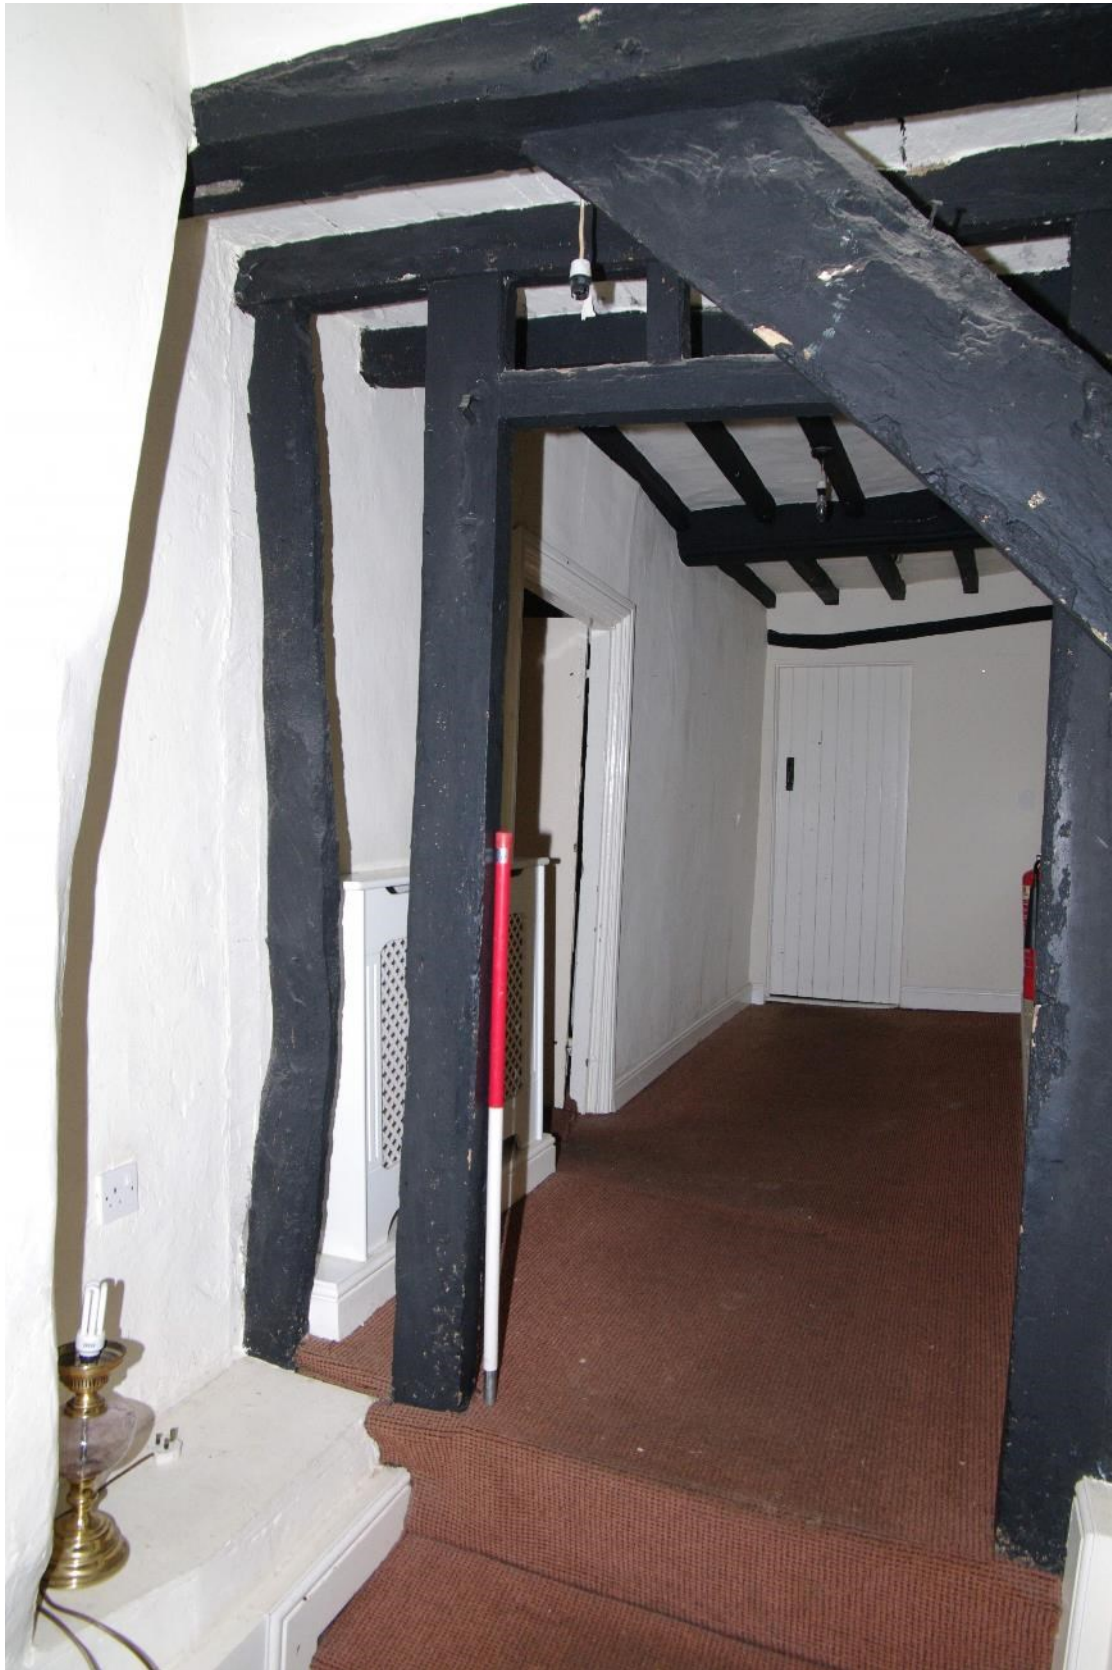
Figure 89 Corridor 12 timber stud walling  
Looking south. 1m scale. Note redundant mortice hole in closer beam

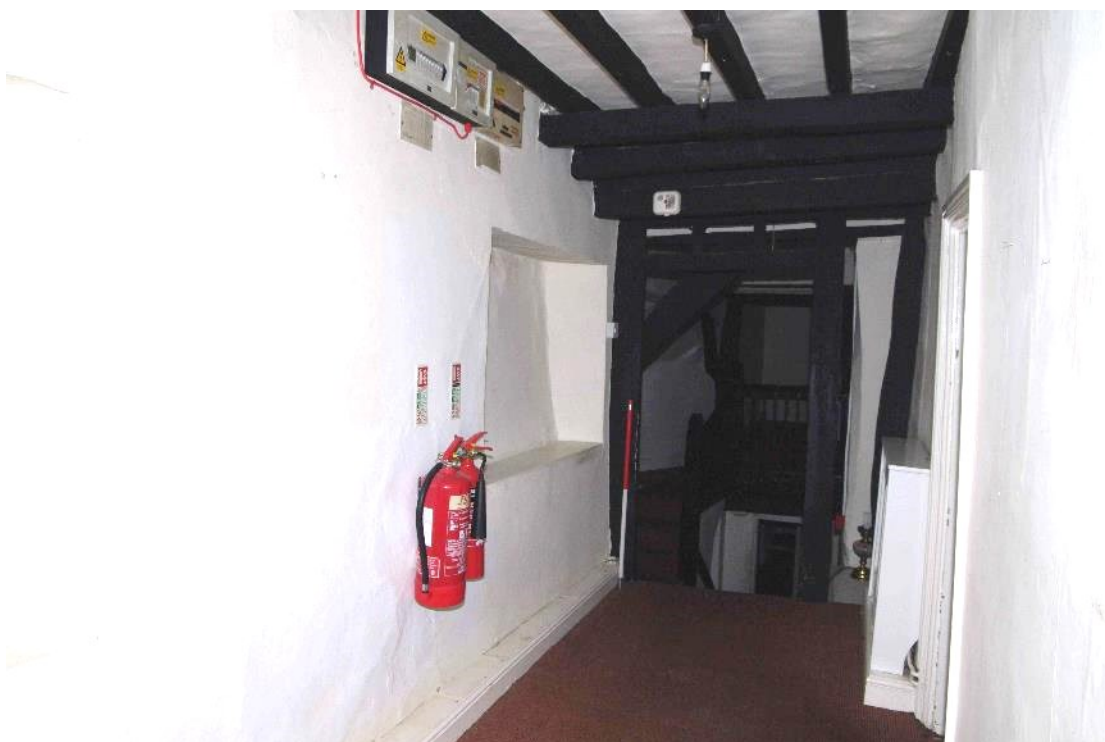
At the southern end of corridor 12 on the west wall is the recess of a window which has been blocked by the addition of the east to west range (Fig. 90). This part of the corridor also has exposed ceiling joists unlike the rest of the corridor.

Figure 90 Corridor 12, south end  
Looking north. 1m scale. Note blocked window on west (left) wall

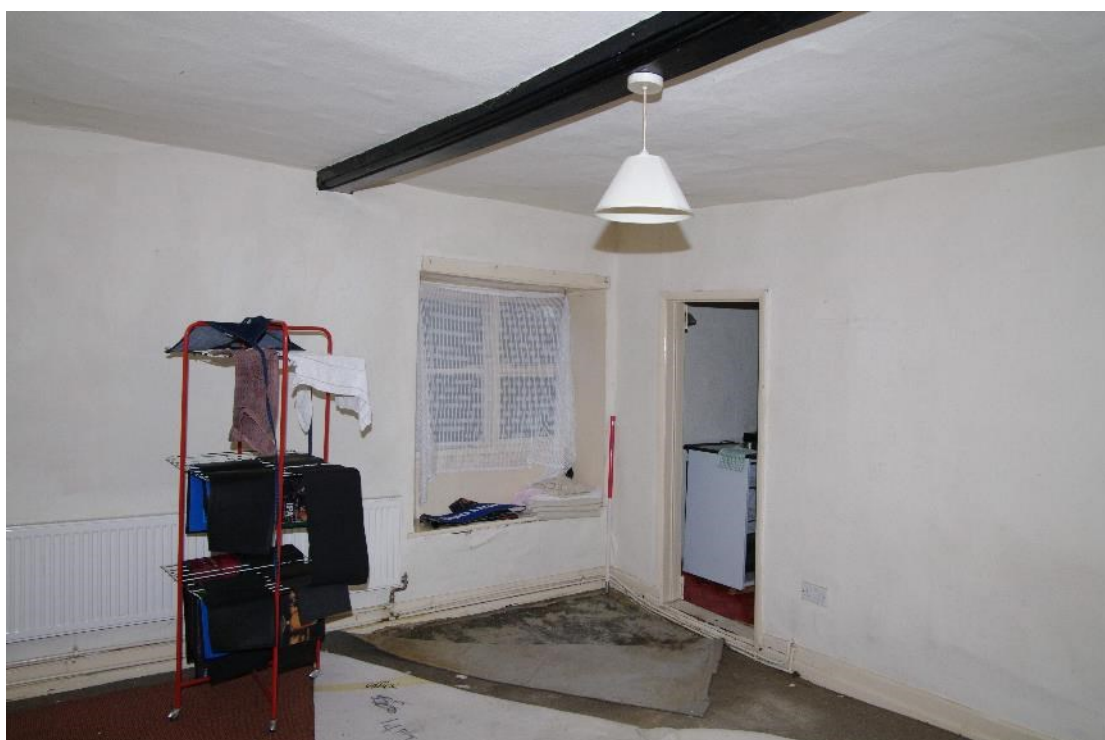
Room 15 is quite a plain room with an uneven plaster floor, painted plaster and woodchip covered walls and a low undecorated skirting board (Figs 91 and 92). There is no evidence of a fireplace which may have been blocked. Due to the uneven floor the doorframe from Corridor 12 is slightly skewed and the plank-built door has been trimmed at its base. The door has handmade strap hinges and a latch with a heavily painted lock case which may be made of wood (Fig. 93). A modern door leads into Room 14. In the north-east corner of the room is another plank-built door leads into a large cupboard against the side of the chimney breast (Figs 92 and 94). The inside face of the door is bare wood with handmade strap hinges, a wooden handle and a wooden lock case (Fig. 95). The handle is very crude and little more than a short length of squared wood which has been recessed on the underside and nailed to the door with hand forged nails. The presence of a handle on the inside of the cupboard suggests that the door may have been relocated from elsewhere. The wooden lock case has a faintly inscribed decorative border around it suggesting that it was intended to be seen and was not a simple agricultural lock. There is a wooden catch for a latch on the jamb of the doorframe. Both plank-built doors are likely to be at least later of 18th or early 19th century date and may be significantly earlier.

Figure 91 Room 15  
Looking south-east towards door to Room 13. 1m scale
