**A Level 3 Historic Building Survey at  
The Rose and Crown,  
Tilton on the Hill,  
Leicestershire**

**NGR: SK74292 05655**

ULAS Report No. 2018-024  
©2018

**For: D W Hicks Building Co**

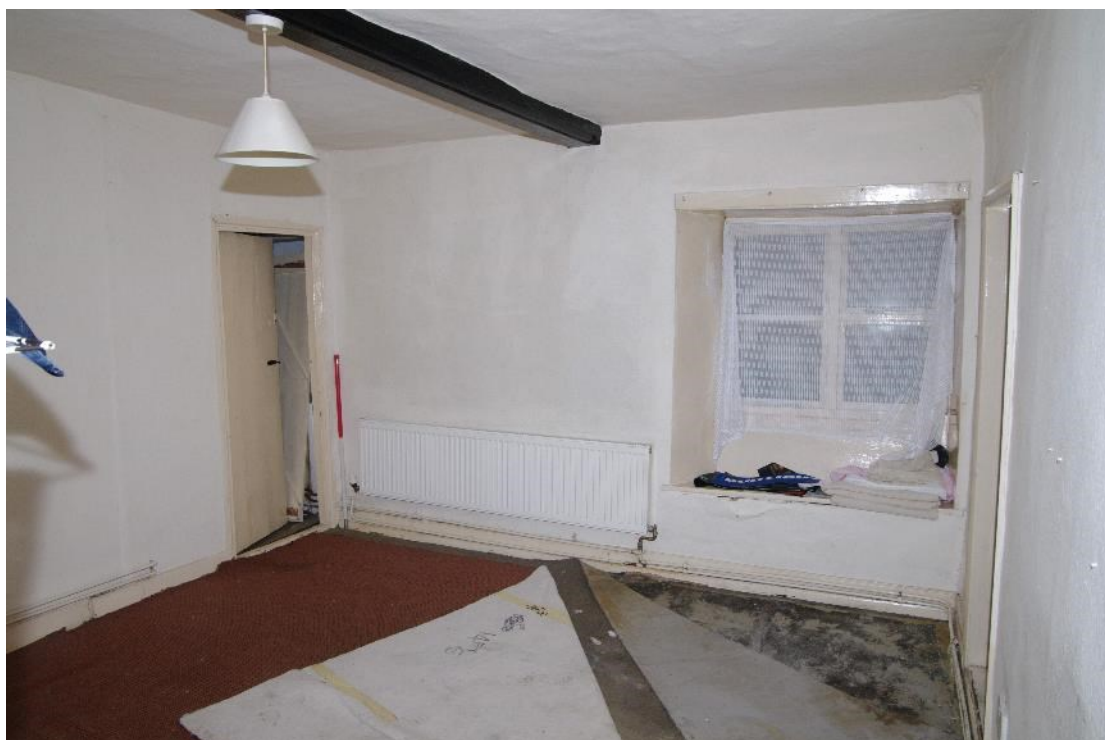
Room 15 is quite a plain room with an uneven plaster floor, painted plaster and woodchip covered walls and a low undecorated skirting board (Figs 91 and 92). There is no evidence of a fireplace which may have been blocked. Due to the uneven floor the doorframe from Corridor 12 is slightly skewed and the plank-built door has been trimmed at its base. The door has handmade strap hinges and a latch with a heavily painted lock case which may be made of wood (Fig. 93). A modern door leads into Room 14. In the north-east corner of the room is another plank-built door leads into a large cupboard against the side of the chimney breast (Figs 92 and 94). The inside face of the door is bare wood with handmade strap hinges, a wooden handle and a wooden lock case (Fig. 95). The handle is very crude and little more than a short length of squared wood which has been recessed on the underside and nailed to the door with hand forged nails. The presence of a handle on the inside of the cupboard suggests that the door may have been relocated from elsewhere. The wooden lock case has a faintly inscribed decorative border around it suggesting that it was intended to be seen and was not a simple agricultural lock. There is a wooden catch for a latch on the jamb of the doorframe. Both plank-built doors are likely to be at least later of 18th or early 19th century date and may be significantly earlier.

Figure 92 Room 15  
Looking north-east. 1m scale. Door to right leads to Room 13. Door to left leads to cupboard with timber studded wall

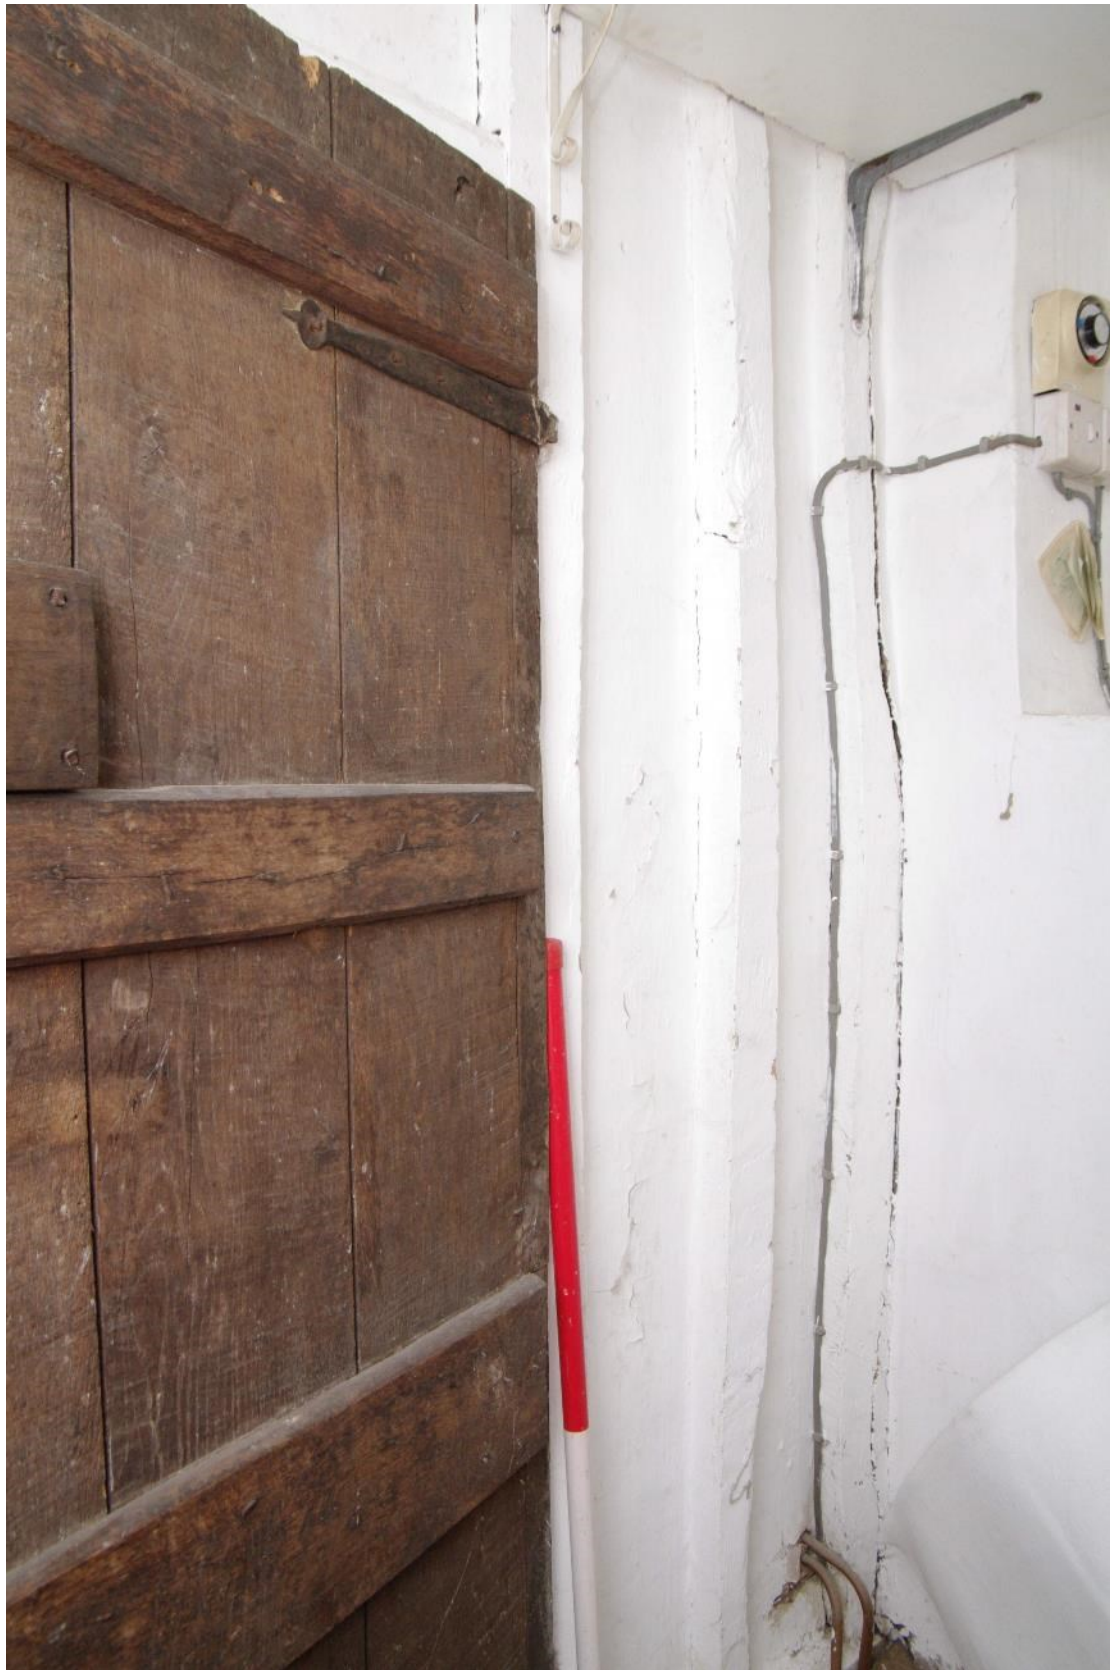
Still within the cupboard, on the west side of the plank door running up to the side of the chimney breast is a stud wall with wattle infill (Fig. 96). The timber uprights are quite crudely squared off on their edges but still retain a pronounced bend and twist from the original branch they were cut from. The redevelopment plans suggest that this wall and the plank door will be removed during the proposed works.

Figure 96 Room 15 timber stud wall in inside of cupboard  
Looking south-west. 1m scale

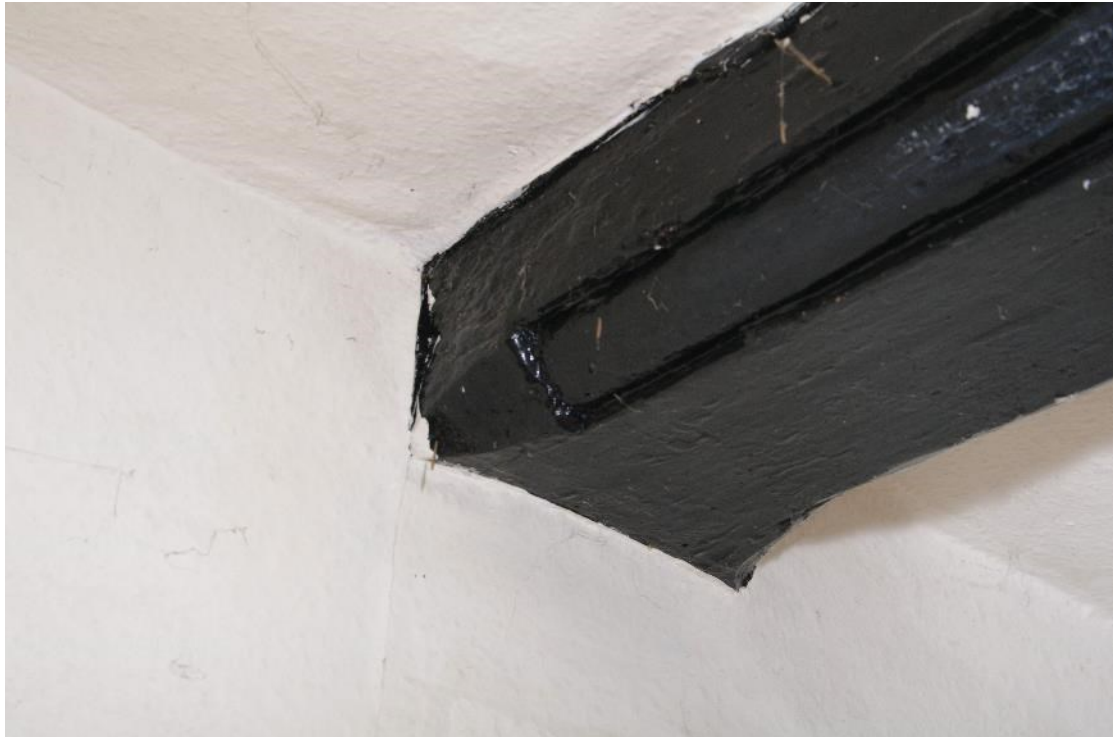
Running from east to west across Room 14 is a large timber axial beam with a moulded chamfer and stops (Fig. 97). Such a decorated beam, and its location close to the head of the stairs may suggest that this was a room of some importance. This may be especially true as the room has a plaster floor.

Figure 97 Room 15 axial beam detail

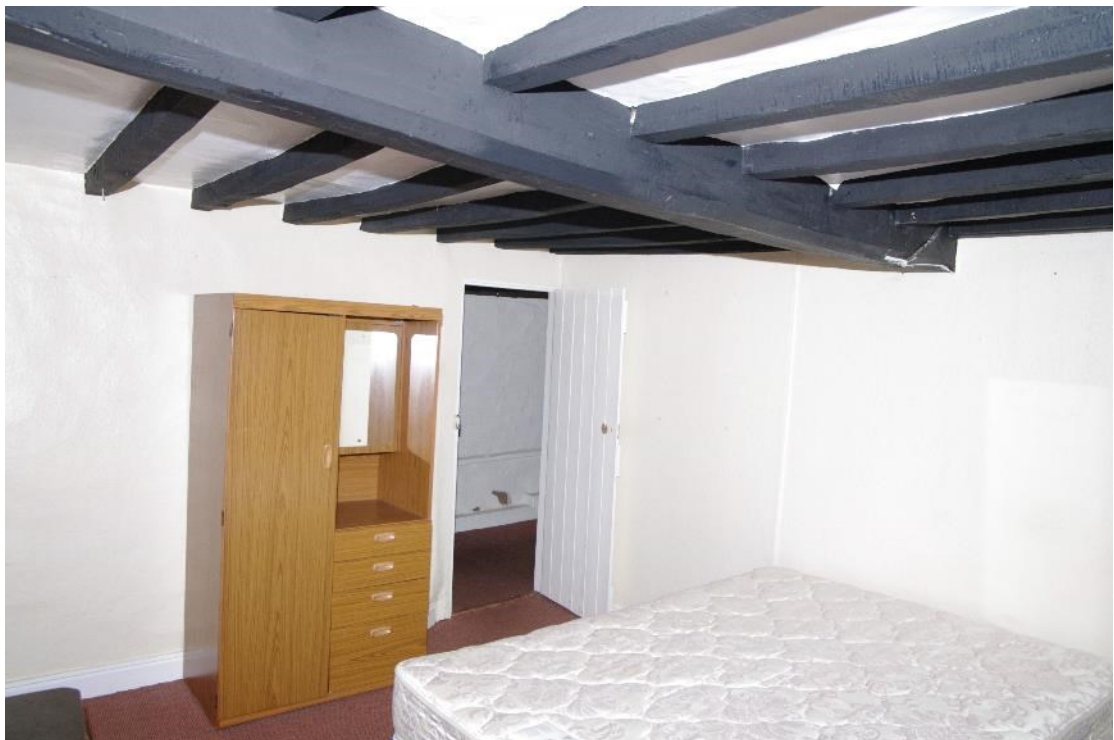
Room 16 is a fairly small room with exposed ceiling joists radiating from a north to south axial beam (Figs 98 and 99). The beam has a simple chamfer with a stop at the north end only. It is not clear if the joists were ever intended to be seen. The south wall chimney breast has a large patch of uneven plaster showing where a fireplace has been blocked in.

Figure 98 Room 16  
Looking north-west towards corridor 12.

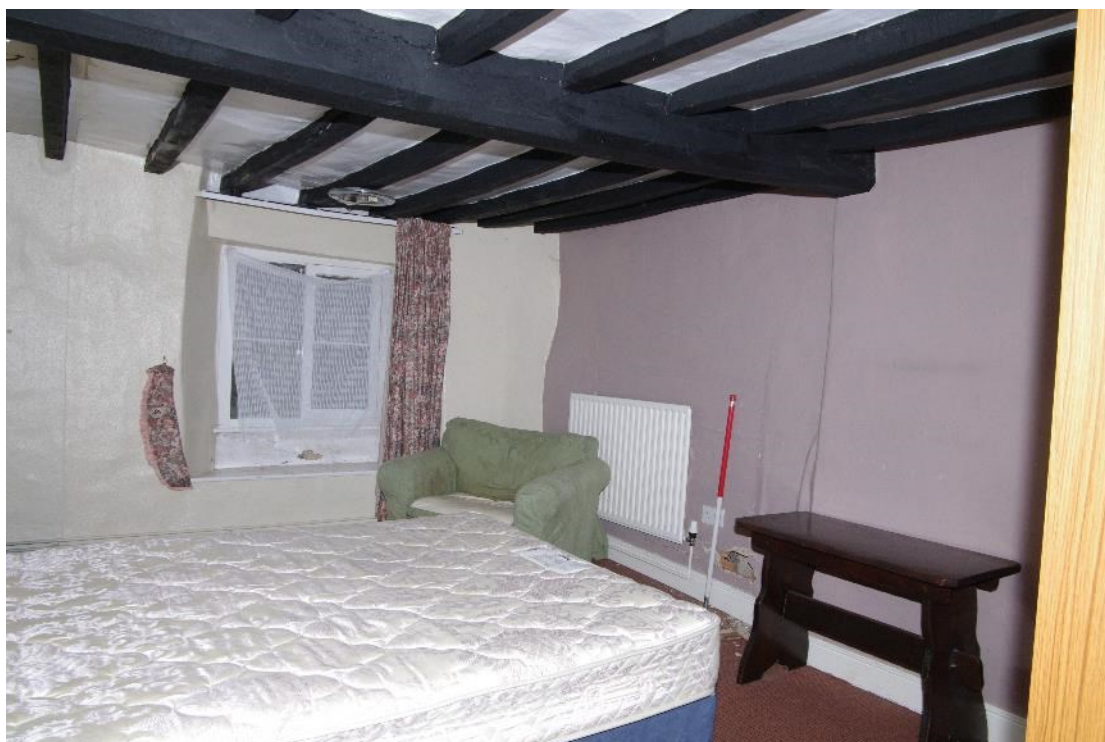
Figure 99 Room 16  
Looking south-east. 1m scale. Former fireplace evident behind radiator

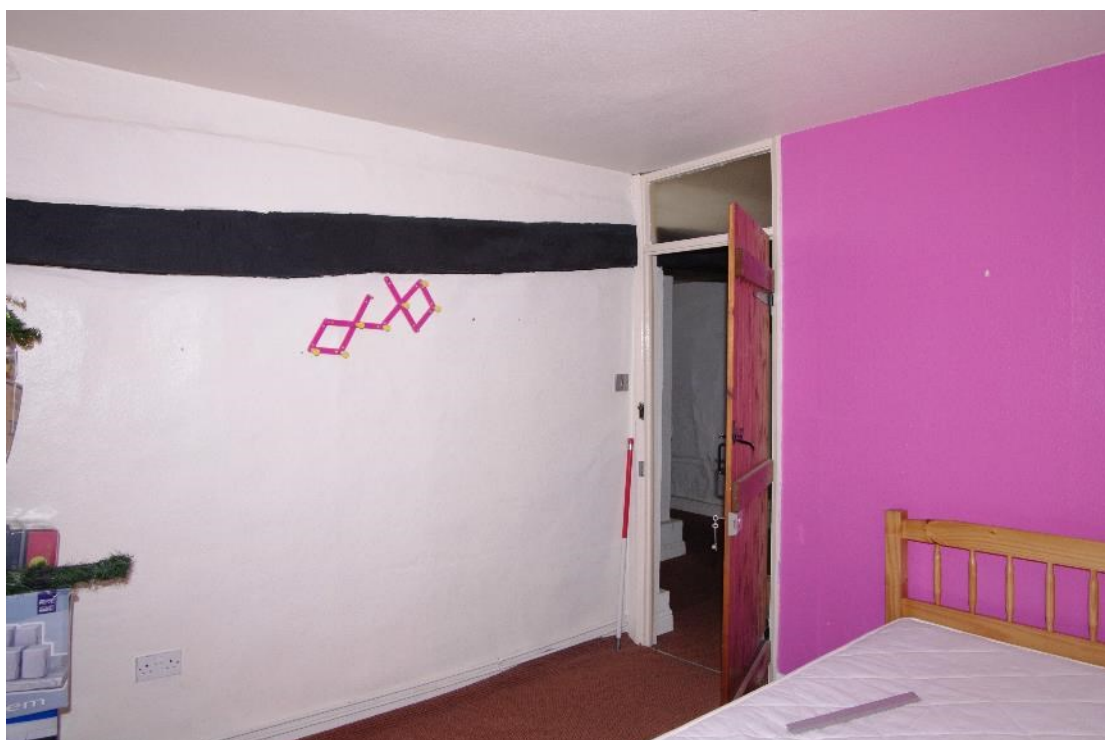
Room 18 also has a modern door to the corridor and a glass panel above it (Figs 101 and 102). An east to west timber beam is set into the south wall which continues westwards out across Corridor 12. The underside of the beam in the corridor has some empty sockets towards the east end which may indicate the presence of an earlier corridor wall which has now been shifted slightly further east (Fig. 103). In the north-east corner a 1930s style two-panelled door leads into a large cupboard filling the space between the chimney breast and the east wall. Inside the cupboard the back (north) wall is made from wooden pole uprights with wattle infill (Fig. 104). The upright poles have had their bark removed but no more effort than absolutely necessary has been made to square them off. A wooden hook has been attached to one of the poles and was probably used for hanging coats on.

Figure 101 Room 18  
Looking south-west towards corridor 12. 1m scale

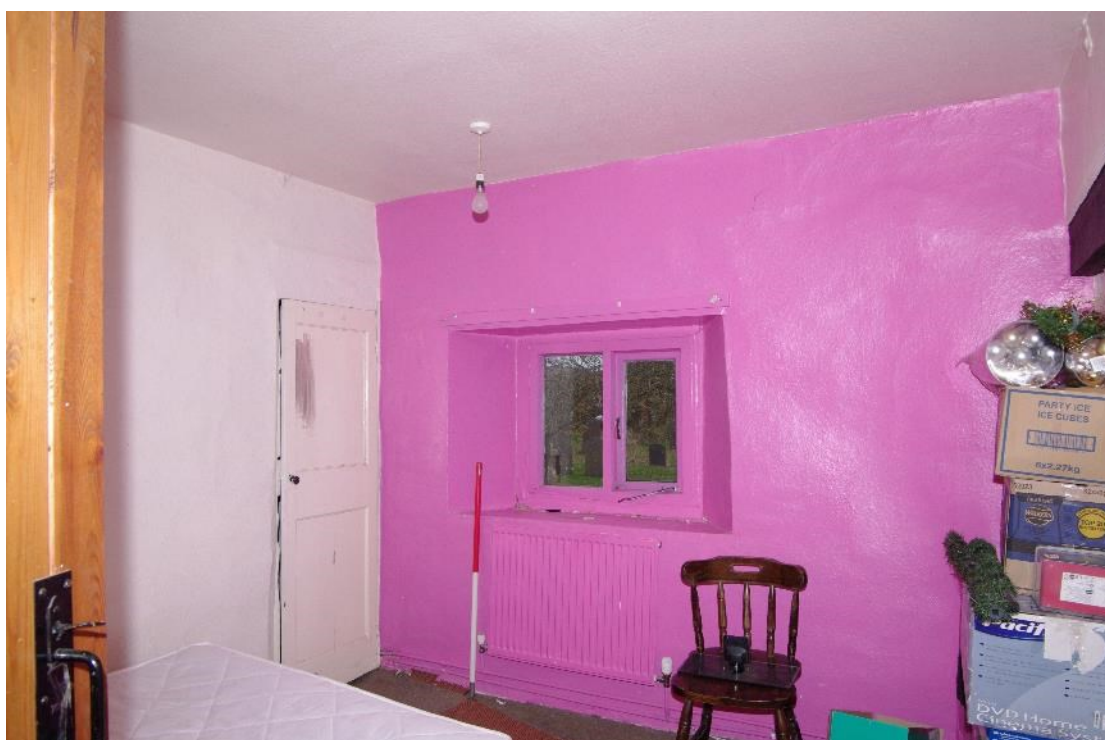
Figure 102 Room 18  
Looking north-east. 1m scale. Cupboard door to left of window

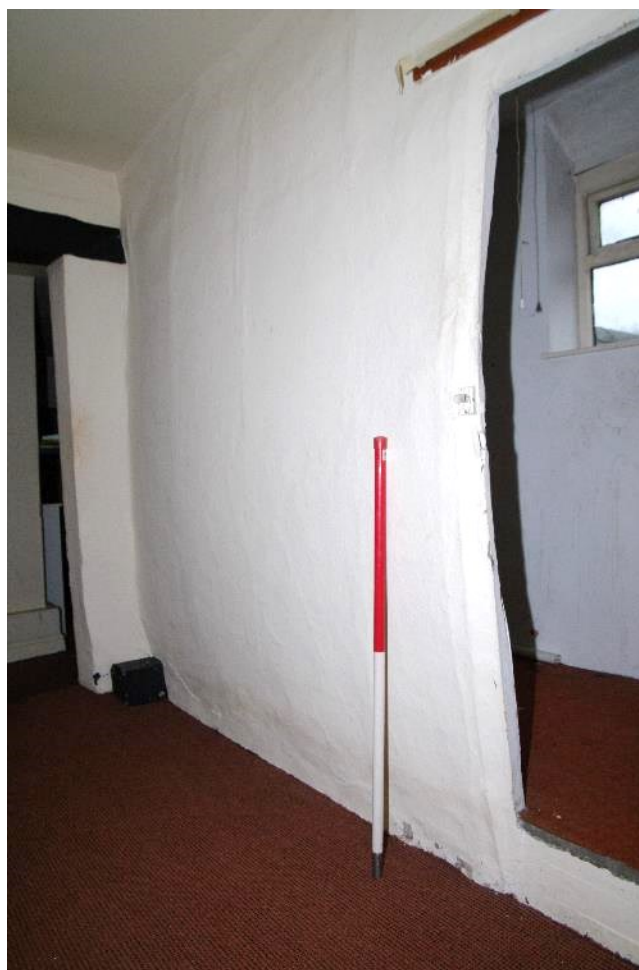
Room 19 is a small room built on the west side of the corridor 12. The corridor wall has a distinct convex curve out into the corridor suggesting that stone or brick has not been used (Fig. 105). The small room has a modern casement window on its west wall. The convex eastern wall has a covering of relatively modern hardboard. Beneath the hardboard can be seen more crudely shaped poles with wattle infill (Fig. 106). The door lintel is also quite crude and is attached to the upright poles by hand forged nails. This wall is proposed to be removed during the redevelopment work.

Figure 105 Room 19 seen from Corridor 12  
Looking south-west. 1m scale

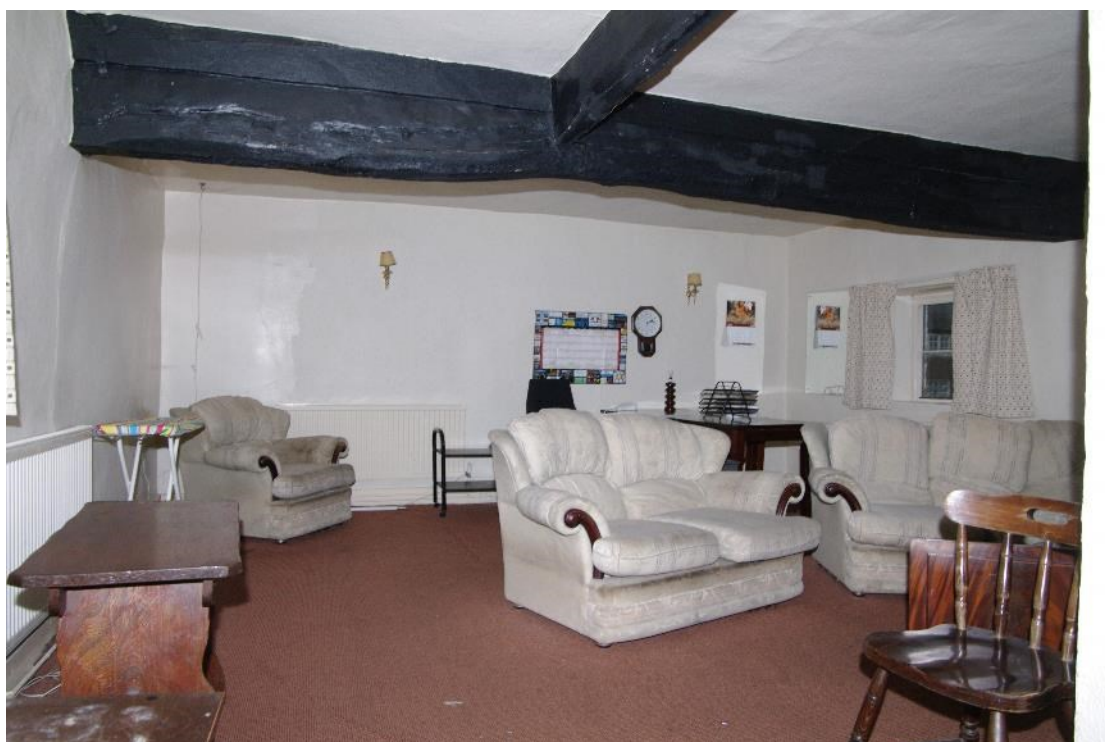
Room 20 is a large room filling the entire width of the range at the northern end. A stepped recess at the side of the chimney breast contains the other side of the wattle panelled wall seen in the cupboard in Room 18 (Figs 107 and 108). There is no evidence of a fireplace although the plasterwork appears to be quite fresh and is likely to mask a blocked fireplace. A number of larger timbers run across the ceiling. The central large east to west axial beam has a roughly chamfered giving the impression that an adze or axe may have been used (Fig. 109). Attached to the south side of the east to west axial beam and running to the corner of the chimney breast is a tall but narrow board or timber (Fig. 110). This timber is very narrow and rather than being structural may be part of a former dividing wall. A second east to west beam runs from the corner of the chimney breast to the west wall (Fig. 111). This is also crudely chamfered and does not seem to have been intended for decoration.

Figure 107 Room 20  
Looking north-east

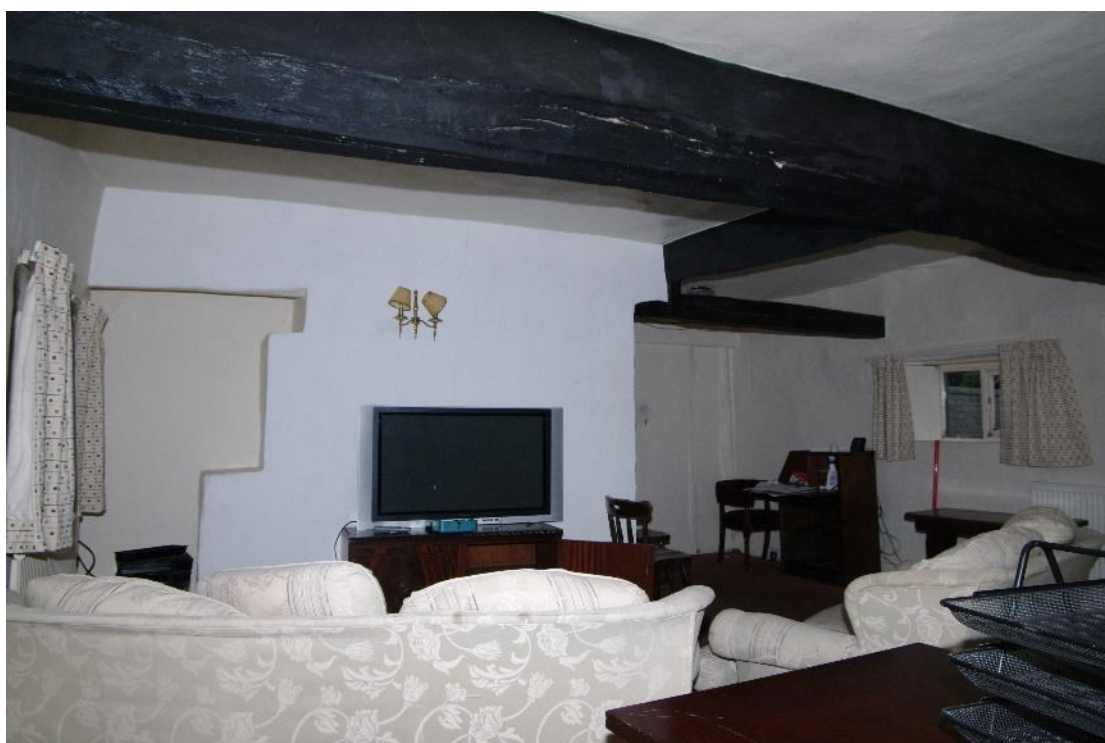
Figure 108 Room 20  
Looking south-west

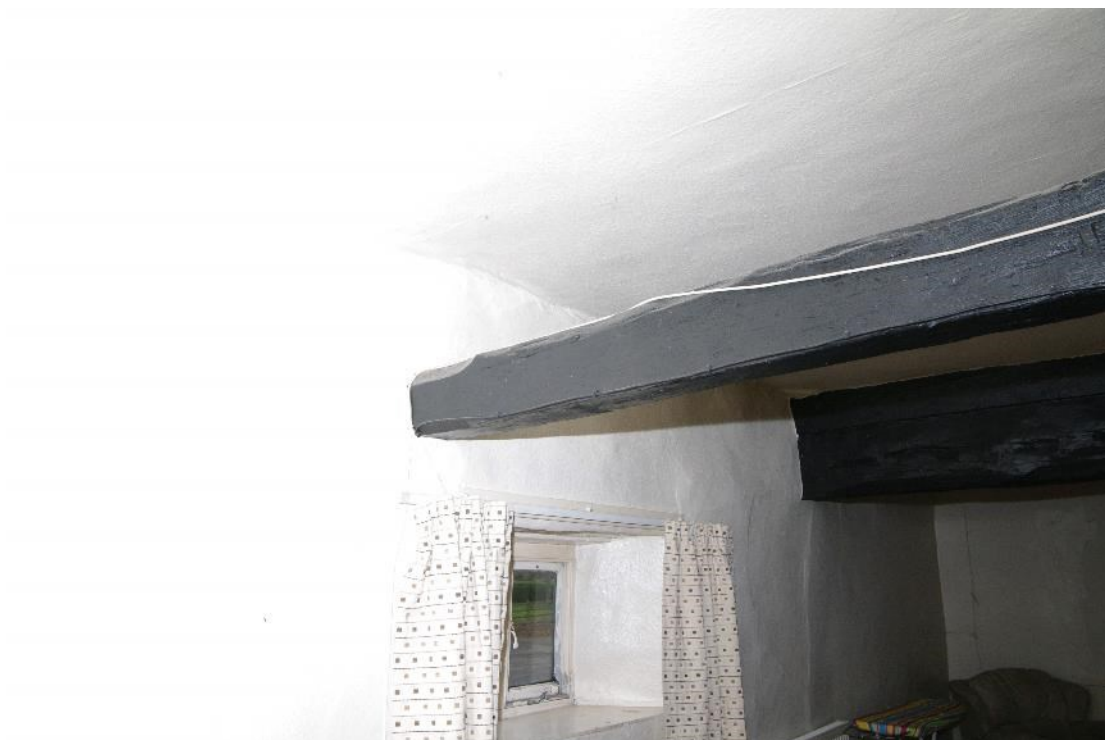
Figure 111 Room 20 smaller east to west beam  
Looking west. Larger axial beam to right

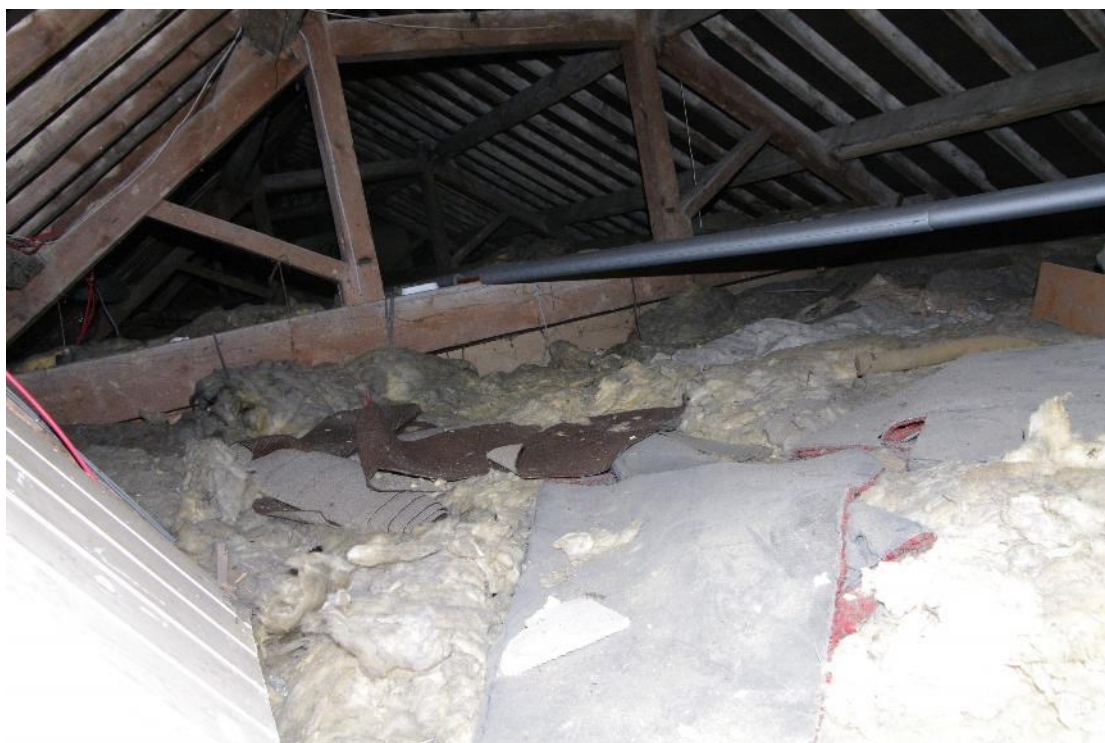
A small loft hatch near the top of the staircase allowed a brief inspection of the roof structure although it was not felt safe to enter the roof space. The access hatch showed the roof structure above Rooms 17 and 18 as far as the chimney stack between Rooms 18 and 19. The structure consists of two queen posts with raking struts supporting the purlins (Fig. 112). The raking struts appear to be pegged to the queen posts which are socketed into the tie beam. The clasped purlins are held on the backs of the principal rafters.

Figure 112 Roof structure above Rooms 17 and 18  
Looking north-east from staircase
