**A Historic Building Recording  
At Old Warren Farm,  
Lubbesthorpe,  
Leicestershire,**

**NGR: SK 53070 02290**

ULAS Report No. 2018-050  
©2018

**For: Andrew Hiorns Ltd**

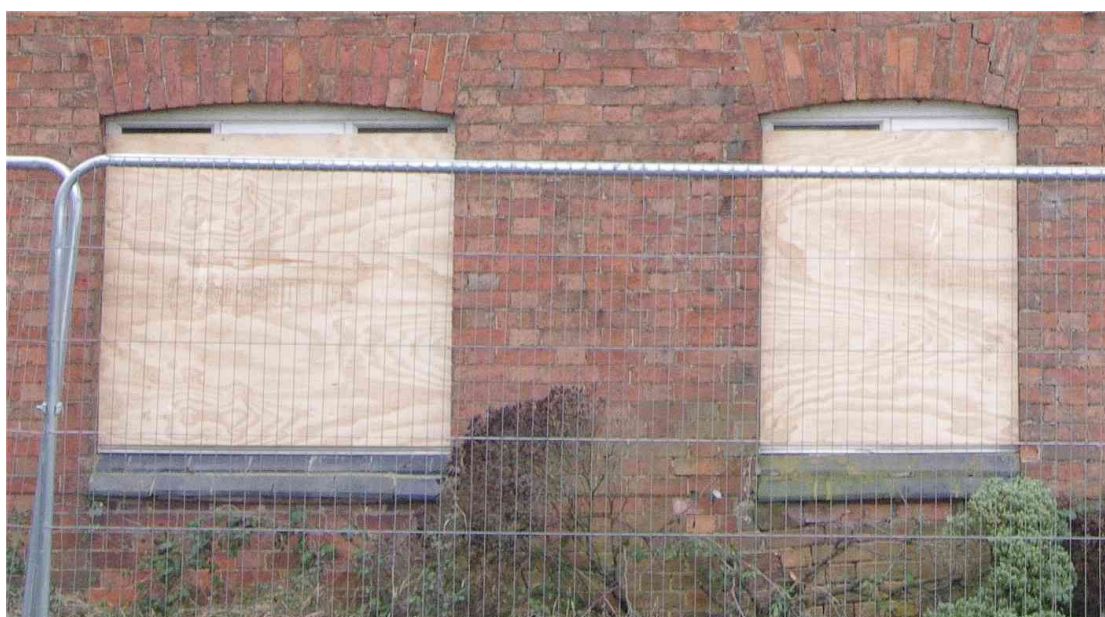
The elevation has three symmetrical bays with the window openings having brick-built flat-arched heads suggesting an early 19th century construction date (Figure 11). As noted earlier, all of the windows have recently been replaced with modern uPVC frames. The sills are made using chamfered blue bricks which appear to be machine-made rather than handmade as the red bricks are likely to be. This suggests that, at their earliest, the sills are later 19th century in date and are therefore probable replacements of the original sills. A series of photographs taken in the late 1920s indicates that, at least during this period, the windows were wood-framed casements with centrally opening panes (Figure 12). The casement windows may have been replacements of original early 19th century sash windows which were likely to have been installed when the farmhouse was first built. A cellar window or vent is located at ground level beneath the southernmost window. Despite being the principal elevation there is no doorway on this side of the house. The central bay however is quite narrow and may have been a doorway although there is no clear scar or joint on the brickwork where a door might have been.

Figure 11 Farmhouse west facing elevation ground floor window detail  
Looking east

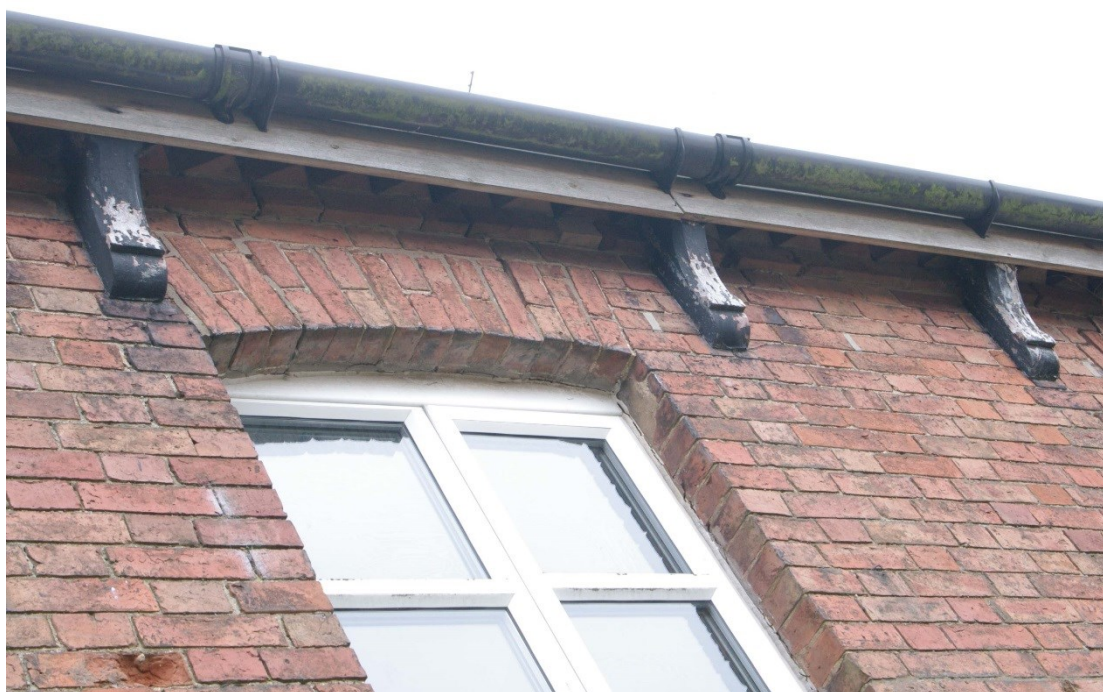
At eaves level is a course of decorative brickwork laid in a dog-tooth course (Figure 13). The decorative course is hidden behind a modern soffit board which holds the guttering. A series of large wooden brackets support the soffit. The brackets appear to be mid to late 19th century in date although they could be earlier.

Figure 13 Farmhouse west facing elevation eaves detail

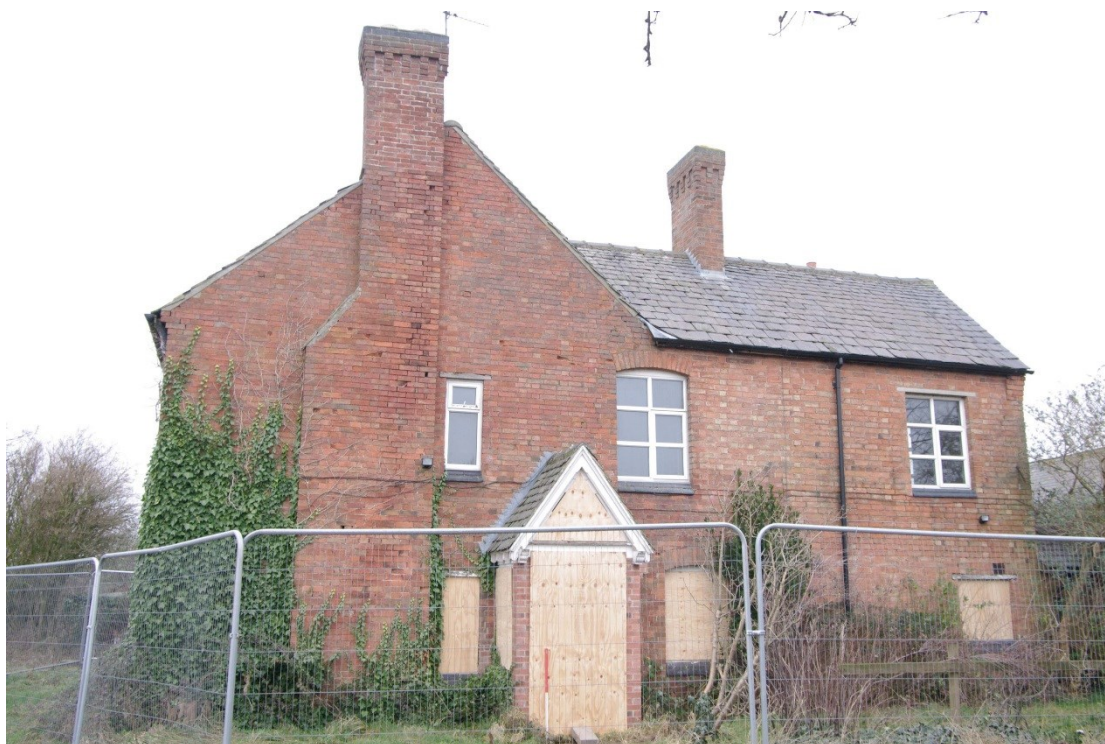
The south facing elevation clearly shows the key phases of the farmhouse (Figure 14). The original early 19th century gable end of the farmhouse is seen at the western end of this elevation and is mostly obscured by a large chimney stack which projects out from the main façade (Figure 15). The stack serves both floors which makes it quite wide at the base. The bricks for the stack match the main house almost up to roof level where it has been rebuilt using slightly lighter bricks. The top of the stack has the same corbelled decoration as the two chimney stacks serving the rear wings of the farmhouse which suggests that they were built, or rebuilt, at the same date. The brick courses on the gable are not quite as decorative as on the west facing elevation but seem to be laid in courses approximating to 1 header to 2 stretchers rather than header/stretcher. Two narrow windows with horizontal wooden lintels and chamfered blue brick sills are located to the eastern side of the stack. Both windows may be late insertions as a photograph taken in the later 1920s indicates that these windows were not present at this time (Figure 16).

Figure 14 Farmhouse south facing elevation  
Looking north-east. 1m scale. Note single storey part of range on far right of photo

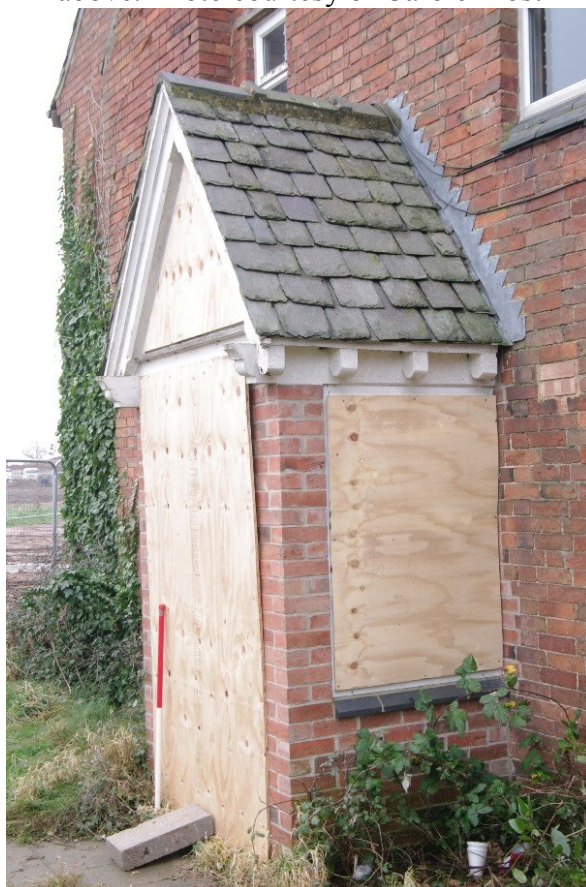
To the east of the chimney stack is a tall late 19th century style porch with a Swithland slate roof (Figure 17). The porch is enclosed with small uPVC windows on either side and has a modern uPVC door on the front, south, side. The brickwork of the porch appears to be quite new and is probably of later 20th century date. The 1920s photograph (Figure 16) also shows that the porch was originally built with just the roof and no sides. The front door inside the porch is of 19th century design and will be discussed later in this report. This doorway appears to have been the main entrance into the house which is rather surprising given the somewhat unprepossessing aspect of this elevation when compared to the west facing elevation. This may be the result of an internal reorganisation of the rooms which is discussed later. The ground and first floor windows immediately to the east of the porch have brick-arched segmental heads laid in soldier courses unlike the flat-arched heads seen on the west facing elevation and are likely to be of a later date. They do however have matching chamfered blue brick sills.

Figure 17 South facing elevation, porch detail  
Looking north-west. 1m scale

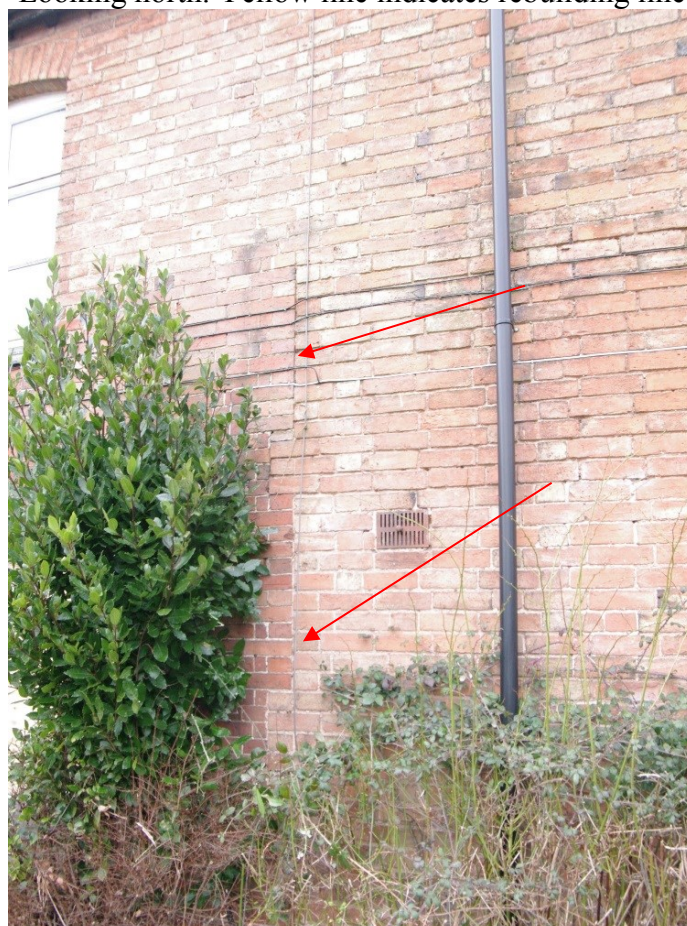
Figure 19 South facing elevation butt-joint between farmhouse and rear range  
Looking north-west. Joint arrowed

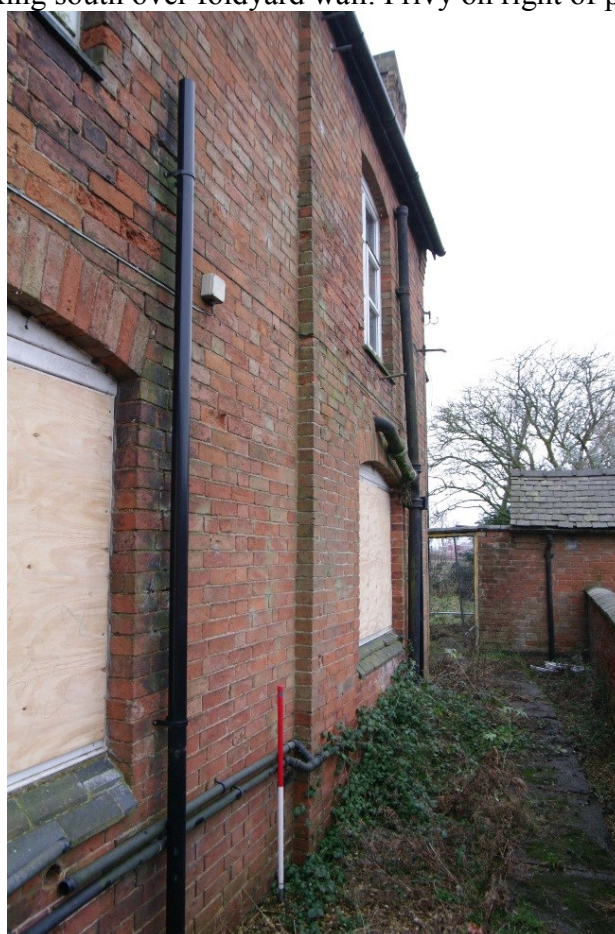
Figure 27 North facing elevation and foldyard wall  
Looking south-west. 1m scale. Note step in wall just beyond the scale

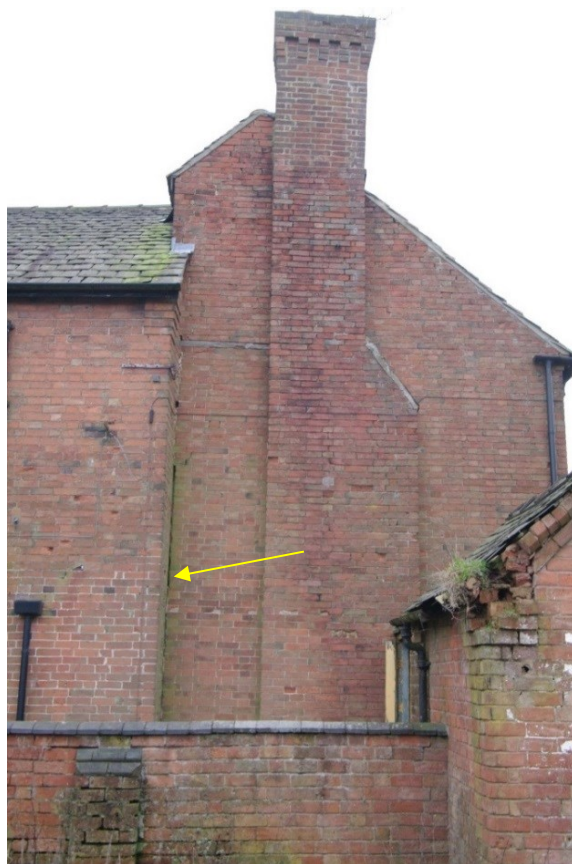
Figure 28 North facing gable of main farmhouse  
Looking south. Foldyard wall in foreground. Privy on right. Arrow points to butt joint  
of farmhouse and rear range

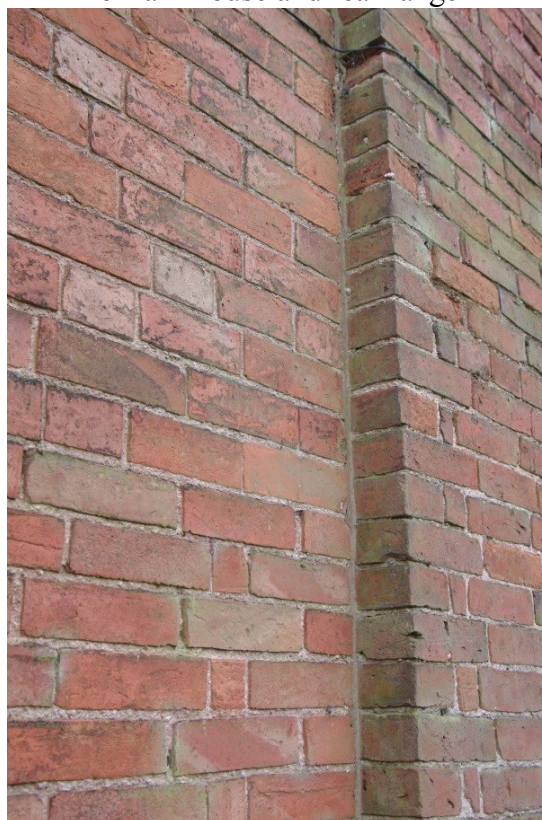
Figure 29 Close-up of step in north wall of rear range  
Looking south-west

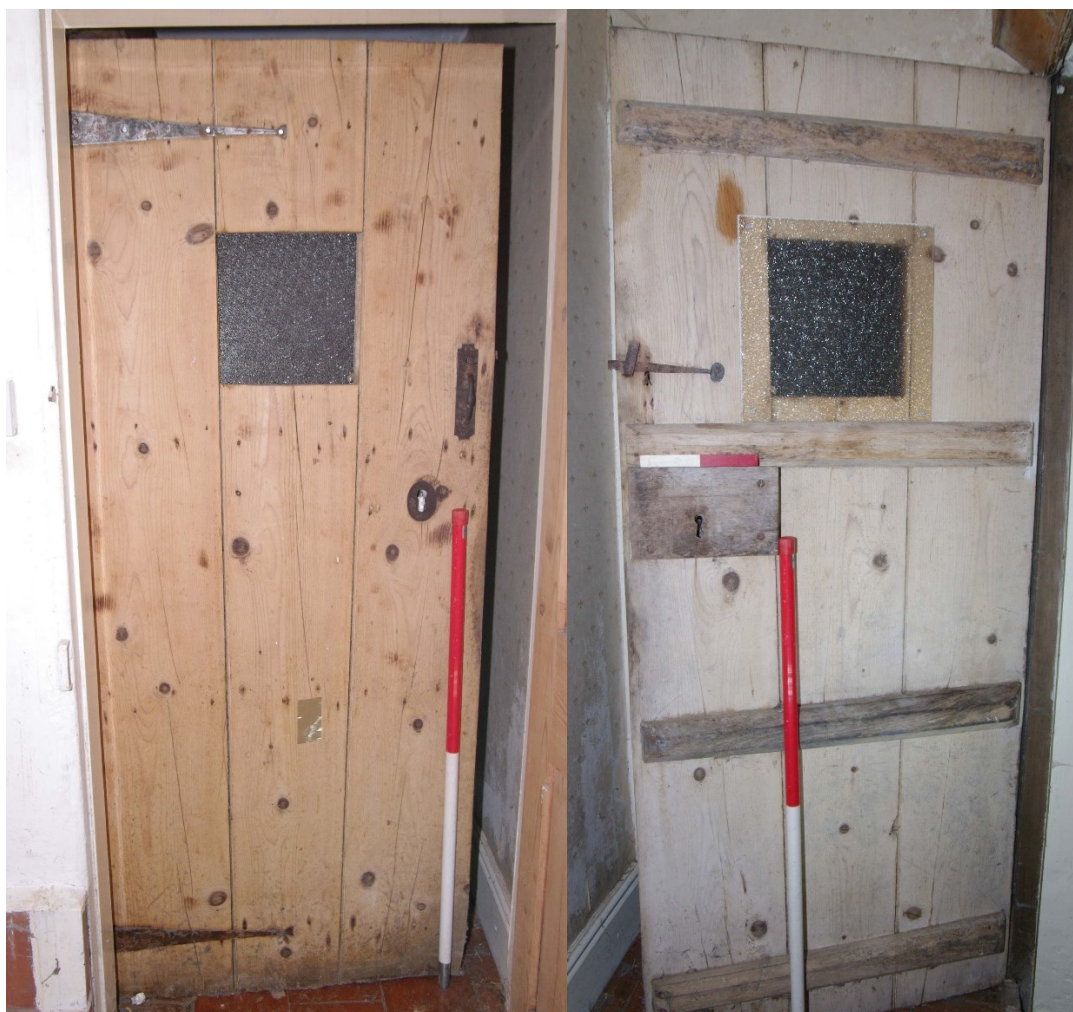
As noted, the cellar is reached via a set of brick steps beneath the main staircase (Figure 54). The door at the top of the steps is a three-plank and batten door with a hand-made latch, strap hinges and a wooden lock case (Figure 55). The door and fittings are probably of early 19th century date, if not earlier, and may have been re-used from another location. The brick steps are quite worn and pass beneath the main staircase which is constructed using parallel strings with the treads being supported on short wooden brackets (Figure 56). The cellar has stone walls with a vaulted brick ceiling and a brick floor (Figure 57 and Figure 58). A low brick thrall runs around the edges of the room. An opening with a uPVC window is located on the west wall. The choice of stone walls for the cellar is perhaps unusual considering the rest of the farm buildings are all built with brick. It may be possible that the cellar belonged to an earlier and smaller building, although map evidence suggests that this may not be the case.

Figure 55 Cellar door detail  
Left: outside, right: inside. 1m scale

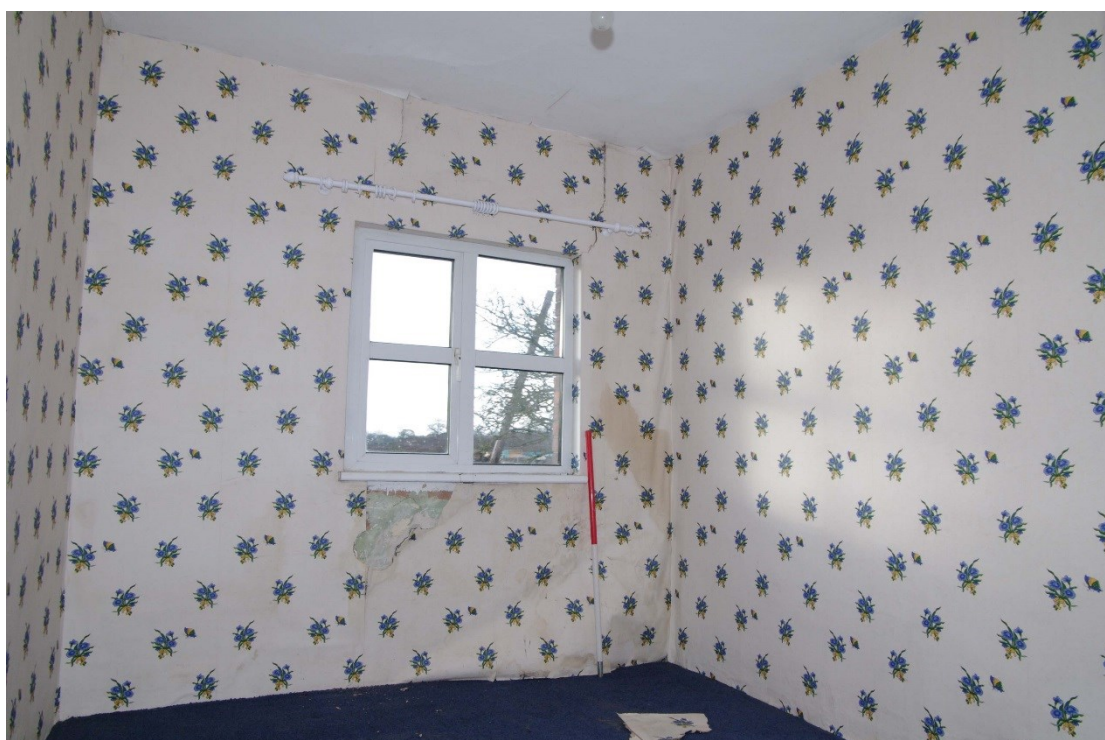
Room 9 is a very small room with no skirting board or picture rail. The four-panelled door and frame is the same as in Room 8. This room, unlike the ground floor rooms, has the small middle window centrally located rather than against the south wall (Figure 63). The floor drops down to the north in the same way as the west facing elevation brickwork drops due to the settlement of the north side of the house.

Figure 63 Room 9  
Looking north-west. 1m scale

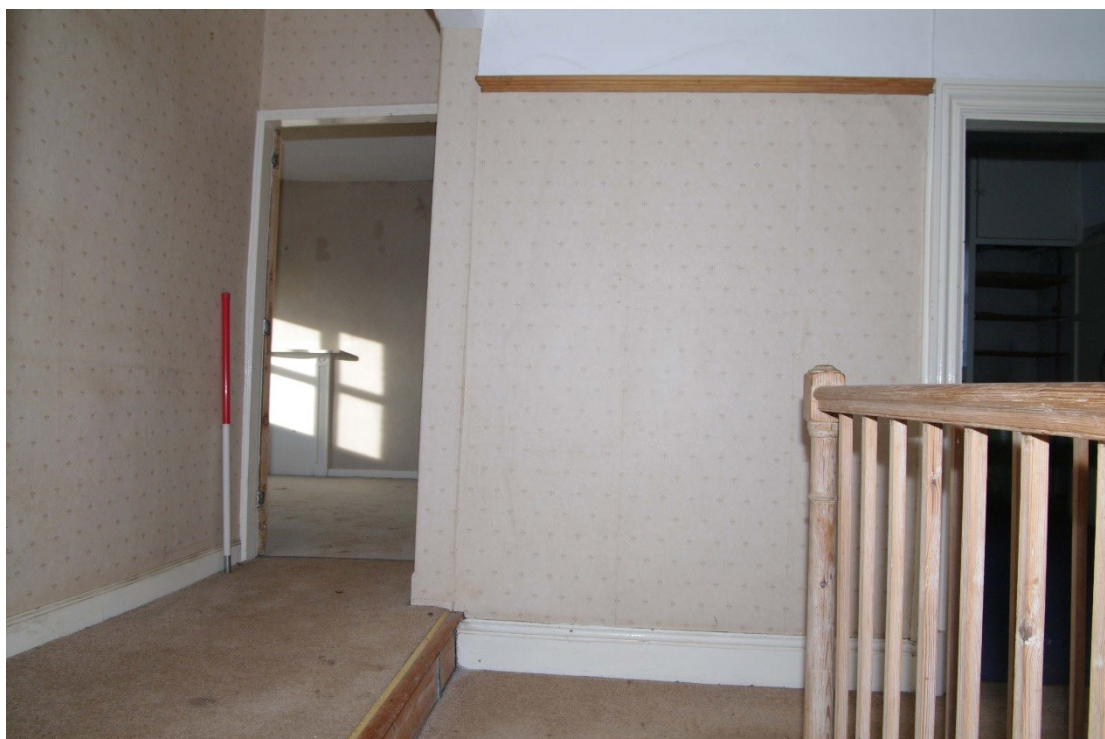
The landing area roughly corresponds to the area over the hallway on the ground floor. The floor level steps up to reach Rooms 8, 9 and 10 in order to accommodate the slightly higher ceilings of the two ground floor rooms (Figure 67 and Figure 68). The dog-leg stair case continues northwards from a half-landing before rising up two steps both to the east and to the west (Figure 69 and Figure 70). The rather awkward arrangement at the top of the stairs may be due to the added rear east to west ranges. The skirting board is quite low in the western part of the landing but is higher to the east. There is a picture rail around the walls although it is not clear if this is part of the original design. The doorframes around the eastern doorways (Rooms 11, 13, 14 and 15) have deeper mouldings and match those in the ground floor hallway.

Figure 67 Room 12/landing  
Looking north-west. 1m scale. Note step in floor level, also note difference in door frame moulding detail

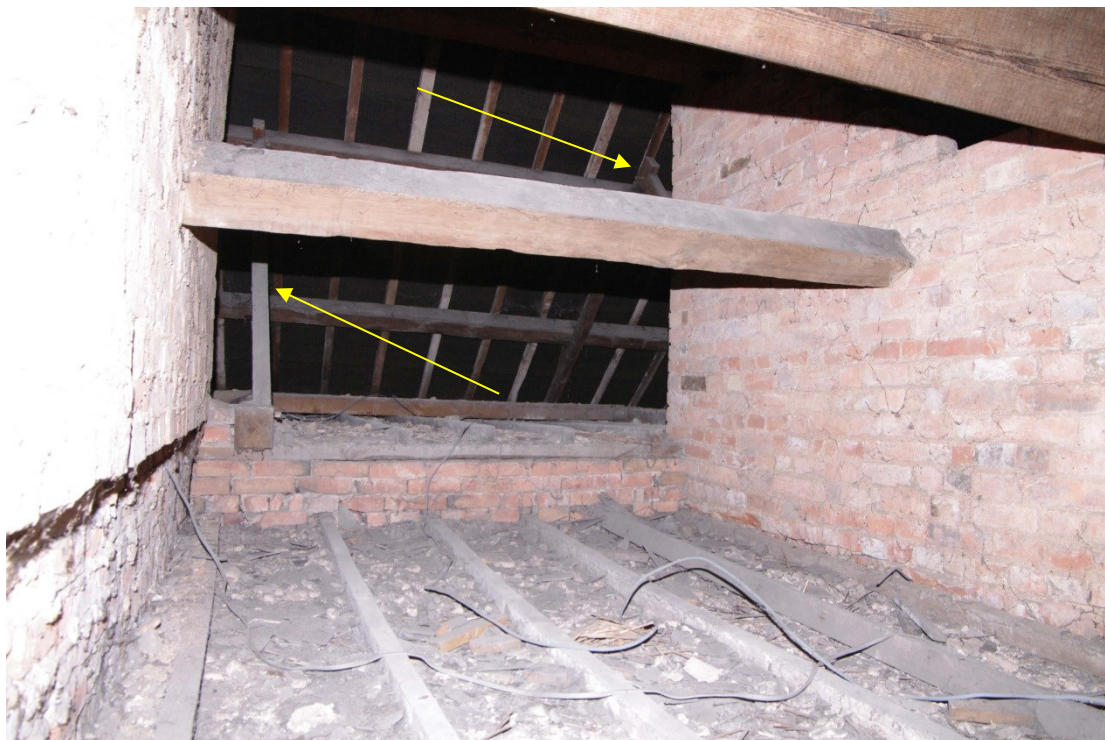
Running from north to south above the stairs is an exposed purlin which may be a remnant of the original roofline of the farmhouse before the rear ranges were added (Figure 71). A small hatch above the stairs allows a limited view of the farmhouse roof structure (Figure 72). It can be seen that the front (west) half of the roof has two cleated purlins supported on the backs of the principal rafters. The rear (east) half of the roof structure has been modified by the addition of the two rear ranges which has left the original purlins truncated and supported by the landing walls. The lower of the two purlins is the one on the landing seen in the ceiling above the stairs. The modified roof structure appears to have caused an imbalance in weight distribution. To remedy this the west side of the farmhouse roof has had to be supported by two additional props running from the top of the east wall of Rooms 8 and 10 up to the top purlin. The props have been pegged to the principal rafters. The added rear ranges appear to be of mid-19th century date so the use of wooden pegs in the modified roof is perhaps unusual. It

may be that the props were a quick solution to an unexpected problem and the repair was made by a local builder who was still using traditional techniques.

Figure 72 Roof structure of main farmhouse  
Looking west from hatch over staircase. Pegged supports arrowed

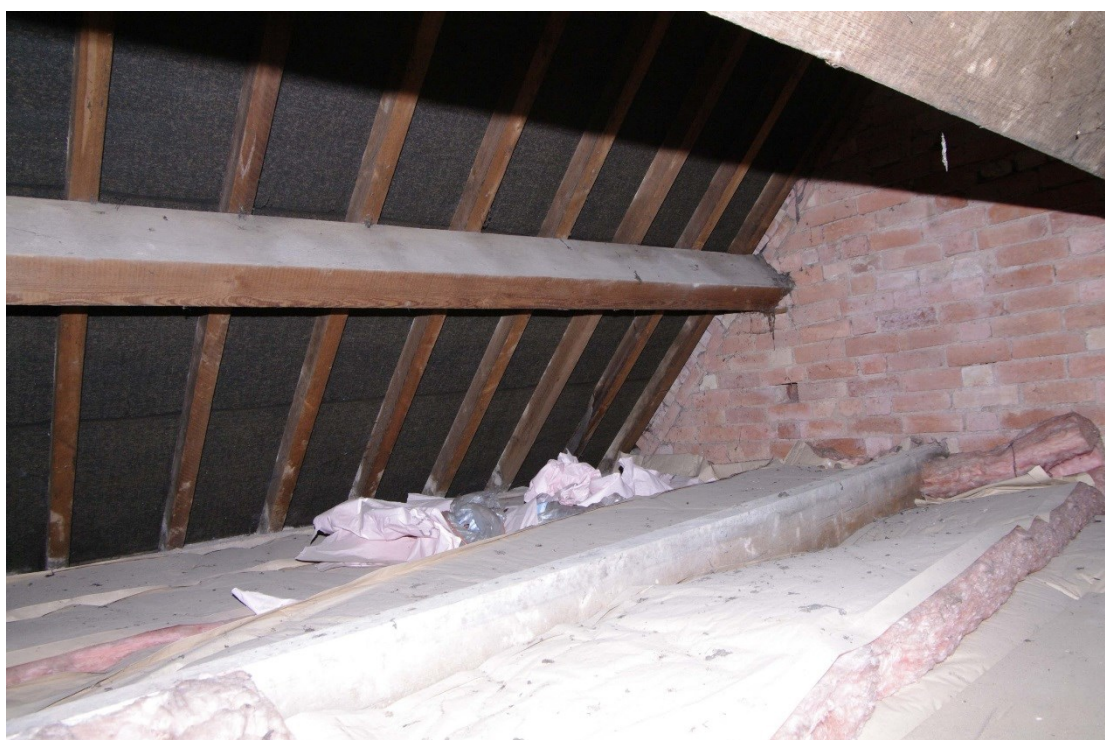
A small hatch in the ceiling gives access to the roof space above the southernmost east to west range (Figure 77). Although the view is limited it can be seen that the structure is quite simple and consists of a pair of purlins supported at each end bay a brick gable. The common rafters all sit on the backs of the purlins. Roofing felt has been laid beneath the slates which suggests that the roof has been repaired recently.

Figure 77 Roof structure above Room 14  
Looking south-west

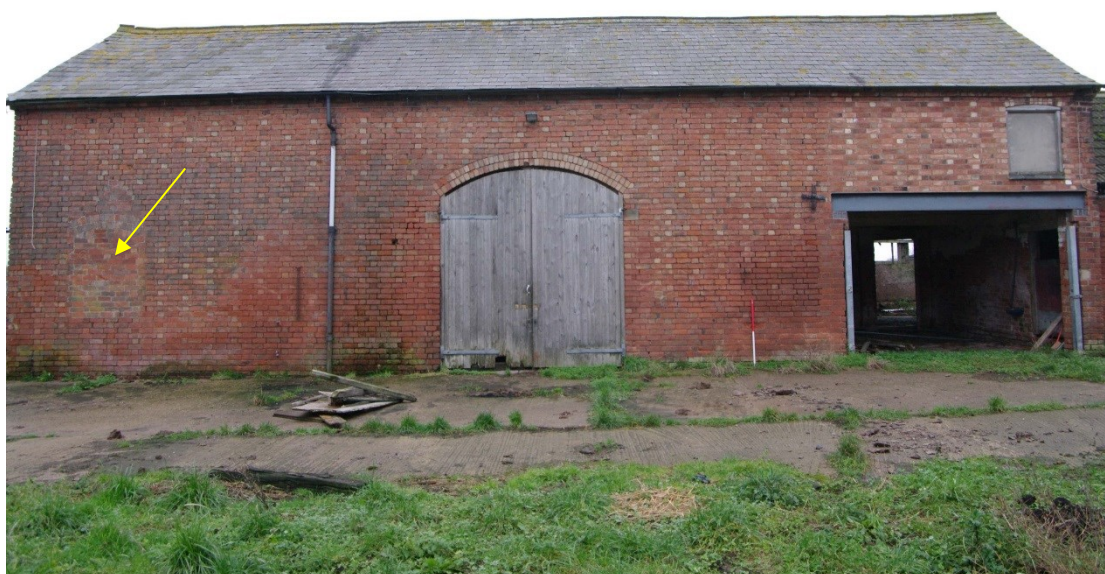
Figure 83 North to south barn. West facing elevation of north end of range  
Looking east. 1m scale. Arrow points to blocked window. Note rebuilt brickwork  
above steel lintel on right

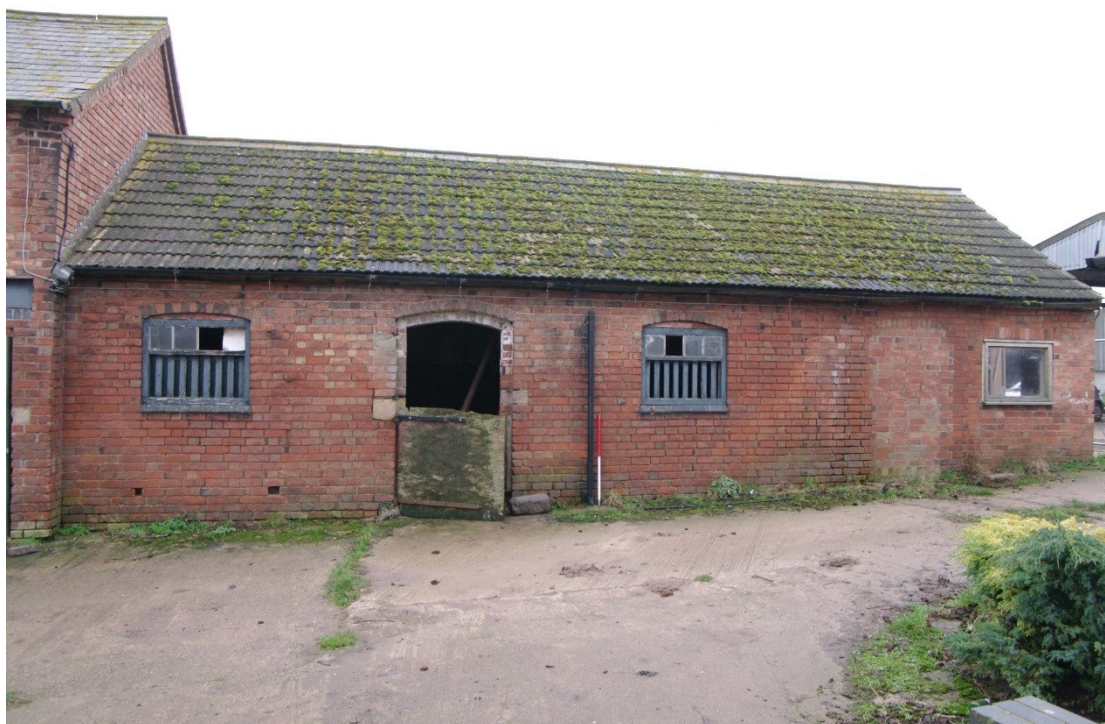
To the south of the modern opening the roofline drops down and the wall-line steps in slightly to form the southern half of the range (Figure 84). Although the wall steps inwards the brickwork appears to be the same and the courses align with each other from the north side to the south side. This suggests that the two sides were probably built at the same time. As noted, the roof covering is of modern cement tiles.

This part of the range appears to have been built as a set of loose boxes with two sets of wide doors and three matching windows with chamfered blue brick sills. The southernmost doorway has been blocked with bricks and the southernmost window next to the door has been rebuilt to house a modern rectangular glazed window with a horizontal lintel with a wooden sill. The remaining two windows have hit and miss wooden shutters and brick-arched heads. The remaining single doorway has a recessed jamb housing a stable door with stone blocks housing the pintles. Only a modern plywood door is present. The blocked door and modified window appears to have taken place when the southern end room was modified to form a milk processing room. This will be discussed later as part of the internal discussion. Most of the southern end of the barns has a brick bonding pattern of three headers to one stretcher although where the doorway has been blocked and around the southernmost window the bonding pattern becomes rather random which suggests that this part of the wall has been rebuilt.

Figure 84 North to south barn. West facing elevation, south end of range  
Looking east. 1m scale

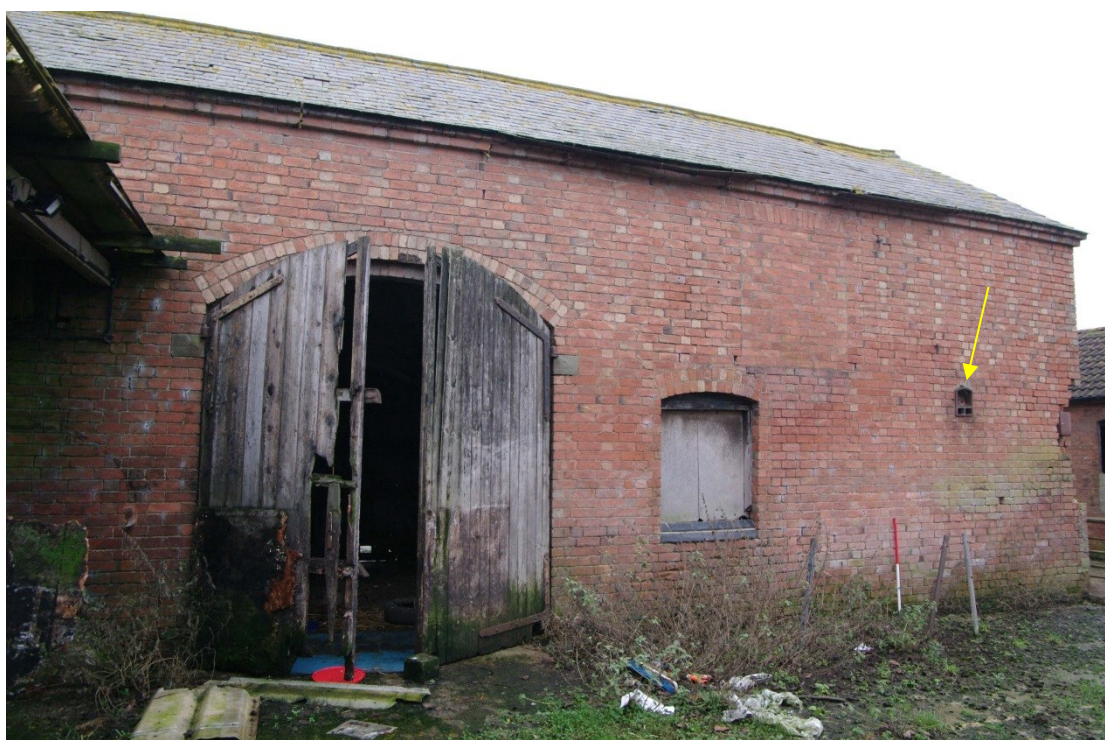
Figure 91 North to south barn. East facing elevation, northern end  
Looking north-west. 1m scale. Bearing box arrowed

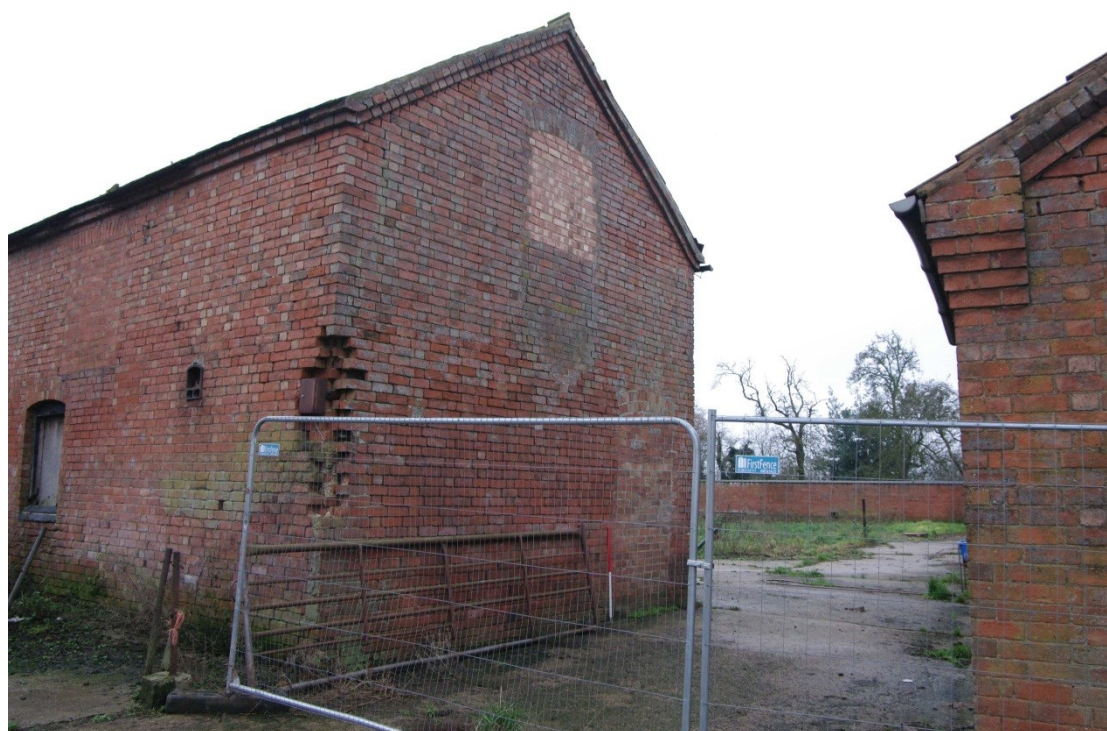
The north facing gable end of this range has two blocked openings (Figure 92). At ground floor level is a single width doorway with an arched brick head which has been blocked with red bricks. The first floor window also has a brick arched head but the blocking brickwork appears to be quite recent. The gable-end brick courses and bonding of three stretchers to one header matches that seen on the other elevations of this building. At eaves level the brickwork has a low-relief decorative course which matches that on its south facing gable. The north-east corner of the elevation has been damaged, probably by modern equipment cutting the corner too closely.

Figure 92 North to south barn. North facing gable end  
Looking south-west. 1m scale. Blocked doorway to right of scale. Compare brickwork  
decoration of both ranges

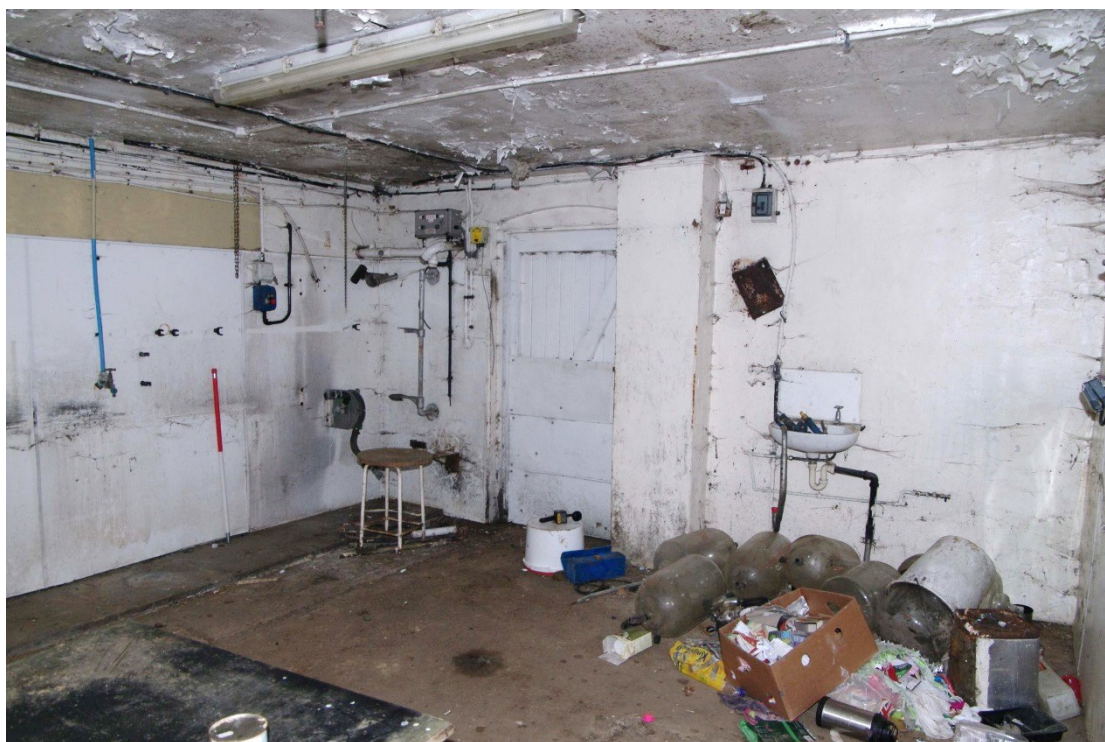
Room 4 is the southernmost room of the north to south barn. Most recently it has been used as the milk processing and storage area and has had modern white panelling attached to the walls for cleanliness (Figure 102). The ceiling has modern plasterboard attached to the joists and the floor is modern concrete. A number of junction boxes and electrical equipment connected to milking are attached to the walls. The modern additions are likely to have been installed at the same time as the doorway on the west wall and the window was modified. The modifications may also have been carried out when the south end wall was rebuilt and the roof covering was changed to cement tiles.

Figure 102 North to south barn. Room 4  
Looking north-east. 1m scale. Note glass milk receptacles on floor

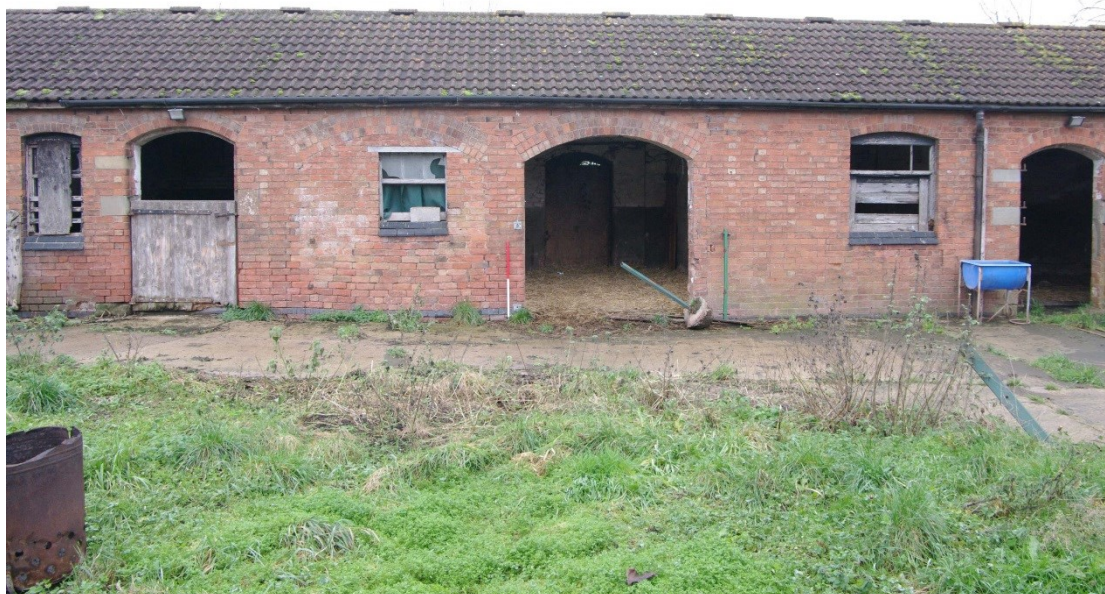
Figure 107 East to west barn. South facing elevation, centre section  
Looking north. 1m scale. Note blocked arch to left of scale

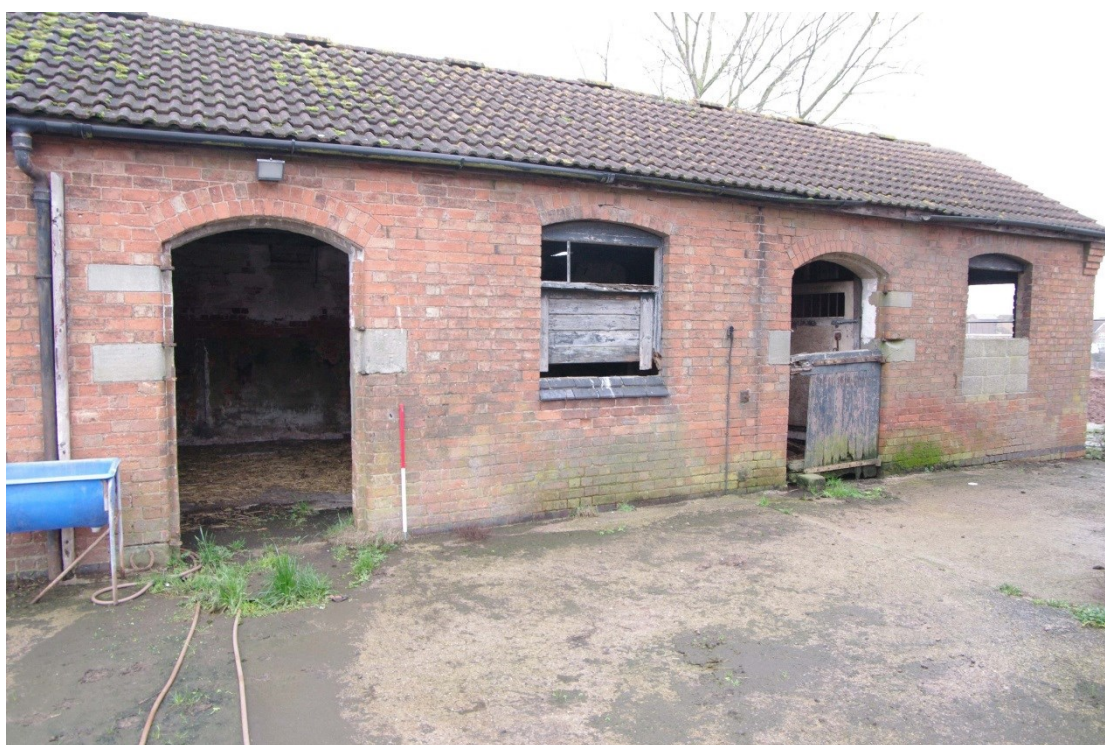
To the east of the two central arched openings are a series of windows and stable doors which lead into what were probably a number of loose boxes when first built (Figure 108). Two of the three windows have chamfered blue brick sills matching the farmhouse sills. The easternmost window has been partially blocked with modern breeze-blocks and has had its sill removed. The two doorways have stone blocks and pintle indicating the former presence of stable doors.

Figure 108 East to west barn. South facing elevation, eastern end  
Looking north-east. 1m scale

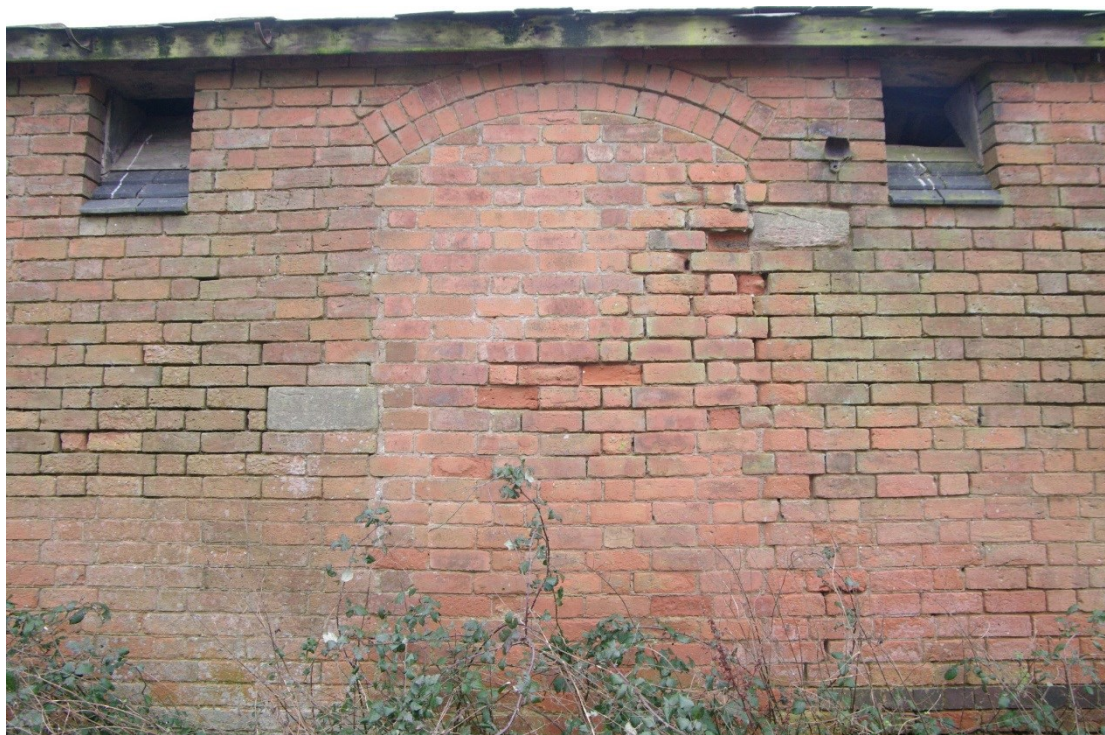
The north facing elevation is a long brick-built façade broken only by a regular series of vents below the eaves and by two single-width doorways (Figure 110 and Figure 111). The vents have chamfered blue brick sills and wooden frames. One of the doors has been blocked with red bricks laid in courses of three stretchers to one header which matches the rest of the wall. The other doorway has a wooden door but, at the time of the survey, was heavily overgrown and obscured with brambles and shrubs.

Figure 112 East to west barn, north facing elevation, vents and blocked doorway  
Looking south

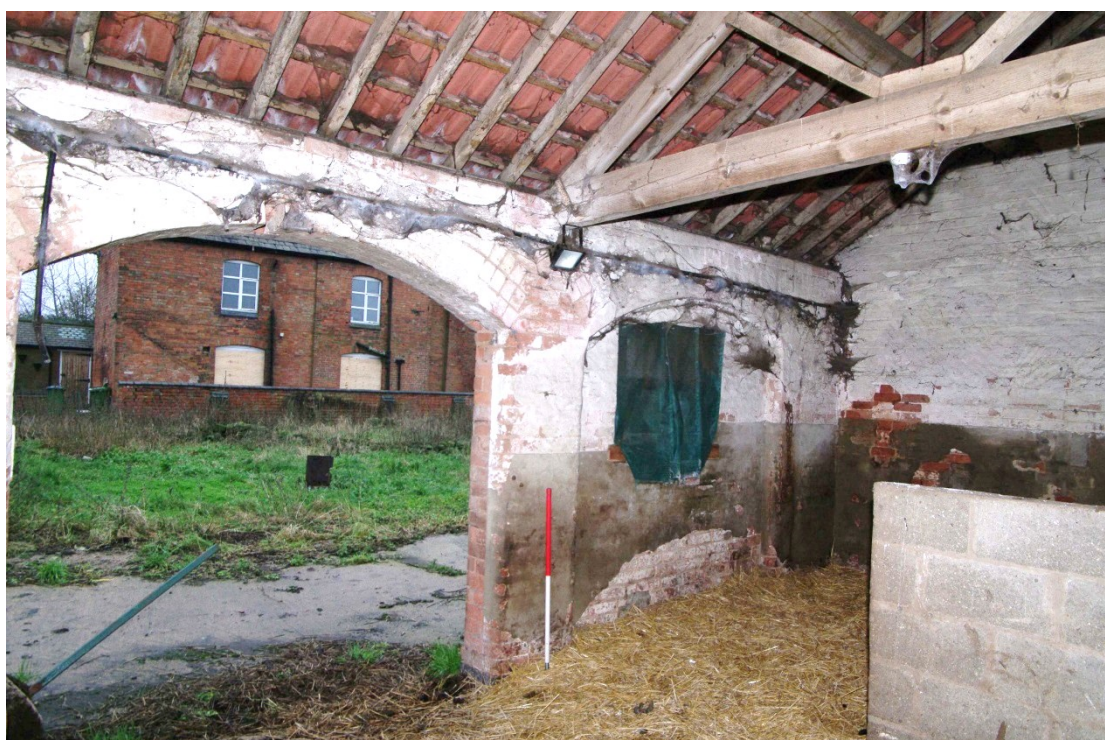
Room 4 appears to have been built as an open-fronted room with two wide arches on the south wall. The westernmost arch has been blocked and replaced with a wooden-framed casement window (Figure 119). A single-width doorway still survives on the north wall although the door has been replaced by a sheet of plywood (Figure 120). There are two doorways on the east wall leading to Room 5. The southernmost of the two doorways is quite wide and appears to be the original doorway and has a plank-built door. The northern doorway is not quite as wide and is fairly rough around the edges suggesting that it has been broken through at a later date. The door also appears to be more domestic in style rather than the expected agricultural door which might be used. It seems likely to have been reused from elsewhere. A modern breeze block wall creates a small animal stall in the western part of the room.

Figure 119 East to west barn. Room 4  
Looking south-west. 1m scale. Note blocked arch to right of scale

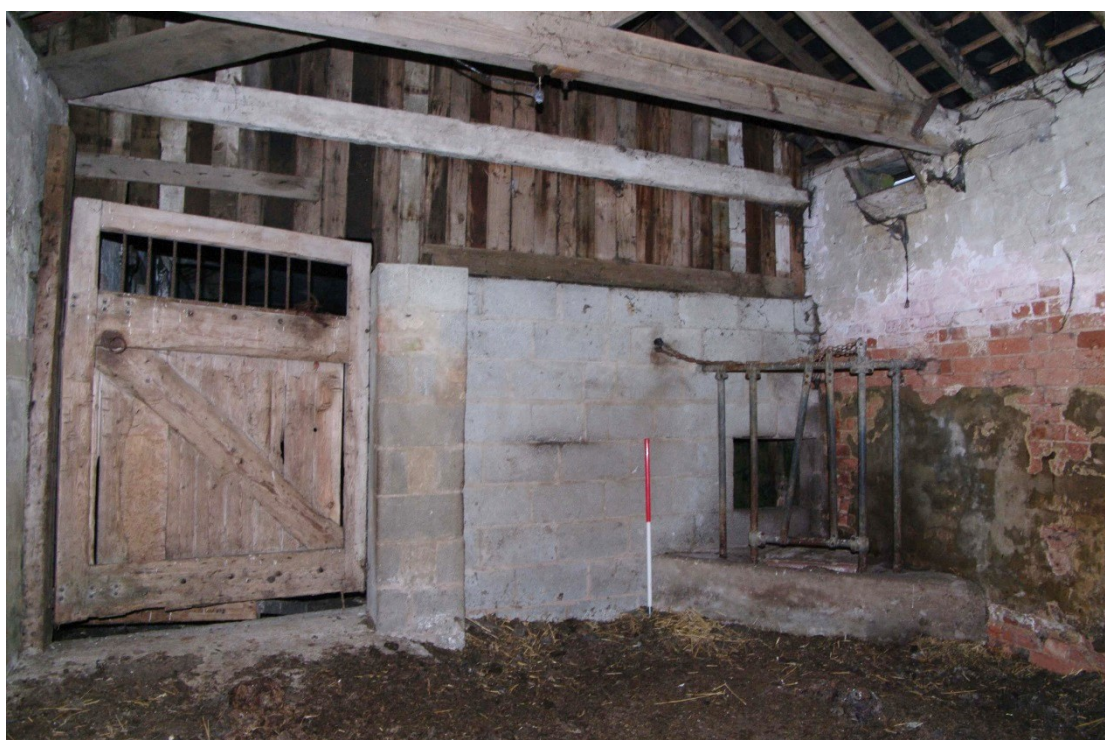
Room 6 is a modern inserted room created by the breeze block dividing wall to Room 5. It appears to have been used as a possible animal treatment room or isolation room with a small trough in the north-west corner which has a head restraint bar in front (Figure 123). The east wall has the modified doorway leading outside as discussed above. The sides of the doorway have been extensively rebuilt making it impossible to tell if this opening started as a window.

Figure 123 East to west barn. Room 6  
Looking north-west. 1m scale

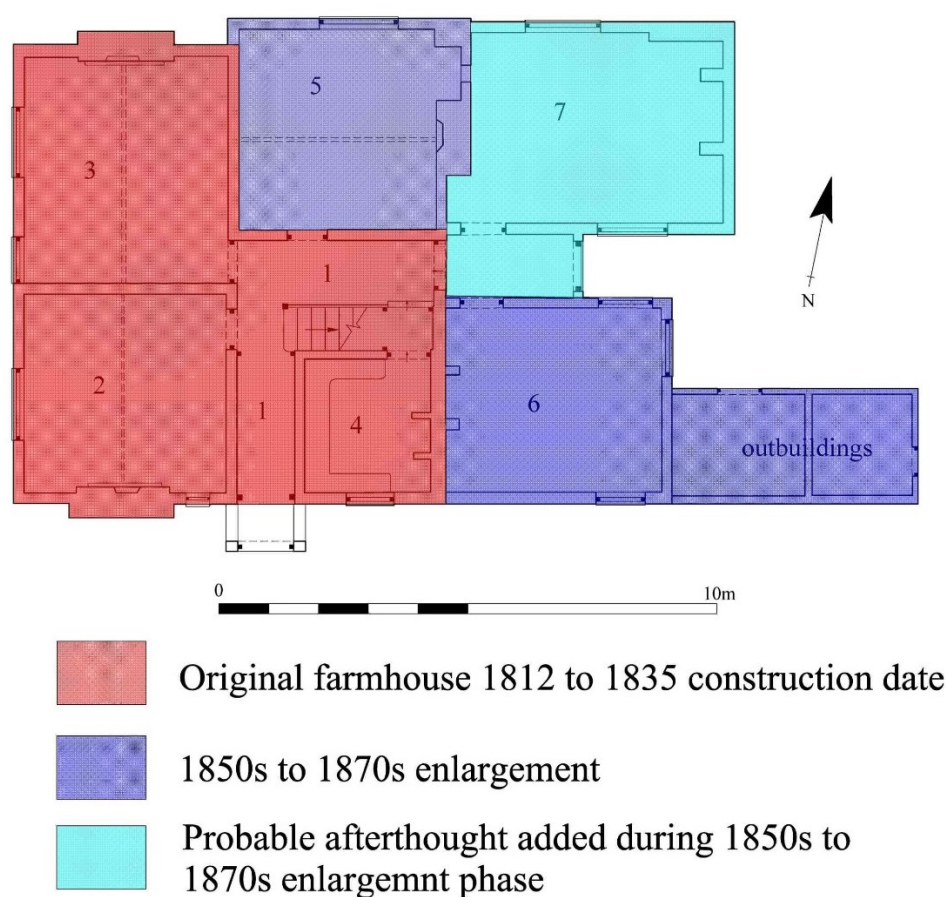
A major change and reorganisation swept over the farm in the mid to later 19th century, probably between the 1850s and the 1870s (Figure 124 below). This phase completely rebuilt the rear, east facing, side of the house and also placed the front door on the south facing elevation. Two new east to west ranges were added along with a rebuilding of the existing chimney stacks. The northernmost of the two new rear ranges appears to have been modified as an afterthought during its construction and was extended further east to add an extra room on both floors. This phase of extension appears to have been carried out with some care as a lot of attention was paid to the matching brick decoration around the tops of the chimney stacks and corbelled corners of the buildings. The matching blue brick chamfered window sills appear to have been part of the refurbishment scheme too. The enlargement of the house was not without its problems as the truncation of the east side of the roof appears to have needed some remedial work with props having to be added to support the uneven weight of the roof. The rather awkward set of extra stairs on the east side of the original dogleg which leads to Rooms 14 and 15 are another example of where the extension did not quite work. At the same time as the farmhouse extension the east to west barn on the north side of the foldyard was added. The privy was also rebuilt or added at this stage too.

Figure 124 Likely phases of farmhouse development
