**A Historic Building Recording at
Heather Hall,
Sweepstone Road,
Heather,
Coalville,
Leicestershire**

ULAS Report No. 2018-055
©2018

For: David Granger Architectural Designs Limited

A Level 3 Historic Building Recording of the Morning Room at Heather Hall, Swebstone Road, Heather, Coalville, Leicestershire. NGR SK 3818 1057

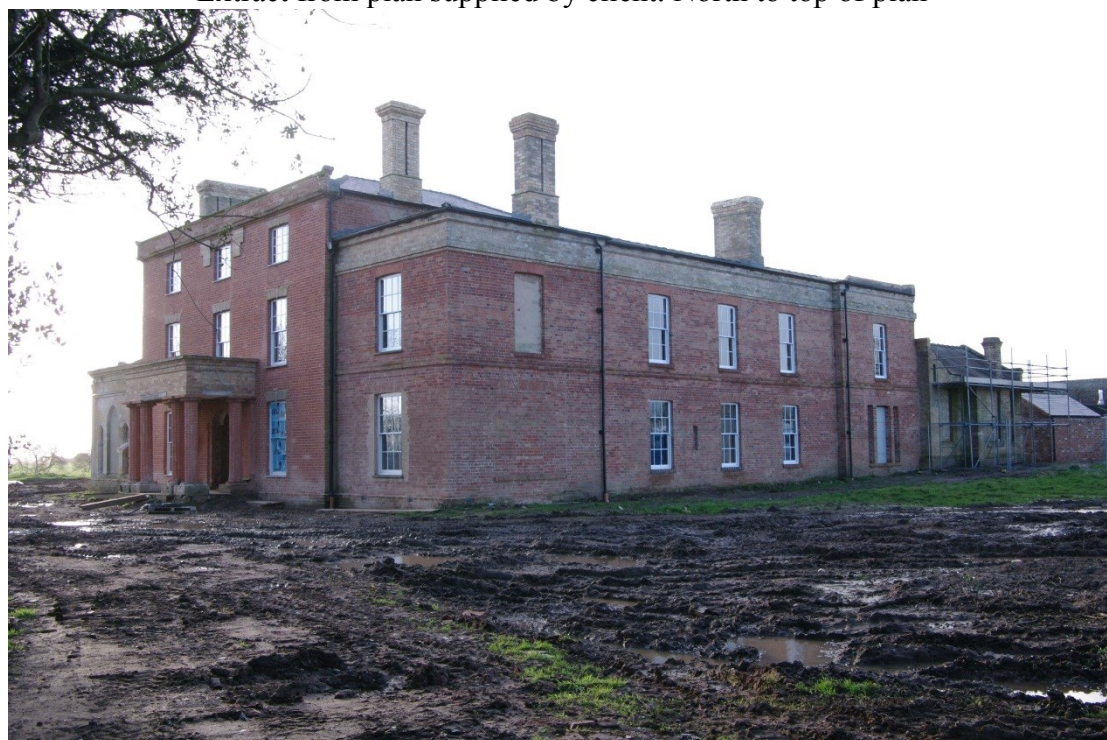
Figure 3 Heather Hall north and east facing elevations
Looking south-west. Morning room on far left behind added-on porch. Original 18th century farmhouse core in centre with later added wing to right. Part of stable block on far right of picture

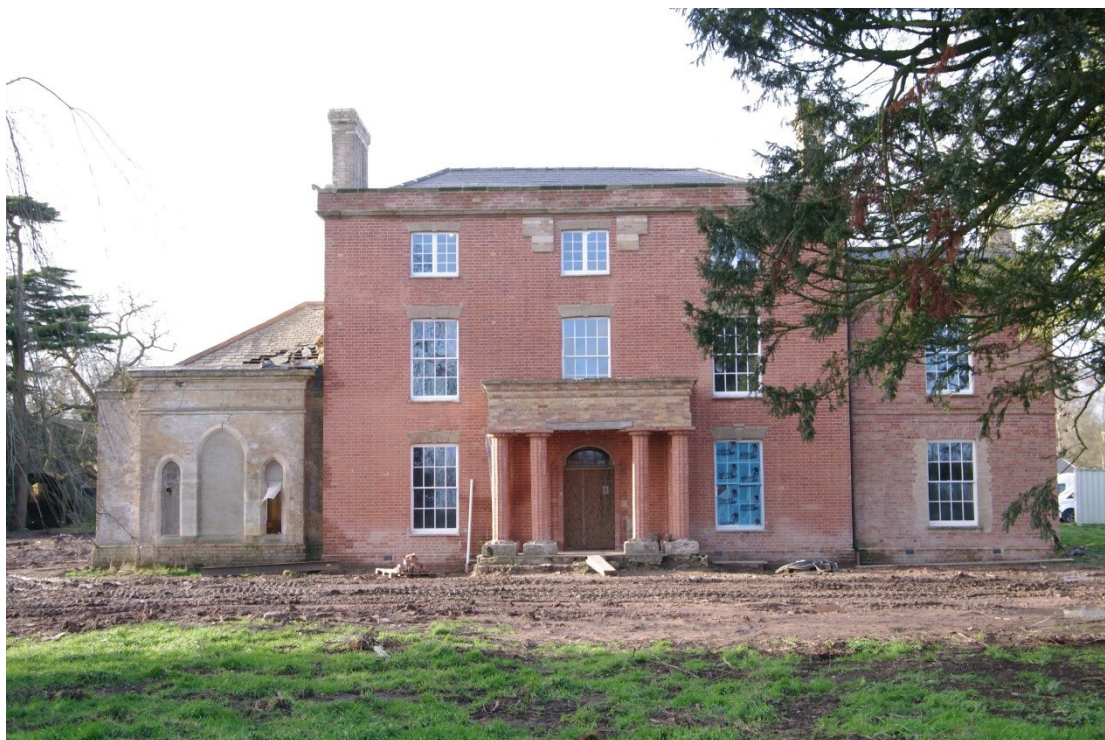
Figure 4 East facing elevation of Heather Hall and the morning room
Looking west. Morning room on left of picture

The east facing elevation is located on the south side the principal east facing façade of the original late 18th century farmhouse building (Figure 4 above). Where the two structures join the wall-line steps in to create a noticeable change rather than trying to blend seamlessly with each other (Figure 7). The brickwork of the morning room butts against the farmhouse rather than having been keyed into it. The east facing elevation has three lancet windows set below a projecting entablature and above a brick plinth. String courses and the top of the entablature are all made from yellow bricks. The window surrounds are made of fine-grained limestone with some moulding detail. The centre window has been blocked but a photograph taken in the early 1900s and shown in Finn's 2015 report shows this to be glazed, although there is no tracery present even at this time. There is a small settlement crack in the arch of this window which extends up to the top of the wall. The two flanking windows are smaller and retain some of their very plain wooden frames. Some glazing survives but most has been broken.

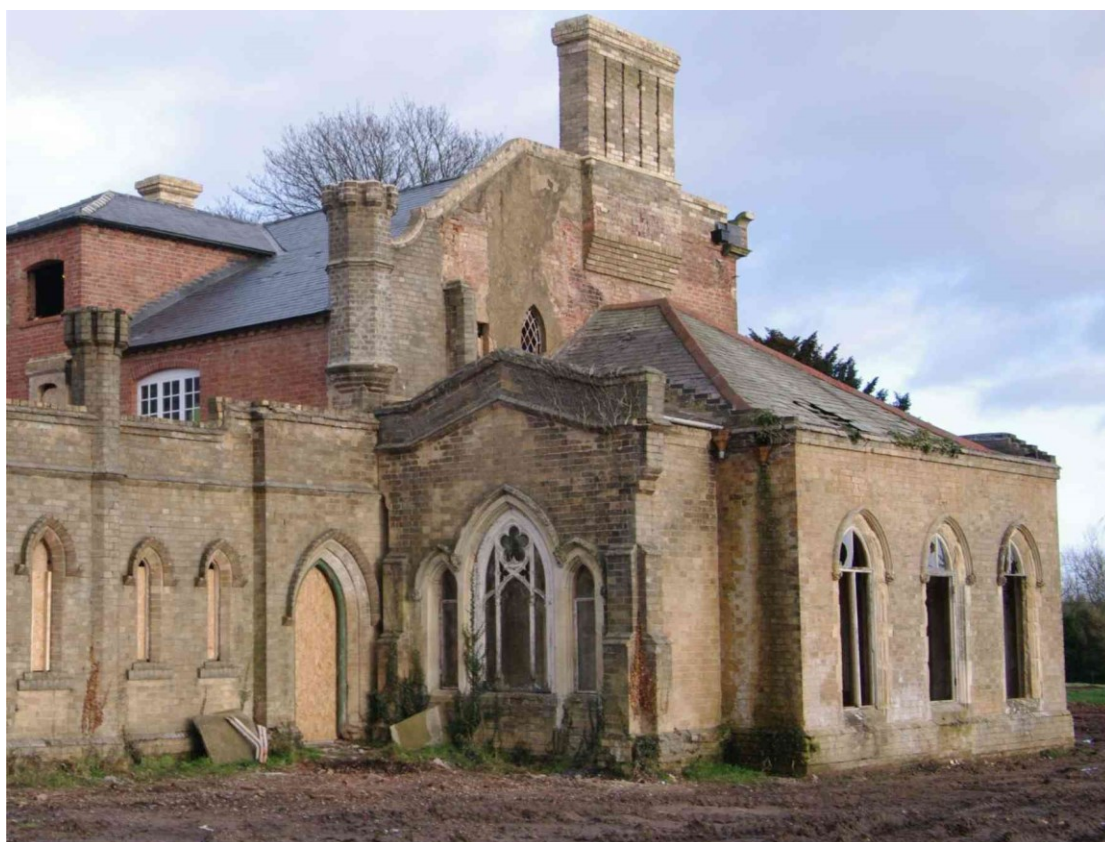
The south facing elevation also has three lancet windows although on this elevation the windows have hood mouldings and floral decorative stops (Figure 8). The hipped roof rises up to join the main farmhouse wall where the brickwork shows clear signs that the morning room once extended to two stories (Figure 9). Figure 10 shows the two-storied morning room in the early 1900s when it also retained its traceried ground floor window frames. At the time of the survey the windows only had glazing in the heads of the arches and remnants of very plain wooden window frames. The frames match those on the east facing elevation and indicate that the original frames are likely to have been replaced since the 1900s photograph was taken. The proposed new-build structure will be accessed through the centre window which will be lengthened to create a new doorway. This should cause minimal damage to the existing fabric of the building.

Figure 9 West and south facing elevations of morning room
Looking north-east. Compare with Figure 10 below

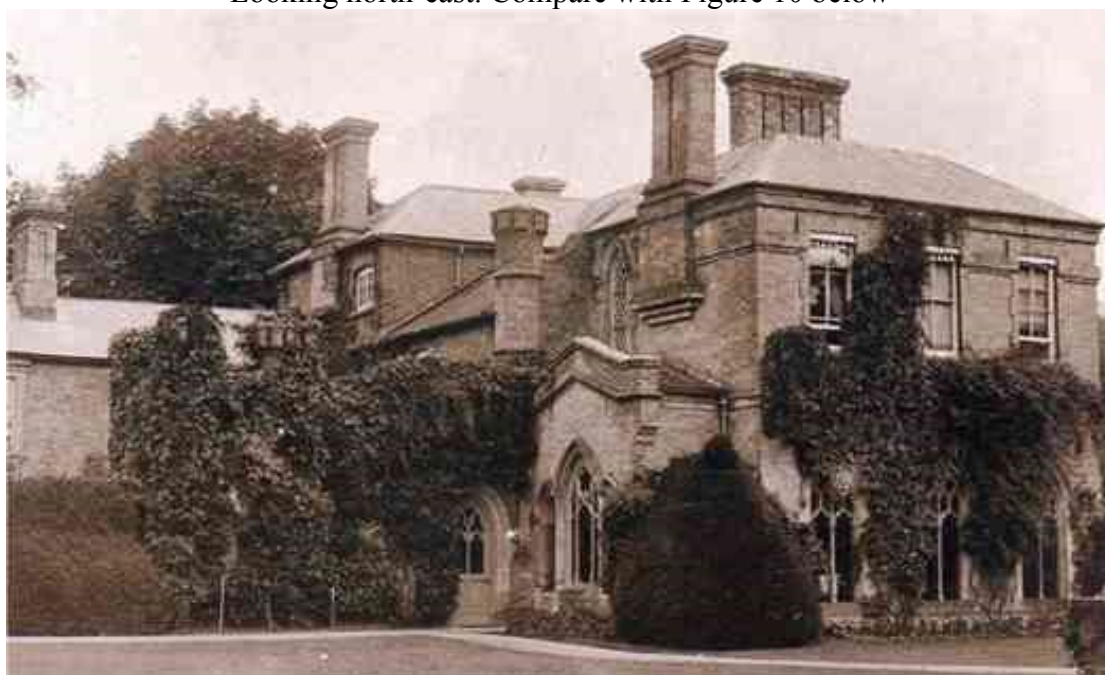
Figure 10 West and south facing elevations of morning room c1900
Looking north-east

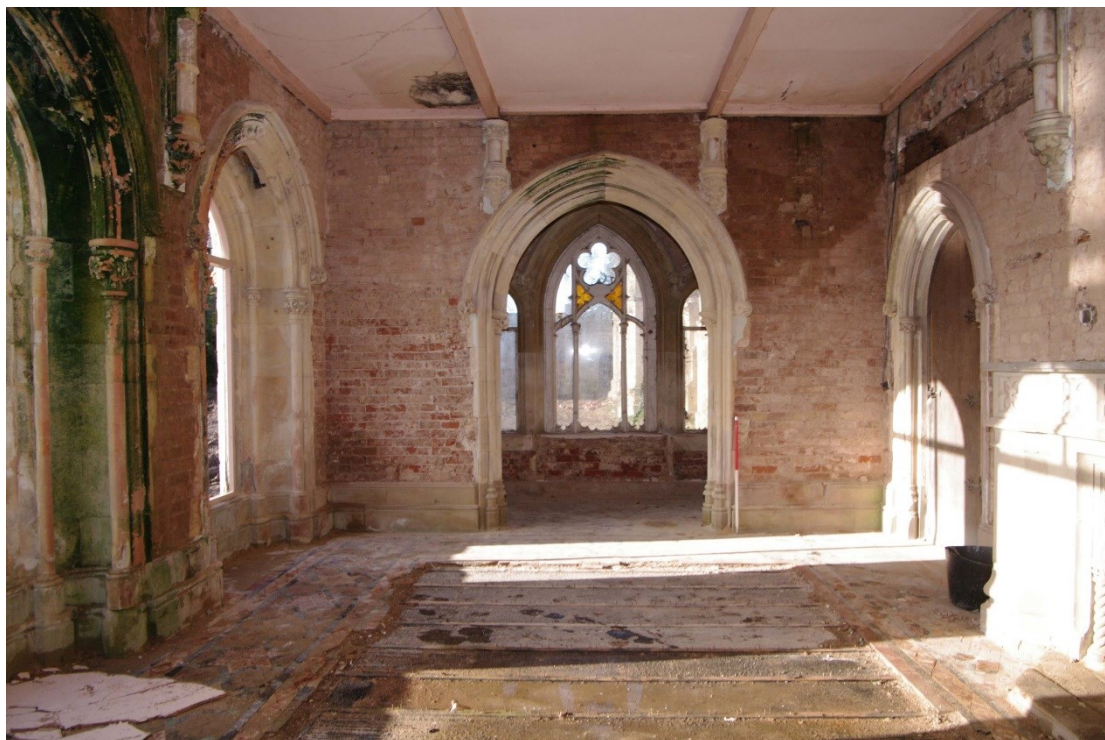
The morning room is reached from the main house through a wide doorway set close to the north-western corner of the room. It consists of a large open space with the smaller orangery set into a wide recess at the western end (Figure 13 and Figure 14). The poor state of the slate roof has resulted in significant water damage to both the woodwork and the masonry components of the fabric. At the time of the survey all of the wall plaster had been stripped away leaving the bare brickwork. Finn's 2015 survey shows the room with the plaster still in-situ. In his report the plasterwork appears to be quite plain and undecorated.

Figure 13 Morning room general view
Looking west. 1m scale. Arched doorway into main house on right

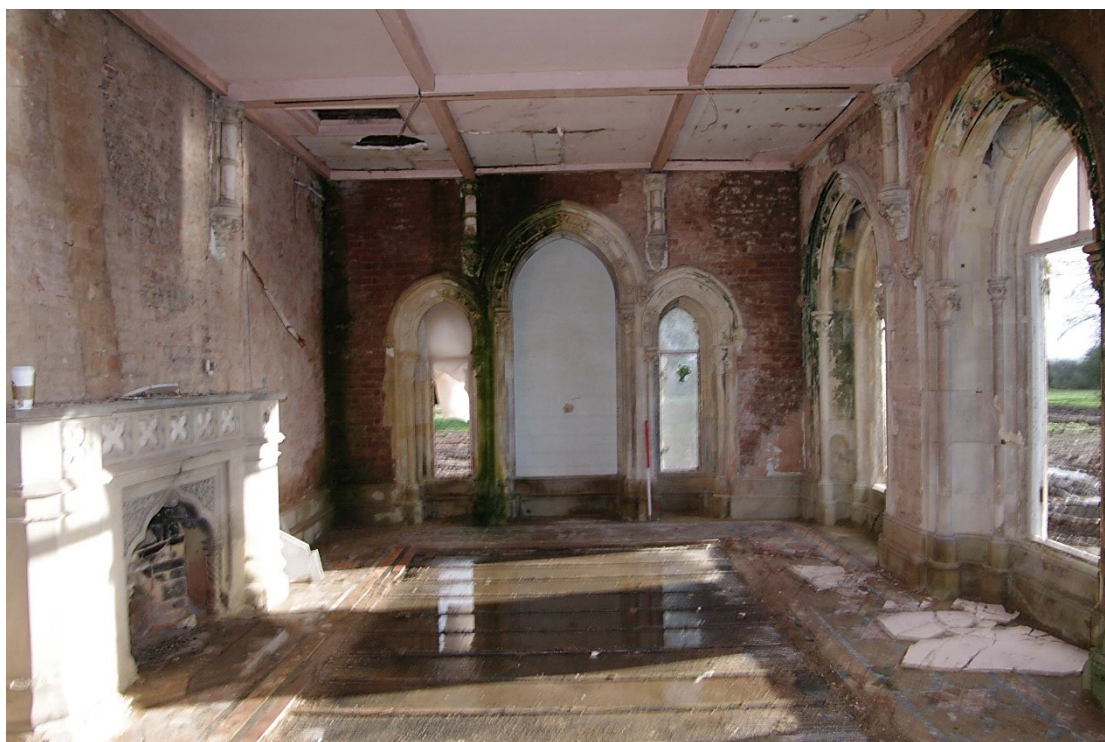
Figure 14 Morning room general view
Looking east. 1m scale

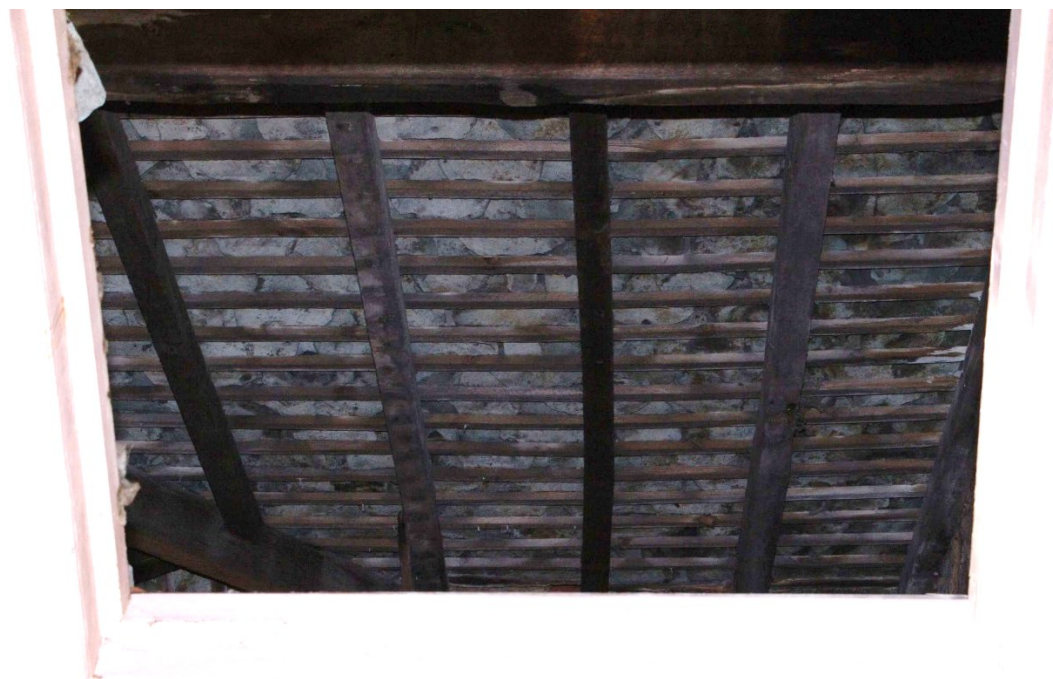
The ceiling has a relatively modern flat covering supported by narrow wooden beams attempting to create a panelled effect. A hatch in the ceiling shows the underside of the slates which are crudely shaped and likely to be Swithland slates (Figure 16). The flat ceiling appears to have been constructed following the removal of the first floor. It is clearly not the original ceiling as a series of limestone and marble rounded pilasters run around the room at ceiling height (Figure 17). These now support the modern ceiling woodwork but presumably supported a much more decorative structure. Each has a delicately carved base with flowers and foliage (Figure 18). Many of the flowers appear to be associated with spring time which is in keeping with the room's original use as a garden room.

Figure 16 Underside of slates seen through hatch in ceiling

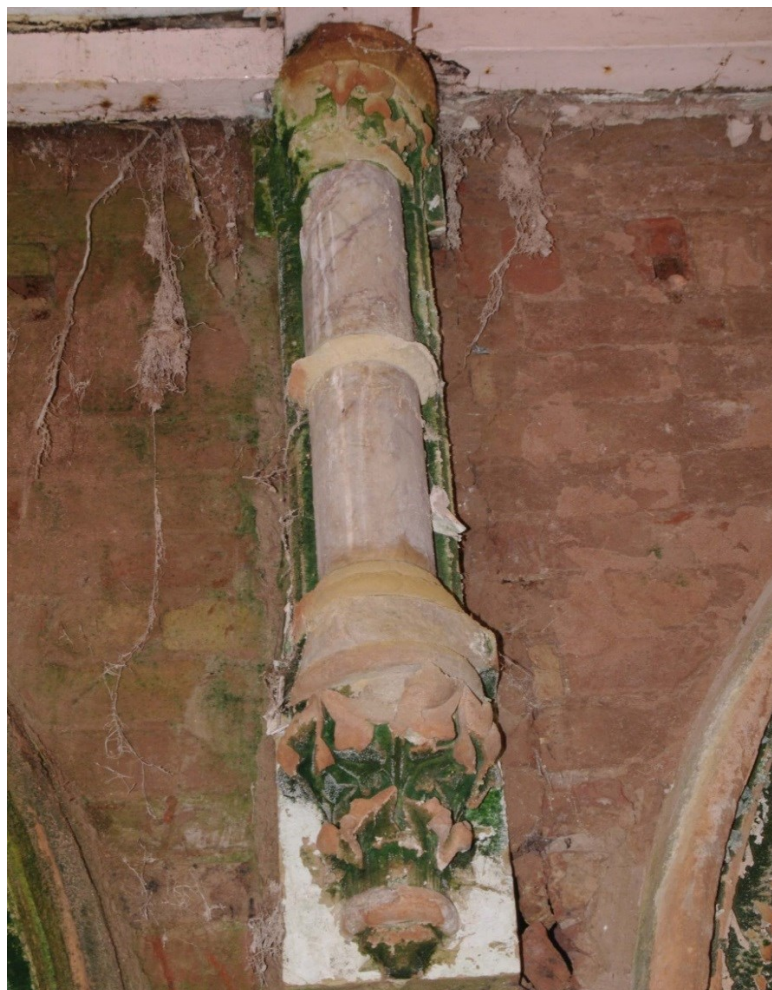
Figure 17 Original stone and marble ceiling support
North-east corner of room

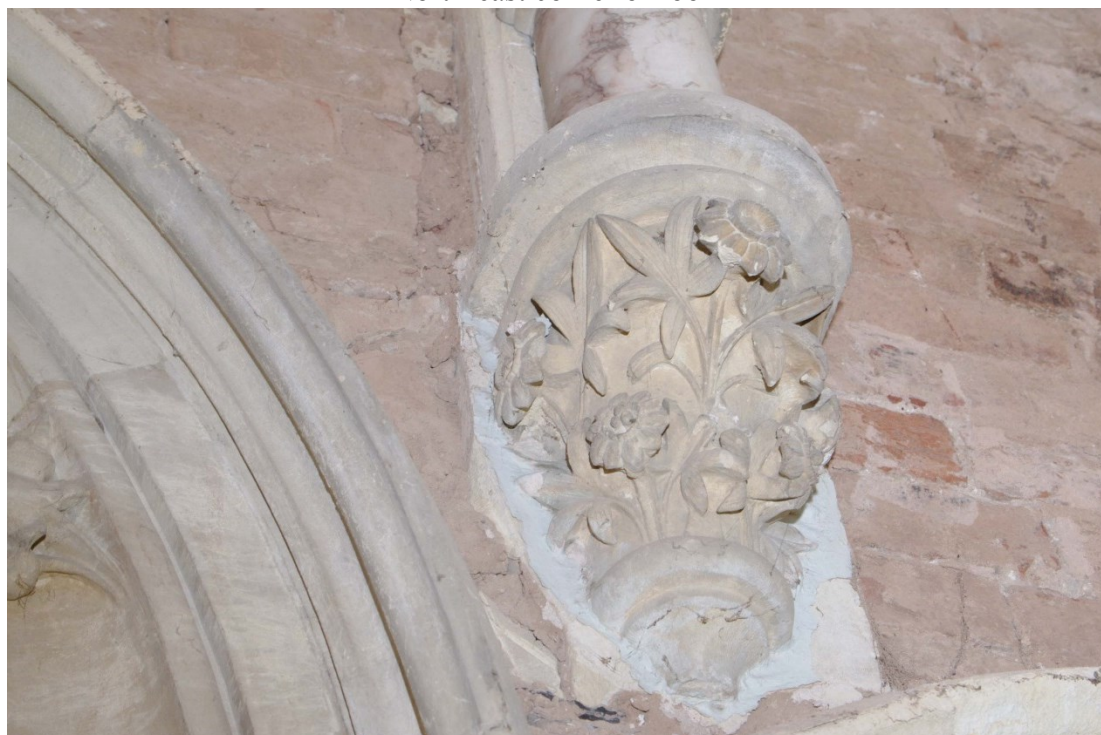
Figure 18 Example of carving on bases of ceiling supports

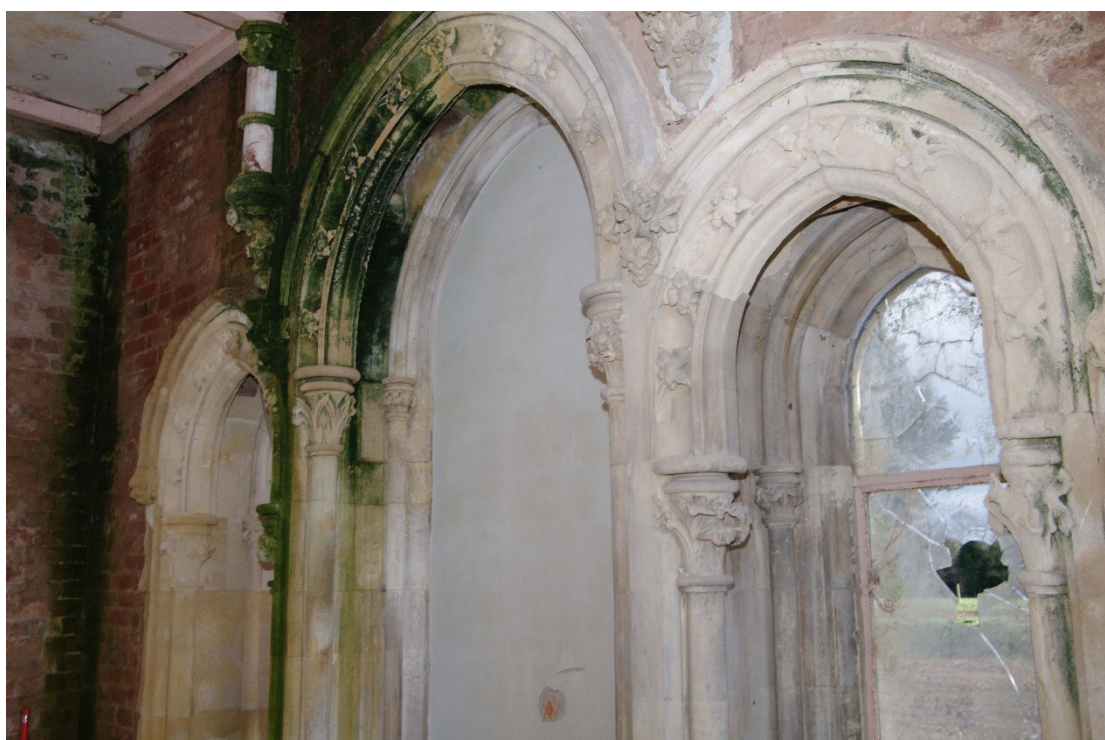
The east wall is dominated by the three Gothic lancet windows (Figure 21). The recessive arches are richly carved with additional decoration on the column capitals which run up the sides of each window. Each capital is different and includes a variety of foliage and flowers including daffodils and also one which contains a bird's nest including mother and chicks (Figure 22). In places the stonework has been badly affected by damp and has a large amount of green mould growing on it. Other areas of

stone are also crumbling away. The central window is the largest of the three and, at the time of the survey, was blocked. The proposals are to reopen this window which should have little or no adverse effect upon the historic fabric of the building. The two side windows have partial metal frames and monkey tail handles on the latches suggesting a 1920s date when they probably replaced the earlier frames. Modern fittings for blinds have been fitted into the apex of each arch.

Figure 22 East wall close up of detail around lancet windows
Looking north

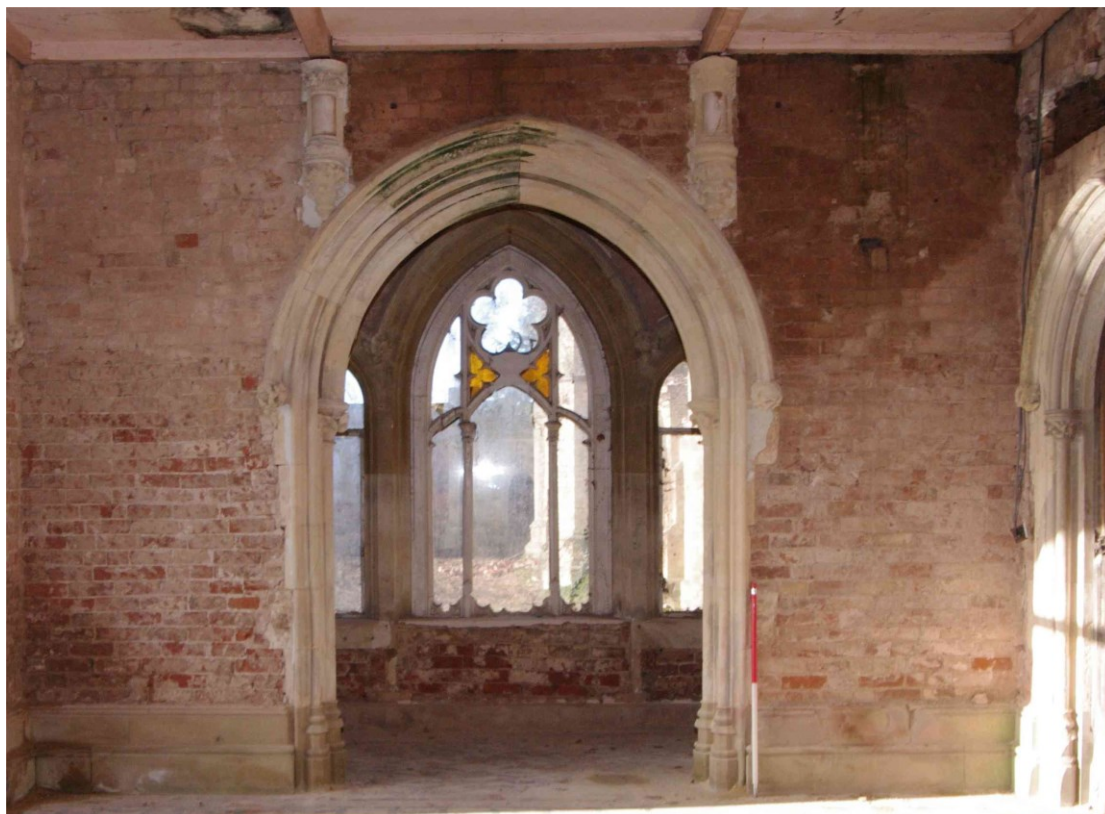
The west wall of the morning room is formed by a large recessed area currently known as the orangery (Figure 27). The space is reached by passing beneath a large arch which dominates the western end of the room. Three lancet windows are located within the space (Figure 28 and Figure 29). The centre window, as noted outside, has some wooden tracery remaining along with some stained glass panels. Although this seems to be late 19th century in date it appears to have been modified from a former doorway as the brickwork below the present window has been inserted between the original stone door jambs (Figure 30).

Figure 27 West internal wall of morning room
Looking west. 1m scale

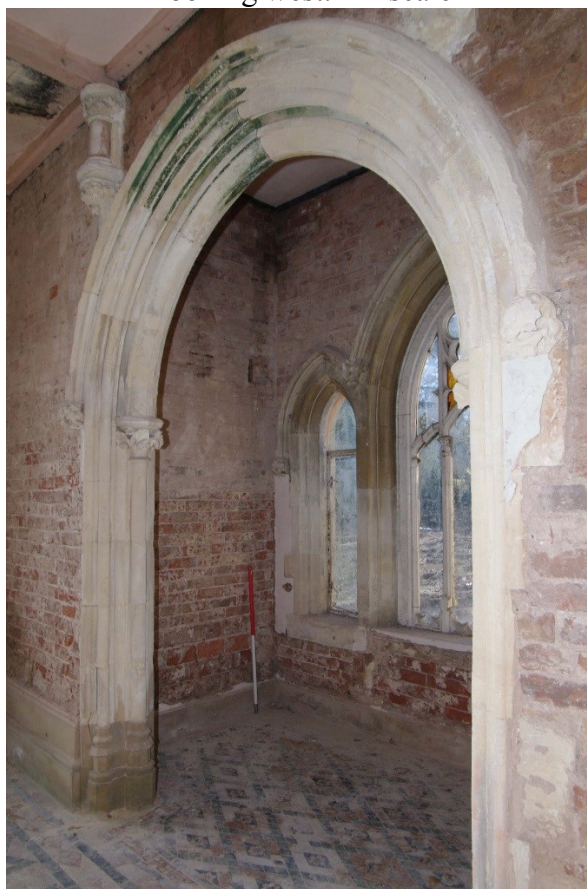
Figure 28 West end of morning room
Looking south. 1m scale

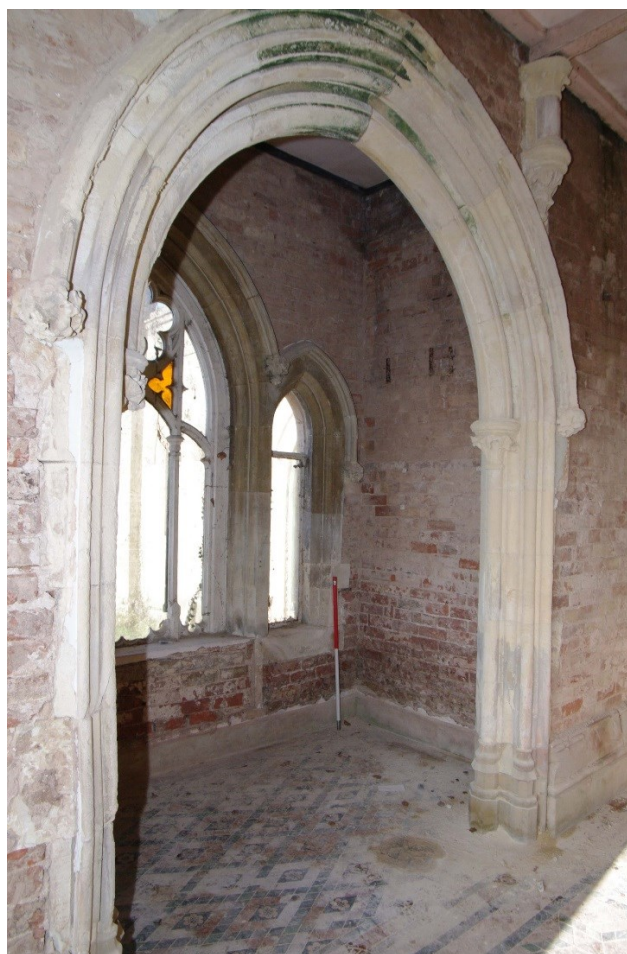
Figure 29 West end of morning room
Looking north-west. 1m scale

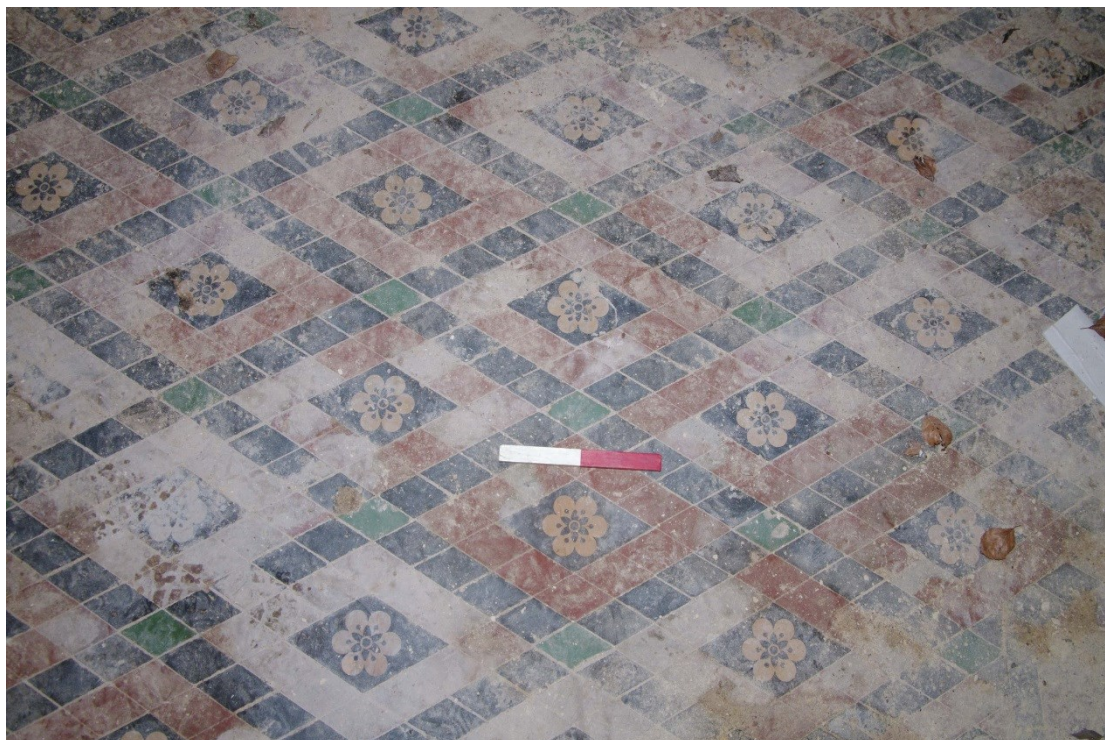
The floor of this recessed area has Minton style tiles which are of a different pattern to those in the main part of the room (Figure 31). The side walls (north and south) have traces of a vaulted ceiling which has since been replaced by a later flat ceiling (Figure 32). Despite it being called the orangery this space seems likely to have been built as a grand outside entrance porch to the morning room.

Figure 31 Floor tiles at west end of morning room
0.2m scale
