**A Historic Building Recording at the
Tudor Inn Hotel,
Bondgate,
Castle Donington,
Leicestershire.**

ULAS Report No. 2018-100
©2018

For: Castle Donington Parish Council

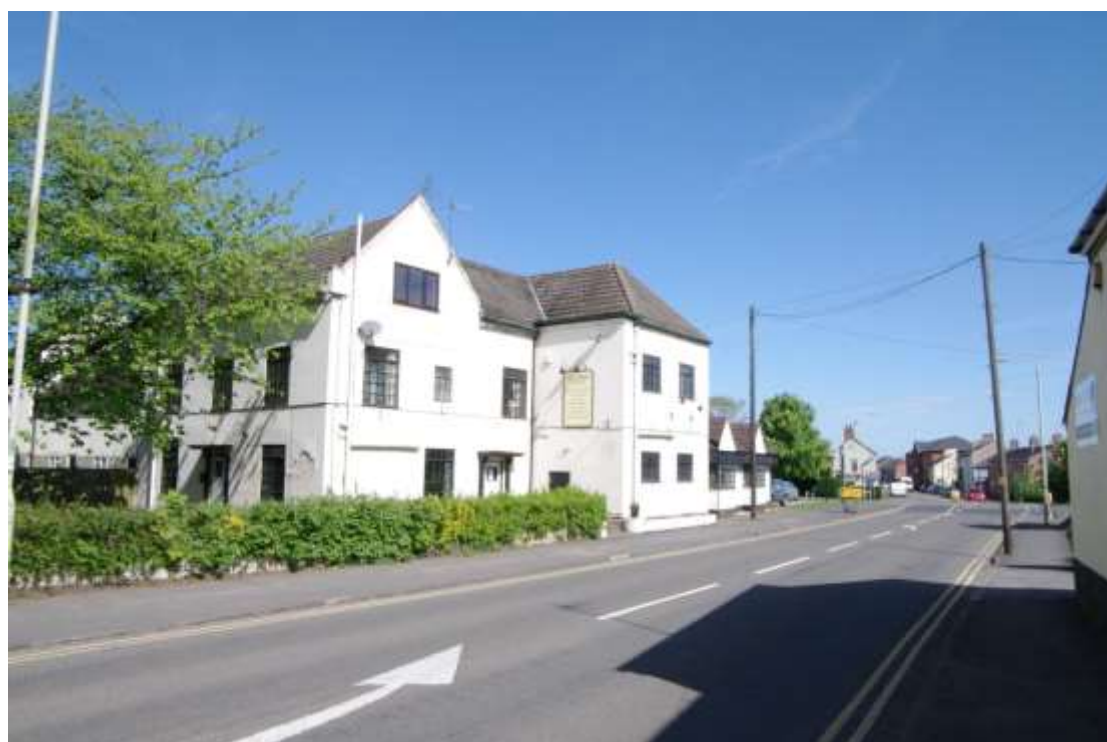
Figure 3 Tudor Inn viewed from Bondgate
Looking north-east. Tanyard Close is just beyond the yellow road sign

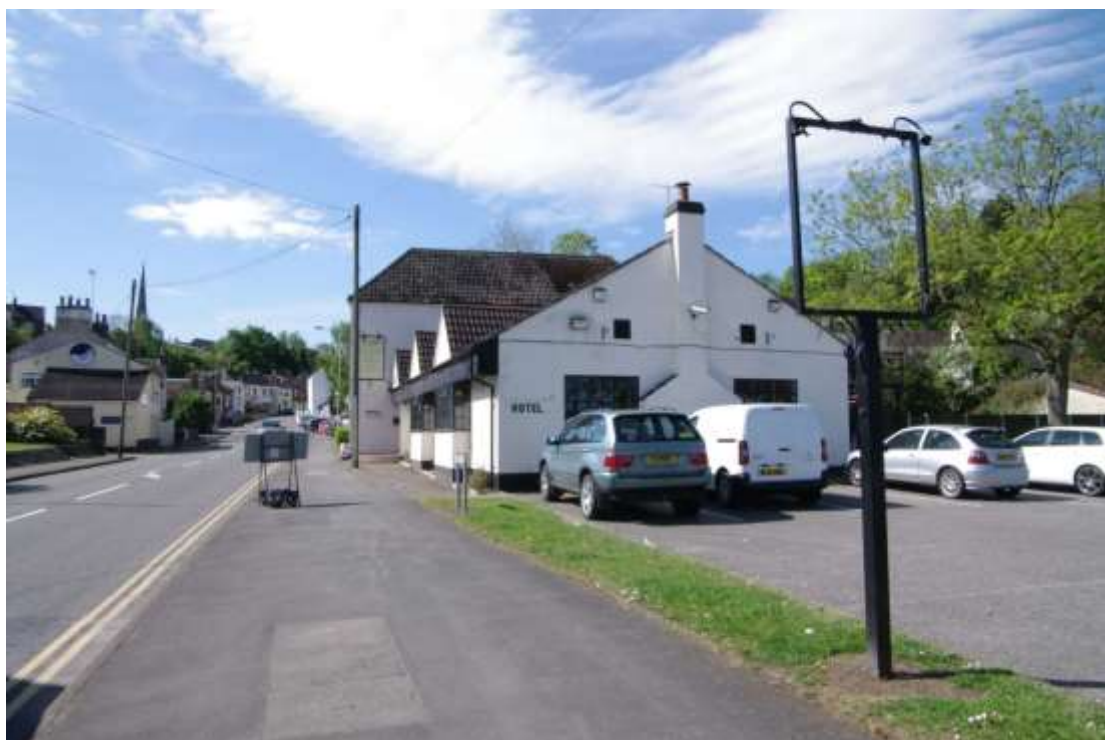
Figure 4 Tudor Inn
Looking south-west up Bondgate from the corner of Tanyard Close

Much of the south-east facing is obscured by the later function room which has probably covered a number of openings, especially at ground floor level (see Figure 4). Two off-set windows are located at first floor level which again have modern frames. A small added-on two-storey toilet block with its own pitched roof has been built onto the north-east corner of the main building.

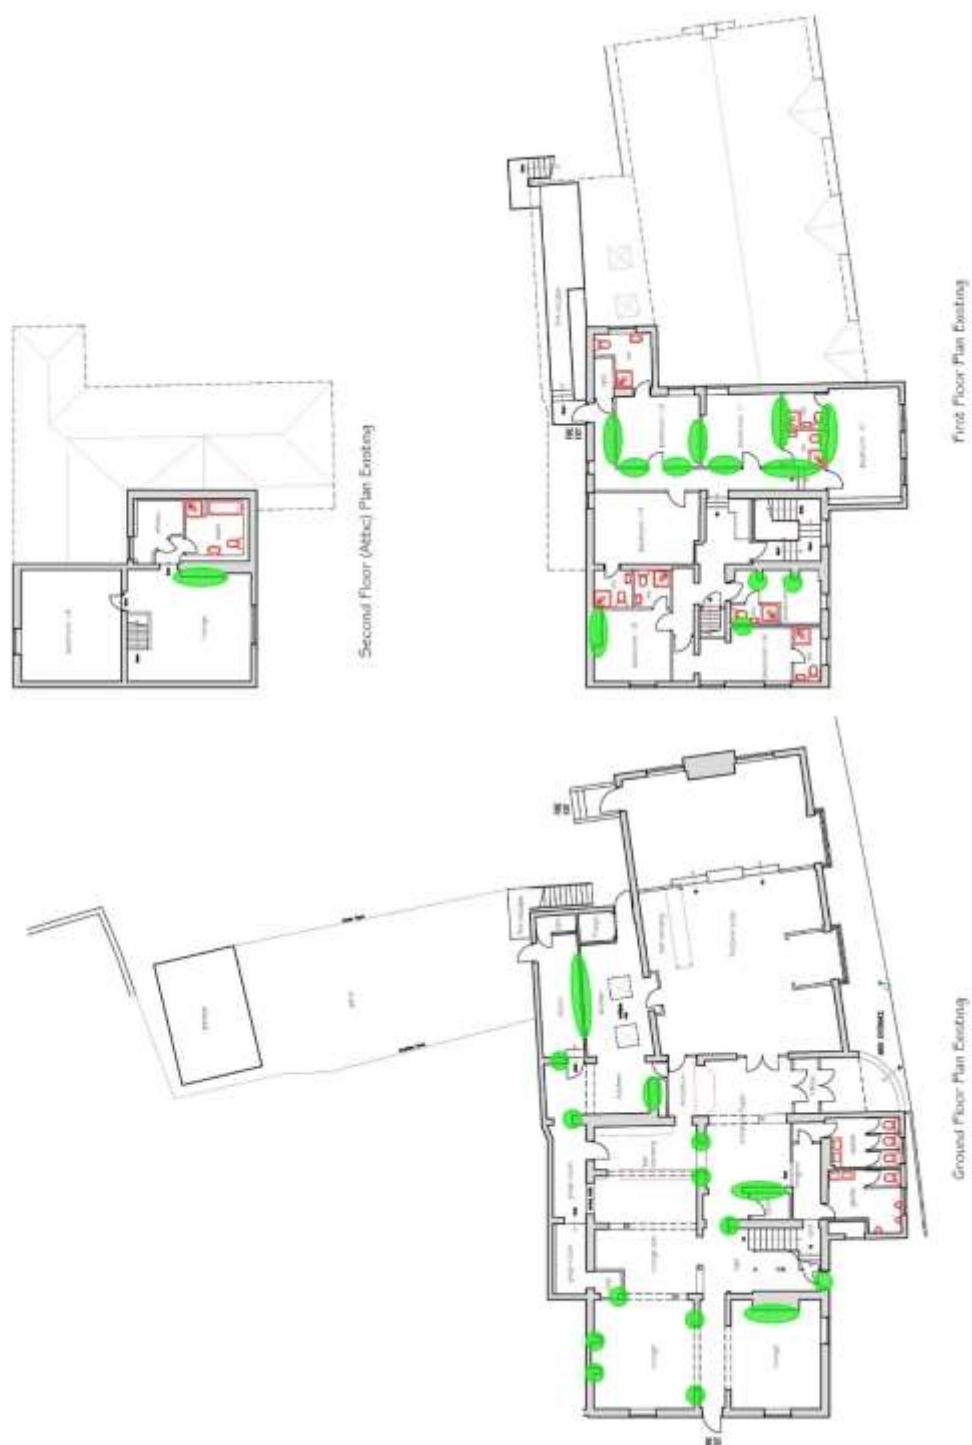
The proposed alterations to create the new community centre include the installation of replacement windows, replastering the outside walls and the removal of a number of internal walls and wall stubs. A new range of external storage rooms will be built in an open space to the north-west of the Inn (Figure 6).

Figure 6 Proposed alterations
Areas highlighted in green are subject to modification
Note that this drawing was issued in 2016 by M Blood Design and details may have been amended since this date

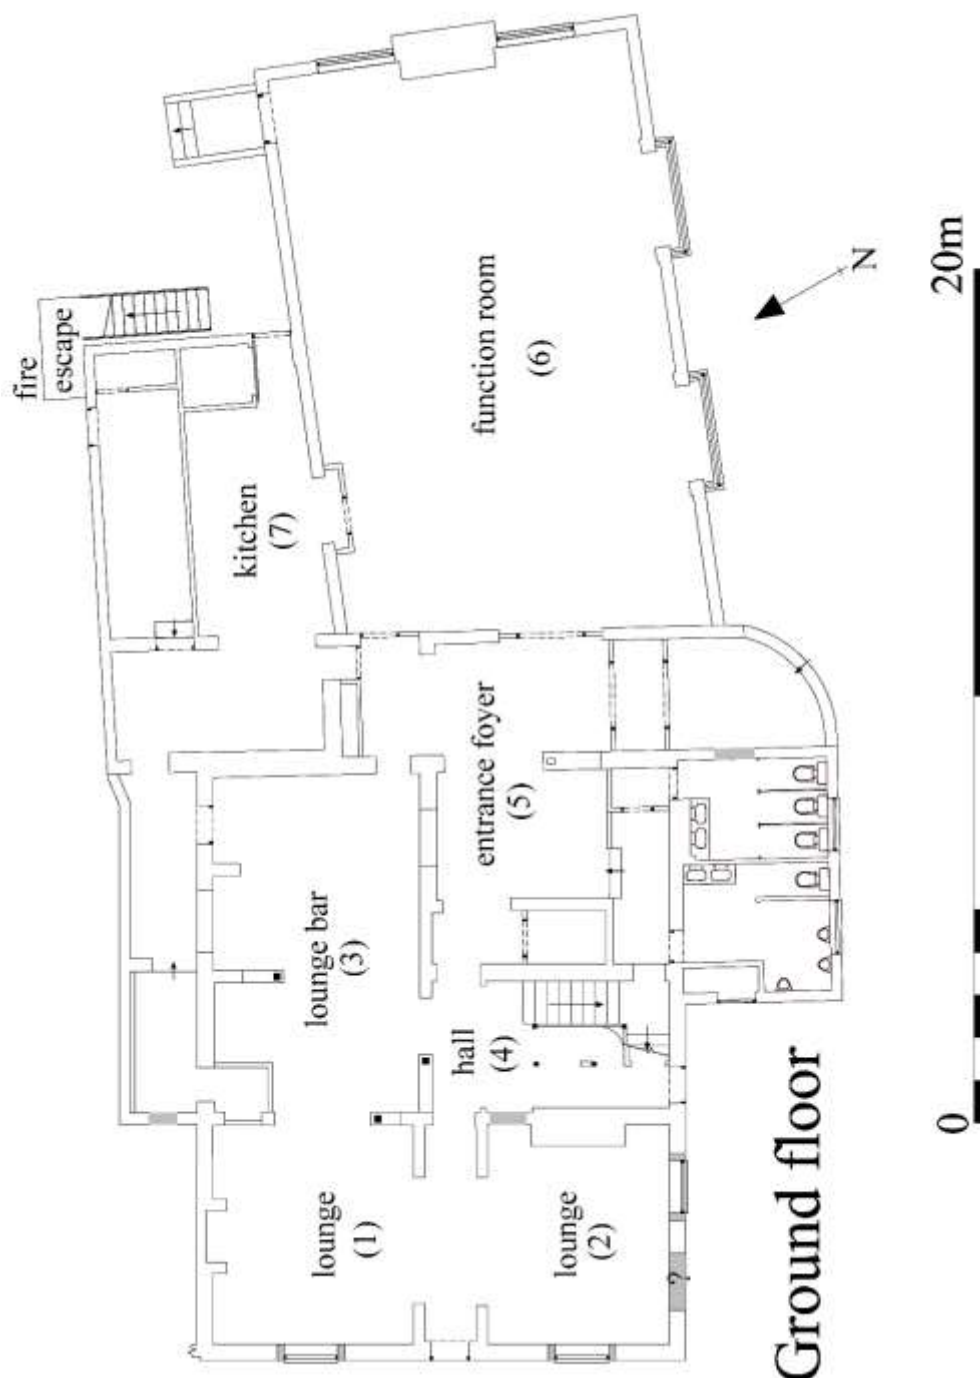
Figure 13 Ground floor plan of the Tudor Inn
Modified from client's drawings

The main entrance into the Tudor Inn is now from Bondgate through a modern set of doors which give access to the function room on the east side and to the main building to the west. However, the plan of the ground floor suggests that the main entrance was originally from The Spittal through the north-west facing doorway (Figure 13). This doorway appears to have opened onto a narrow axial corridor which led to the rear (eastern side) of the house. Doorways along with most of the internal walls, which have since been removed, must have led to the north and south to give access to equally sized rooms. Most of brickwork of the corridor walls has been removed, possibly when the house was modified into a public house, leaving only small stubs of the walls at each end of the rooms (Figure 14 and Figure 15). The result of this is to create a much larger open space identified as Lounge Rooms 1 and 2. Prior to the soft-strip the walls were covered with mock-Tudor panelling with a false ceiling and thin wooden strips made to represent timber framing. The floor in both rooms was concrete. Following the removal of the panelling it could be seen that the windows had been slightly reduced in width to their present size (Figure 16). The modified brickwork around the windows appears to be relatively old, possibly 19th century in date. The brickwork in the wall in the south-west corner of Lounge 1 has been heavily disturbed which may suggest that there was once a window in this location as discussed earlier. This would make sense if the balanced façade facing onto Bondgate is to be considered although the presence of a window is by no means certain and the brickwork may simply be a repair.

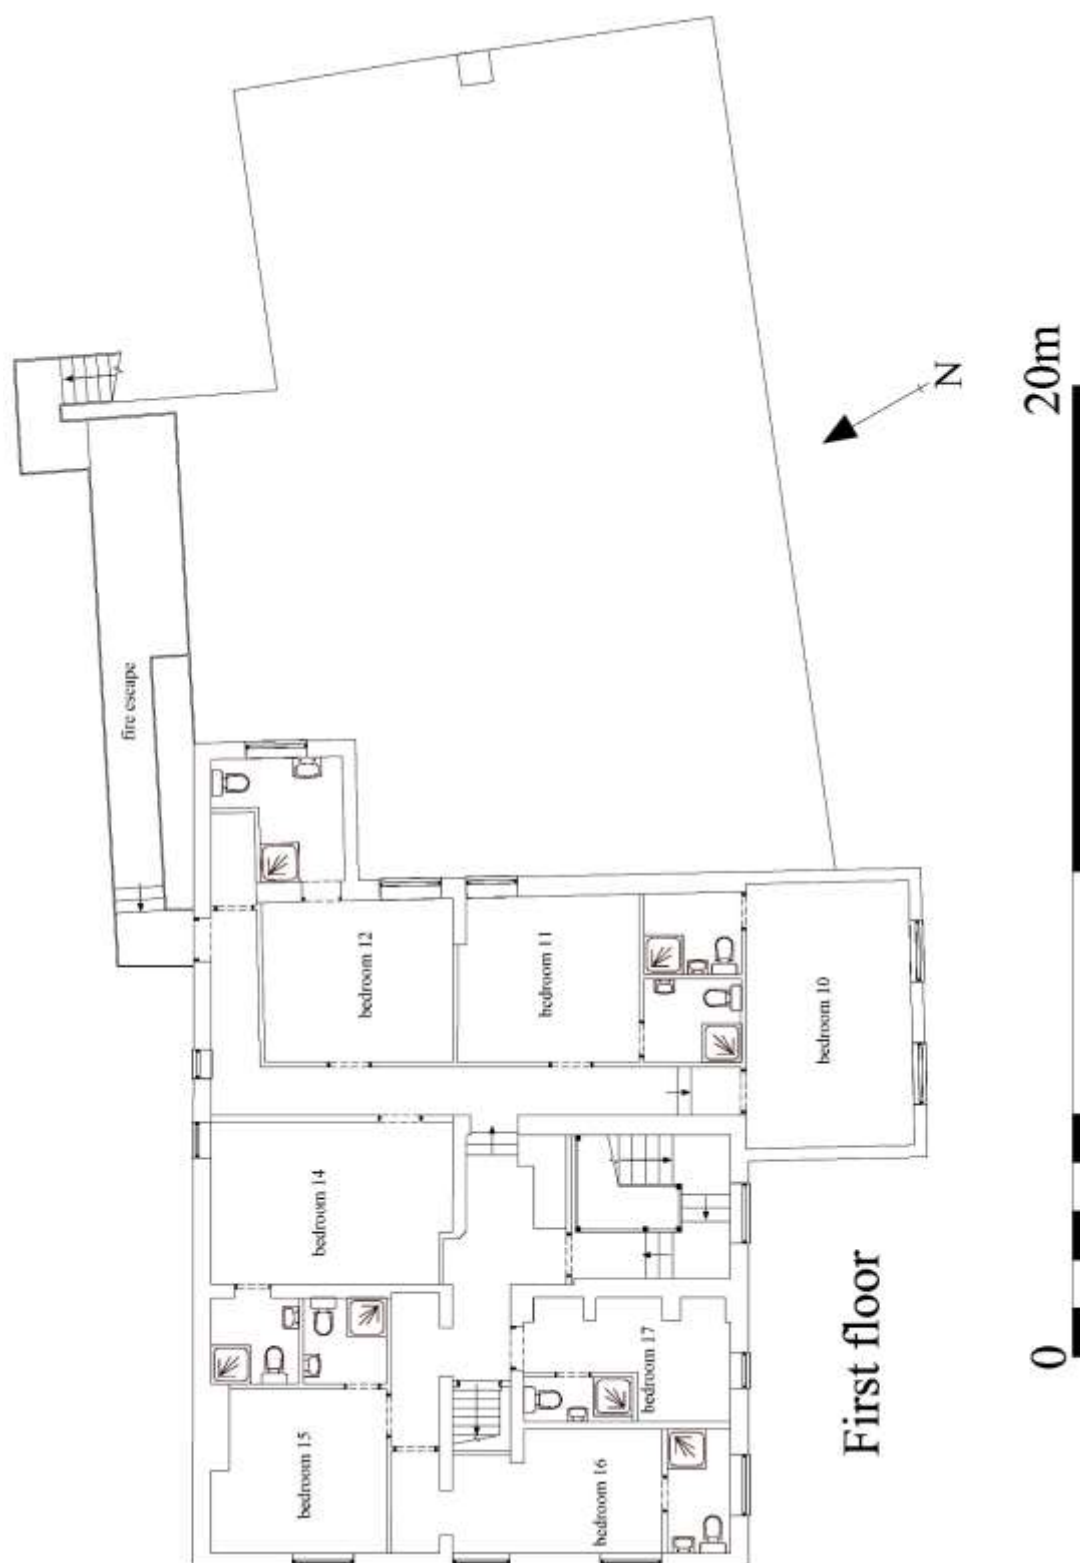
Figure 24 First floor plan
Modified from client's drawings

Prior to the soft strip much of the first floor had been sub-divided with stud walls into a number of smaller rooms to create seven bedrooms all with en-suite facilities (Figure 24).

Following the soft strip all of the stud walls had been removed which returned the floor to what appears to be its original room layout. The modern lowered false ceilings had also been removed which revealed the presence of steel beams supporting many of the original timber beams. In places the floor had also been removed showing that much of the original fabric had long-since been removed and replaced. This may have followed the fire. Most of the main supporting timbers still survive however but are in a poor condition and have had to be supported by steelwork (Figure 25). The timber beams, whilst not appearing to be burnt, have rotted at the ends. The soft strip as removed all of the modern stud walls between bedrooms 10 to 12. The small toilet attached to the north-east corner of the former bedroom 12 is a later extension which sits above the ground floor kitchen.

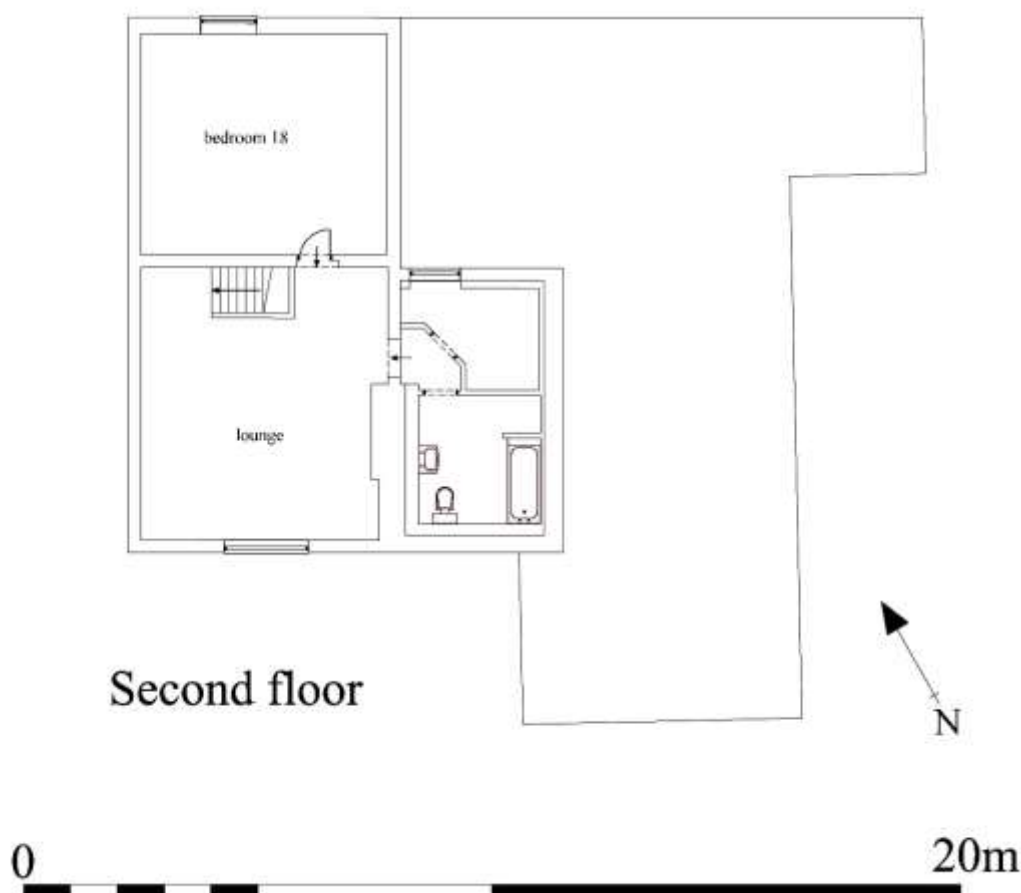
Figure 27 Second floor plan
Modified from client's drawings

As noted the stairs up to the second, attic, floor were probably intended to be used as the service stairs leading to the servant's sleeping quarters. Prior to the soft-strip the stairs served a single suite of rooms consisting of a large lounge, and a bedroom (Bedroom 18) which occupied the space above the original two ground floor rooms. A smaller dressing room and toilet lead eastwards from the lounge to occupy a space over the main hall and stairs (Figure 27 and Figure 28).

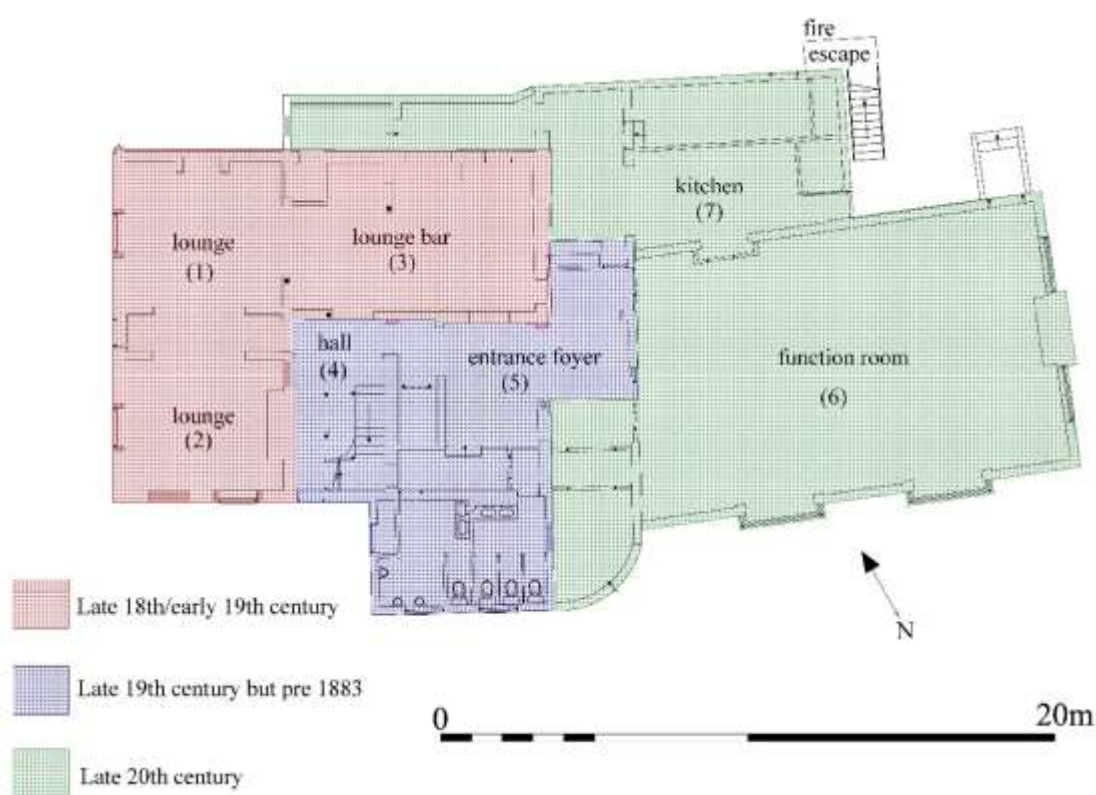
Figure 32 Tudor Inn key phases

There are three key phases of extension of the building (Figure 1 Castle Donington location Figure 32 below). The first phase, built in the later 18th or early 19th century and consisted of the two ground floor rooms separated by the entrance corridor. Attached to the north-eastern side of this building was a probable service wing. The next phase was an extension filling in the south-east corner which was probably added at some point in the second half of the 19th century but before 1883. The reduction in the width of the original windows may also have taken place at this time too. The blocking of the rear entrance into the adjacent cottage appears to have taken place some time ago as the bricks are probably late 19th or early 20th century. This may relate to boundary changes where the cottages seem to have lost much of their back yards. This episode may or may not have happened when the extension was added.

The next phase of alterations is much more recent and took place towards the end of the 20th century. This consisted of the new function room and the kitchen block which appear to have been added in the late 1970s. This work blocked a number of openings on the east and north walls of the house and was probably associated with the remodelling of the entrance foyer.

Other modifications such as the opening of the corridor between the two ground floor lounges are harder to date. It seems likely that they are not much older than the function room addition. Alternatively they may have been part of the extensive rebuilding following what seems to have been quite a major fire. The new floors, new roof coverings, steelwork and staircases probably relate to this event too.

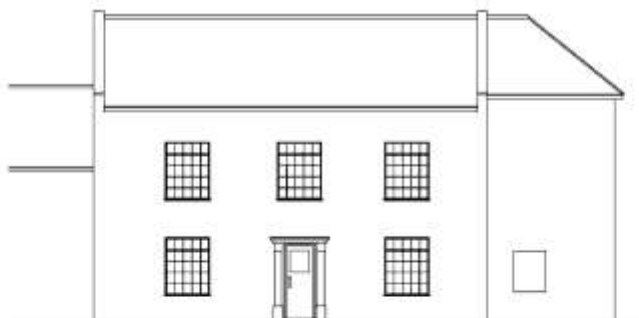
North-west facing elevation

As noted, the north-west facing elevation looks out across a small grassed area onto The Spittal road and Bondgate (Figure 7 and Figure 8). A number of semi-mature trees are located within the grassed area in what was presumably an open garden giving unrestricted views both from the house and of the house. The elevation is relatively plain with three bays and a centrally located ground-floor doorway. The window openings appear to be in their original positions but the frames and fittings are from the later 20th century. When seen from inside the window openings have been reduced in width. This is discussed in more detail in the section below. The doorway has decorative pilasters supporting a small canopy all of which appear to be quite modern. They may have replaced an earlier porch although the plainness of the frontage suggests that the house probably had a relatively simple doorway with little decoration. The whole building has a coat of modern render which masks any indication of earlier modifications. Where the render is breaking away the original brick wall can be seen. It seems likely that the render was added to mask the scars left by the reduction in window size and possibly to hide the soft 18th/19th century bricks which may have been degrading. The bricks appear to be hand-made and of quite soft fabric.

The roof has been covered with modern cement roof tiles which presumably replaced the original slates following the fire. Raised copings run up the gable ends which rise above the roof height. There are no chimneys on the building. These were probably demolished, or collapsed, following the fire.

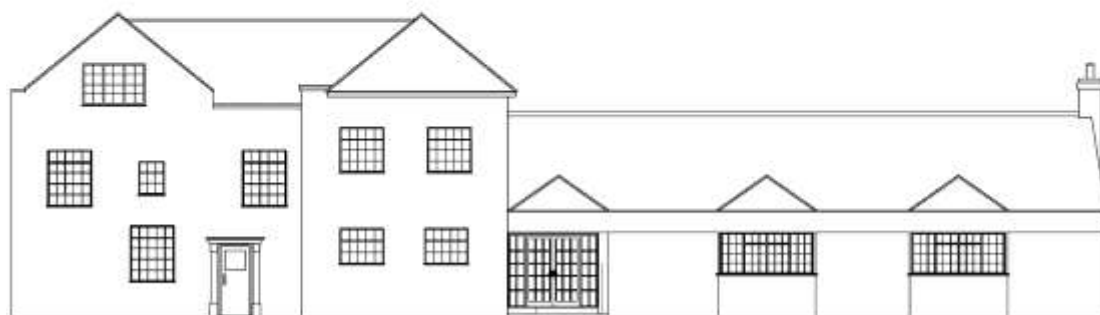
South-west facing elevation

All of the window frames and fittings on this elevation have been replaced with modern ones and the walls are rendered. The elevation has three key components: on the western side is the gable-end of the north-west facing range, this is joined to a projecting range running across the back (south-east) of the north-west facing range. The final element is the single storey function room on the eastern side of this elevation (Figure 9 and Figure 10).
