**A Photographic Survey of Glebe Farm, Shackerstone Walk, Carlton,  
Leicestershire (NGR SK 385 045).**

**Gerwyn Richards**

*University of Leicester Archaeological Services were commissioned by Charlie Yates Homes Ltd to undertake a photographic survey of Glebe Farm, Carlton, Leicestershire. Planning permission had been granted for the demolition of the farmhouse and associated outbuildings.*

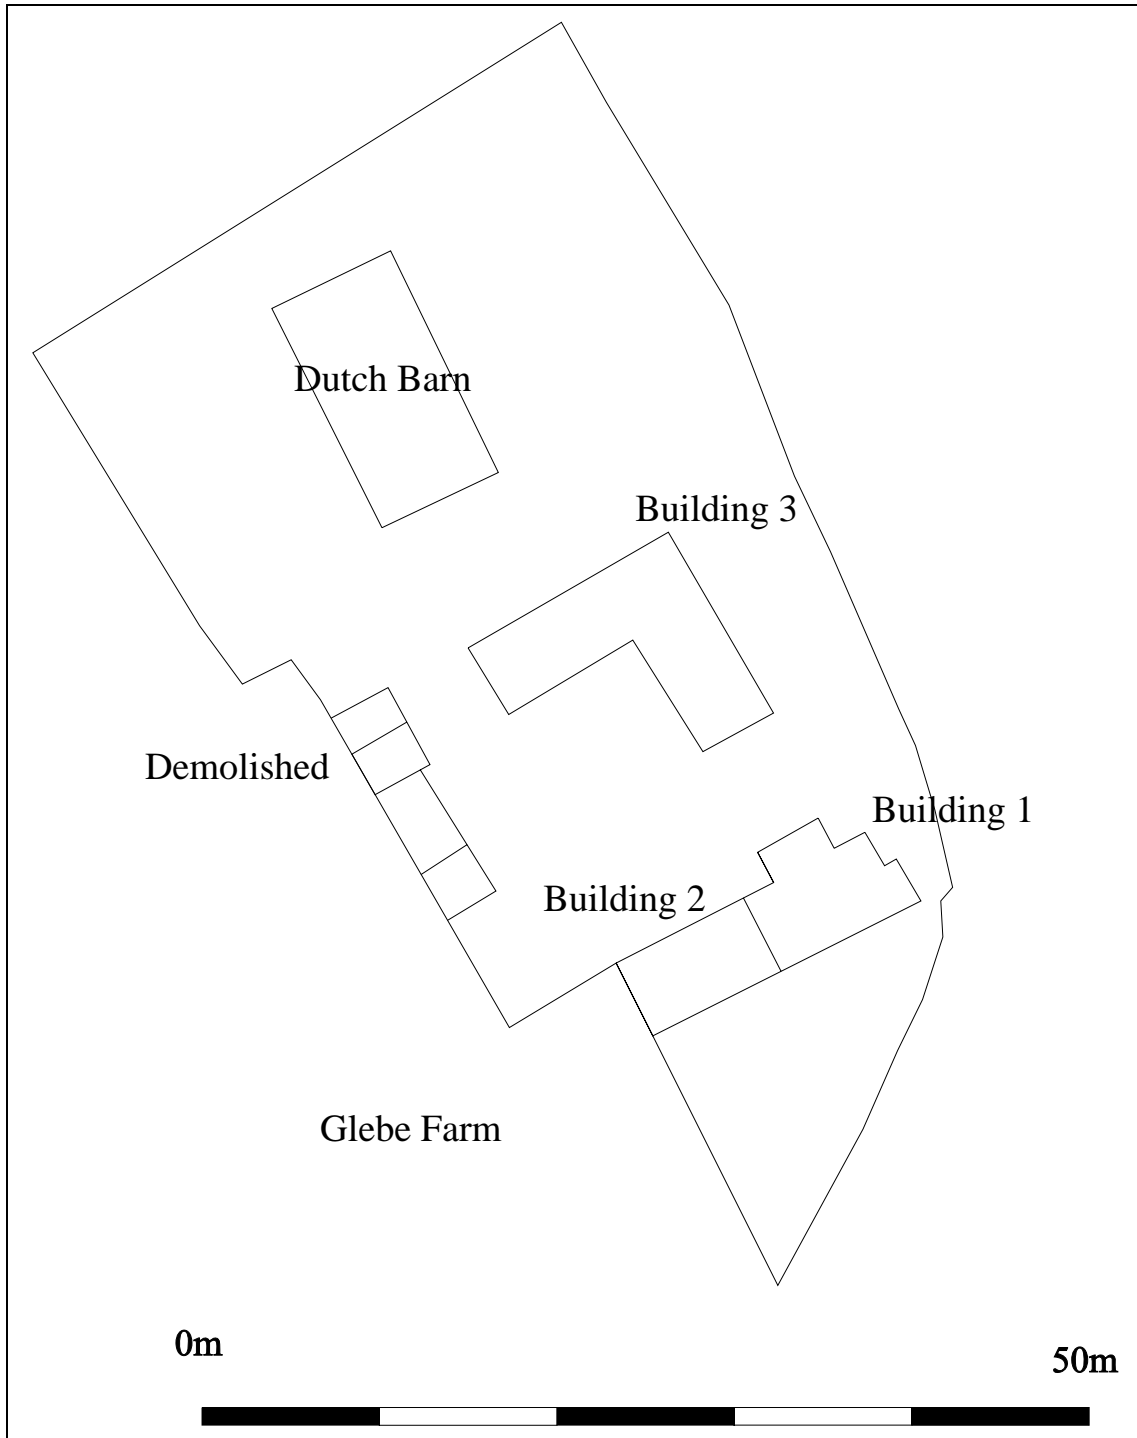
**Figure 2** Building Identification

The proposed development consists of two buildings of interest; the Farm House itself, and the cowshed/milking parlour behind the Farm House. Each building has been allocated a number for identification purposes and a letter where internal subdivision is also required, in the following notes the terms 'left', 'right', 'rear' and 'back' are used in relation to the front elevation of each building.
