**A Photographic Survey in advance of  
redevelopment at the former Mosan Mills,  
12 Sanvey gate,  
Leicester (SK584 050 area )**

**For Thomas Fish and Sons Ltd**

Planning Application No: 2002/0662

Report No. 2004-042      ©ULAS 2004

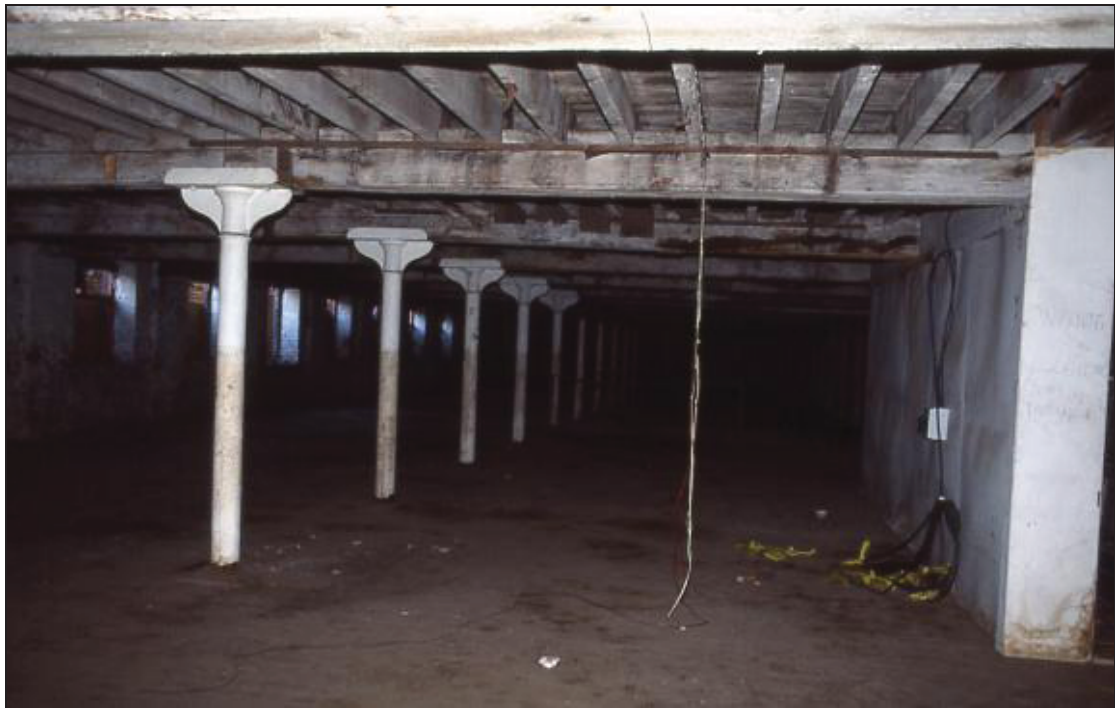
Plate 8 Basement looking west

above, with cast iron supporting columns over a brick floor. As postulated in the building assessment report, the lift does indeed serve the basement. The lift cage was neither present nor visible in the shaft above, as far as could be seen with a torch. The interior of the lift door on the ground floor above was visible: it is provided with a handle, indicating the lift could have been used for passengers as well as goods. There is a modern brick lined pit (plate 10) under the position of the post-war lift, and several smaller shallow brick pits which could be original build, presumably sumps or housings for machinery flywheels.
