**An Historic Building Photographic
Survey at
12 – 16 De Montfort Street,
Leicester**

NGR: SK 5940 0382

ULAS Report No. 2019-066
©2019

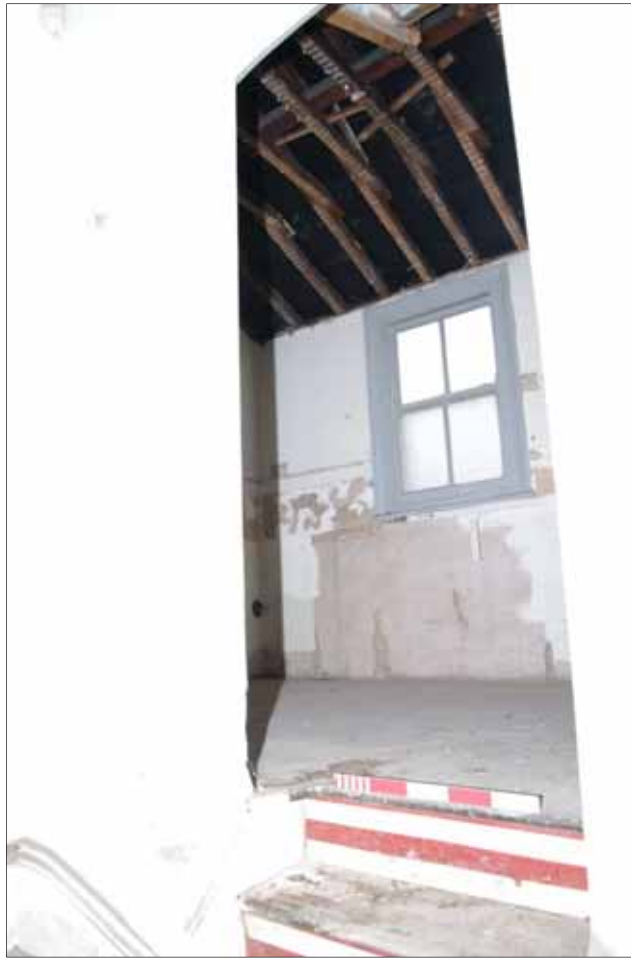
Figure 56 Number 16 first floor rear toilet block
Looking south-east from stairs

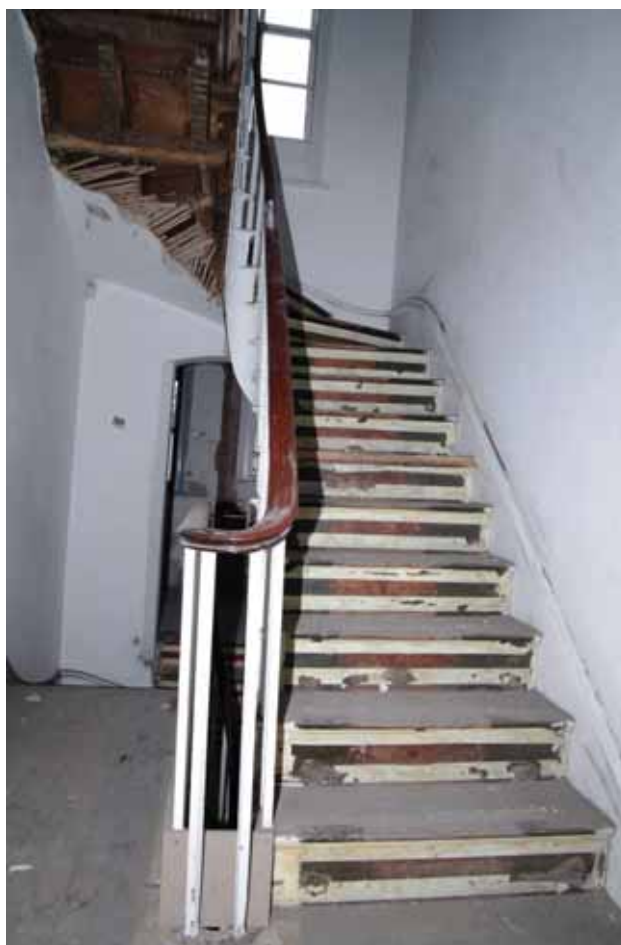
Figure 58 Number 16 staircase up from first to second floor
Looking south-east

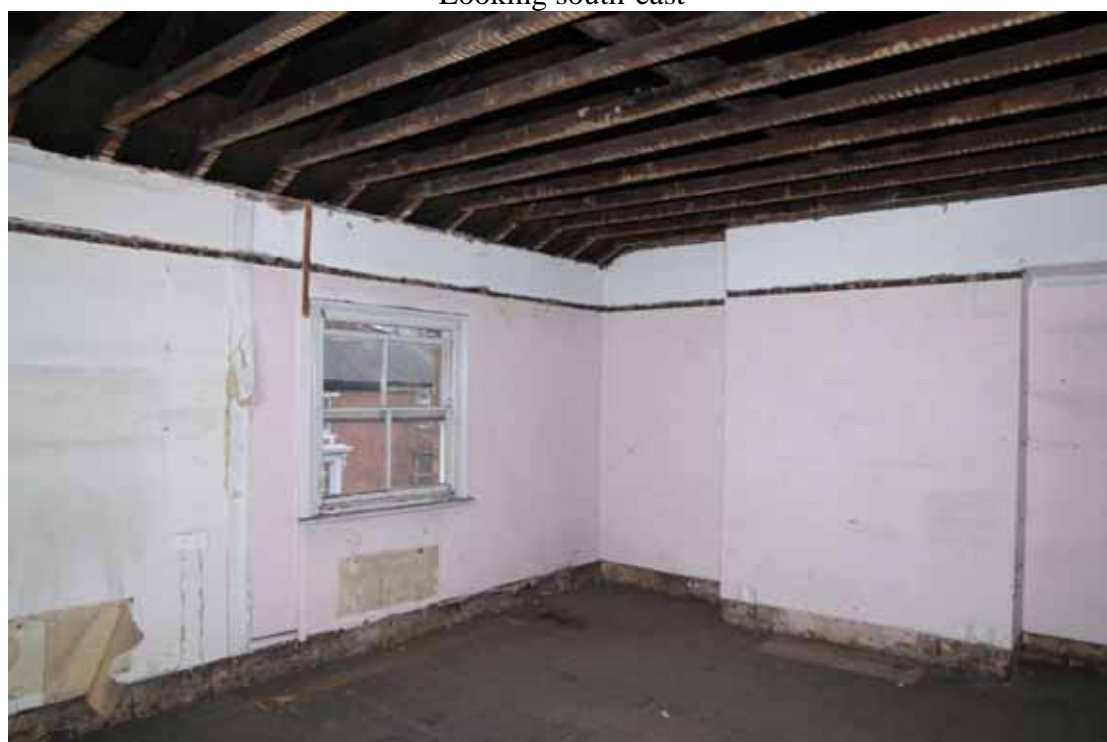
Figure 59 Number 12 second floor front room
Looking north

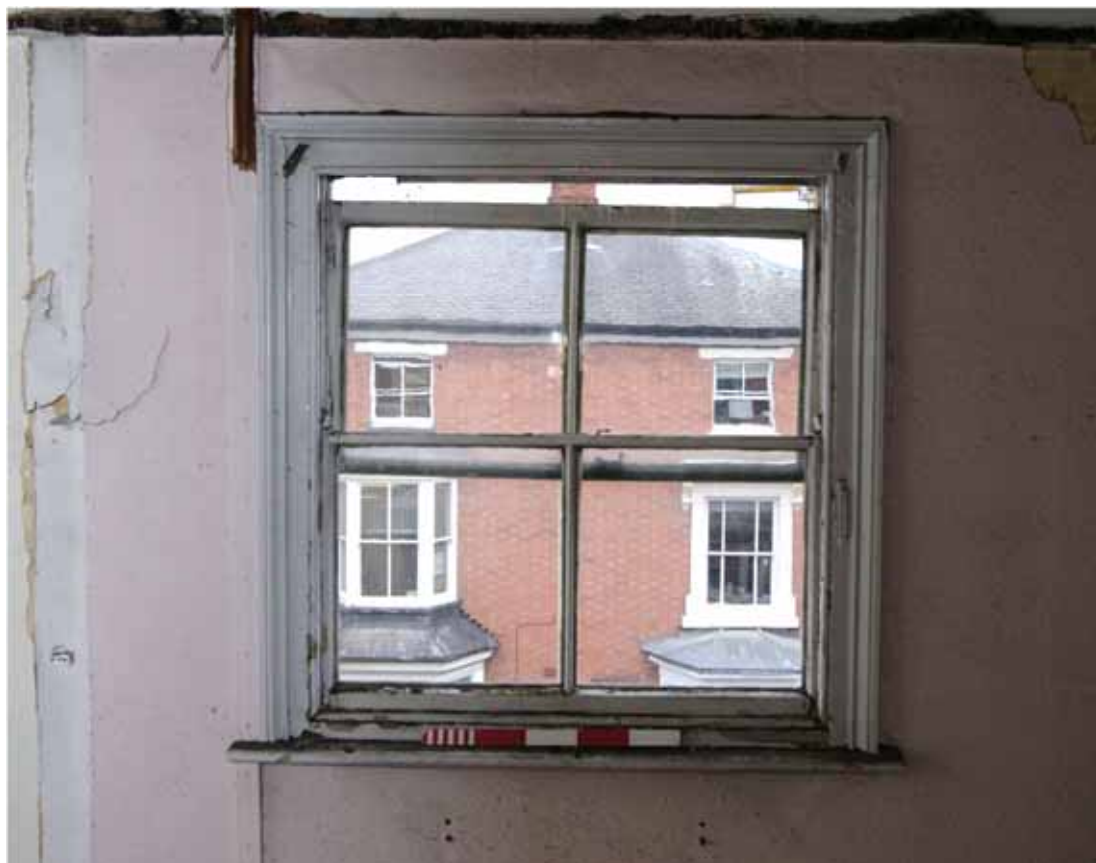
Figure 60 Number 12 second floor front room window detail

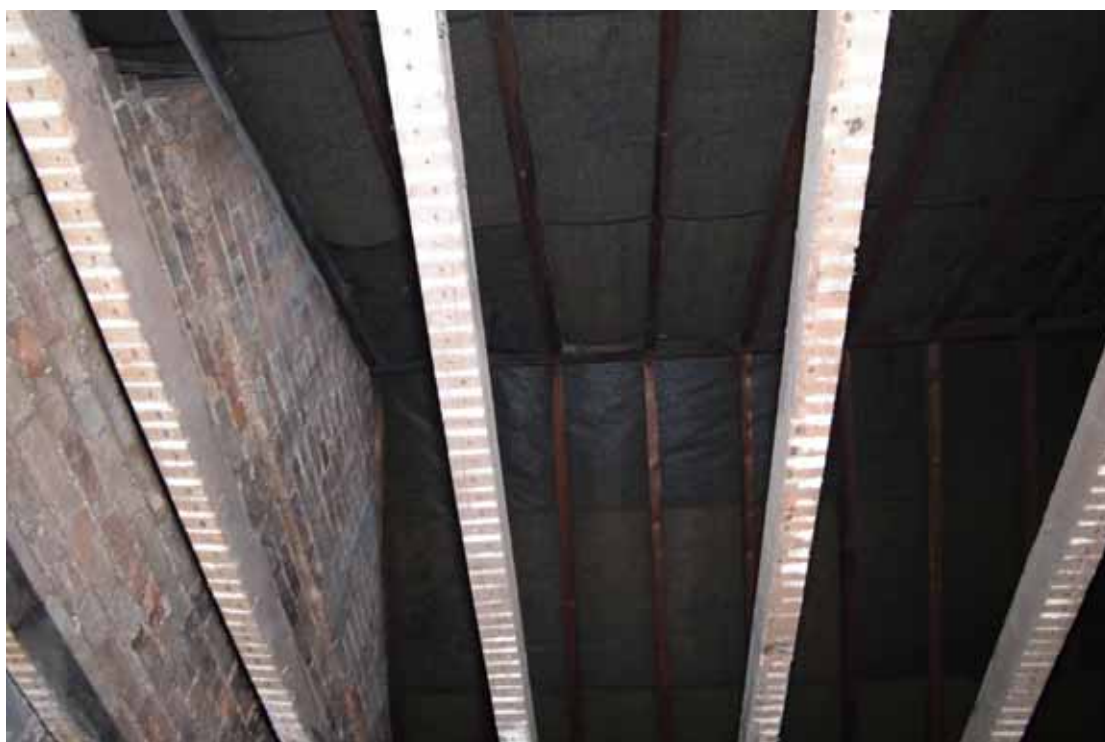
Figure 61 Number 12 underside of roof detail

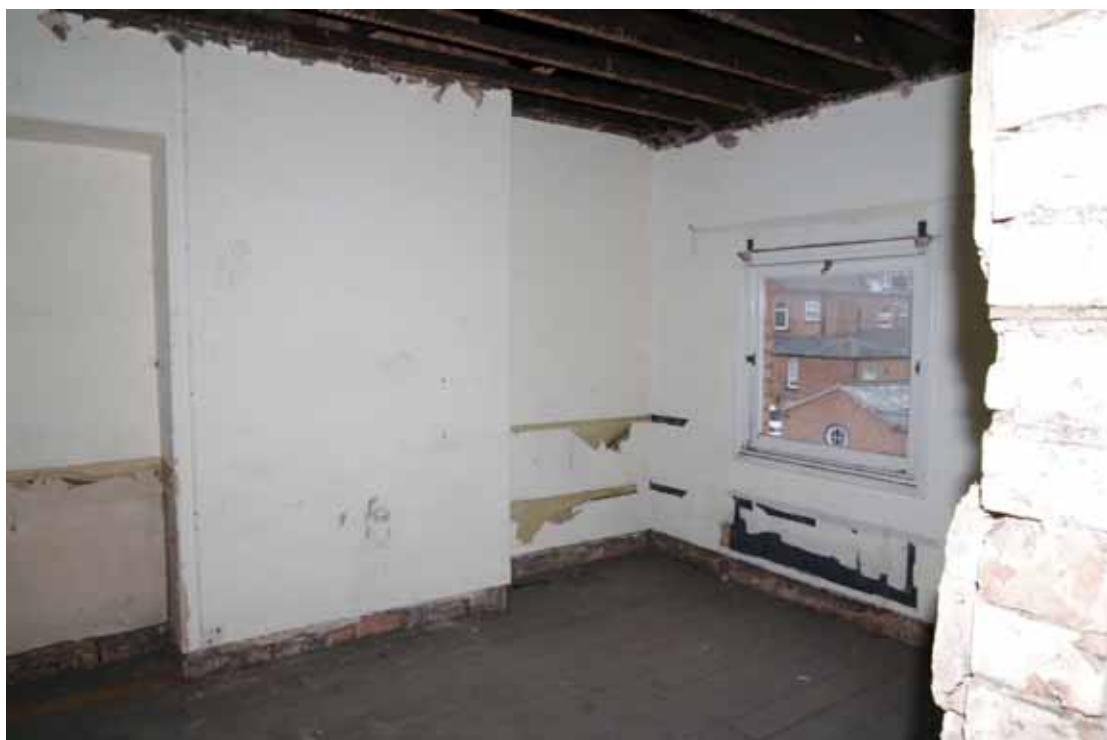
Figure 62 Number 12 second floor rear room
Looking east

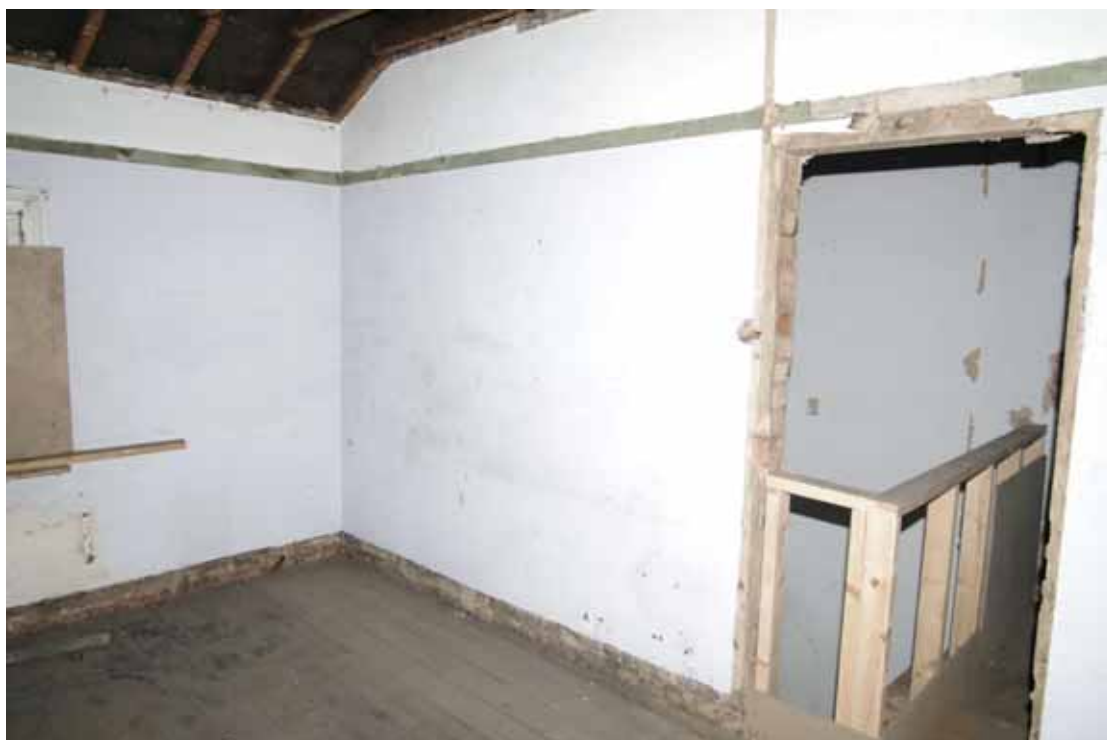
Figure 64 Number 14 second floor rear room
Looking south

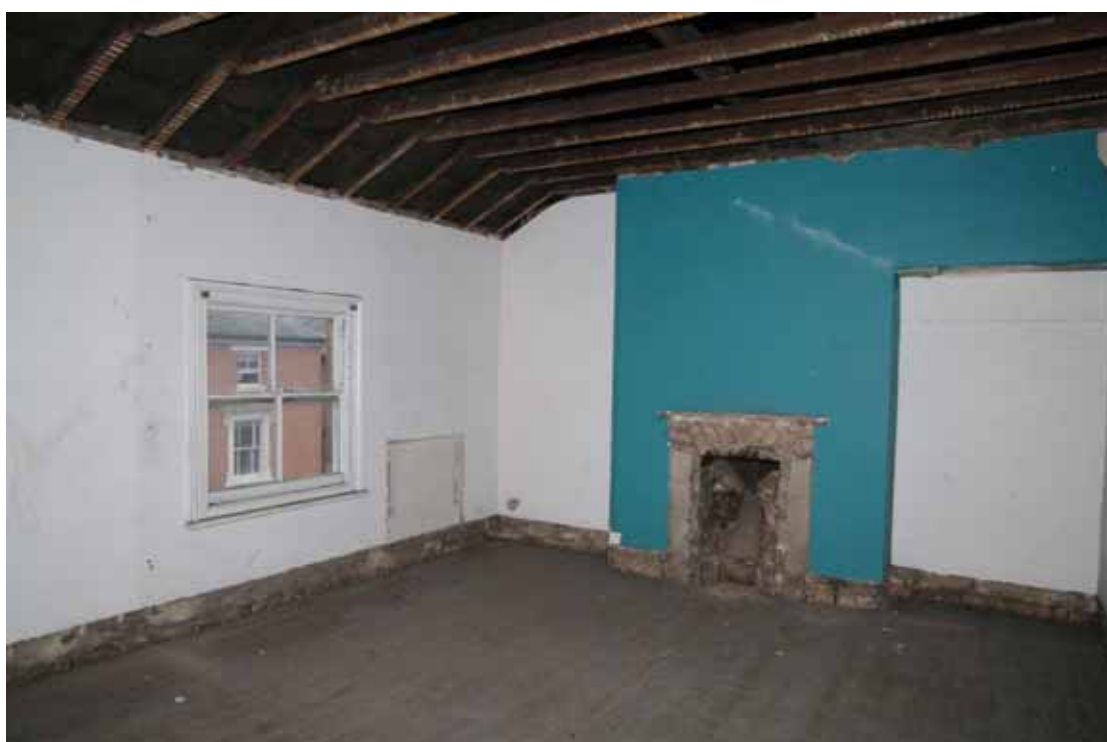
Figure 65 Number 16 second floor front room
Looking north

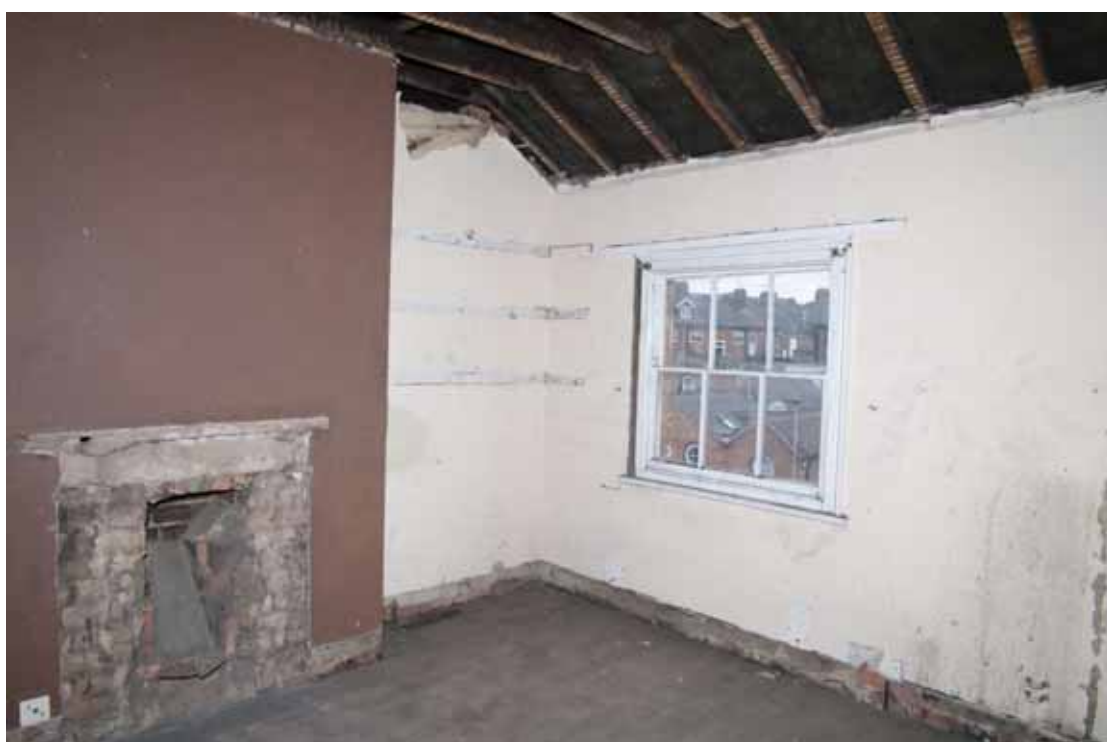
Figure 67 Number 16 second floor rear room
Looking east
