**An Historic Building Photographic
Survey at the former
Rose and Crown Public House,
Leicester Road,
Kibworth Harcourt,
Leicestershire**

ULAS Report No. 2019-080
©2019

For: Staniforth Architects Ltd

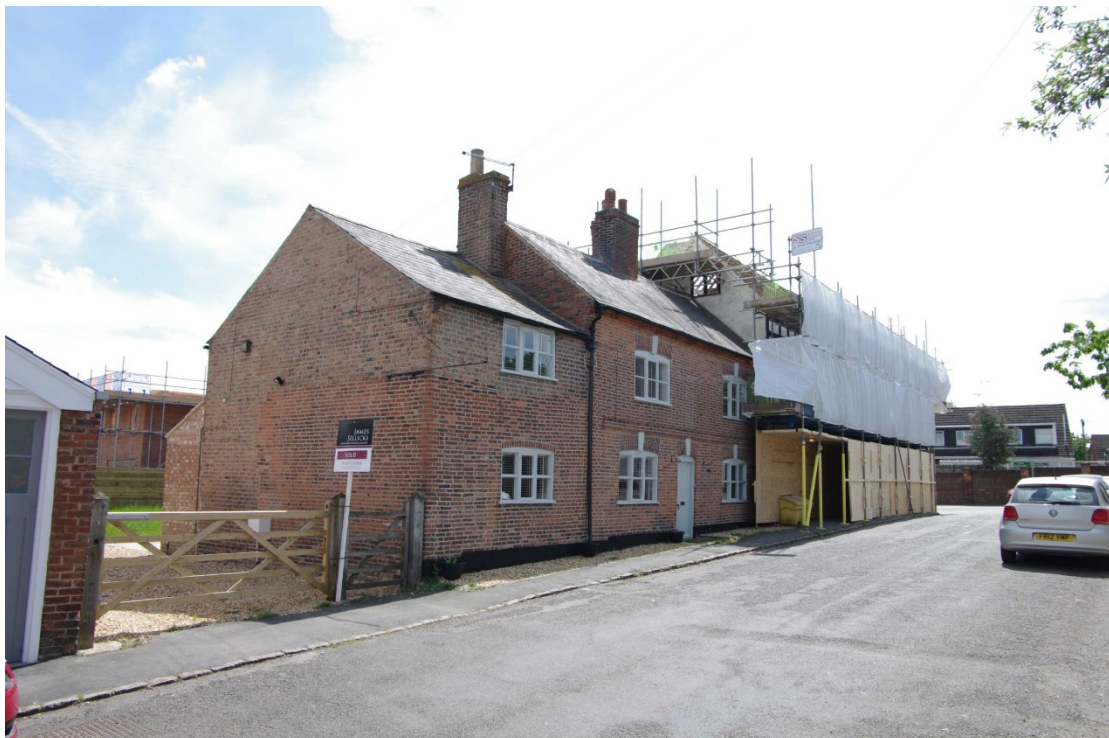
Figure 8 Site seen from Main Street
Looking south-east towards Leicester Road. 1 Main Street on left

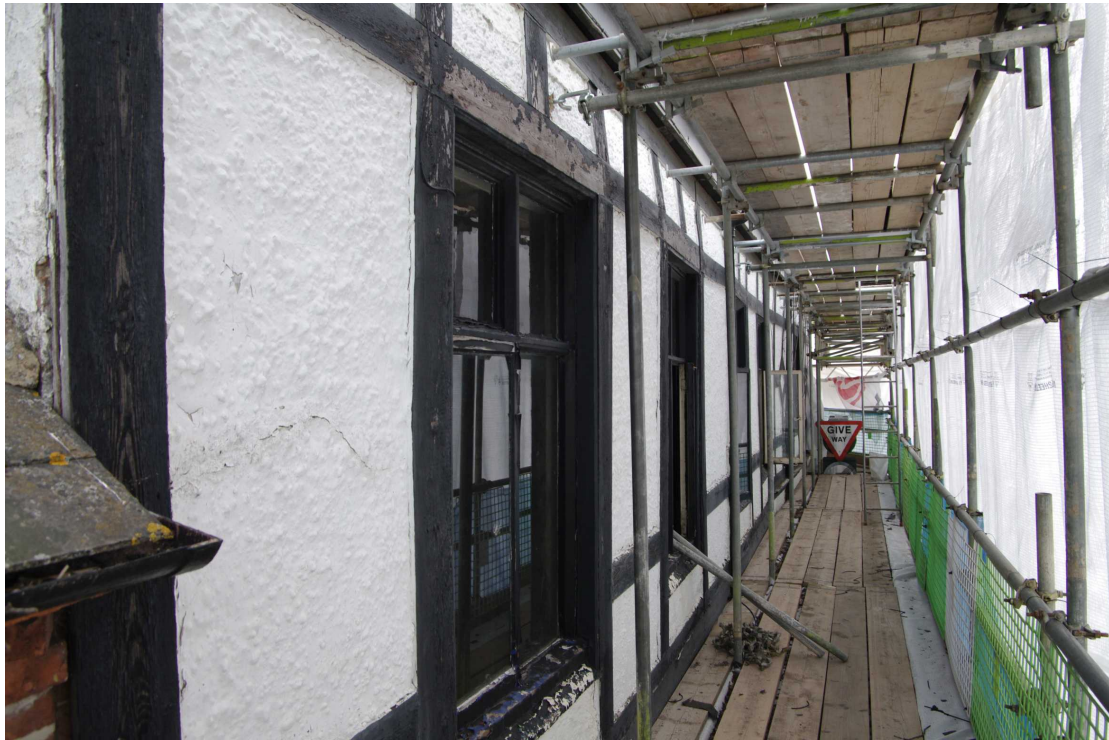
Figure 14 West facing elevation, first floor window detail
Looking south. Gutter of 1 Main Street on left

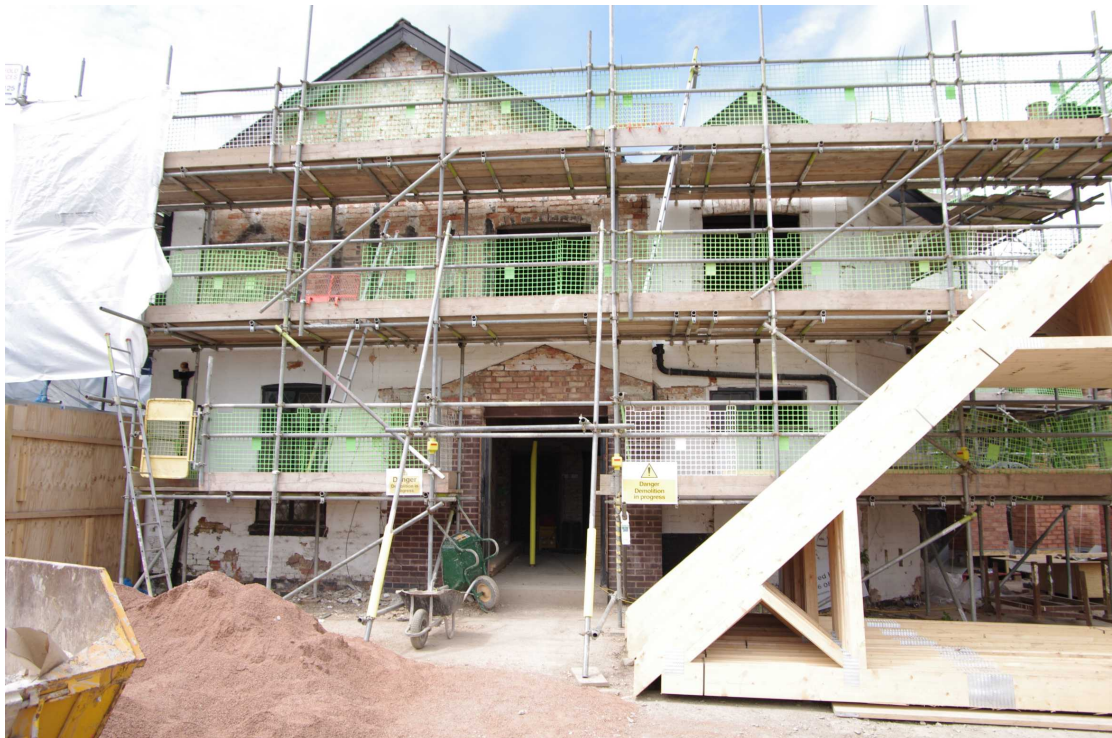
Figure 17 East facing elevation of rear southern range
Looking west. Leicester Road behind hoardings on left

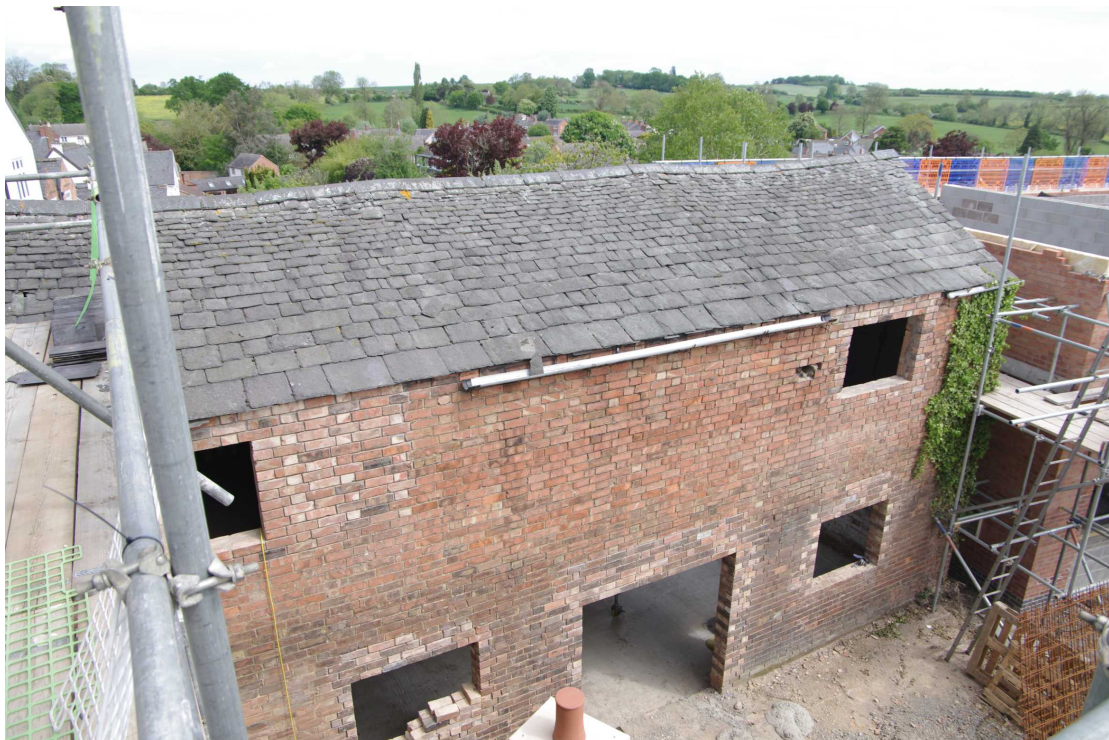
Figure 21 Remaining outbuilding along northern boundary of site
Looking north-east. New housing to right

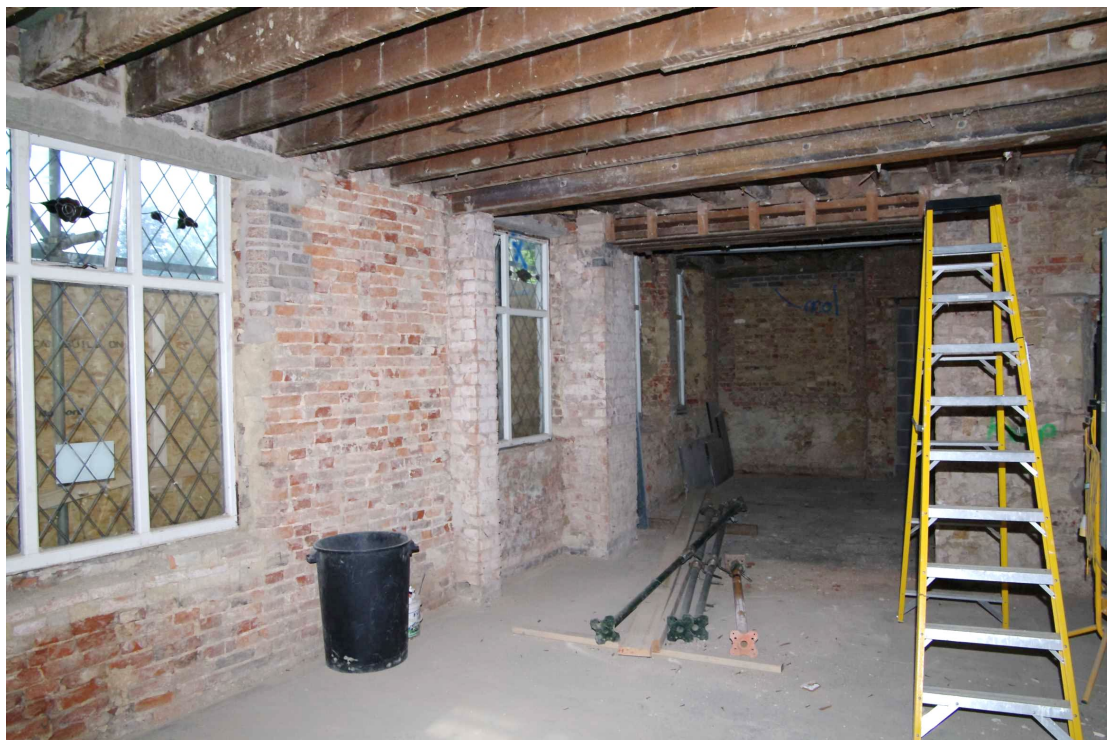
Figure 28 Southern extension Room 4 looking into Room 3
Looking west

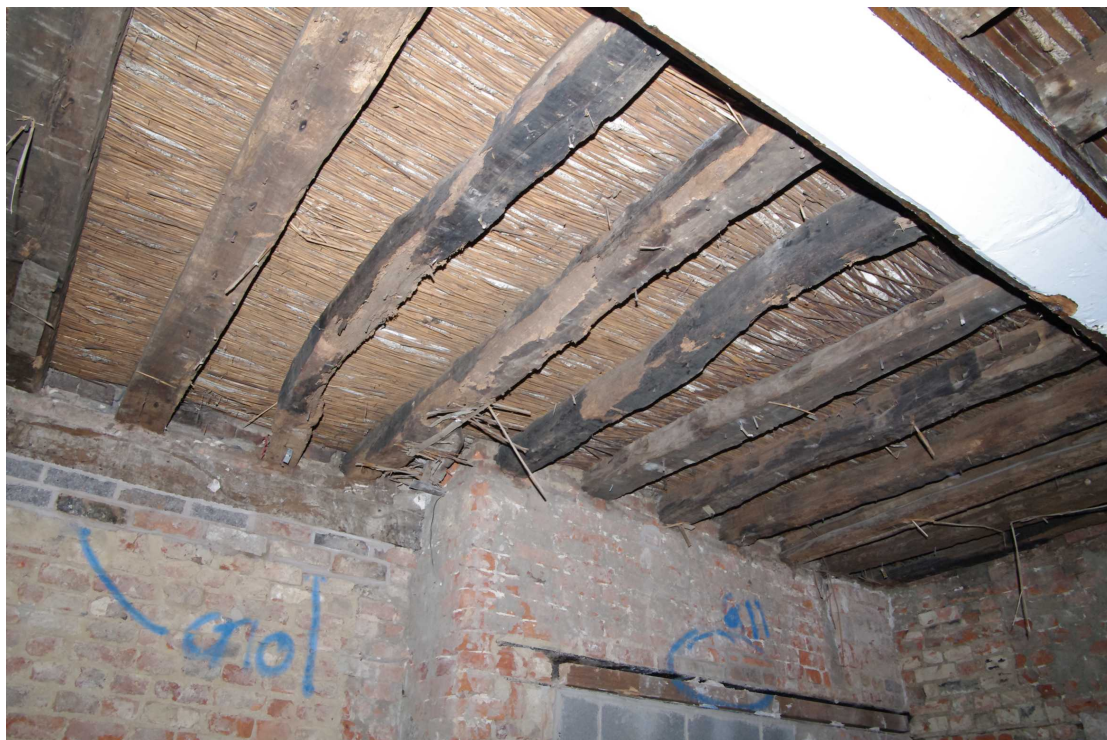
Figure 30 Room 3 ceiling details
Looking north-west

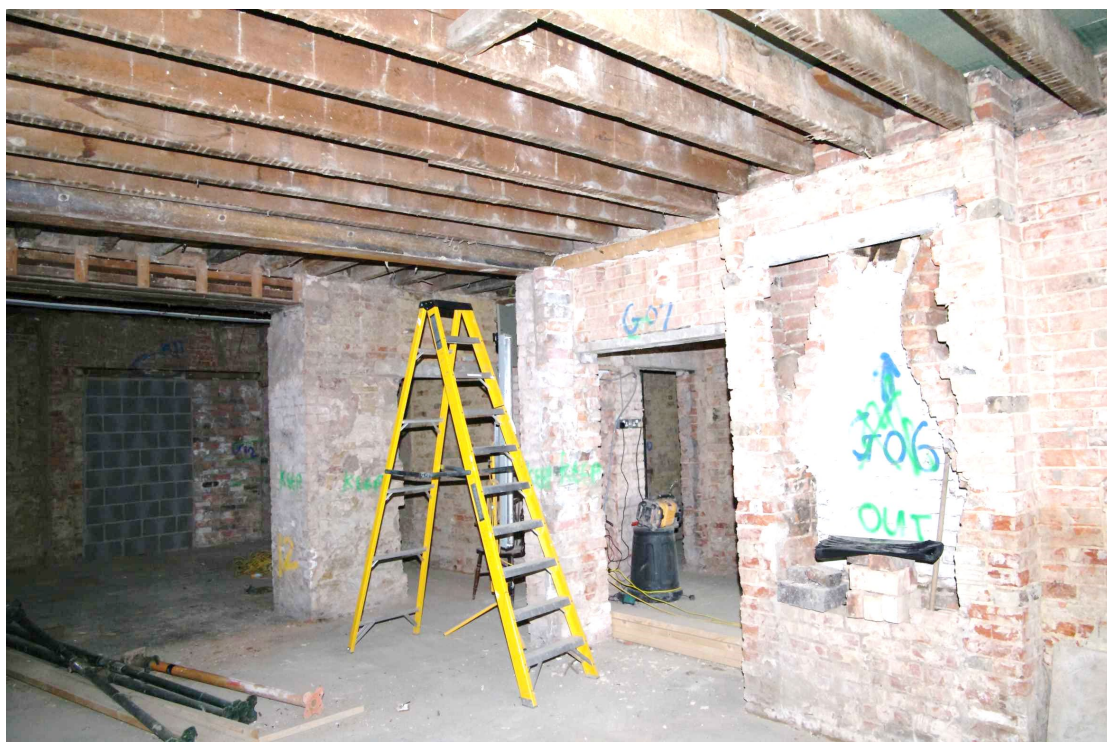
Figure 31 Rooms 3 and 4
Looking north-west from Room 4

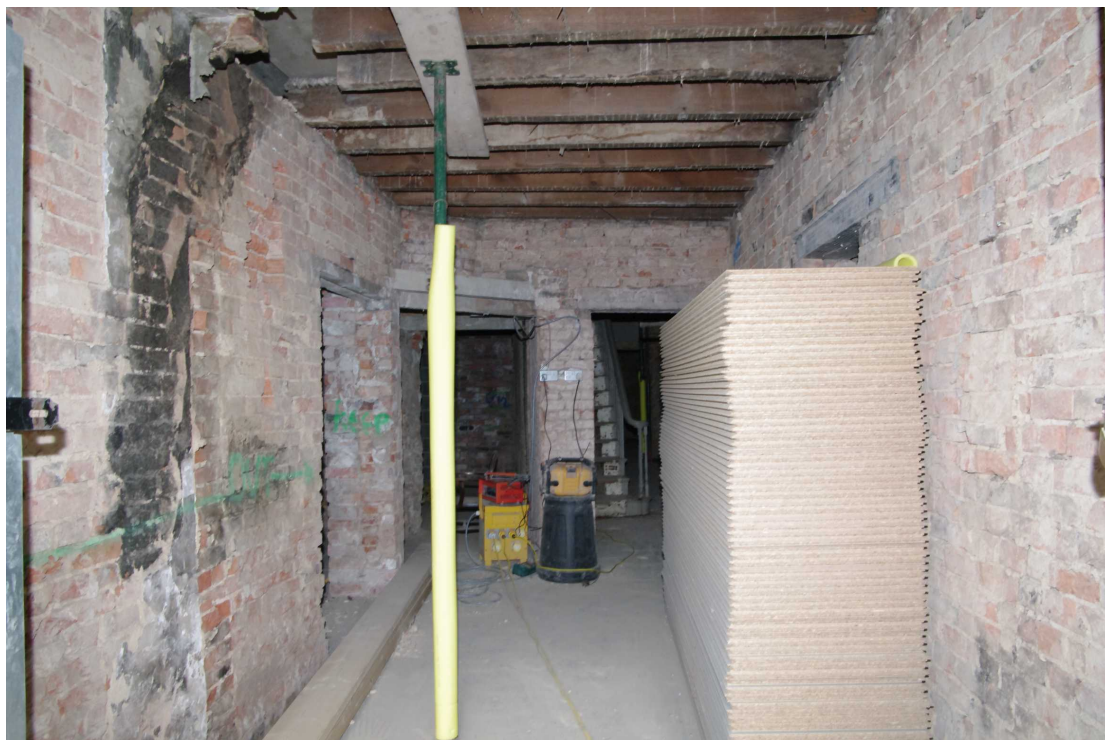
Figure 40 Ground floor entrance hallway (Room 8)
Looking west. Room 4 on left, stairs to first floor on centre right

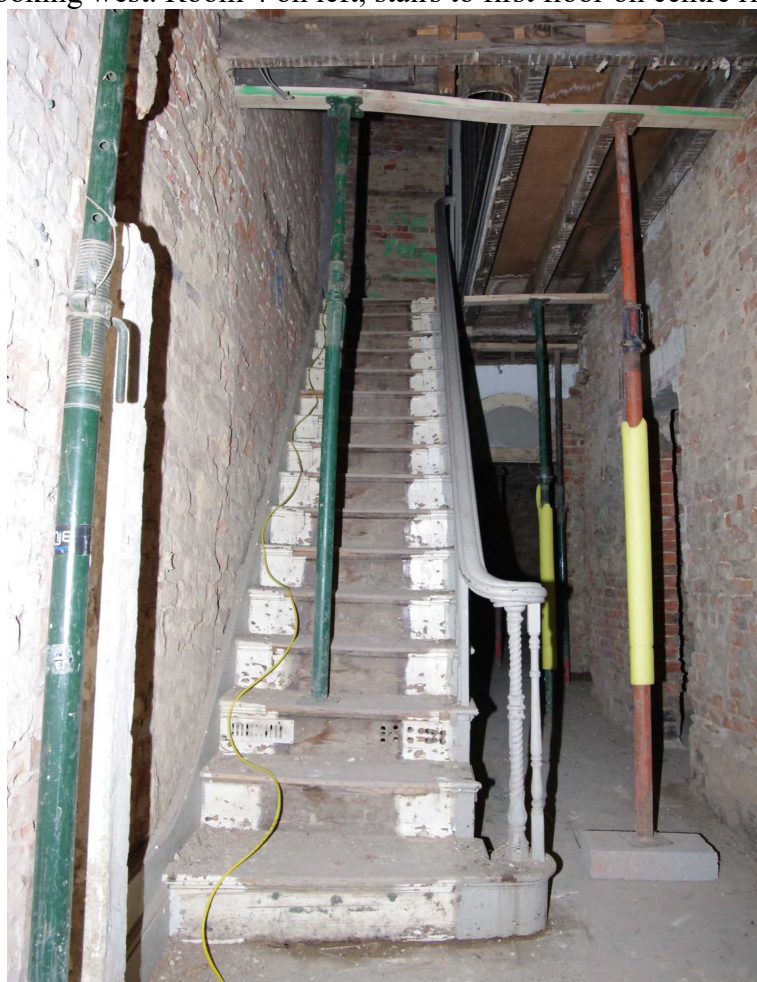
Figure 41 Stairs to first floor (Room 8)
Looking west. Door to Room 2 on right

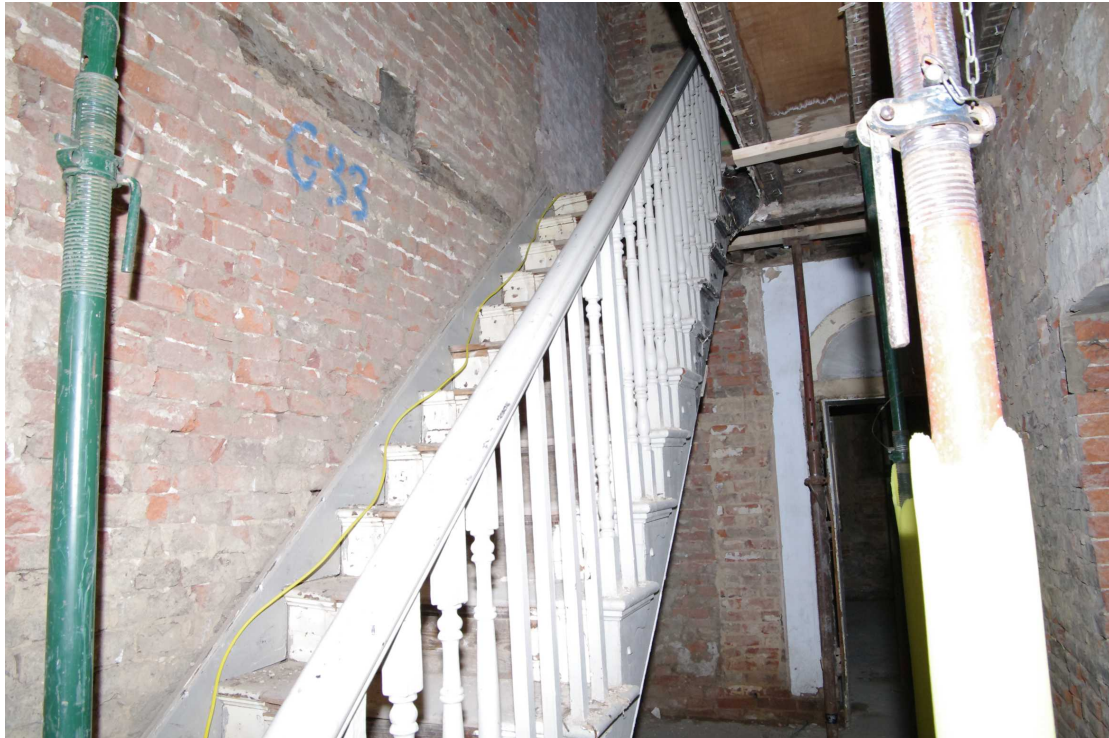
Figure 42 Staircase detail (Room 8)
Looking south-west

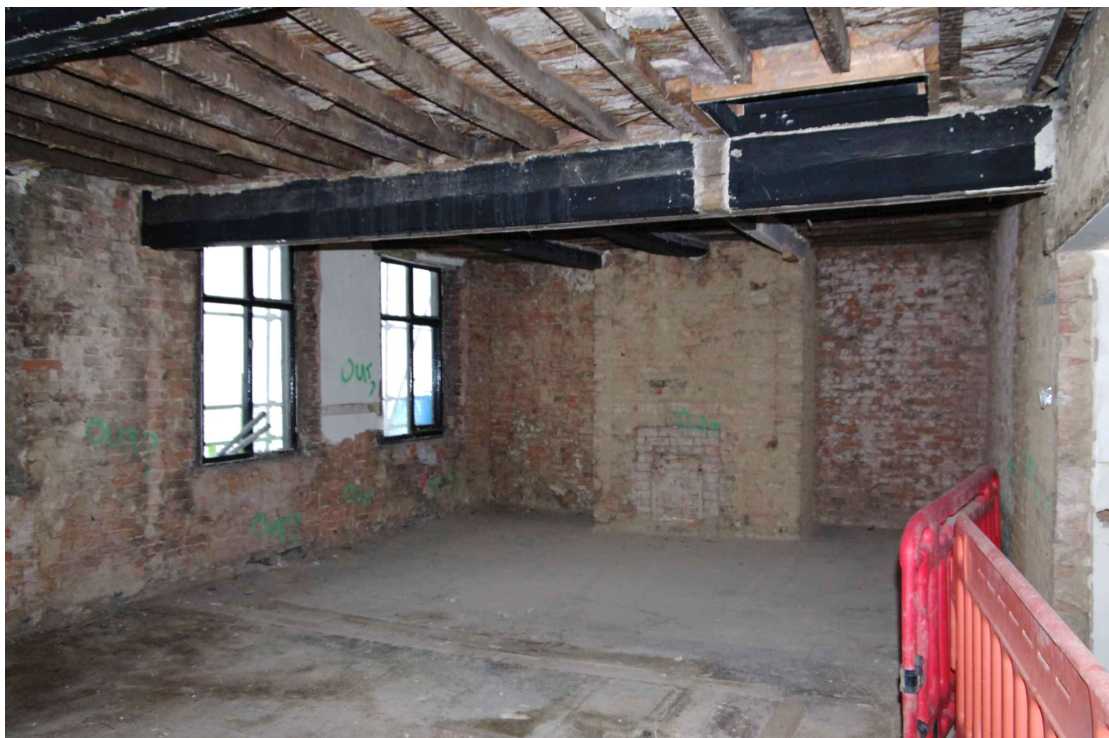
Figure 43 First floor Room 9
Looking north-west

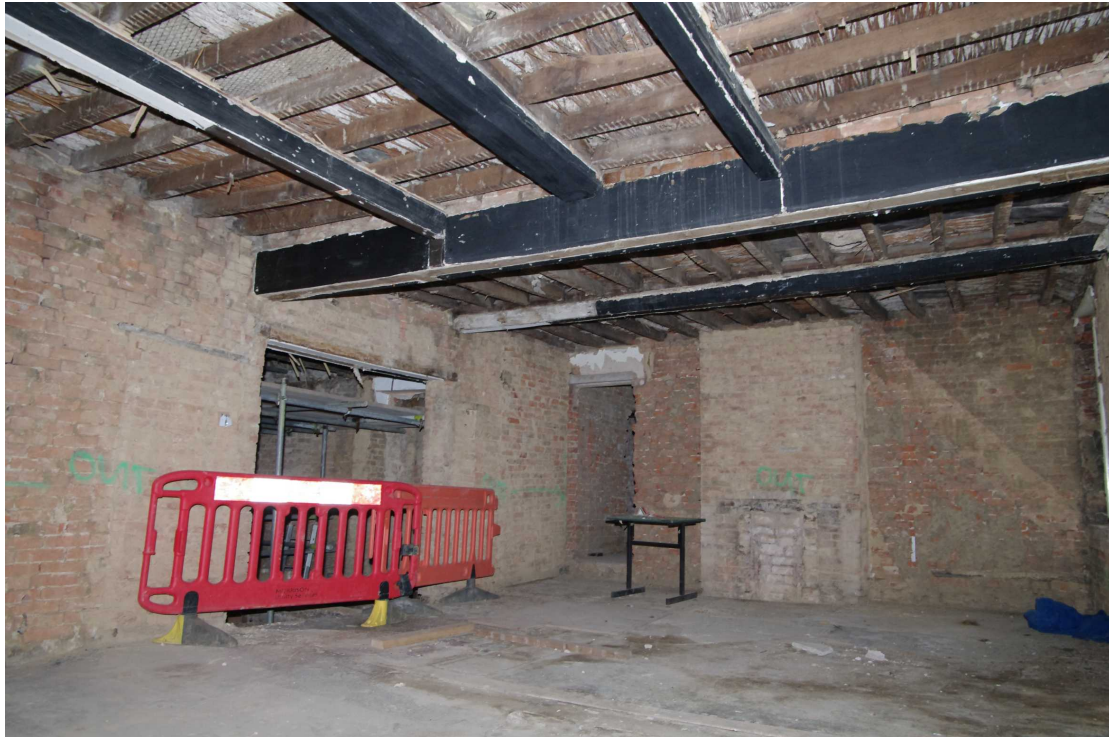
Figure 44 First floor Room 9
Looking south-east. Doorway to Room 10 centre right

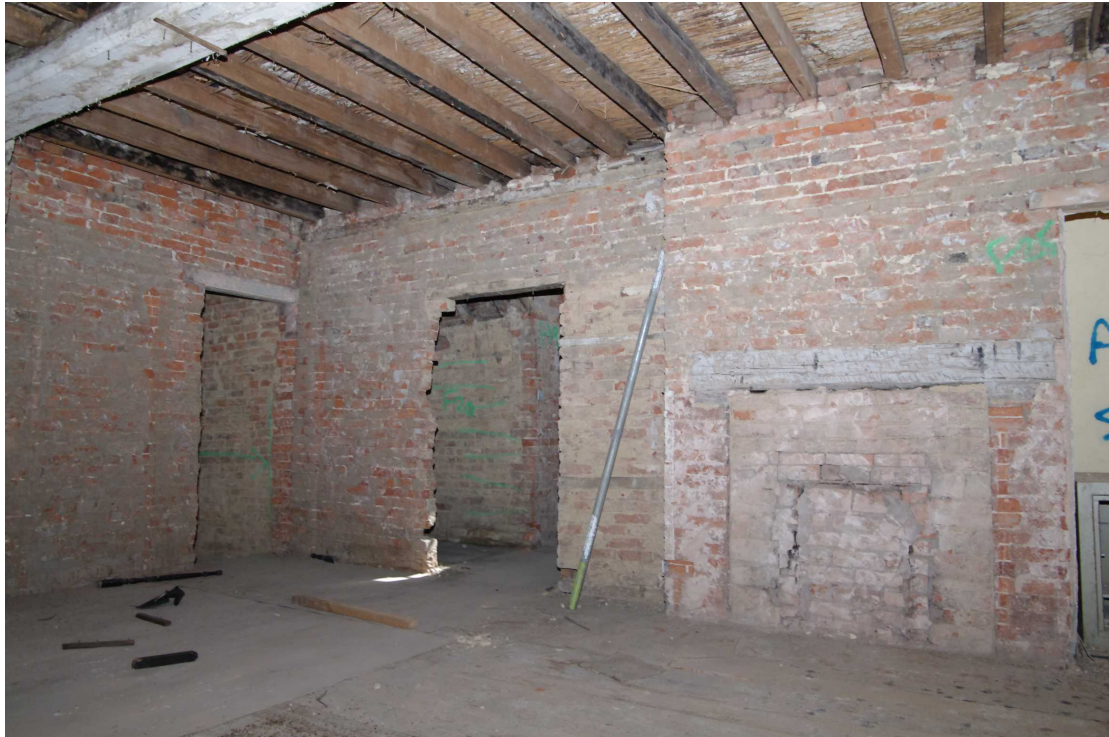
Figure 46 First floor Room 10
Looking south-east

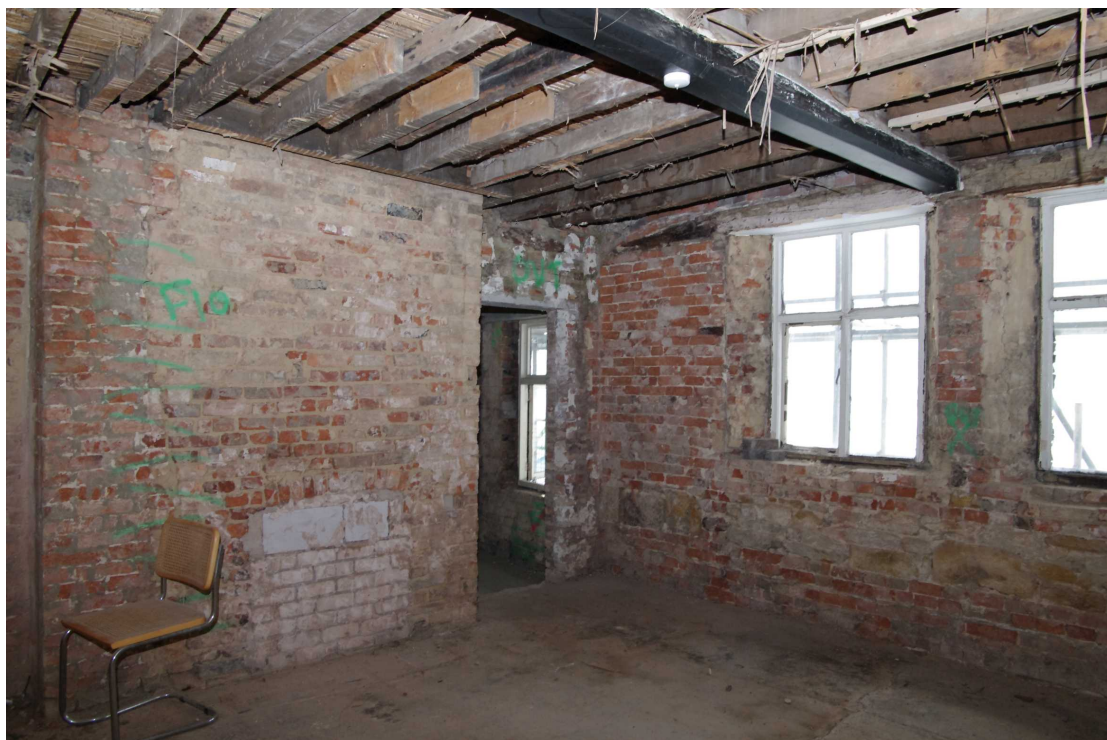
Figure 49 Room 11
Looking south-east. Note step down in floor level to Room 12 through doorway

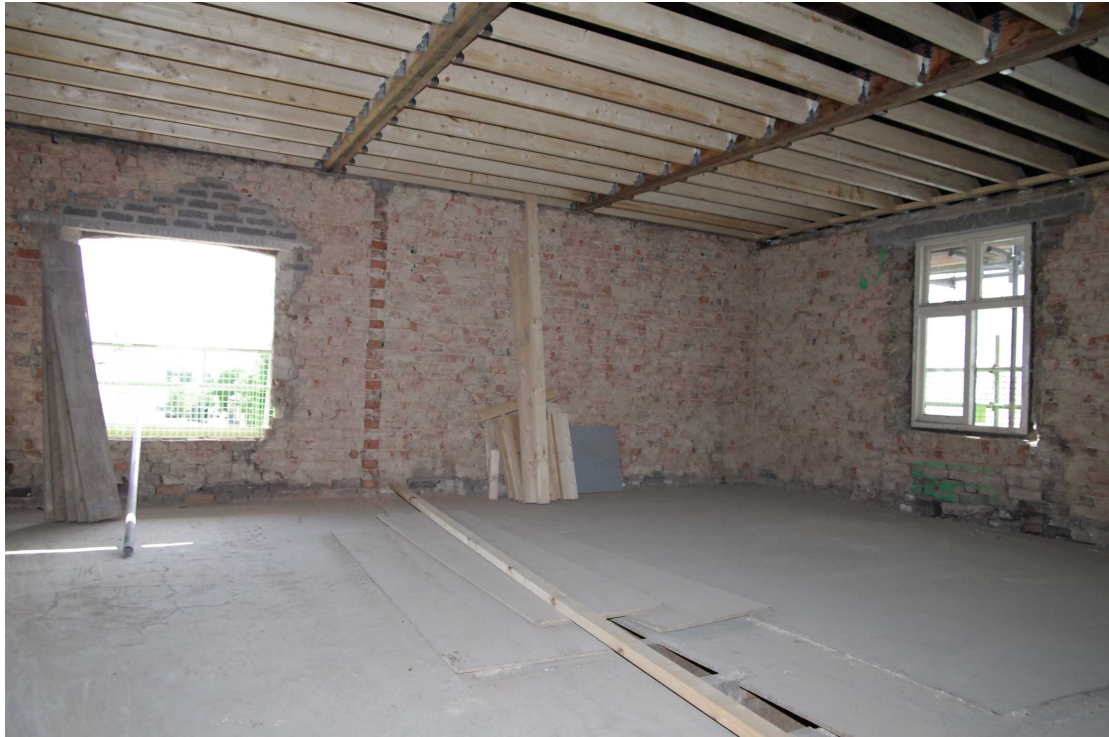
Figure 50 Room 12
Looking south-east after removal of internal walls and new ceiling insertion

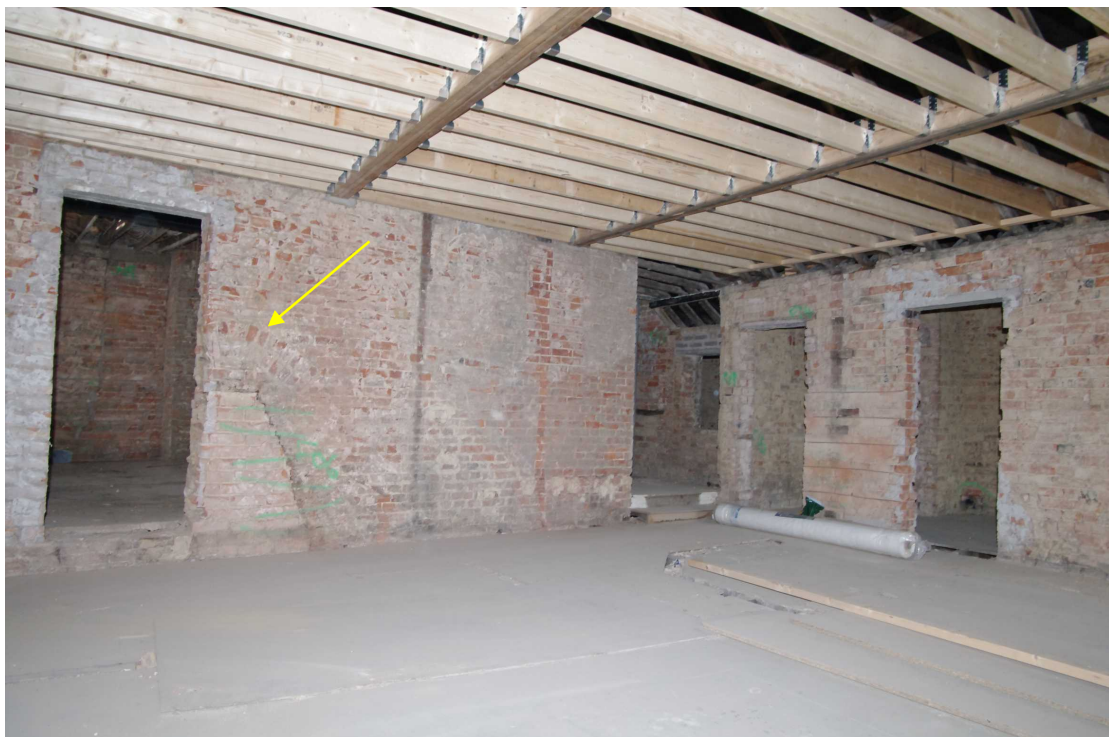
Figure 51 Room 12
Looking north-west. Note remnant of brick arch on right of left hand door
Doors on right lead to Room 15, doorway in centre leads to hallway 16

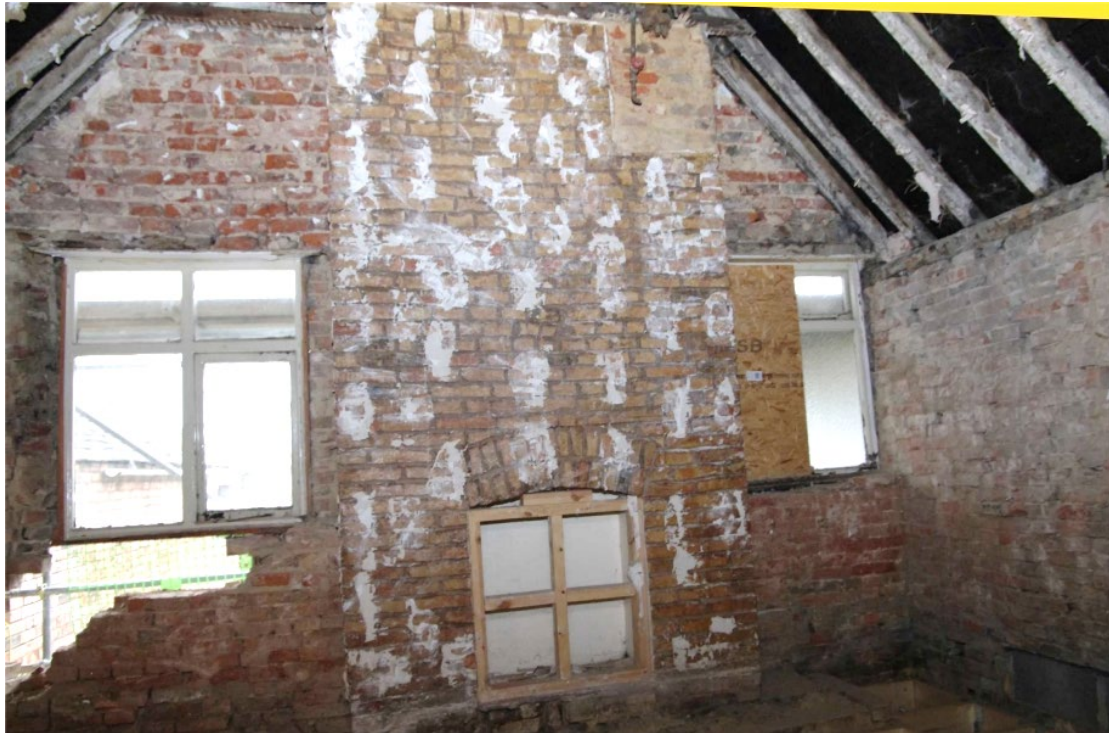
Figure 52 Room 13 after removal of floor and ceiling
Looking south-east. New window to be located in central fireplace

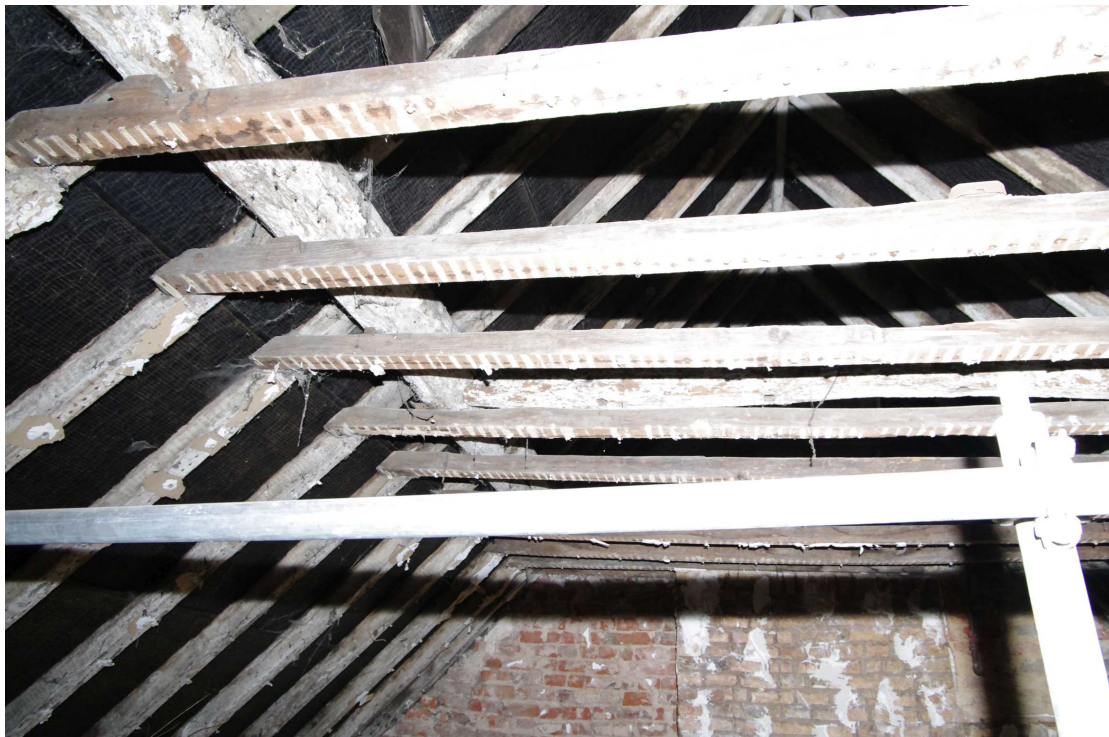
Figure 53 Room 13 roof structure
Looking east. Note round section purlin and tie-beam. Tie-beam has a row of circular holes for wattles

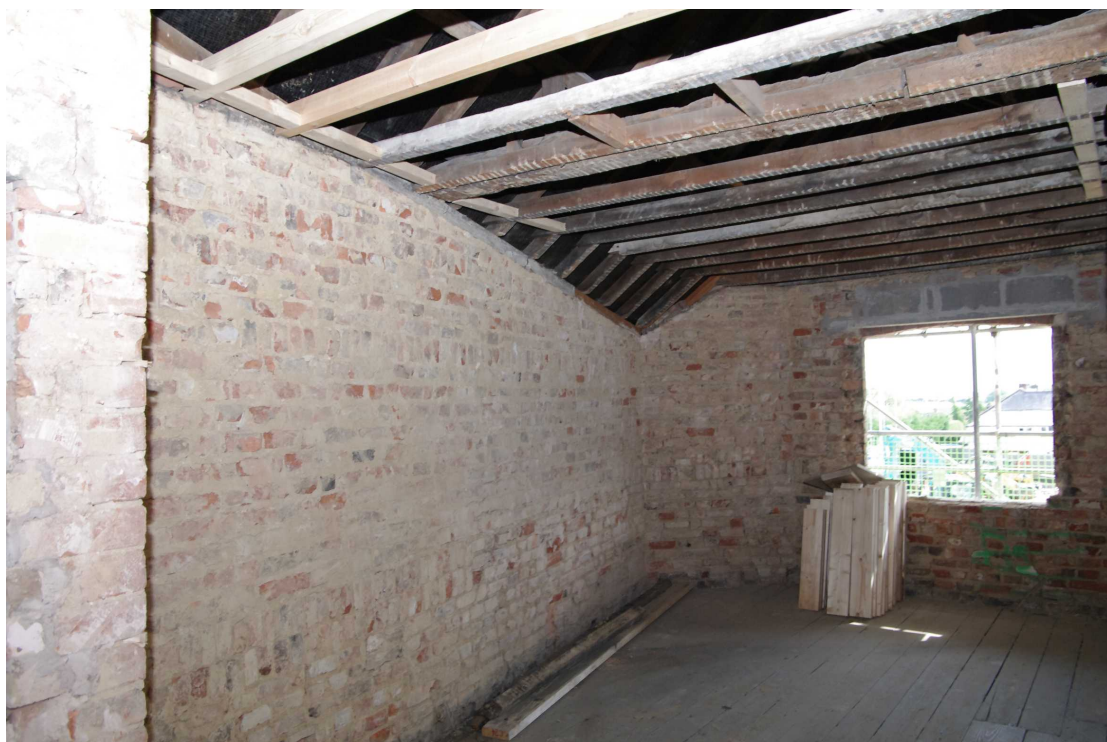
Figure 55 Room 15
Looking north-east

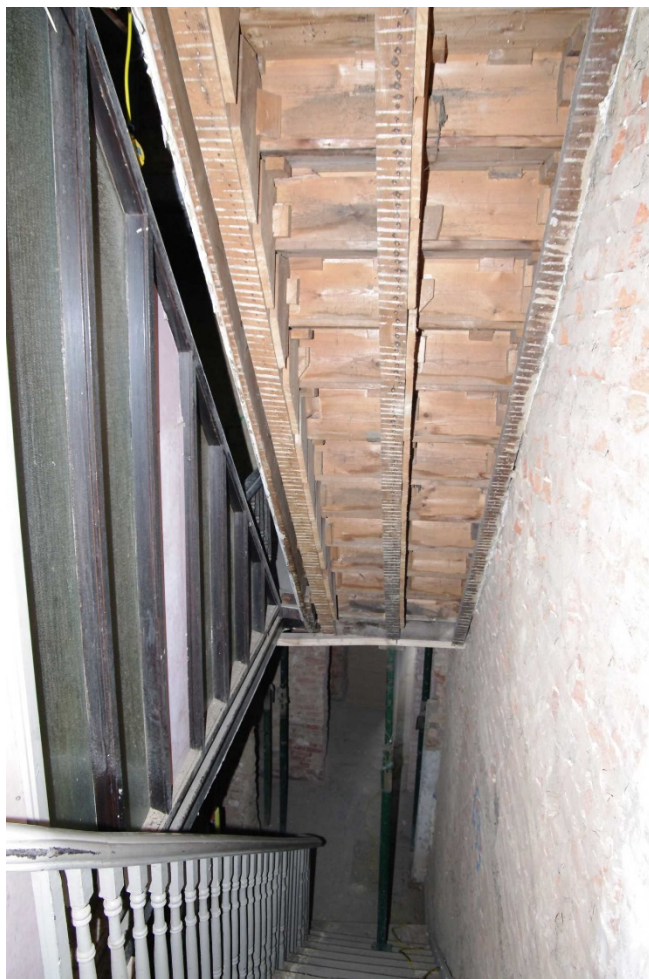
Figure 56 Stairs down to ground floor
Looking east. Underside of stairs up to first floor also visible

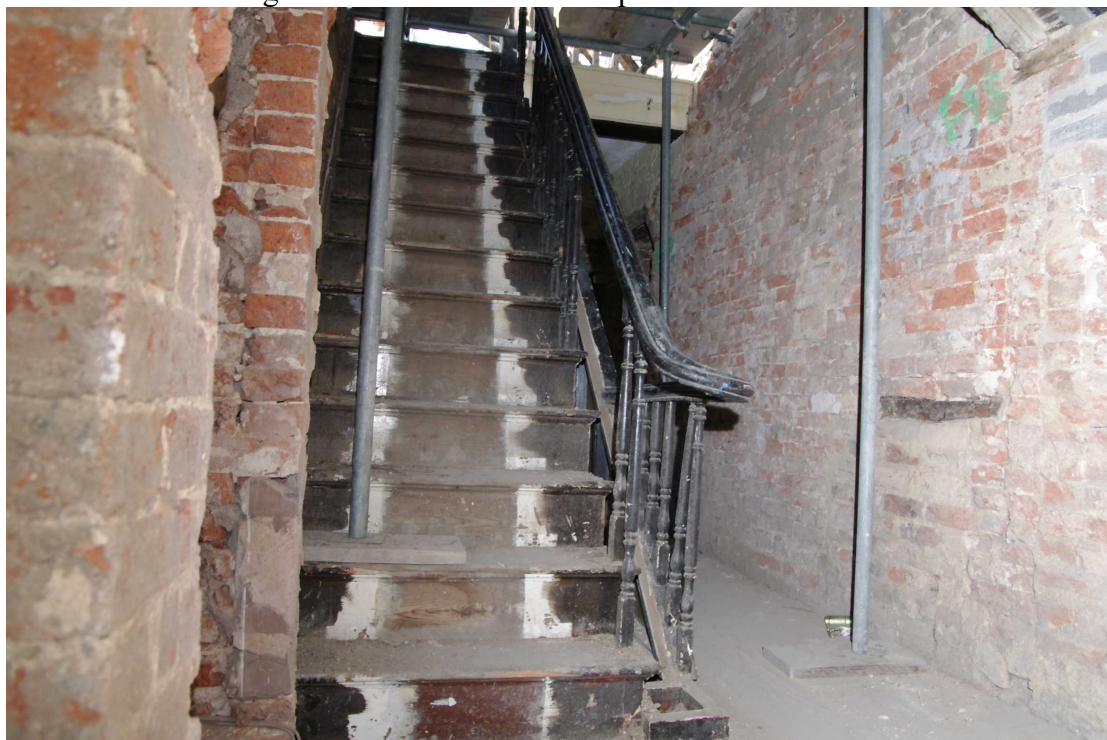
Figure 57 Stairs up to second floor
Looking west

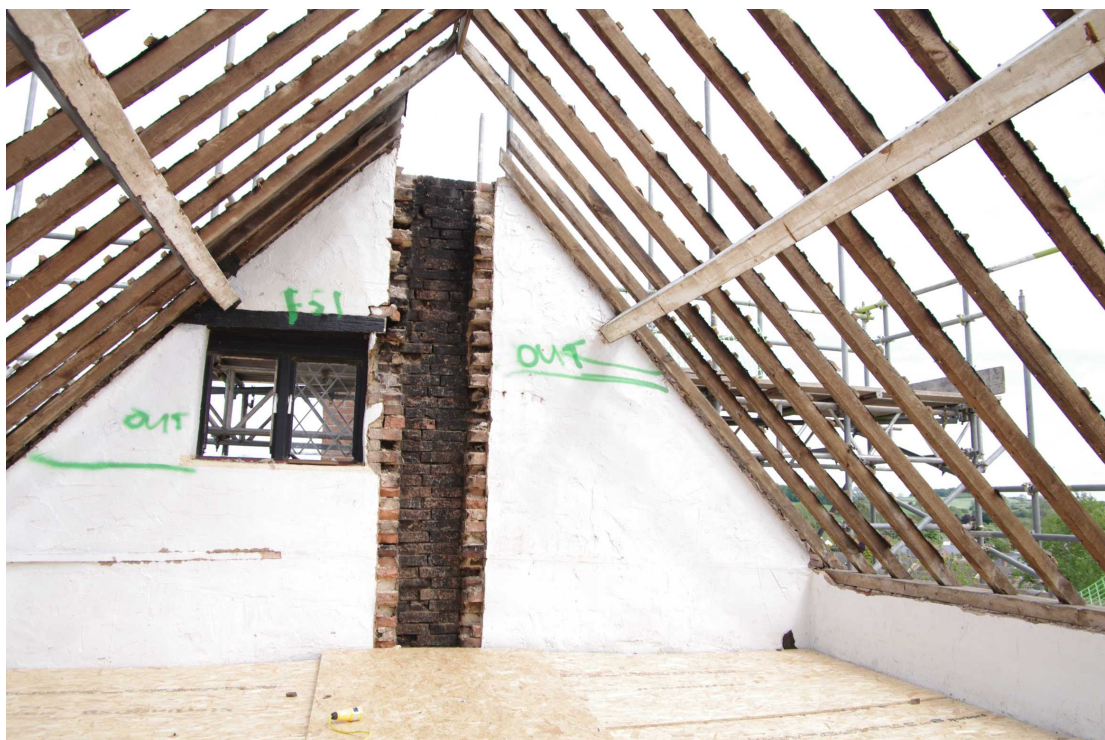
Figure 58 Second floor Room 17
Looking north. Chimney stack of 1 Main Street visible through window

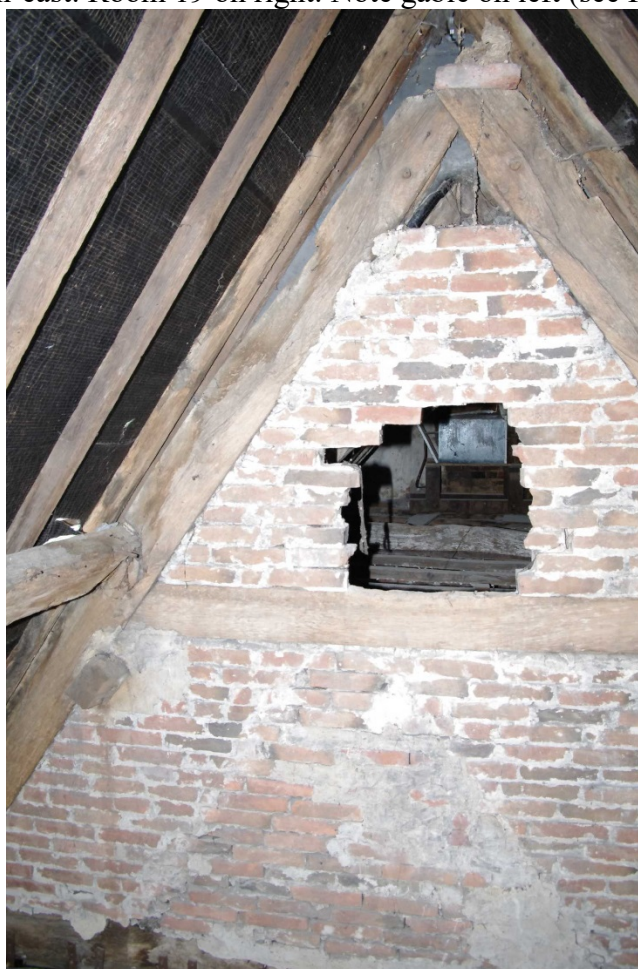
Figure 61 East gable over Room 13 seen from Room 18
Looking east. Note pegged apex and scar from earlier lower gable

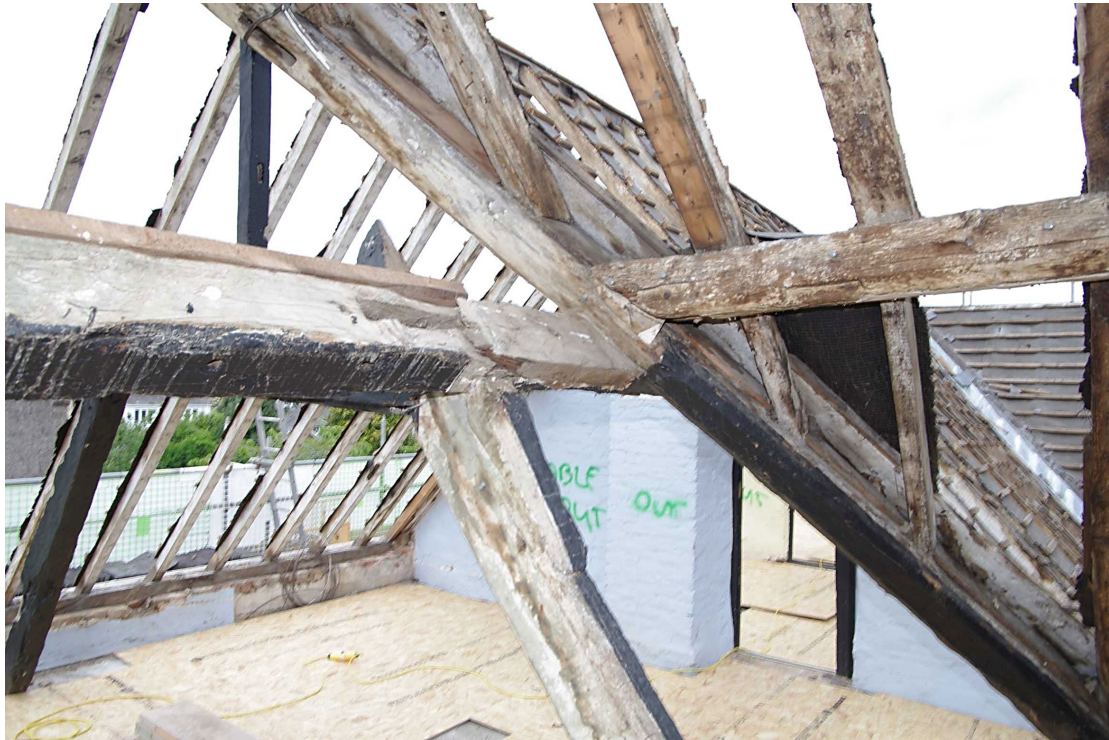
Figure 69 Room 19 roof detail
Looking north-west through former slated roof. See also Figure 70 below

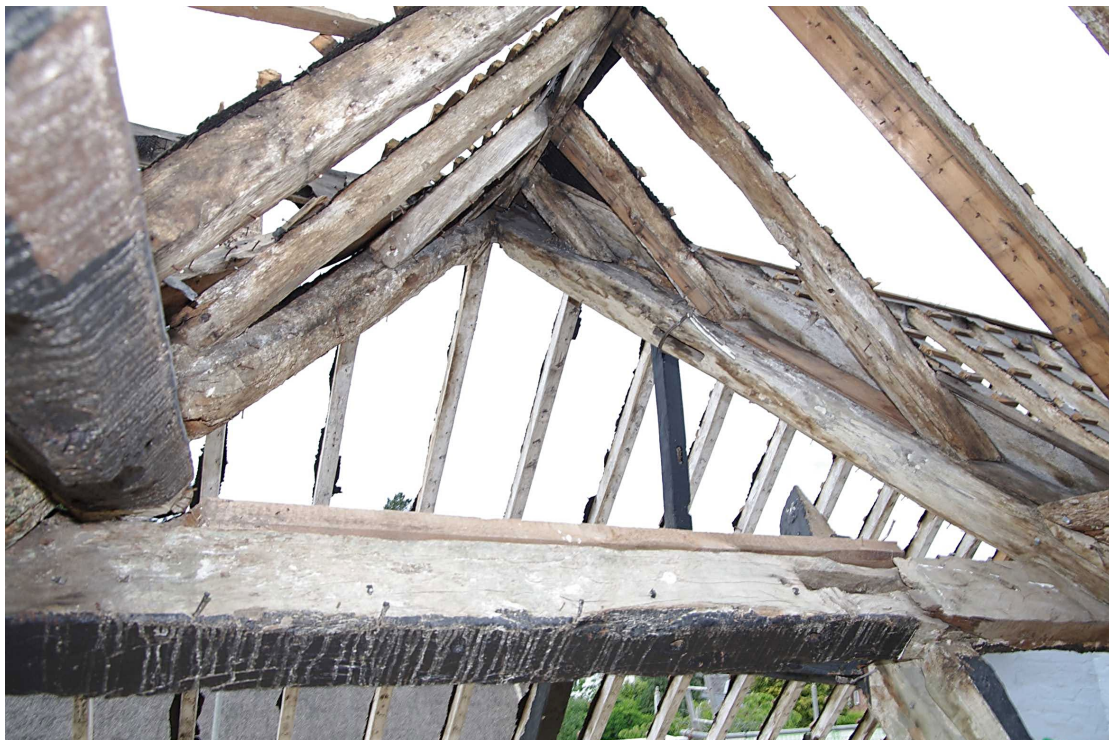
Figure 70 Room 19 roof detail
Looking west. See also Figure 69 above

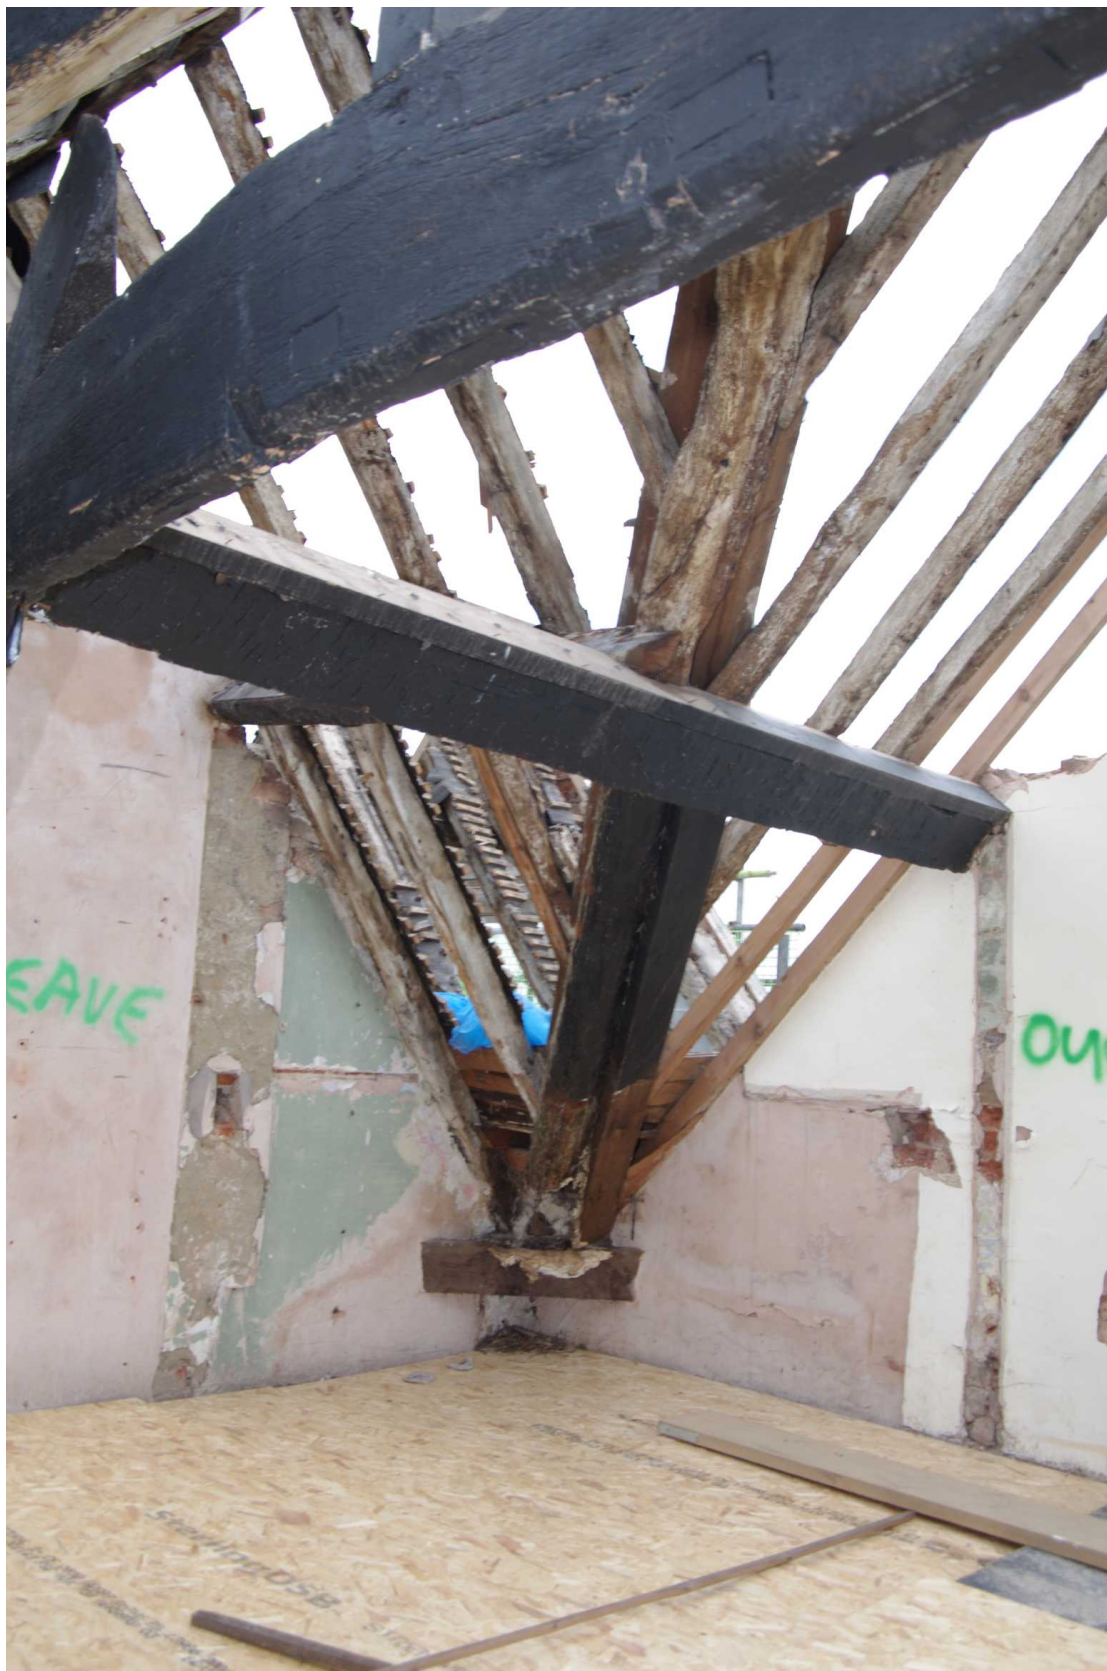
Figure 71 Room 19 corner roof structure
Looking south-east

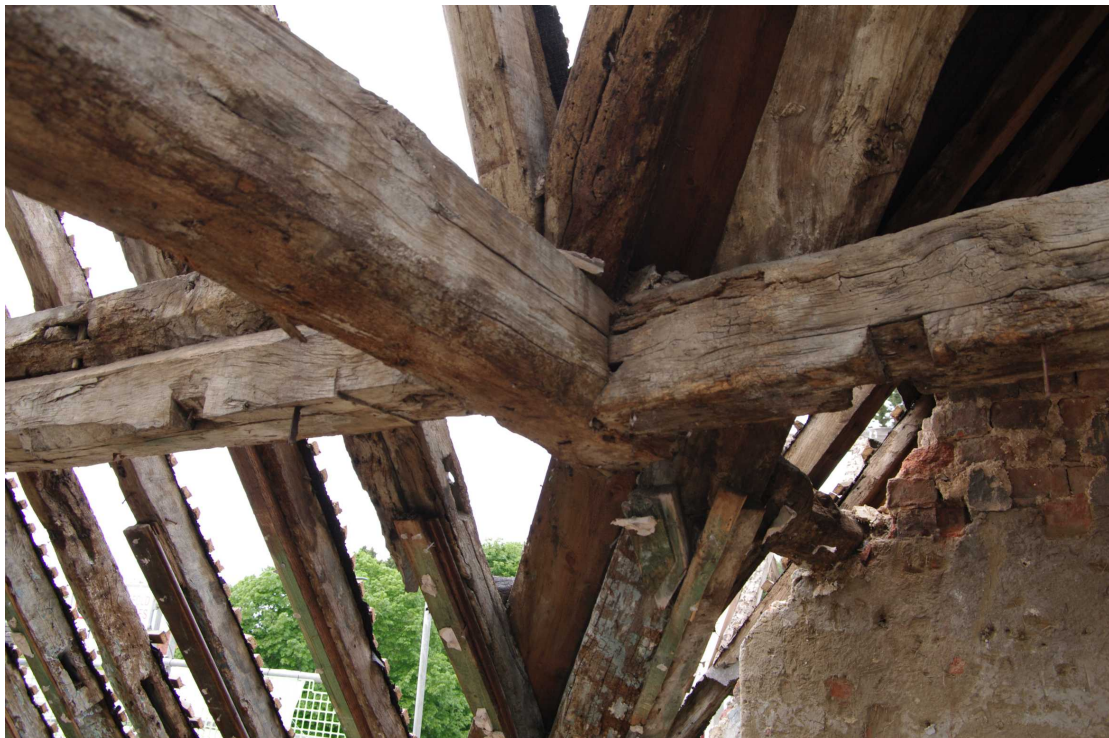
Figure 75 Room 20 joint detail in NW corner
Looking west
