**An Historic Building Photographic
Survey at the former
Rose and Crown Public House,
Leicester Road,
Kibworth Harcourt,
Leicestershire**

ULAS Report No. 2019-080
©2019

For: Staniforth Architects Ltd

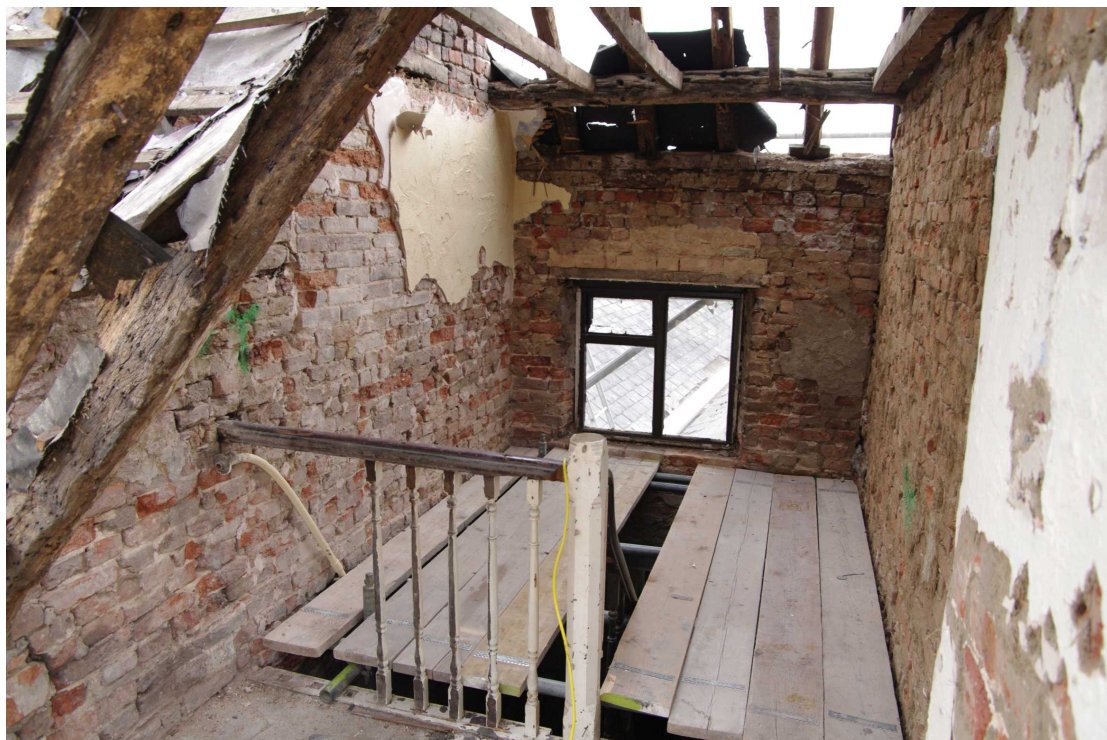
Figure 76 Room 21 top of staircase
Looking east

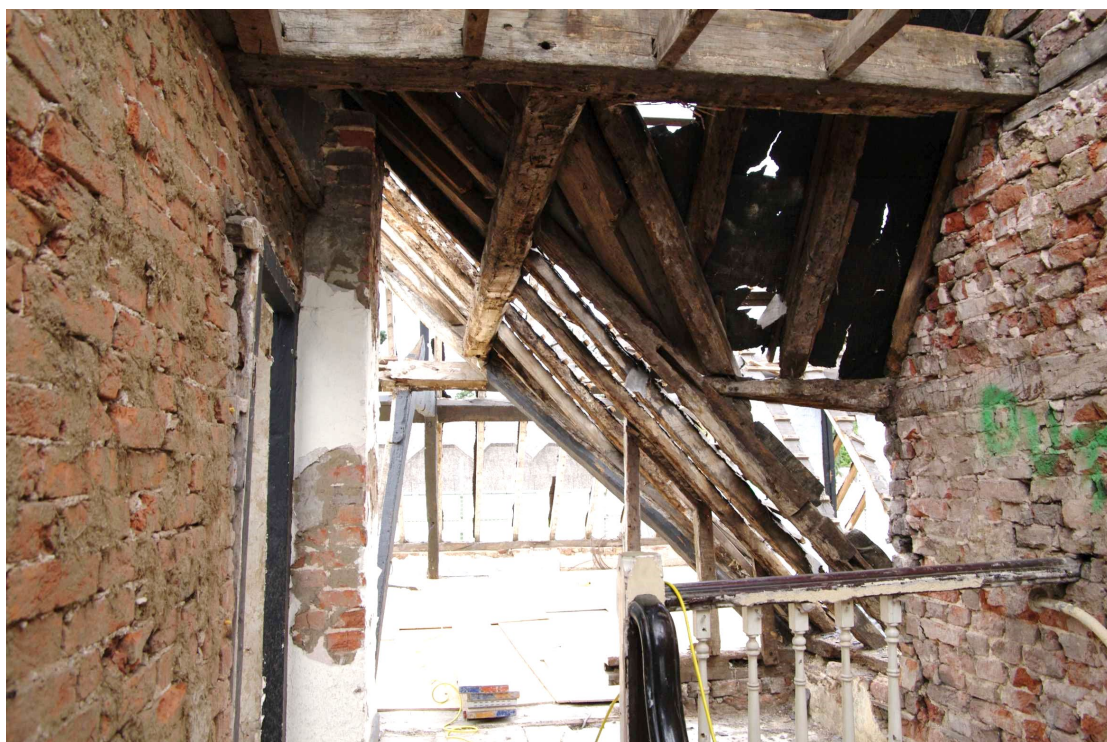
Figure 77 Room 21 top of stairs
Looking west into Room 19
