**Free Grammar School,
Highcross Street, Leicester:
Report on Phase 2 Intrusive
Opening Up Works**

For Shires GP Ltd.

University of Leicester Archaeological Services

Report 2005/009 ©2005

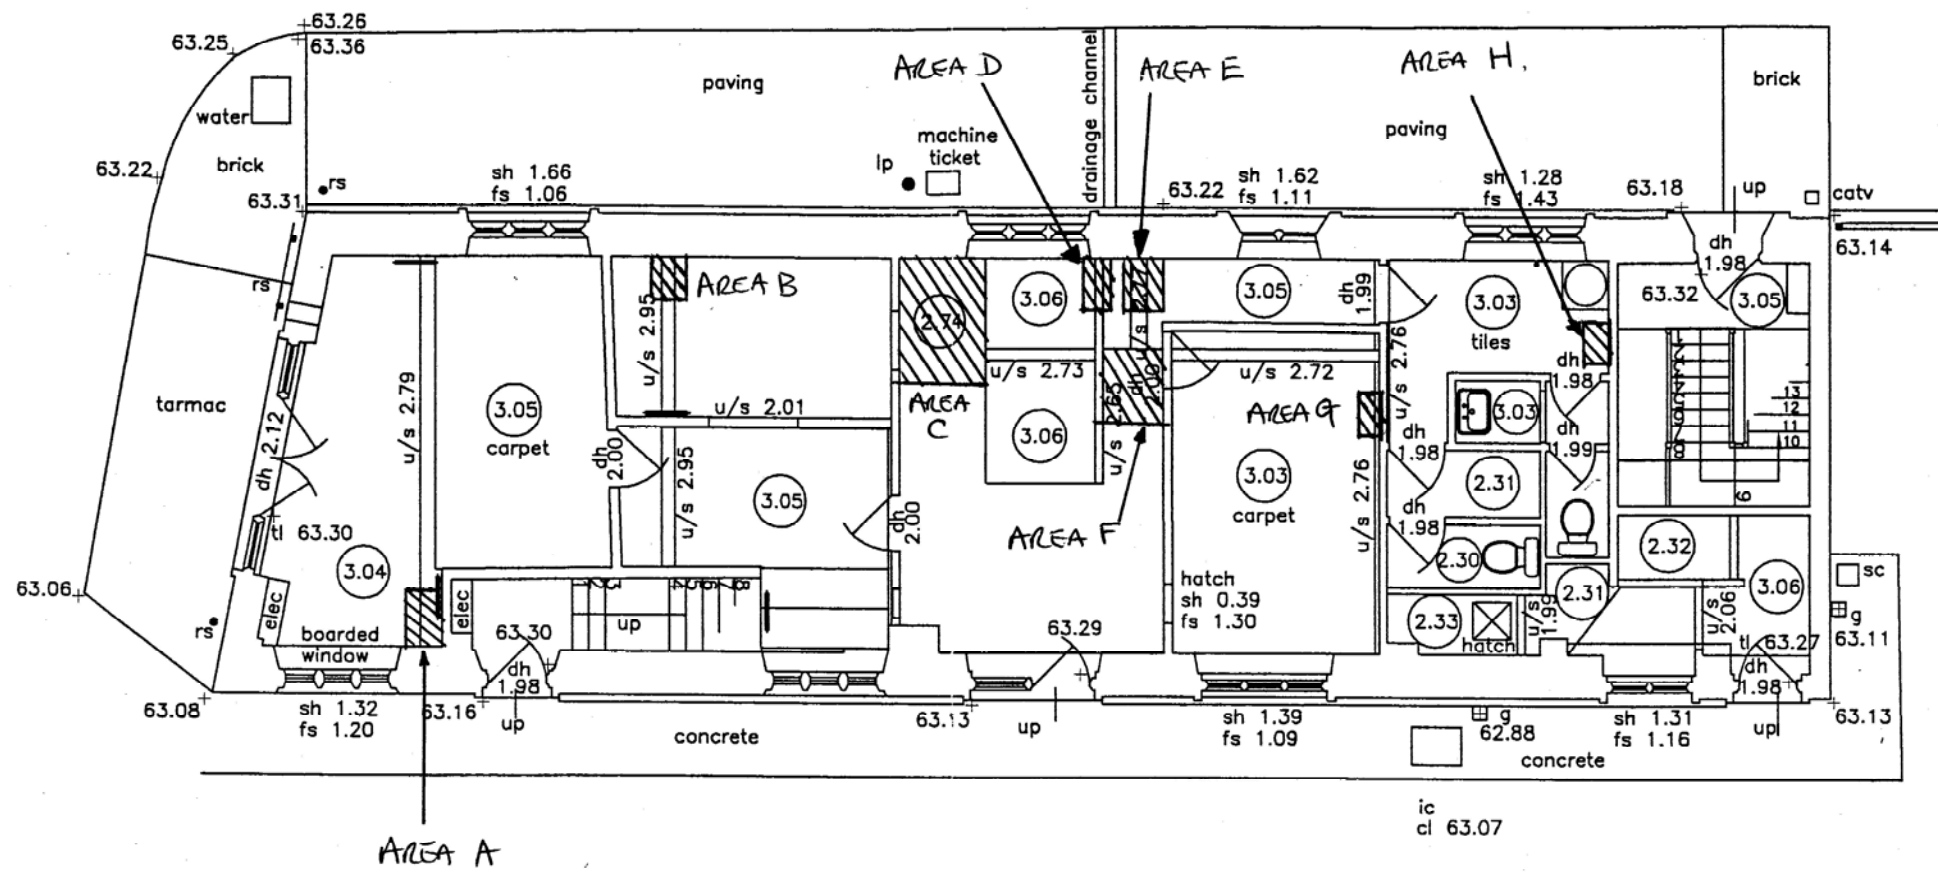
Figure 1. Free Grammar School, Highcross Street, Leicester. Scale 1:100. Ground Floor Plan showing location of openings to investigate first floor structure.

Nothing survives of the original/early first floor structure. A series of transverse beams at the bay intervals that were extant in 1966 are no longer *in situ*. These were probably removed as part of the 1966 development and were replaced with steel I-beams. The sequence of coverings over the I-beams corresponds with the requirements of contemporary fire regulations. None of the fabric of the first floor structure is likely to be earlier in date than 1966.

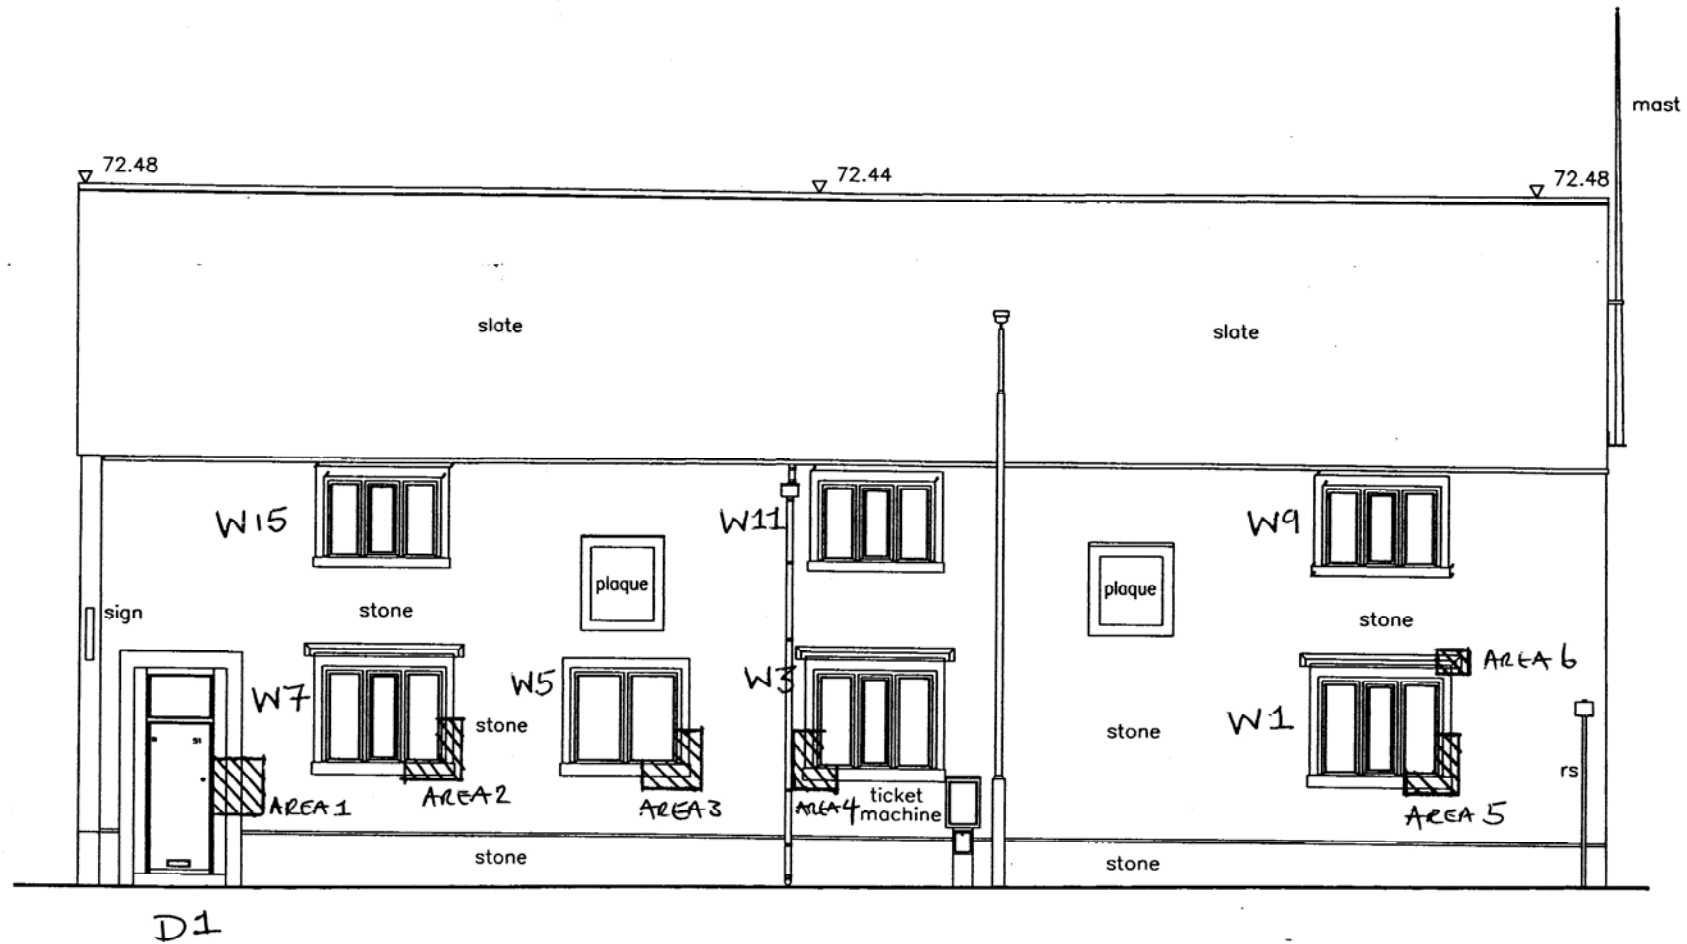
Figure 2. Free Grammar School, Highcross Street, Leicester. Scale 1:100. West (Highcross Street) elevation showing location of openings to investigate window & door surrounds. Numbering of windows and doors follows that of RG+P.

The early stone windows on the Highcross Street elevation use a combination of oolitic limestone and a shelly limestone. The stone appears to be in reasonably good condition, however assessment by a specialist in the conservation of historic stonework would be required to confirm this, and to provide an informed assessment of the potential for removing subsequent coverings without causing excessive damage to the underlying stonework, if exposure of the early surrounds is proposed as part of the development.

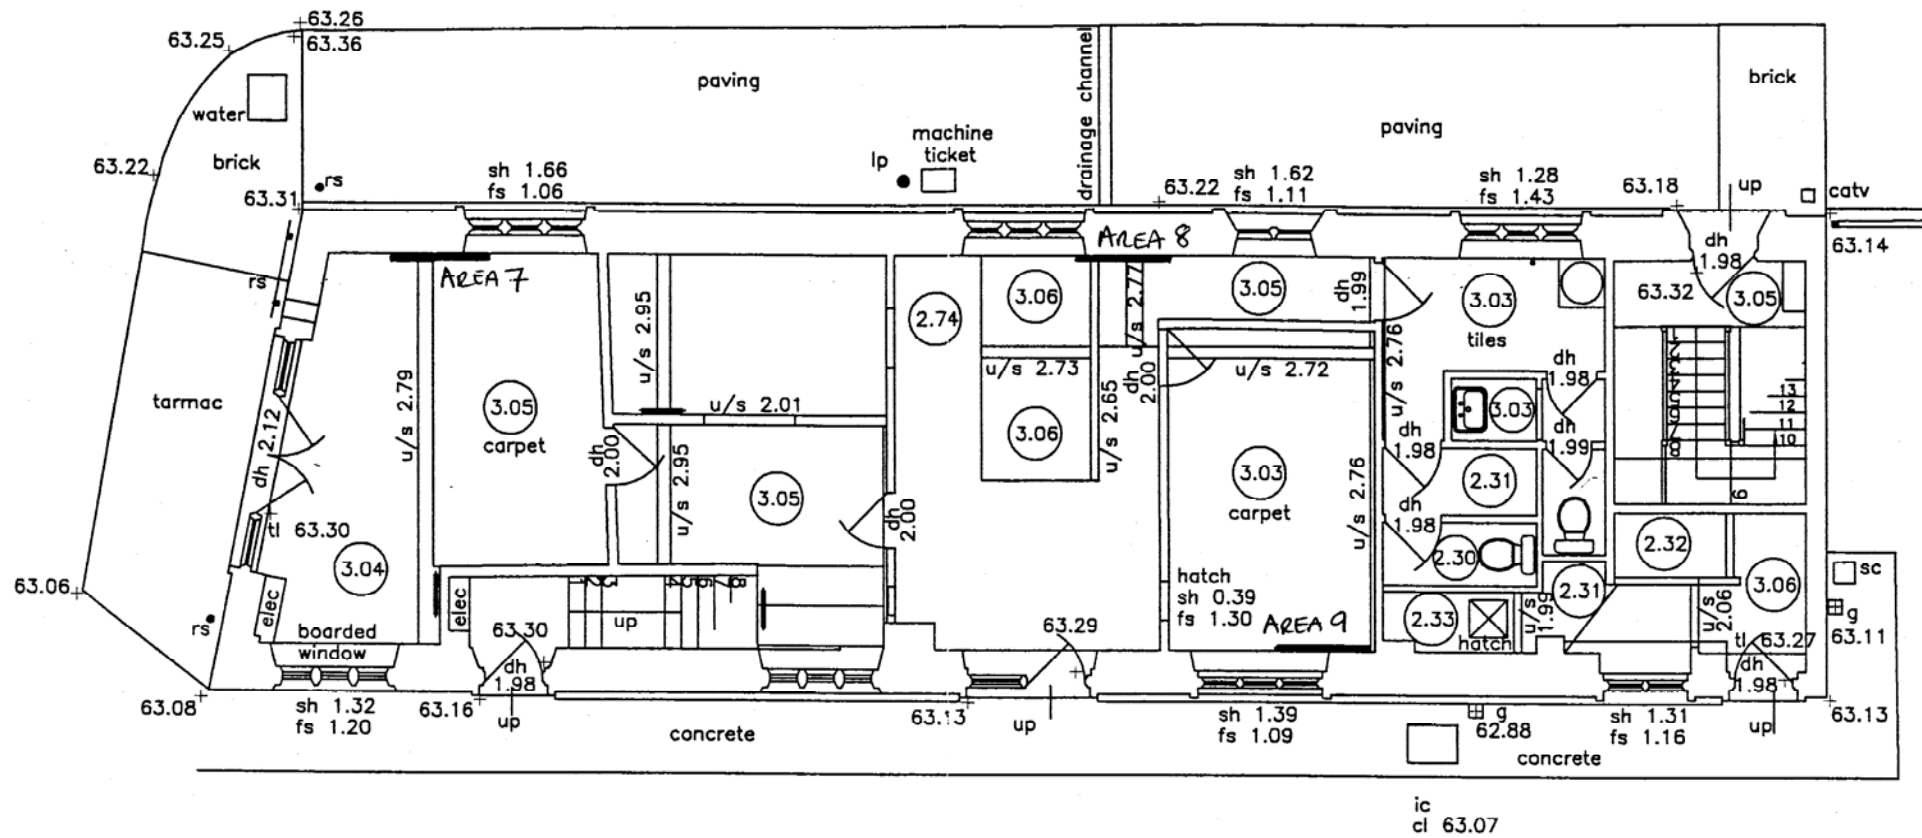
Figure 4. Free Grammar School, Highcross Street, Leicester. Scale 1:100.
Ground Floor Plan showing location of openings to investigate internal wall coverings
and assess historic precedent of current openings in east wall.

gypsum plaster on steel mesh over lime render over stonework. There is localised damage to the lime render from nails used to fix mesh. Wall is slightly damp and steel mesh, corner reinforcing and fixing nails have corroded, resulting in rust staining to surviving render in window splay. Any early render on inner wall face must have been removed as part of, or prior to, the 1966 alterations.

Traces of earlier internal wall finishes (of unknown date) survive beneath the modern gypsum plaster in several locations on both the ground and first floors. Significant damage to these earlier finishes was caused in the 1960s when steel mesh was nailed to the internal wall faces to provide a key for plastering. In some locations (eg. Area 8) early wall coverings appear to have been deliberately removed in the past, though at what date and for what reason is uncertain.

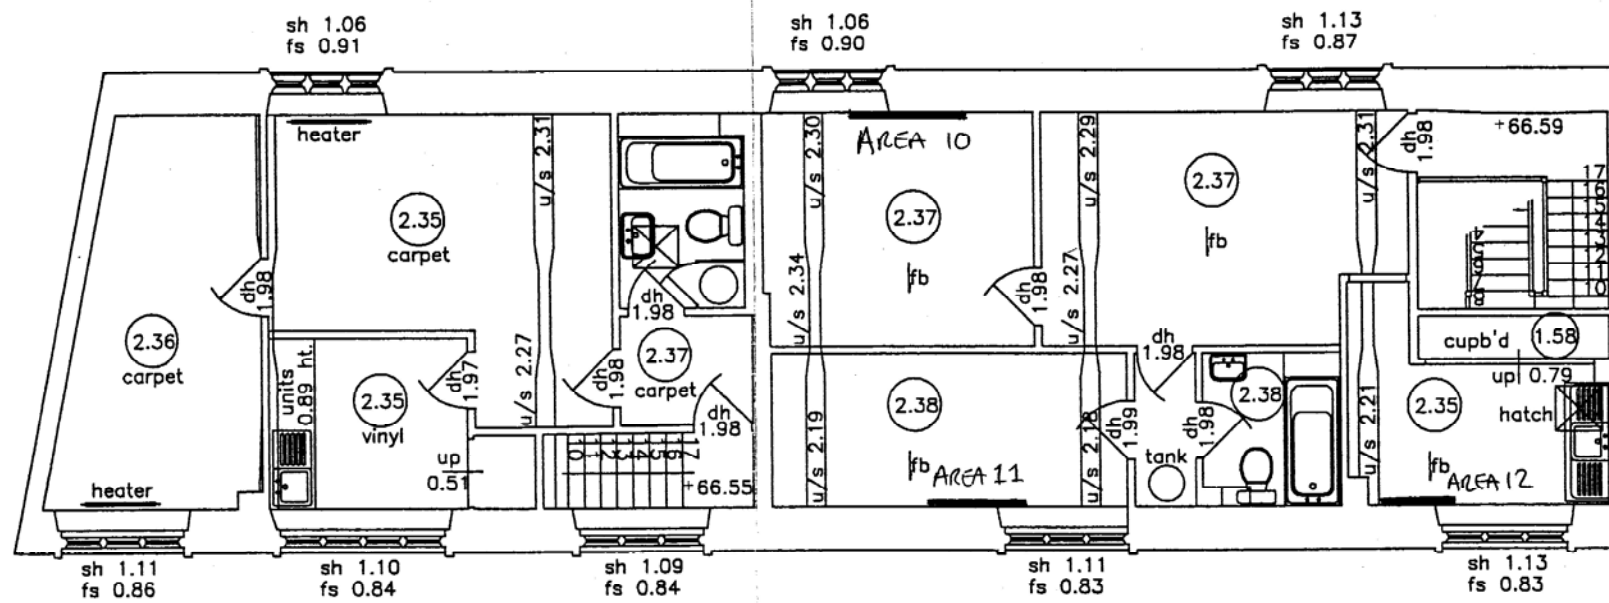
Figure 5. Free Grammar School, Highcross Street, Leicester. Scale 1:100.
First Floor Plan showing location of openings to investigate internal wall coverings
and assess historic precedent of current openings in east wall.

Opening to the south of 3-light mullion window W14 on east (car park) elevation. Dimensions: 0.5m wide x 0.5m high; return into window aperture: 0.25m wide x 0.5m high. Lower edge of opening 0.2m above sill level. Total thickness of wall coverings: 25mm. *Sequence*: Late 20th century wallpaper on c.1966 gypsum plaster on steel mesh, over smear-rendered stonework with limewash finish, this badly damaged by nails used to fix steel mesh. The window opening is finished in brick with cement mortar. The exposed stonework is random rubble with no clear indication (e.g. larger dressed blocks) of an original window opening at this point (c/f Area 12 below).

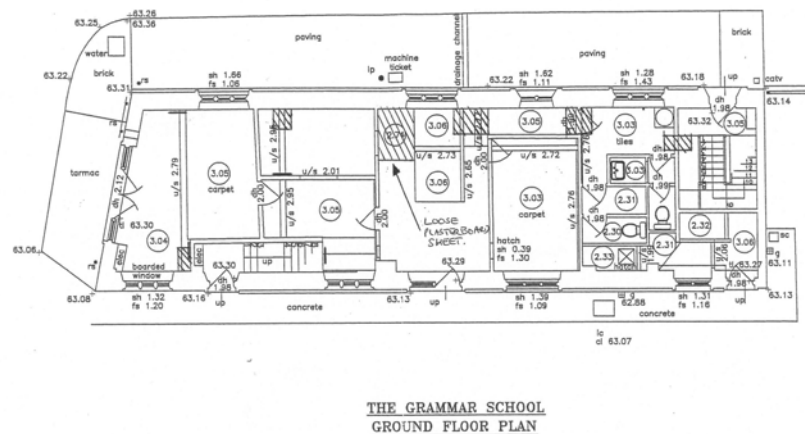
Fig. 1: proposed areas for investigation of first floor structure (hatched)

Removal of cladding/boxing in on the underside of ceiling beams in six locations (hatched). Largest area (towards the centre of the building) corresponds with a loose sheet of plasterboard where the transverse beam is fully underdrawn in the present reception area. Positions against the side walls have been chosen to permit assessment of the condition of timbers in areas most vulnerable to rot (ie beam ends).

At the northernmost area of proposed intervention it appears that the ceiling beam may have been removed. Areas on one, and if necessary both, sides of the 9 inch brick wall that closes off the staircase to the N end first floor flat will be opened up to verify this.
