**An Historic Building Photographic  
Survey at  
Saddle House, Churchgate,  
Hallaton,  
Leicestershire**

ULAS Report No. 2019-092v2  
©2019

**For: Mr D Pochin.**

## **An Historic Building Photographic Survey at Saddle House, Churchgate, Hallaton, Leicestershire.**

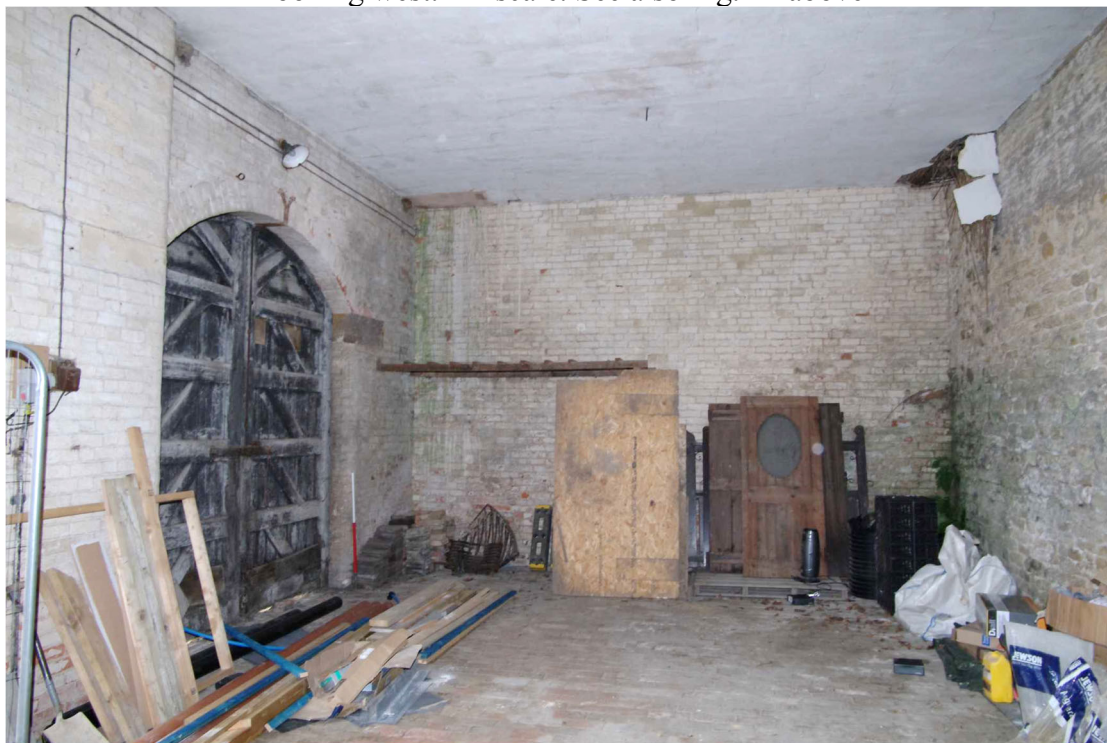
Figure 52 The Coach House ground floor east wing  
Looking west. 1m scale. Note hooks on ceiling for holding lights

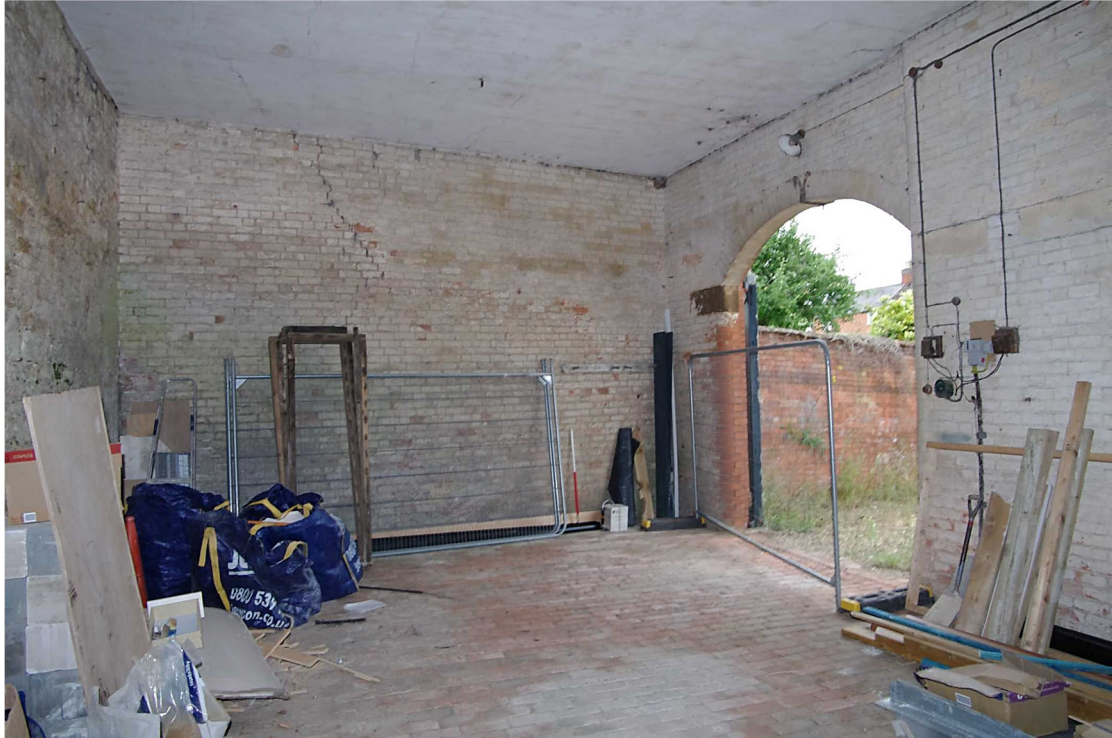
Figure 53 The Coach House ground floor east wing  
Looking south-east. 1m scale. Note wooden pegs above the scale

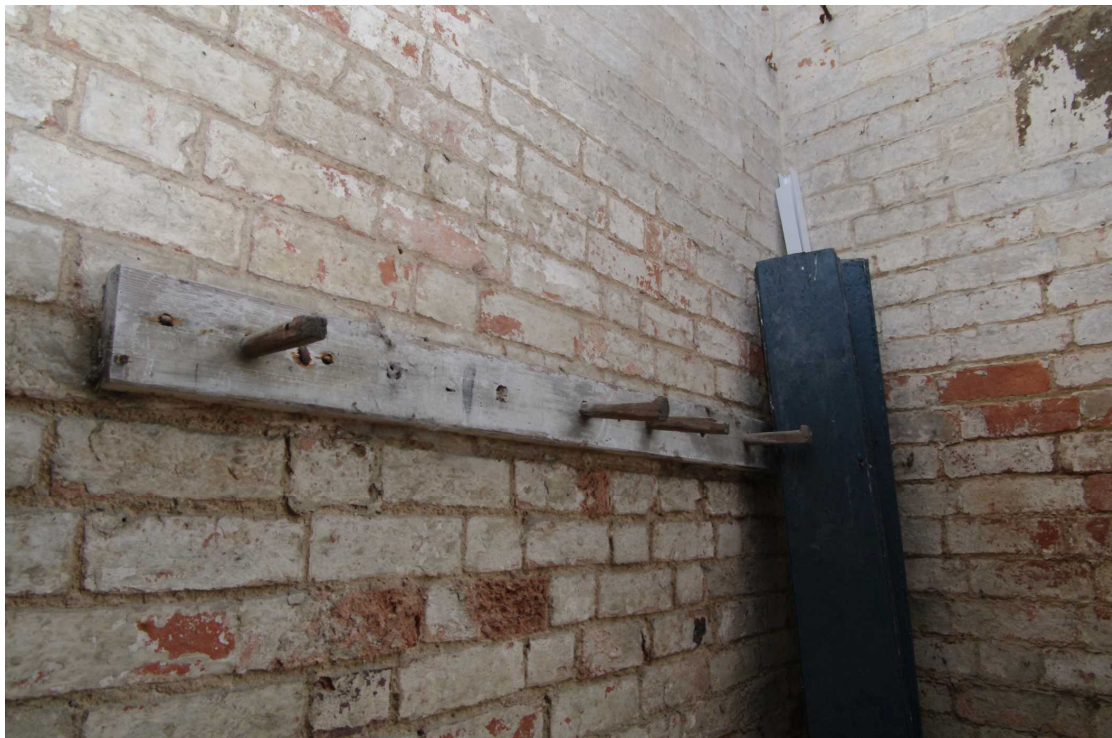
Figure 54 The Coach House ground floor east wing  
Wooden pegs/hooks on eastern wall (see Fig. 53 above)

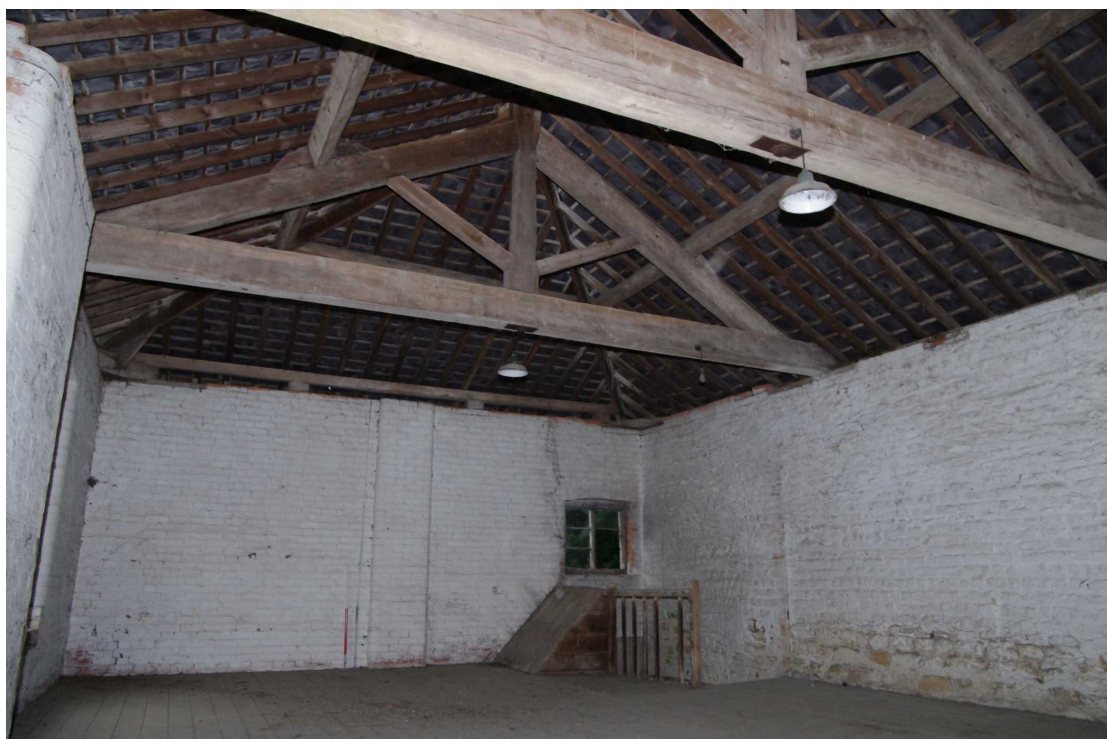
Figure 56 The Coach House first floor  
Looking north-west. 1m scale. Stairs in far corner

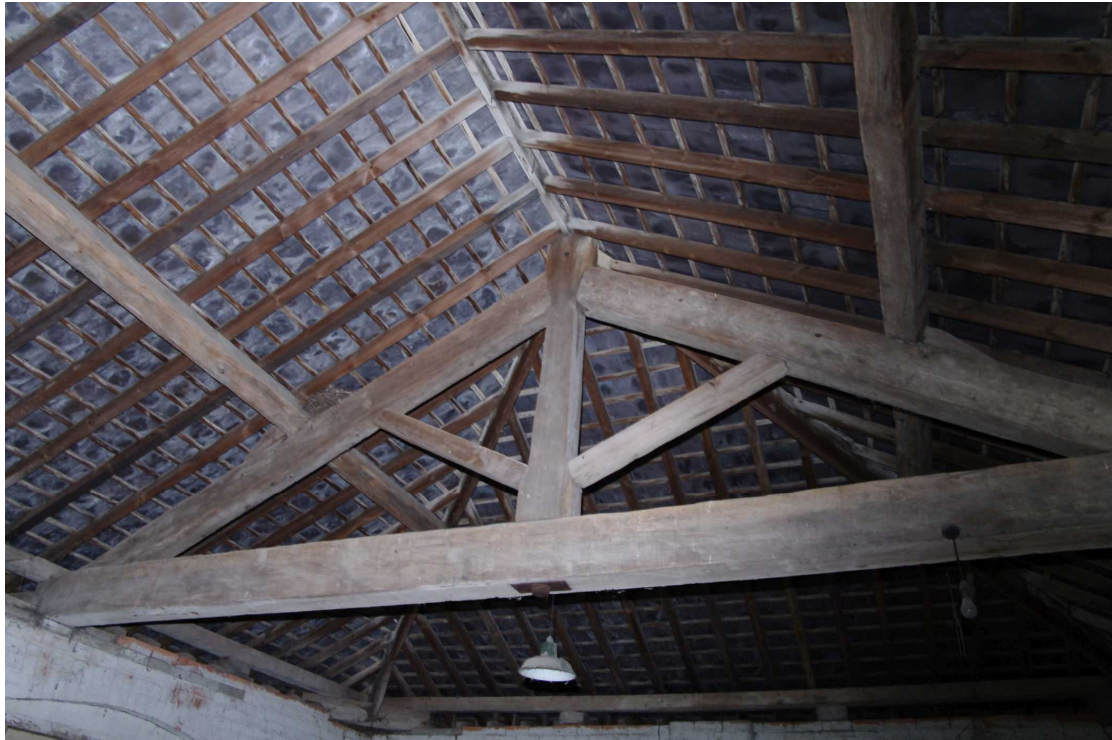
Figure 57 The Coach House first floor, roof detail  
Looking south-west at western truss

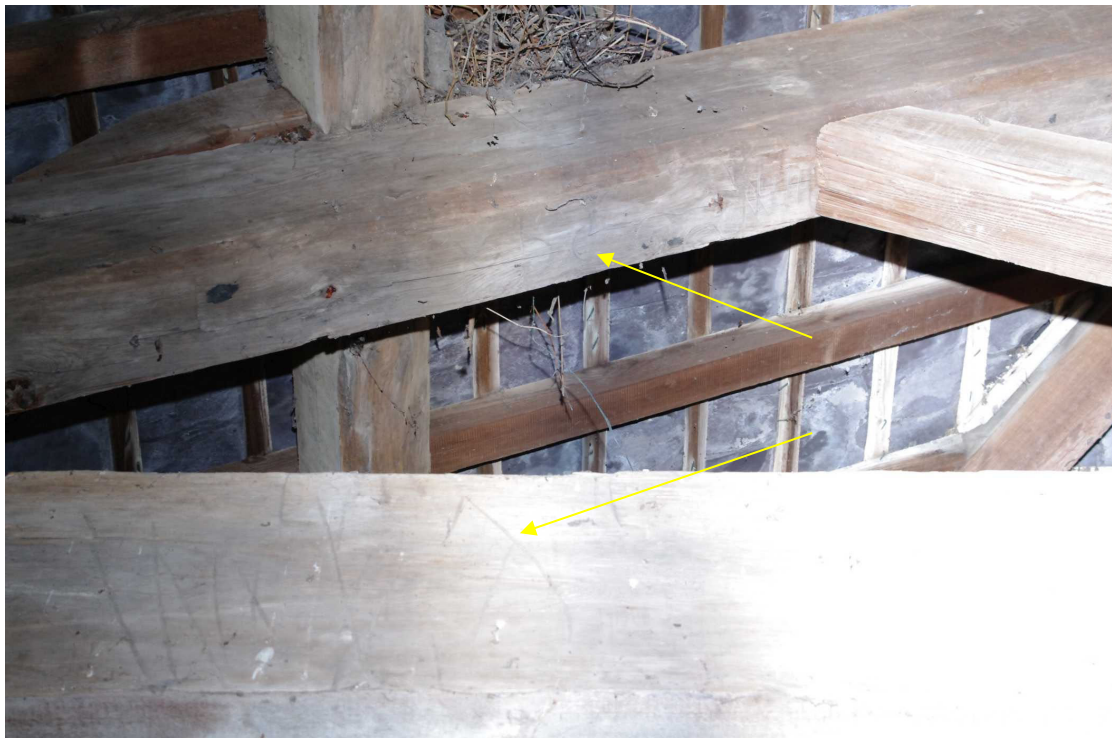
Figure 58 The Coach House first floor  
Rase marks or apotropaic marks on western truss
