**A Standing Building Survey  
of Farm Buildings,  
Old Hayes Farm,  
Ratby,  
Leicestershire  
(SK 490 064 centre)**

**For Lychgate Homes Ltd**

Report No 2006-021

## **A Standing Building Survey of Old Hayes Farm, Rathby, Leicestershire (SK 490 064)**

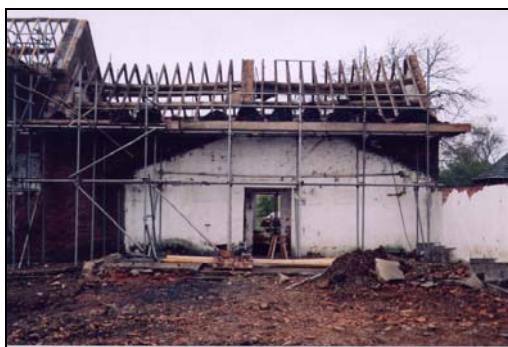
Plate 11. The segmented arch above the east elevation door. Plate 12. East elevation of building three showing former milking shed outline.
