**A Level 2 Historic Building Assessment  
at Hall Farm, Hall Lane, Packington,  
2 Leicestershire SK 36047 14710**

ULAS Report No. 2018-067

**For: Lychgate Homes Ltd**

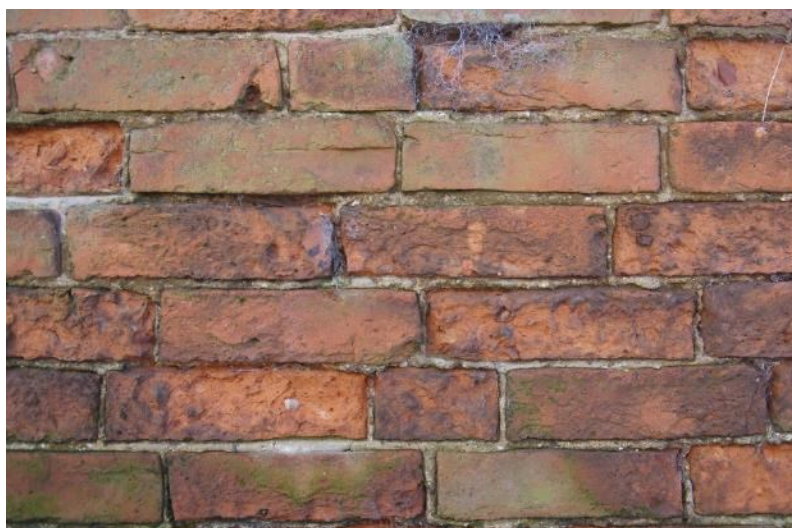
The rear wall (fronting the street, Figure 6, Figure 8) is mostly of early 18th-century style brick, hand-made; the lower part of the middle and west end is rougher quality, exhibiting a high percentage of spalled, overfired, and ill-sorted fabric (Figure 7). This could indicate a different build, or may just be that the lower part was a different firing, as brick kiln firing conditions were not tightly controlled at this date. Blocked openings onto the street are in evidence.

*Figure 7 Block A detail of brickwork on lower north elevation*

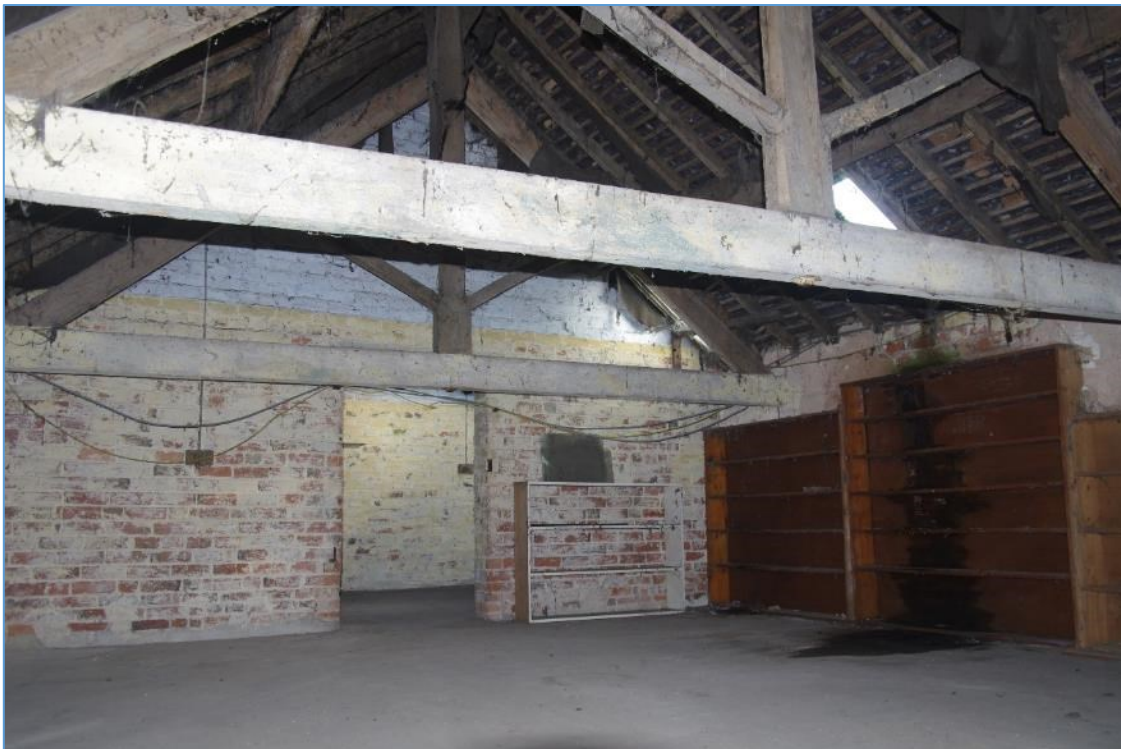
The west end is two storied with access to the upper floor via brick stairs (Figure 9). The floor of the upper story is machined deal, probably of the same date as the roof (Figure 11); it looks to be an insertion or replacement. A small section of floor (Figure 12) on the eastern side of the west end has earlier hand-sawn beams of much larger scantling.

*Figure 11 Block A upper floor, west end looking east*

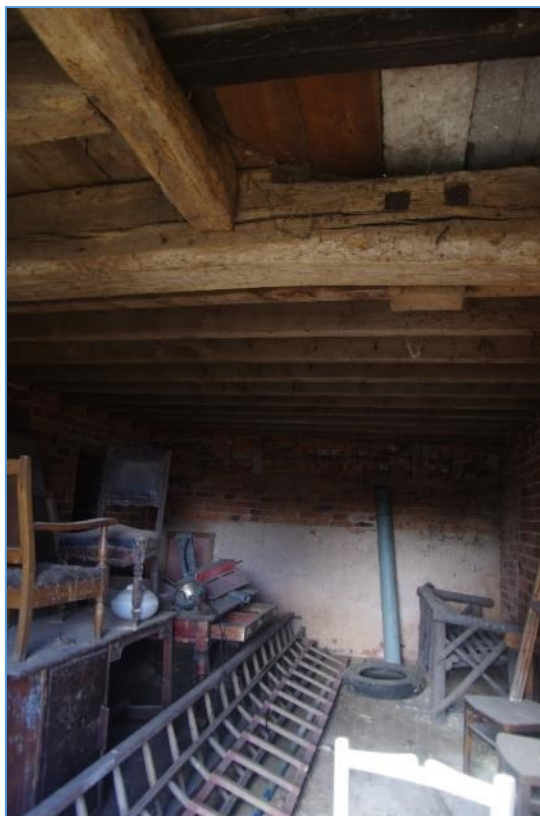
*Figure 12 Block A, looking north. Small area of earlier carpentry visible in ceiling*

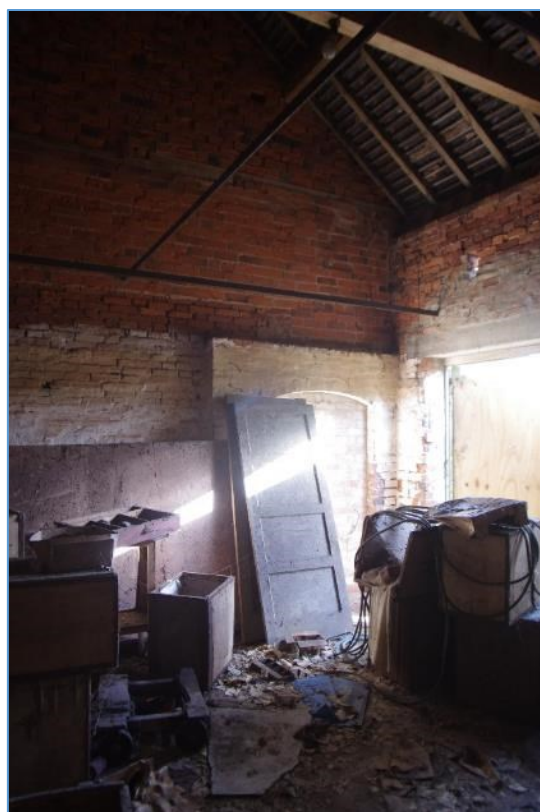
*Figure 13 Block A east end, showing blocked door in gable end. Looking south-east*

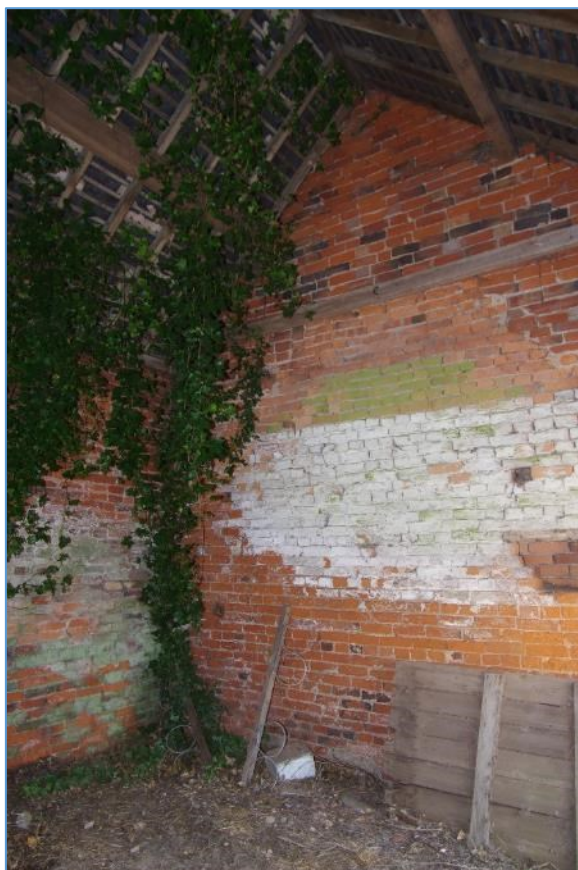
Block C comprises two units. To the north is a tall sub square unit (Figure 17, Figure 20, Figure 21). This appears to have started life as a single storey building of probable 18th century. It was subsequently heightened to allow space for another storey, and there is an opening high up in the north gable, but there is little indication that any floor has been removed and so if it were two storey, perhaps a free-standing platform arrangement was used. The roof is common rafter.

*Figure 21 Block C, north unit, looking south east.*

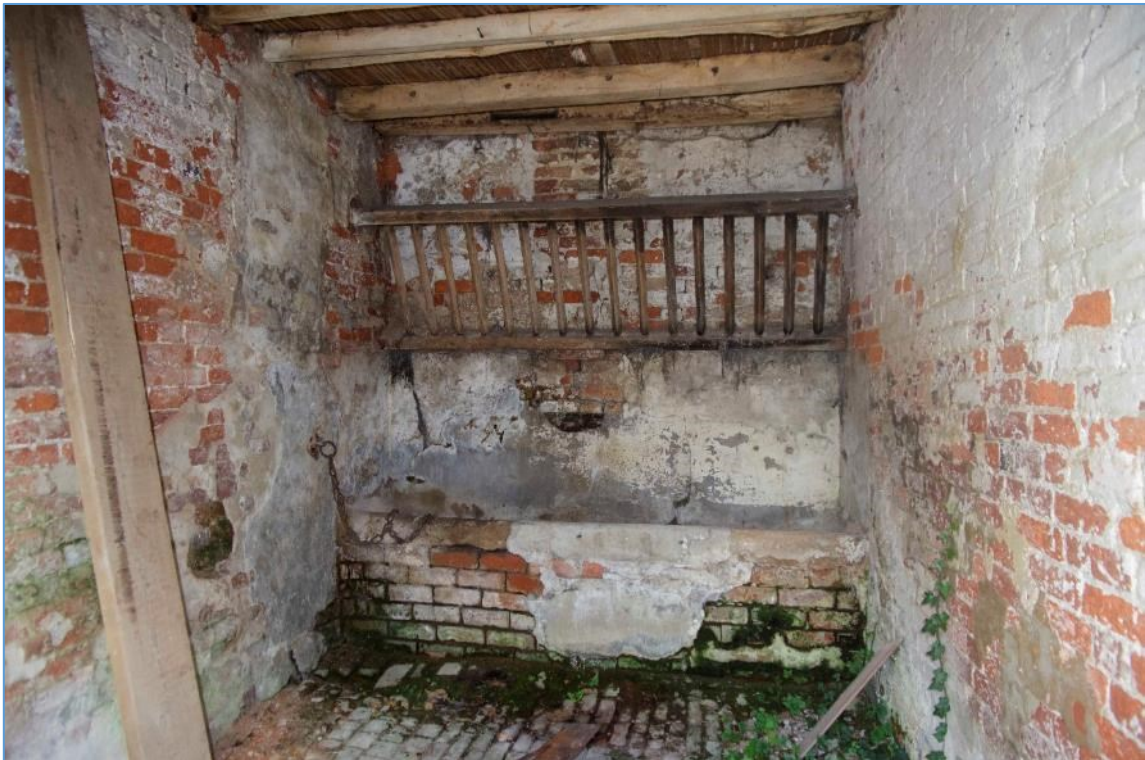
Block E (Figure 27 - Figure 31) is a unit of four stables, with probable haylofts over (there is no safe access into the upper floor), accessed by external stairs. The stall at the north end is still in reasonable condition but water damage gets progressively worse towards the southern end, which is derelict.

*Figure 29 Block E northern stall*

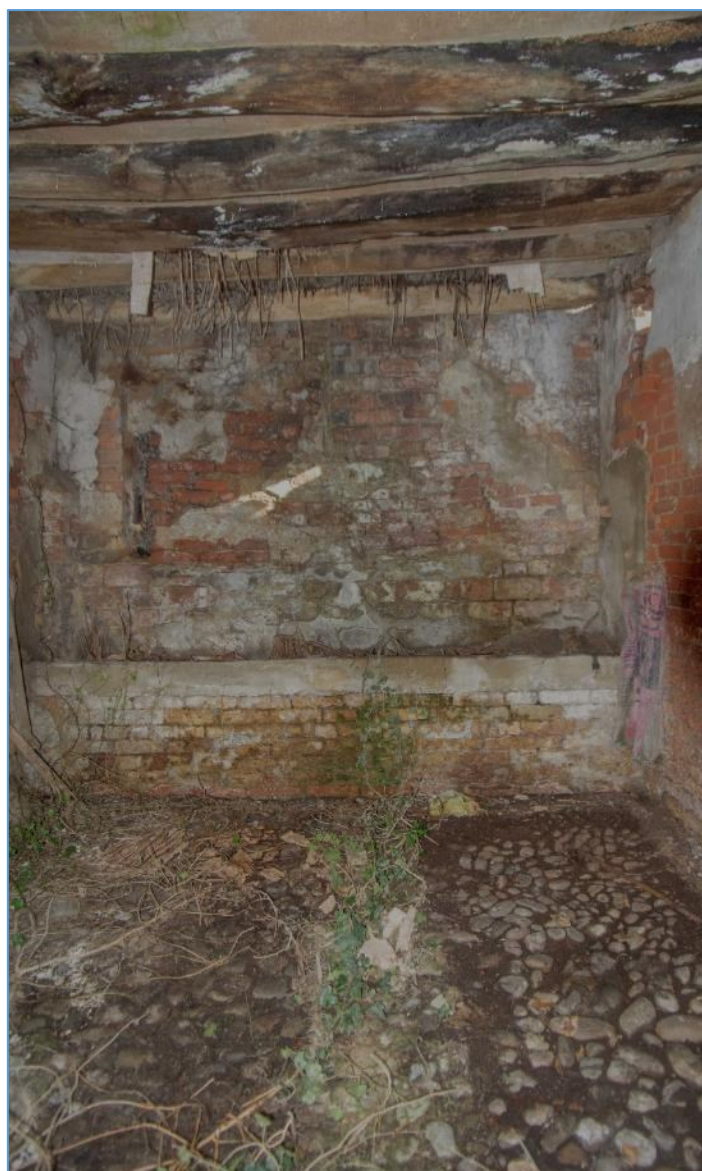
*Figure 30 Block E, third stall from the north*

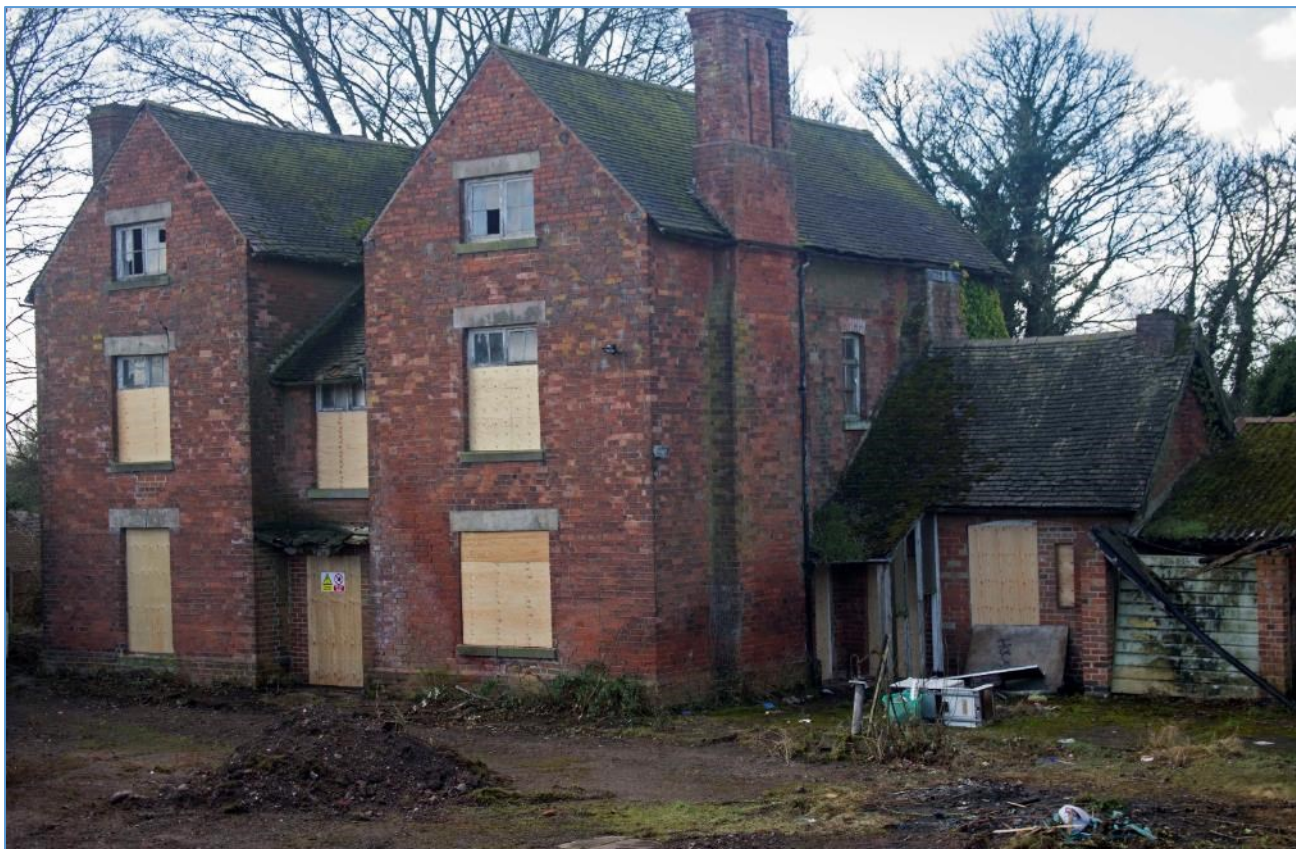
The bakehouse/scullery block sits to the north of the main house. A curiosity is that that chimney serving the scullery oven and house bedroom on the upper floors terminates at the eaves line (Figure 39), and a possible re-building line shadows the edge of the chimney flue. Possibly this stack had structural problems in the past and had to be truncated and patched up. This might explain the lack of fireplace in the top bedroom on this side, but servant's rooms were not necessarily provided with fires in any case.

*Figure 39 East and north elevation, looking south west*

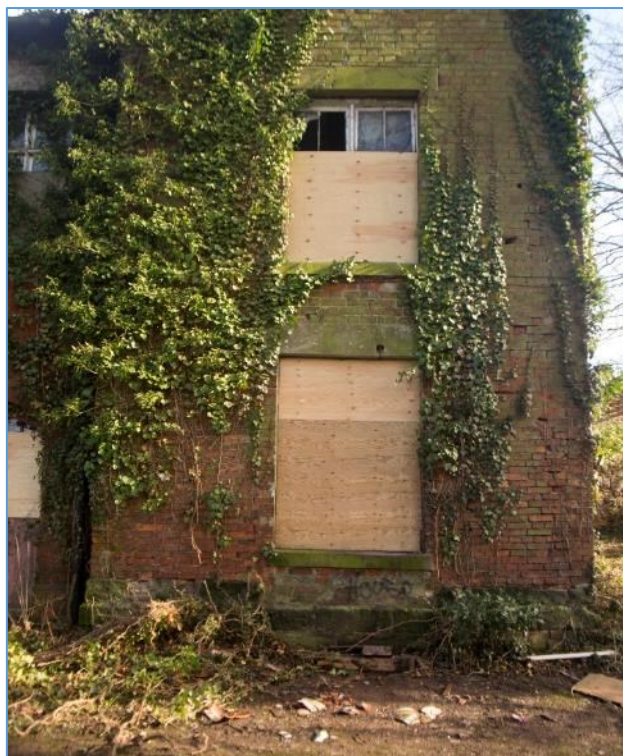
The south elevation (Figure 41) is mostly obscured by ivy, but of note is that the south west stack, or at least its lower portion, is masonry, and moreover the south-west corner has what appears to be earlier brickwork up to head height. Moving around this south-west corner, it can be seen that where the brickwork looks older, the building sits on a stone plinth, whereas the more recent brickwork sits on a brick plinth (Figure 42). The main part of the house has bricks of 24 x 7 cm length x height, the southwest corner 23 x 5 cm length x height, although this is an average as they are irregular.

*Figure 42 Detail of southwest corner, looking east*

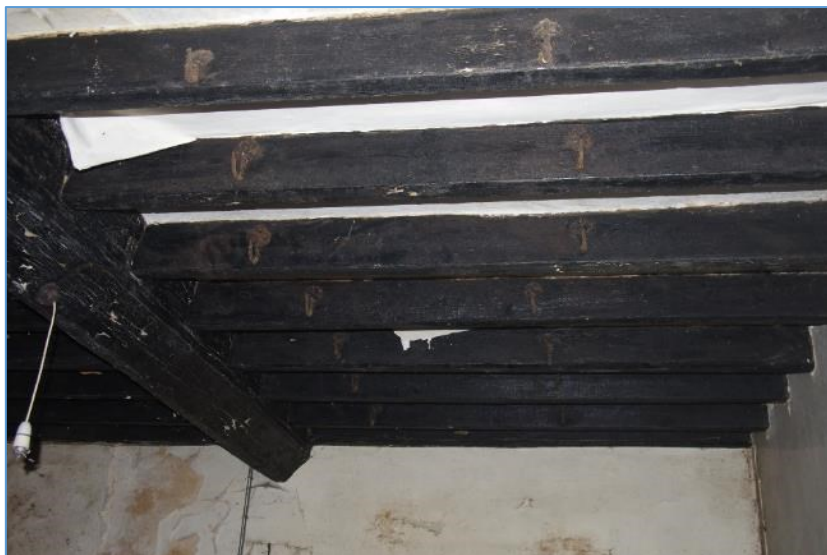
The room in the north-east corner was the kitchen, which looks out over the farmyard. A much decayed closed range (Figure 45) is set into one wall. The latches on the six-panel fielded door are likely to be original, and the servants bells still *in-situ*. The floor over is supported on a heavy axial beam with very wide chamfer, plain joists still have meat hooks (Figure 46).

*Figure 46 Joists with meat hooks*

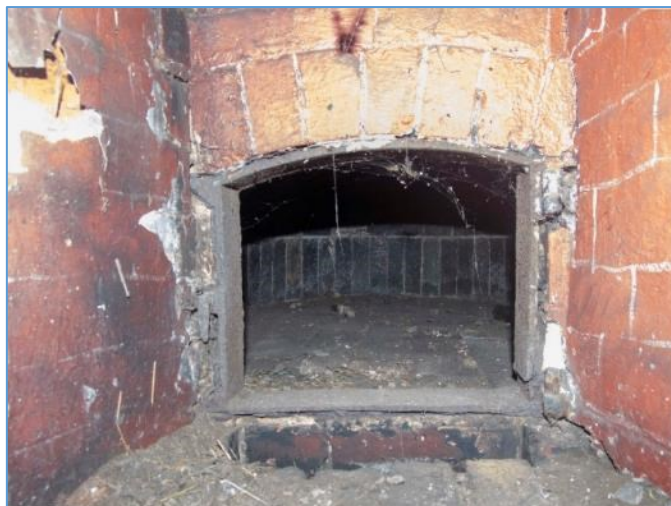
*Figure 51 Mouth of oven, showing firebrick back*

The scullery/bakehouse has an oven (Figure 50) in the south west corner, probably for bread; it is a domed affair lined with firebrick. The large door in the stack above could have been for access to an arrangement for smoking meat in the flue. In addition another range (Figure 52) sits on the north wall.

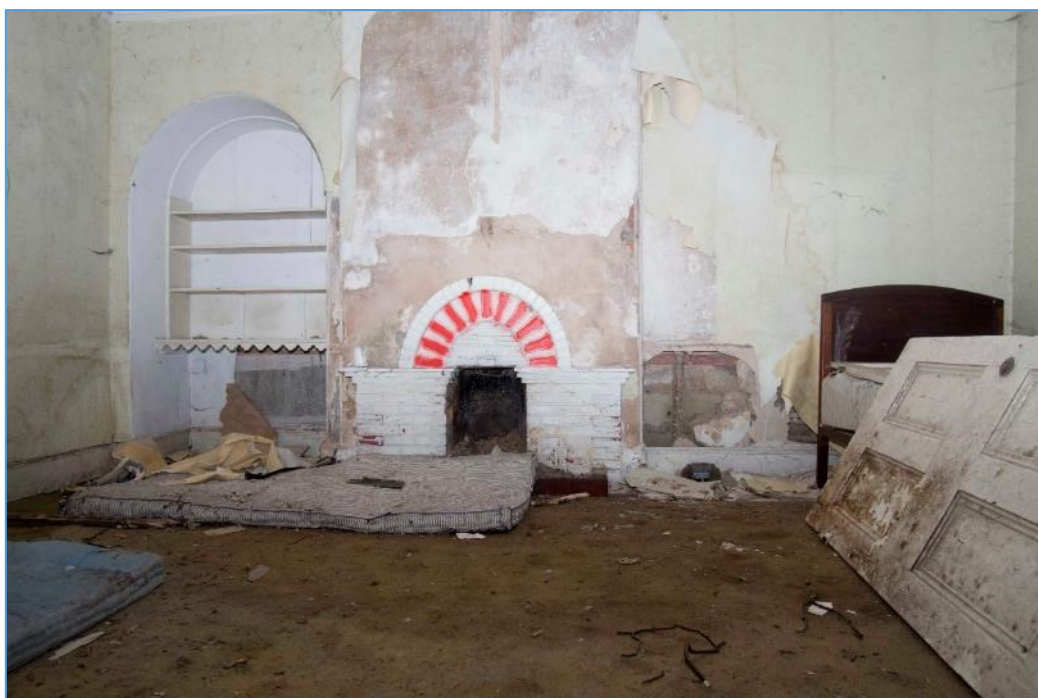
*Figure 56 South west reception room looking south*

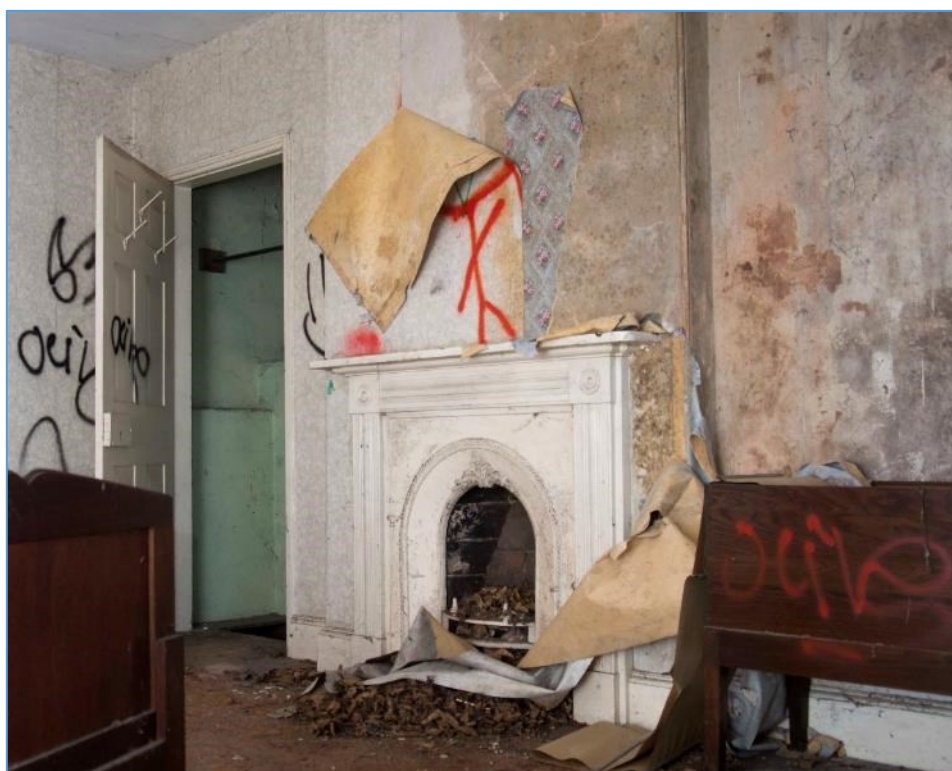
On the first floor, the main bedroom (Figure 57) would appear to have been the one to the south west, although slightly smaller than the south-east one. It would have had the view over the garden and orchard rather than the farmyard to the rear. Both rooms have arched fire surrounds, which is a shape more used in the second half of the 19th century than the first; the one in the main bedroom has moulding similar to the main downstairs reception room.

*Figure 57 South-west bedroom first floor*

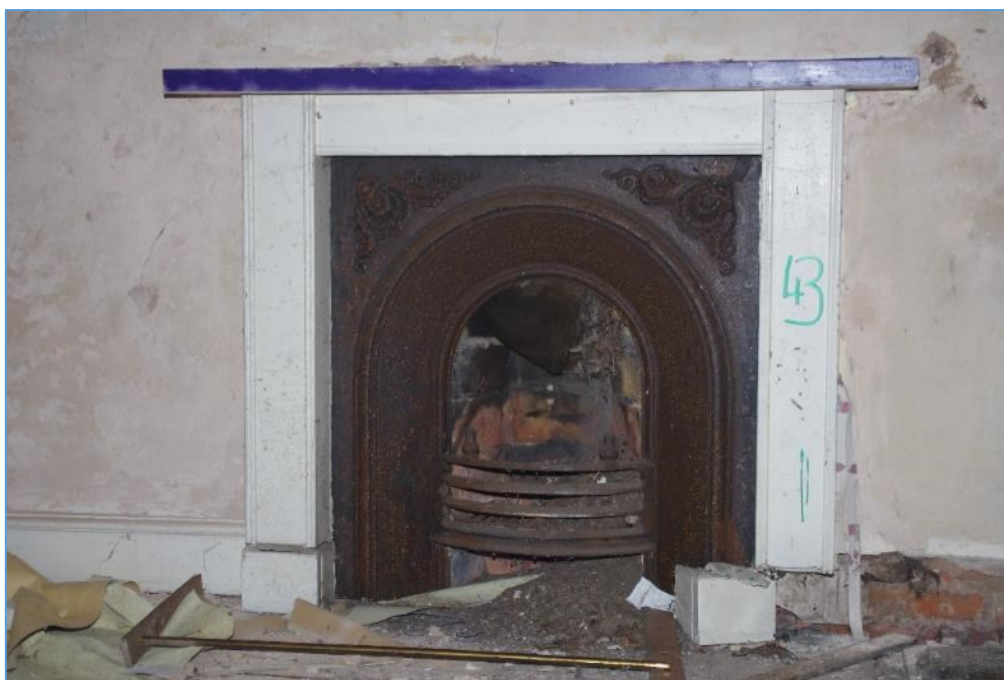
*Figure 58 Fireplace in south-east bedroom first floor*

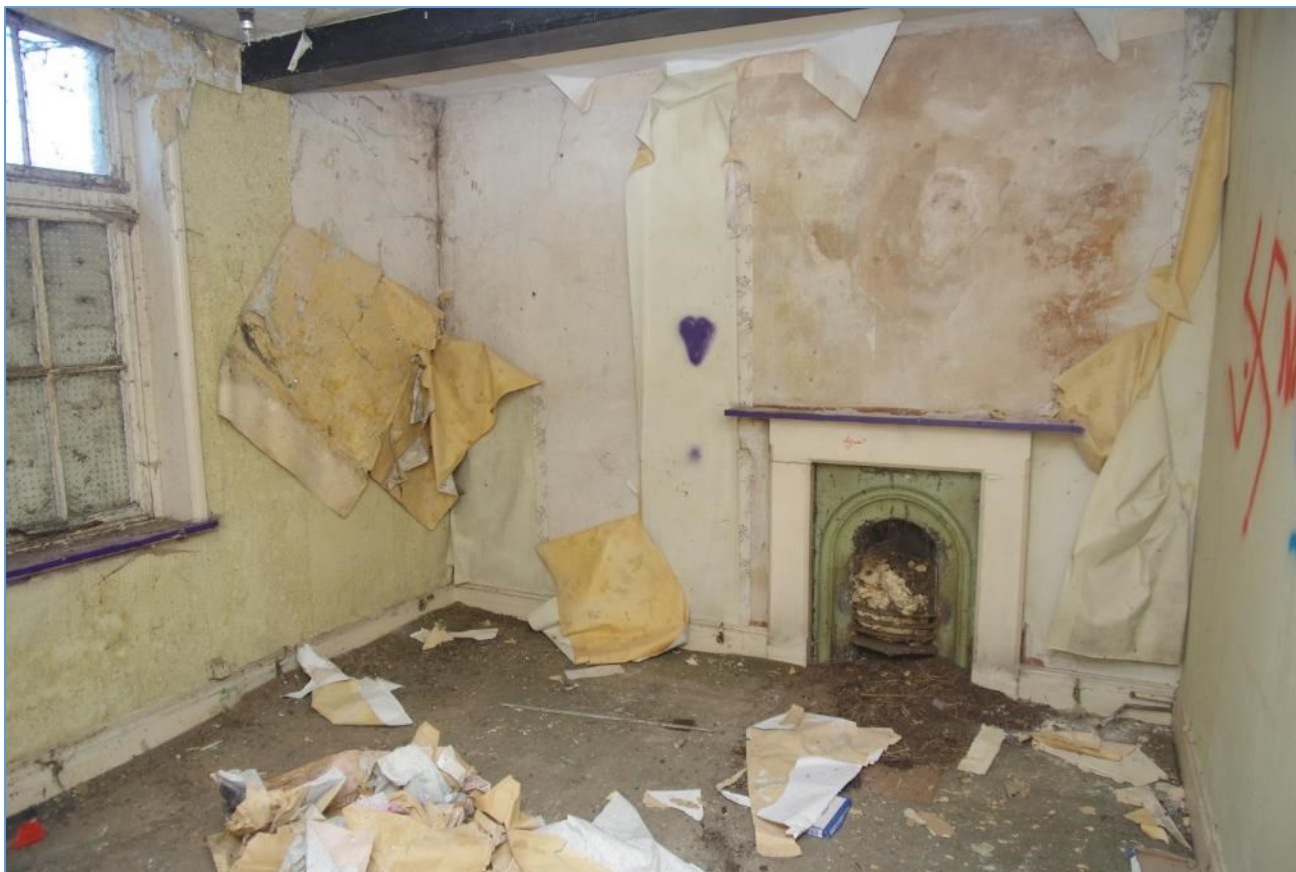
The fireplace in the north-east bedroom has been removed; the one in the north-west bedroom (Figure 60) is arched and probably mid-to-late 19th century.

*Figure 60 First floor north-west bedroom, looking north*

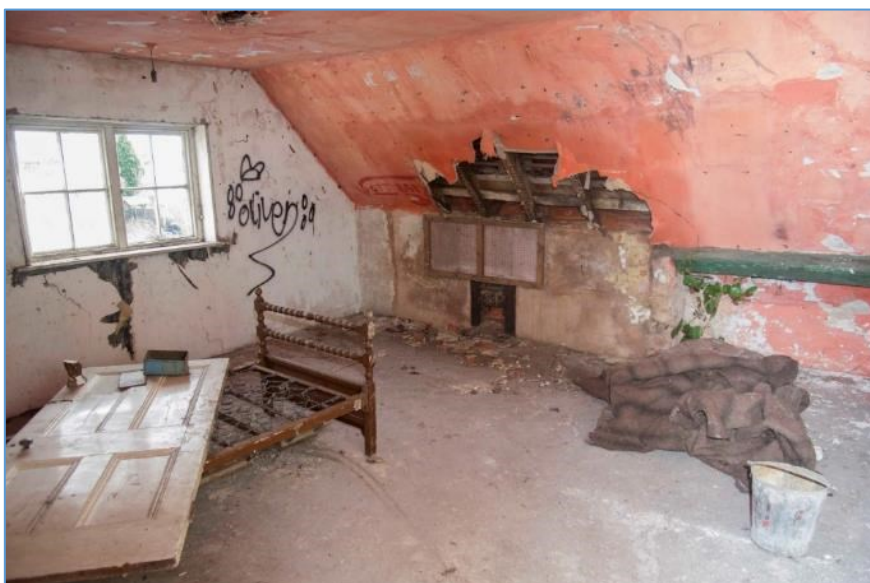
The service stairs give access to the top floor. Of note is that all of the three fire grates are late 18th century in design: two Pantheon patterns, one quite decayed, and one Forest pattern in slightly better condition. There is no fireplace in the north-west chamber, where the chimney has been truncated.

*Figure 61 Second floor south east bedroom, looking south east*

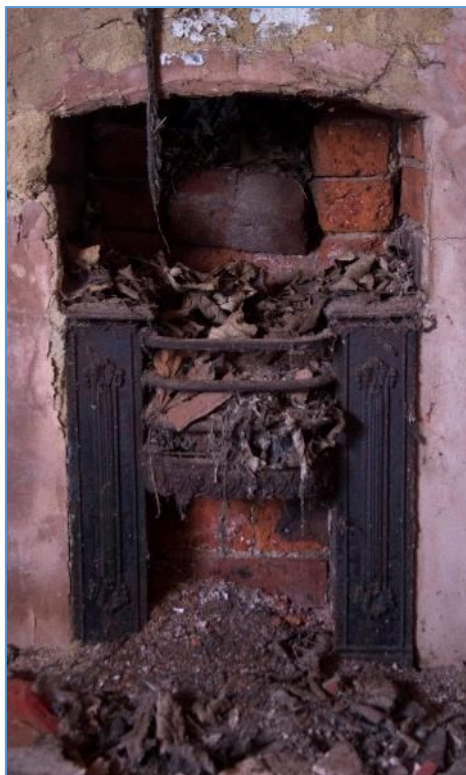
Figure 62 Detail of Pantheon hob grate

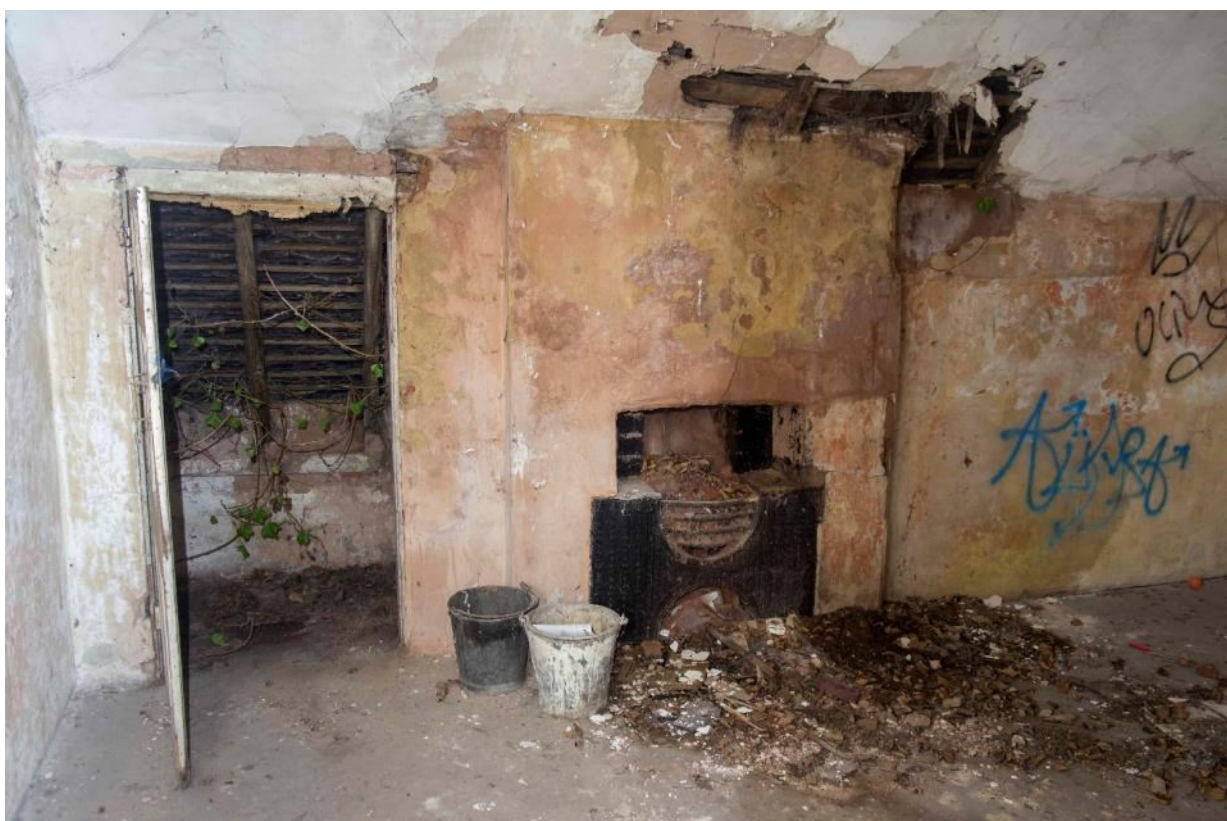
Figure 63 Second floor south west bedroom, looking south. Forest hob grate

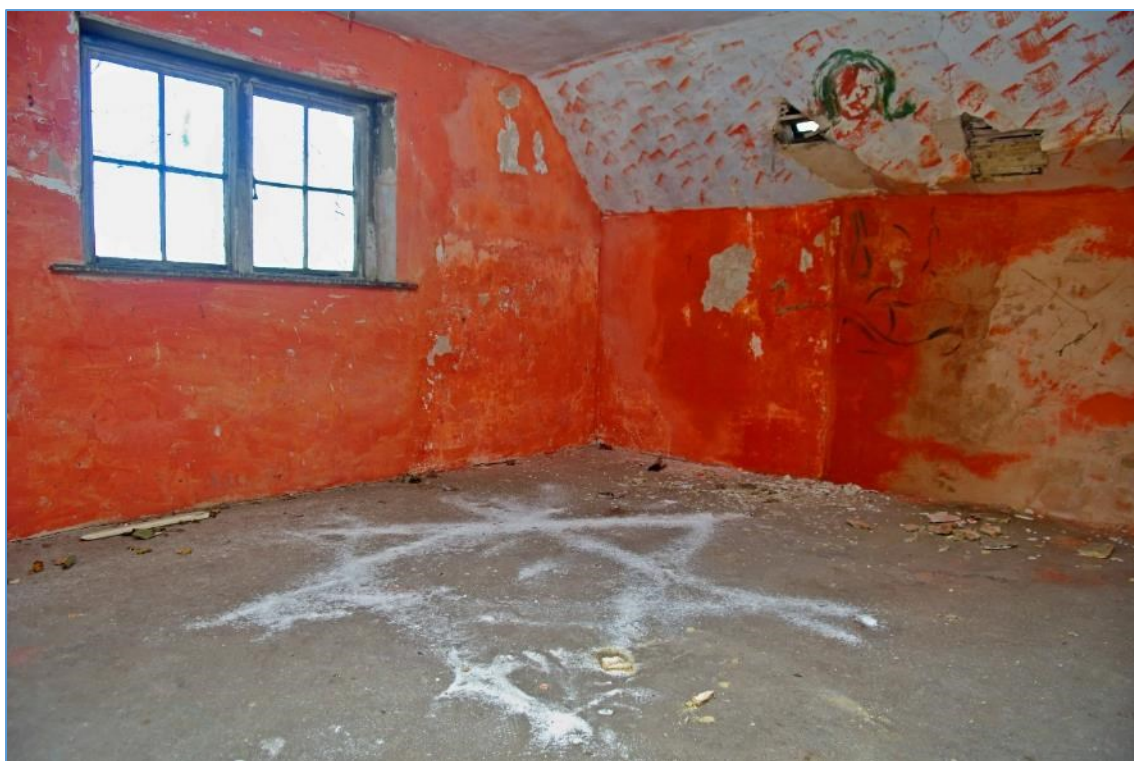
*Figure 64 Second floor north west chamber, looking north west*

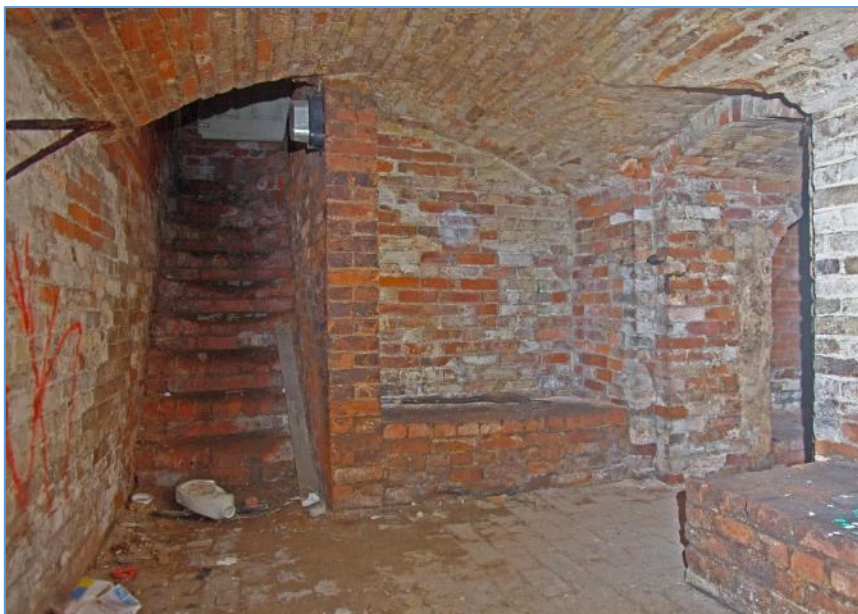
The cellar (Figure 65, Figure 66) is accessed via a four panelled door in the hallway. Descending some very worn brick steps, the two rooms occupy the space under the front of the hallway, and the south-west corner. The ceilings are brick vaults, and much of the construction uses the older-looking early 18th-century style bricks, although the thralls and the supporting wall down the side of the stairs appear to be 19th century. The southern room has what looks like a blocked coal chute set into the west wall, and has curious blocking apparent along part of the east wall, as though there may have been another room.

*Figure 65 Cellar, beneath hall, looking east up stairs*

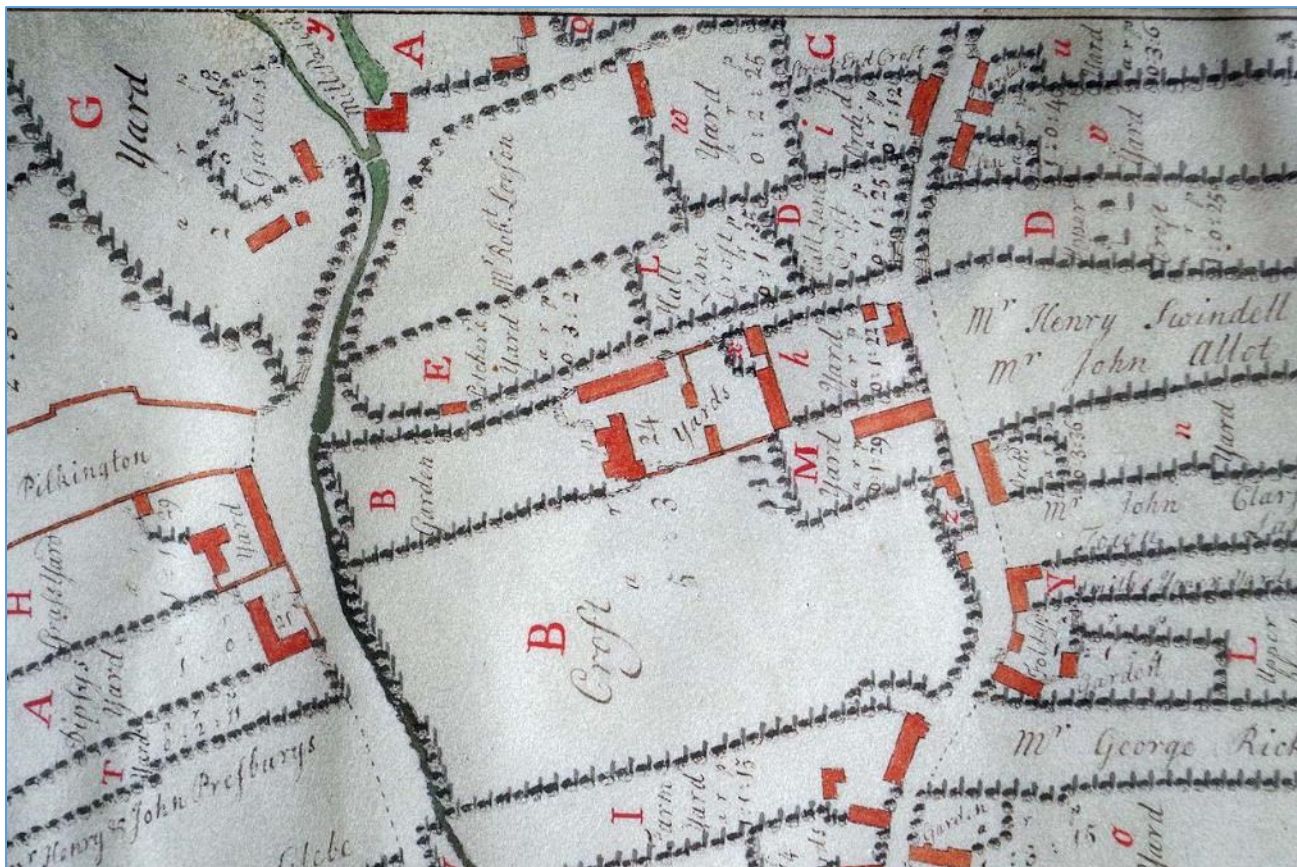
Figure 67 Map of the estate of Lord Hastings, 1735. Hall farm centre.

There is a very useful estate map from 1735 (Figure 67) which shows the house and farm buildings; this is discussed more fully in Finn 2015. The salient points are that although there was a house in the same position in 1735, the outline shown on the plan is subtly different to the present structure, and the most likely explanation is that the house was rebuilt in virtually the same place, but perhaps re-used part of the original structure (e.g. the south west corner and cellars).

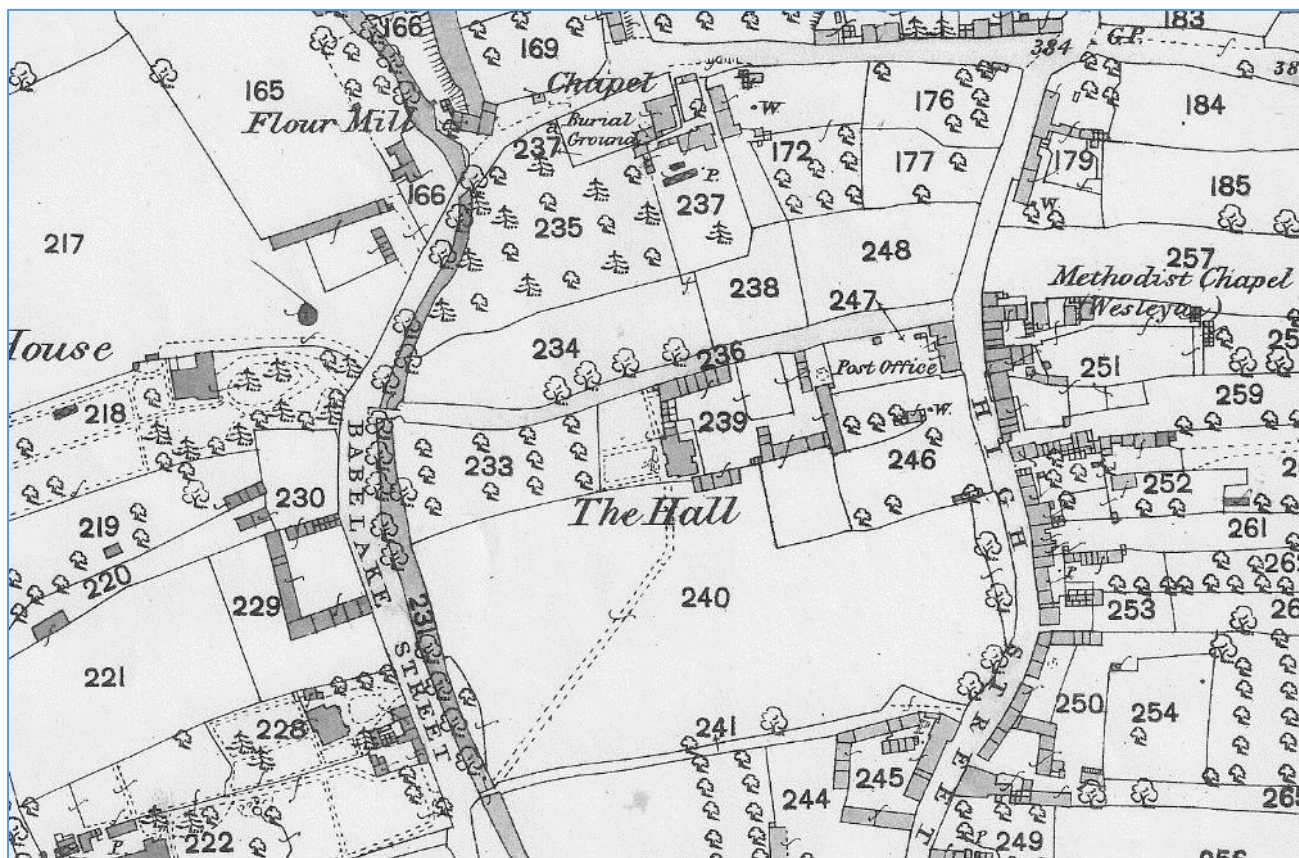
Figure 68 O.S. First edition 1885

longer on the estate map than the O.S. first edition of 1885 (Figure 68); it is possible that one bay on the west had been removed.
