**A Level 2 Historic Building Survey and Heritage Statement for
The Old School, Church Lane,
Goadby, Leicestershire (SP 74999 98818)**

ULAS Report No. 2018-010

A Level 2 Historic Building Survey and Heritage Statement for The Old School, Church Lane, Goadby, Leicestershire (SP 74999 98818)

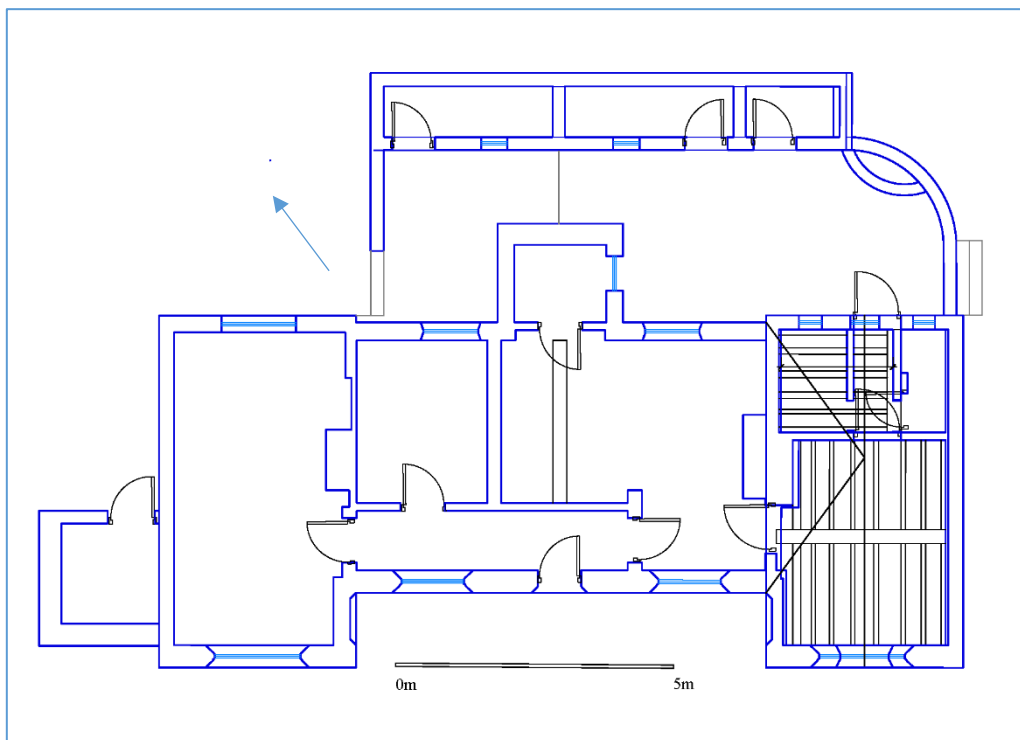
Figure 5 Ground plan. Provided by client

The listing description is slightly misleading in that the school (Figure 5) is built of brick, in an irregular Flemish bond; only the façade is in ironstone. The style is heavily Gothic. There are three entrances into the front of the building: two side doors (blocked internally) into the projecting wings, and one central. The right-hand wing (seen from the front) has the teachers' accommodation on ground and first floor, the left hand wing is curious in having a ground floor room with ceiling, but no access into the space above, even though the upper window provides light into this area. The school is orientated roughly north-west to south-east.

The range has been removed from the fireplace. There is little to say about the scullery except that the existing plan shows the ceiling joists between this and the stair as parallel, whereas they are actually staggered to enable each joist to sit fully across the supporting wall. Comparison of the plan with Figure 5 shows the arrangement of joists in the main room to be slightly more irregular than shown on plan.
