**A Level 3 Historic Building Survey of  
10 Short Hill and the rear wings of  
54-56 High Pavement,  
Nottingham,  
NG1 1HW  
Final Report  
NGR: SK57749 39620**

ULAS Report No. 2019-115  
©2019

**For: MDA Consulting Limited**

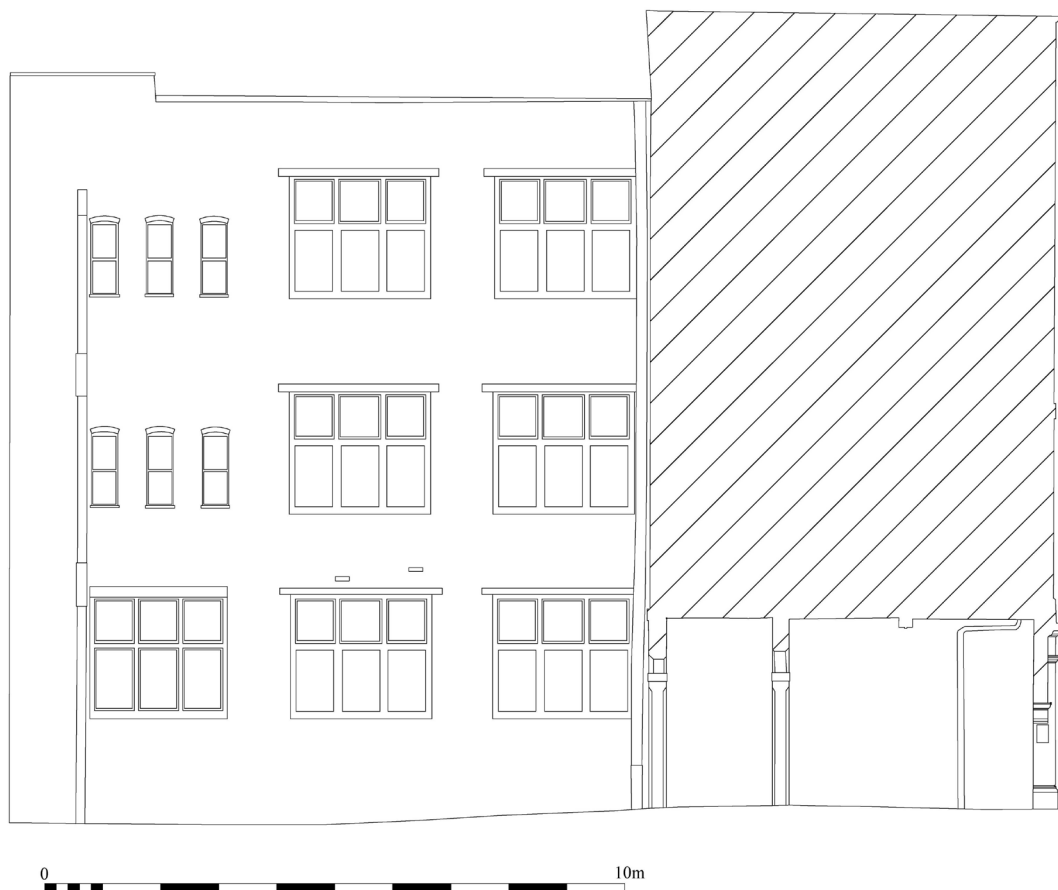
Figure 14 Number 10 Short Hill, east facing elevation

The east facing elevation was inspected in heavy rain conditions which showed the bricks to be quite porous and that water was running down many parts of the wall (Fig. 20). A network of scaffolding had been erected to protect occupants of adjacent buildings from falling masonry. Despite the scaffolding being in place it could be seen that this elevation served the toilet block of the three storey building with rows of three narrow sash windows towards the southern end of the east facing wall. The sashes were made of wood whilst the arched window lintels were brick-built. Wider windows with timber lintels on each floor continued northwards and lit the warehouse rooms (Figure 21). The window frames of the wider windows appeared to be quite modern and may date to the second half of the 20th century. It is not clear if the wider window openings had been modified from earlier and smaller openings.

A pair of vertical timber and steel beams at either end of the wall appeared to be bracing the brickwork below. These appeared to have been present for some time and probably represent a longer-term structural problem dating to the wartime bomb damage. The

eaves finished in a flat parapet wall which shows evidence of modification and rebuilding. The parapet may be responsible for some of the blocked gutters and the consequent water damage. Patches of brickwork were bulging outwards in places and a number of apparent settlement cracks in the brickwork were visible.

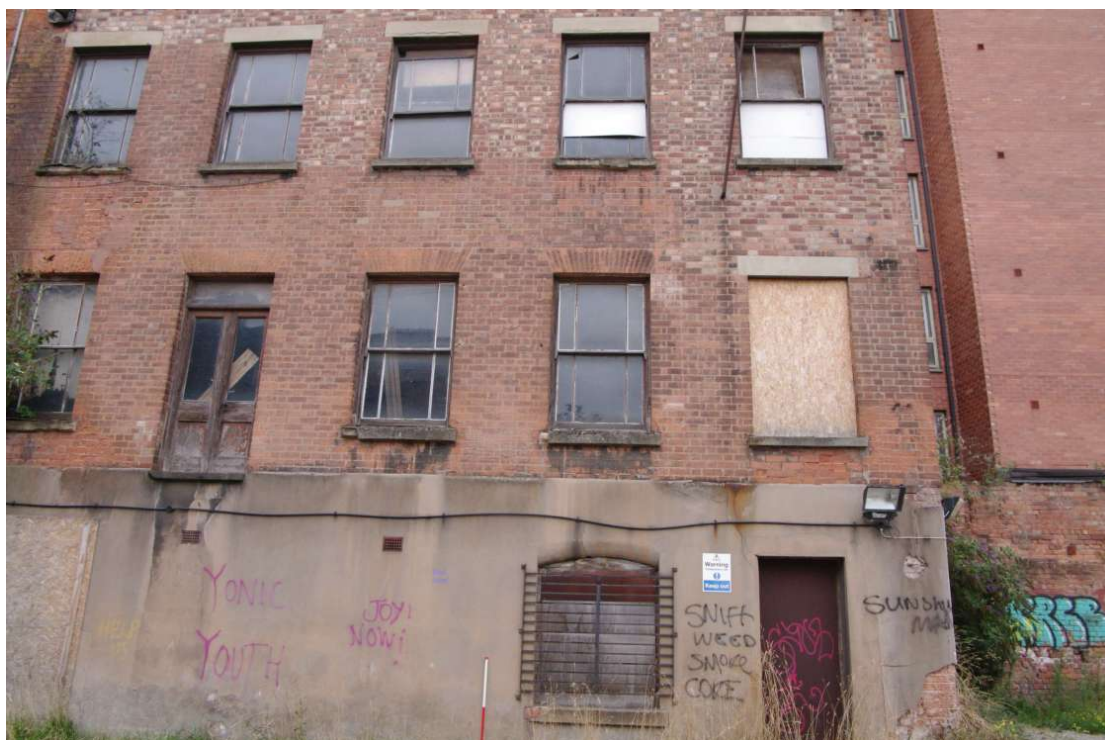
Figure 26 Number 10 Short Hill, west facing elevation. Southern section  
Looking east. 1m scale

The rear southernmost section had only two stories plus a basement and was on the same alignment as the middle section of the building. The listing description indicates that this part of the building was added to the 1860/1870 building in 1909 which may be possible although map evidence suggests a slightly earlier date. The brickwork between the middle section and the southern section is different although a long-term leaking gutter had affected the area around the change in brickwork making it difficult to show the exact point of change (Fig. 26). Another change in the brickwork could be seen running from above the top floor windows from the joint with the higher middle section. This change in the brickwork then ran down to the sill level of the top floor

windows and southwards to the final bay where it dropped down to basement level (see Figure 15 above). This line also corresponded with windows that had concrete lintels rather than gauged brick and seems likely to correspond to a partial rebuild of this range, possibly as a result of bomb damage.

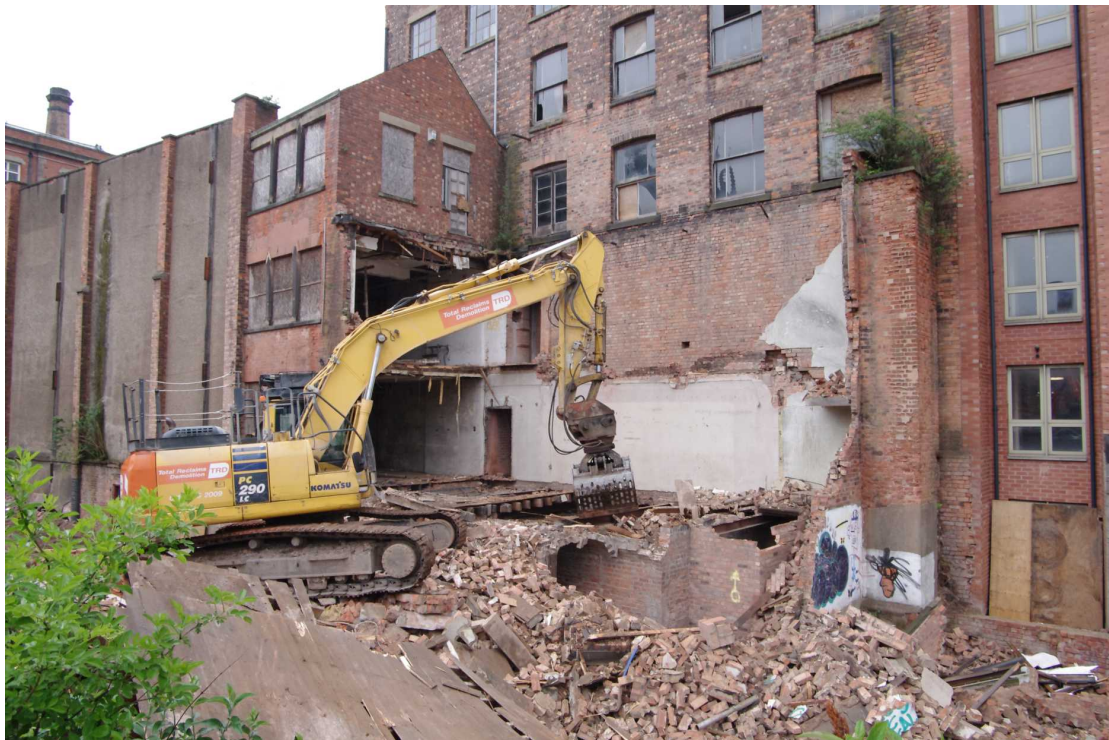
Much of the rear section of 10 Short Hill had been removed before a site visit could be made (Fig. 32). However, enough still remained to show that the east wall of Number 10 was not bonded to the adjacent building (Number 9) to the east (Fig. 33). Two single-width doorways at ground floor and first floor levels connected Number 10 to Number 9 but there was no apparent goods access between the two buildings. The blank western wall of Number 9 indicates that this was built against Number 10 and that it is therefore of a later date. A modified window on the second floor of Number 9 led out onto the flat roof of Number 10.

Figure 32 Rear (southern) section of 10 Short Hill during demolition  
Looking north-east. Note arched ceiling of cellar. Centre gable-ended section still  
intact at this stage

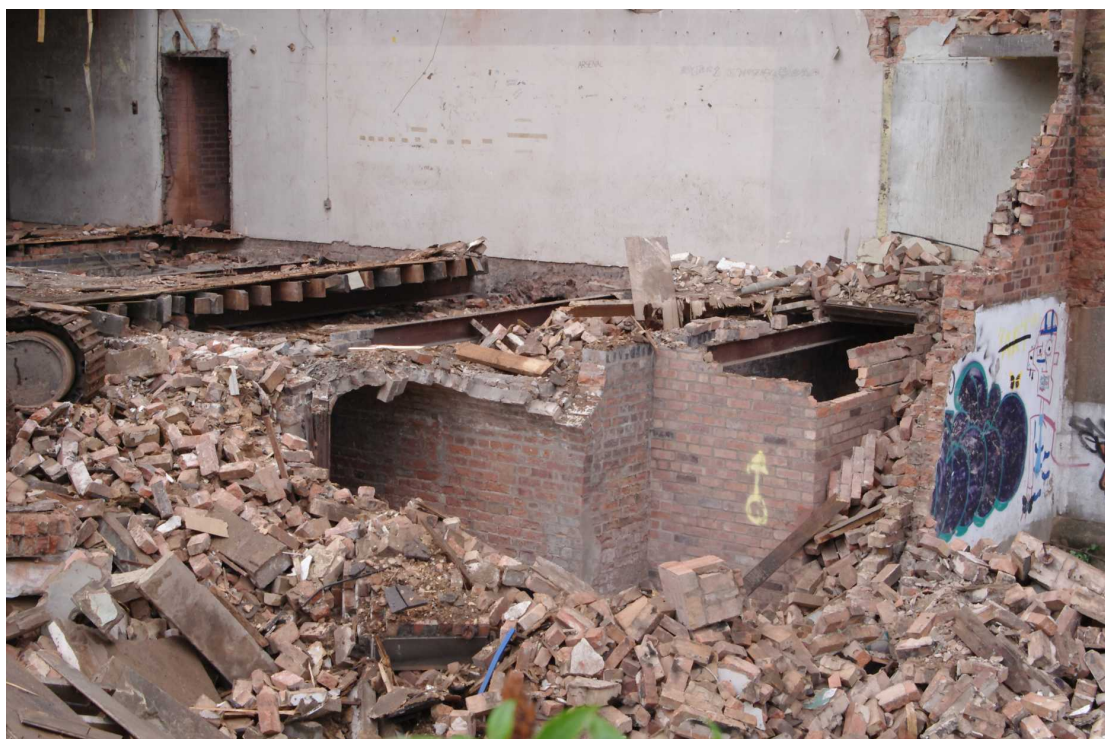
The basement of the rear section of Number 10 appeared to have a vaulted corridor running from north to south along the western edge of the basement (Fig. 34). The corridor extended as far as the middle three storey range but did not go into it. The rest of the flat-roofed basement had a ceiling supported by transverse I-section steel girders. The wooden joists and floorboards of the ground floor rested on the girders.

Figure 34 Rear (southern) section of 10 Short Hill, basement  
Looking north-east

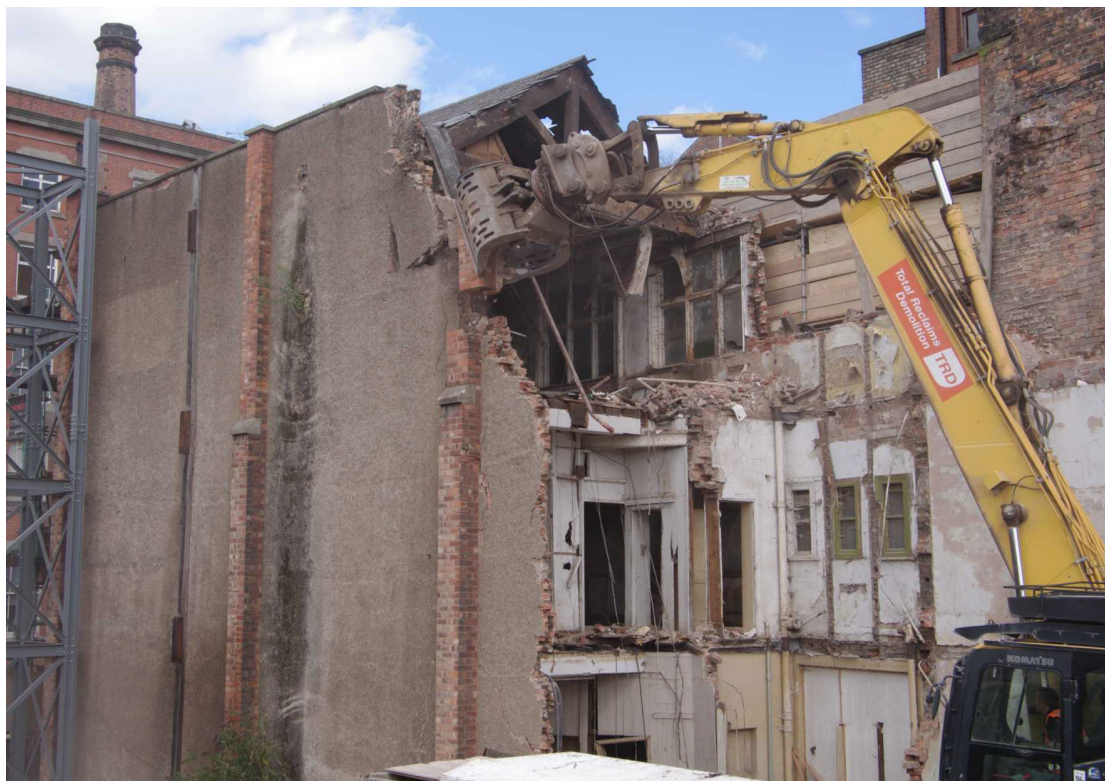
Each floor had a small toilet block built into the south-eastern corner of the building (Fig. 43). The walls of the toilet block appeared to be built from brick whilst other partition walls were of plaster and lath or matchboard.

Figure 43 Front section, internal room details  
Looking north-east. Toilet block on right (green windows)

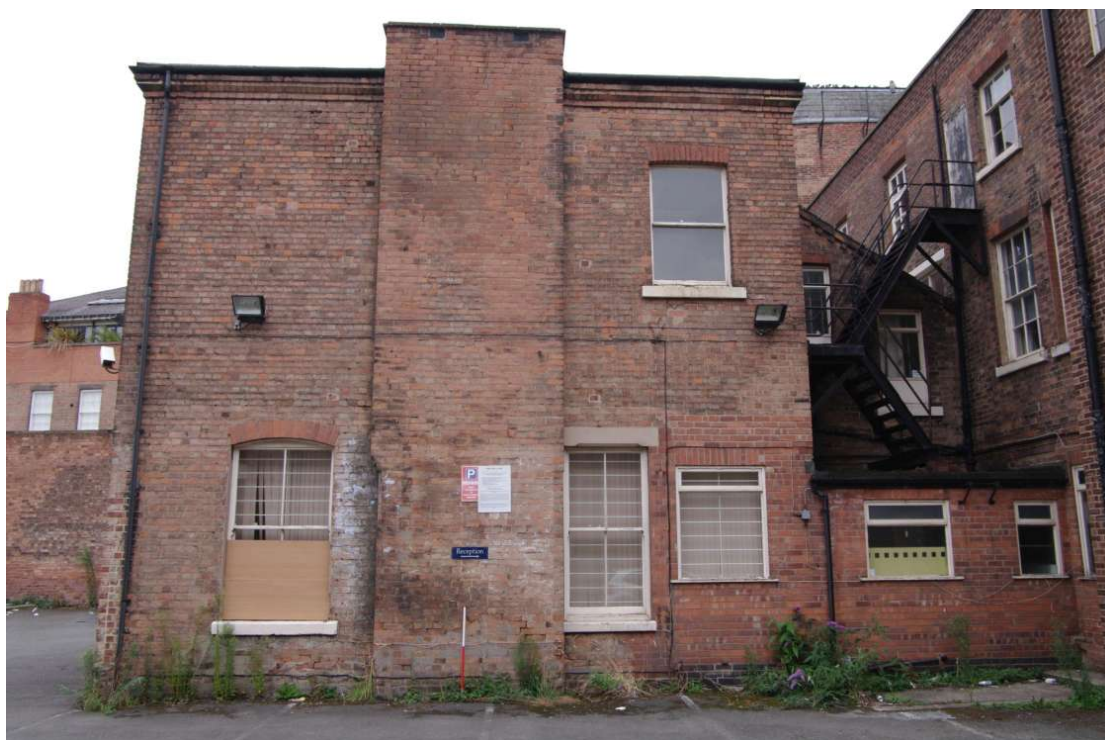
Figure 50 19th century extension, east facing elevation  
Looking west. 1m scale

The main extension was dominated by a wide chimney stack which projected out from the wall (Fig. 50). The top of the stack had been truncated and at the time of the survey lacked any chimney pots. The lower corners of the stack had chamfered corners which were presumably added to allow more light into the ground floor windows. The eaves had chamfered and stepped brick cornice decoration typical of the later 19th century.

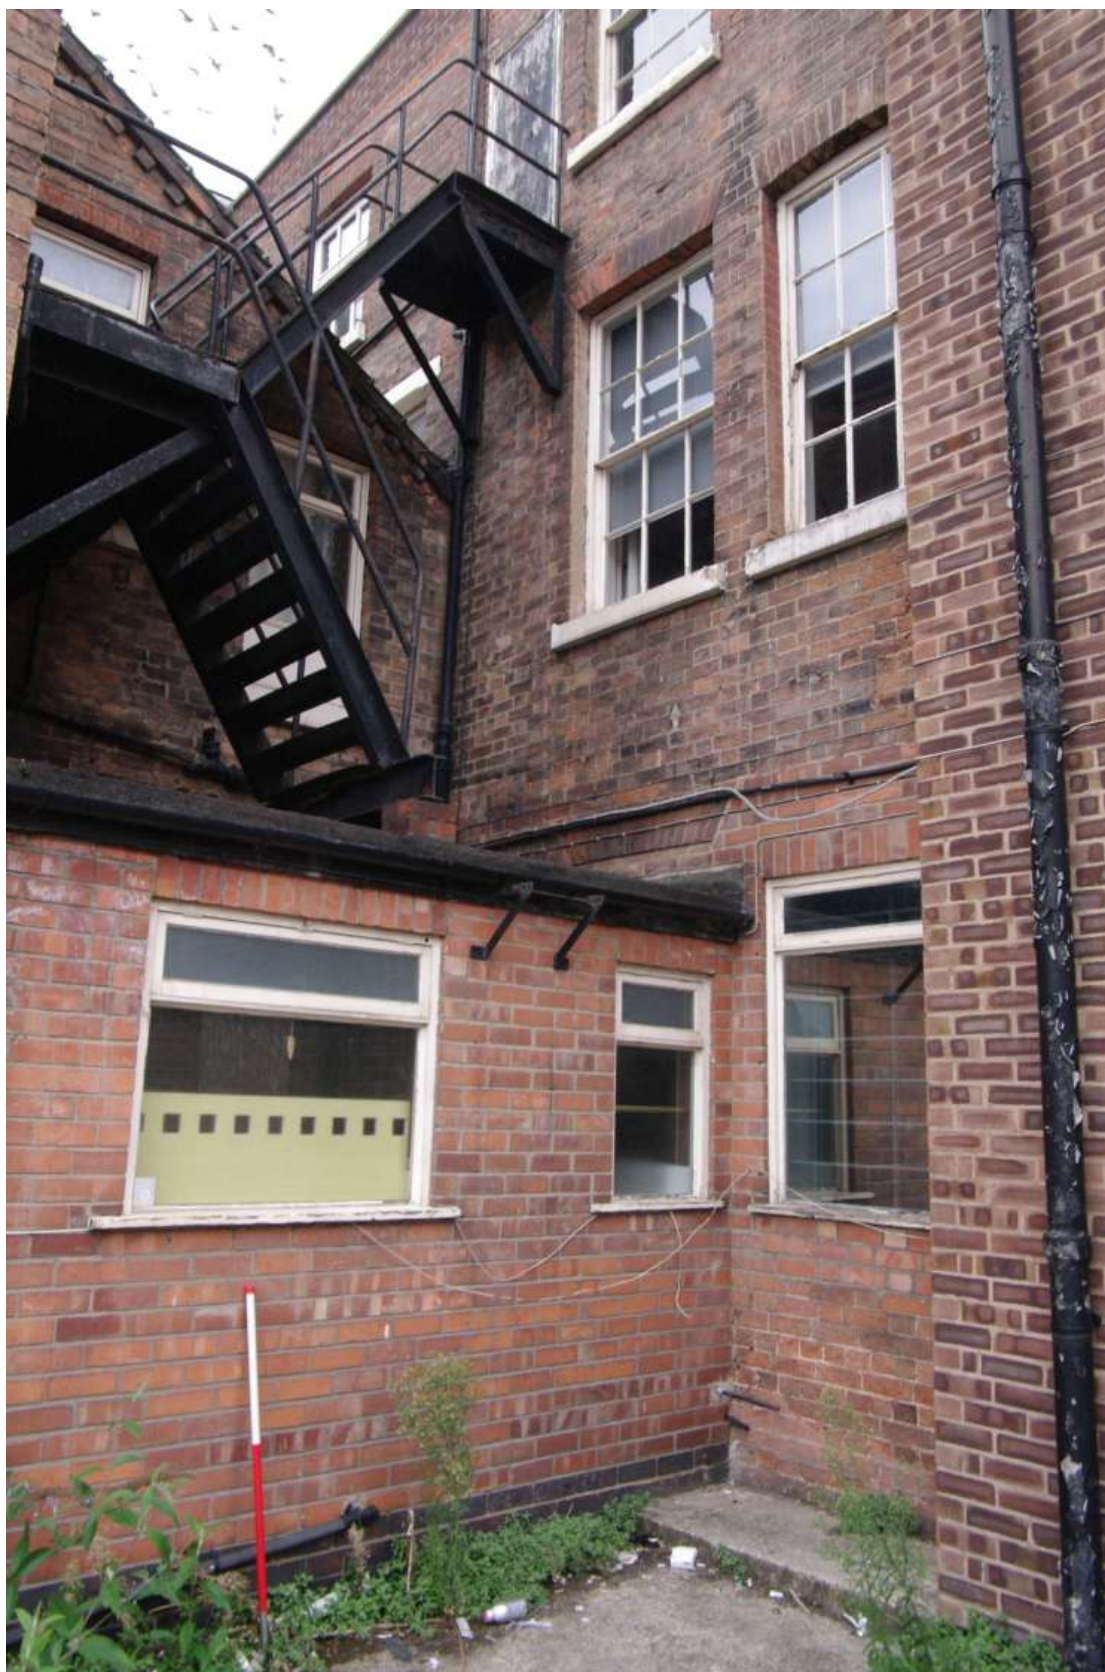
Figure 51 19th century extension, east facing elevation and link to main building  
Looking north-west. 1m scale

There were a number of styles of window on this elevation although most appeared to be part of the original design. The ground floor southernmost window had an arched brick lintel and a stone or cement sill. The sash window had narrow glazing bars with each sash having two panes. The ground floor window to the north of the chimney stack was slightly more decorative and had a stop-chamfered stone lintel but was not as wide. There is no clear reason why the two windows had different lintels as they both served the same room (see below). The ground floor bottom right (north) corner had been rebuilt using modern bricks and housed a modern wooden-framed window. This rebuilding extended as far as the back wall of Number 56 and housed a modern toilet block with an open fire escape built onto its roof. This may have been of similar age to the 1960s corner extension. This modern addition appeared to have blocked one of Number 56's ground floor windows leaving only the brick lintel visible (Fig. 51)

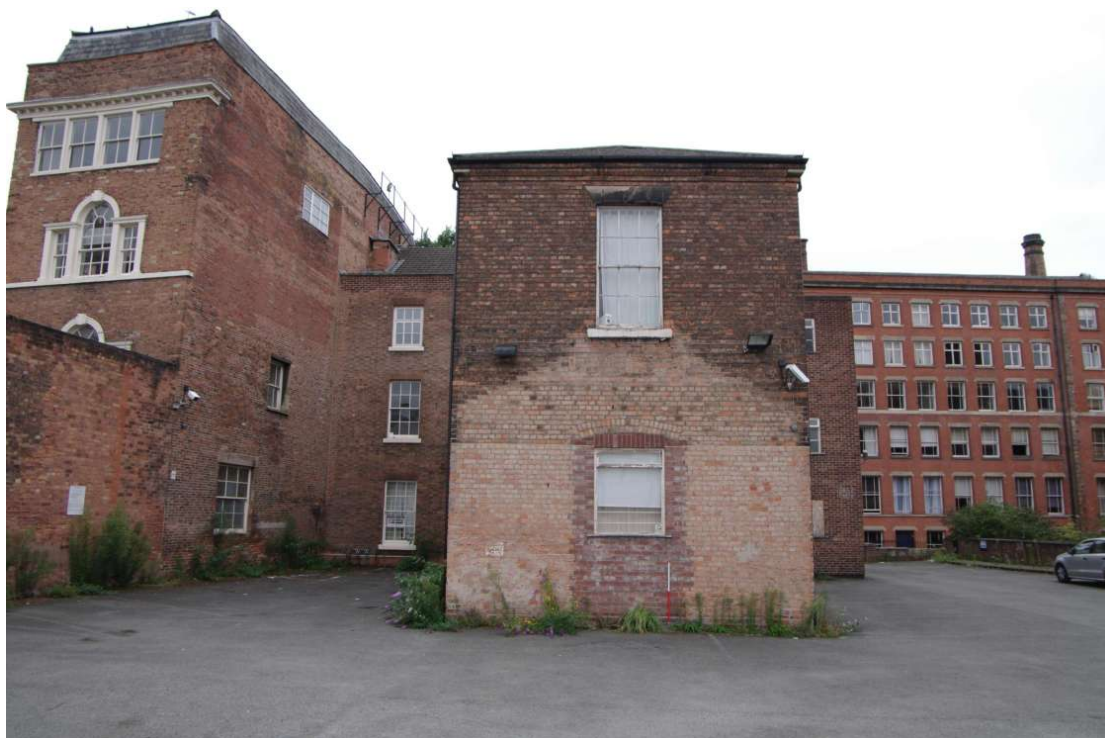
Figure 52 19th century extension, south facing elevation  
Looking north. Note infilled ground floor doorway. 1m scale

The south facing elevation had the same red brick façade and cornice detailing as the east and west facing elevations of this 19th century extension (Fig. 52). A modern ground floor wooden-framed window partially filled a former doorway which had been infilled with modern brick. The doorway had an arched brick lintel and presumably led into the glass house or conservatory shown on the earlier Ordnance Survey maps. The single storey outline of this now-removed structure showed very clearly on this elevation as an area of much lighter cleaner brickwork which appeared to have had plaster removed. The pitched roof of this structure reached as far as the stone sill of the first floor window. The first floor window had a six over six-paned sash fitted which appeared to be part of the original design. This window had a chamfered stone lintel which matched those on the west facing elevation but not on the east facing.

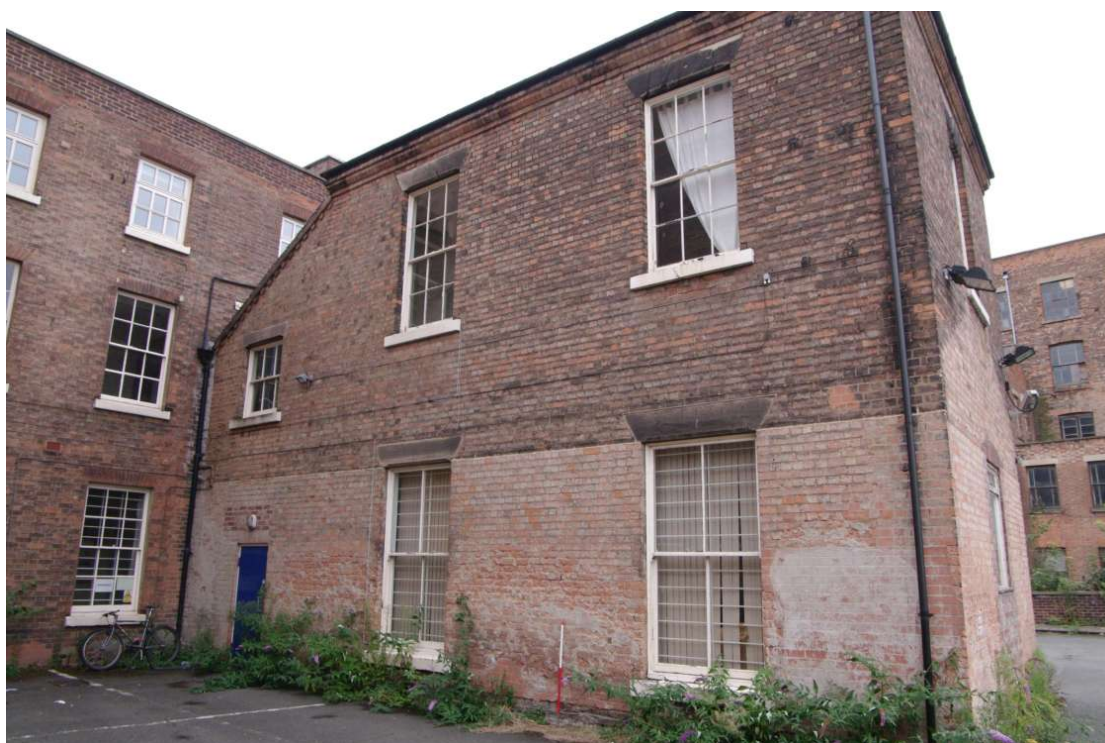
Figure 53 19th century extension, west facing elevation  
Looking north-east. 1m scale

The west facing elevation also showed evidence of a former single storey structure which may have continued around the extension from the south facing elevation (Fig. 53). This structure appeared to have covered both ground floor windows although they both still retained their large sash frames and stone sills and lintels. Also at ground floor level was a modern fire exit door which may have been modified from an earlier opening. The two first floor windows matched the ground floor ones although these had six over six panes rather than two over two as on the ground floor. The link between the extension and Number 56 was flush with the south facing elevation (Fig. 54).

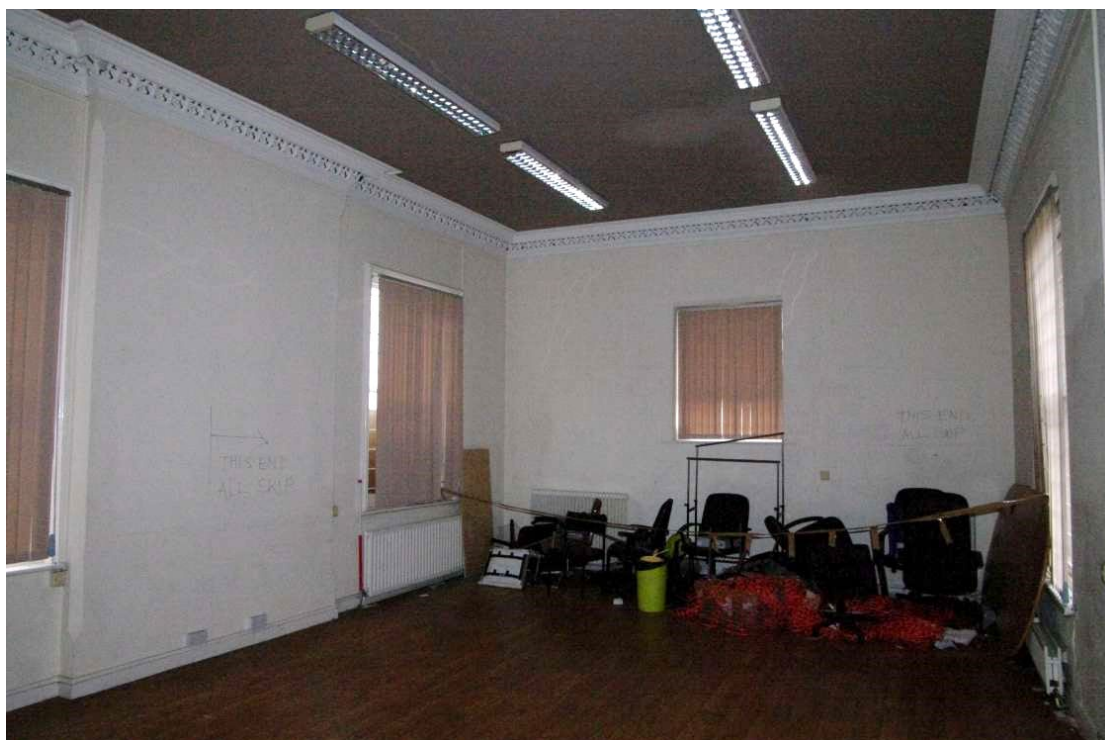
Figure 57 Ground floor room of 19th century extension  
Looking south-east. 1m scale

The main ground floor room of the extension was a large open space with a high ceiling (Fig. 57). A pierced moulded plaster cornice ran around the entire room showing that this room was always intended to be a single open space (Fig. 58). It is not clear why the windows should have different styles of lintel and other details if this was a single room. Internally the windows on the eastern side of the room had a moulded surround whereas those on the west side have chamfered masonry. The chimney breast was chamfered but the fireplace has been blocked in.

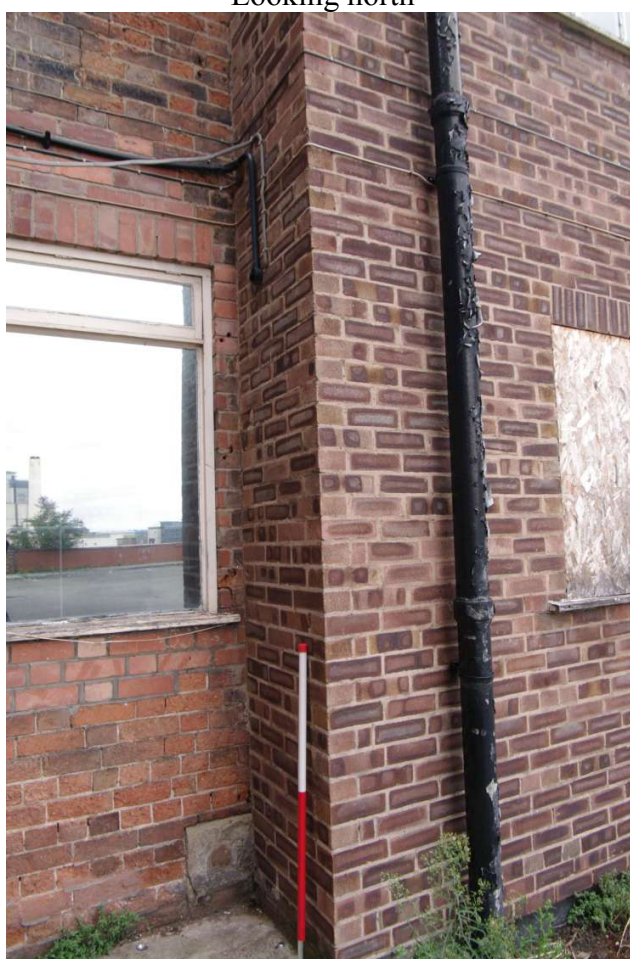
Figure 65 1960s extension, south facing elevation and ground floor joint  
Looking north-east. 1m scale

The south facing elevation wrapped around the south wall to create a butt joint against Number 56 (Fig. 65). The ground floor window and part of the wall of Number 56 had been rebuilt close to the junction of the 1960s extension which may have either been part of this extension or as part of the toilet block rebuilding phase of the 19th century extension.

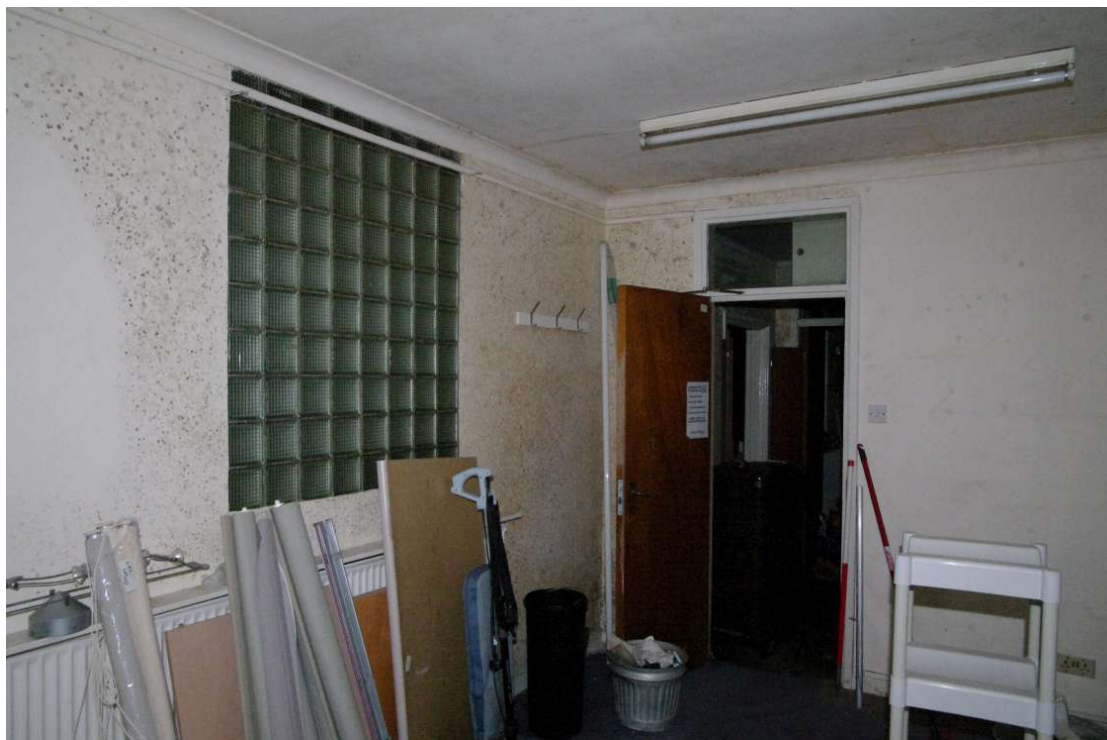
Figure 66 1960s extension, ground floor room  
Looking north-west. 1m scale

by going past the service stairs and through a narrow doorway which may have once led outside. The room was a plain rectangular room with a low ceiling and plastered walls. In place of a former outside window on the west wall the opening had been infilled with glass bricks (Fig. 66). The room had plain skirting boards and narrow coving.
