**A level 3/4 historic building survey of the Old Mill,
Mill Lane, Castor,
Peterborough,
Cambridgeshire
NGR: TL1280 9682**

Site Name: The Old Mill, Mill Lane, Castor, Peterborough,
Cambridgeshire. PE5 7TB

Client: WGP Architects

ULAS Report Number: 2020-088v2

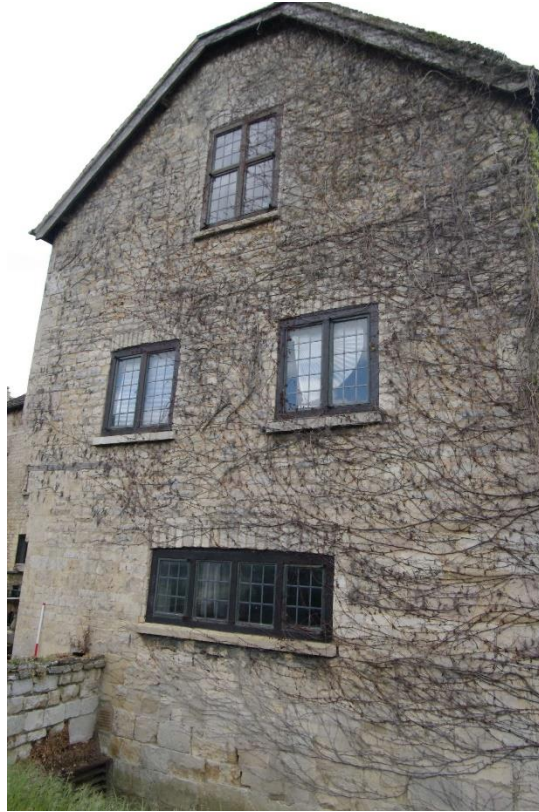
Initial inspection indicates that the north-west facing elevation appears to be composed of four main phases. On the western side, closest to the river, is a projecting gable-ended two-storey plus attic structure with a half-hipped roof (Fig.16). This north-west to south-east aligned range is probably the oldest part of the existing buildings and is sub-rectangular in plan with the north-west facing gable end being angled slightly to allow for an easier flow of water under the mill wheel and past the building (Fig. 17). As such this is likely to be the earliest surviving mill building

Figure 16: Western gable end of NW facing elevation
Looking east. 1m scale

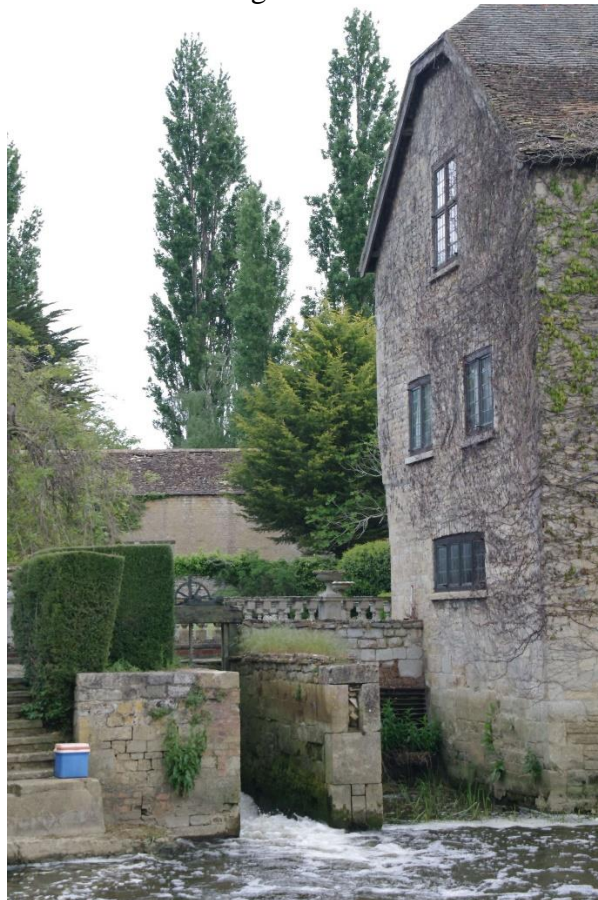
Figure 17: Western gable end of NW facing elevation and bypass sluice
Looking north-east. The external mill wheel was located in front of the metal grille

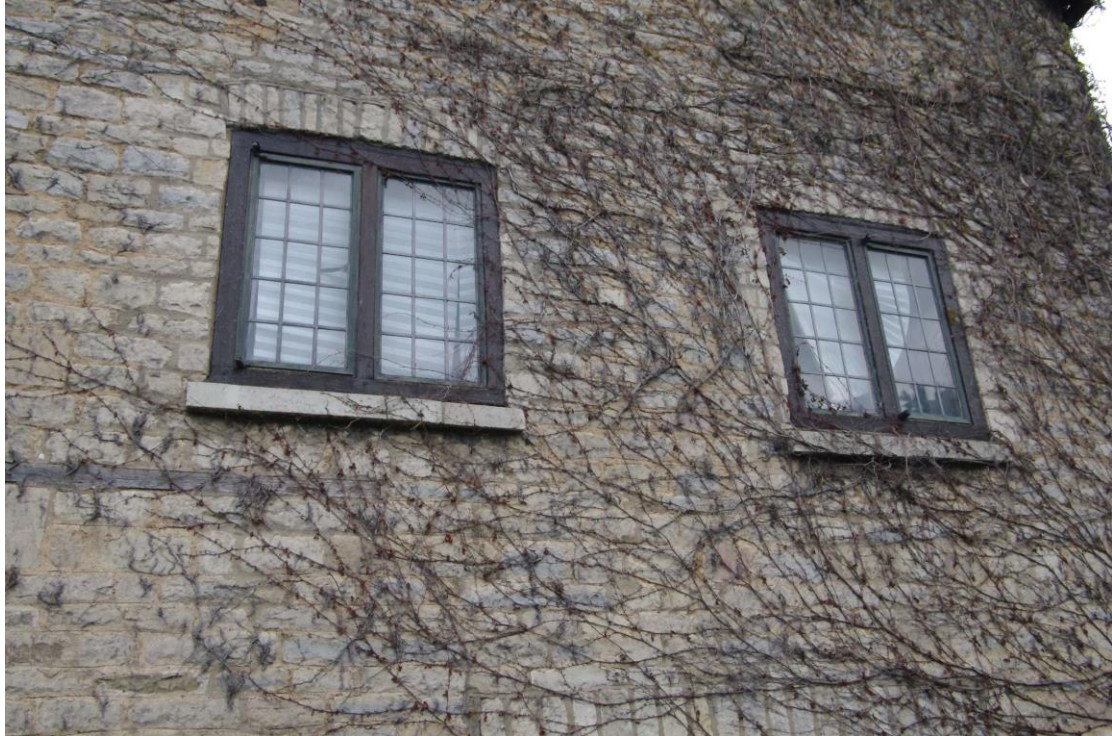
There is no evidence in the stonework of any earlier window openings and none of the window openings appear to show any modification to the surrounding stonework such as infilling (Fig. 18). This suggests that the windows may be new openings or have been enlarged rather than reduced in size. At ground floor level is a wide but low window lighting the ground floor room. This window is probably a 1930s insert as it would have been behind the external water wheel when it was in use (Fig. 19). Approximately 1m below the ground floor window are the roughly carved initials "WB" which may belong to William Brown or perhaps another WB who was repairing the earlier water wheel (Fig. 20). Just to the right of the WB mark are faint circular scored marks caused by the water wheel when in operation. The stonework has been crudely pointed where the shaft entered the building and careful removal of this pointing may reveal the diameter of the shaft. At the approximate point where the shaft would have entered the building is a large block of dressed stone which would be capable of supporting the bearing and the weight of the wheel. Around this block the stones are larger and more irregularly laid which may be evidence of the foundations of an earlier building upon which the present building sits. Alternatively, larger blocks may have been used for structural strength.

Figure 18: First floor windows, western end of the NW facing elevation
Looking south-east

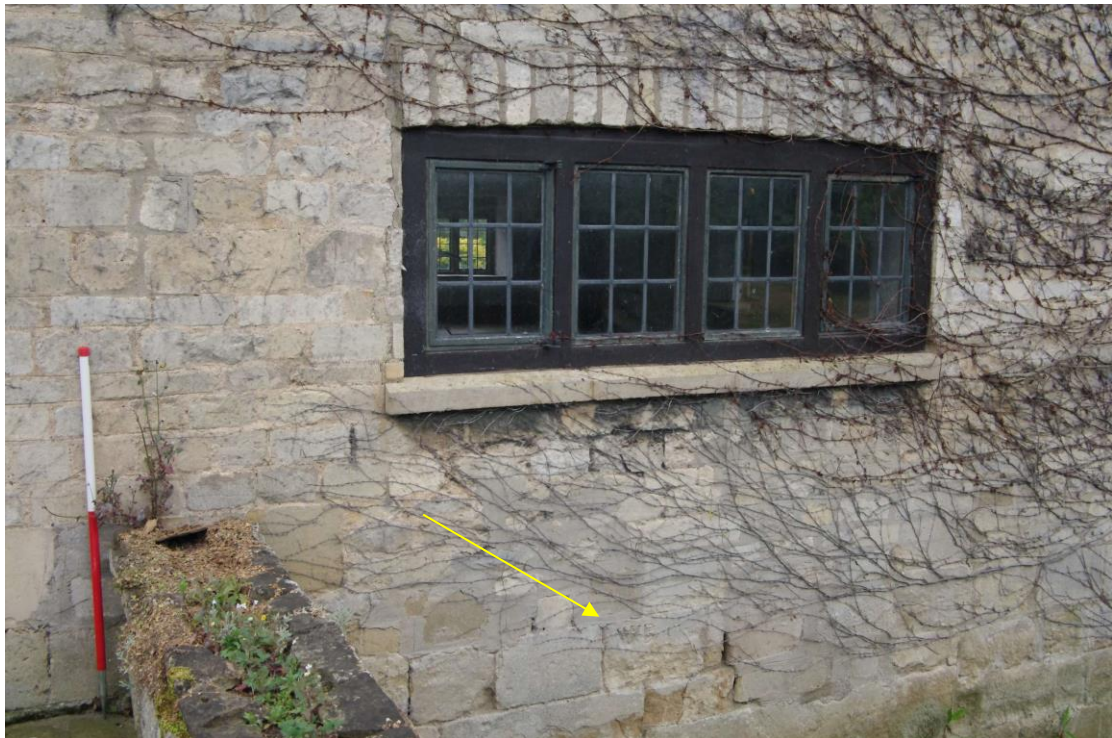
Figure 19: Ground floor window, western end of the NW facing elevation
Looking south. 1m scale. The arrow points to the WB graffiti (see Fig. 20)

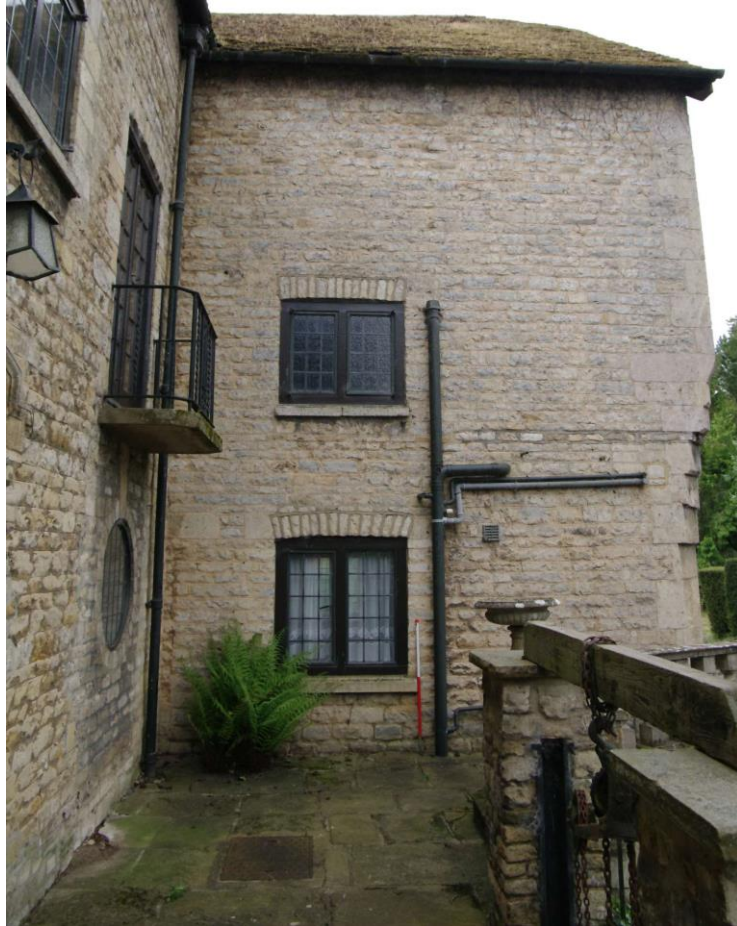
The north-west facing gable end projects out beyond the wall line of the rest of the mill resulting in a small north-east facing elevation belonging to the first mill (Fig. 24). It is easiest to discuss this part of the building in this section. At ground and first floor level this elevation has the same 1930s wooden-framed windows as elsewhere in the building. At ground level a doorway with a limestone lintel has been blocked with stonework and partially obscured by the construction of the second mill building against the north-western wall of the first mill indicating that this may have been built as a single free-standing structure (Fig. 25). No other former openings are visible on this elevation.

Figure 24: North-east facing end of first mill building
Looking south-west. 1m scale. Sluice gate to internal wheel in foreground left

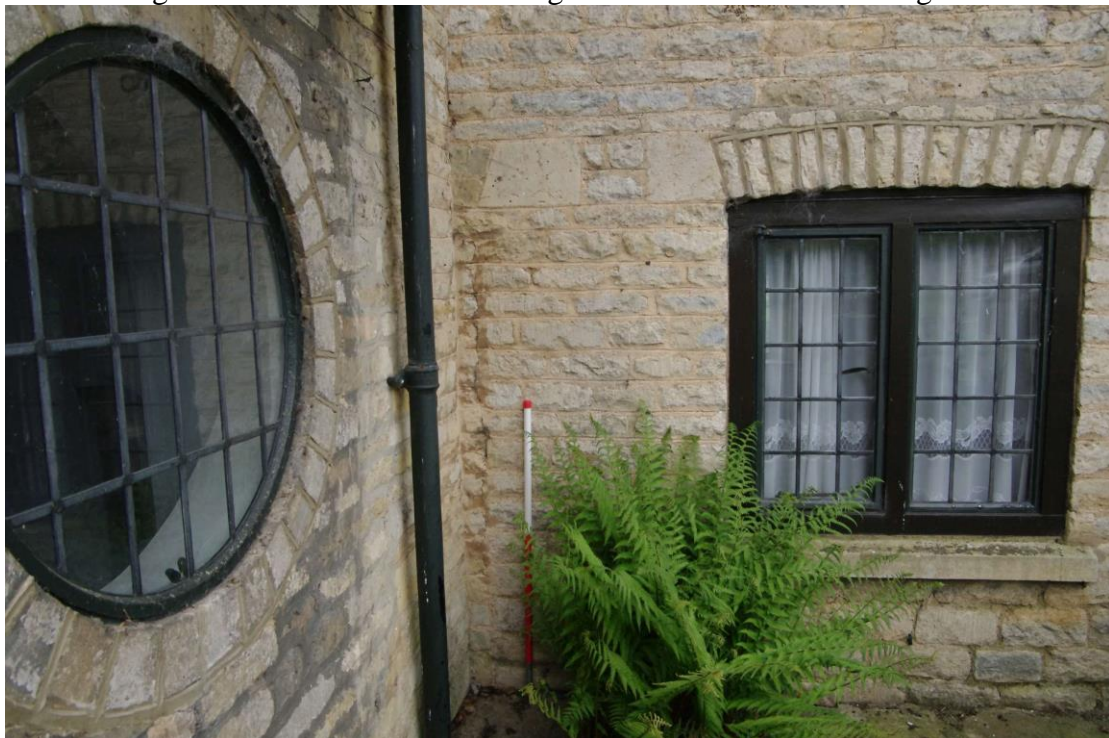
Figure 25: Blocked doorway on NE facing side of the first mill building
Looking south-west. 1m scale. The blocked door and lintel are partially visible in the corner to the left of the scale

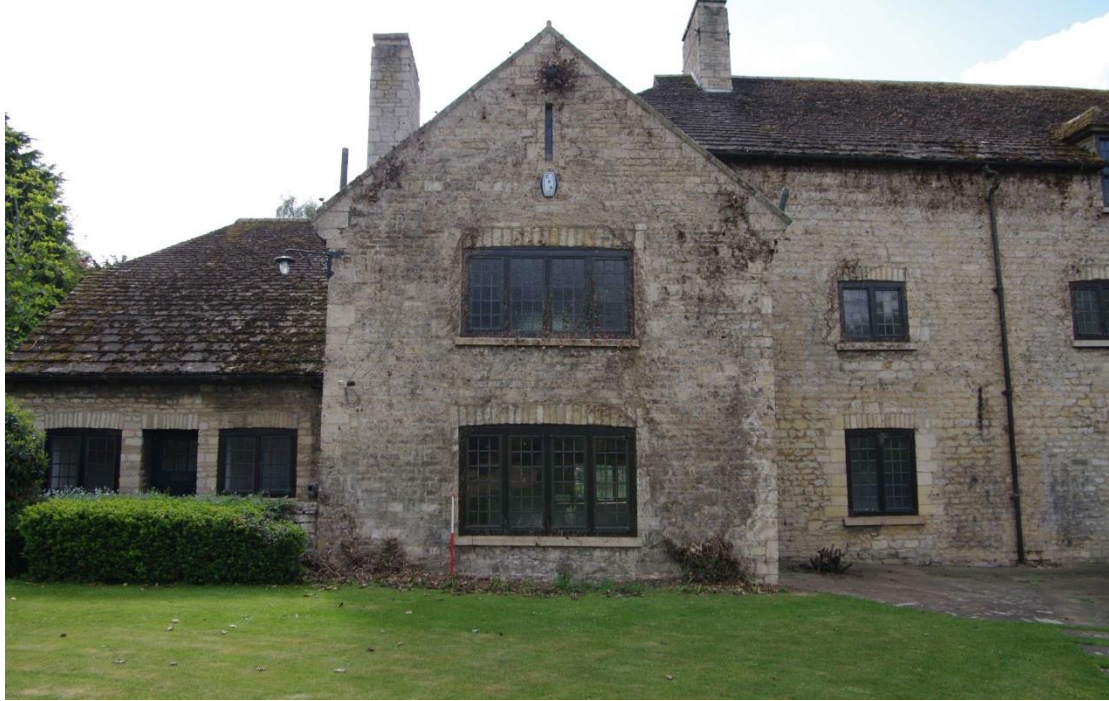
The roofline above the gabled range has been raised to the north side of the ridgeline chimney stack when compared to the early photographs seen in Figures 10 and 11. The

roofline modification appears to have taken place during the 1930s alterations so it is tempting to place the reconstruction of this gable to this time. The pre-1950s Ordnance Survey maps show a range of buildings extending out from this approximate location. It is possible that when these were removed a certain amount of reconstruction work had to be done to create the current gable.

Figure 33: North-west facing elevation, north gable end
Looking south-east. 1m scale

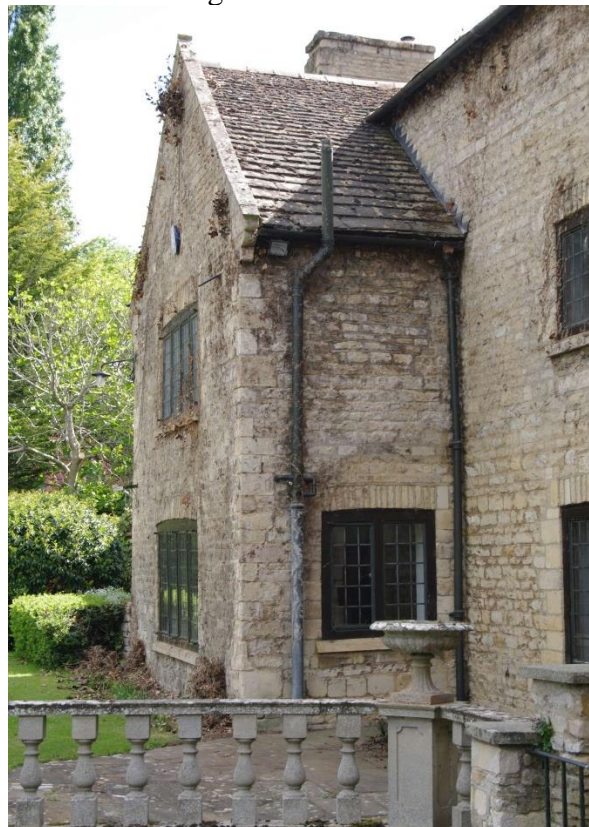
Figure 34: Projecting gable end of north-west facing elevation

Looking east. Note the trace of a structure above the window

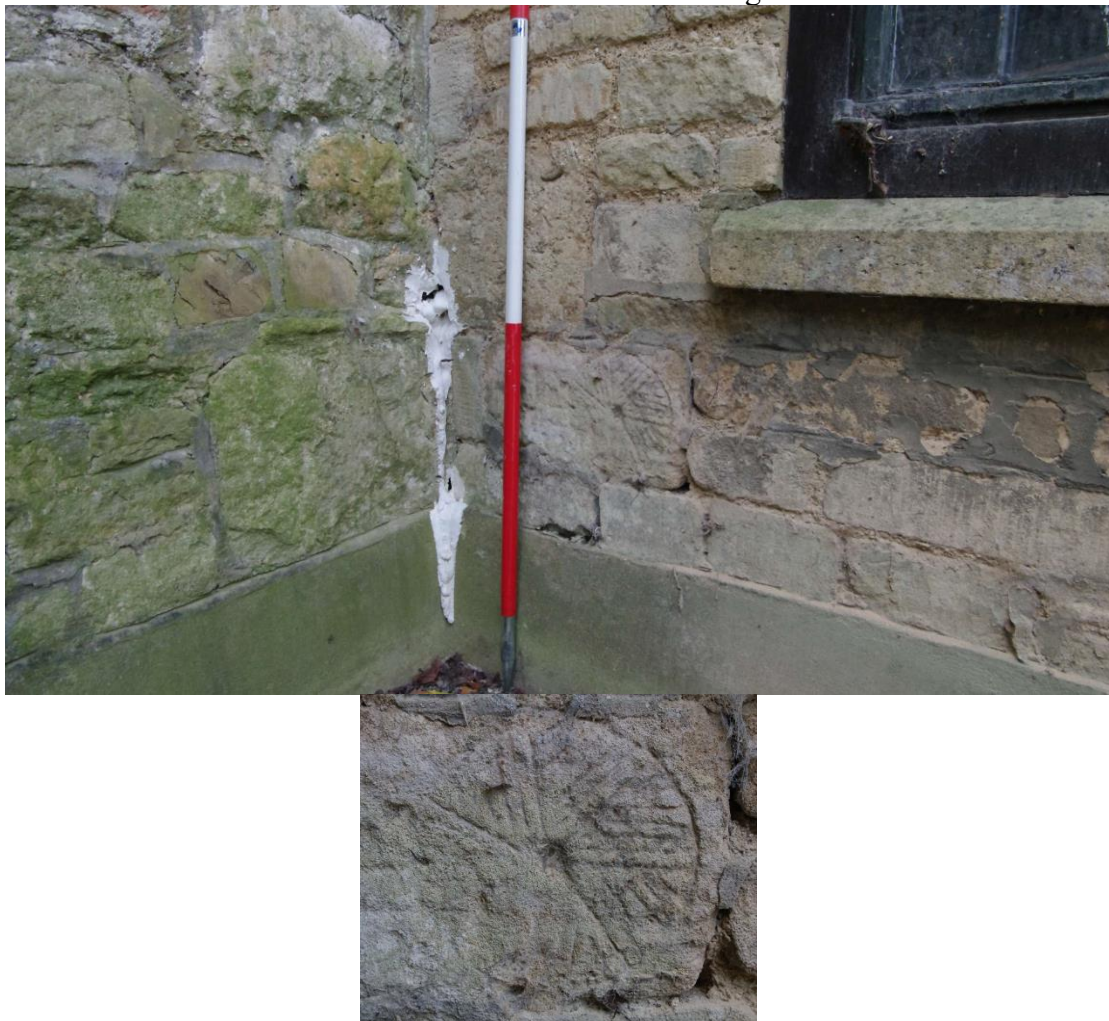
Close to the ground, on the eastern side of the elevation is a carved representation of a segmented mill stone measuring approximately 0.2m in diameter (Fig. 40). This is a relatively accurate depiction of a number of millstones still to be seen around the grounds and appears to have been made by someone who was familiar with such stones.

Figure 40: Carved picture of a mill stone on the north-east facing elevation
Looking south. 1m scale. Lower picture: close up

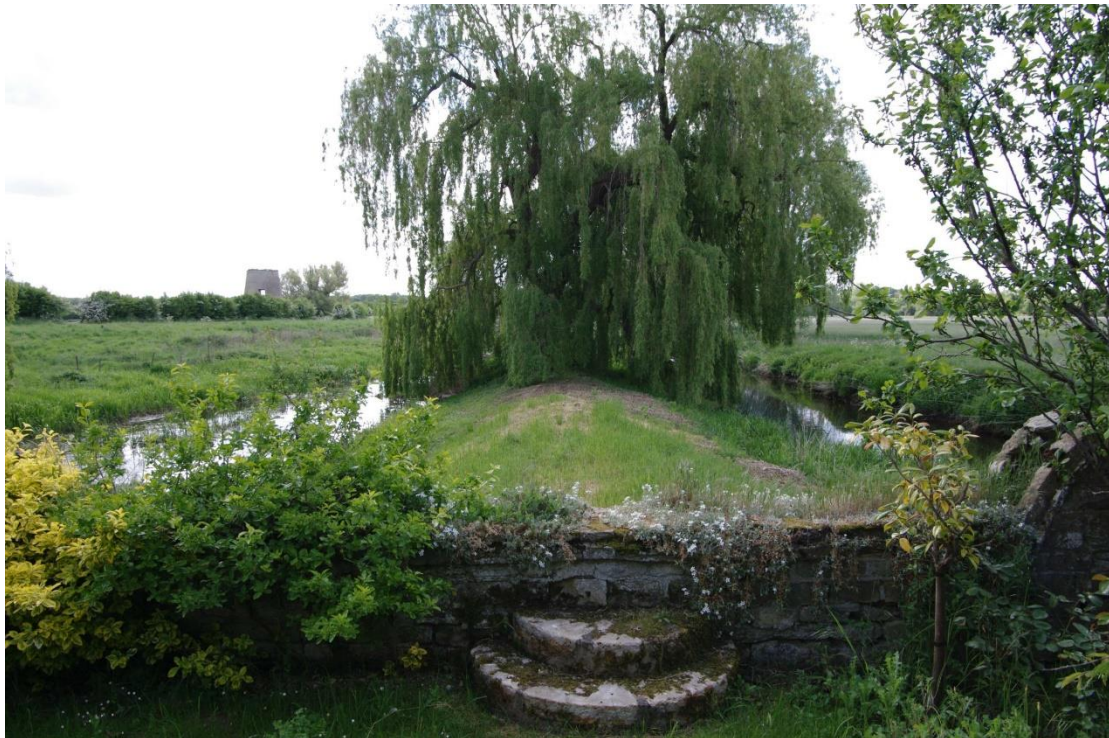
A terrace in front of the elevation is presently laid out as a patio and garden with a concrete balustrade around the water's edge. There is no above ground trace of the buildings to the east shown on the early OS maps although the outline of the balustrade and wall still follow the outline of the small former two-storey building seen in Figure 10. The former building constructed on the spit of land extending to the south-east is still shown by a rectangular footprint of walling and presumably the foundations survive (Fig. 43).

Figure 43: Former wall line of detached building to the south-east of the mill
Looking south-east. The steps are made using mill stone fragments. Former windmill
on horizon to left

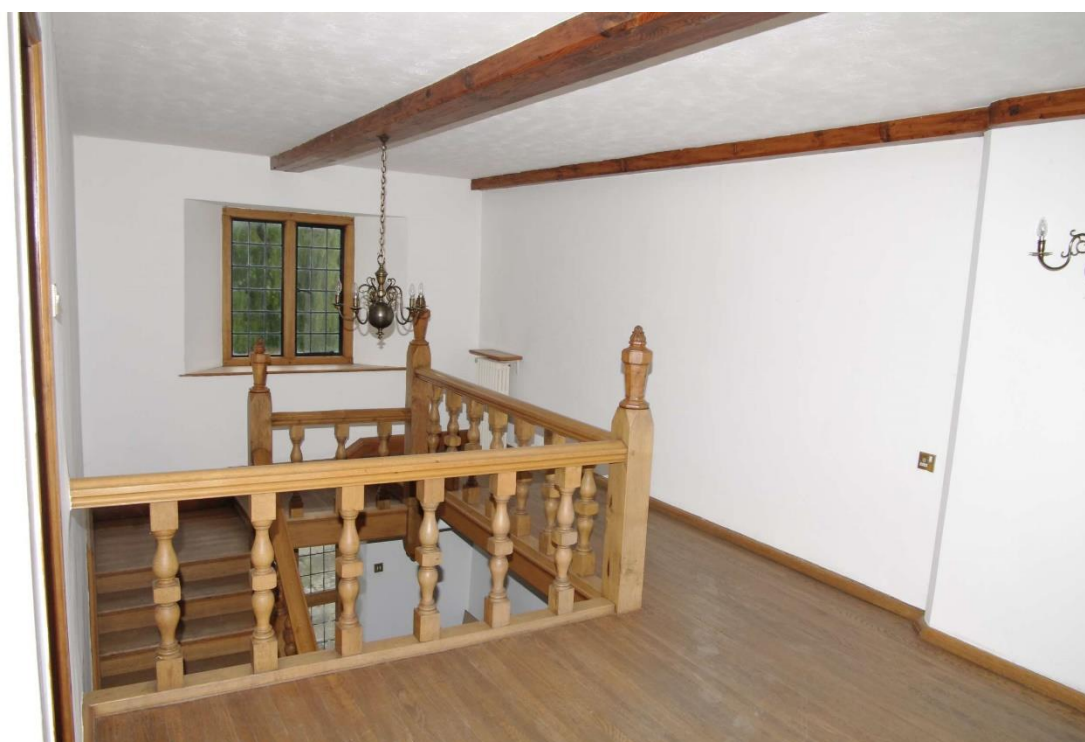
Figure 88: F4 stairwell and landing
Looking south. Note step in wall on left where the inserted chimney stack rises up from the ground floor

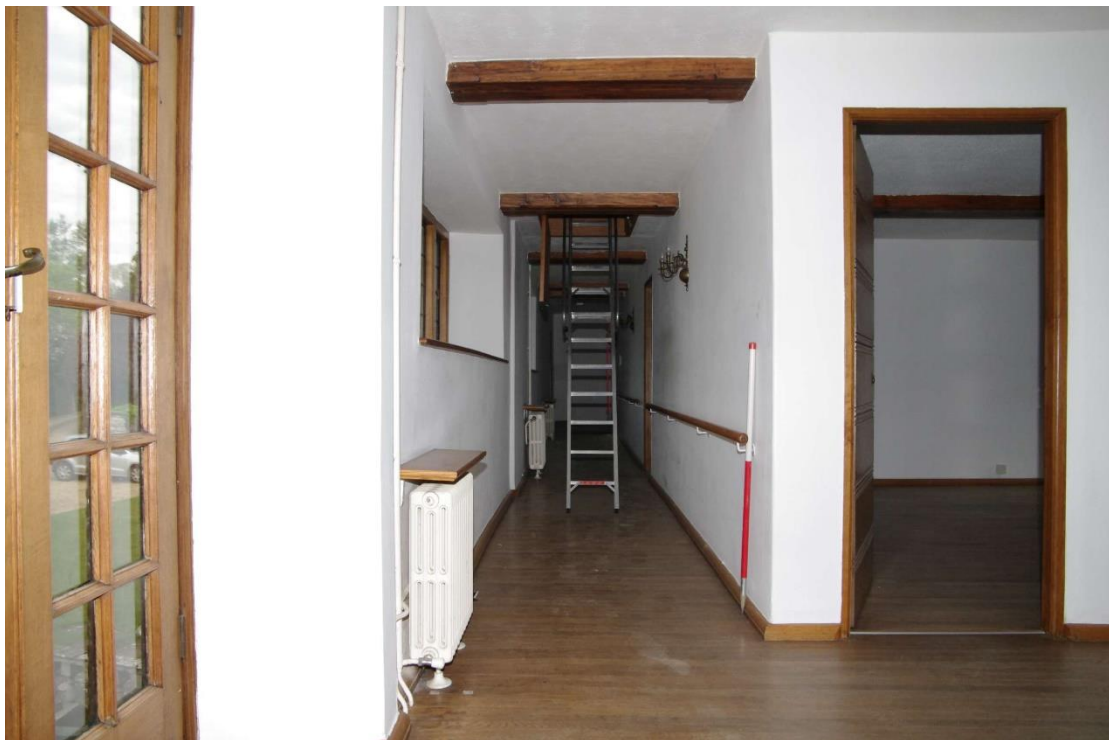
Figure 90: F4 landing and corridor
Looking north-east. 1m scale. The metal steps are the only access to the roof space.
Note the step in wall thickness just beyond the corridor window close to the steps.
Doorway to Room F5 on right of picture. Balcony doors on left

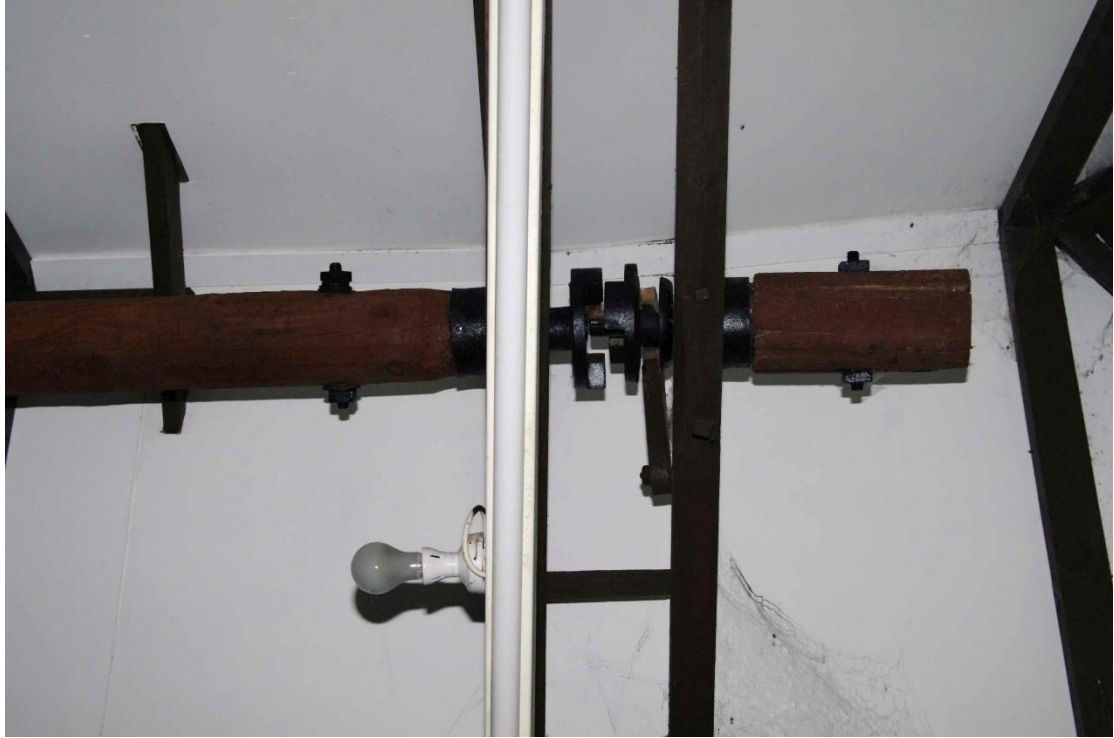
Set into the apex of the roof structure are the remains of the sack hoist which extended out to the dormer projecting from the south-east facing elevation (Fig. 106). Not all of the mechanism has survived and some parts appear to have been crudely altered. Clark notes that the mechanism is of a traditional standard design which incorporates a Fairbairn dog clutch (Fig. 107). The belt wheel is still present and, along with evidence of rope wear on the shaft, shows where the drive belt and ropes would have been located (Fig. 108). It is possible that beneath the modern floor covering the original holes and traps in the floor may still survive although limited opening work has not revealed any evidence. If the original floor survives it may also show where stairs may have been located along with other equipment such as grain bins.

Figure 107: Dog clutch on the sack hoist
Northern end of the mechanism

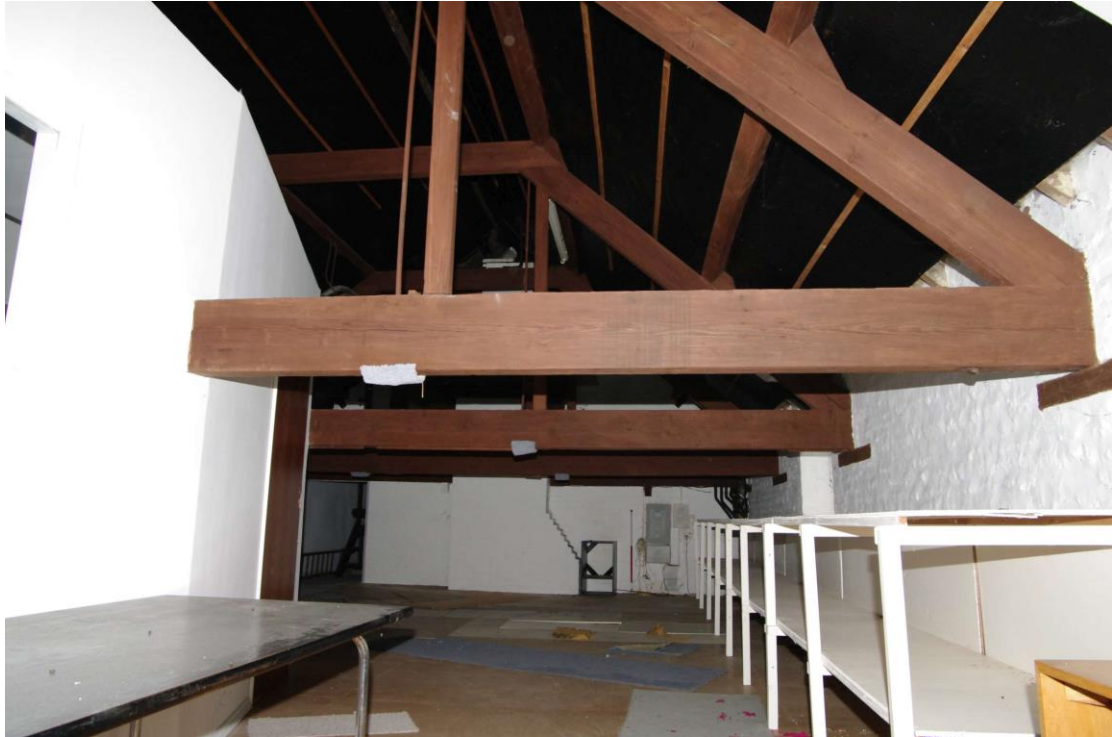
This room forms the roof space of the second mill building and is reached from the temporary steps from corridor F4 below. The floor level is higher than the adjacent floor of R1. A series of trusses run across the length of the space and are low enough to prevent easy use of the area. Bolted queen posts support cleated purlins which in turn support principal rafters which are cut off at the second purlin height (Figs 110 and 111). The underside of the roof has modern felting material suggesting relatively recent repairs.

Figure 110: General view of R2
Looking north-east. 1m scale. The partitions on the left are wooden temporary walls

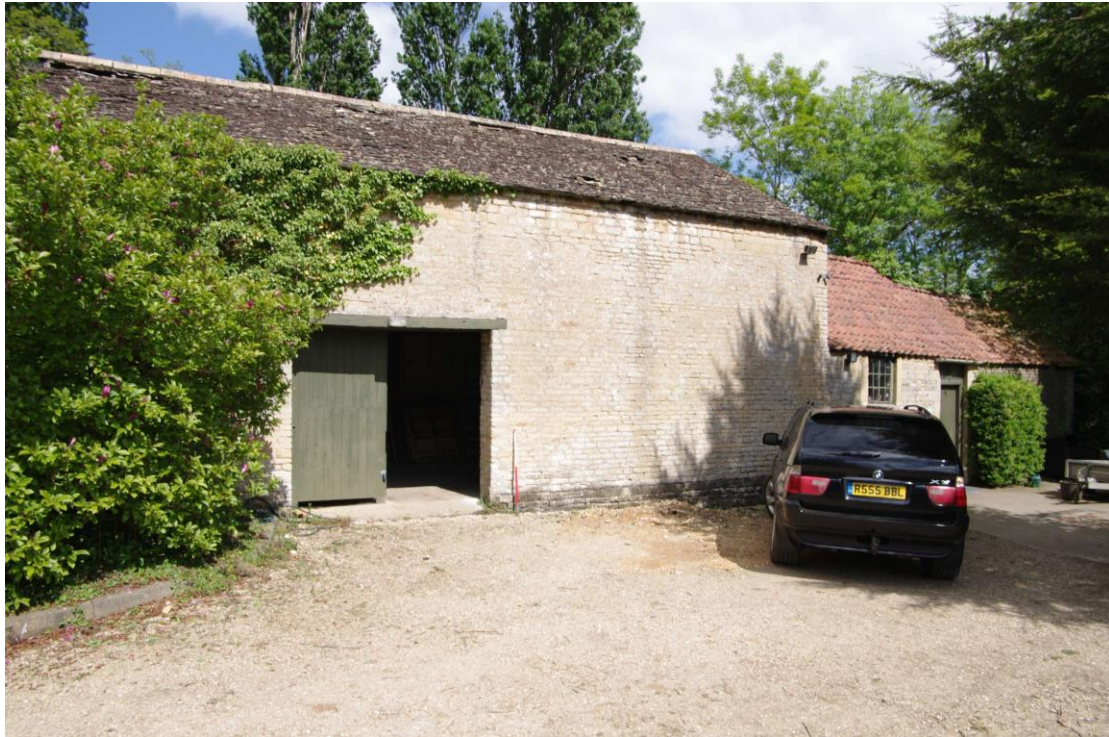
The barn has a set of large double doors in the centre of the south-west facing elevation but no other openings (Fig. 118). The roof is of Collyweston slate but is in a very poor state. The line of the wall between the barn and the single storey outbuilding curves slightly although there is no trace of a joint which suggests that the buildings may be of the same date (Fig. 119). The outbuilding which is next to the barn has a much lower roofline and also has a wooden door and a three over three paned cast iron window (Fig. 120). This is likely to be part of the original structure. To the south-east of the doorway the stone wall changes to modern brown brick where another building is shown as being attached in early OS maps. This, now demolished, building cannot be seen on the early photographs. The stone stub of this wall can be seen at the south-eastern end of the outbuilding (Fig. 121).

Figure 118: Barn, south-west facing elevation
Looking east. 1m scale

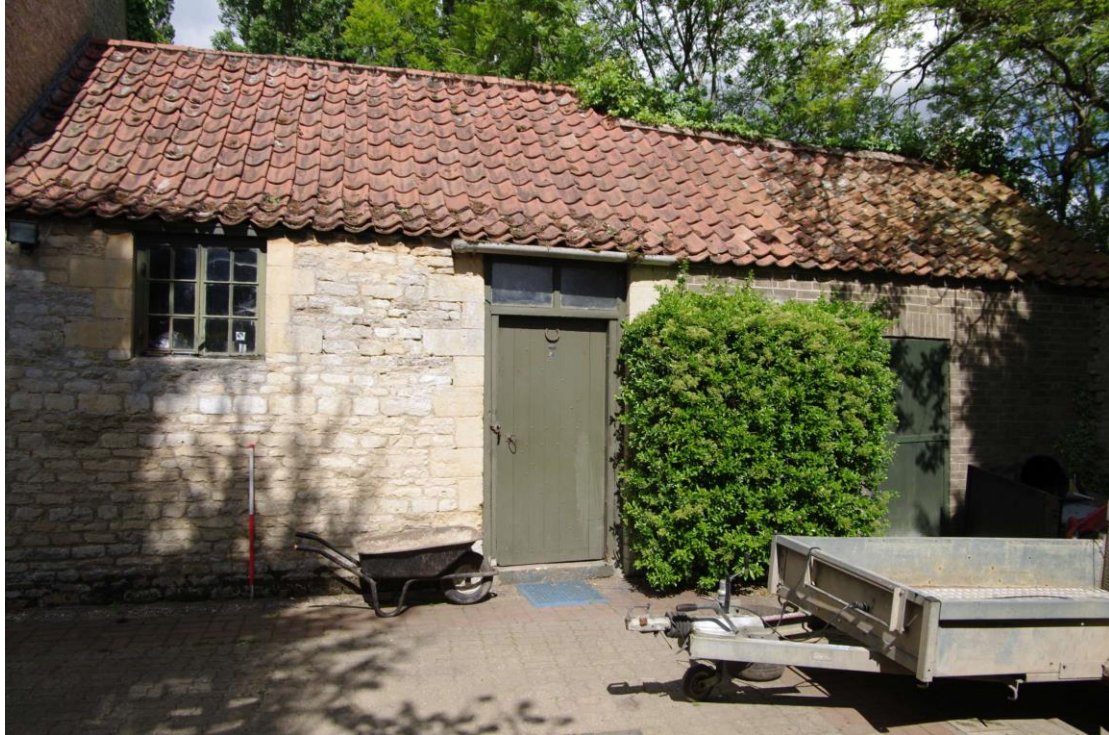
Figure 120: Outbuildings, south-west facing elevation
Looking north-east. 1m scale. Note brickwork on right hand building

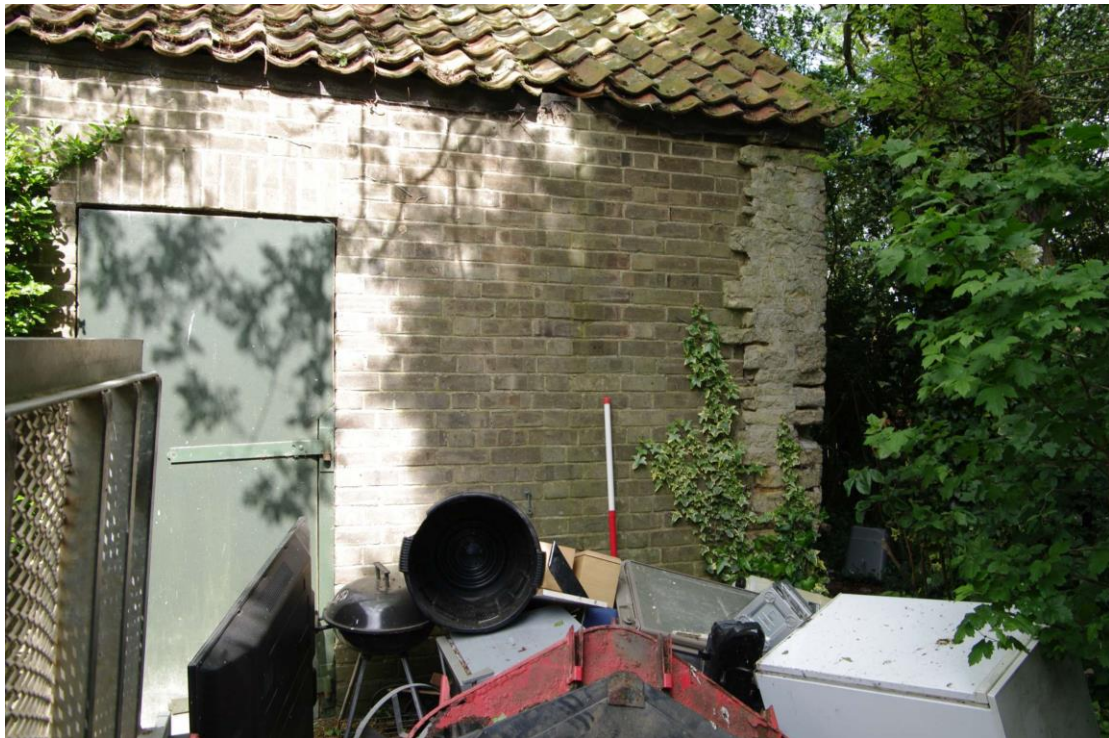
Figure 121: South-eastern outbuilding brick infill on south-west facing elevation
Looking north. 1m scale

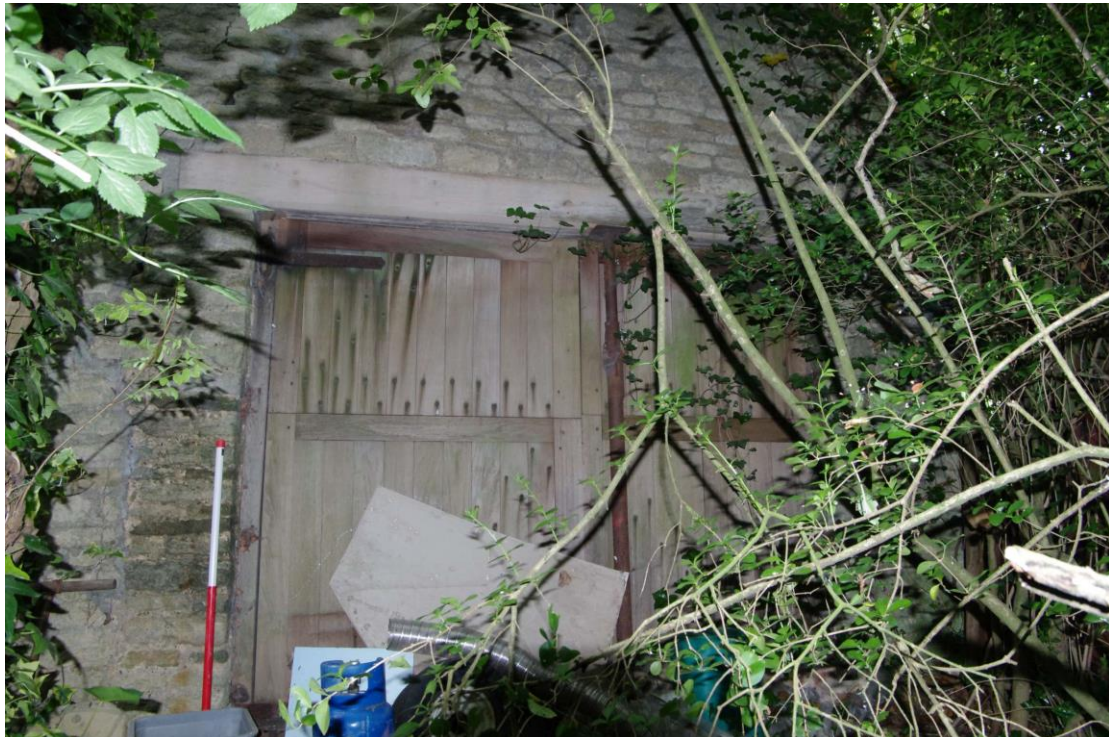
Only the gable end of the lowest outbuilding on the south-east facing elevation is visible (Fig. 122). This is built using coursed stone rubble and has a wide double doorway with a substantial timber beam. The stone and woodwork are in a poor state and are supported by a metal prop.

Figure 122: South-east facing elevation of outbuilding
Looking north-west. 1m scale
