**A level 2 historic building survey at
Hallaton Grange,
5 Churchgate, Hallaton
Leicestershire,
NGR: SP78728 96510**

**ULAS Report No 2020-120
©2020**

Site Name: Hallaton Grange, 5 Churchgate, Hallaton, Leicestershire.
LE16 8TY

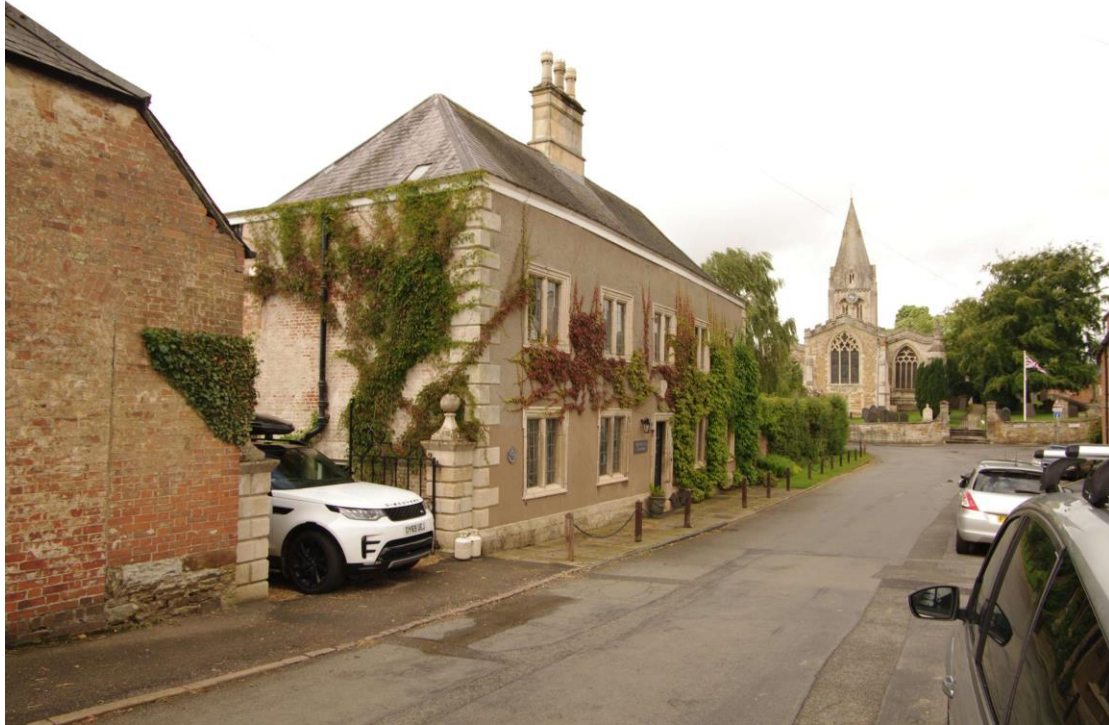
Figure 3 Hallaton Grange seen from Churchgate
Looking west. Gateway into grounds on left. The red brick wall forms the range of outbuildings belonging to the Grange

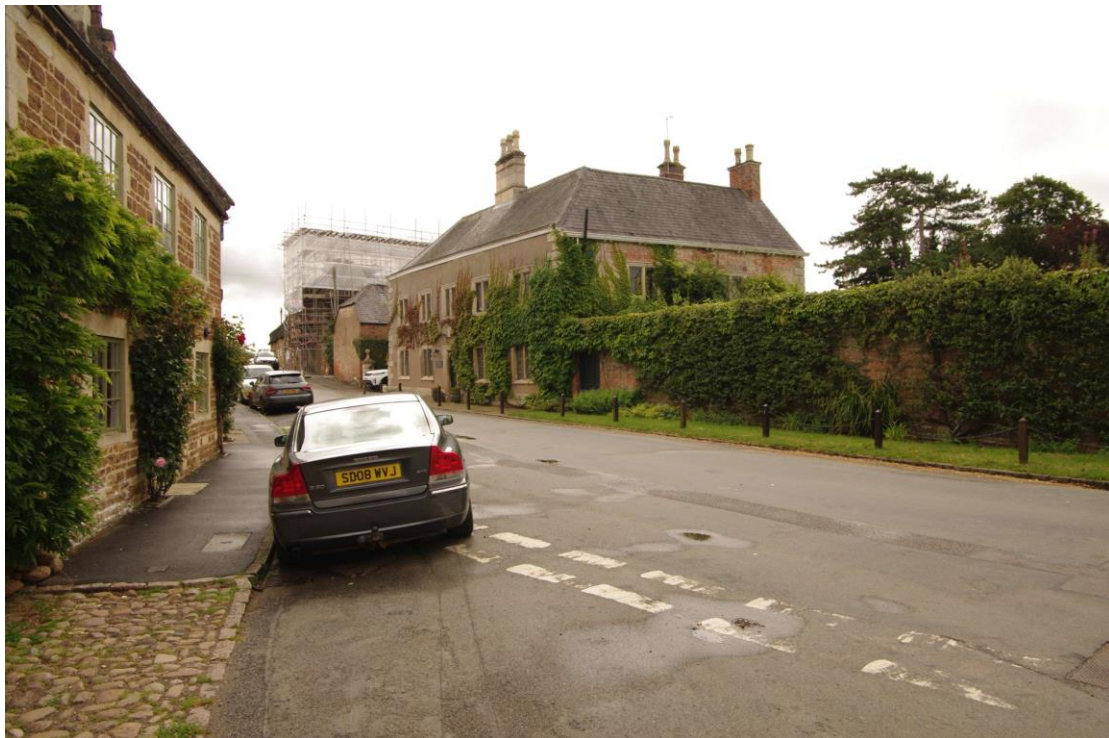
Figure 4 Hallaton Grange from the Churchgate/Hunt's Lane
Looking south-east along Churchgate

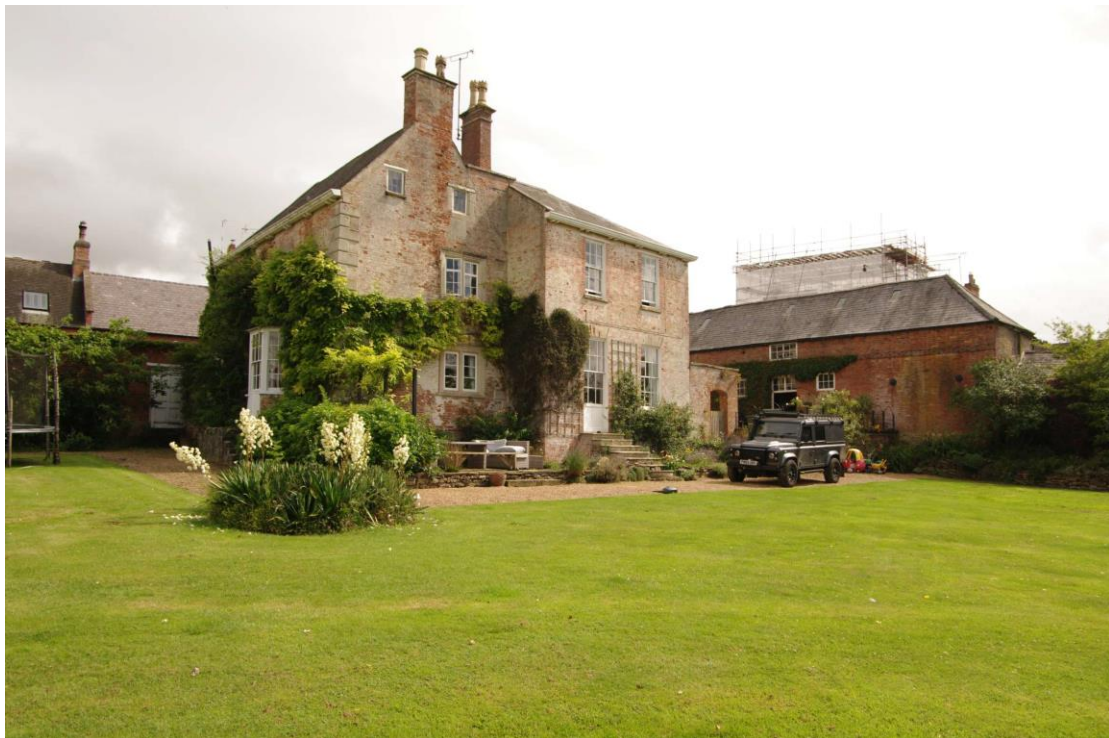
In the 18th century the 1691 range was extended by adding a two-storey extension to the rear by infilling the L-shaped building (Fig. 6). Subsequent internal and external alterations have taken place throughout the life of the building. These changes include alterations to the layout of staircases and insertion of internal walls.

Figure 6 Rear view of Hallaton Grange
Looking north-east. 1691 phase on left, the infilled 18th century addition is in the
centre of the picture

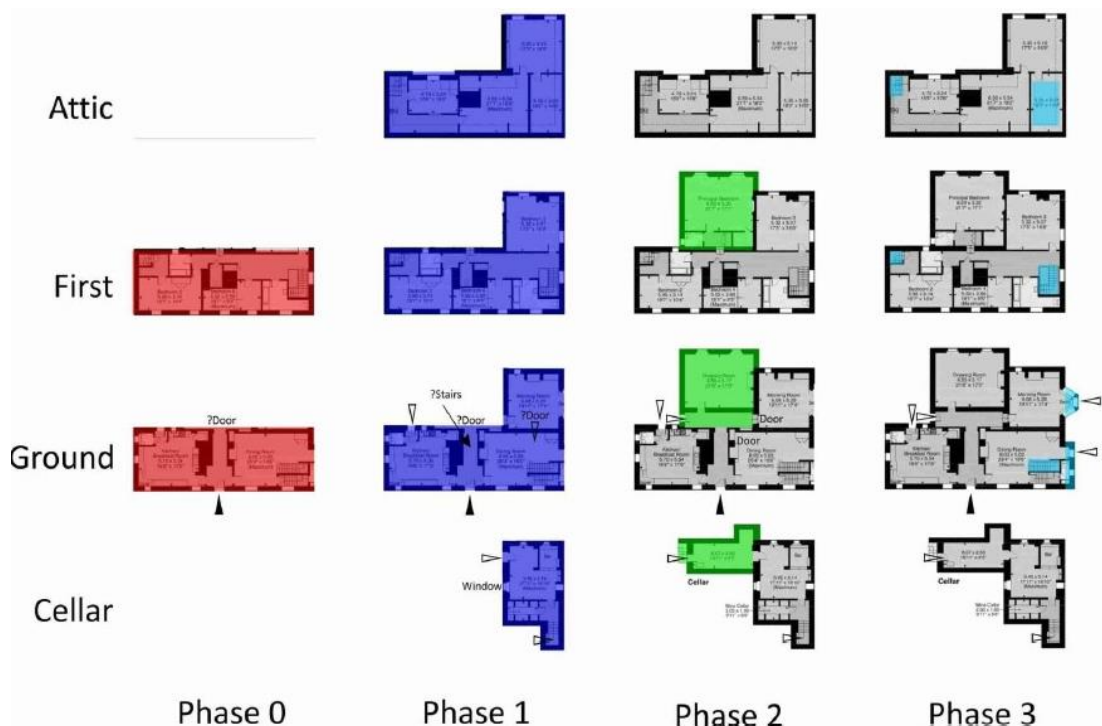
The Heritage Matters report produced a likely phase plan of Hallaton Grange as shown in Figure 7 below. As noted, the report suggests that the main range of the 1691 building may well sit on the footprint of an earlier building. This is quite possible and may mean that traces of this earlier building could be exposed during the proposed programme of works. Although not part of the planned changes a wide central hallway leading from the front door to the rear of the house may be the ghost of the earlier cross-passage. A new toilet was proposed for this location but, following advice from the Conservation Officer, this alteration was removed from the proposals.

The phase plan produced by Hickie also suggests that there may have been a doorway on the west facing elevation where there is currently a small extension proposed for demolition. The door would have led into a hallway where the main stairs are located. At present the extension masks any physical evidence which may support, or disprove, this suggestion. Removal of the extension may expose more historic fabric.

Figure 7 Likely development phases
Source: Heritage Matters Assessment p.56

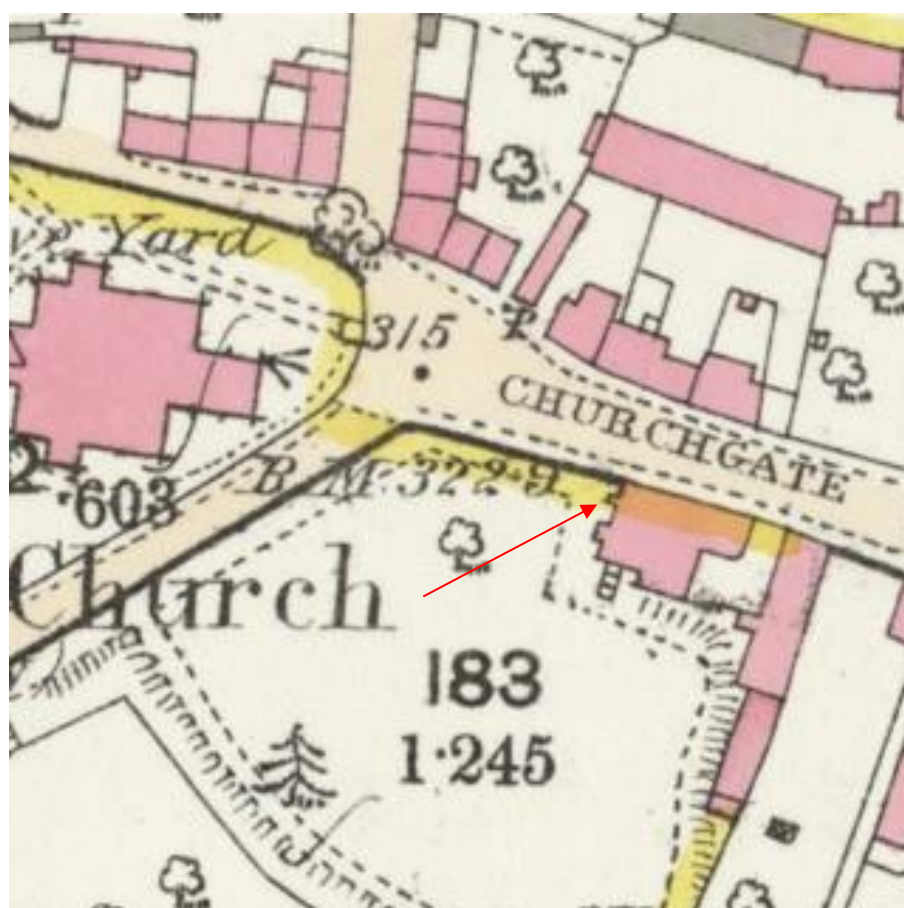
By the time of the First Edition Ordnance Survey map, published in 1886, the buildings to the side of the Grange shown on the 1814 map have gone leaving the Grange on its own as it does to the present day. On the western side of the building two structures can be seen. The first appears to show the steps and bay which are still present (Fig. 8). To the north of this is a small structure which perhaps appears to be slightly smaller than the present extension which is due to be demolished. Subsequent editions of the Ordnance Survey maps show no more useful detail in this area.

Figure 8 Detail from the First Edition 1886 Ordnance Survey map
Note size of extension (arrowed) on NW side of the Grange
Sheet: Leicestershire XXXIX.15 Blaston, Hallaton, Horninghold

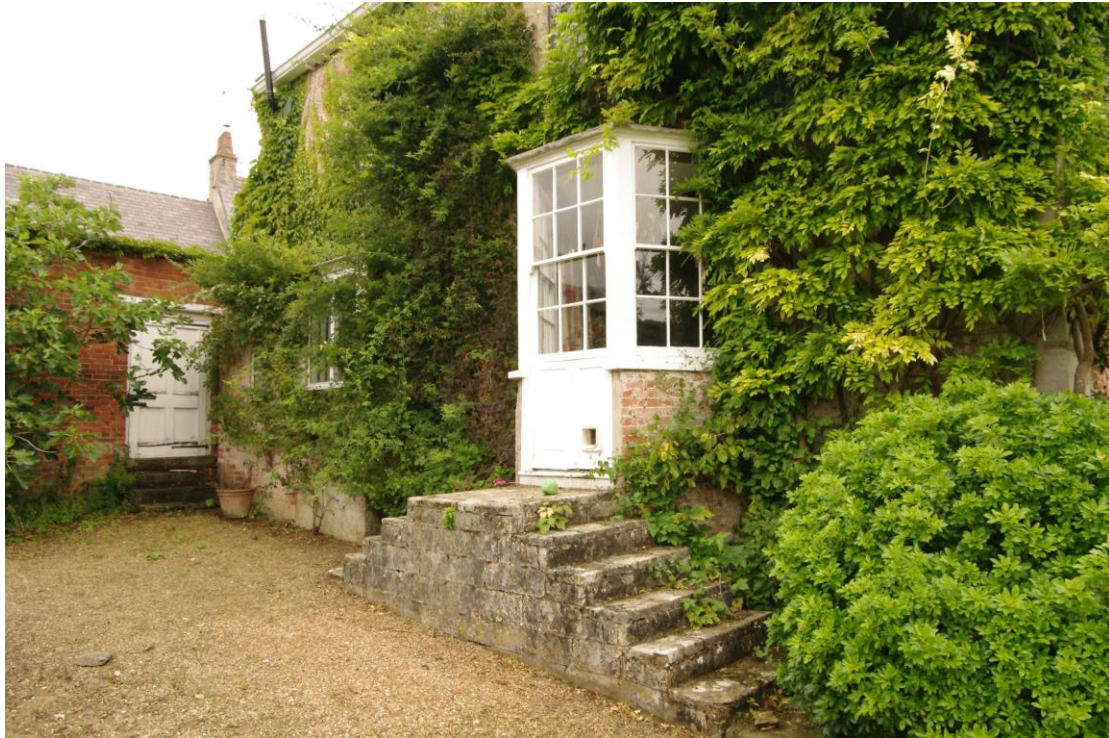
The only alterations proposed which will be visible on the outside is the demolition of the single storey extension on the west facing elevation (Figs 15 to 17). This has a flat roof and appears to use modern hard-fired bricks of probable mid-20th century date. It is significantly longer than that shown on the First Edition OS map suggesting a rebuild or replacement of an earlier structure. The windows are metal Crittal-style frames with leaded lights and concrete lintels (Fig. 18). At ground level there is evidence of a blocked opening which may be access to the cellar, perhaps for a former coal chute (Fig. 19). Much of the extension and the west facing elevation is obscured by vegetation making inspection difficult although there did not appear to be any visible evidence of a former doorway at this point. Removal of the vegetation may expose the wall and removal of the extension would give a better view of the original fabric.

Figure 17 Single storey extension and adjacent steps
Looking north-east.

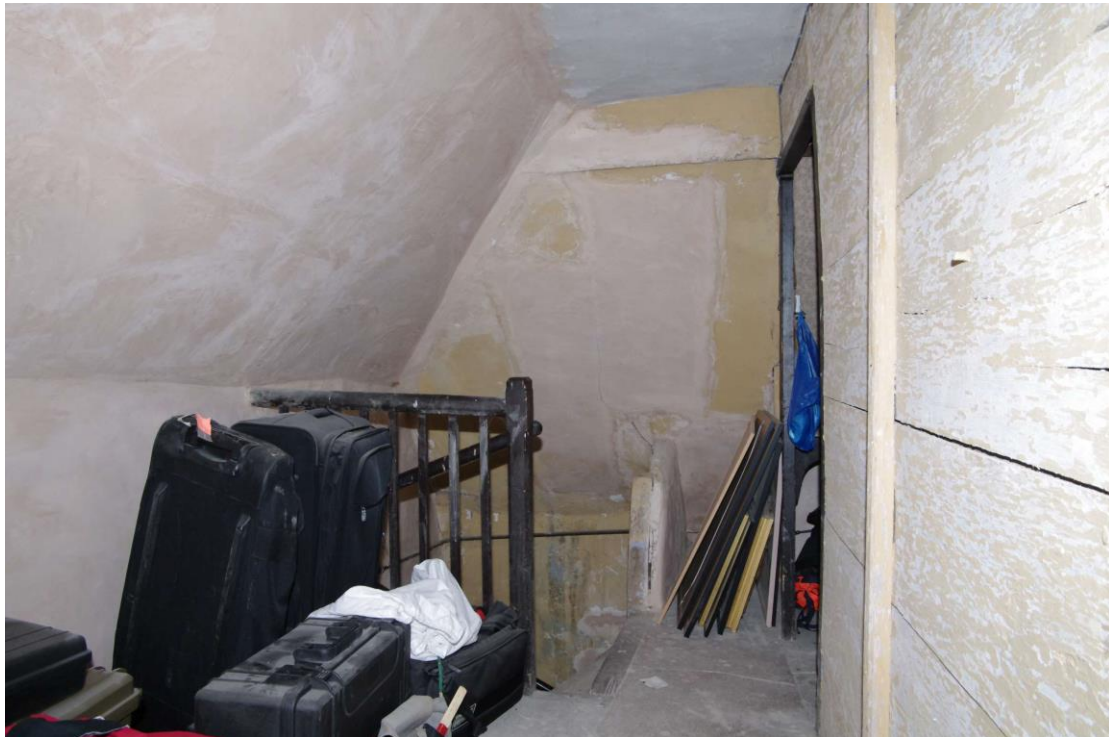
Current access to the second floor is via a narrow set of service stairs in the south-eastern corner of the house. These would have risen all the way from the ground floor kitchen. The stairs lead to a corridor which has a partition wall made from wide horizontal boards (Figs 33, 34 and 35). The wide boards are of variable width and clearly have been cut from substantial logs. They are supported by timber uprights cut from smaller stock and are still partially in the round. The partition wall creates a smaller room with a dormer window which may have been allocated to one of the more senior servants. Inside the room the boards have remnants of wallpaper on them which may be of early to mid-20th century date (Fig. 36). A new doorway will be created on the north wall of the partition which will entail the loss of part of the partition wall but will retain the majority of this wall. The existing door into this room is the original door made from four vertical planks battened together with hand-made metal latch and hinges (Figs. 37 and 38). It has a sliding wooden lock operated from the inside which again suggests that the occupant of this room was one of the higher status servants who

Figure 33 Second floor and top of service stairs
Looking south. Note boarded partition wall on right

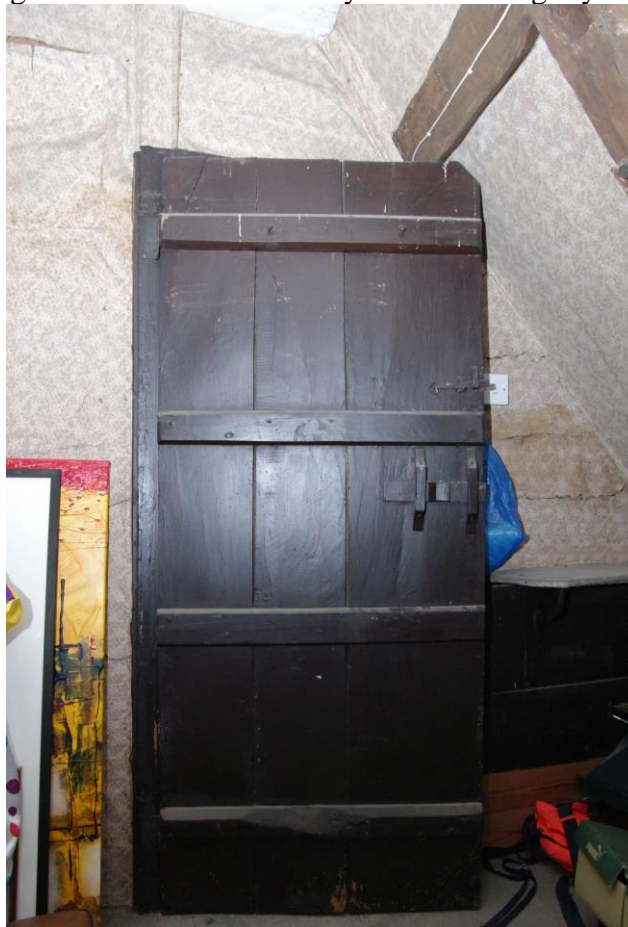
Figure 38 Second floor. Door detail in south-eastern boarded room
Looking east. Note wooden sliding lock

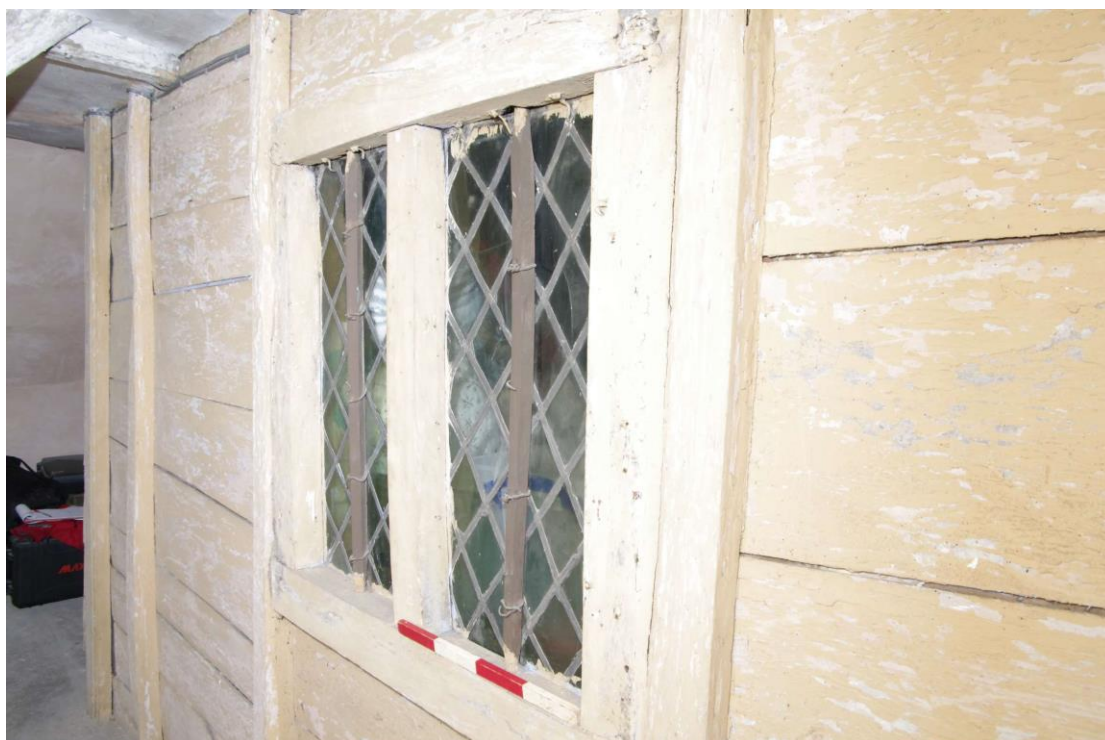
The leaded window on the boarded partition wall allows light into what would otherwise be a very dark low corridor (Fig. 39). To the west of the partition wall the roof space opens out to a large room with wooden floorboards. A new fire escape door will be fitted here which will lead into a new bathroom (Fig. 40). On the western side of the large room is a plastered wall with a small leaded window separating the former staircase (Fig. 41). This wall will have a new doorway inserted to access the proposed new stairs in the north-western corner of the house. The present doorway from this room leads into the rear range room and is the original door and doorway with hand-made metal and wood fittings (Figs 42 and 43). The door is made from three wide planks with uneven shaped edges which are from the outer sawings of a wide tree trunk. Such boards would not be good enough for the owners of the house but would be more than adequate for servants. The proposals are to block this doorway to prevent direct access from the two rooms. Access will then be via the landing area.

Figure 39 Leaded window in partition wall
Looking south-east. 0.4m scale

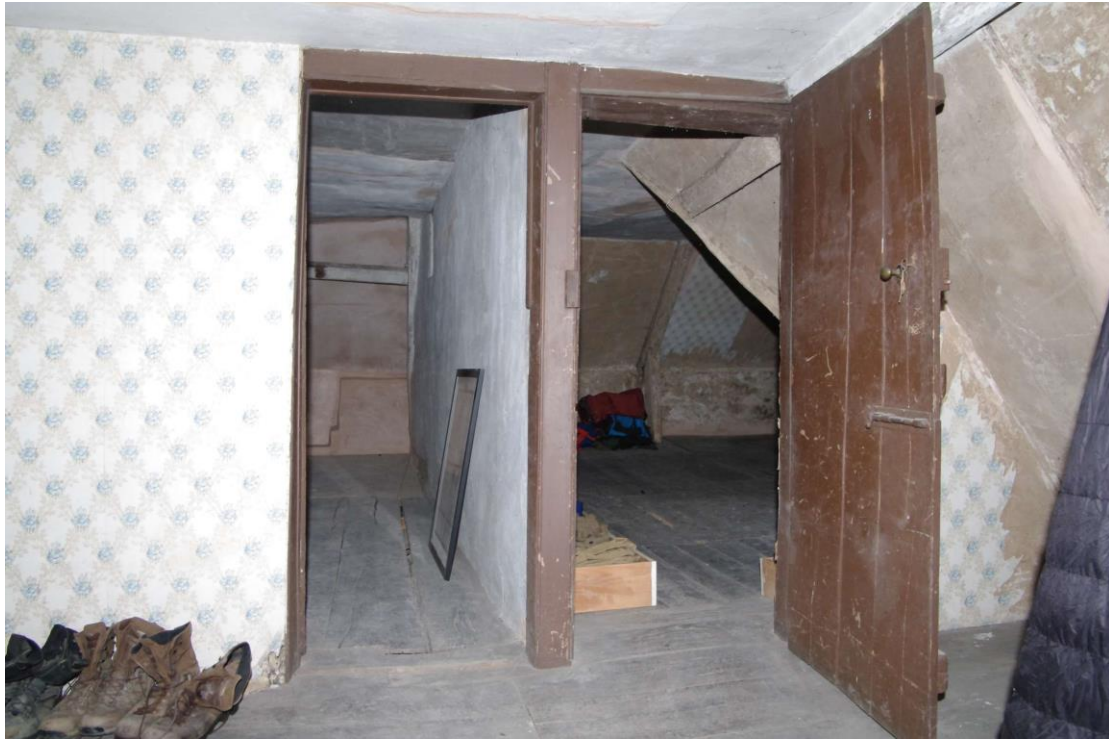
Figure 43 Second floor. Landing to former stairs
Looking north from rear bedroom. Former landing on left. Middle room on right. The door on the right is that shown in Figure 42

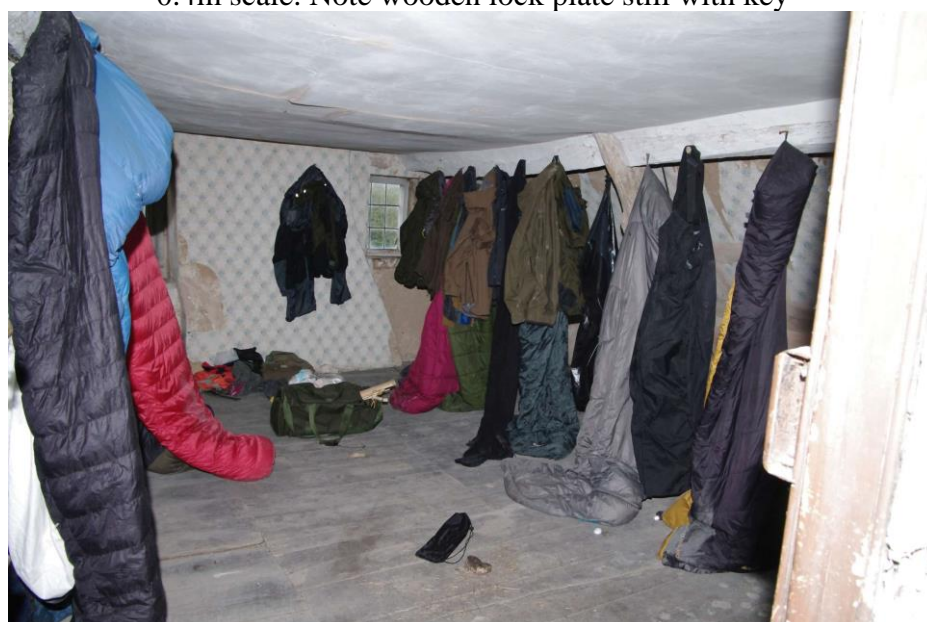
Figure 46 Rear second floor room
Looking south-west from doorway
