**An Archaeological Standing Building Survey and
Trial Trench Evaluation of the Former King William IV
Public House, Barsby, Leicestershire.**

Planning Application: 05/01833/6

For: Darian Homes

University of Leicester

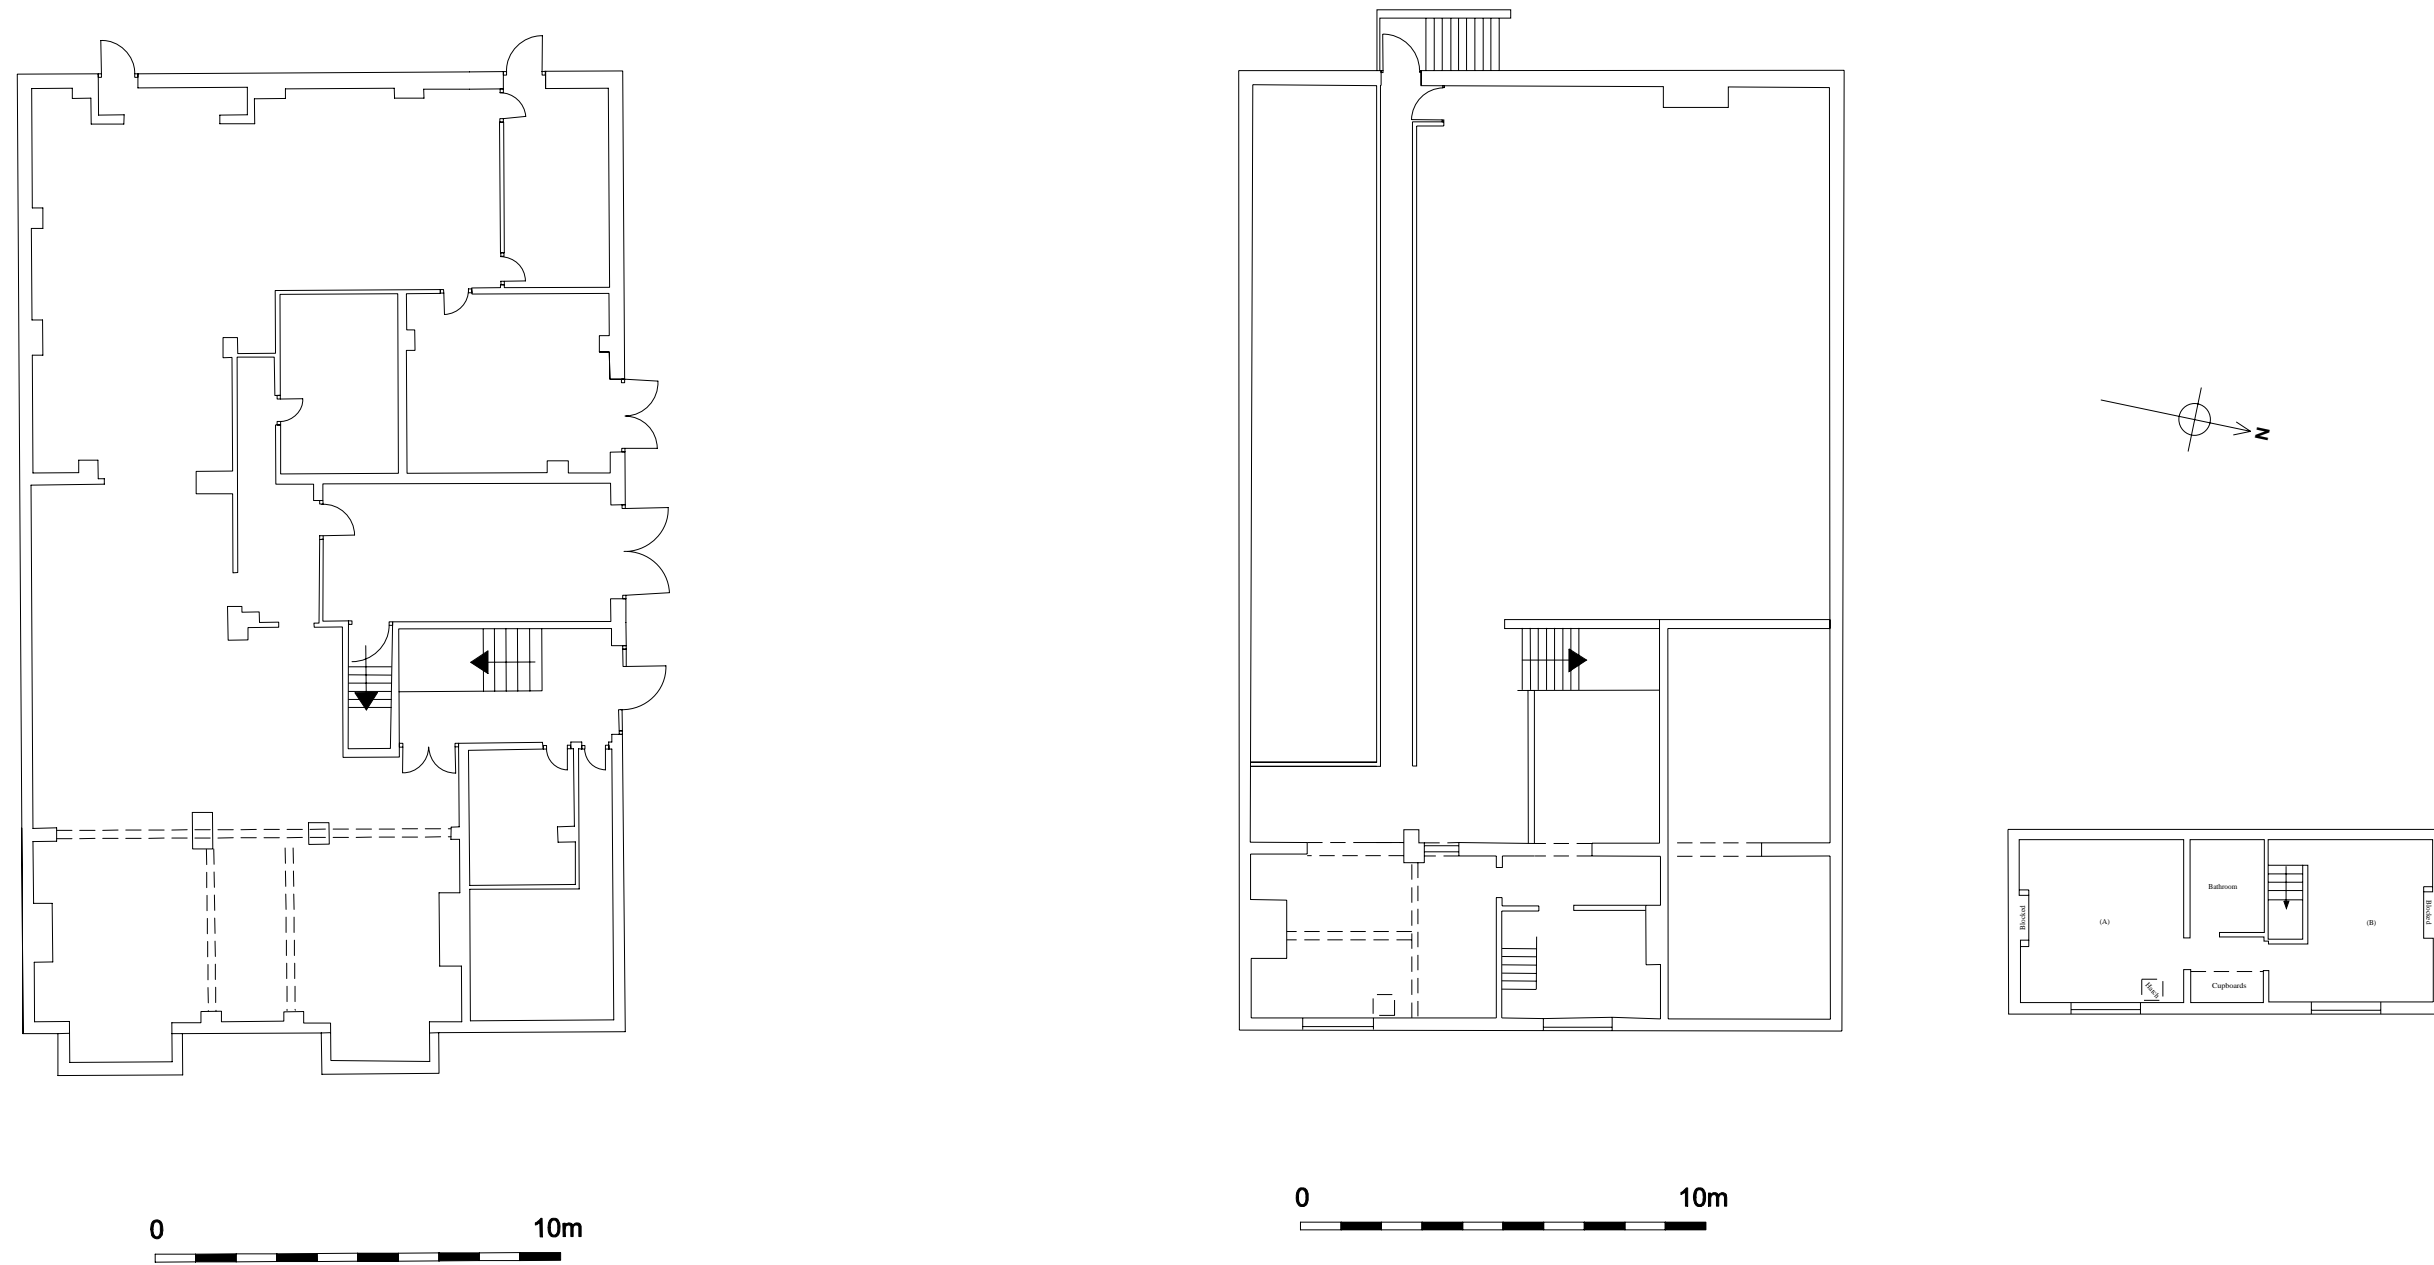
Figure 2 Building Plans (Left to Right) Ground Floor, First Floor & Second Floor.

Internally there is very little of architectural or historical interest surviving. The ground floor of (A) has suffered extensive fire damage and has subsequently been stripped of all fixtures and fittings. There are two gable fireplaces, apparently of modern brick; the original line of the back wall can be seen as a stub projecting from the left hand wall

and damaged plaster work here revealed Fletton bricks beneath. These bricks indicate a twentieth century date. The collapsed ceiling panels also revealed modern timbers. This along with the Fletton bricks suggests extensive structural work, if not rebuilding was carried out in the later part of the twentieth century.

The rear of the building (B) is of very limited interest, both architecturally and historically. As with (A), the ground floor has suffered considerable fire damage and is now devoid of any fixtures and fittings. The walls are breeze blocks, there is a concrete floor and all timbers are new. The left hand part of the wing is an open plan area accessed via an arched entrance through what was originally the rear wall of (A). The right hand part has been extensively subdivided into storage and service areas.

The first floor level is again only of limited interest, the left hand part having been subdivided into a number of small rooms off a central corridor, probably bedrooms for non-residential use. The right-hand side is a large open area, complete with dance floor, fake fireplace and exposed modern roof timbers, no doubt to create a rustic country pub feeling. The forward most rooms on the right-hand side of (B) are service rooms and a kitchen.
